CLIENT:
CITY OF WINNIPEG

PROJECT:
LOT 16 BANK STABILIZATION

DWG DESCRIPTION:
SITE PLAN, TEST HOLE LOCATION PLAN AND PHOTOGRAPHS 1 AND 2

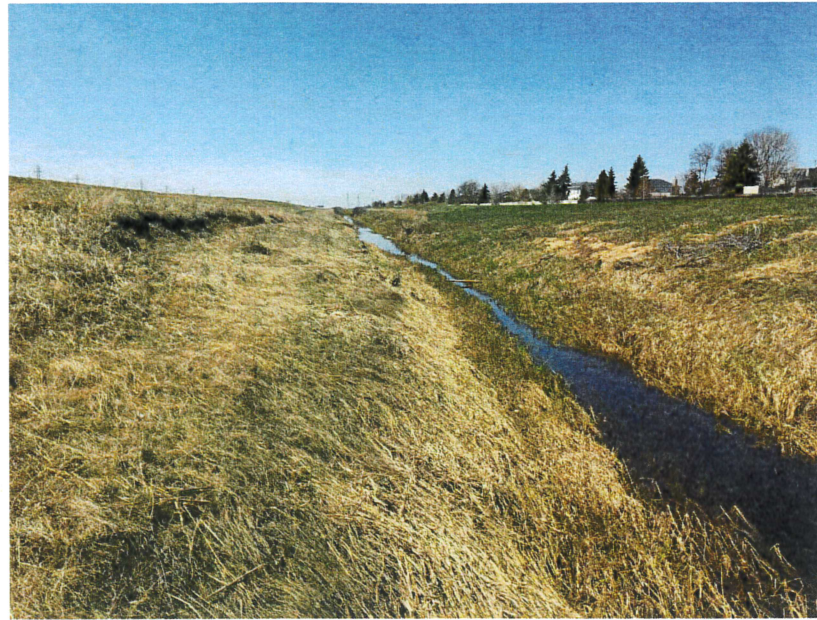
PHOTOGRAPH 1: FACING SOUTH WEST SHOWING SEVERE BANK FAILURE

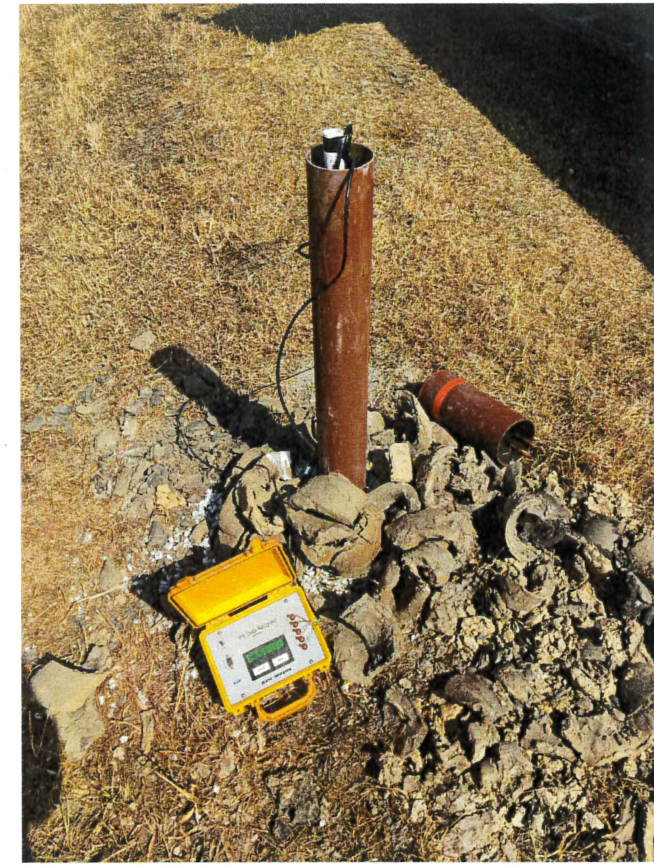
PHOTOGRAPH 2: VW PIEZOMETER IS TO BE PRESERVED
