# PHASE I ENVIRONMENTAL SITE ASSESSMENT

## NORTH GARAGE OAK POINT HIGHWAY, WINNIPEG, MB

PHASE I  
ENVIRONMENTAL  
SITE ASSESSMENT  
NORTH GARAGE OAK  
POINT HIGHWAY,  
WINNIPEG, MB  
CITY OF WINNIPEG

PROJECT NO.: 221-07203-00  
DATE: JANUARY 24, 2023

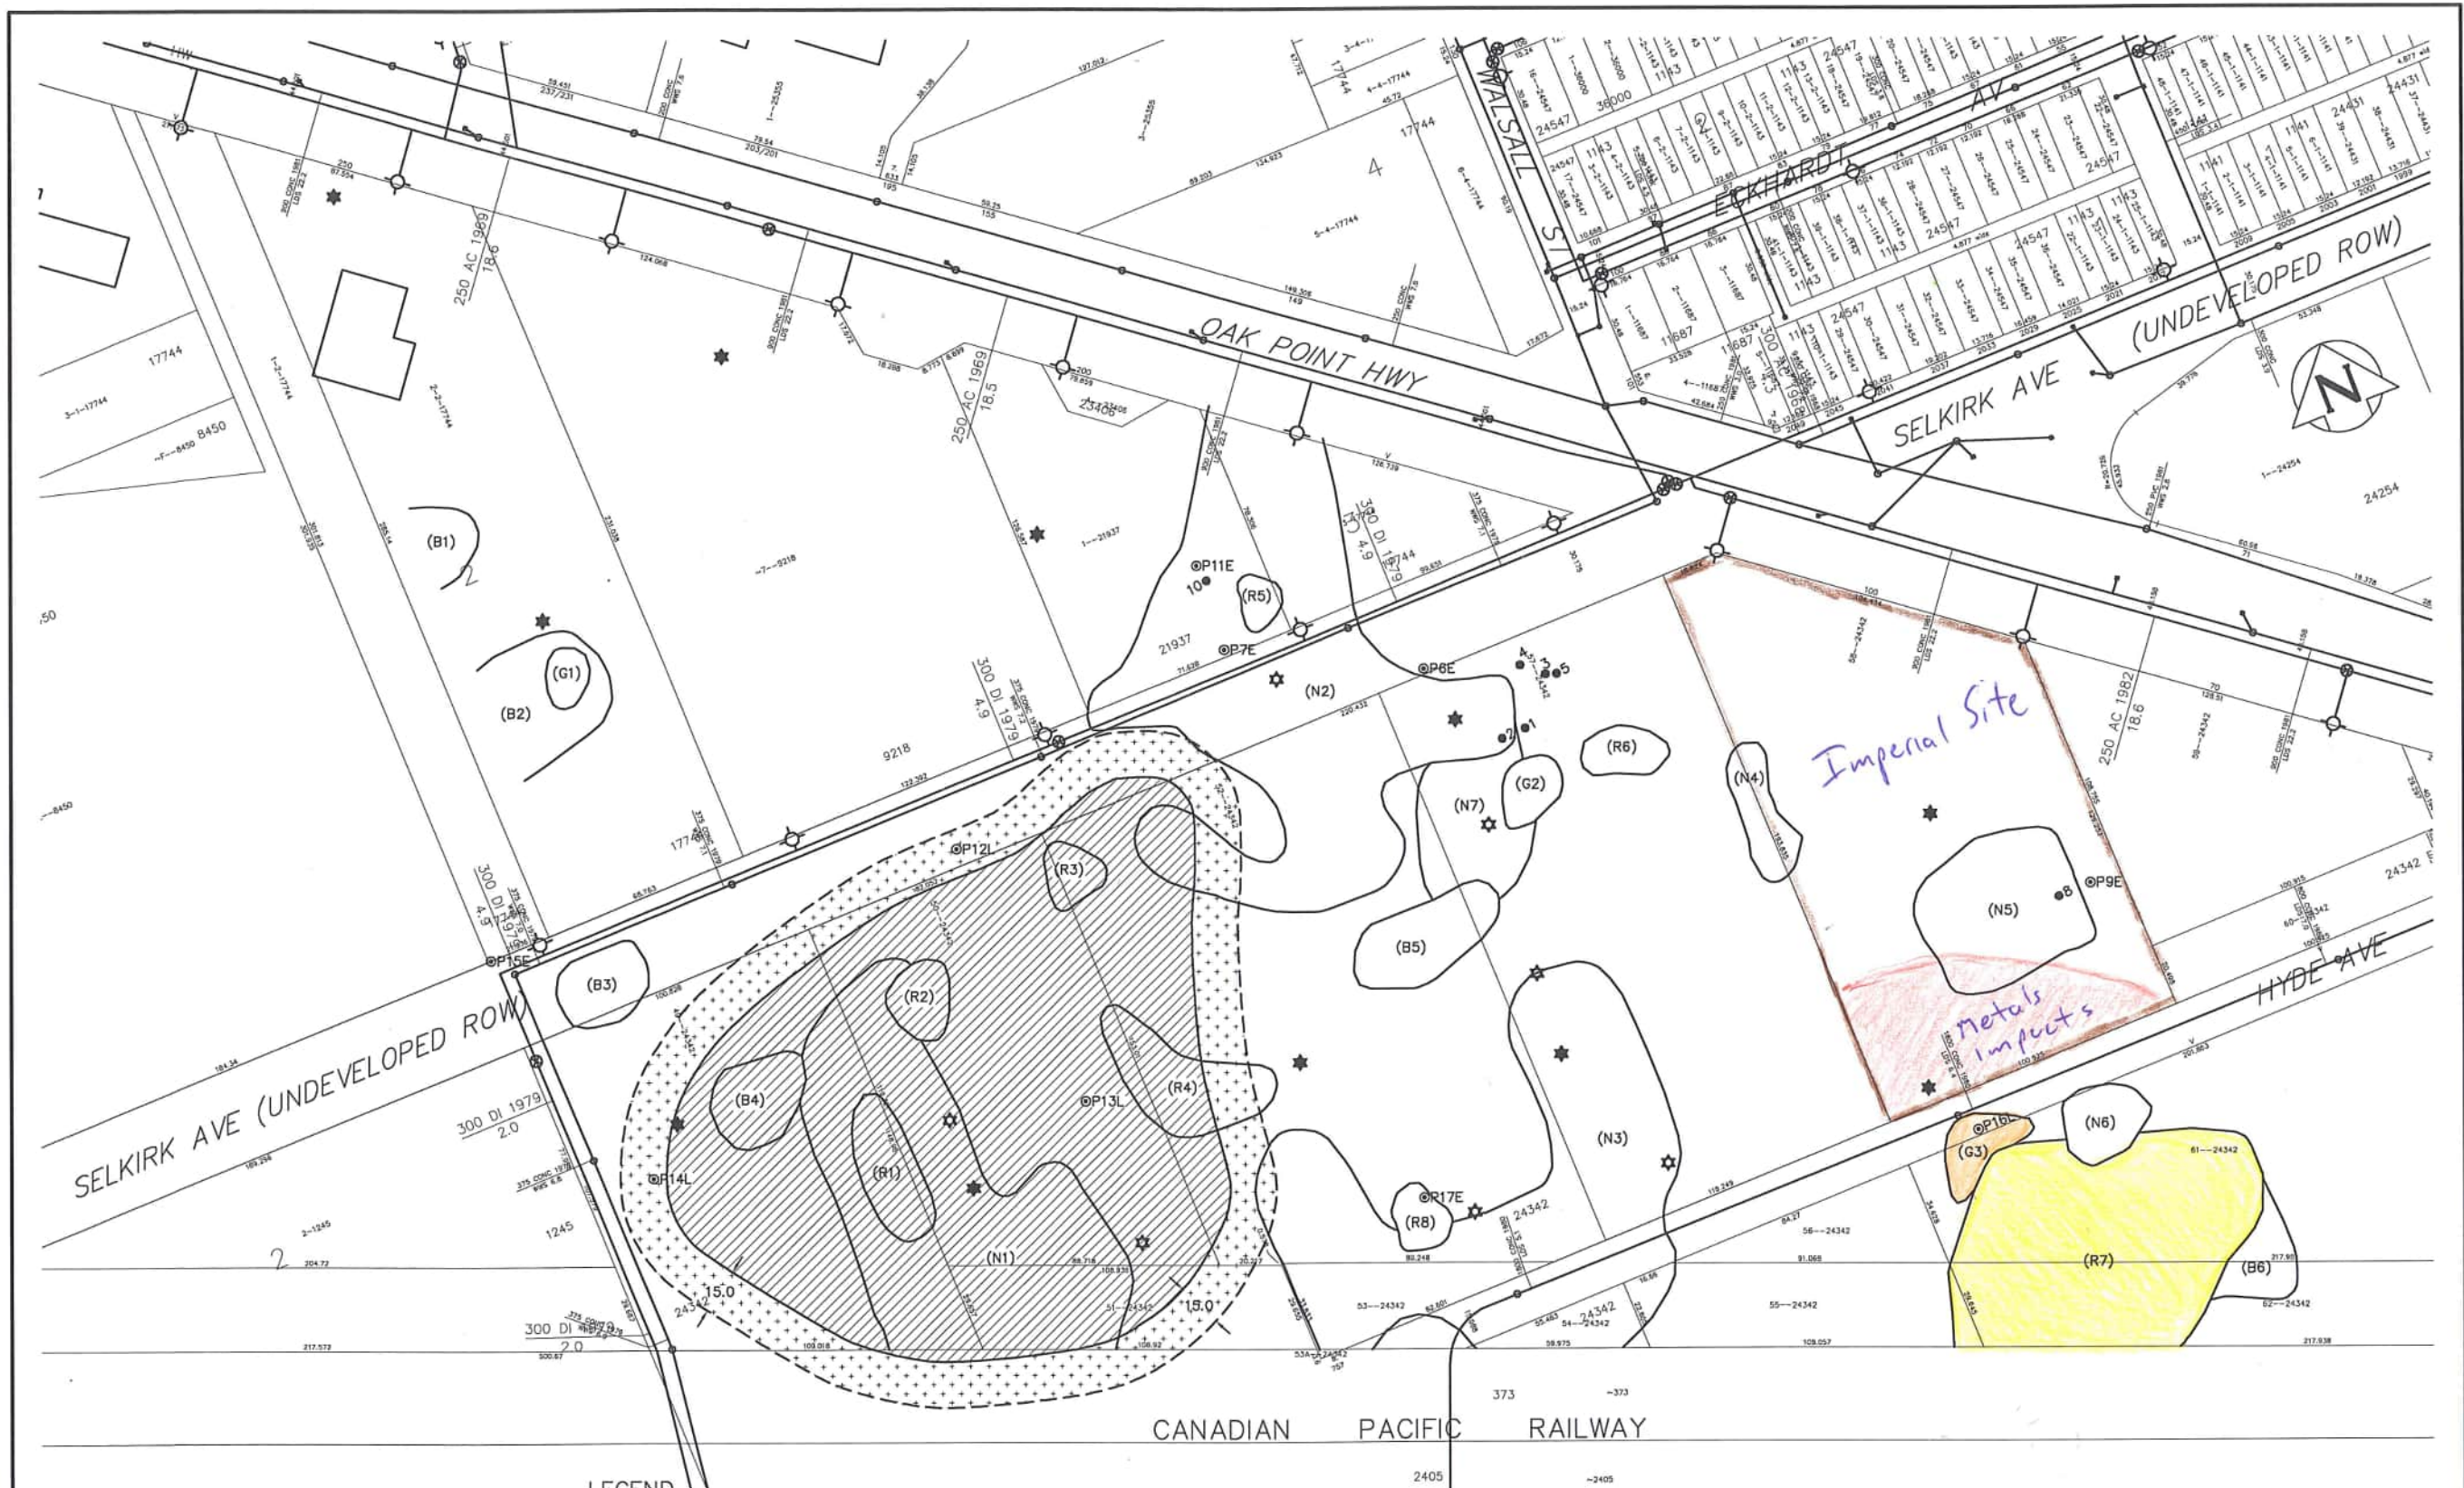
NO.28  
 BROOKLANDS  
 LANDFILL SITE DETAIL

- LEGEND**
- CONTROL ZONE
  - DUMP OR LANDFILL SITE
  - TEST HOLE ( BY LANDFILL ENVIRONMENTAL SECTION )
  - GAS PROBE ( BY LANDFILL ENVIRONMENTAL SECTION )
  - TEST HOLE ( BY OTHERS )
  - GAS PROBE ( BY OTHERS )
  - (N2) AREA DELINEATED AS CONTOURS OF DETECTABLE GAS CONCENTRATIONS
  - (R3) REFUSE
  - (G2) CINDERS, ASH
  - (B5) IMPORTED ORGANICS

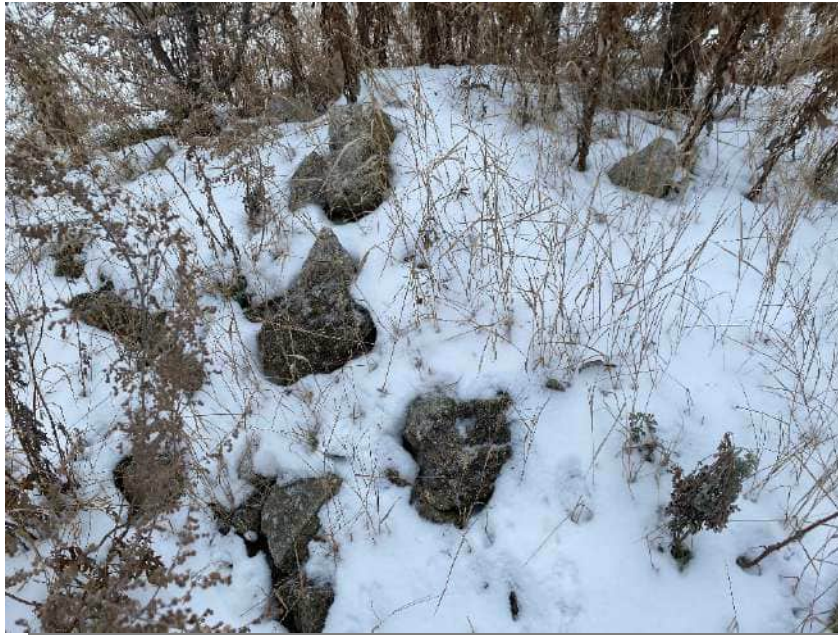
Photograph 19 – View of one of the small stockpiles present within the Study Area  
*Looking at concrete rubble found in the small stockpiles, south of the POI.*

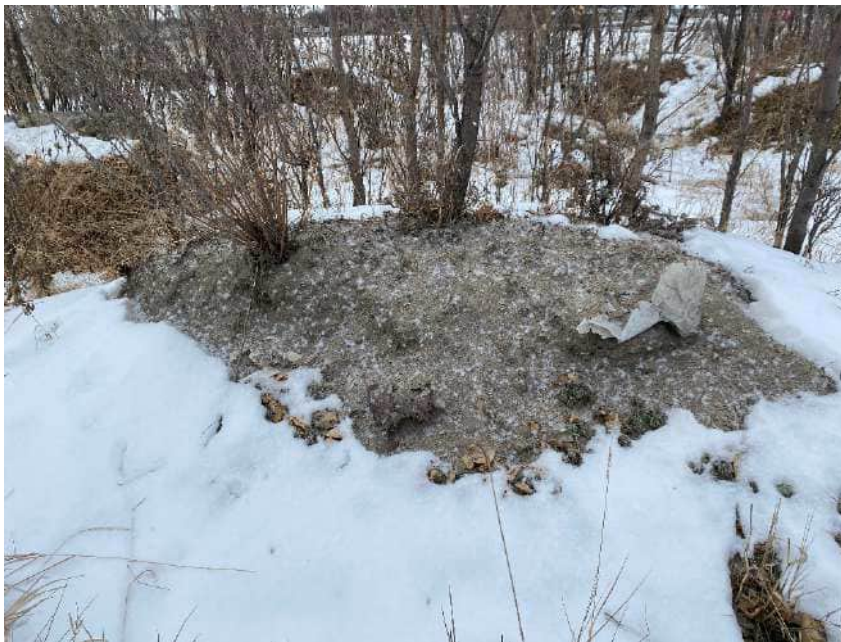
Photograph 20 – View of one of the Small Stockpiles  
*Looking at the fill stockpiles located within Subject Parcel Lot 57, Plan 24342.*

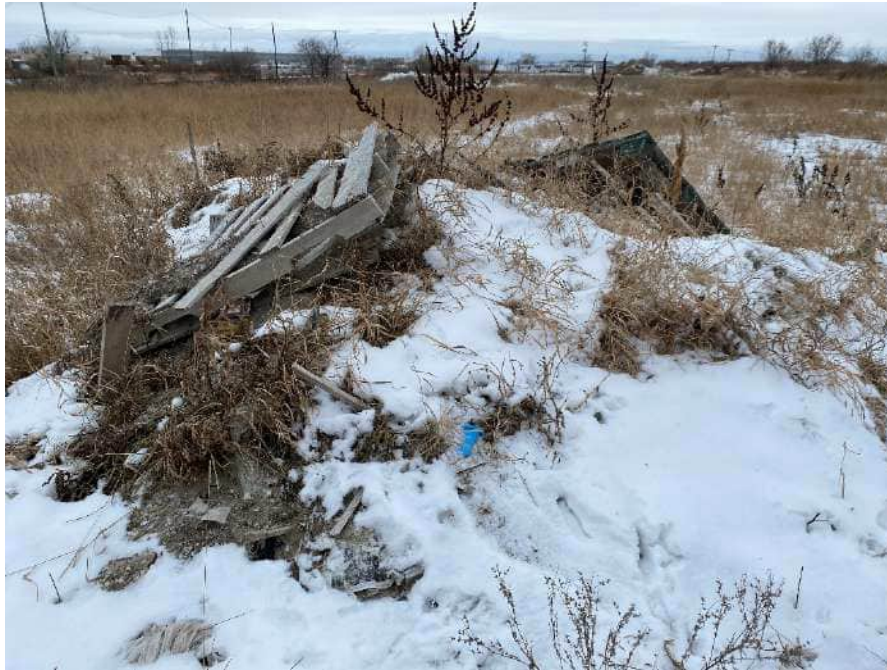
Photograph 21 – View of a Rubble Pile

*Looking at a waste pile located in the southwest corner of Subject Parcel Lot 57, Plan 24342.*

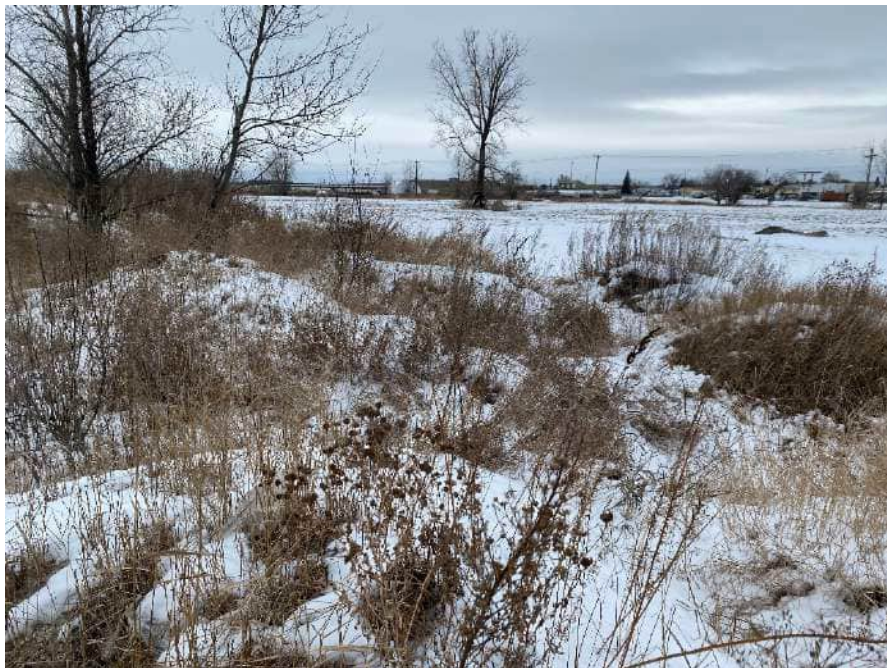
Photograph 22 – View of Multiple Small Stockpiles

*Looking west over multiple small stockpiles along the west portion of Subject Parcel Lot 57 and 52, Plan 24342.*

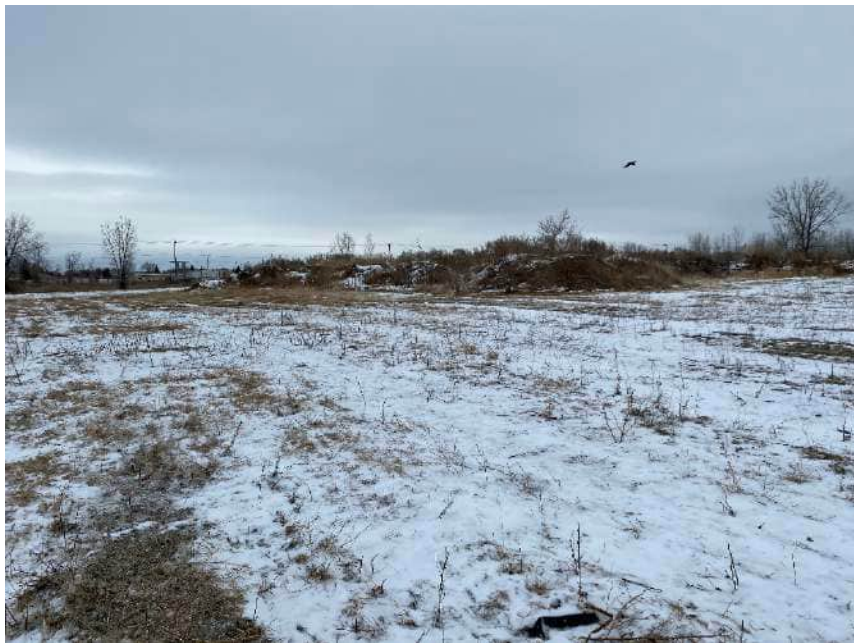
Photograph 24 – View of large Stockpile in Subject Parcel Lot 49 & 50, Plan 24342

*Looking north from Subject Parcel Lot 51, Plan 24342 towards the large stockpiles located in Subject Parcel Lot 49 & 50, Plan 24342, at the former location of the Brooklands Landfill.*

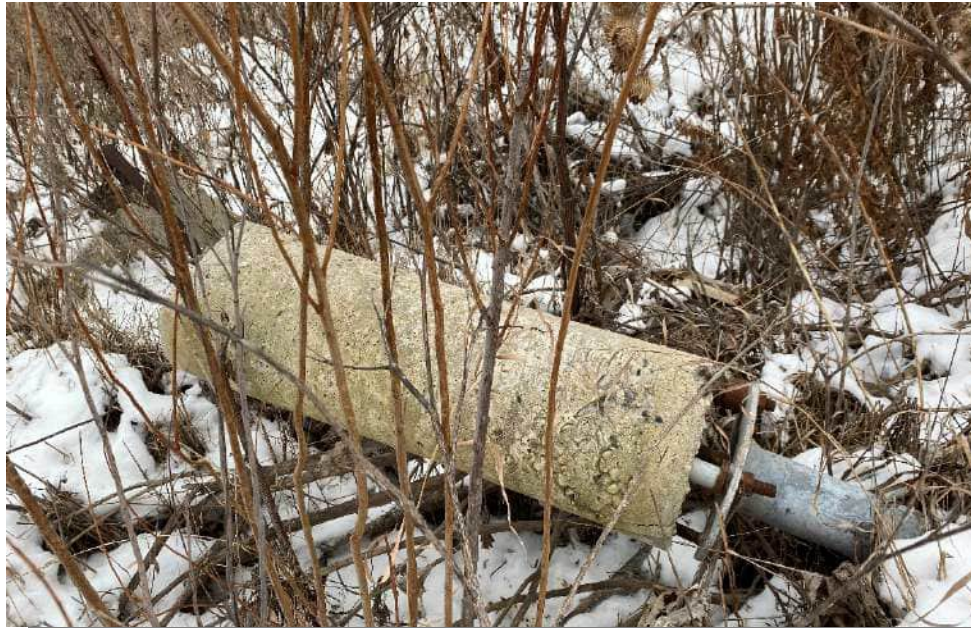
Photograph 25 – Concrete and Scrap Metal

*Looking at a concrete pile with metal, located in the southwest corner of Subject Parcel Lot 49, Plan 24342.*

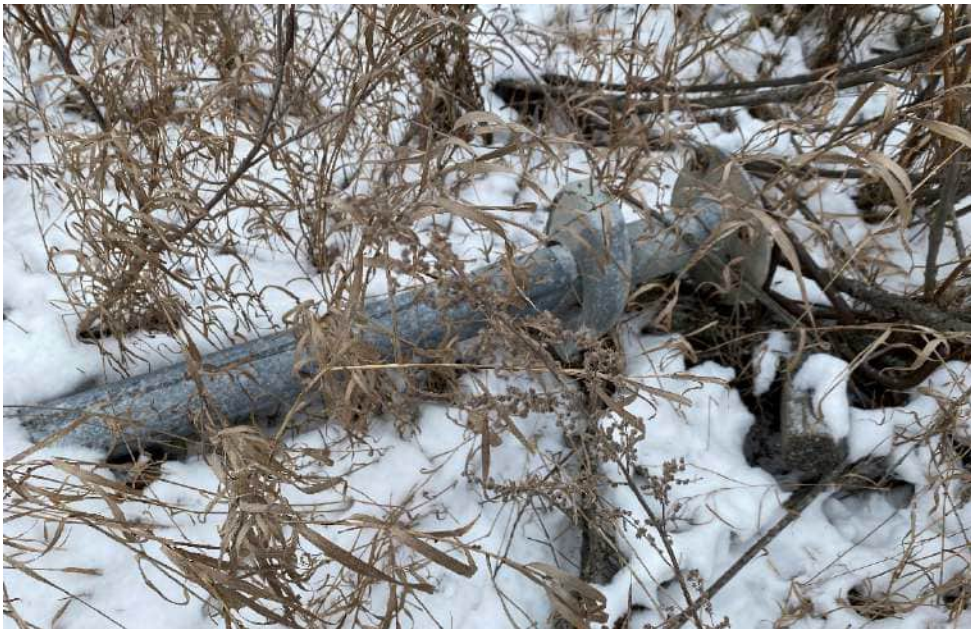
Photograph 26 – Scrap Metal

*Looking at a large piece of scrap metal, located in the southwest corner of Subject Parcel Lot 49, Plan 24342.*

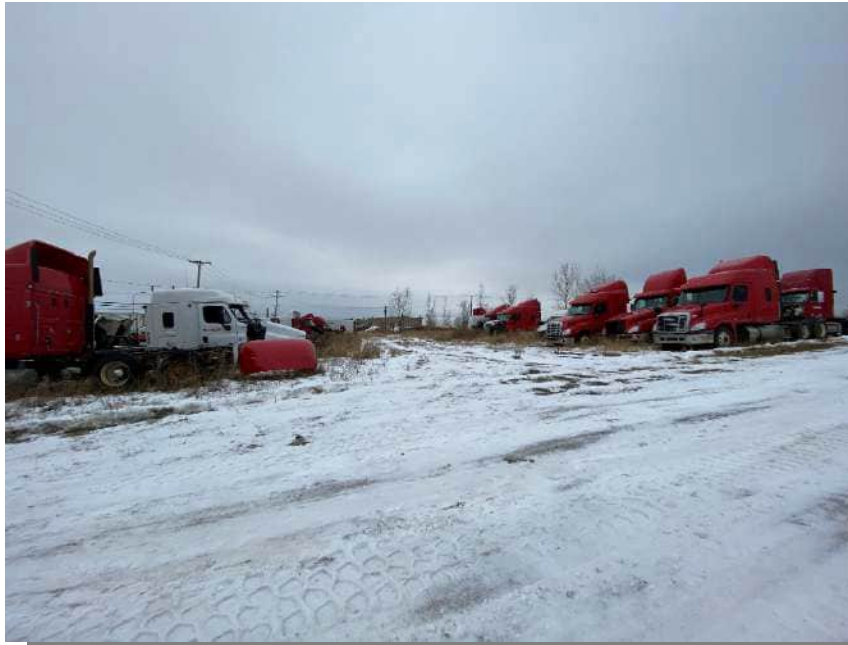
Photograph 27 – Vehicles stored on Subject Parcel Lot 57, Plan 24342

*Looking at northwestern portion of Subject Parcel Lot 57, Plan 24342 where multiple semi truck cabs are being stored.*

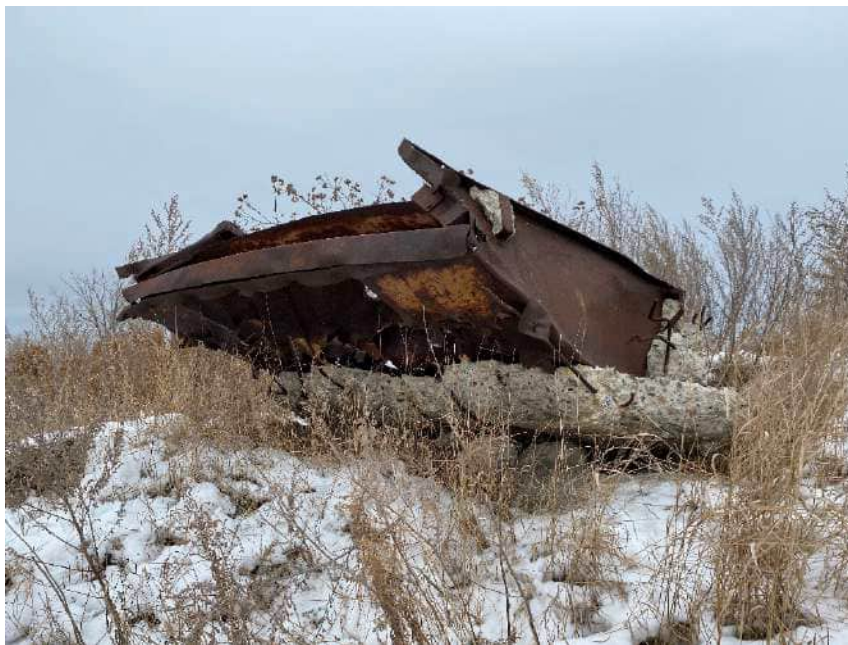
Photograph 28 –Scrap Vehicle Frame

*Looking at the frame of a scrap vehicle, located at the top of the large stockpile in Subject Parcel Lot 50, Plan 24342.*

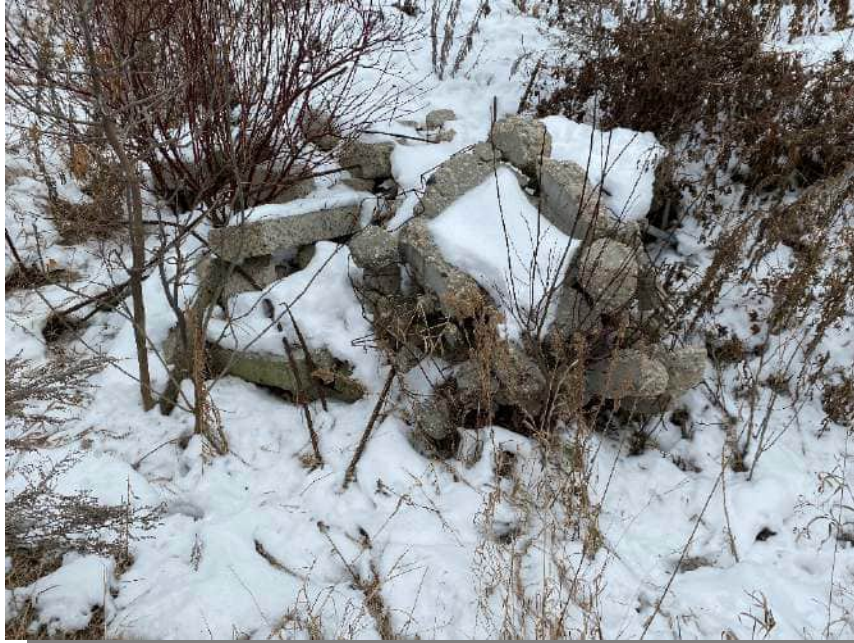
Photograph 29 – Concrete with Rebar

*Looking at concrete with rebar located in the large stockpile in Subject Parcel Lot 50.*

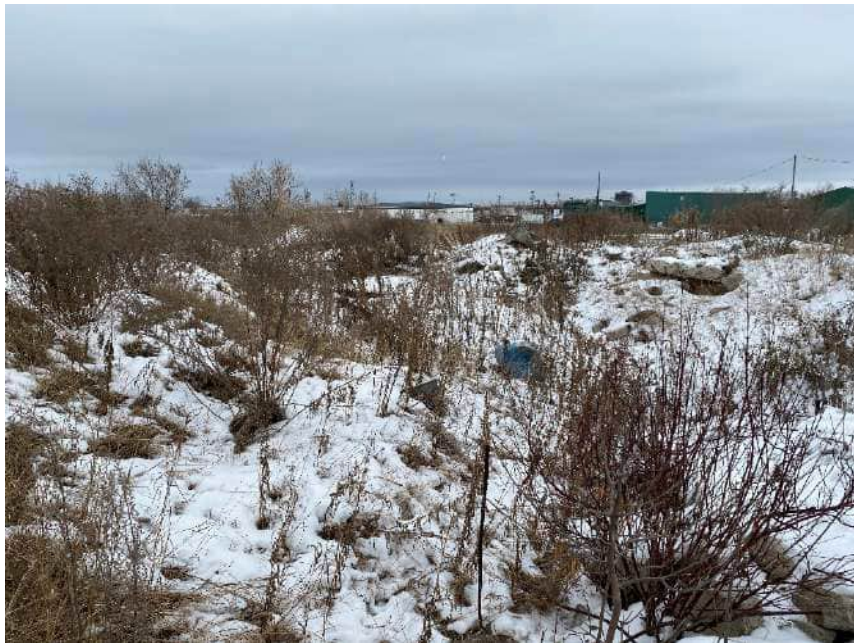
Photograph 30 – Interior of the Large Stockpile

*Looking at the inner portion of the large stockpile depression with garbage, scrap metal and concrete visible.*

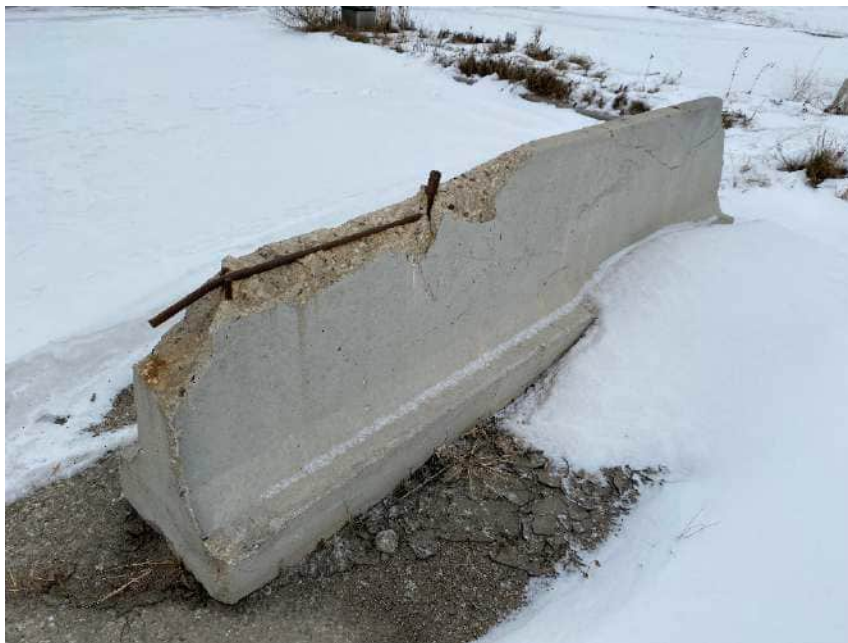
Photograph 32 – Concrete Blockade Barrier

*Looking at one of the multiple concrete blockades that surround the POI Site.*

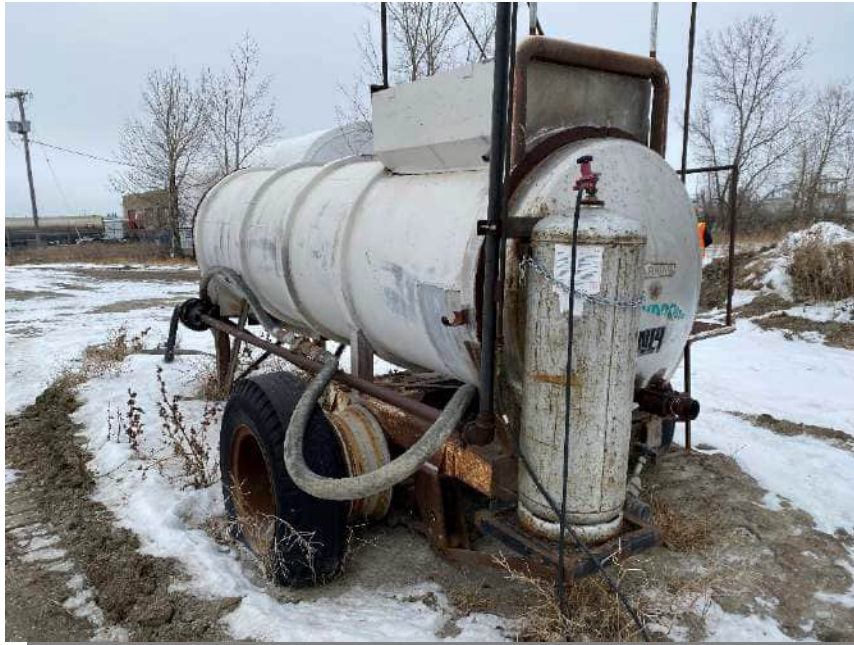
Photograph 33 – Off-Site AST

*Looking at an above storage tank located just off-site to the west of the southwestern portion of Subject Parcel PT 7, Plan 9218.*

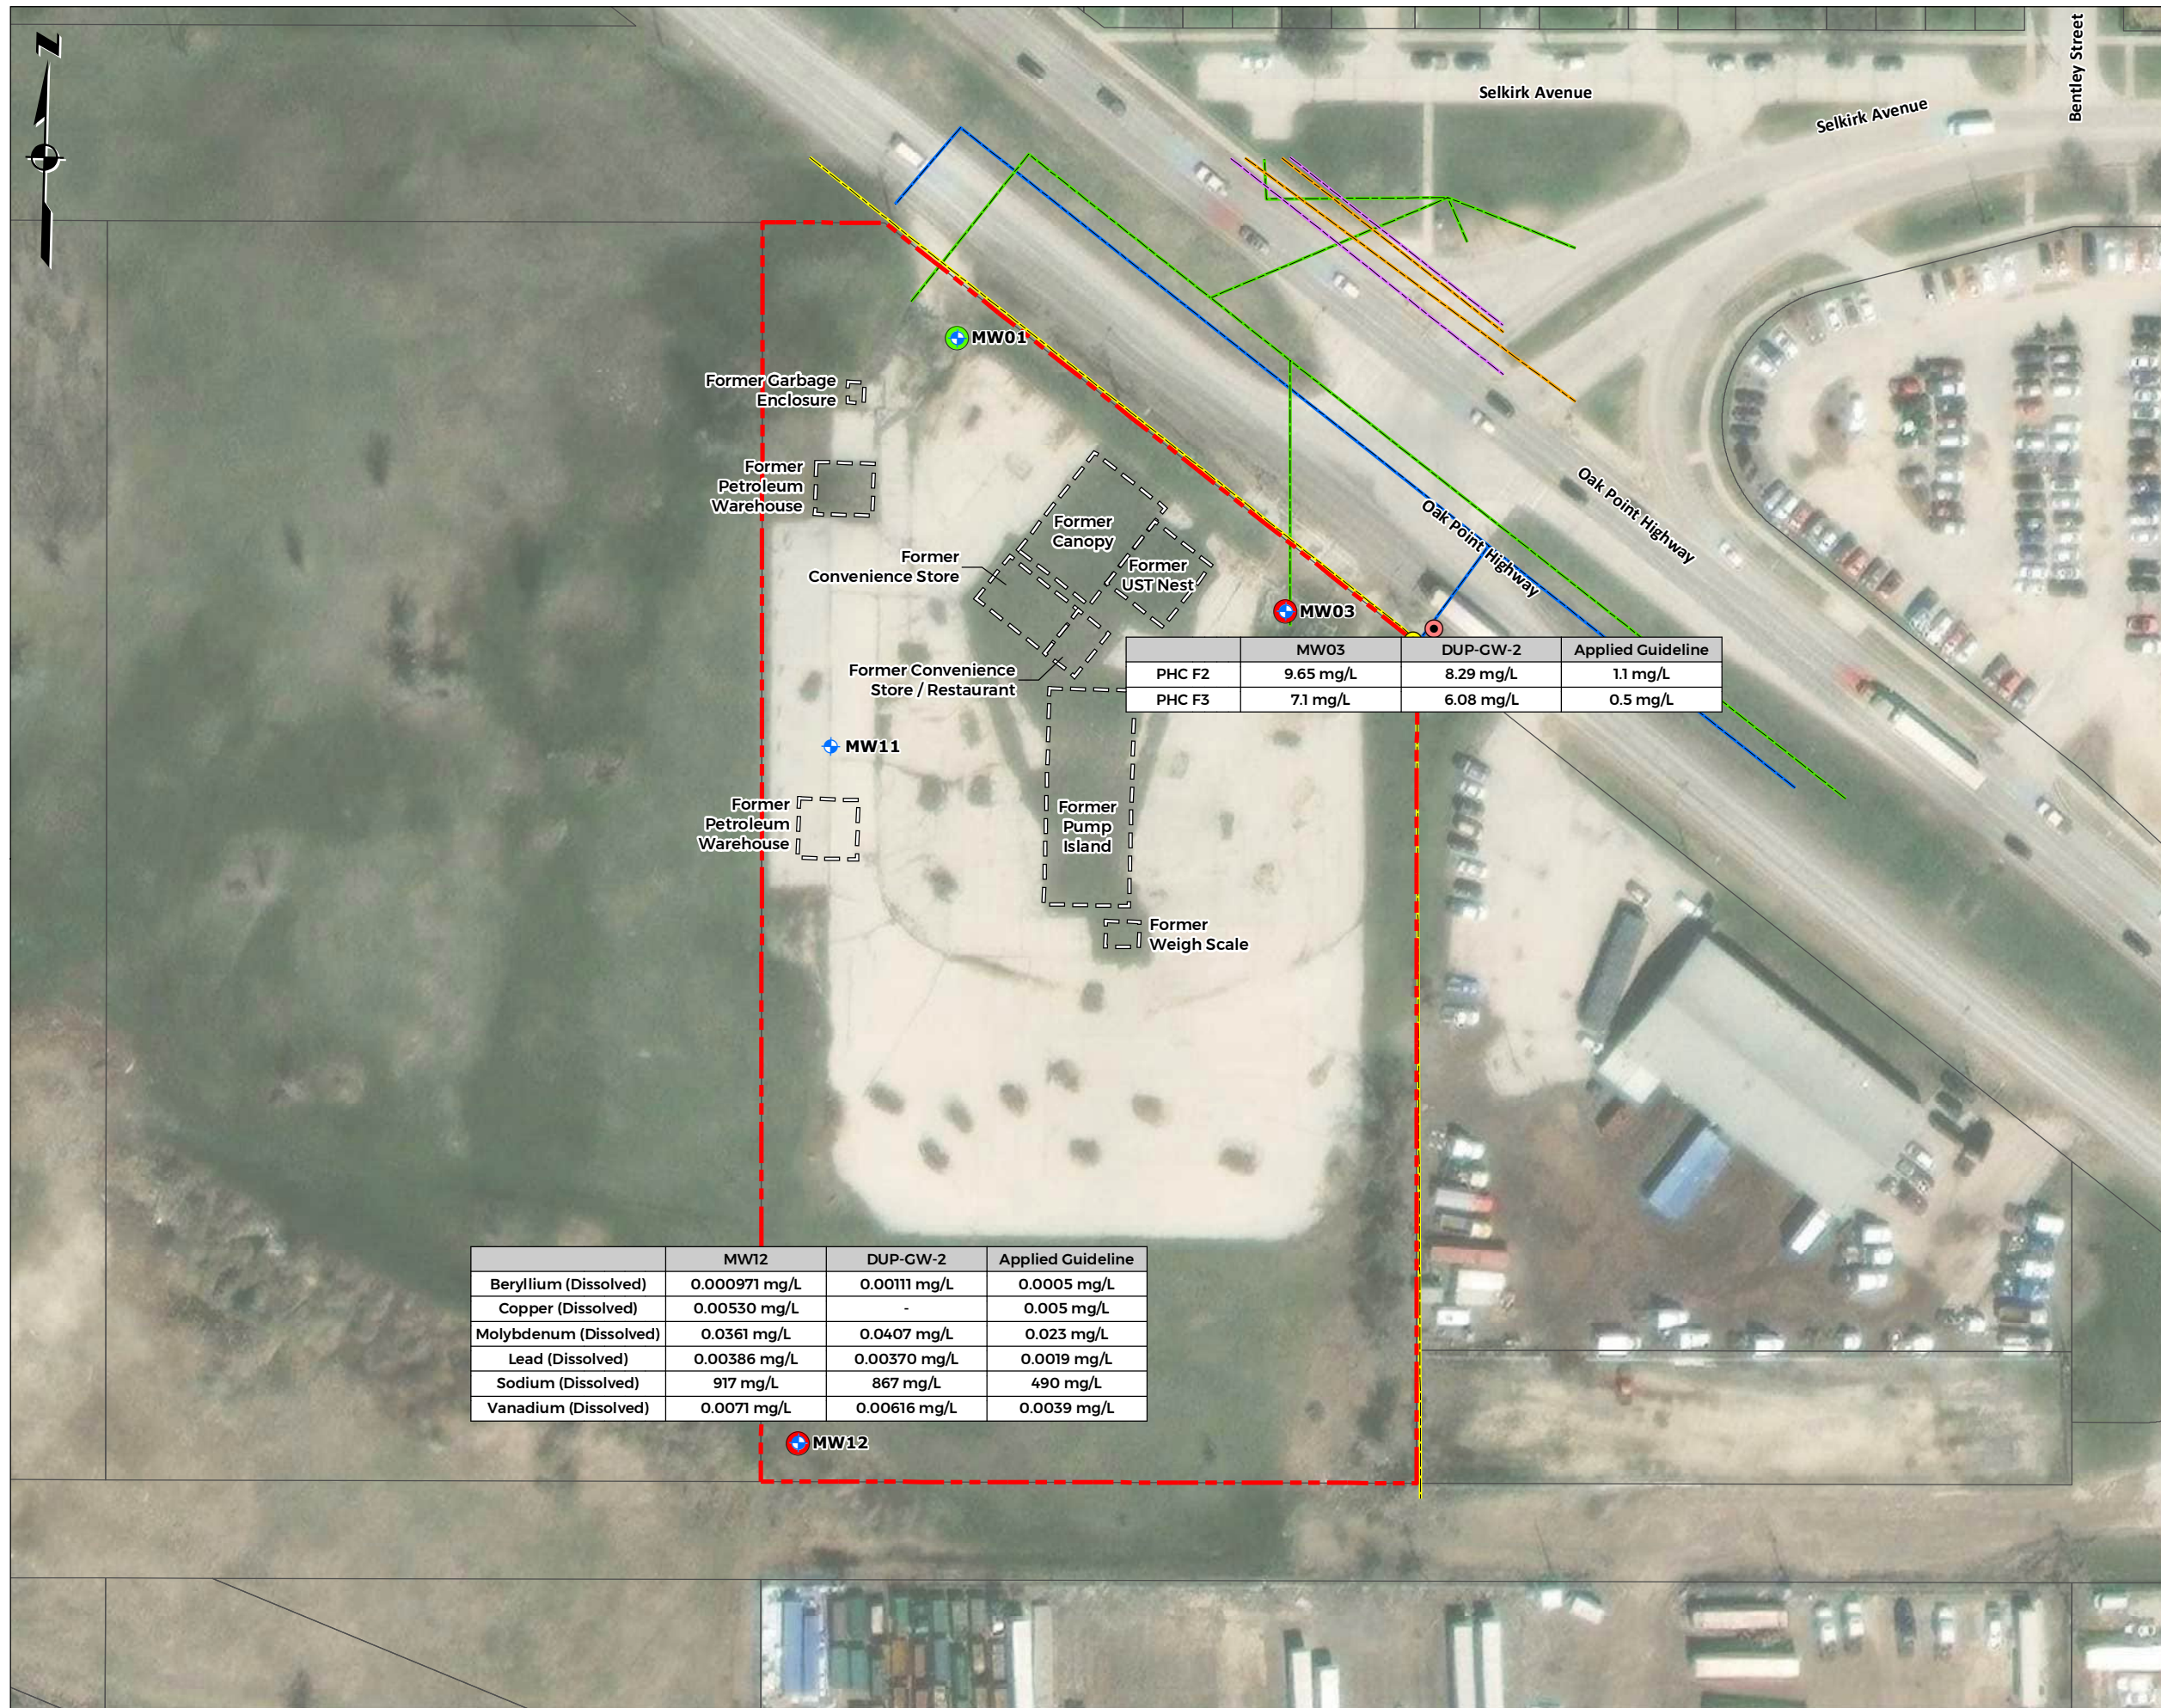
MW03	DUP-GW-2	Applied Guideline
PHC F2	9.65 mg/L	8.29 mg/L	1.1 mg/L
PHC F3	7.1 mg/L	6.08 mg/L	0.5 mg/L

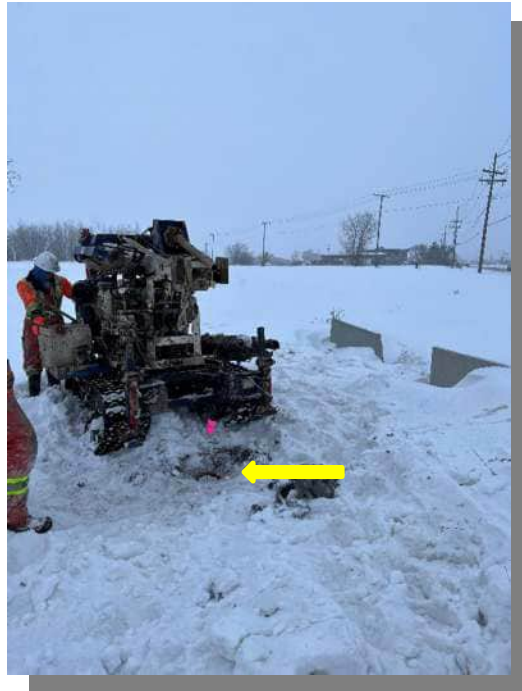
Photograph 1 – Northeast portion of the Site  
*Looking west at the location of monitoring well MW01 (yellow arrow).*

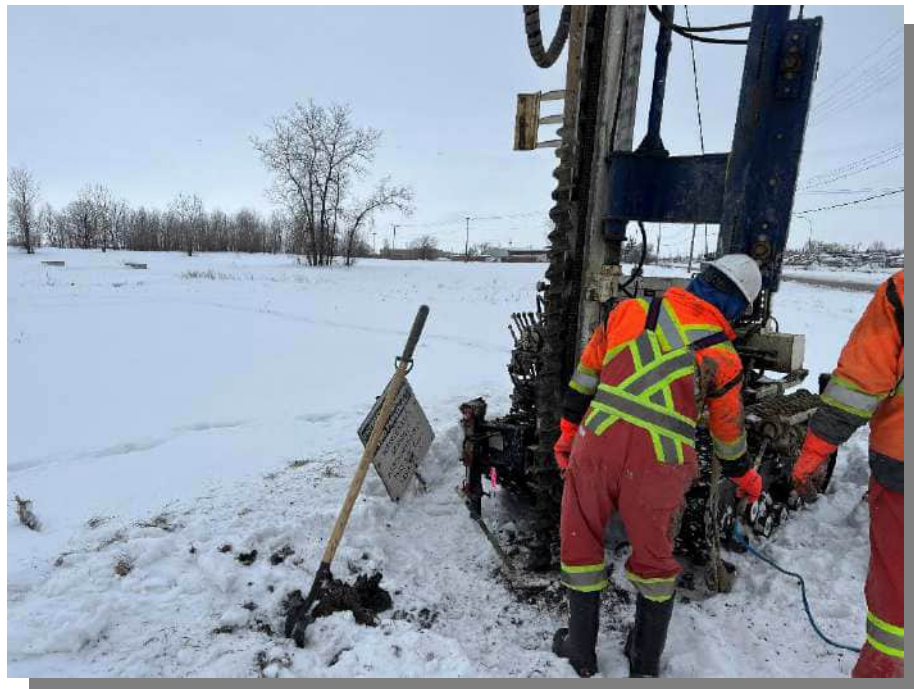
Photograph 2 – North portion of the Site  
*Looking west at the location of testhole TH02.*

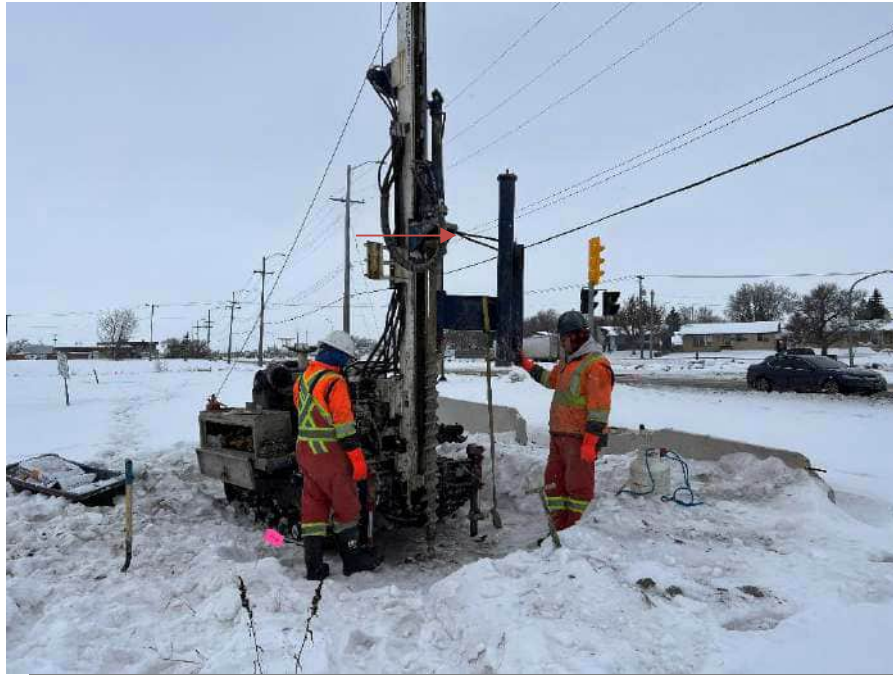
Photograph 3 – Northeast portion of the Site  
*Looking west at the location of monitoring well MW03.*

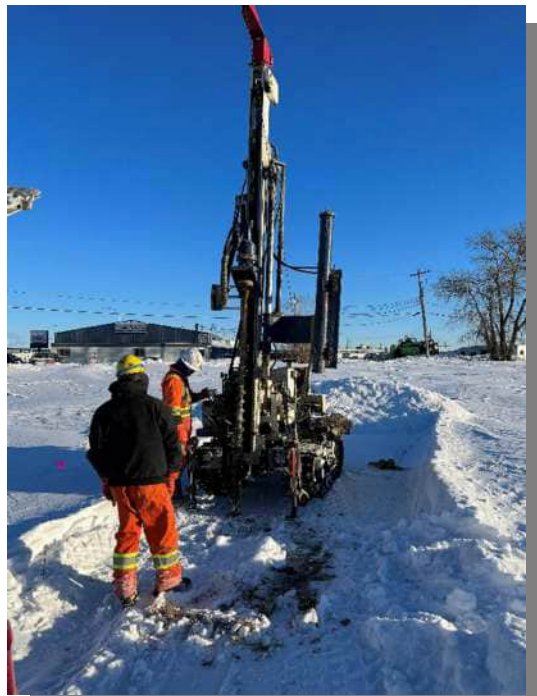
Photograph 4 – Central portion of the Site  
*Looking east at the location of testhole TH05.*

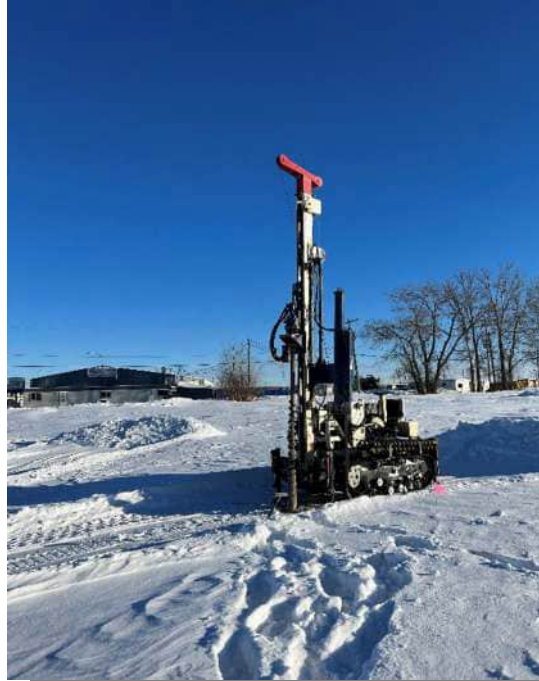
Photograph 5 – Central portion of Site  
*Looking east at the location of testhole TH06.*

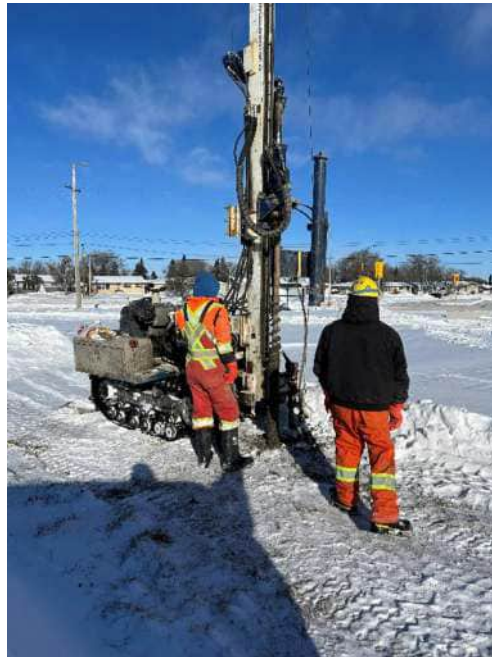
Photograph 6 – Central portion of Site  
*Looking north at the location of testhole TH07.*

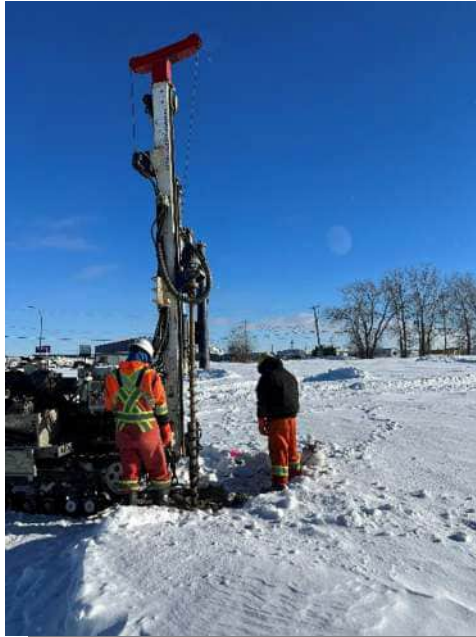
Photograph 8 – Central portion of Site  
Looking southeast at the location of testhole TH08.

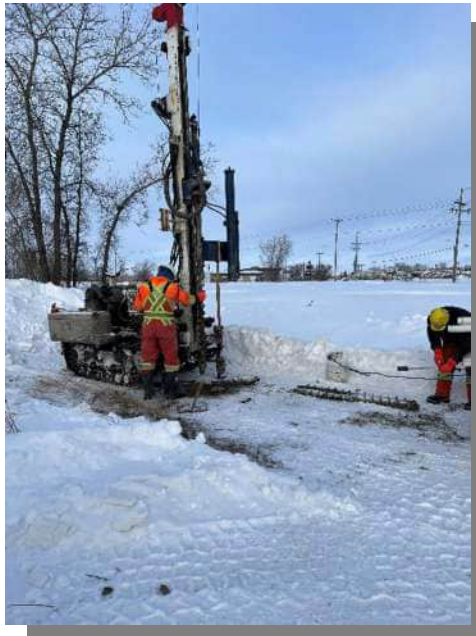
Photograph 9 – Northwest portion of the Site  
Looking west at the location of testhole TH10.

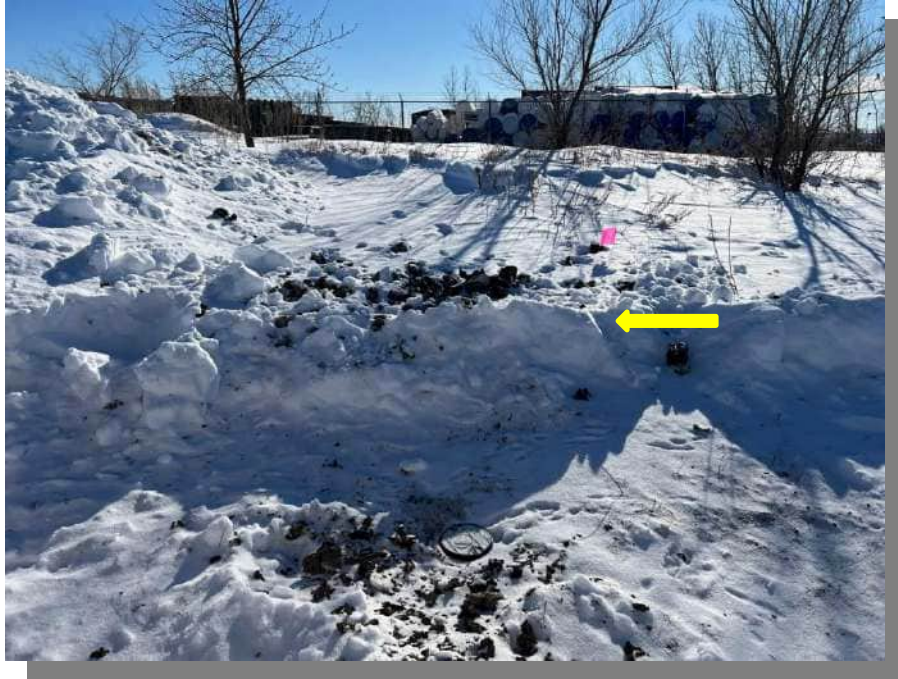
Photograph 10 – South portion of the Site  
*Looking south at the location of monitoring well MW12 (yellow arrow).*

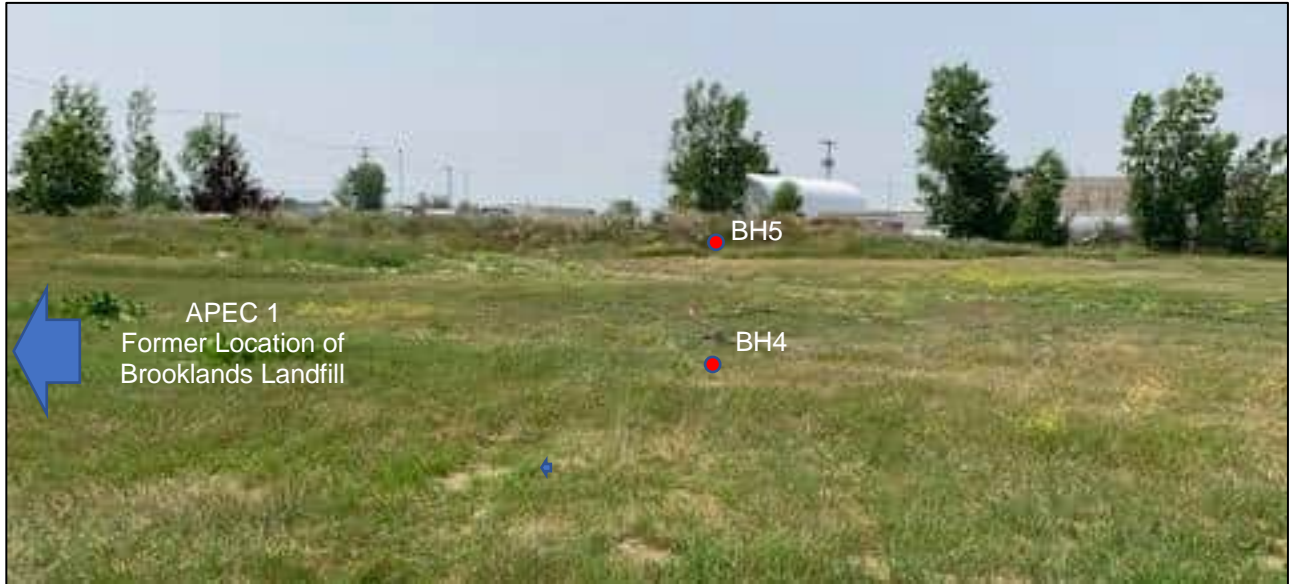
Photograph 2: Boreholes BH4 & BH5, looking west

that five boreholes, BHs 1, 2, 3, 4 & 5 be drilled approximately 30 m north of the marsh (Photographs 2 & 3). A groundwater monitoring well (MW1) was installed in BH3.

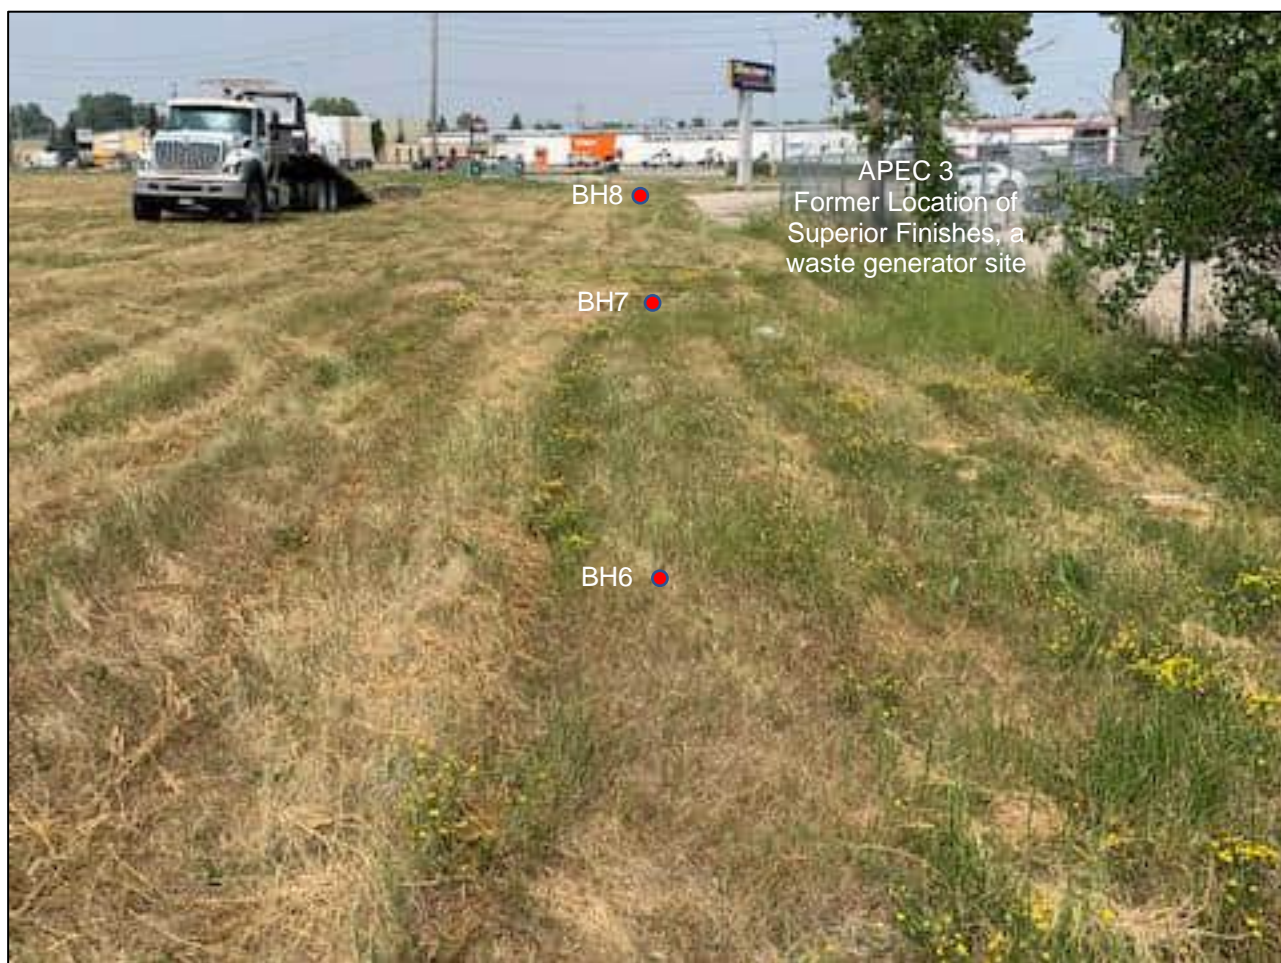
Photograph 4: Locations of BH6, BH7 and BH8, looking north

This area is located along the east property line of our subject site, Site A. Investigation in this portion of Site A was recommended to determine if activities at this former waste generating site may have resulted in the migration of VOC and/or metals impact to our subject site, Site A. Three boreholes, BHs 6, 7 & 8, were drilled approximately five m west of the east property line (Photograph 4).

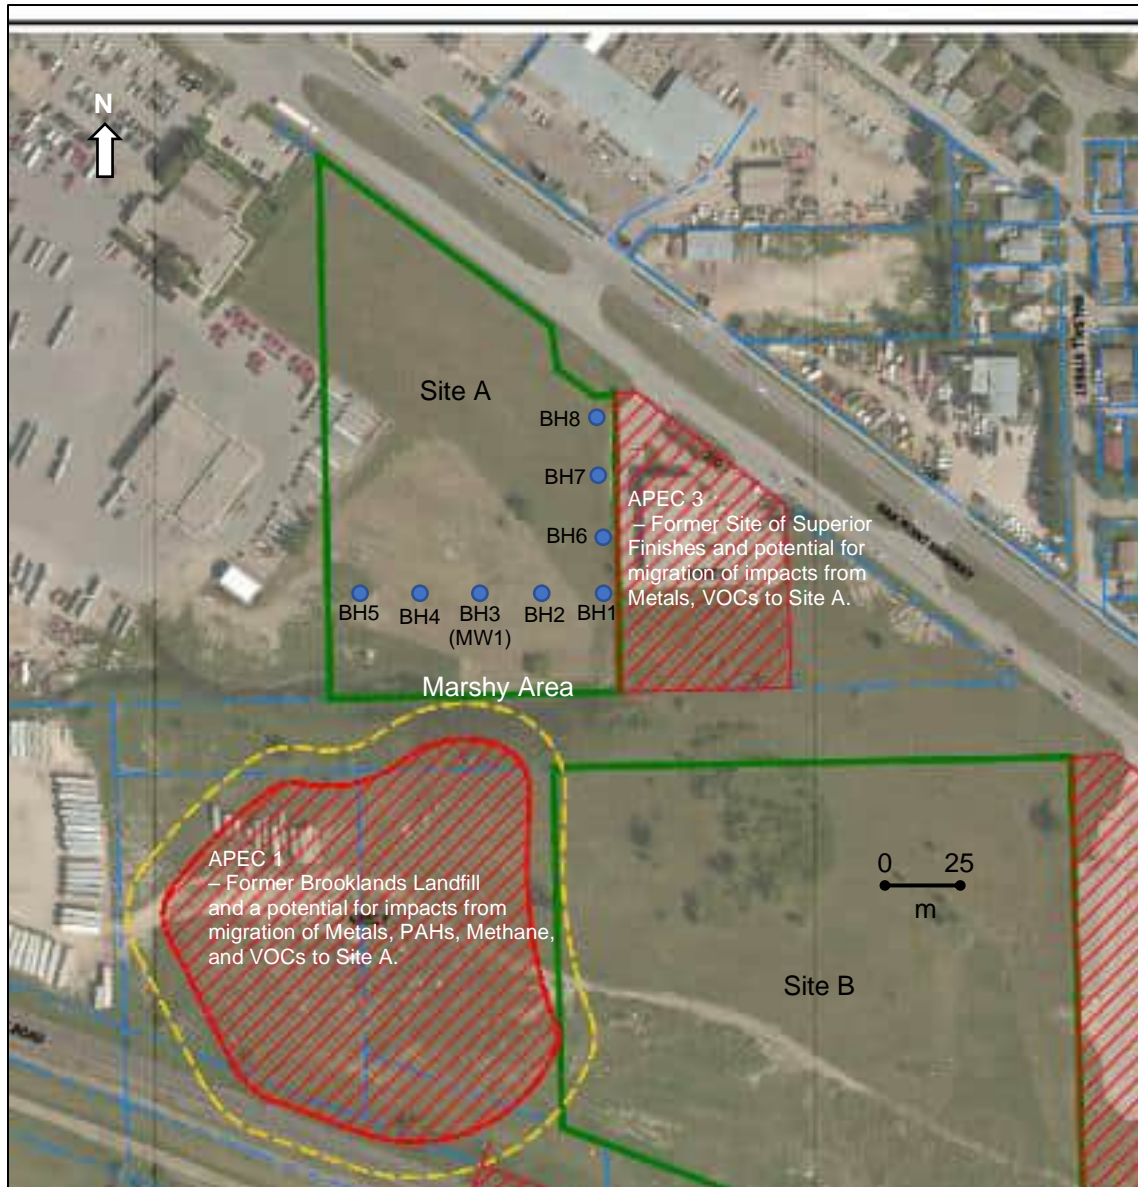
Figure 1  
Borehole Location Plan  
Parcel 7 of Plan 9218 WLTO (Site A)  
Winnipeg, Manitoba
