# PHASE I ENVIRONMENTAL SITE ASSESSMENT

## NORTH GARAGE OAK POINT HIGHWAY, WINNIPEG, MB

PHASE I  
ENVIRONMENTAL  
SITE ASSESSMENT  
NORTH GARAGE OAK  
POINT HIGHWAY,  
WINNIPEG, MB  
CITY OF WINNIPEG

PROJECT NO.: 221-07203-00  
DATE: JANUARY 24, 2023

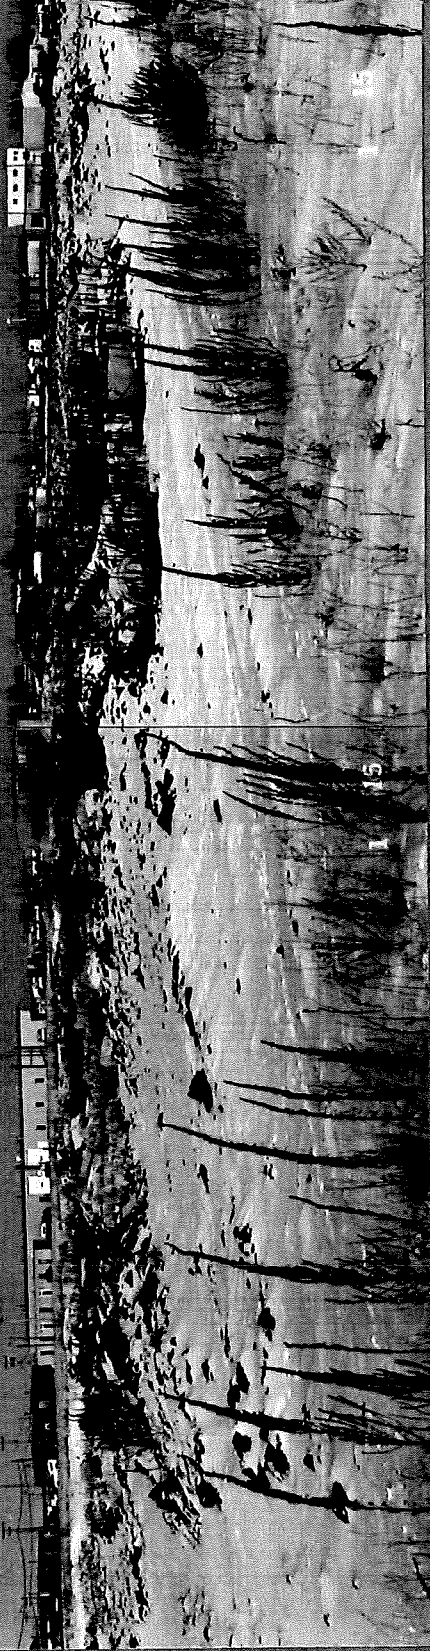
Area 3 - Concrete rubble

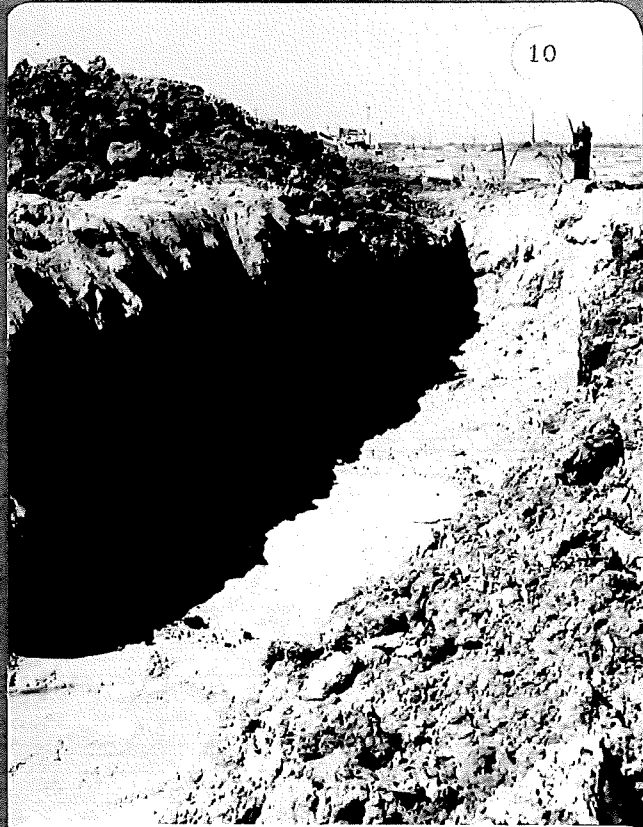
Watermain extension
