APPENDIX 'D'
GEO TECHNICAL REPORTS

City of Winnipeg Branch I Aqueduct Underdrain Outfalls (RFP No. 512-2023) – Rue Plinguet Outfall Geotechnical Report

RE: City of Winnipeg Branch 1 Aqueduct Underdrain Outfalls (RFP No. 512-2023) – Rue Plinguet Outfall Geotechnical Report

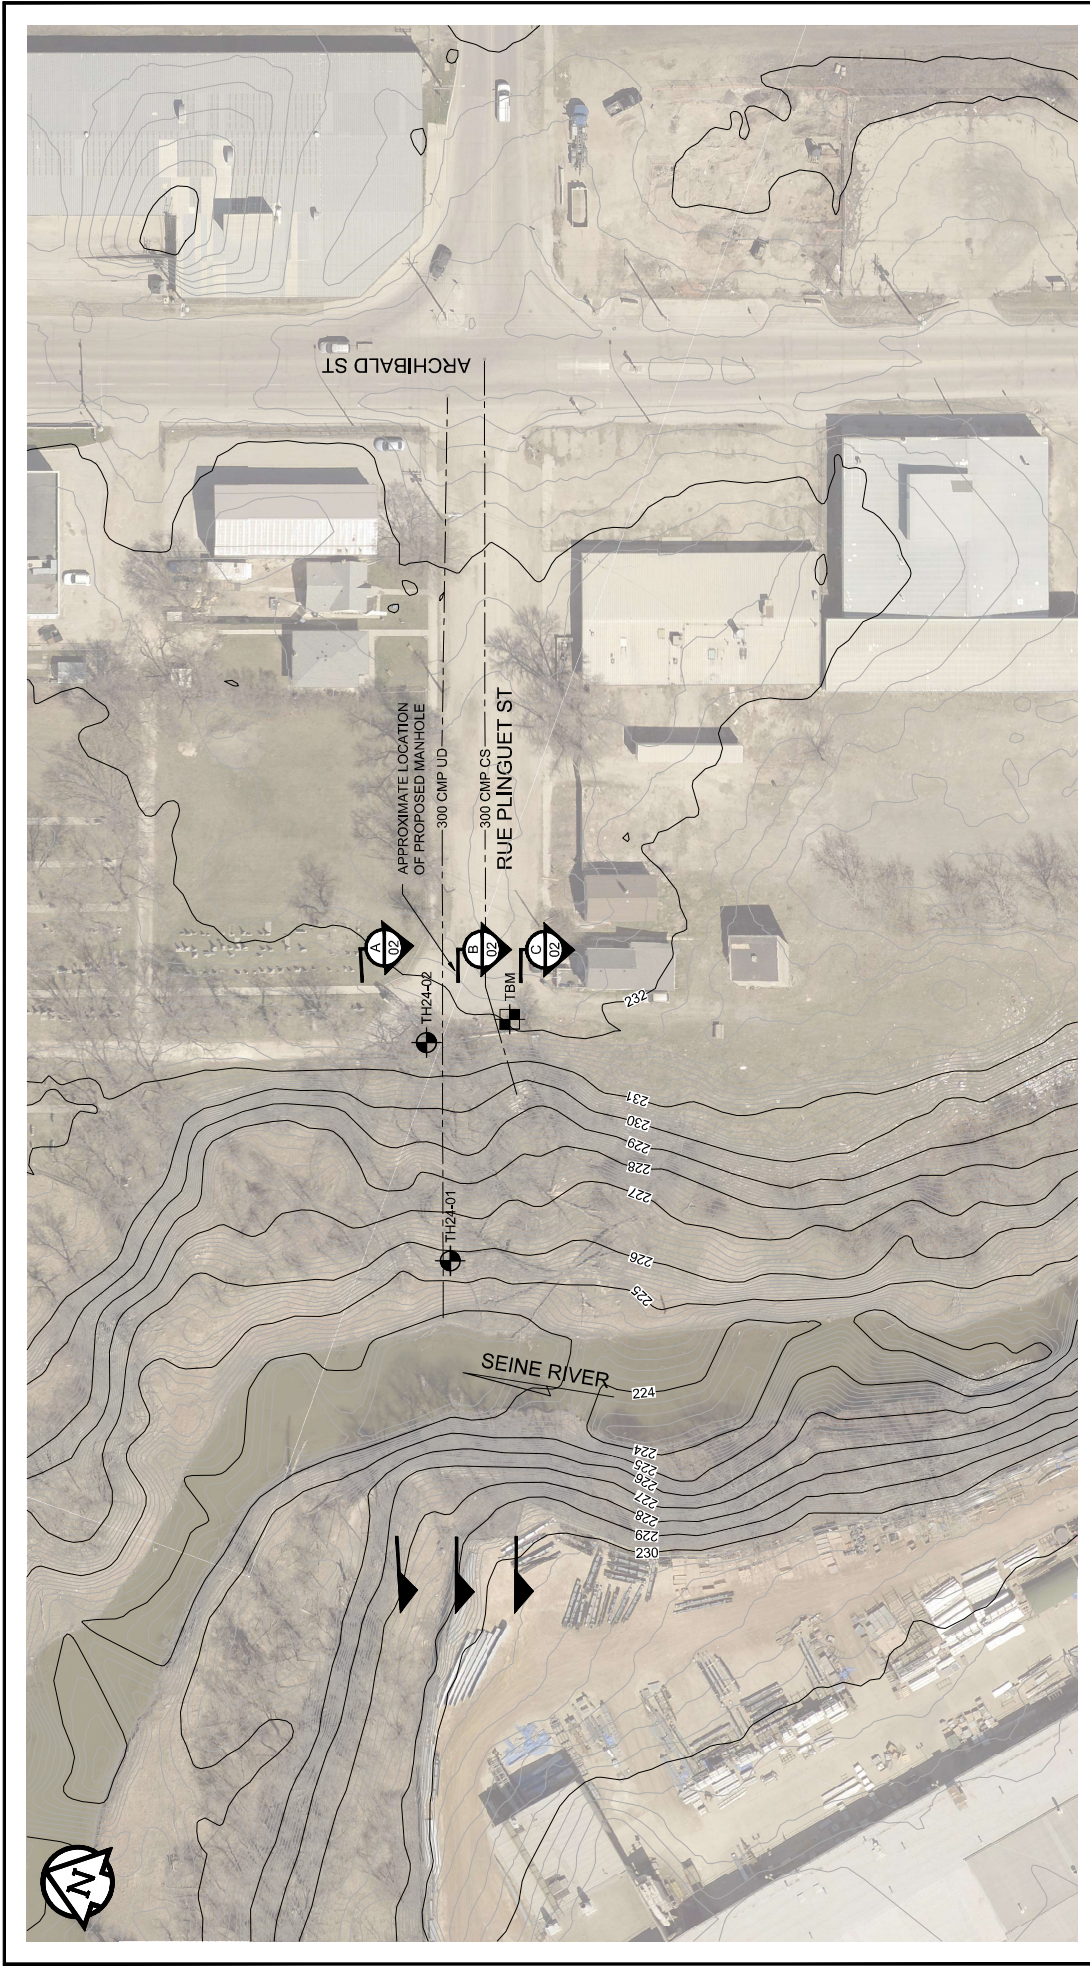
Figure 01
Site Plan

A sub-surface investigation was completed under the supervision of TREK personnel to determine the soil stratigraphy and groundwater conditions at the site. Test Holes (TH) 24-01 and 24-02 were drilled at the locations shown on Figure 01 by Paddock Drilling Ltd. on January 8 and 9, 2024 using an Acker SS3 track-mounted drill rig equipped with 125 mm diameter solid stem and 200 mm hollow stem augers. TH 24-01 and 24-02 were drilled to power auger refusal at depths of 11.7 m and 17.6 m, respectively. Test hole locations were established using a hand-held GPS device and the ground surface elevation surveyed relative to a temporary benchmark (TBM) as shown on Figure 01.

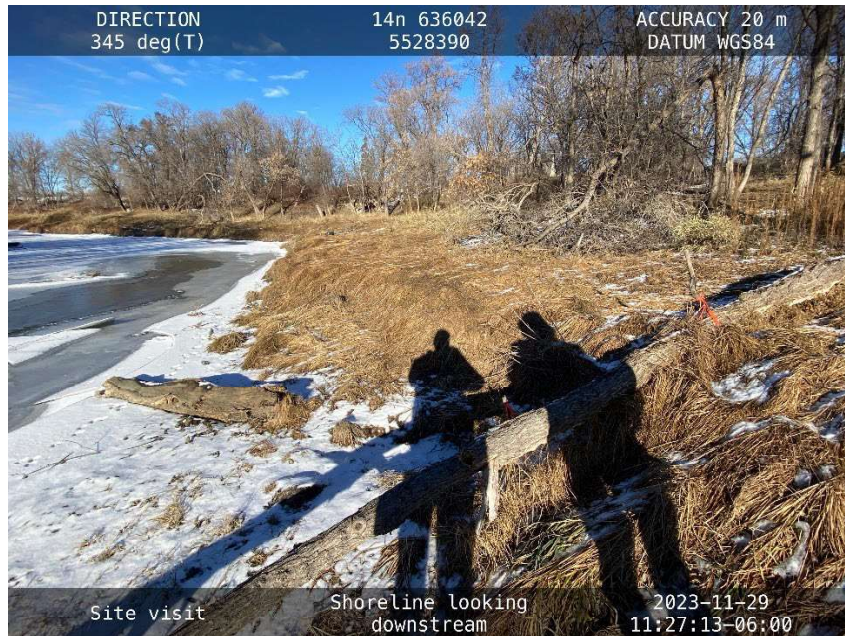
Photo 1 – Shoreline looking downstream from outfall location

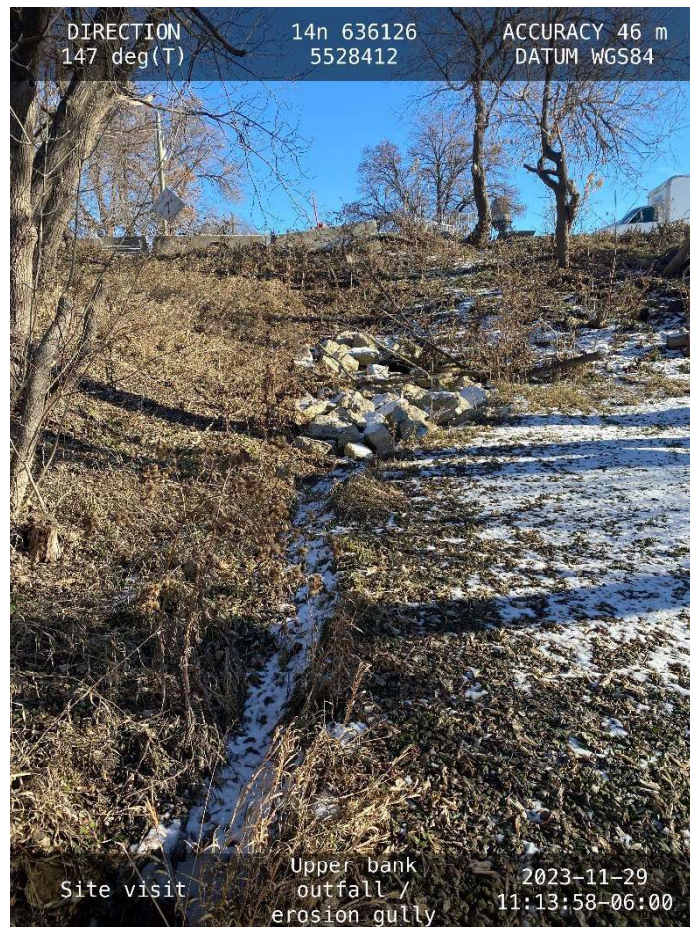
Photo 2 – LDS Outfall in upper bank and erosion gully extending down slope

To prevent future shoreline erosion and the associated reduction in riverbank stability, TREK recommends the provision of erosion protection measures (riprap) during the outfall repair works. The riprap blanket should extend to the limits of the outfall right-of-way and ideally, 10 m upstream and downstream of the right-of-way limits. TREK’s hydraulics engineers will complete a desktop assessment to determine riprap gradation and assess any adverse impact on channel geometry (a requirement of the necessary Waterways Permit).

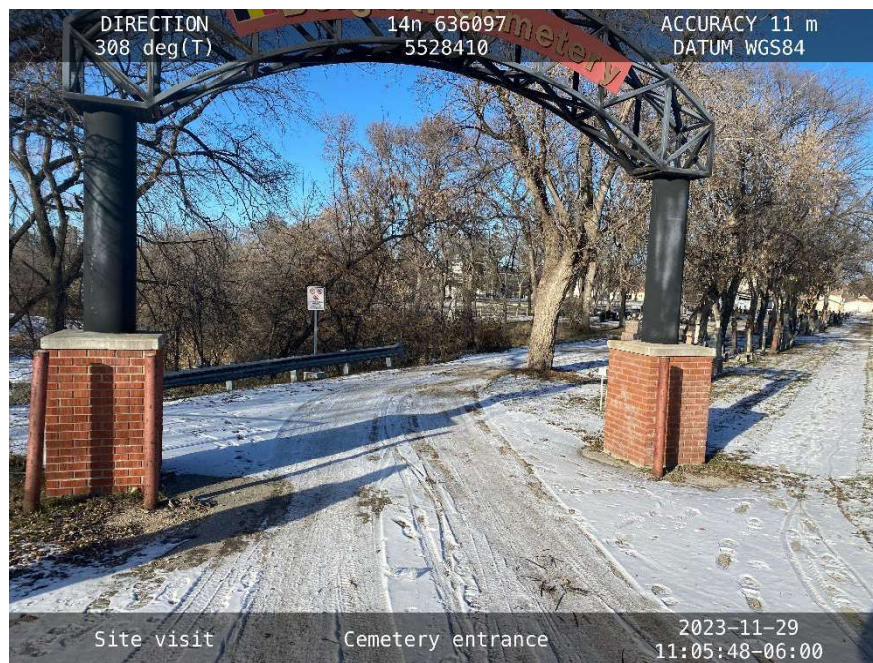
Photo 4 – Cemetery entrance in upper bank area

Discharge from a land drainage sewer (LDS) outfall south of the underdrain outfall pipe has created an erosion gully extending from the upper to lower bank areas (Photos 2 and 3). Beyond the slope crest, Plinguet Street terminates in a widened roadway area, and an access road to the adjacent cemetery to the north is located immediately adjacent to the bank crest (Photo 4). Photo 5 shows an overview of the site from an aerial drone perspective.

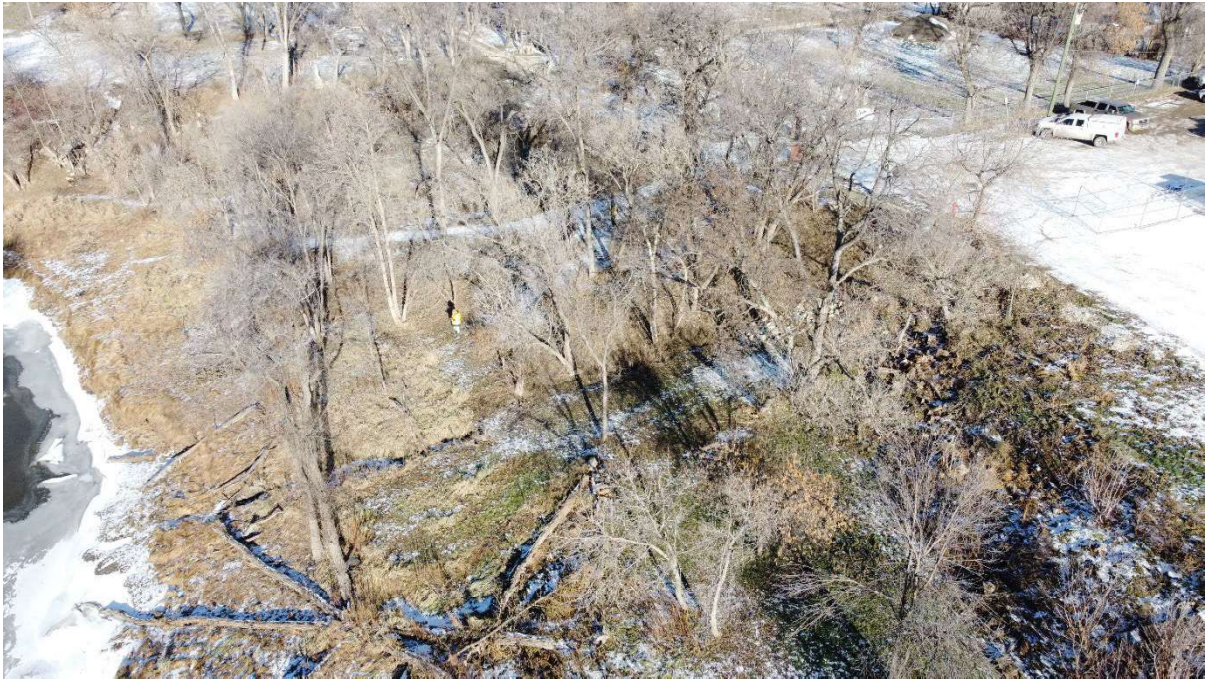
Photo 5 – Aerial drone view of site looking north

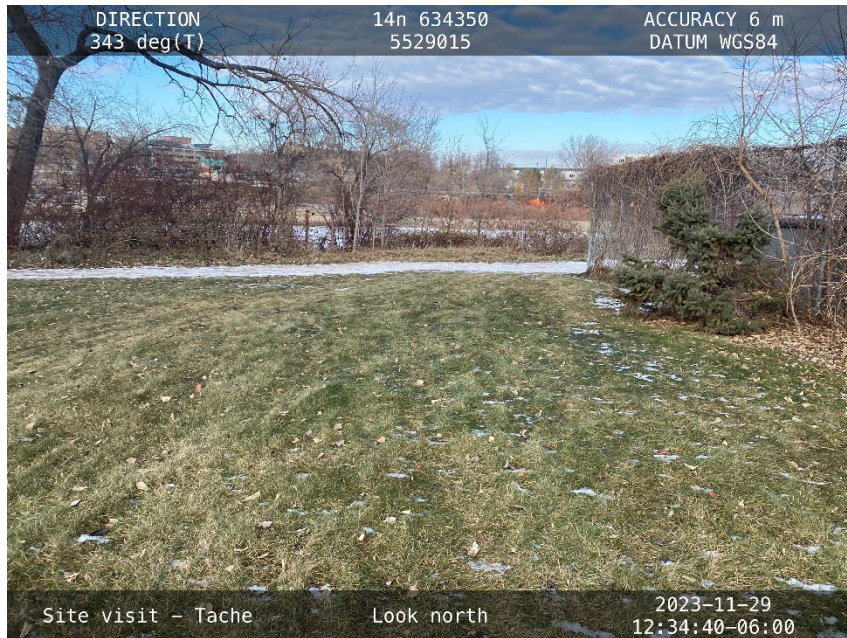
Photo 1 – Upper bank area along outfall alignment

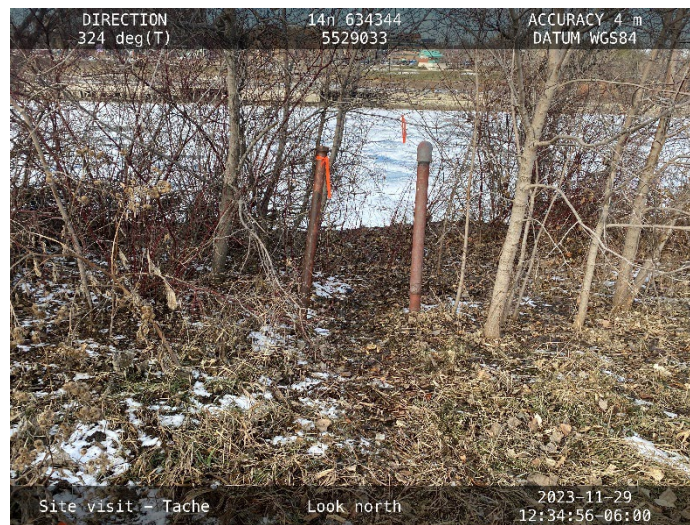
Photo 2 – Riverbank crest at outfall

The underdrain outfall pipe runs north along Avenue Tache crossing the intersection with Rue Messenger before crossing an upland area green space to the outlet at a tight inside bend of the Red River (Figure 01). The uplands between the top of bank and Rue Messenger is flat, and grass covered with young and mature trees along the riverbank crest (Photo 1). The riverbank is about 7 m high and sloped at about 2.5H:1V. No active riverbank movements were noted within the outfall right-of-way, although some evidence of shoreline erosion was noted. We understand from MHL that the outfall outlet is buried under a thick layer of river sediment, suggesting the lower bank may be subject to aggradation, at least under normal flow conditions, and may experience net erosion only during large flood events.
