Project Number: 7004

Lead Exposure Survey

Please find below the results of the lead worker exposure survey performed for Winnipeg Transit in Building B located at 421 Osborne Street, Winnipeg on September 29th, 2023.

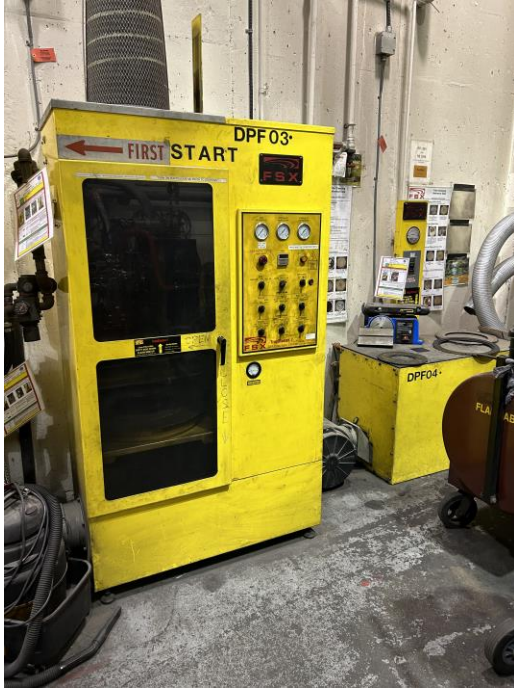
Dyno 2: Control Panel

*These areas had been recently cleaned so samples were collected at the end of the testing period after the DPF filter cleaner had been running.

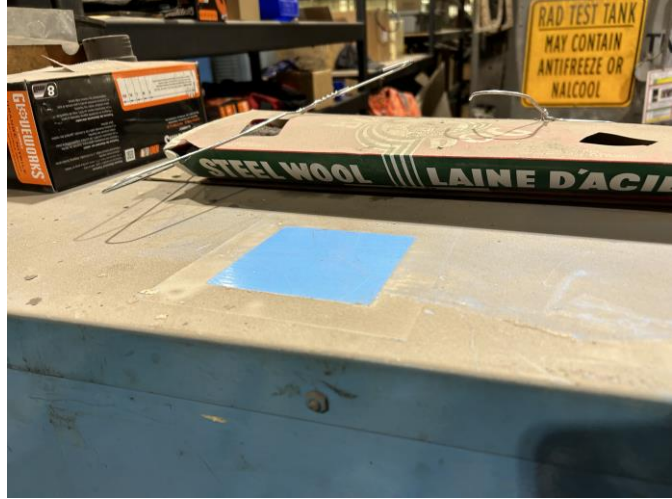
Rebuild – Rad Shop: Top of Blue Cabinet

Higher, but not unusual, levels of lead were found on the high-dust areas. These areas are not touched or used often and some lead accumulation has occurred. Good hygiene practices, including washing hands after touching dirty/dusty objects prior to eating, drinking, or smoking, significantly reduces the potential for lead ingestion.
