TRANSIT MAINTENANCE AND REPAIR BUILDING MECHANICAL UPGRADE - CENTRE HIGH BAY WINNIPEG MANITOBA

PARTIAL ROOF PLAN PLUMBING DEMOLITION

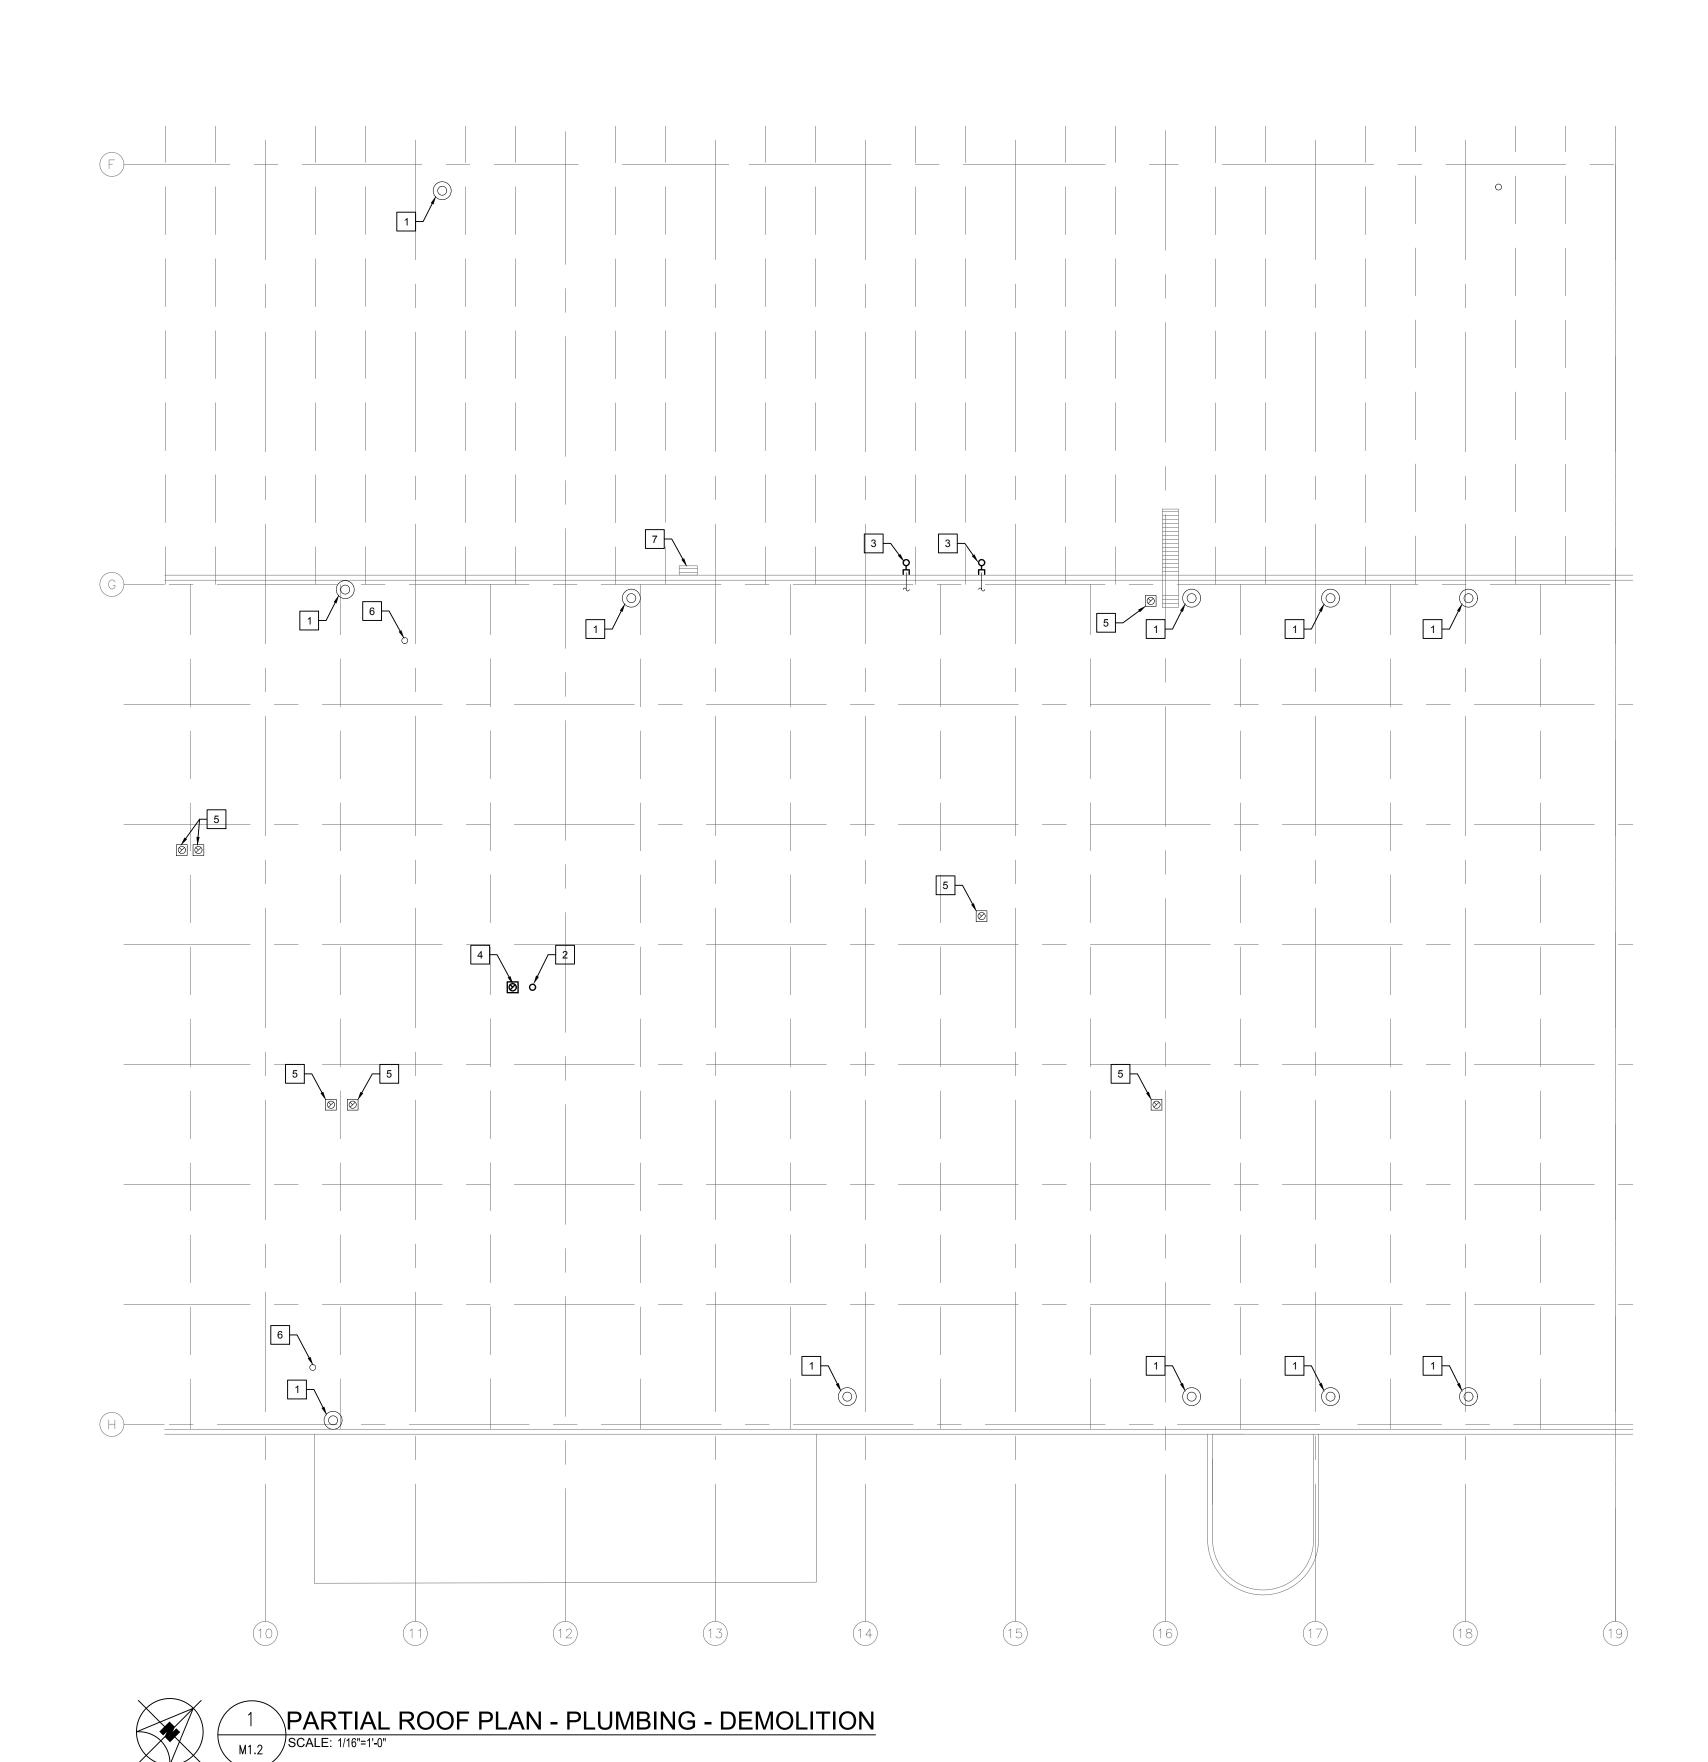
- 1. EXISTING ROOF DRAIN TO REMAIN.
- DEMOLISH AND REMOVE NATURAL GAS PRV VENT BACK TO PRV, REPAIR AND SEAL PRV VENT ROOF OPENING. REFER TO ROOFING SPECIFICATION/DETAILS.
- EXISTING INFRARED HEATER VENT THROUGH WALL BETWEEN HIGH BAY AND LOW BAY ROOF TO BE DEMOLISHED, CAPPED AND ABANDONED AS SHOWN.
- 4. DEMOLISH AND REMOVE MUA VENT. REPAIR AND SEAL ROOF OPENING. REFER TO ROOFING SPECIFICATION/ DETAILS.
- 5. EXISTING INFRARED HEATER VENT TO REMAIN.
- 6. EXISTING INFRARED HEATER COMBUSTION AIR INTAKE TO REMAIN
- EXISTING LADDER TO BE REMOVED. REFER TO STRUCTURAL DRAWINGS.
