CITY OF WINNIPEG

Deck and Patio Areas of Bill and Helen Norrie Library – Geotechnical Assessment Report

Final Rev 0

24-0107-011

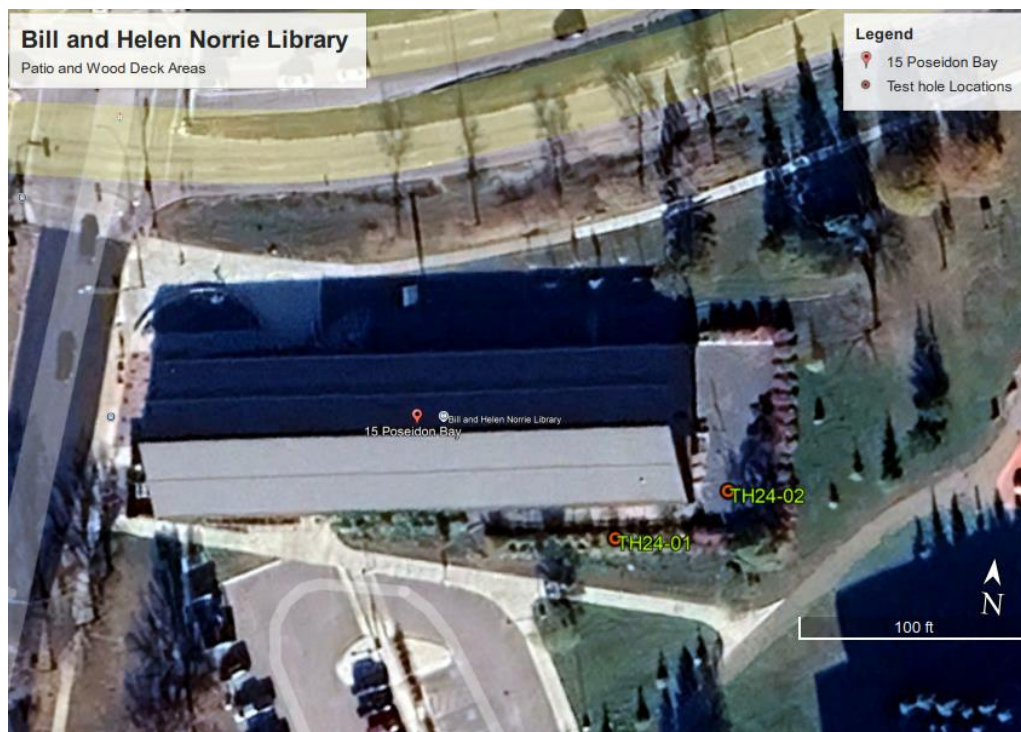
FIGURE 1: TEST HOLE LOCATION PLAN

Test hole locations are shown on Figure 1. Test hole summary and UTM coordinates are provided in Table 1.

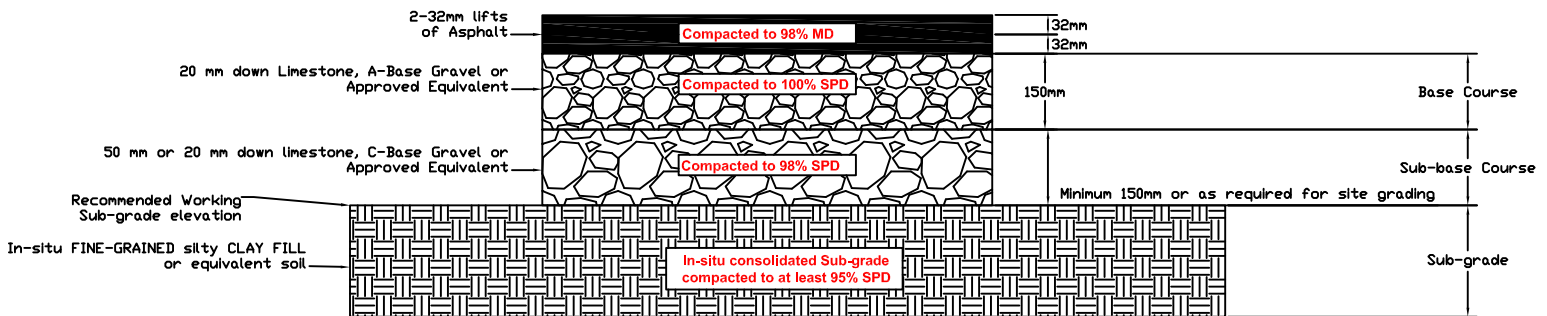
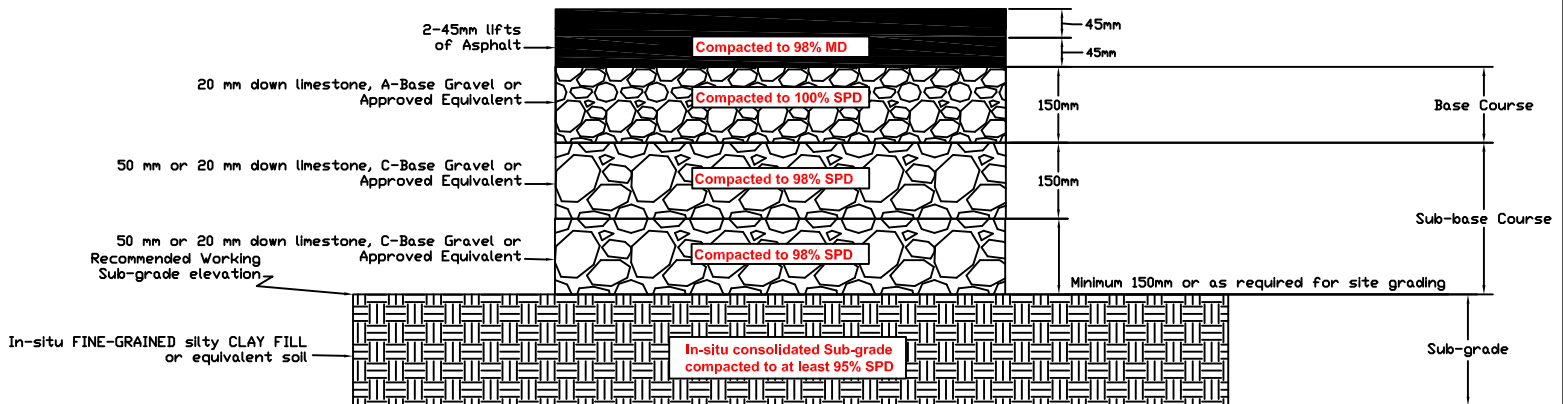
Drawing: PAVEMENTS' STRUCTURES

Car Traffic Areas

Truck Traffic Areas

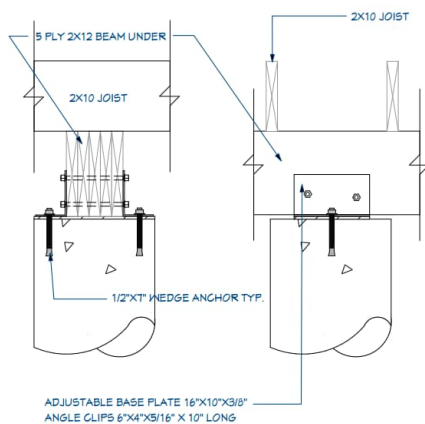
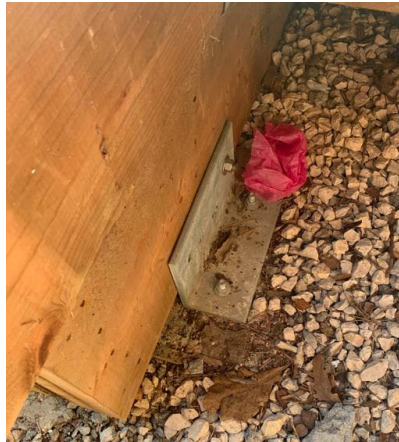
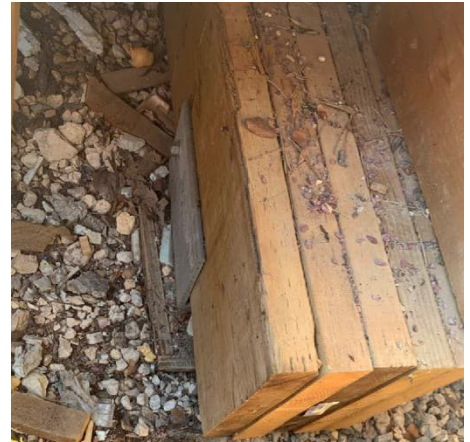
It was noted that the deck had heaved significantly on the east end of deck. From what could be seen on site it appears that the construction of the deck follows what is shown on the original shop drawings (and not CWO No.14) in general with some noted discrepancies;

- It was noted that the connection between the piles and built-up beams does not match what was shown on the shop drawings. The beam is to be sitting directly on the piles with 2 angles framing on either side of the beam connected to the pile. On site it was noted one of the angles is turned to be under the beam so the beam does not have full bearing as it is sitting on top of the bolt or shimmed. In one location it appeared the beam was not bearing on anything as a large space was noted under the beam.

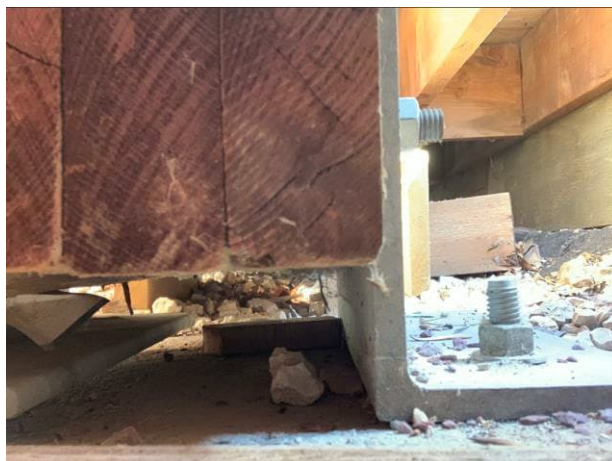
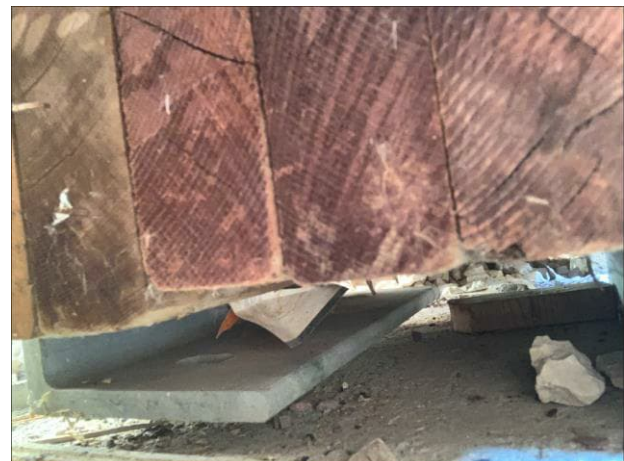
- Per the shop drawings the connection between the beam and pile was to have one anchor bolt on each side to connect the angle and pile. It was noted that only one angle was connected to the pile, and the other angle was not connected at all. This allows for the beam to rotate and lift if uplift soil pressure is applied. Also, there were gaps noted between the pile and the underside of the angle as well as the angle and beam. It also appeared that a square pile cap was poured on top of the pile which did not allow the beam to pile connection as per the shop drawings.

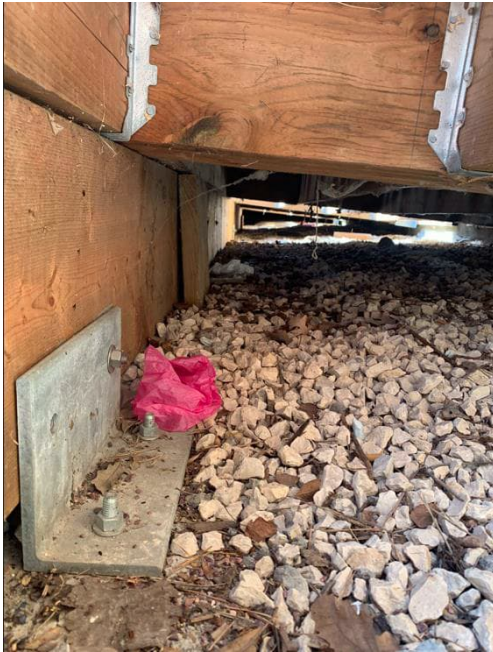
The subgrade below the deck did not appear to have a slope as noted on the HTFC drawings and the beam was sitting directly on the subgrade in some locations. There should be minimum 6" space between the structure and the subgrade to avoid the soil from heaving against the beams and joists.

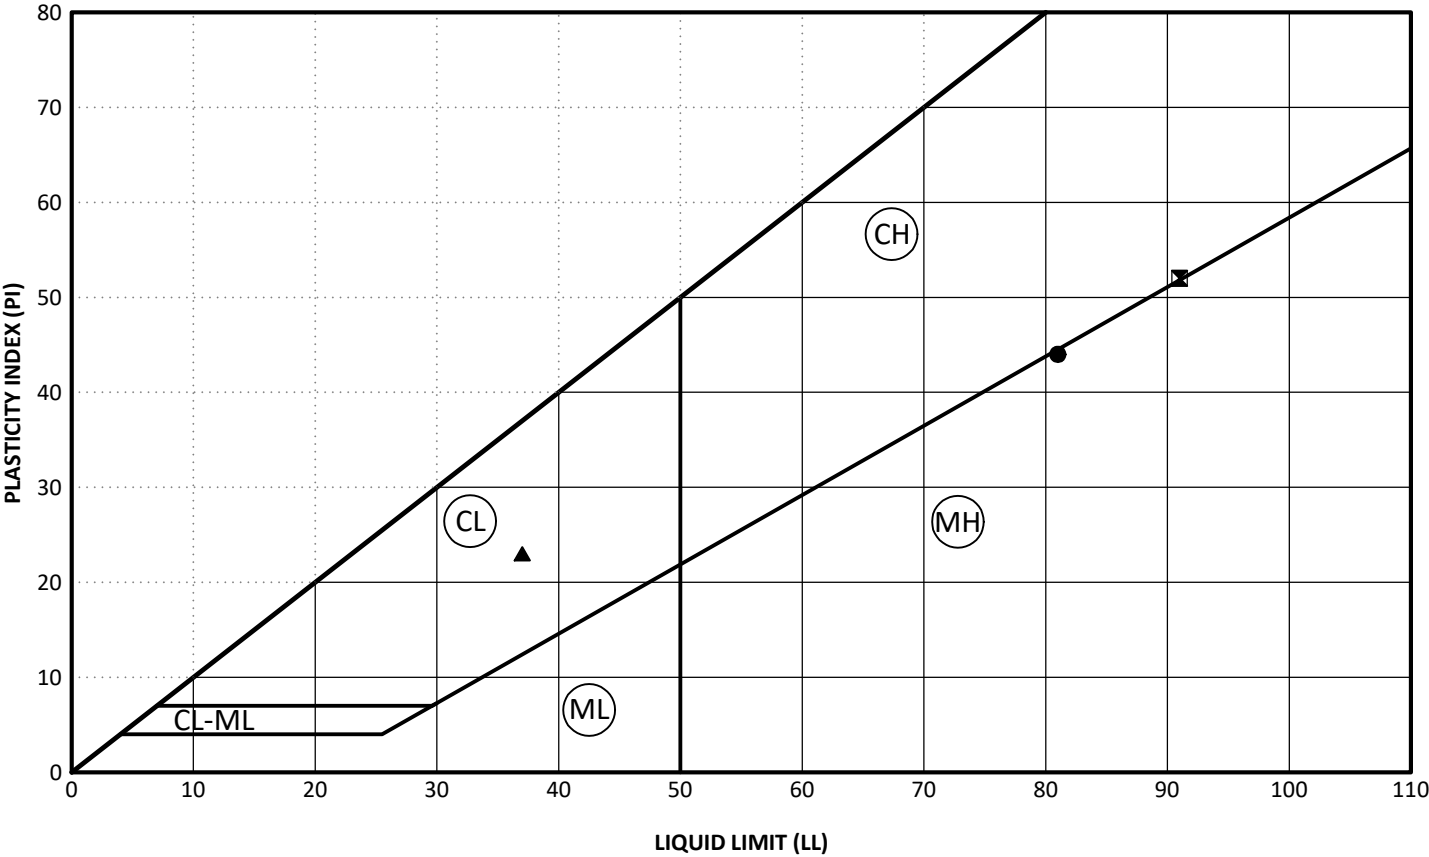
ATTERBERG LIMITS

HOLE	DEPTH (m)	SAMPLE #	LL	PL	PI	SAND (%)	SILT (%)	CLAY (%)	SILT & CLAY (%)	MC (%)	CLASSIFICATION
●	TH24-01	0.9	S2	81	37	44	1	9	90	99	31	CH
⊠	TH24-02	1.8	S4	91	39	52	2	13	85	98	40	CH
▲	TH24-02	10.4	S10	37	14	23					25	SILT TILL
