# **APPENDIX A: GEOTECHNICAL REPORT**

## **Louise Bridge Rehabilitation Preliminary Design Geotechnical Investigation Report**

**Project Number:** 0002-171-00

**Date:** February 25, 2026

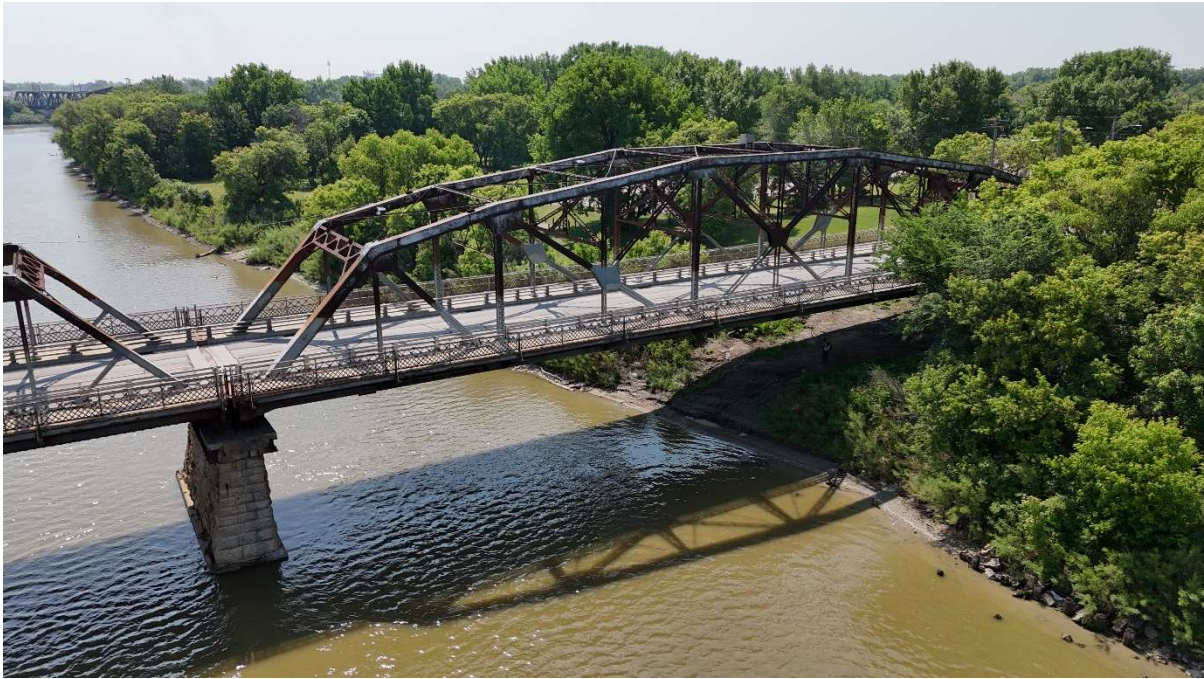
**Photo 1- View of the South Riverbank (Downstream looking east)**

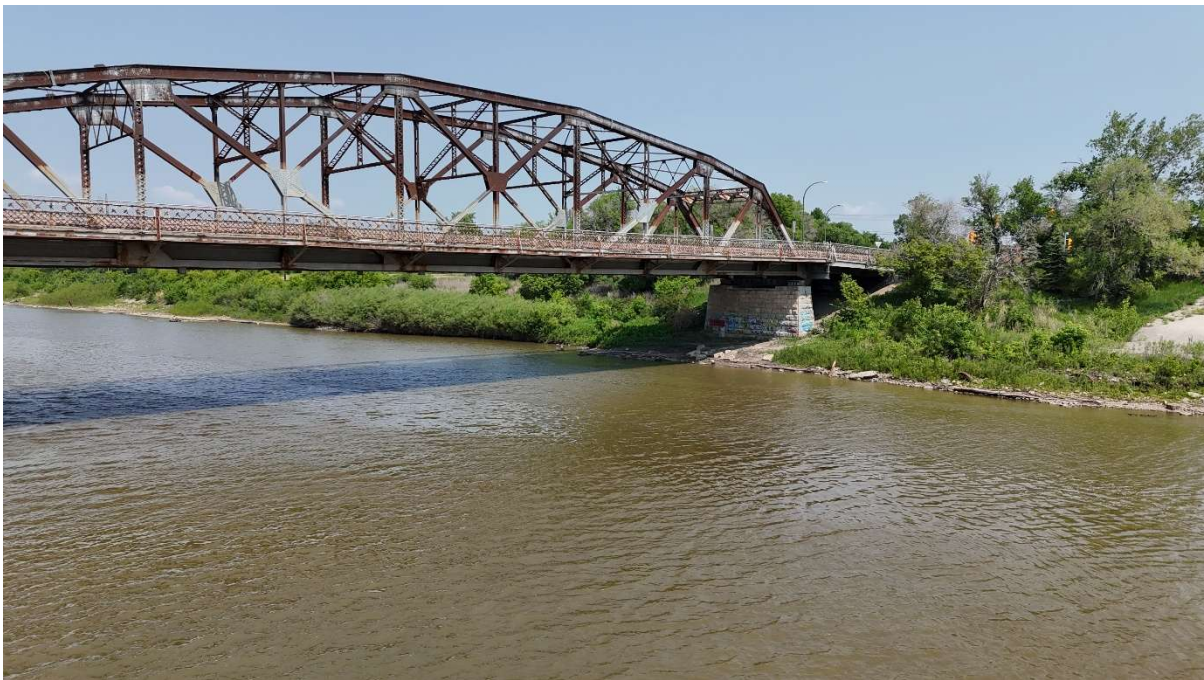
**Photo 2 - View of the North Riverbank (Upstream looking West)**

On the north riverbank, downstream (west) of the bridge, global instabilities are present throughout Ernie O'Dowda Park, and it appears that slope movements have been progressing towards the bridge since 1992 (as noted in the previous KGS report).

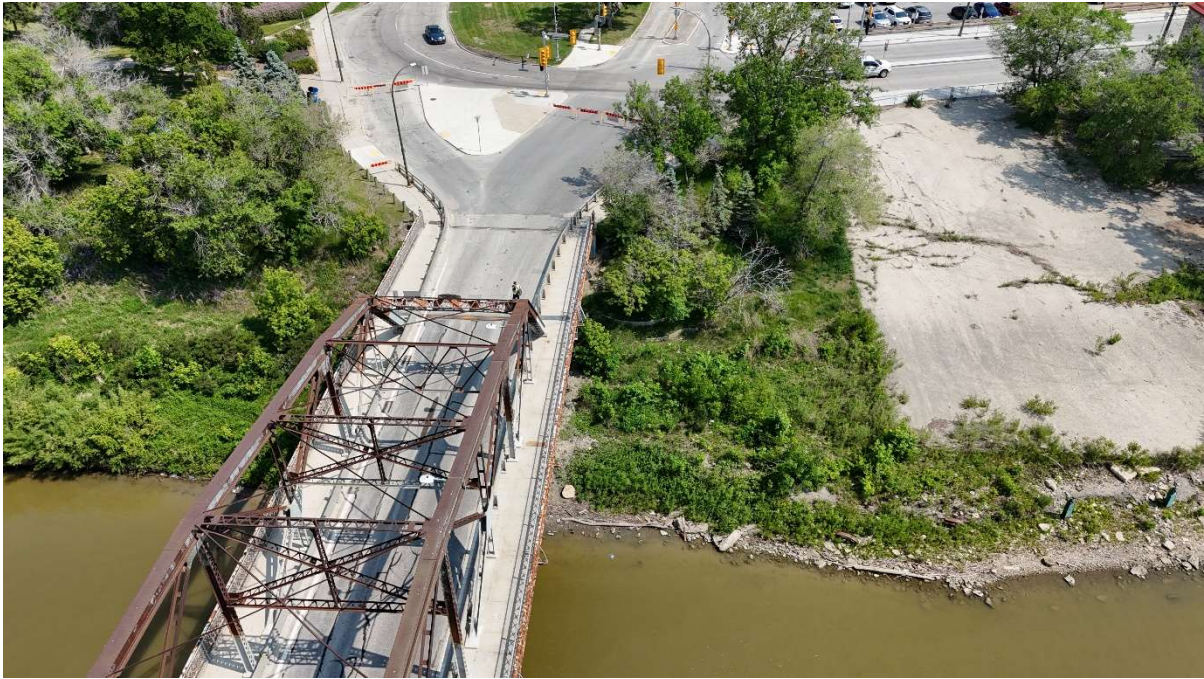
**Photo 3 - View of the North Riverbank (looking North)**

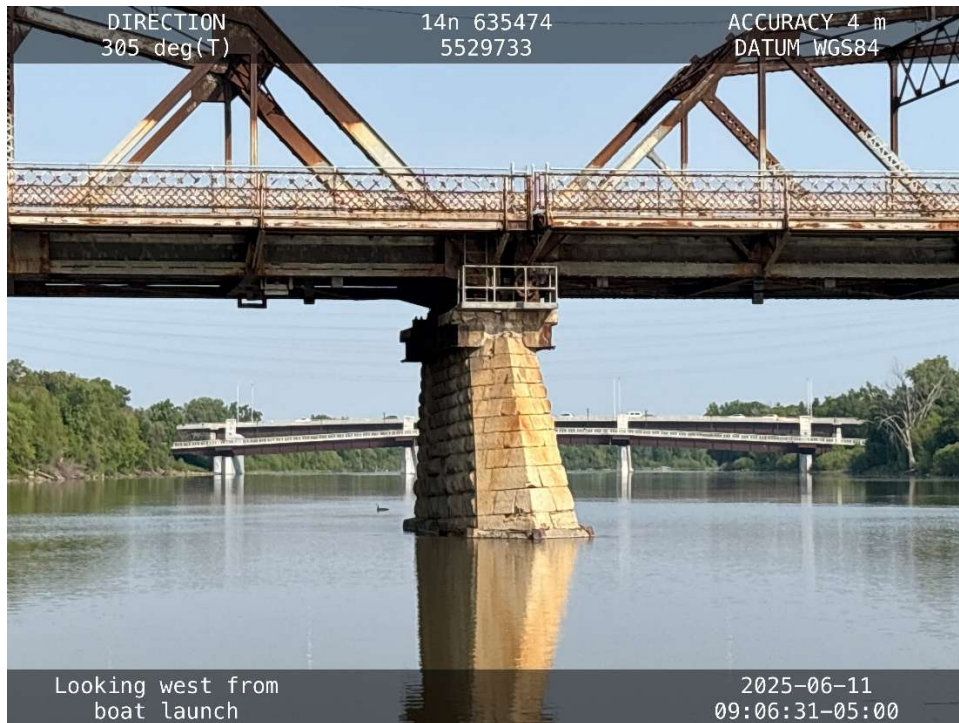
**Photo 4 - Pier 2 Looking West from South East Shoreline**

Pier 2 (south river pier) is visibly tilted to the west and south (Photos 4 and 5). The concrete collar installed around the base of the pier in the 1960's does not appear to tilt as much as the upper portion of the pier, which may suggest that the pier movements pre-date the installation of the concrete collar. Further discussion on the history of pier movements is included in Section 5.2.

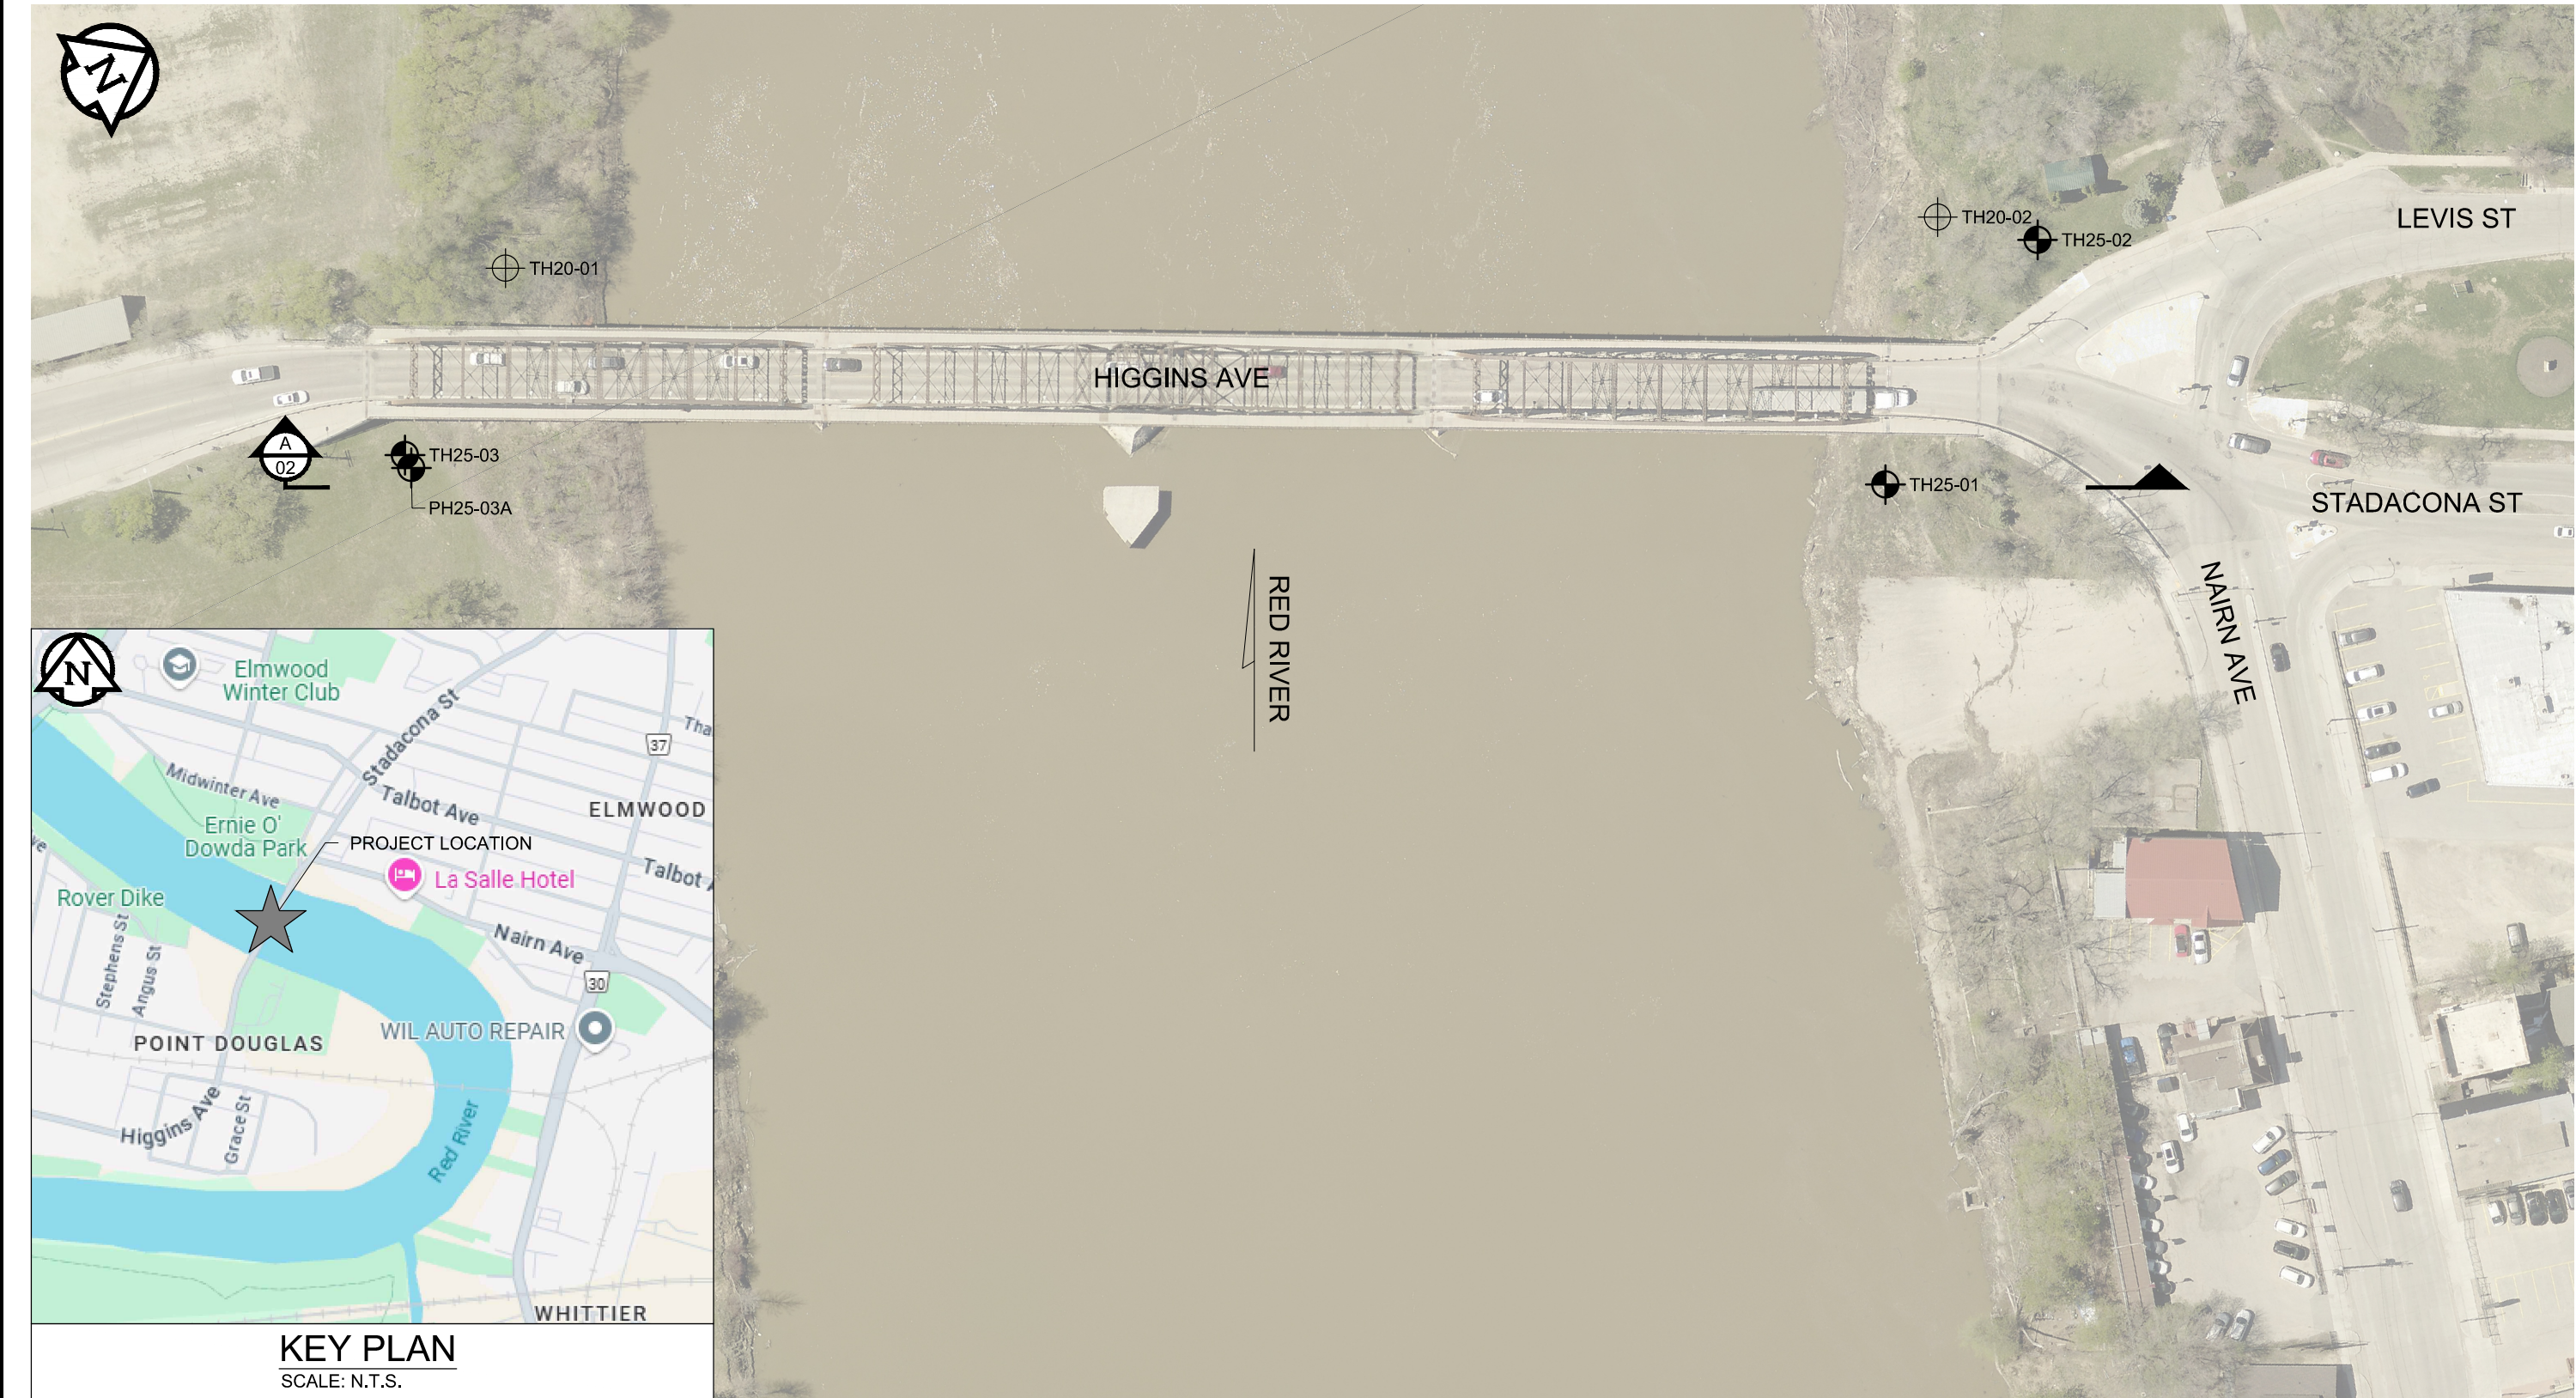
Figure 01

Test Hole Location Plan

A sub-surface investigation was completed under the supervision of TREK personnel to determine the soil stratigraphy and groundwater conditions at the site. Three test holes (TH25-01 to 03) and one probe hole (PH25-03A) were drilled by Paddock Drilling Ltd. from March 24, 2025, to April 4, 2025, using a CME 850 and a Mobile B57 track-mounted drill rig, equipped with 125 mm diameter solid stem auger and HQ coring. One test hole (TH25-03) and one probe hole (PH25-03A) were drilled near the south abutment, and two test holes (TH25-01 & 02) were drilled on either side of the north abutment of the bridge. Slope inclinometer casing SI25-01 was installed in TH25-01 to a depth of 16.2 m, while slope inclinometer casing SI25-03 was installed in a separate probe hole (PH25-03) located approximately 1.5 m east of TH25-03 to a depth of 18.4 m. Four Vibrating wire piezometers (VW's) were installed in both TH25-02 (two VW's) and TH25-03 (two VW's) at varying depths. All test holes were backfilled with a cement-bentonite grout mixture to surface.
