## **GEOTECHNICAL REPORT**

# **Pavement Investigation for The Local Street Renewal Program**

## **2026 Local Streets (26-R-02)**

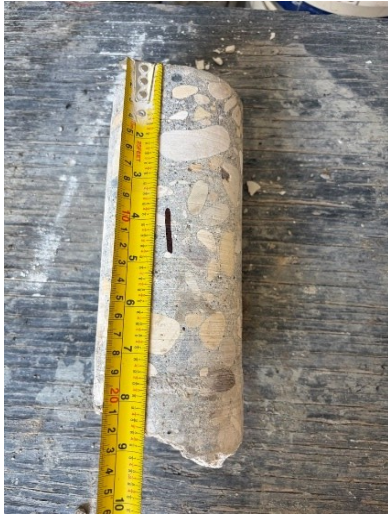
Core 1 - Joint

| CORE HOLE NO. | CORE HOLE LOCATION | PAVEMENT STRUCTURE | |
|---|---|---|---|
| 1 | Joint; NBL Front of House #83 Arlington; 1.3m away from the curb<br>14 U, 631489 m E 5526900 m N | 30 <sup>A</sup> | 220 <sup>A</sup> |

| Core Location | Length as Drilled (mm) | Core Diameter (mm) | Tested Core Length (mm) | Length / Diameter | Correction Factor | Mass (kg) | Age at Break (days) | Date of Break | Type of Fracture | Comp. Strength as Calculated (MPa) | Comp. Strength as Corrected (MPa) |
|---|---|---|---|---|---|---|---|---|---|---|---|
| Core 1 - 83 Arlington, NBL | 220 | 95.5 | 119 | 1.25 | 0.93 | 1.95 | - | 28-Jul-26 | 2 | 29.32 | 27.27 |

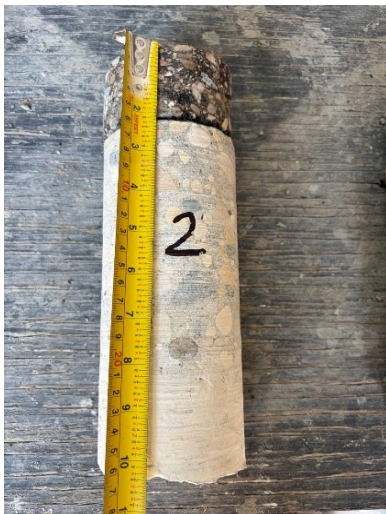
Core 2 - Mid Slab

| CORE HOLE NO. | CORE HOLE LOCATION | PAVEMENT STRUCTURE | |
|---|---|---|---|
| 2 | Mid Slab; SBL Front of House # 138 Arlington; 1.5m away from the curb<br>14 U, 631487 m E, 5527047 m N | 53 | 265 |

| Core Location | Length as Drilled (mm) | Core Diameter (mm) | Tested Core Length (mm) | Length / Diameter | Correction Factor | Mass (kg) | Age at Break (days) | Date of Break | Type of Fracture | Comp. Strength as Calculated (MPa) | Comp. Strength as Corrected (MPa) |
|---|---|---|---|---|---|---|---|---|---|---|---|
| Core 2 - 138 Arlington, Mid Slab, SBL | 265 | 95.5 | 128 | 1.34 | 0.94 | 2.11 | - | 28-Jul-26 | 2 | 25.27 | 23.75 |

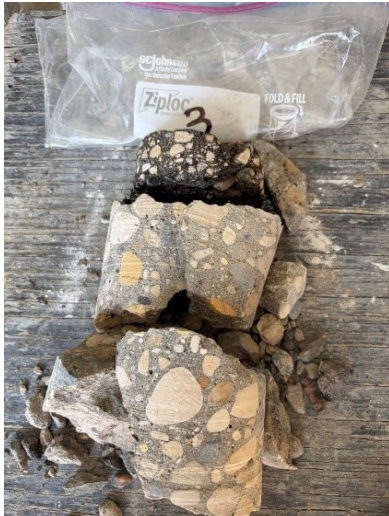
| CORE HOLE NO. | CORE HOLE LOCATION | PAVEMENT STRUCTURE | |
|---|---|---|---|
| 3 | Joint; NBL Front of House # 163 Arlington; 1.6m away from the curb<br>14 U, 631494 m E, 5527158 m N | 30 <sup>A</sup> | 200 <sup>A</sup> |

<sup>A</sup> - Thickness can not be identified due to deterioration of sample during coring

Core 3 - Joint (Deteriorated)

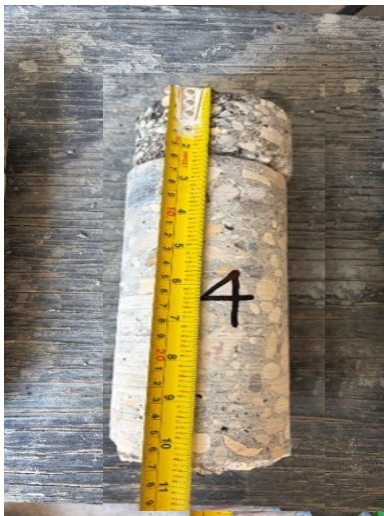
Core 4 - Mid Slab

| CORE HOLE NO. | CORE HOLE LOCATION | PAVEMENT STRUCTURE | |
|---|---|---|---|
| 4 | Mid Slab; SBL Front of House # 205 Arlington; 1.2m away from the curb<br>14 U, 631493 m E, 5527300 m N | 52 | 270 |

| Core Location | Length as Drilled (mm) | Core Diameter (mm) | Tested Core Length (mm) | Length / Diameter | Correction Factor | Mass (kg) | Age at Break (days) | Date of Break | Type of Fracture | Comp. Strength as Calculated (MPa) | Comp. Strength as Corrected (MPa) |
|---|---|---|---|---|---|---|---|---|---|---|---|
| Core 4 - 205 Arlington, Mid Slab, SBL | 270 | 95.5 | 191 | 2.00 | 1 | 3.34 | - | 28-Jul-26 | 2 | 49.31 | 49.31 |

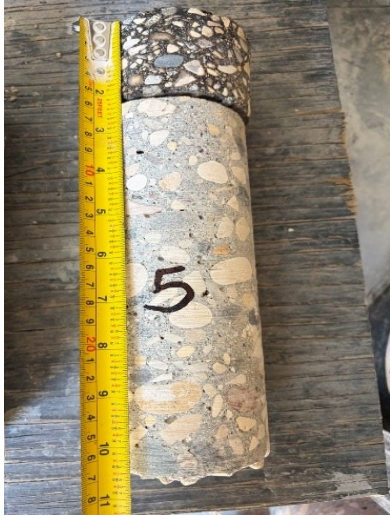
Core 5 - Mid Slab

| CORE HOLE NO. | CORE HOLE LOCATION | PAVEMENT STRUCTURE | |
|---|---|---|---|
| 5 | Mid Slab; NBL Front of Bus Stop 11100; 1.4m away from the curb<br>14 U, 631501 m E, 5527473 m N | 54 | 270 |

| Core Location | Length as Drilled (mm) | Core Diameter (mm) | Tested Core Length (mm) | Length / Diameter | Correction Factor | Mass (kg) | Age at Break (days) | Date of Break | Type of Fracture | Comp. Strength as Calculated (MPa) | Comp. Strength as Corrected (MPa) |
|---|---|---|---|---|---|---|---|---|---|---|---|
| Core 5 - Bus Stop 11100 Arlington, Mid slab, NBL | 270 | 95.5 | 130 | 1.36 | 0.94 | 2.05 | - | 28-Jul-26 | 3 | 28.89 | 27.16 |

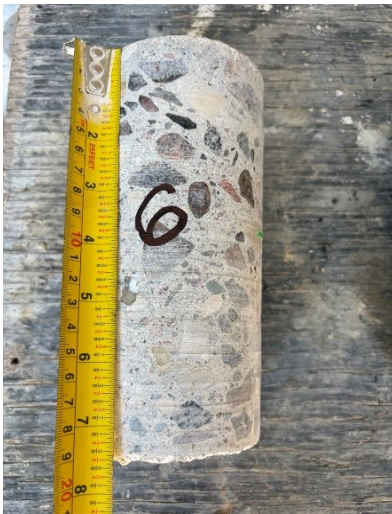
Core 6 - Mid Slab

| CORE HOLE NO. | CORE HOLE LOCATION | PAVEMENT STRUCTURE | |
|---|---|---|---|
| 6 | Mid Slab; EBL Front of House #17 Burnett Ave; 2.3m away from the curb<br>14 U, 638834 m E, 5532895 m N | - | 200 |

| Core Location | Length as Drilled (mm) | Core Diameter (mm) | Tested Core Length (mm) | Length / Diameter | Correction Factor | Mass (kg) | Age at Break (days) | Date of Break | Type of Fracture | Comp. Strength as Calculated (MPa) | Comp. Strength as Corrected (MPa) |
|---|---|---|---|---|---|---|---|---|---|---|---|
| Core 6 - 17 Burnett Ave, Mid slab, EBL | 200 | 95.5 | 182 | 1.91 | 0.99 | 3.10 | - | 28-Jul-26 | 2 | 40.96 | 40.63 |

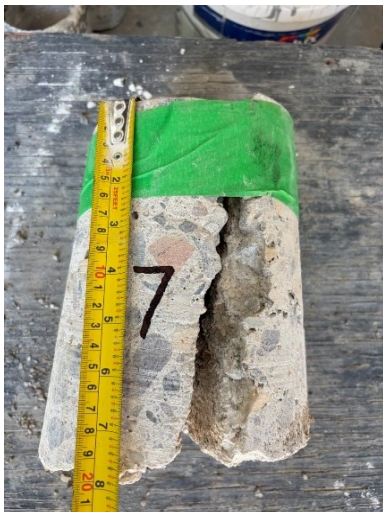
Core 7 - Joint

| CORE HOLE NO. | CORE HOLE LOCATION | PAVEMENT STRUCTURE | |
|---|---|---|---|
| 7 | Joint; EBL Front of House #68 Burnett Ave; 1.6m away from the curb<br>14 U, 638980 m E, 5532820 m N | - | 210 |

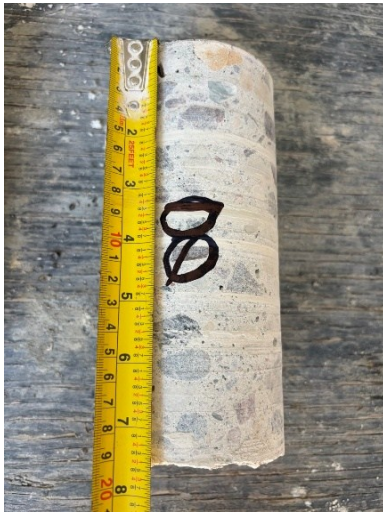
Core 8 - Mid Slab

| CORE HOLE NO. | CORE HOLE LOCATION | PAVEMENT STRUCTURE | |
|---|---|---|---|
| 8 | Mid Slab; WBL Front of House #151 Burnett Ave; 1.4m away from the curb<br>14 U, 639252 m E, 5532695 m N | - | 209 |

| Core Location | Length as Drilled (mm) | Core Diameter (mm) | Tested Core Length (mm) | Length / Diameter | Correction Factor | Mass (kg) | Age at Break (days) | Date of Break | Type of Fracture | Comp. Strength as Calculated (MPa) | Comp. Strength as Corrected (MPa) |
|---|---|---|---|---|---|---|---|---|---|---|---|
| Core 8 - 151 Burnett Ave, Mid slab, WBL | 209 | 95.5 | 181 | 1.90 | 0.99 | 3.11 | - | 28-Jul-26 | 2 | 30.61 | 30.37 |

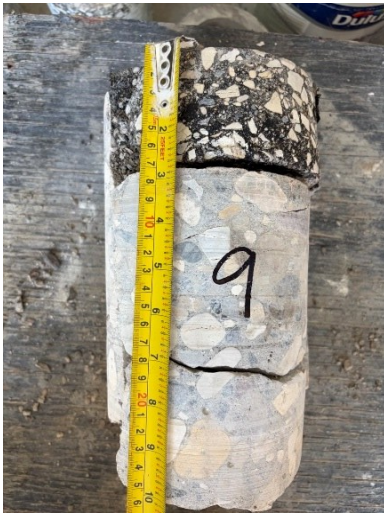
Core 9 - Joint

| CORE HOLE NO. | CORE HOLE LOCATION | PAVEMENT STRUCTURE | |
|---|---|---|---|
| 9 | Joint; SWBL STA 0+180;<br>1.35m away from the curb<br>14 U, 639572 m E, 5533989 m N | 65 | 230 <sup>A</sup> |

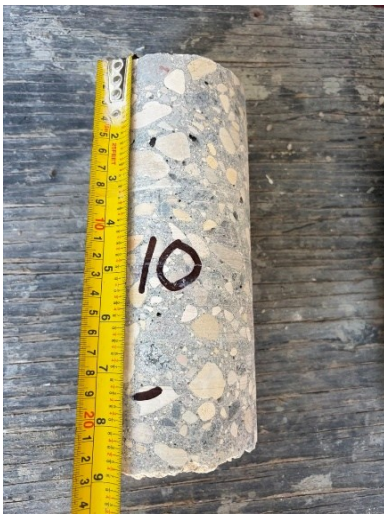
Core 10 - Mid Slab

| CORE HOLE NO. | CORE HOLE LOCATION | PAVEMENT STRUCTURE | |
|---|---|---|---|
| 10 | Mid Slab; NEBL STA 0+260;<br>1.1m away from the curb<br>14 U, 639621 m E, 5534046 m N | - | 225 |

| Core Location | Length as Drilled (mm) | Core Diameter (mm) | Tested Core Length (mm) | Length / Diameter | Correction Factor | Mass (kg) | Age at Break (days) | Date of Break | Type of Fracture | Comp. Strength as Calculated (MPa) | Comp. Strength as Corrected (MPa) |
|---|---|---|---|---|---|---|---|---|---|---|---|
| Core 10 - STA 0+260 Gateway, Mid slab, NEBL | 225 | 95.5 | 191 | 2.00 | 1 | 3.38 | - | 28-Jul-26 | 3 | 49.19 | 49.19 |

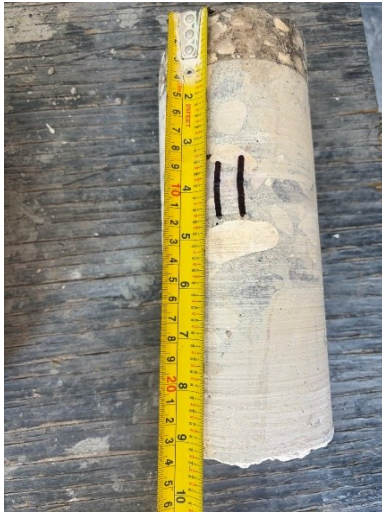
Core 11 - Mid Slab

| CORE HOLE NO. | CORE HOLE LOCATION | PAVEMENT STRUCTURE | |
|---|---|---|---|
| 11 | Mid Slab; NEBL STA 0+380;<br>1.3m away from the curb<br>14 U, 639707 m E, 5534154 m N | 40 | 195 <sup>A</sup> |

| Core Location | Length as Drilled (mm) | Core Diameter (mm) | Tested Core Length (mm) | Length / Diameter | Correction Factor | Mass (kg) | Age at Break (days) | Date of Break | Type of Fracture | Comp. Strength as Calculated (MPa) | Comp. Strength as Corrected (MPa) |
|---|---|---|---|---|---|---|---|---|---|---|---|
| Core 11 - STA 0+380 Gateway, Mid Slab, NEBL | 195 | 95.5 | 190 | 1.99 | 1 | 3.28 | - | 28-Jul-26 | 1 | 41.02 | 41.02 |
