FINAL

Geotechnical Investigation for St. Mary's Road Rehabilitation of 2026 Regional and Local Street Renewal Program

Winnipeg, Manitoba

CA0057241.0340

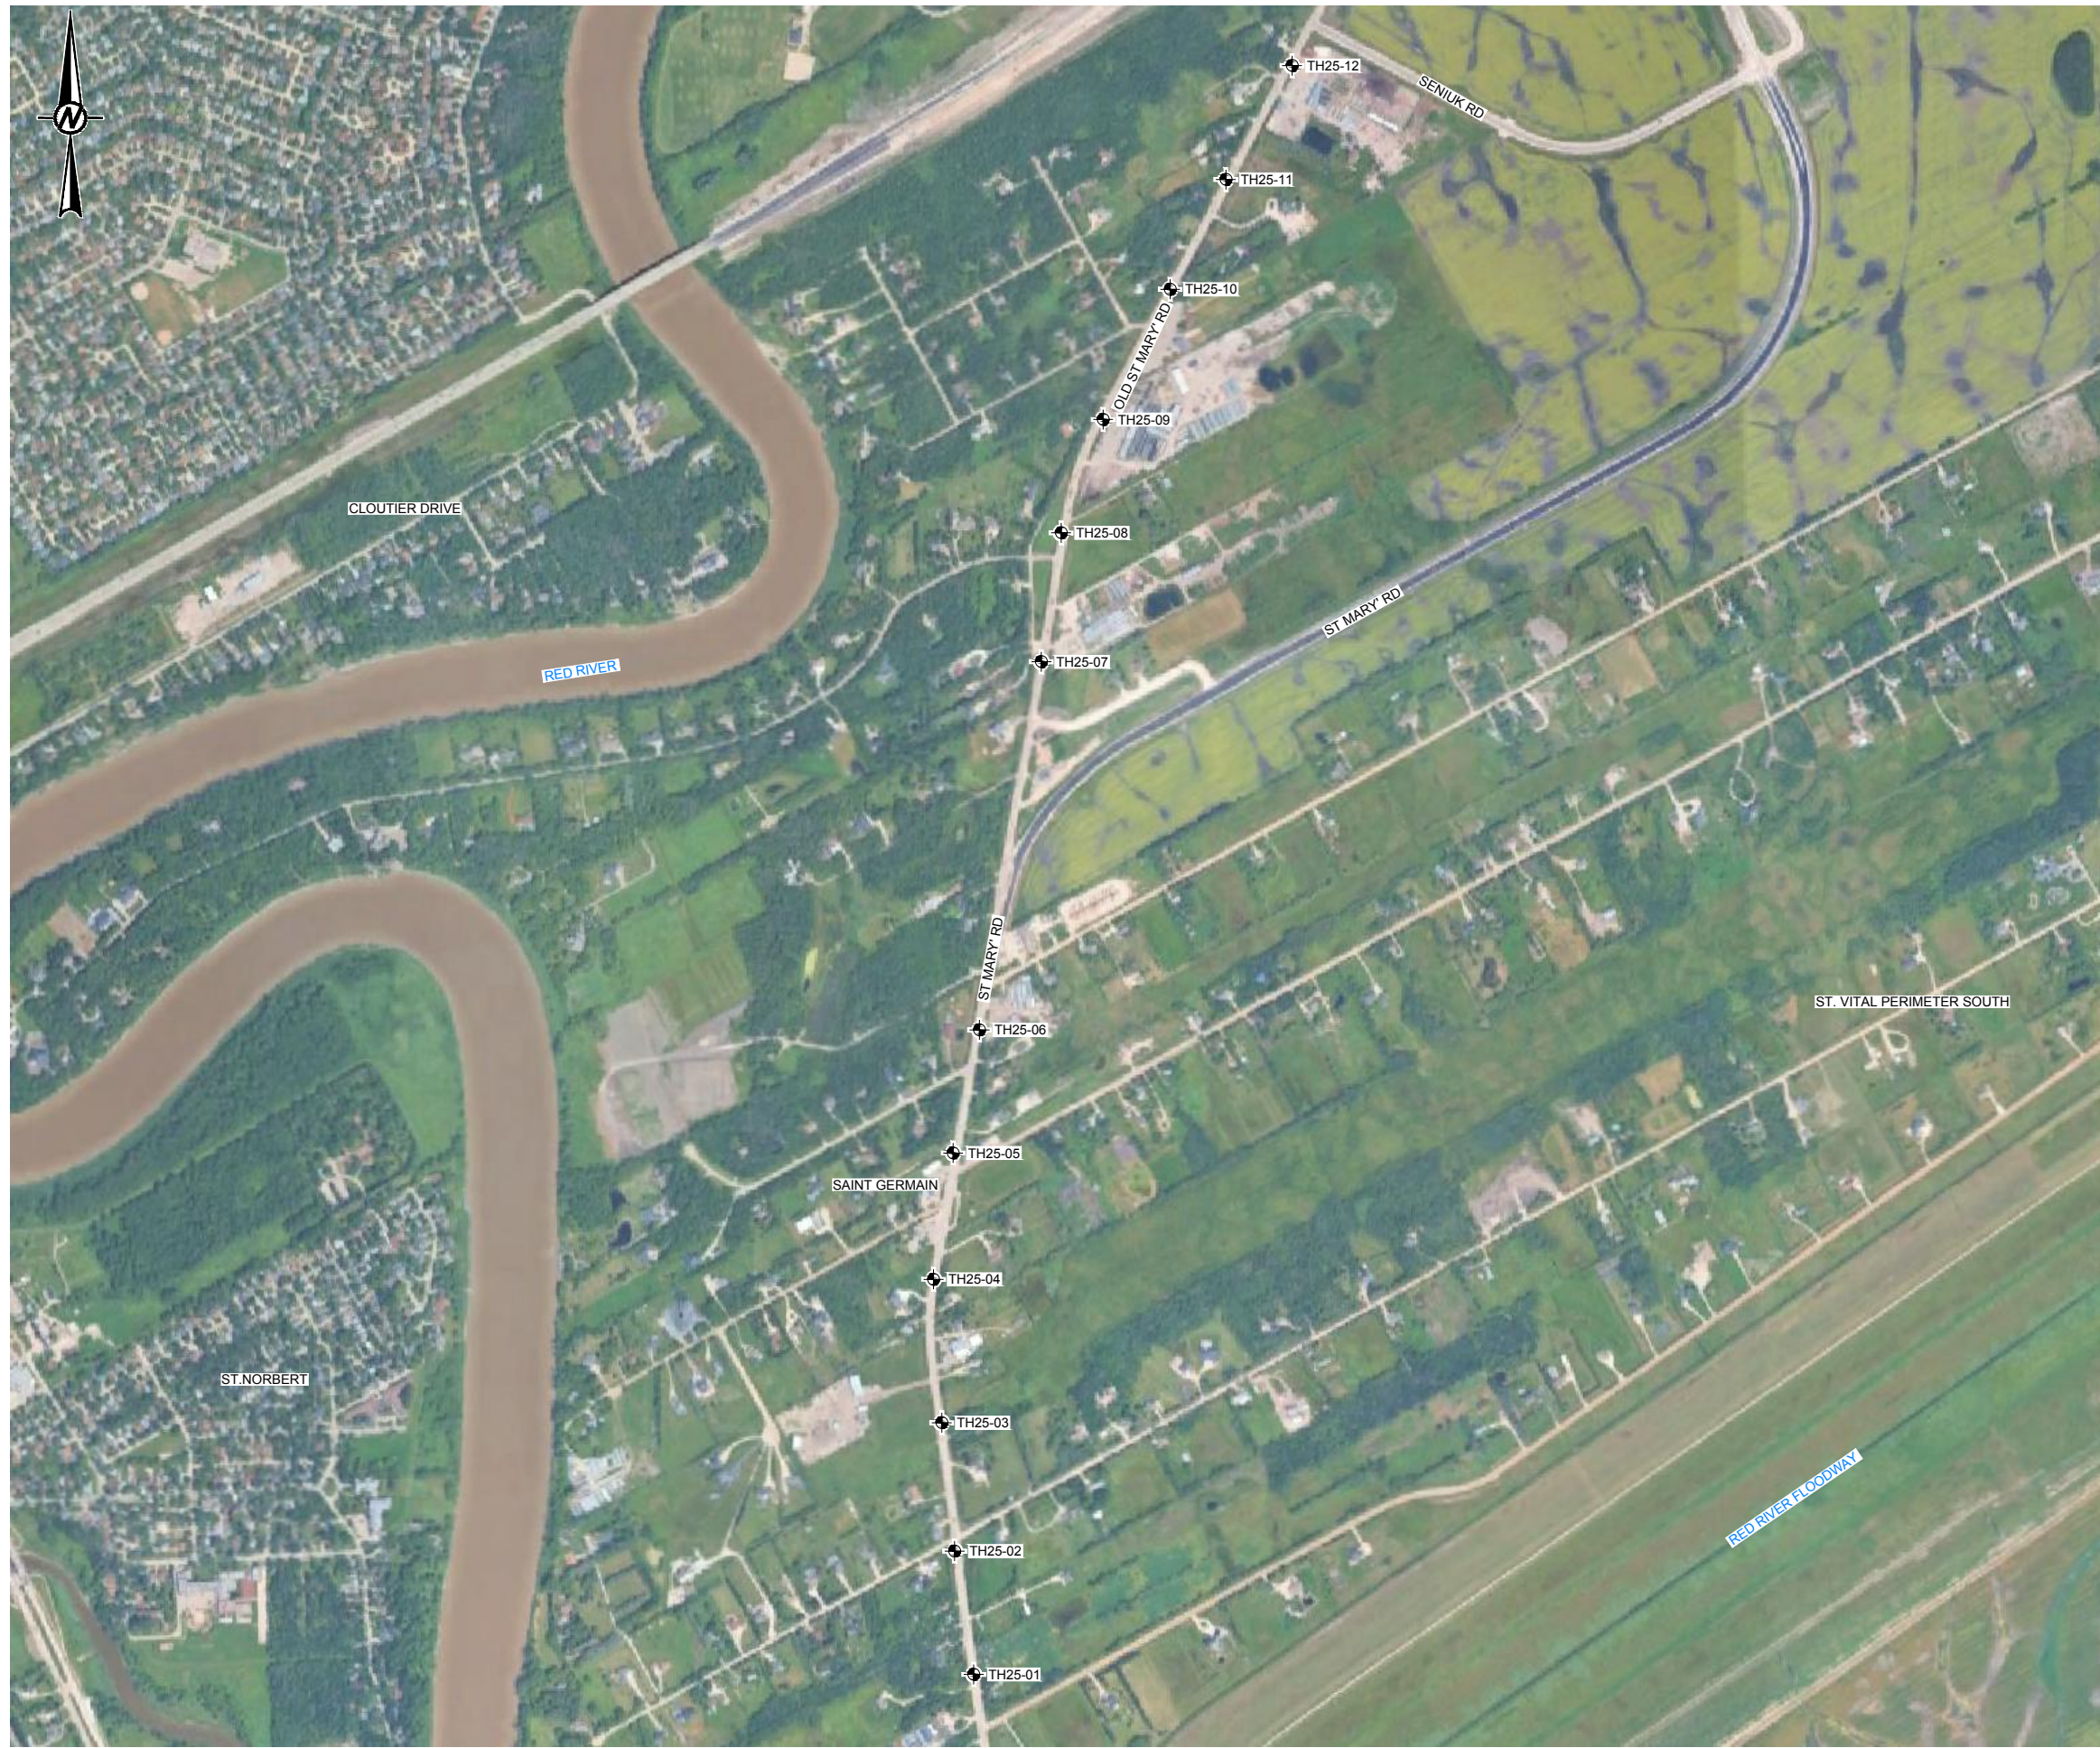
Site and Test Hole Locations Plan

Figure 1 (Appendix A) depicts the site locations. The proposed rehabilitation consists of two sections along St. Mary's Road south of the Perimeter Highway. The north section is about 1400 m long and is located between Seniuk Rd and Viking Rd; the south section is about 1400 m long and is located between Paul Blvd and Chrypko Dr. These sections form part of the City's Primary Line of Defense for flood protection. Based on the City of Winnipeg Transportation Standards Manual, it is understood that the existing St. Mary's Rd within this project is a collector road.

Between 14 and 16 October 2025, WSP supervised the drilling of 12 test holes at select locations along the existing road alignments. Of those, 8 test holes were cored and drilled within the existing roadway to a depth of 3m, and 4 test holes were drilled within the shoulder to 5m for assessment of the temporary dike if installed in the event of flooding as required. The test holes on roadway were staggered across the road centreline to better capture the range of existing pavement structure. The approximate test hole locations are shown on Figure 1 (Appendix A).

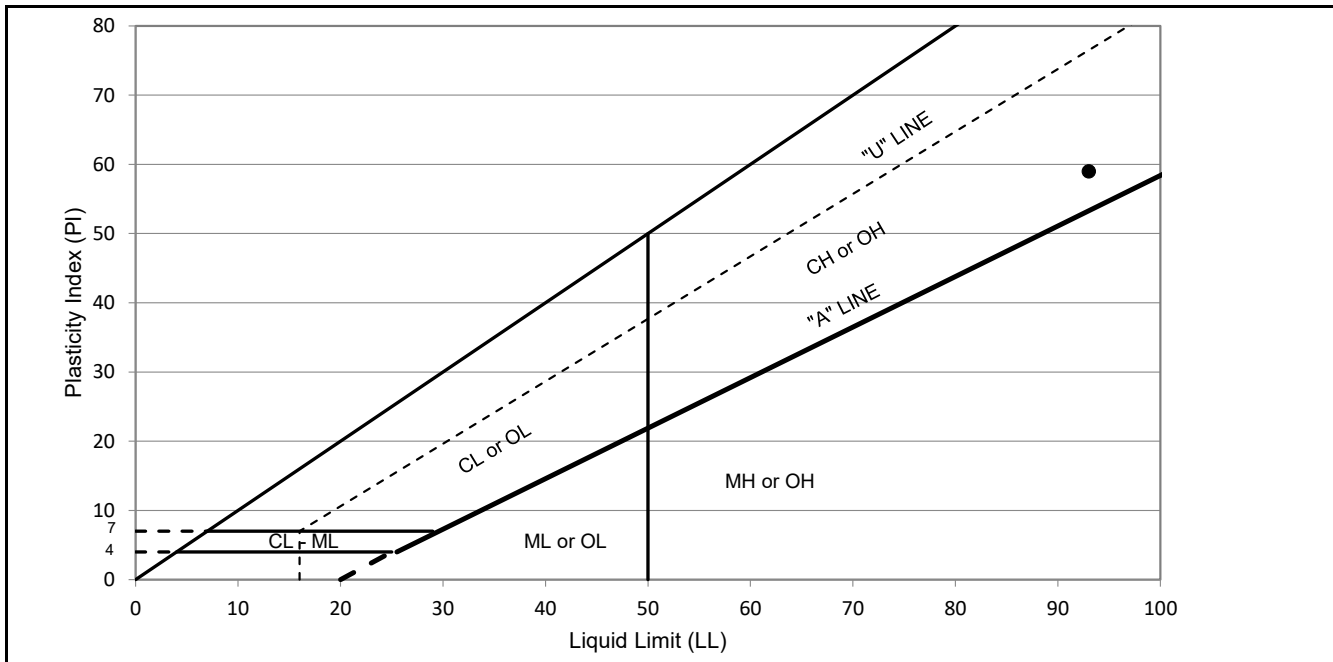
USCS Symbol	CH
LL, Liquid Limit (%)	93
PL, Plastic Limit (%)	34
PI, Plasticity Index	59

Soil Description: High Plastic

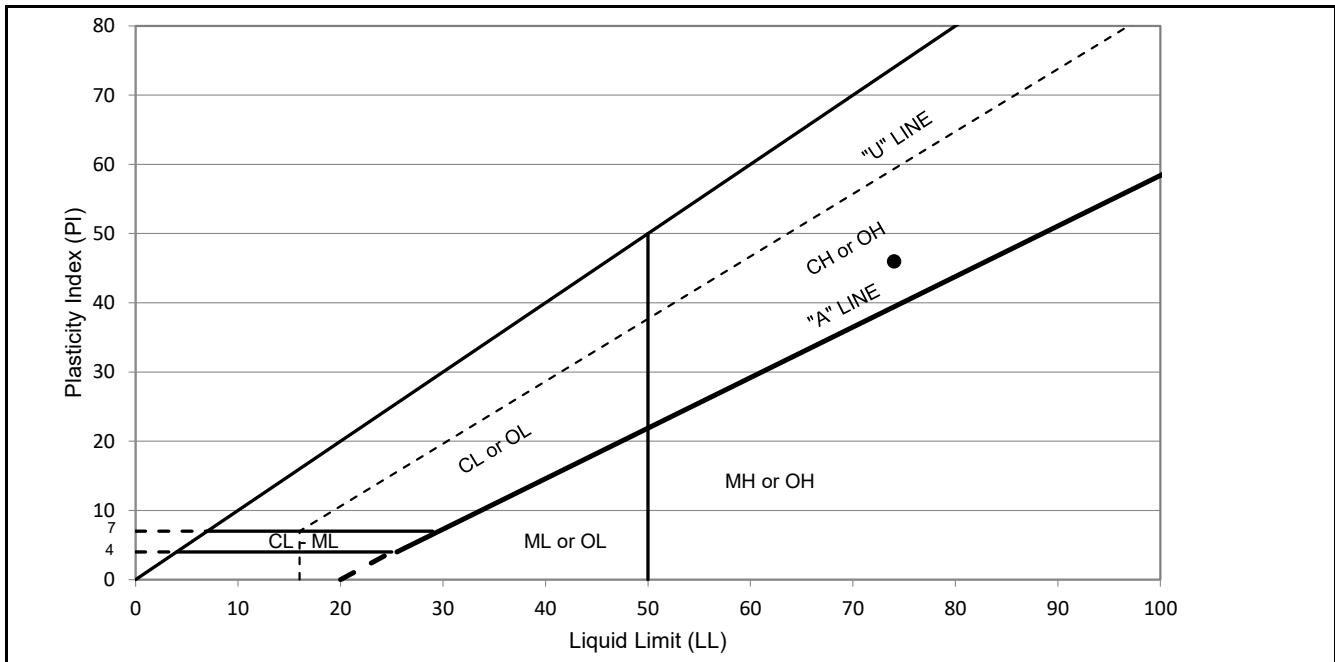
USCS Symbol	CH
LL, Liquid Limit (%)	74
PL, Plastic Limit (%)	28
PI, Plasticity Index	46

Soil Description: High Plastic

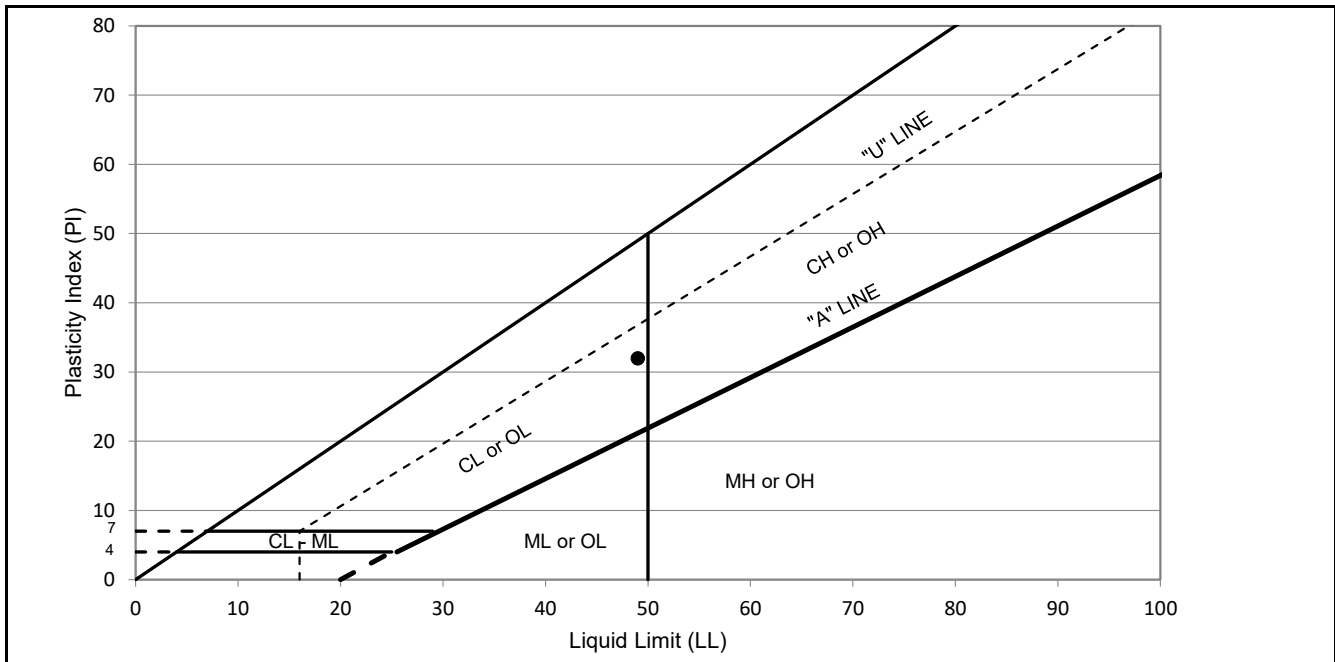
USCS Symbol	CL
LL, Liquid Limit (%)	49
PL, Plastic Limit (%)	17
PI, Plasticity Index	32

Soil Description: Low Plastic

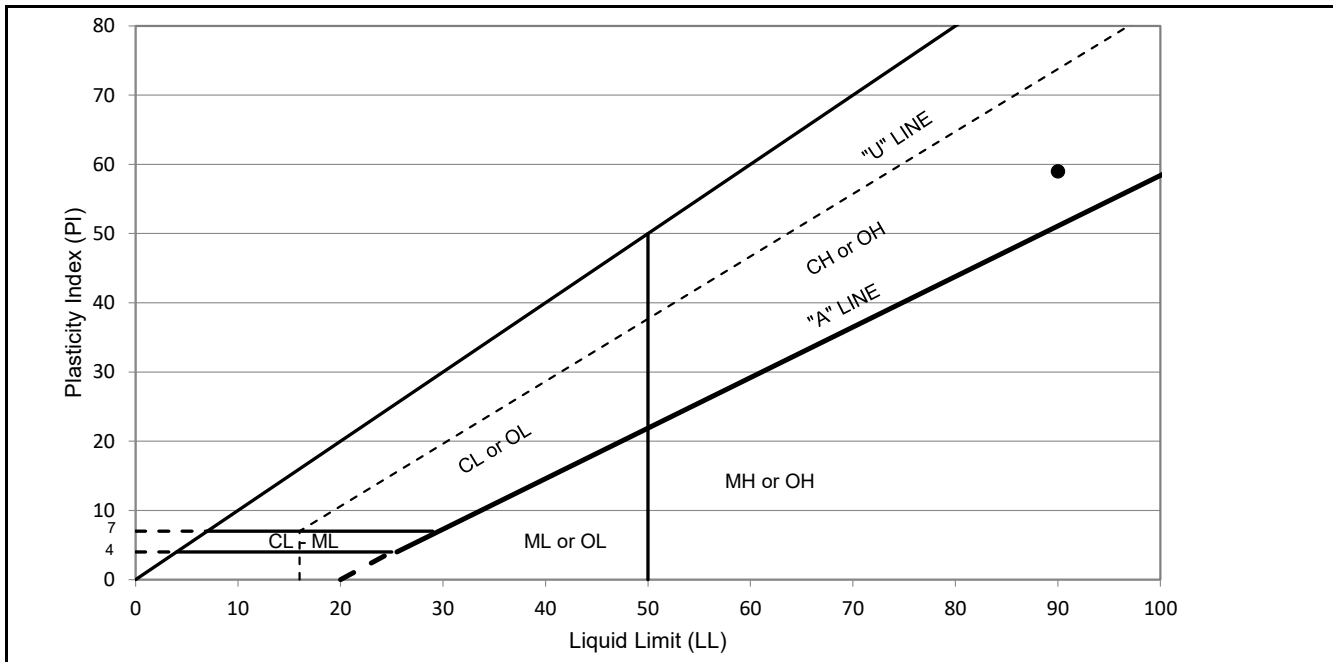
USCS Symbol	CH
LL, Liquid Limit (%)	90
PL, Plastic Limit (%)	31
PI, Plasticity Index	59

Soil Description: High Plastic

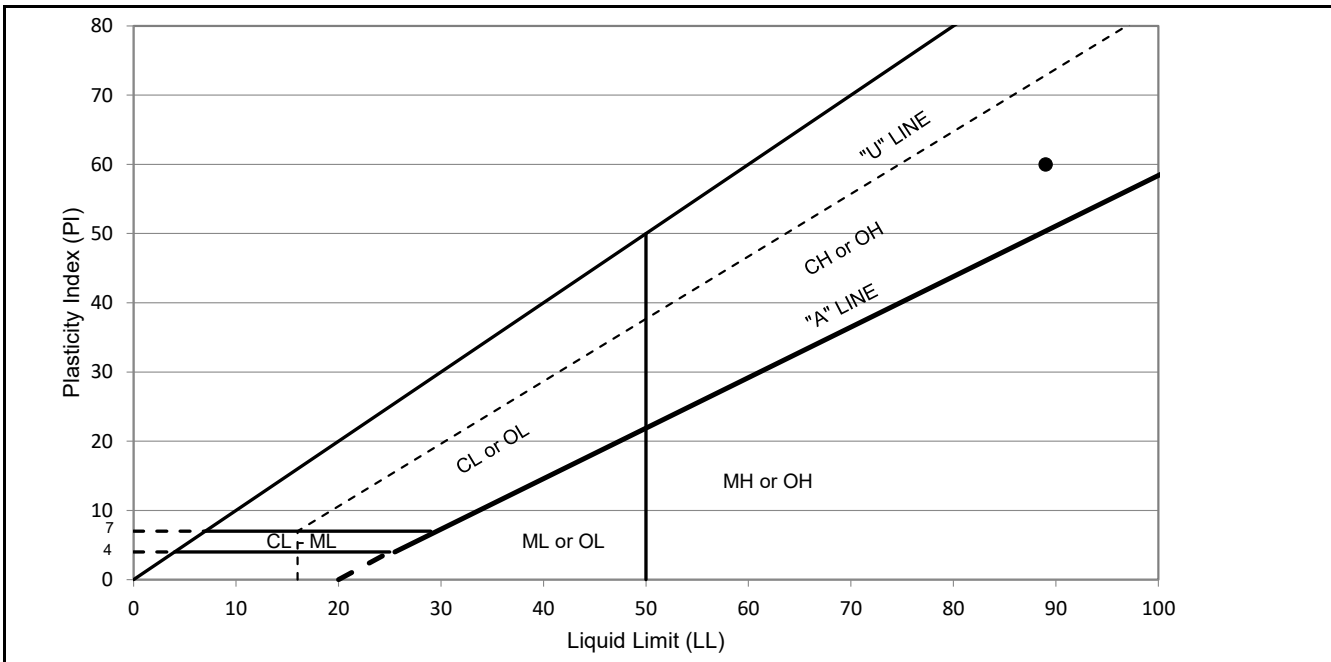
USCS Symbol	CH
LL, Liquid Limit (%)	89
PL, Plastic Limit (%)	29
PI, Plasticity Index	60

Soil Description: High Plastic

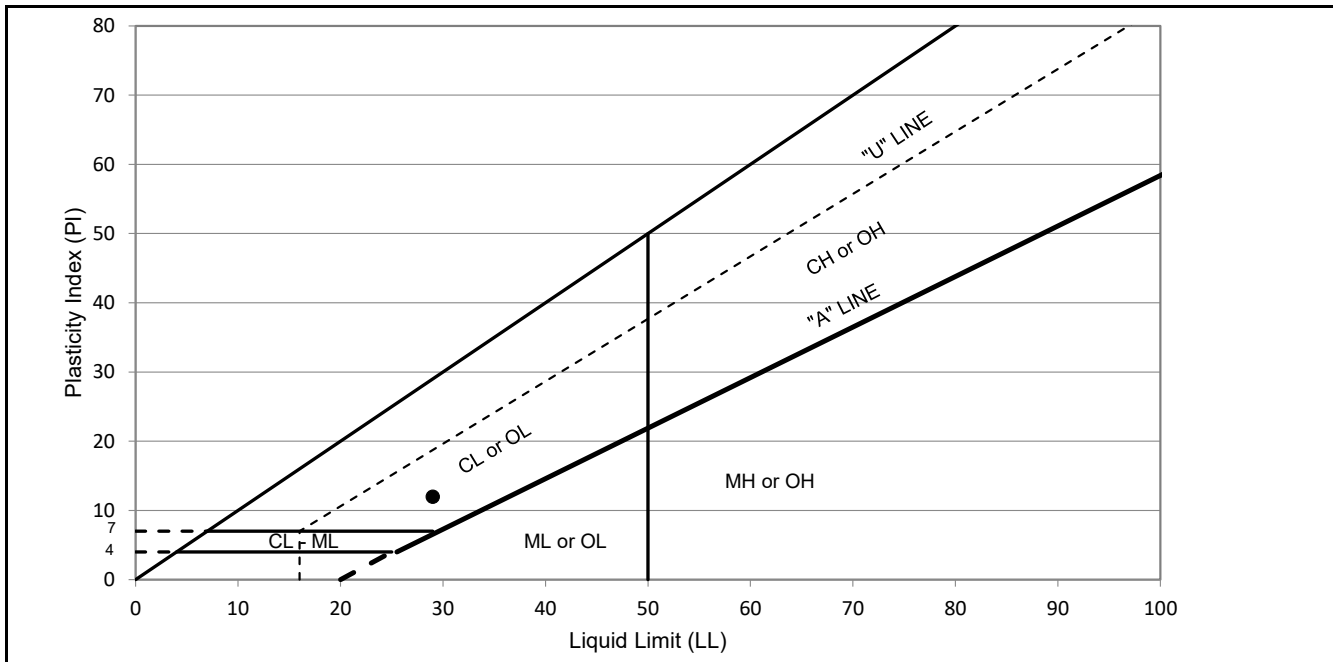
USCS Symbol	CL
LL, Liquid Limit (%)	29
PL, Plastic Limit (%)	17
PI, Plasticity Index	12

Soil Description: Low Plastic

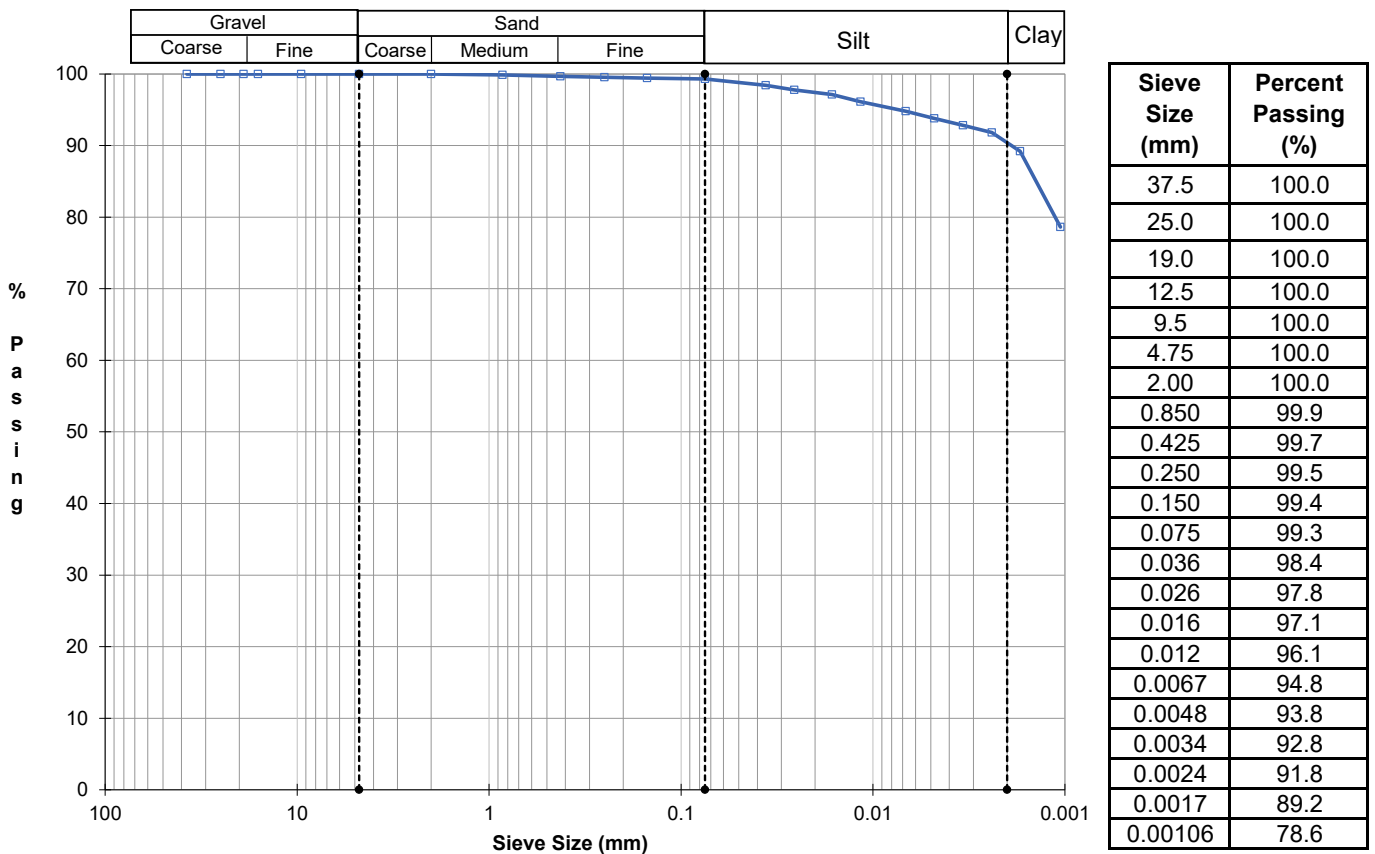
Percent of: Gravel = 0.0% Sand = 0.7% Silt = 8.9% Clay = 90.4%

Sample Discription:
Clay, few silt, trace sand

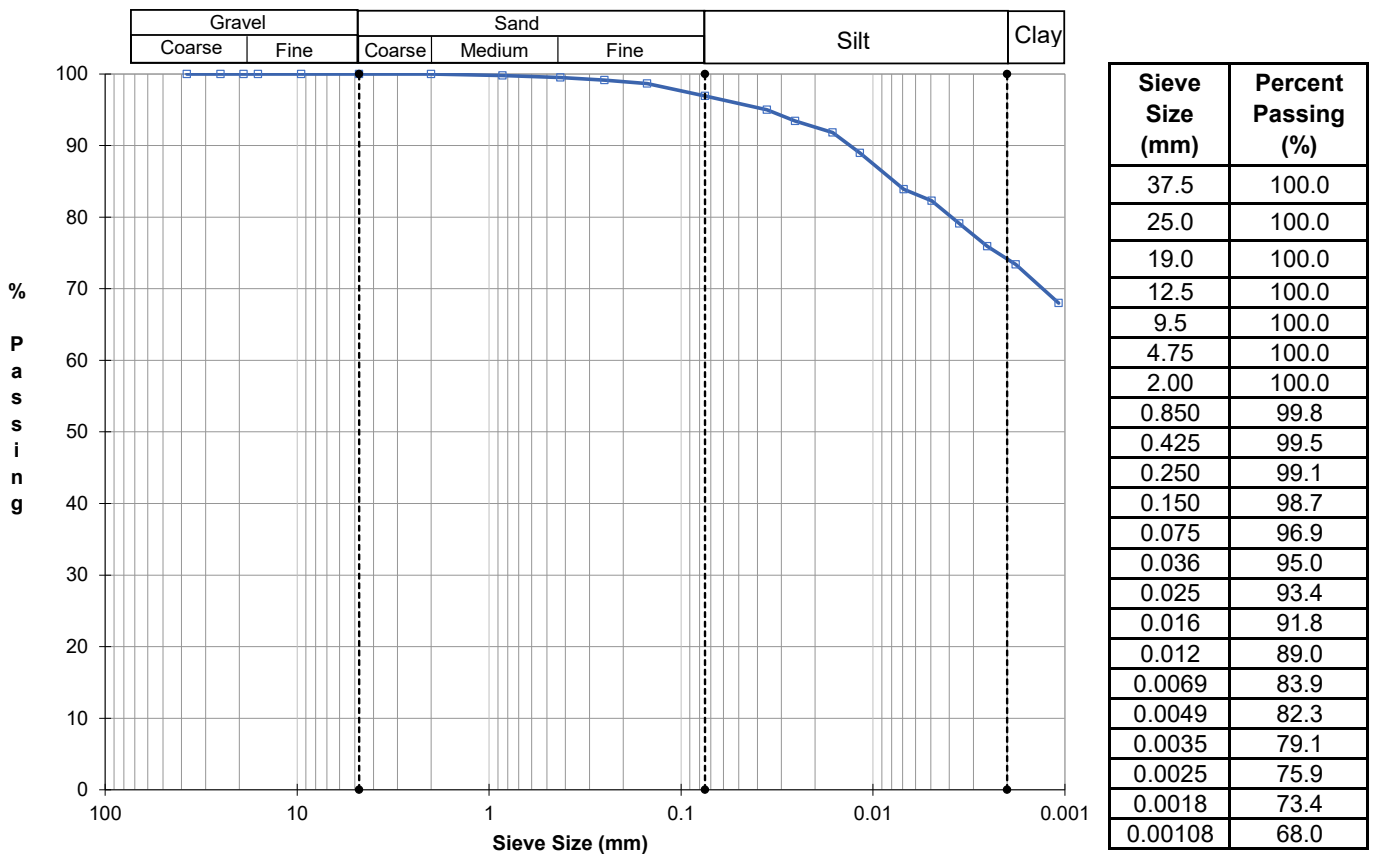
Percent of: Gravel = 0.0% Sand = 3.1% Silt = 22.8% Clay = 74.2%

Sample Description:
Clay, little silt, trace sand

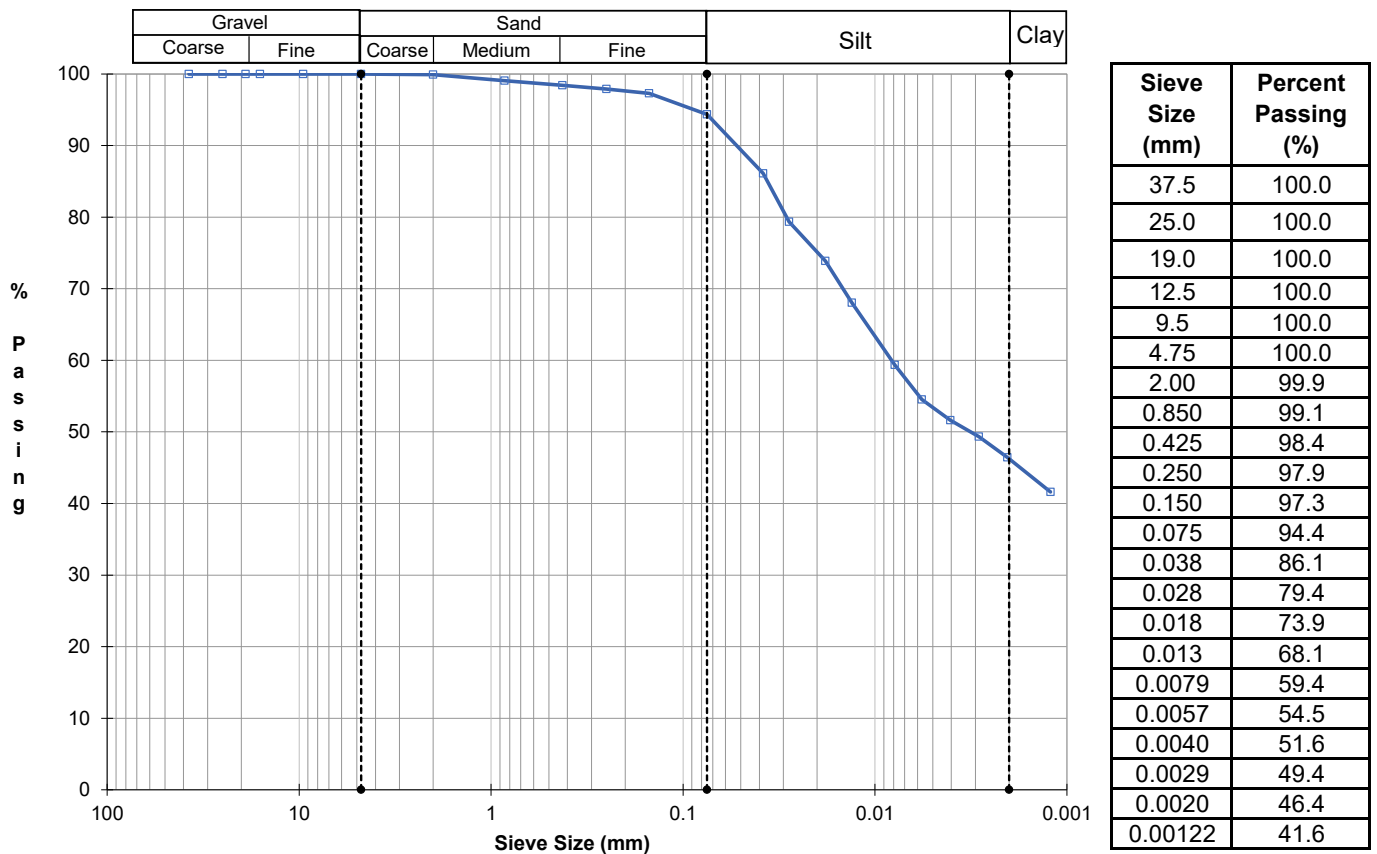
Percent of: Gravel = 0.0% Sand = 5.6% Silt = 48.1% Clay = 46.3%

Sample Description:
Some silt, some clay, few sand

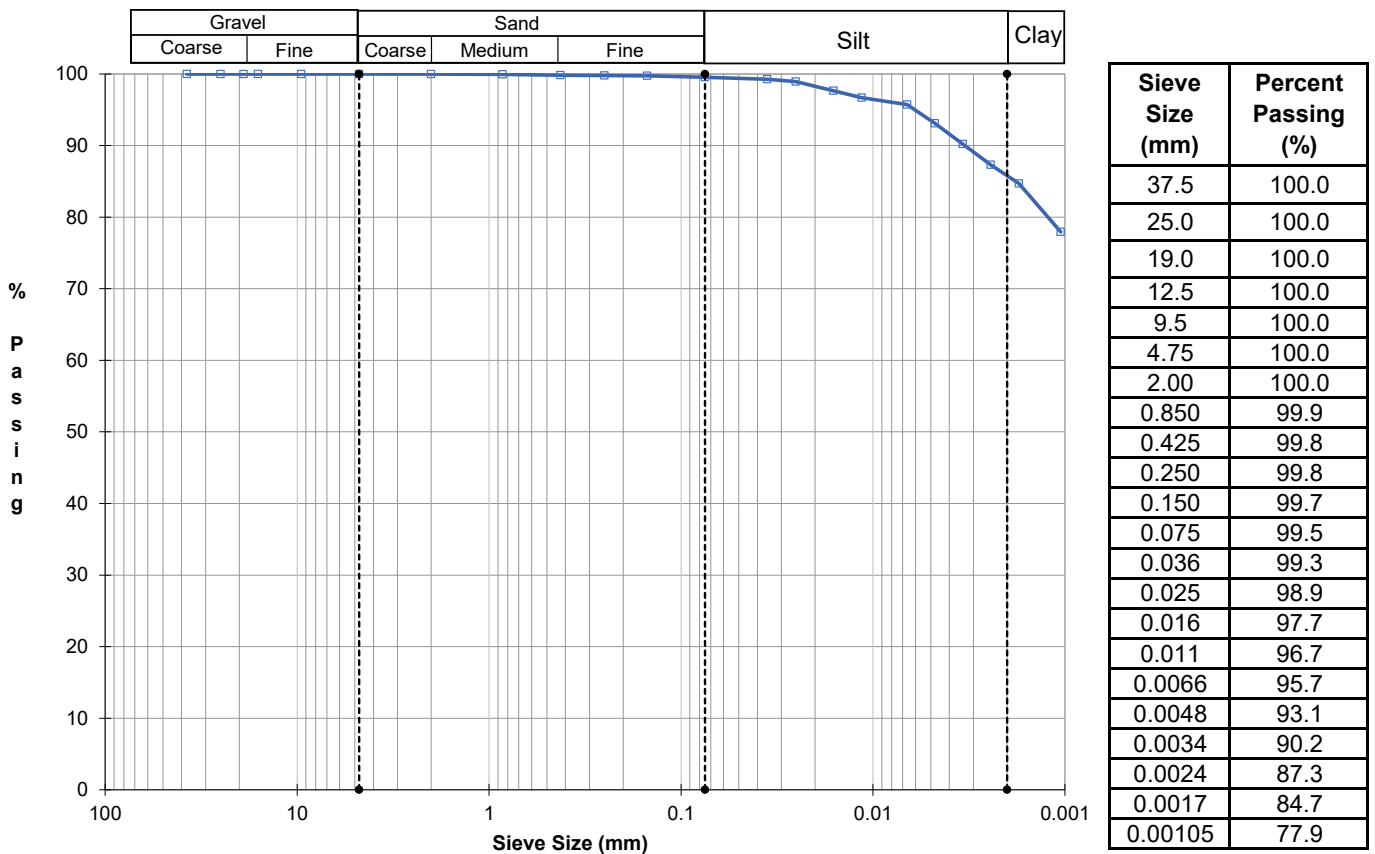
Percent of: Gravel = 0.0% Sand = 0.5% Silt = 13.7% Clay = 85.8%

Sample Description:
Clay, little silt, trace sand

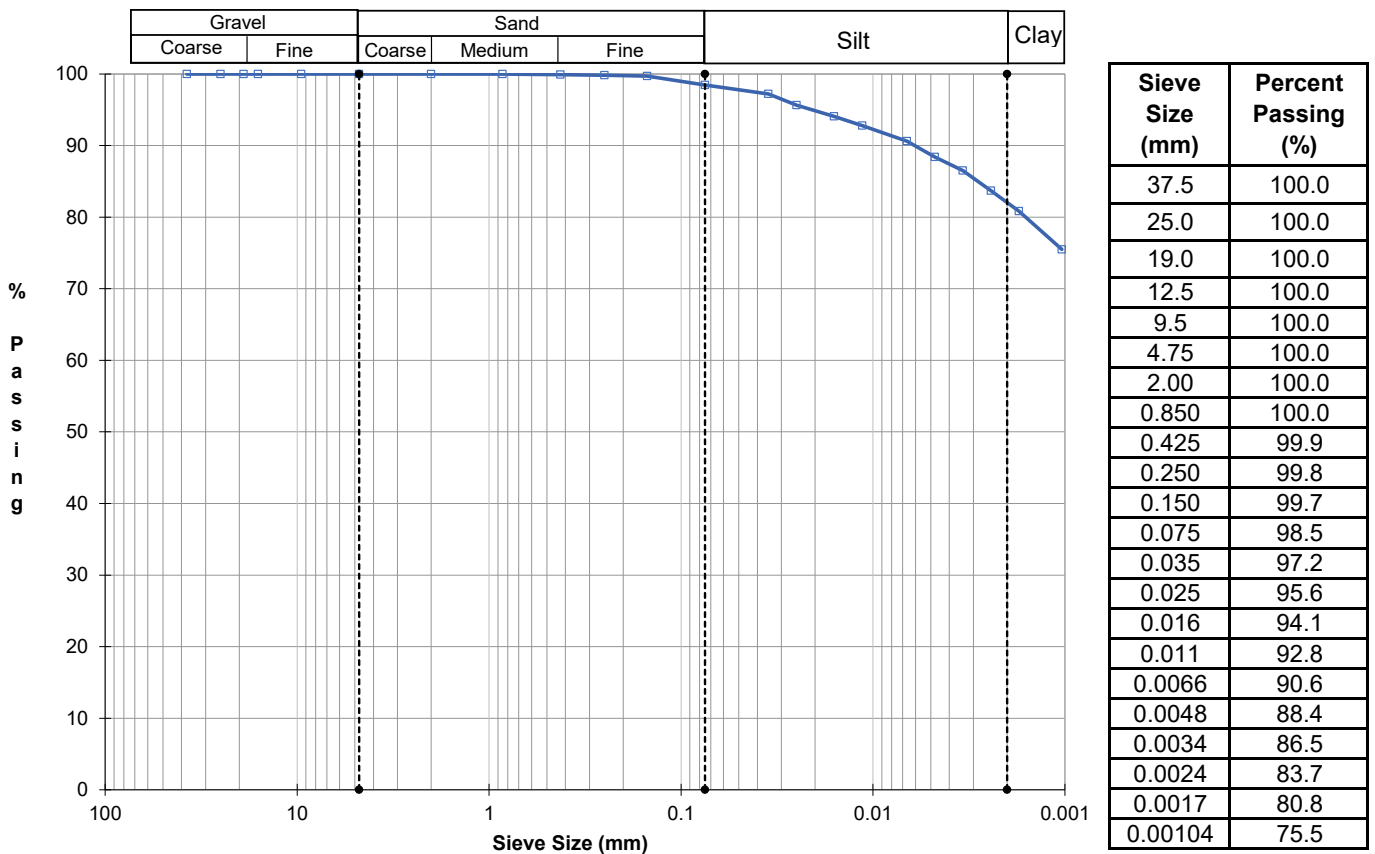
Percent of: Gravel = 0.0% Sand = 1.5% Silt = 16.4% Clay = 82.0%

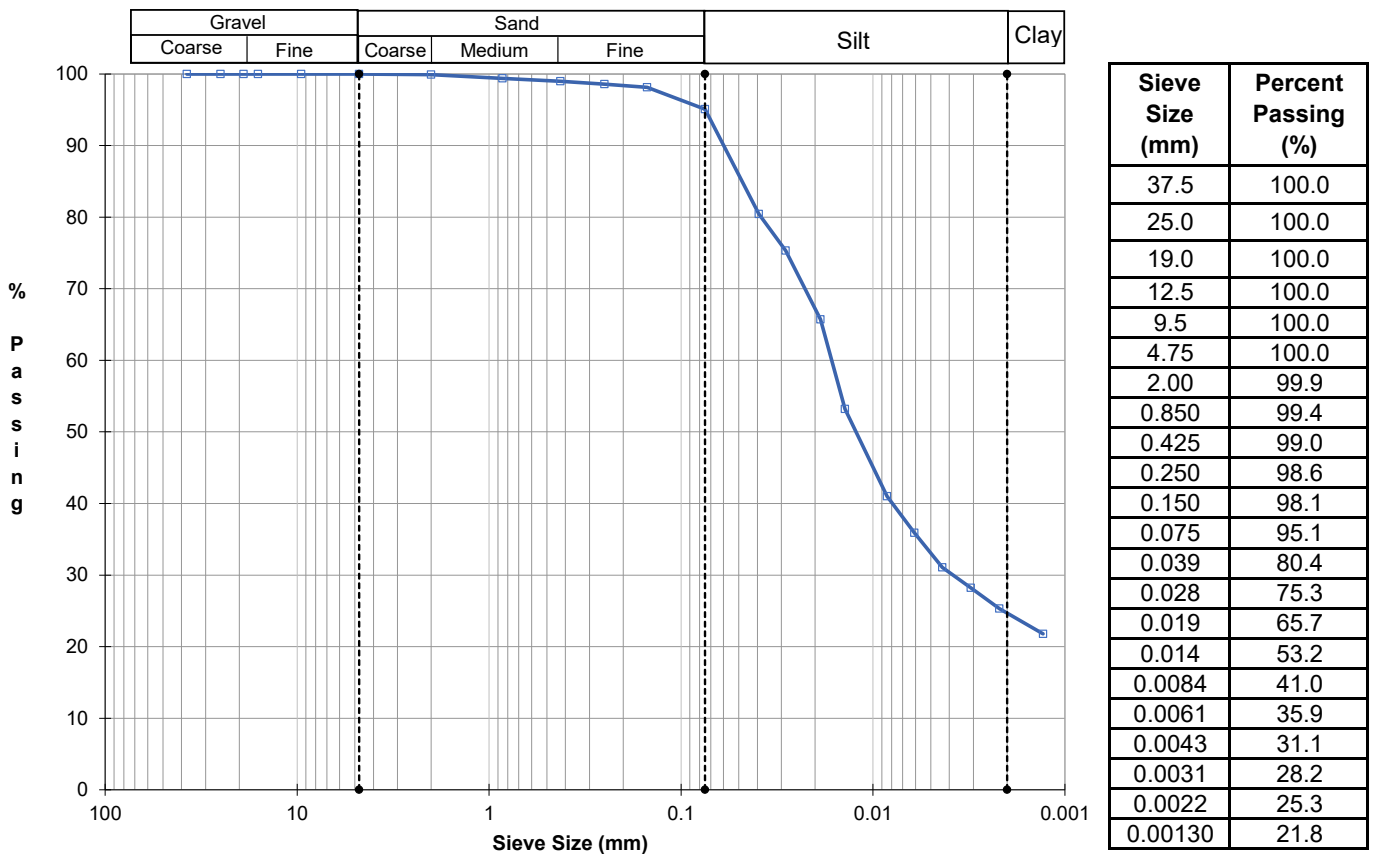
Percent of: Gravel = 0.0% Sand = 4.9% Silt = 70.5% Clay = 24.5%

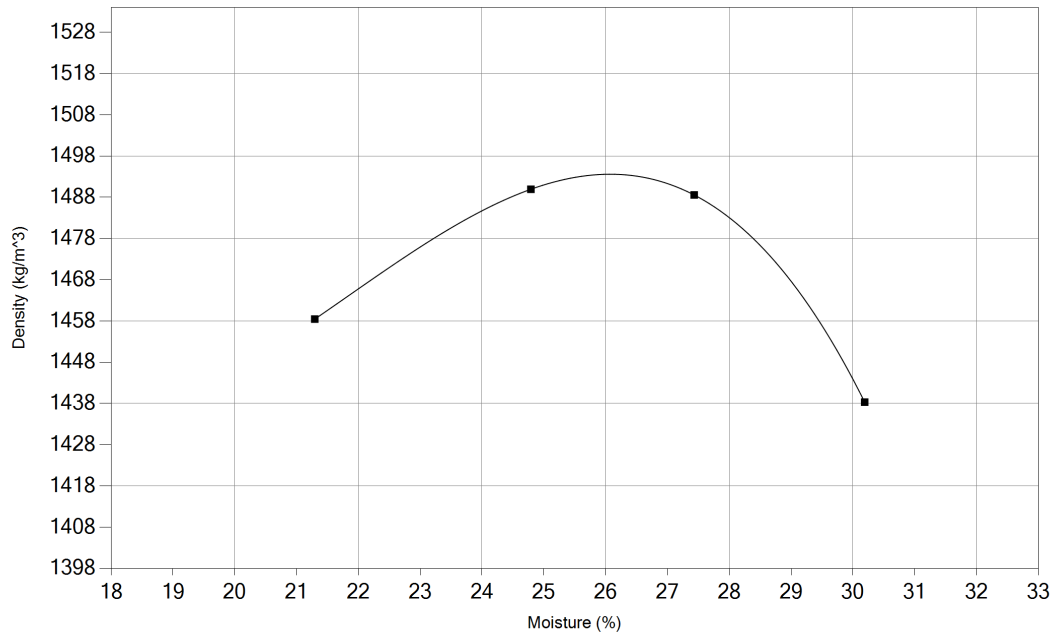
Moisture Density Relationship: (ASTM D698-12) Method: A

Optimum Moisture (%): 26.1

Standard Proctor Results (ASTM D698)	
Max. Dry Density (kg/m ³)	1494
Optimum Moisture Content (%)	26.1
% Retained about 4.75 mm	0.0

Sample	Proctor Test		CBR Test @ 95% SPMDD	
	Optimum Moisture Content (%)	Maximum Dry Density (kg/m ³)	@ 2.5mm Penetration (%)	@ 5.1mm Penetration (%)
North Section				
TP25-03, Bulk 1.5 – 3.0m	26.1	1494	2.2	1.7
South Section				
TP25-07, Bulk 2.0 – 3.0m	23.4	1511	1.5	1.4

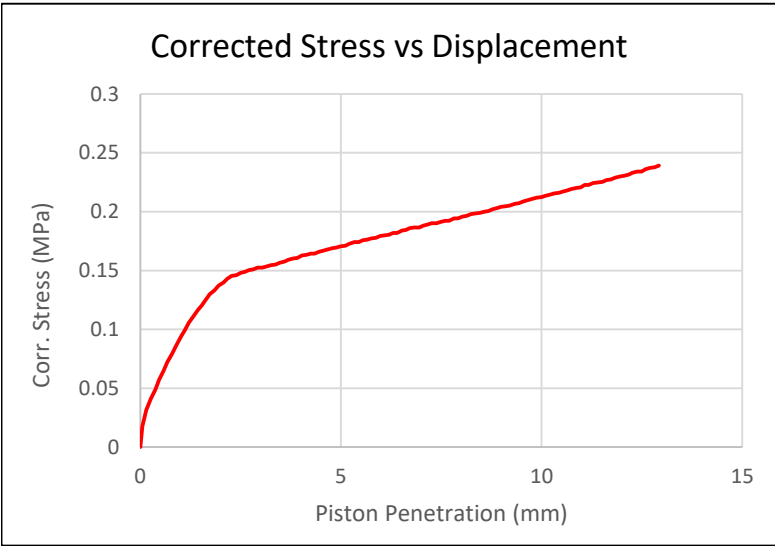
Soaked CBR Test Results	
CBR at 2.5 mm (0.1")	2.2%
CBR at 5.1 mm (0.2")	1.7%
Correction (mm)	0

Stress Data	
Penetration (mm)	Corrected Stress (Mpa)
0.635	0.07
1.270	0.11
1.905	0.14
2.540	0.15
3.175	0.15
3.810	0.16
4.445	0.17
5.080	0.17
6.350	0.18
7.620	0.19
8.890	0.20
10.160	0.21
11.430	0.22
12.700	0.24

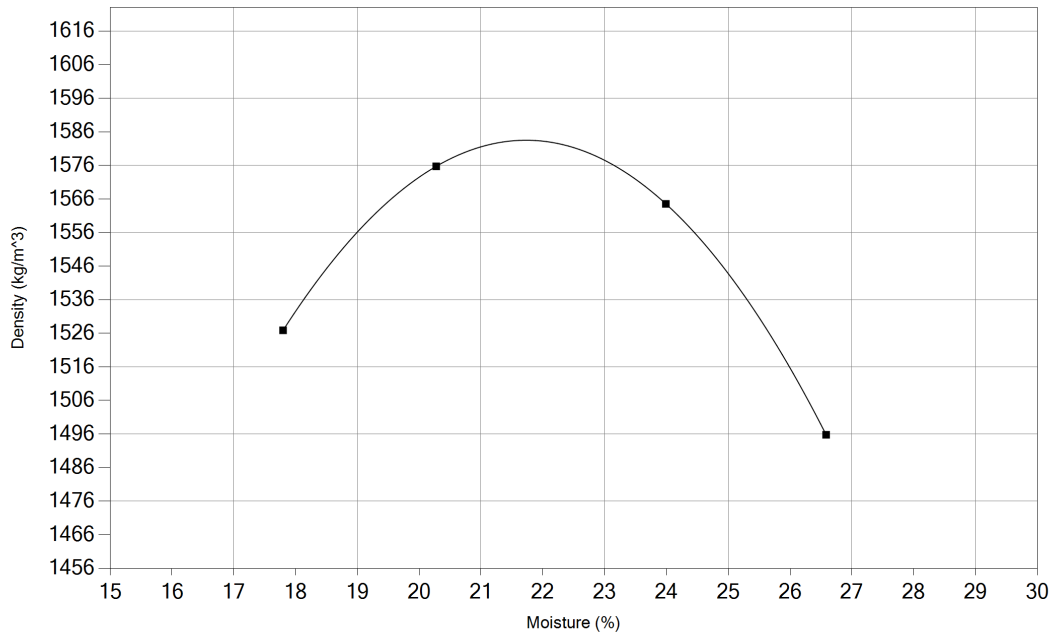
Moisture Density Relationship: (ASTM D698-12) Method: A

Optimum Moisture (%): 21.7

Standard Proctor Results (ASTM D698)	
Max. Dry Density (kg/m ³)	1584
Optimum Moisture Content (%)	21.7
% Retained about 4.75 mm	0.0

Sample	Proctor Test		CBR Test @ 95% SPMDD	
	Optimum Moisture Content (%)	Maximum Dry Density (kg/m ³)	@ 2.5mm Penetration (%)	@ 5.1mm Penetration (%)
North Section TP25-06, Bulk 0.5 – 1.2m	21.7	1584	2.8	2.3
Soth Section TH25-10, Bulk 0.3 – 1.5m	25.6	1489	2.9	1.6

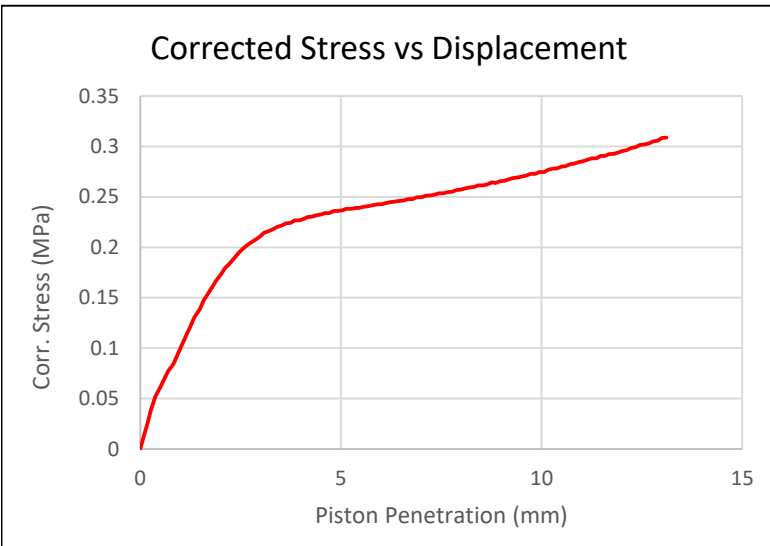
Soaked CBR Test Results	
CBR at 2.5 mm (0.1")	2.8%
CBR at 5.1 mm (0.2")	2.3%
Correction (mm)	0

Stress Data	
Penetration (mm)	Corrected Stress (Mpa)
0.635	0.07
1.270	0.13
1.905	0.17
2.540	0.20
3.175	0.22
3.810	0.23
4.445	0.23
5.080	0.24
6.350	0.25
7.620	0.25
8.890	0.26
10.160	0.28
11.430	0.29
12.700	0.30

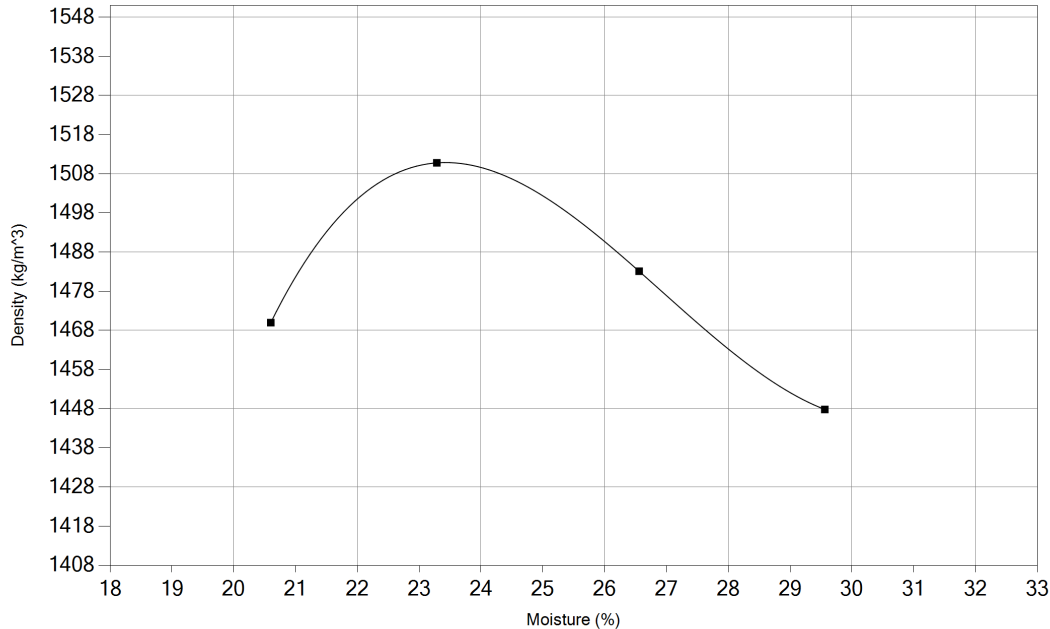
Moisture Density Relationship: (ASTM D698-12) Method: A

Optimum Moisture (%): 23.4

Standard Proctor Results (ASTM D698)	
Max. Dry Density (kg/m ³)	1511
Optimum Moisture Content (%)	23.4
% Retained about 4.75 mm	0.0

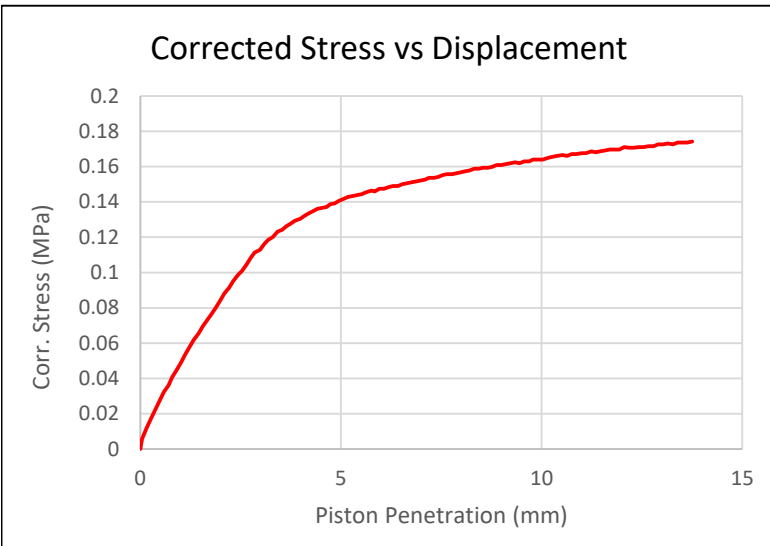
Soaked CBR Test Results	
CBR at 2.5 mm (0.1")	1.5%
CBR at 5.1 mm (0.2")	1.4%
Correction (mm)	0

Stress Data	
Penetration (mm)	Corrected Stress (Mpa)
0.635	0.03
1.270	0.06
1.905	0.08
2.540	0.10
3.175	0.12
3.810	0.13
4.445	0.14
5.080	0.14
6.350	0.15
7.620	0.16
8.890	0.16
10.160	0.16
11.430	0.17
12.700	0.17

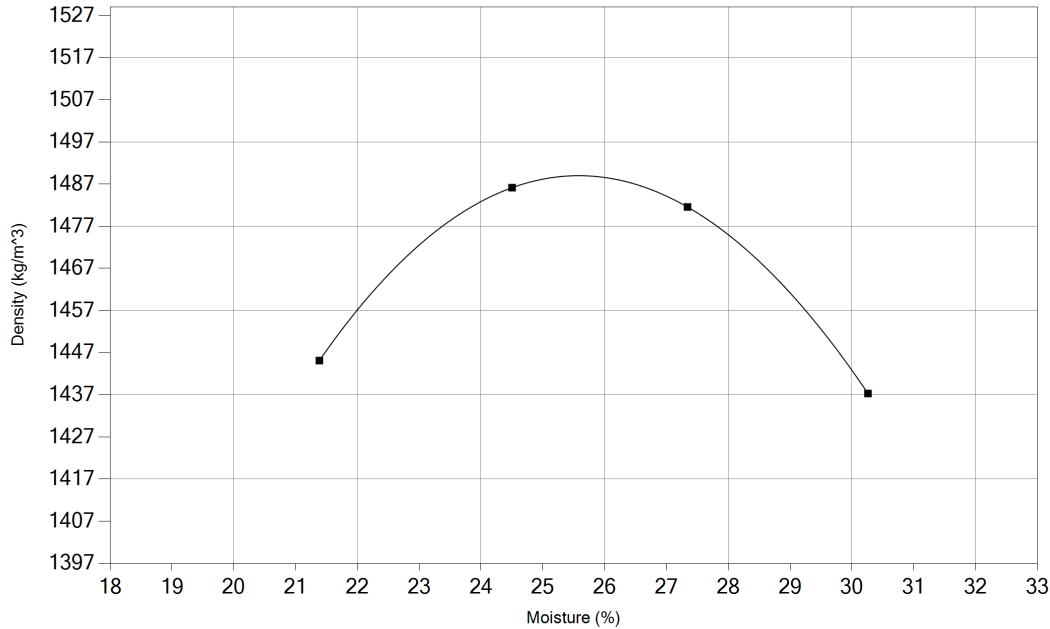
Moisture Density Relationship: (ASTM D698-12) Method: A

Optimum Moisture (%): 25.6

Standard Proctor Results (ASTM D698)	
Max. Dry Density (kg/m ³)	1489
Optimum Moisture Content (%)	25.6
% Retained about 4.75 mm	0.0

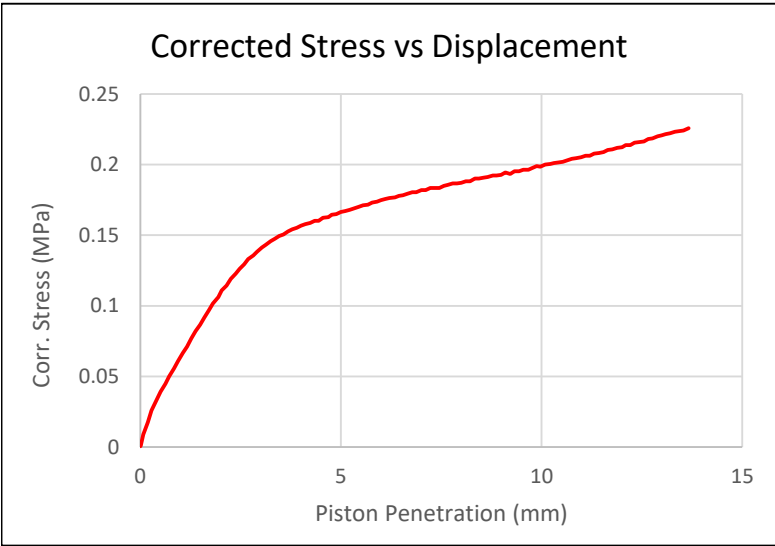
Soaked CBR Test Results	
CBR at 2.5 mm (0.1")	1.9%
CBR at 5.1 mm (0.2")	1.6%
Correction (mm)	0

Stress Data	
Penetration (mm)	Corrected Stress (Mpa)
0.635	0.05
1.270	0.07
1.905	0.10
2.540	0.13
3.175	0.14
3.810	0.15
4.445	0.16
5.080	0.17
6.350	0.18
7.620	0.19
8.890	0.19
10.160	0.20
11.430	0.21
12.700	0.22
