Appendix D – Pictures of Concourse

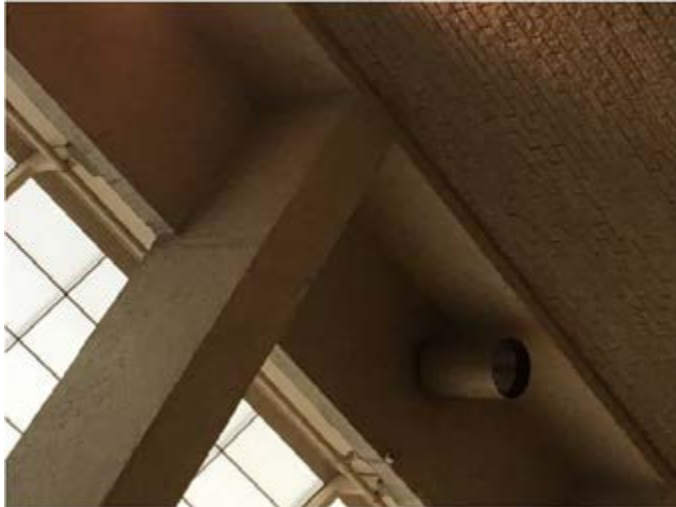
200 Portage Skylight – Water leaks onto escalator and stairs below

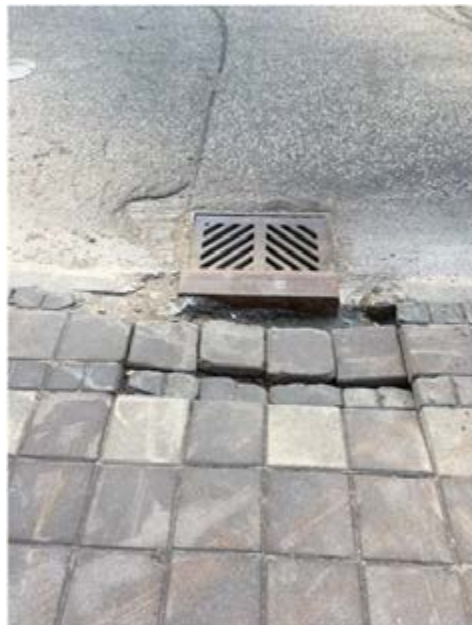
Drainage issues. This drain is directly above the escalators leading into the Concourse from 200 Portage. Issues with the drain at this location have caused the escalators to shut down and have caused damage to the tenant space below.

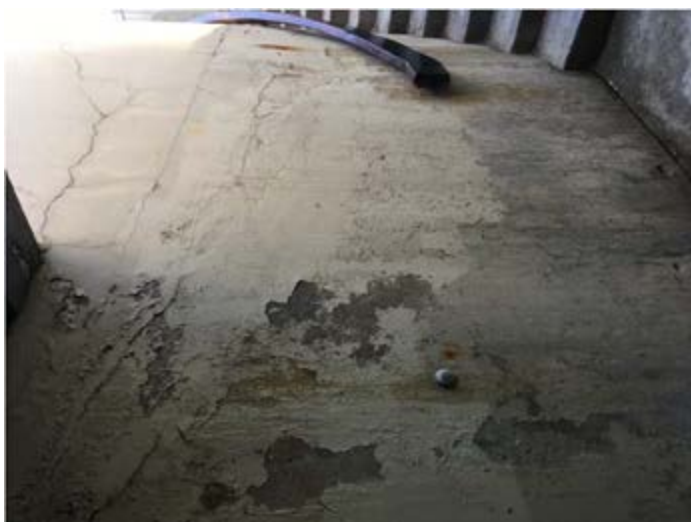
Water damage and spalling (breaking) at 335 Main exterior exit from Concourse.

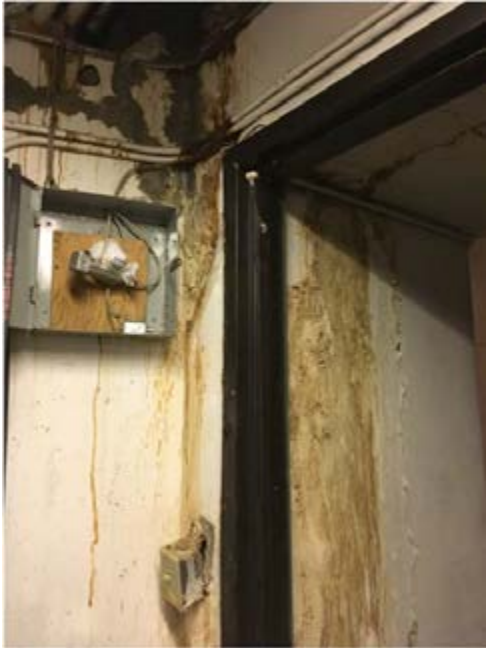
Water damage in mechanical room below Richardson (1 Lombard) promenade due to membrane failure and insufficient drainage on street level

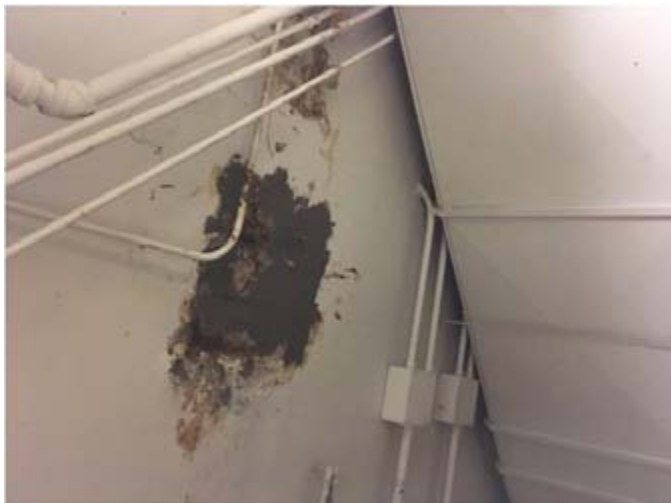
Water damage in mechanical room below Richardson (1 Lombard) promenade due to membrane failure and insufficient drainage on street level

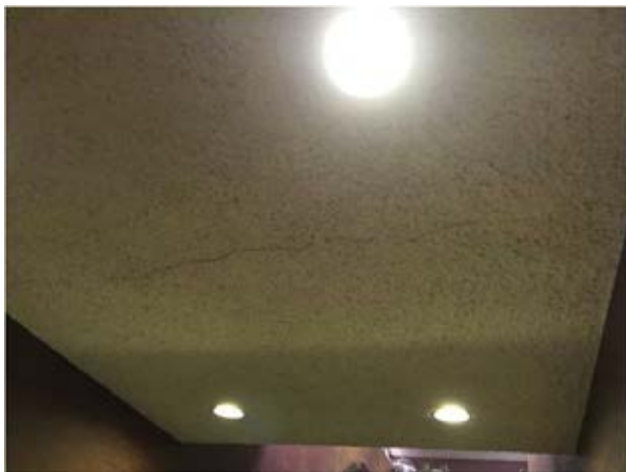
Structural damage to ceiling a base of 1 Lombard escalators

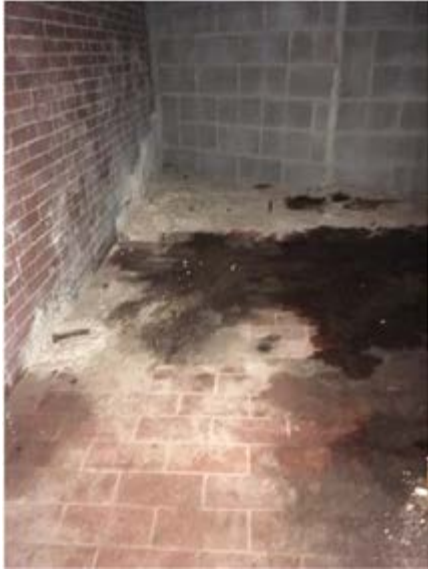
Water damage under escalators at 200 Portage.

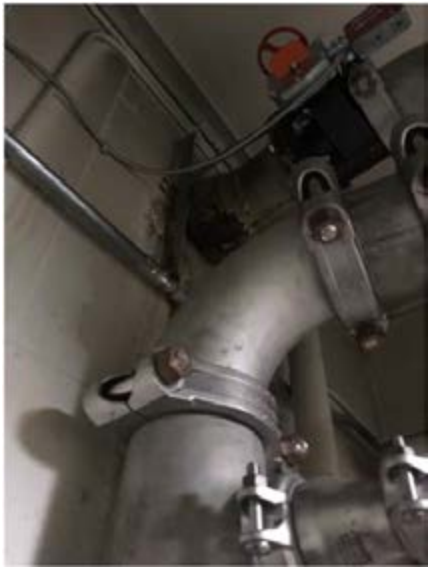
Fire Suppression Valve is cast into concrete. Needs to be replaced and brought to code. Requires an exterior shutoff valve for Water and Waste.

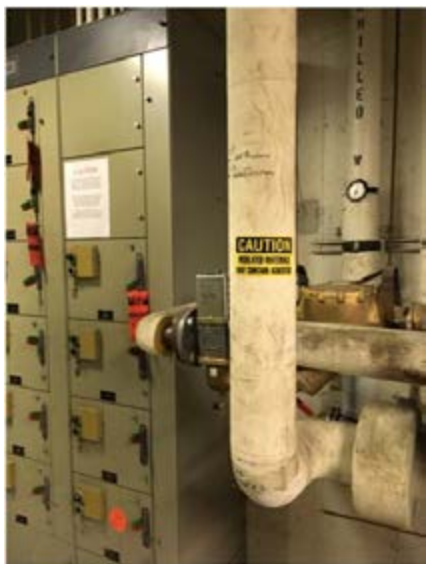
Asbestos has been identified in multiple locations throughout the Concourse and will need to be abated when construction occurs.
