KING'S PARK

REGIONAL PARK EXISTING FACILITY REVIEW &
REINVESTMENT STRATEGY

FEBRUARY 2016

DAVID WAGNER ASSOCIATES INC.

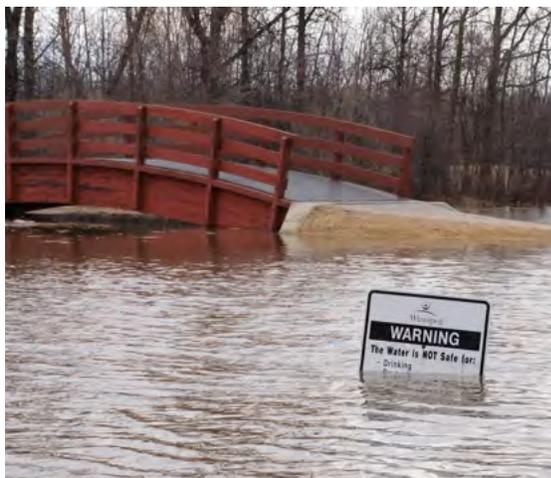
Like many parks along Winnipeg's rivers, King's Park is prone to spring flooding. It experienced extensive damage in 1997 when the Red River reached the top of the dike constructed along the north boundary of the park. Following the retreat of the flood waters, it took a considerable time for the vegetation of the park to recover.

Flooding, 2009, ChrisD.

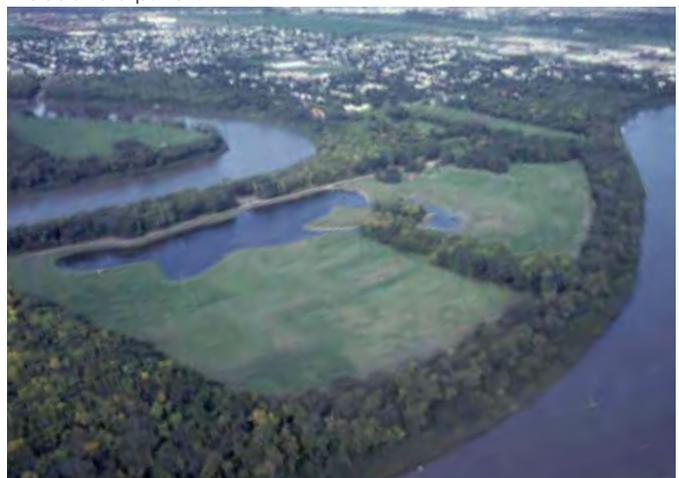
Aerial view of King's Park prior to lake siltation.

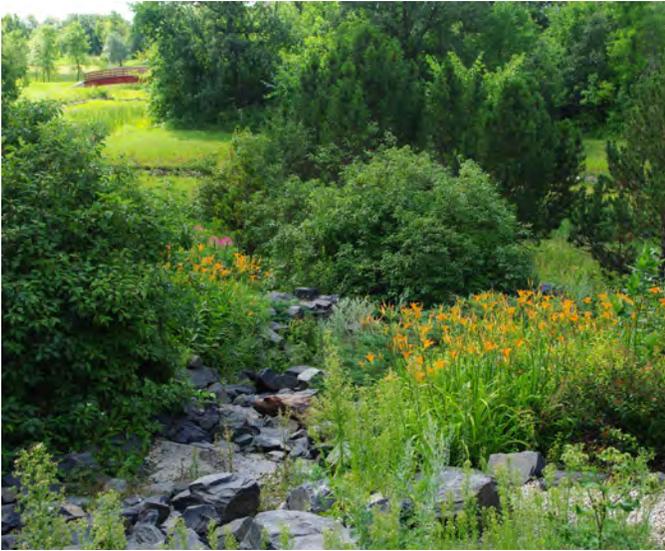
Non-functioning waterfall with perennials and shrubs (15).

- The waterfall pump system, basin head and spillway are not operational.
- The pathways are in poor to fair condition.
- Benches are in good condition but do not coordinate with site furniture throughout the park.
- The perennial, annual and shrub gardens are in poor to fair condition.

- Procure hydrological engineering report to determine well location, pump size, basin condition (size and restoration requirements), and possible recirculation system.
- Prepare design drawings and specifications.
- Remove existing waterfall materials, retain for possible reuse.
- Install well and associated pumps.
- Construct waterfall (basin, channel, rockery).
- Construct rock gardens, including pathways, perennial gardens and site furniture.
- Class 5 Cost Estimate: **\$400,000**

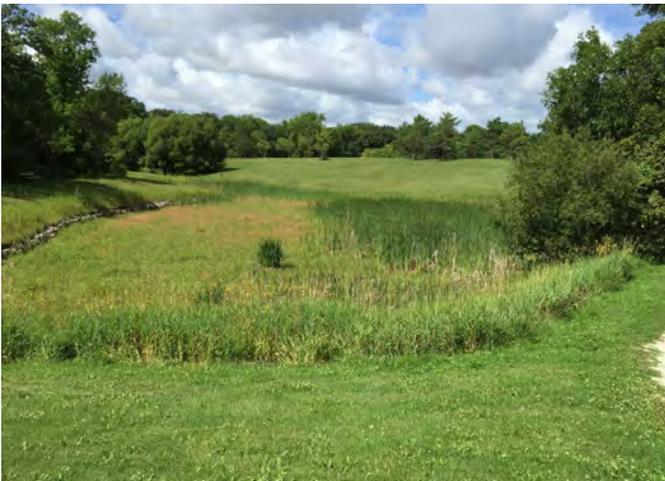
Lake filled in with silt and vegetation.

- Due to the inoperable waterfall, the lake receives little to no inflow and is stagnant.
- The rock works and gabions are in poor condition.
- The shallow areas are filled in with sediment and vegetation, including invasive Flower Rush.
- Bridges that cross the lake to an island are not universally accessible and are slippery in winter.

- Survey existing lake.
- Design lake, including depth profile, possible recirculating fountain, edge conditions, bird habitat, viewing areas and weir repair.
- Prepare design drawings and specifications.
- Remove existing vegetation including measures to eradicate Flowering Rush.
- Dredge pond and dispose of material. Options for disposal of material may include on site dispersal and associated restoration.
- Repair clay liner.
- Restore edge conditions, including native shoreline plantings, restoration of rock gabions and stone edging along waterfall.
- Class 5 Cost Estimate: **\$1,200,000 to \$2,500,000**, pending soils investigation

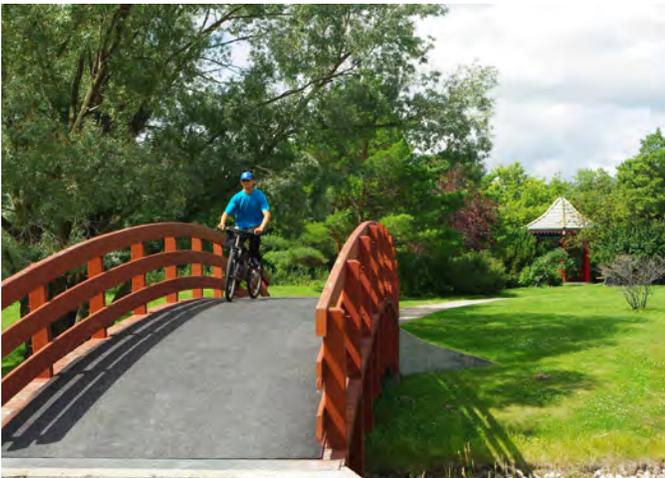
One of two arched bridges (19).

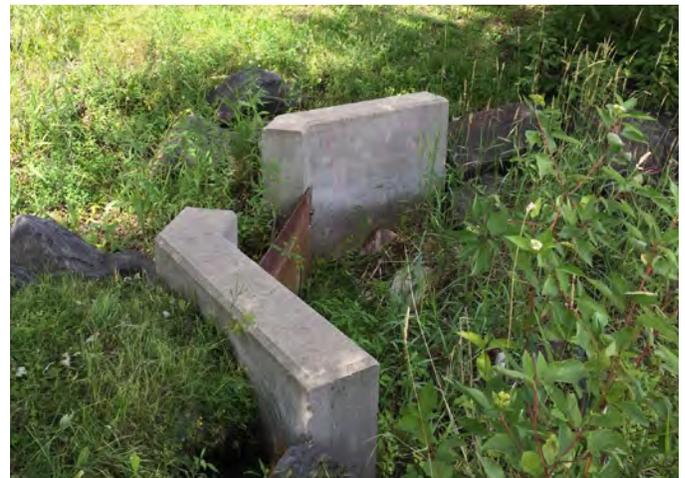
Concrete weir (21).

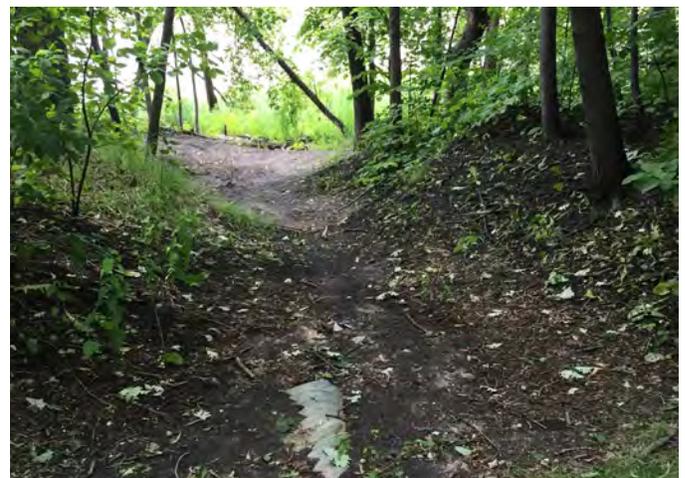
Lake outlet to river (21).

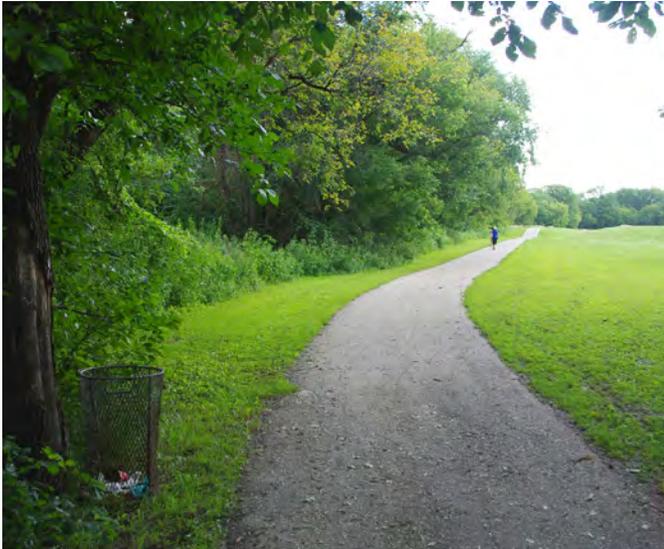
Relocated asphalt pathway between riparian forest and basin.

- Newly relocated asphalt pathways are in good condition.
- Abandoned pathways in the forest are in poor condition and experience frequent spring flooding. These pathways should either be removed or their lack of future maintenance communicated to park users.
- Older asphalt pathways leading to the waterfall from Parking Lot #2 and in the informal gardens have cracking but are in fair condition.
- Some areas of asphalt pathway in the forest, particularly by Baseball Diamond #2, are low lying and frequently wet, and therefore impassable.
- Granular pathways in the waterfall garden are eroding and are in poor condition.
- Granular pathways in the Carol Shields Memorial Labyrinth are in fair condition but are starting to erode without an containment edge treatment.

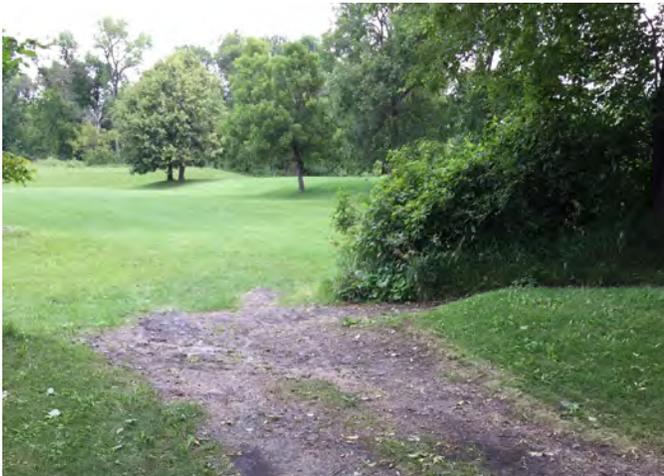
Worn pathway from desire line between Field #2 and Field #1.

- Some worn desire lines could be incorporated into the paved pathway system.

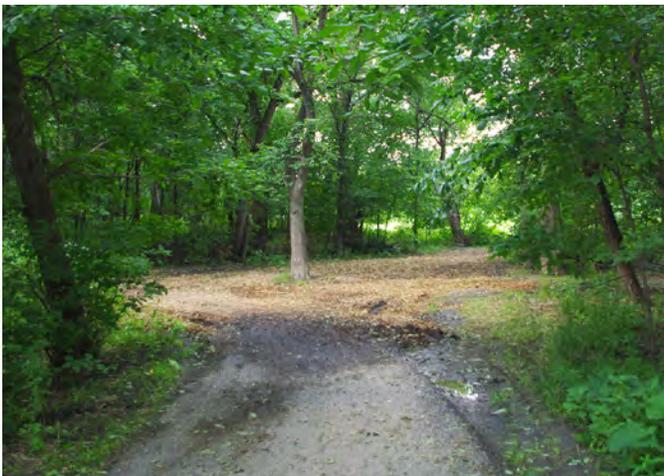
Low-lying pathway.

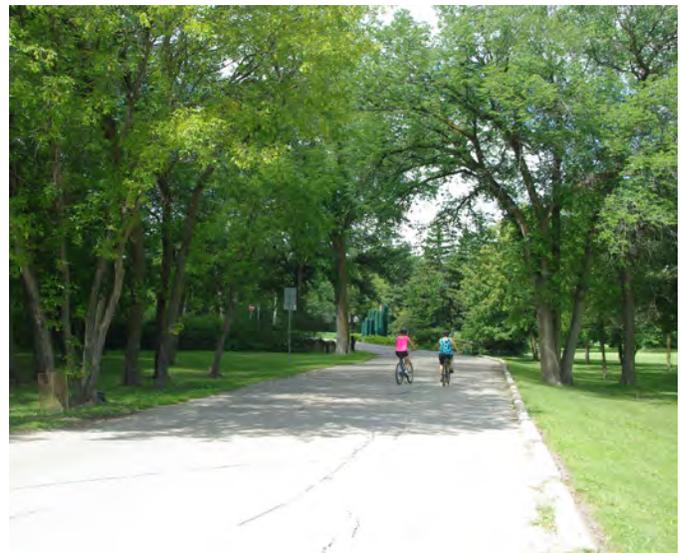
- Parking Lots #1 and 2 are in fair condition.
- Curb stops require straightening.
- The paved road is in fair condition but lacks curbs so there is wear to the adjacent surfacing, which is mainly turf.

Road headed towards Entrance.

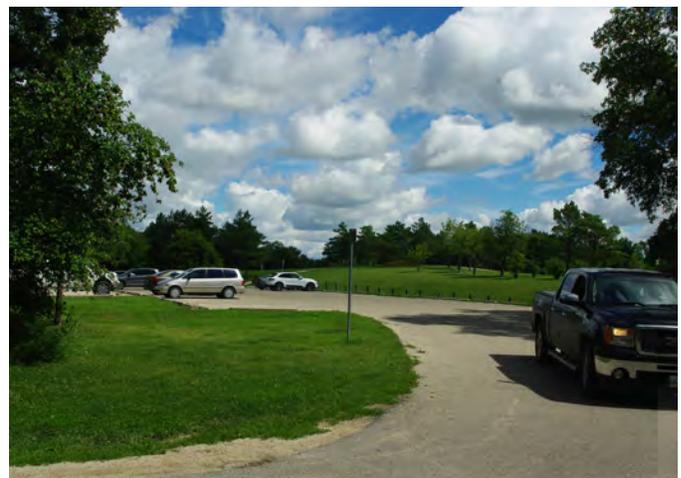
Parking Lot #2 (13).

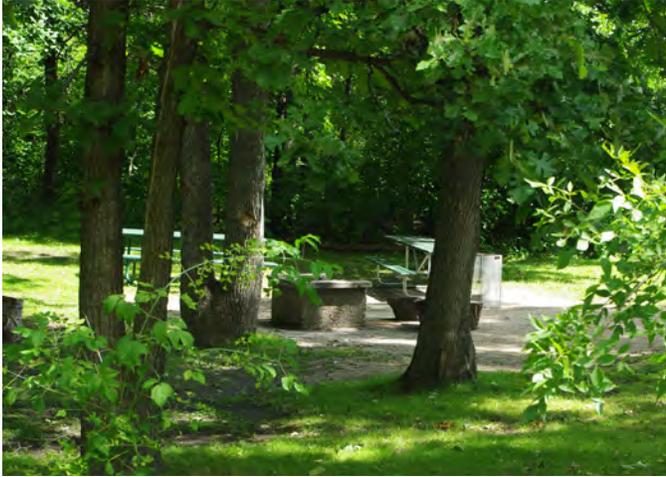
Picnic Site with Fire Pit (12)

- Barbecue is in fair condition although the site is trodden and disorganized.

- Increase number of barbecue and picnic nodes and make them accessible.
- Include site furniture that is complementary to the park image.
- Class 5 Cost Estimate: **\$18,000 each**

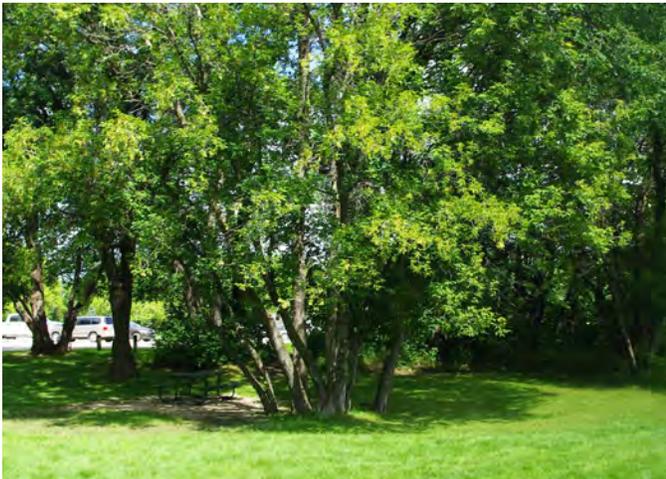
Picnic table near Parking Lot #2.

- Picnic tables are in fair condition.
- Additional picnic tables are required

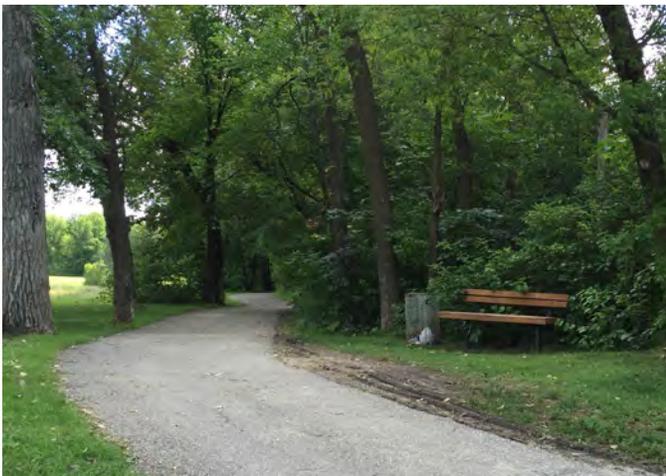
Park bench and waste receptacle.

- The wooden benches are older, and in fair to poor condition.
- The composite benches are in good condition.
- The three types of benches are not unique enough from each other to make a statement regarding location within the park and appear haphazard.

- Waste receptacles in fair to poor condition.
- Expanded metal rusts and is difficult to see against a forested backdrop.
- Visible waste is unsightly.

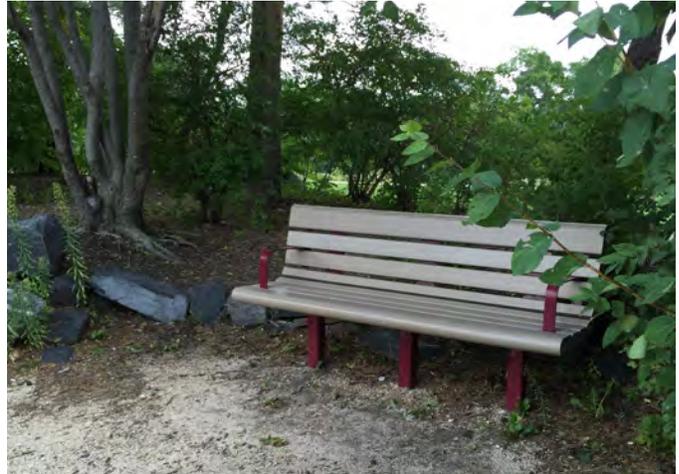
Bench in Waterfall Garden (15).

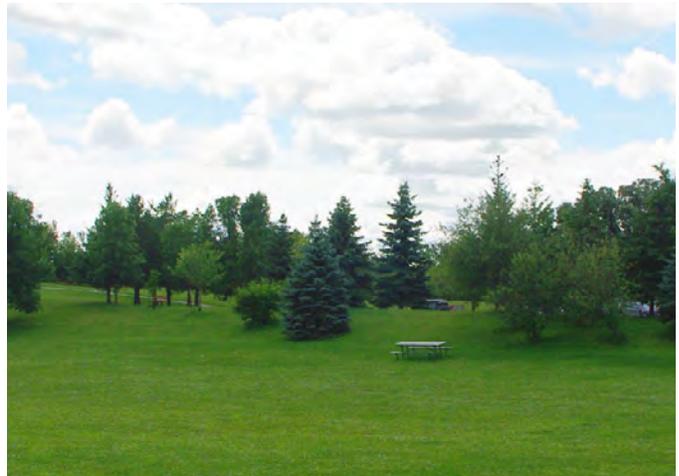
Picnic table in Basin (20).

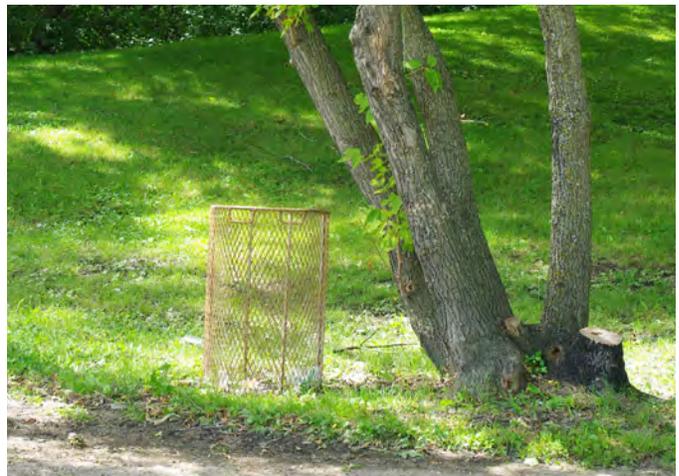
Expanded metal waste receptacle.

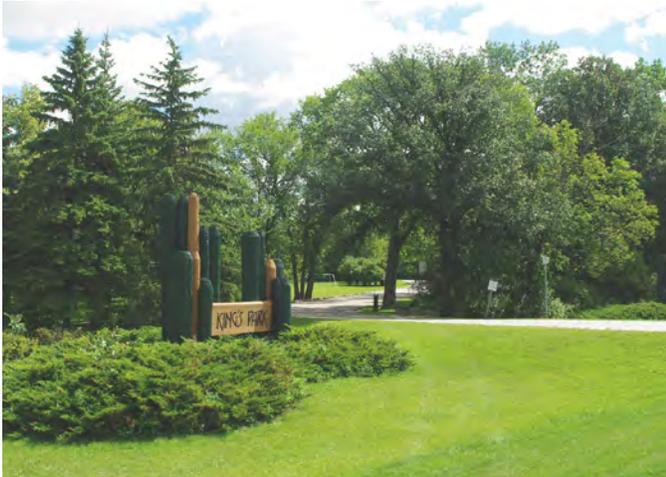
Painted entrance feature and King's Park sign.

- The entrance signage feature is a rustic, wooden post ensemble, in keeping with the natural vocabulary of the park (and less to do with the Chinese and more formal aspects).

- Design new or modified entrance feature and park gate.
 - Class 5 Cost Estimate: **\$140,000**
- Include minor entrance features at two secondary entrances.
 - Class 5 Cost Estimate: **\$40,000 each**
- Provide new decorative barrier treatments at entrances and parking lots.
 - Class 5 Cost Estimate: **\$60,000**

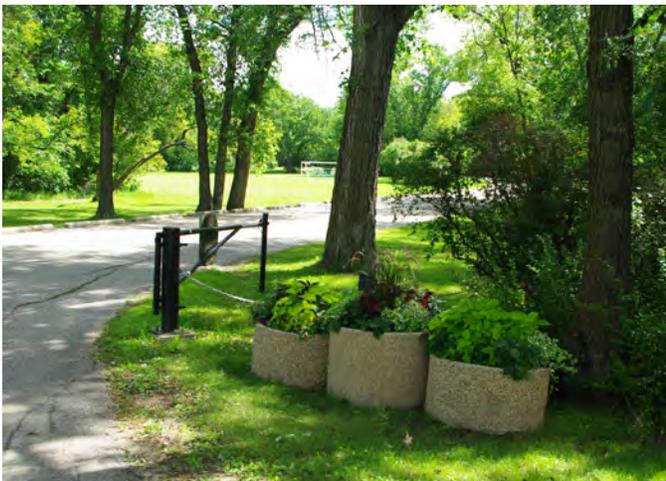
Planters at entrance gate.

- Post and chain fencing is in poor condition.
- Gate is in fair condition.
- Gate is inappropriate / under-scaled for a regional park main entrance.
- Exposed aggregate planters are in fair condition but are dated and visually insubstantial.

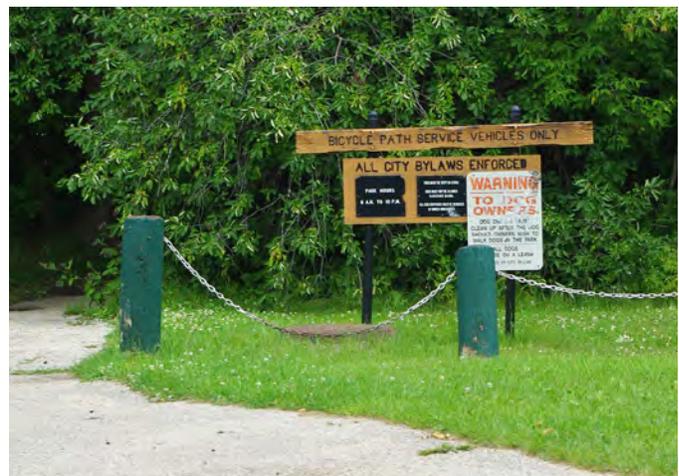
Secondary entrance, Kings Drive at Kilkenny Drive.

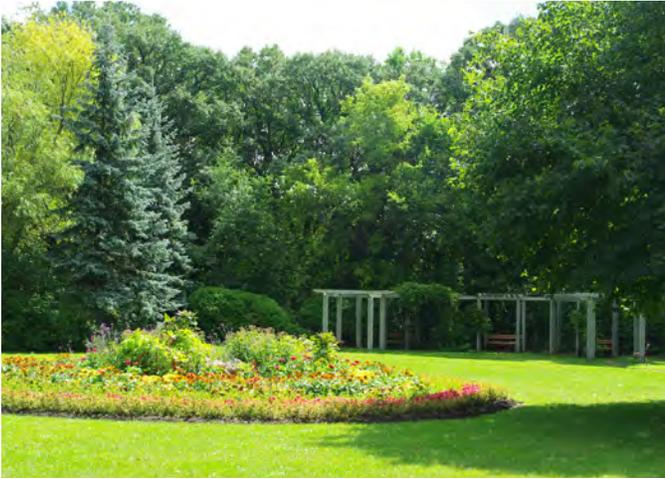
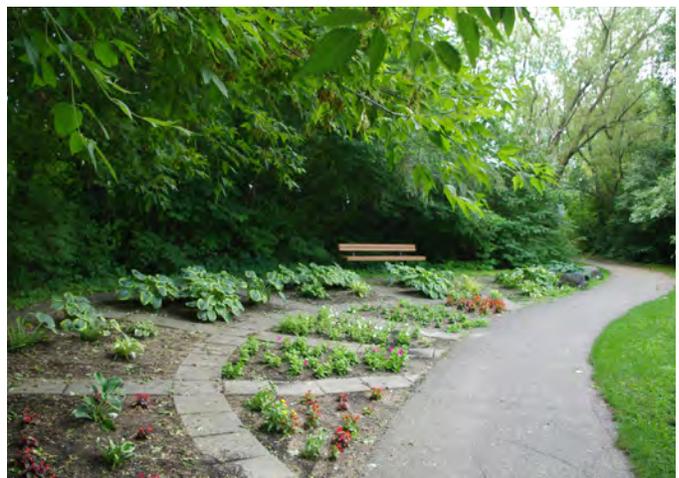
Informal Gardens pergola (24).

- Planting beds are in fair condition.
- Some structures require replacement while most of the wooden ones are nearing the end of their life cycle.
- Benches are in poor condition.

Informal Gardens (24).

- Renovate planting beds to make ongoing maintenance more efficient.
- Upgrade or replace garden features such as pergolas and arbors and

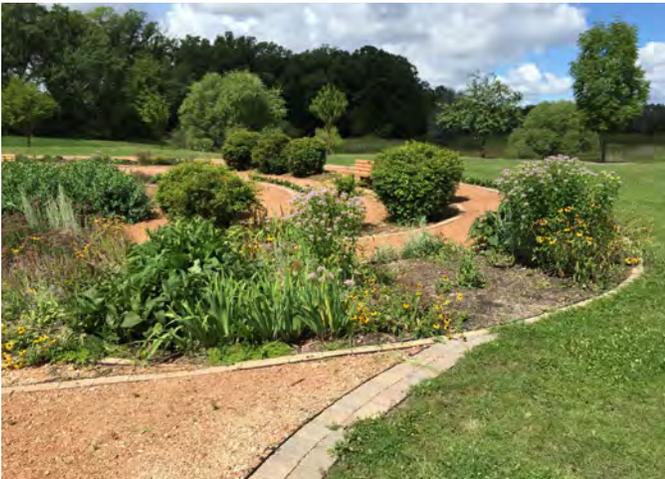
Carol Shields Memorial Labyrinth (23).

- Granular pathways and paving stones are in good condition but some material migration is occurring and weeds have crept in. Better material separation is required as washouts are occurring.
- Benches are in good condition
- Planting beds are in fair condition. Volunteer gardening is no longer available at this site, maintenance resources are limited for the amount of work required to keep the garden as originally planned. The City is making changes to the plantings in order to make maintenance easier.

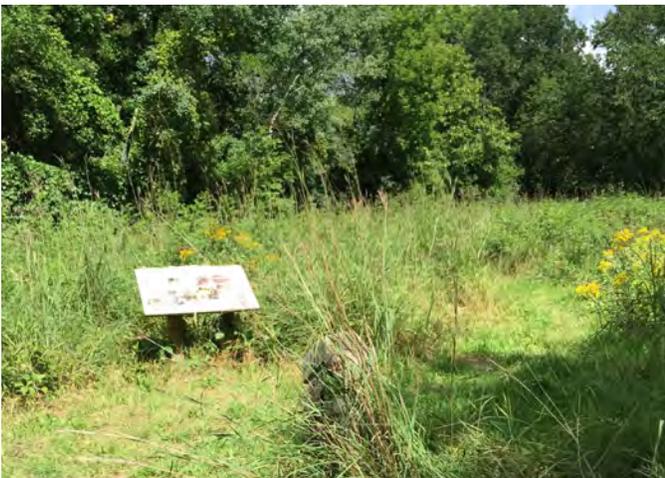
Native Prairie Grass and Wildflower Garden (25).

- The garden is in poor condition. It appears neglected and uninviting.
- The original intent was for predominantly "showy", flowering native plant species, but certain native species such as Big Blue Stem and Licorice have taken over and pushed out the original variety.
- Non-native species are invading the garden
- Interpretive signage is badly sun and water damaged.
- Main sign is dated, difficult to read and blocks entrance into the garden.
- Wooden fence posts have fallen down or are crooked.

- Renovate deteriorated structures such as fencing and signage.
- Create entrance feature and replace interpretive signage, replace bollard fencing, upgrade pathway and replace missing plant species.
- Class 5 Cost Estimate: **\$80,000**

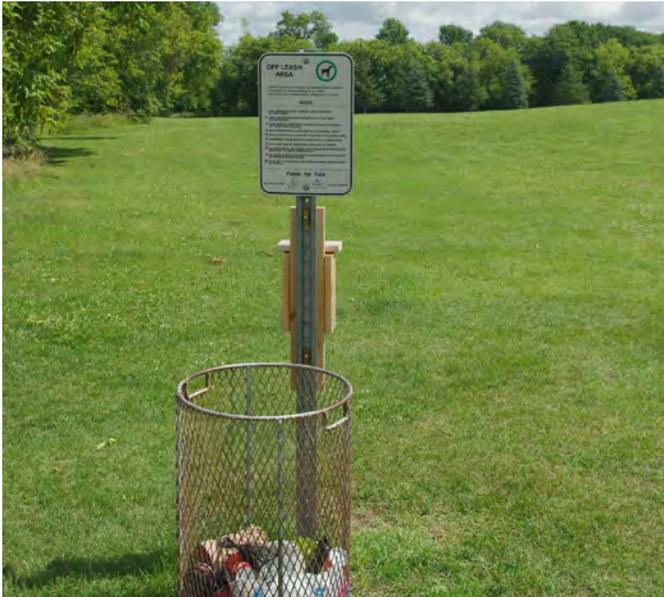
Waste receptacle and community-installed bag dispenser (22).

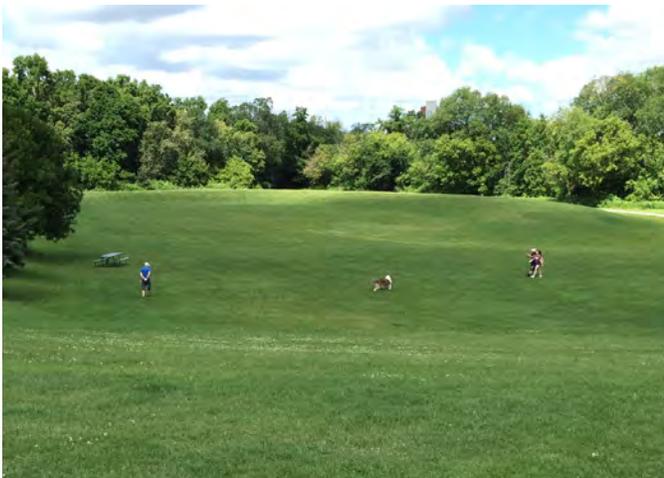
Off leash dog in Basin (20).

- Wayfinding signage is poorly located.
- Boundaries are not defined and dogs are sometimes off leash outside of the designated area.
- Adjacent to forested area that is not maintained by users (i.e., cleaning up after dogs).
- Dogs access lake at a location where erosion is evident.
- Bag dispensers are “home made” and in fair condition.

- Formalize location of the off-leash dog park and install 1.2M high chain link fence around the perimeter.
- Create an entrance feature that incorporates signage, etiquette, waste bag distribution and waste receptacles.
- Incorporate natural-style features for dog agility training.
- Include separate fenced area for small dogs.
- Class 5 Cost Estimate: **\$240,000**

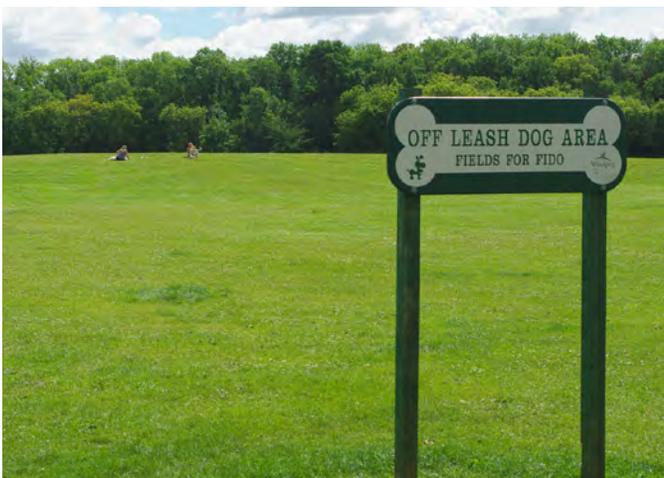
Off Leash Dog Area (22).

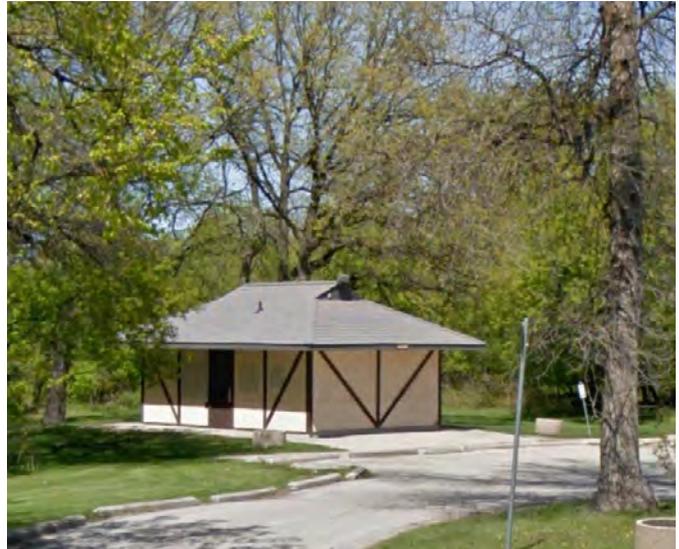
- Washroom is in poor condition with 5± years remaining in its life-cycle, according to City staff.
- Facilities are not universally accessible and cannot be retrofitted due to existing overall size constraints.
- Architecture is dated and not befitting a regional park.
- Location is inconvenient for most park users as it is isolated near the entrance to the park.

Public Washroom (9).

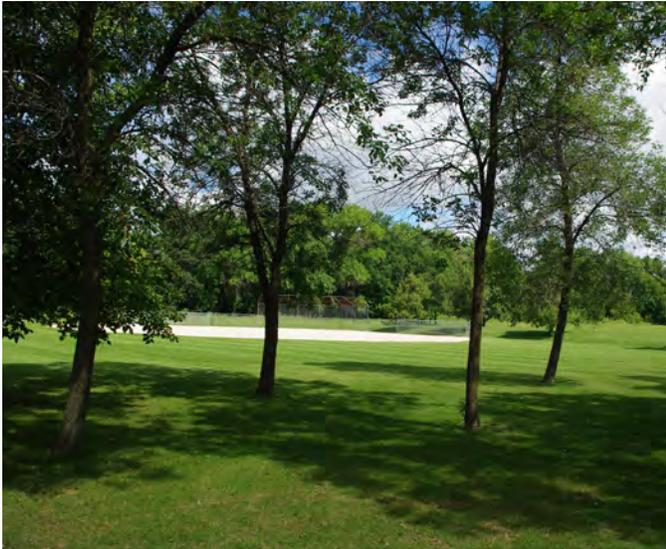
Baseball Diamond #1 (5).

- Two Peewee/Bantam-sized baseball diamonds complete with backstop and players' benches. Outfields not fenced.
- Baseball Diamond #1 appears well-maintained and used.
- Baseball Diamond #2 has been out of use since being damaged by the flood of 1997 and the infield is grown-in.
- A desire line has been established across Baseball Diamond #2 by walkers, cyclists and park utility vehicles.
- Berms and spaced-out trees separate the diamonds from a soccer field, delineating a boundary between the two uses and providing spectators with a pleasant place to sit.
- Location:
 - Baseball Diamond #1 at NE corner of park, visible from Kings Drive.
 - Baseball Diamond #2 at NW corner of park.

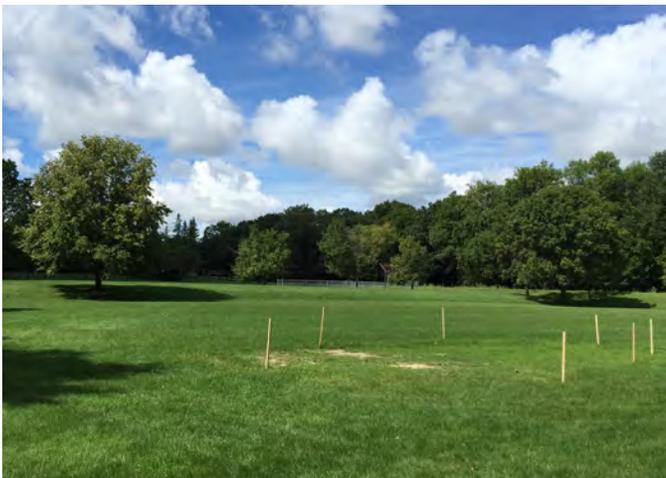
Field #1: Soccer (7).

- Repairs to the turf on Field #1 appear successful in the short term.
- Field #1 would benefit from elevating and re-grading to avoid spring flooding.
- Turf on Field #2 is in good condition but the field is uneven and not suitable for field sports.
- Field #2 could be re-graded for use by soccer and other field sports groups.
- Fields #1 and #2 are too small for a minimum 55 x 73m regulation sized soccer pitch.

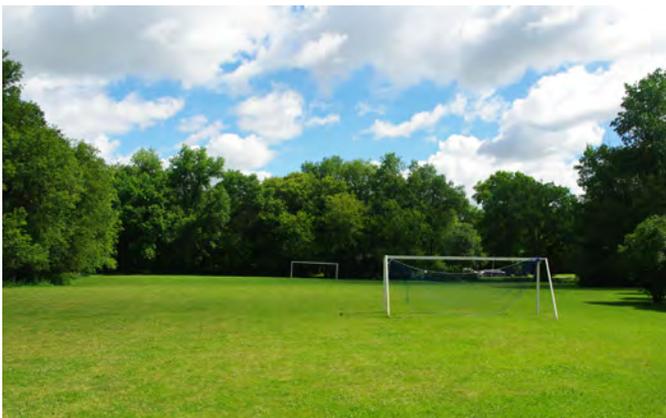
Field #2 (6).

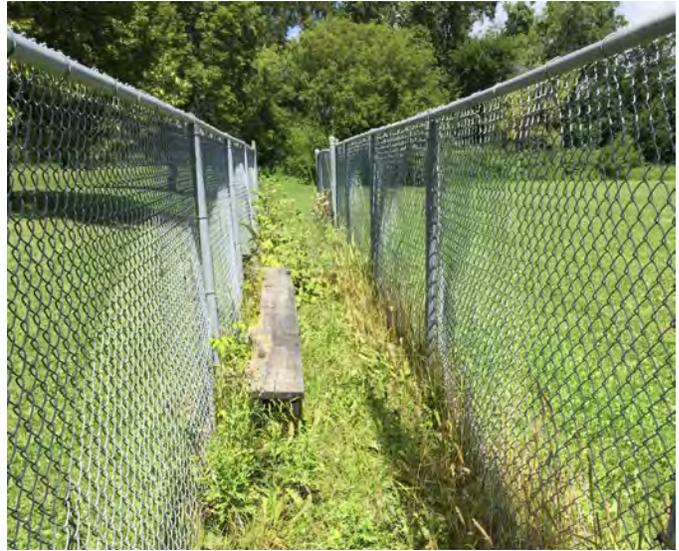
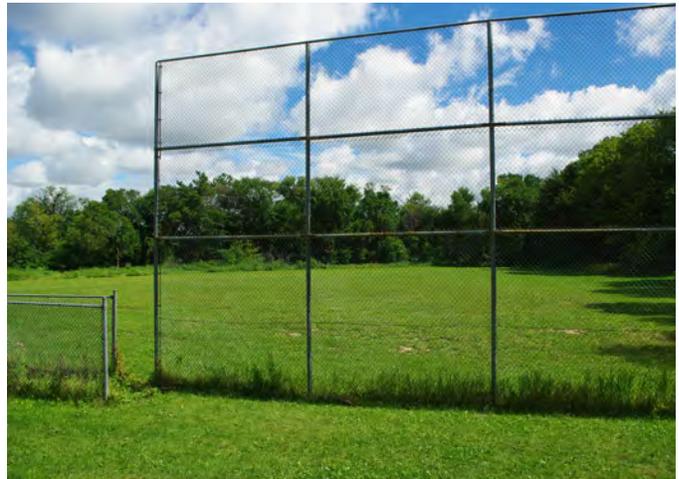
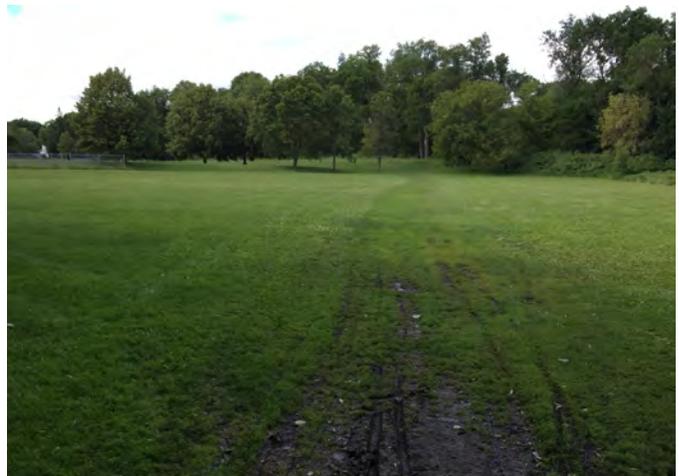
Baseball Diamond #2 player's bench (8).

Baseball Diamond #2 backstop (8).

Baseball Diamond #2 desire line (8).

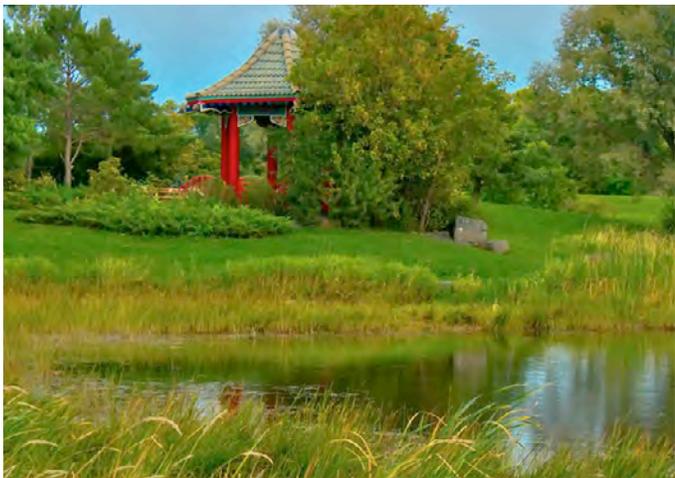
- Pagoda is in good condition but the associated sitting areas and landscape require attention.
- Bridges have high arches that make traversing them difficult for some, especially in slippery conditions.
- Only one bench is accessible off of a paved pathway.

Pagoda.

incorporate new accessible seating areas.

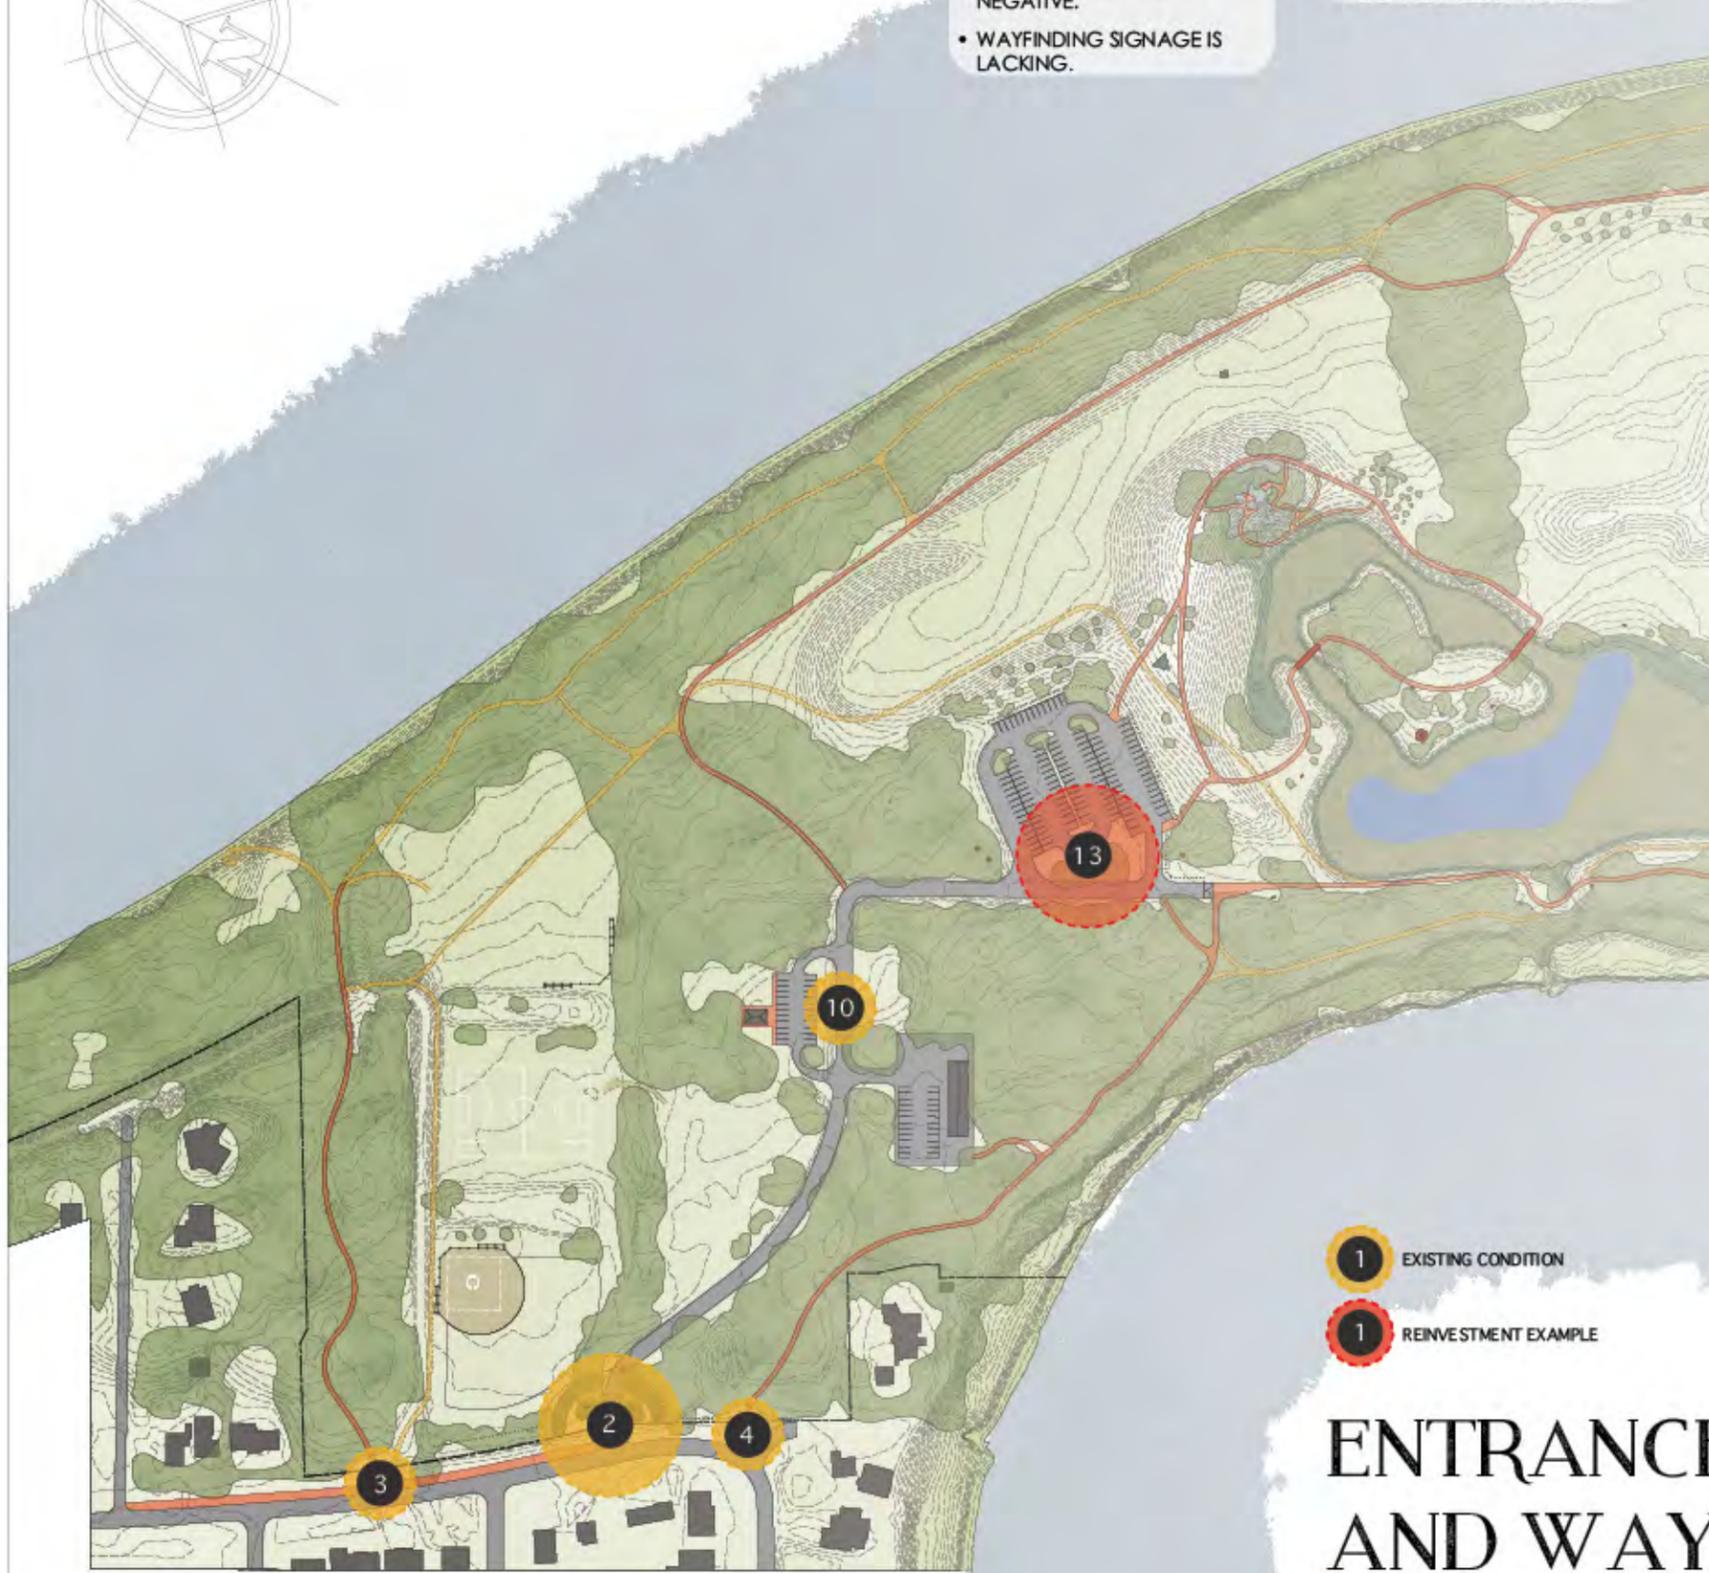
ENTRANCE GATES, SIGNAGE AND WAYFINDING

- 1 EXISTING CONDITION
- 1 REINVESTMENT EXAMPLE

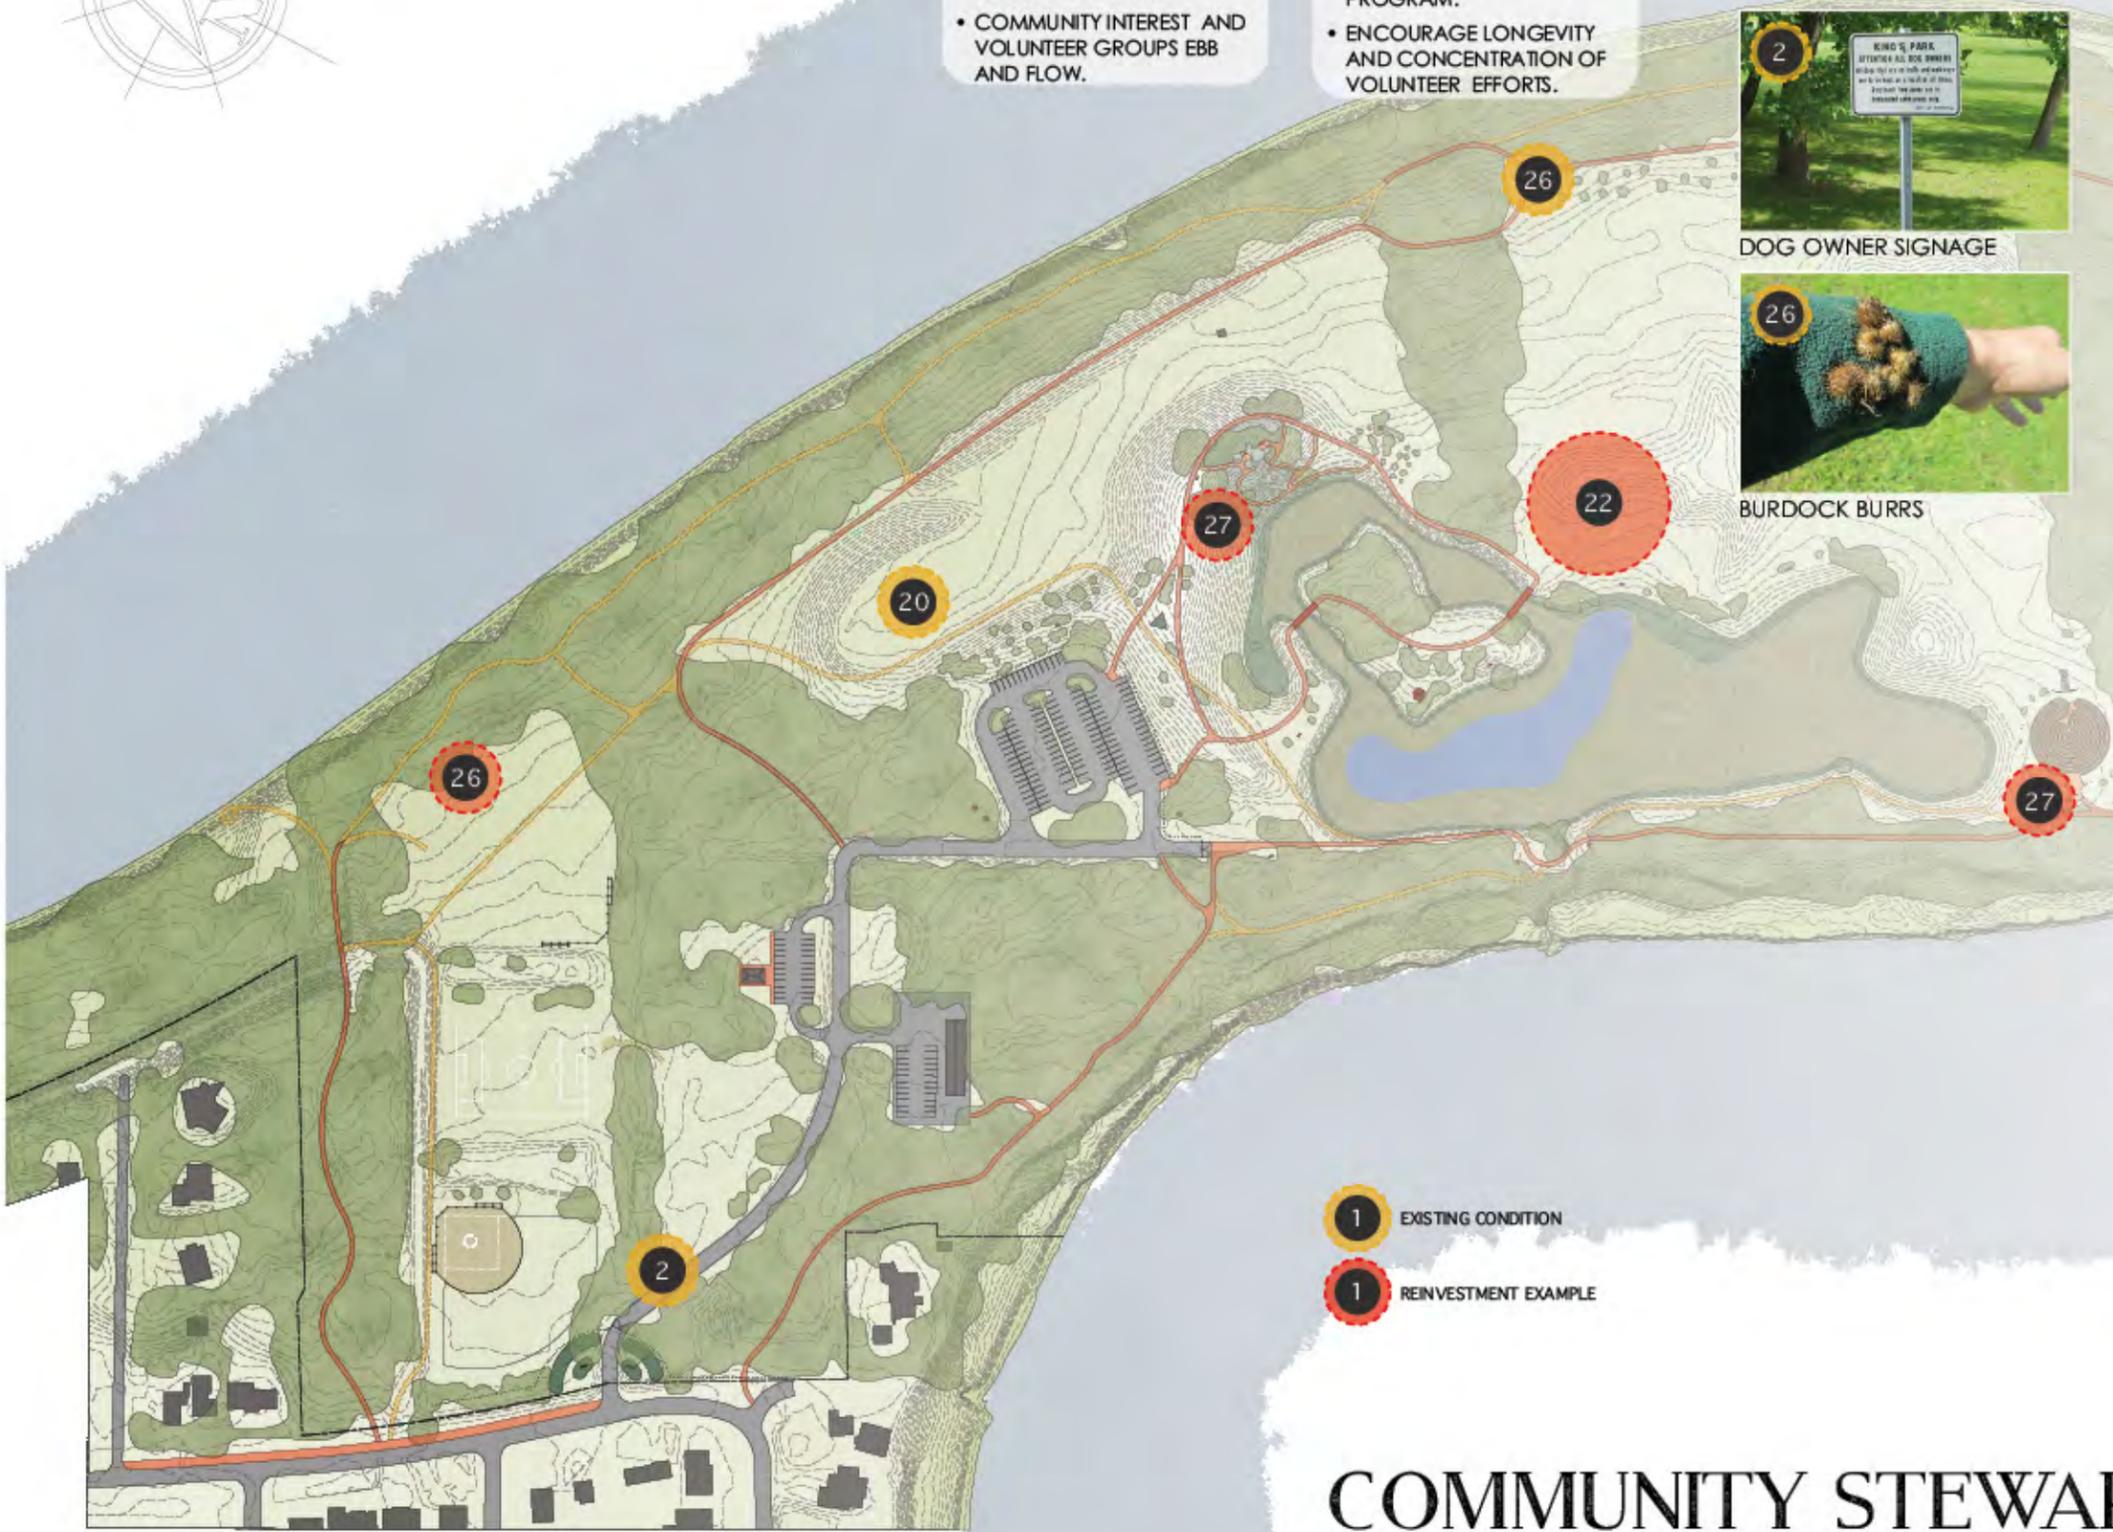
COMMUNITY STEWARDSHIP

- 1 EXISTING CONDITION
- 1 REINVESTMENT EXAMPLE

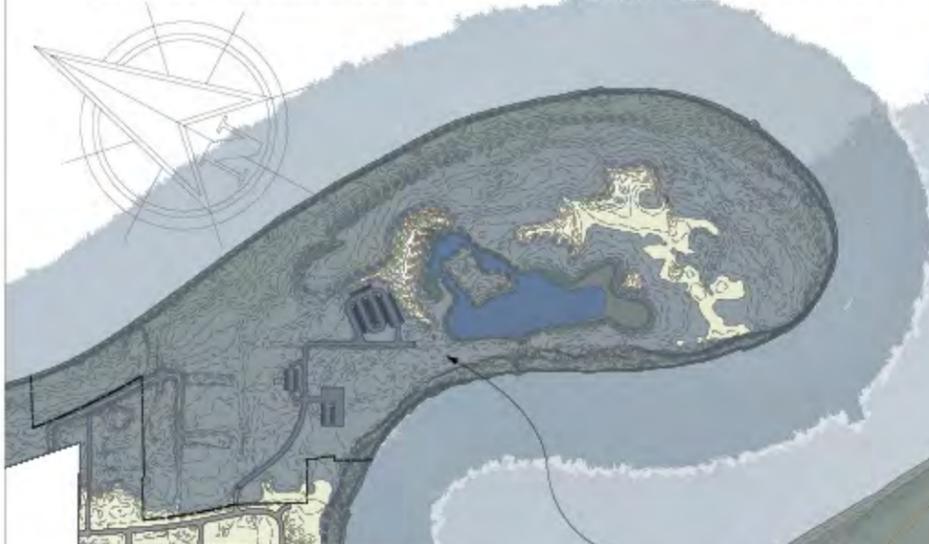
APPROXIMATE SPRING FLOODING TO 1950 LEVELS AND PURPOSEFUL PARK FLOODING BY OPENING THE DIKS

- ABANDON BASEBALL DIAMOND #2 AND ALLOW AREA TO NATURALIZE.
- REPAIR FLOODED PATHWAYS.
- EXPLORE POSSIBILITY OF ELEVATED PATHWAYS IN FLOOD-PRONE AREAS.
- REPAIR AND RESTORE WATERFALL, POSSIBLY DRAWING FROM A WELL.
- DREDGE LAKE BUT RETAIN WATERFOWL HABITAT AT THE SOUTH END. POSSIBLY ADD BOARDWALKS.
- INCORPORATE THE RIVER INTO THE PARK MORE AND ADD INTERPRETIVE ELEMENTS.
