KING'S PARK

REGIONAL PARK EXISTING FACILITY REVIEW &
REINVESTMENT STRATEGY

FEBRUARY 2016

DAVID WAGNER ASSOCIATES INC.

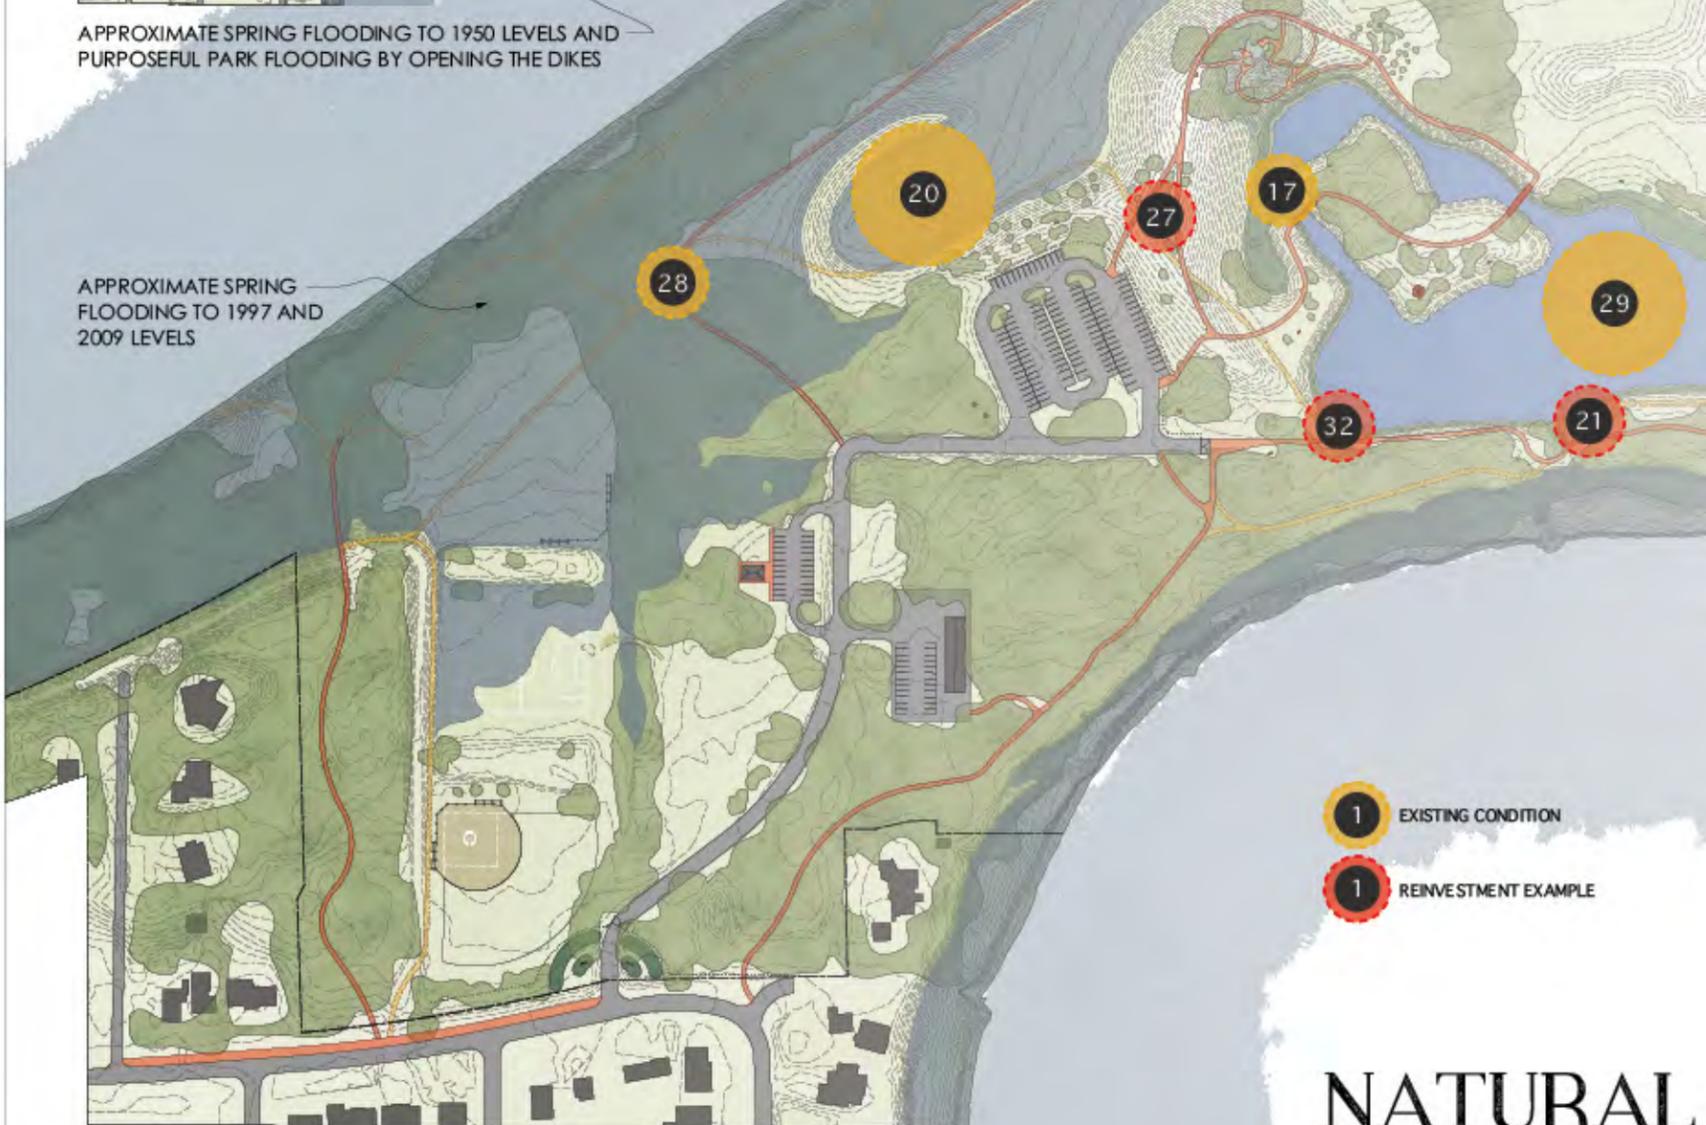
APPROXIMATE SPRING FLOODING TO 1997 AND 2009 LEVELS

- ABANDON BASEBALL DIAMOND #2 AND ALLOW AREA TO NATURALIZE.
- REPAIR FLOODED PATHWAYS.
- EXPLORE POSSIBILITY OF ELEVATED PATHWAYS IN FLOOD-PRONE AREAS.
- REPAIR AND RESTORE WATERFALL, POSSIBLY DRAWING FROM A WELL.
- DREDGE LAKE BUT RETAIN WATERFOWL HABITAT AT THE SOUTH END. POSSIBLY ADD BOARDWALKS.
- INCORPORATE THE RIVER INTO THE PARK MORE AND ADD INTERPRETIVE ELEMENTS.

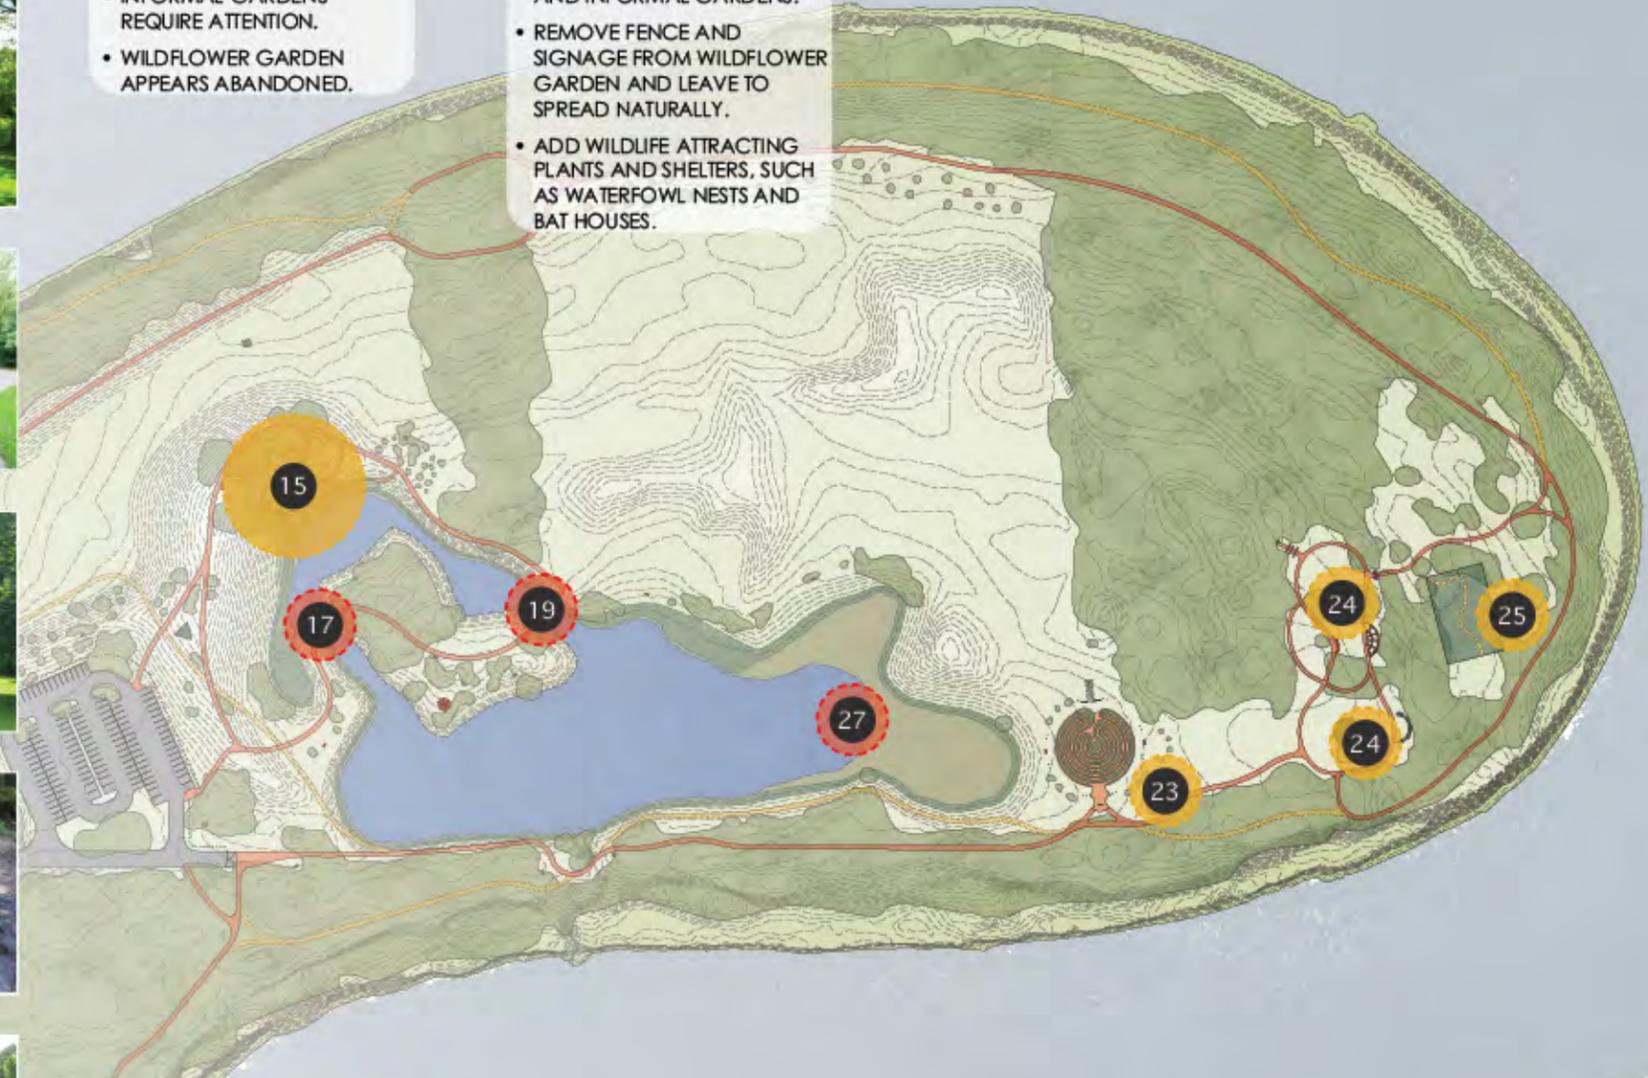
GARDENS: INFORMAL, LABYRINTH & WATERFALL

- WATERFALL IS NOT OPERATIONAL. THE WATERWAY AND PATHWAYS ARE IN POOR TO FAIR CONDITION.
- CAROL SHIELDS LABYRINTH IS IN FAIR CONDITION AND STARTING TO SHOW WEAR.
- INFORMAL GARDENS REQUIRE ATTENTION.
- WILDFLOWER GARDEN APPEARS ABANDONED.

- 1 EXISTING CONDITION
- 1 REINVESTMENT EXAMPLE

- REPAIR WATERFALL, INCLUDING UPGRADES TO PATHWAYS AND GARDENS.
- MAINTAIN PLANTING BEDS IN CAROL SHIELDS LABYRINTH AND INFORMAL GARDENS.
- UPGRADE SELECT GARDEN FEATURES SUCH AS PAGODA AND INFORMAL GARDENS.
- REMOVE FENCE AND SIGNAGE FROM WILDFLOWER GARDEN AND LEAVE TO SPREAD NATURALLY.
- ADD WILDLIFE ATTRACTING PLANTS AND SHELTERS, SUCH AS WATERFOWL NESTS AND BAT HOUSES.

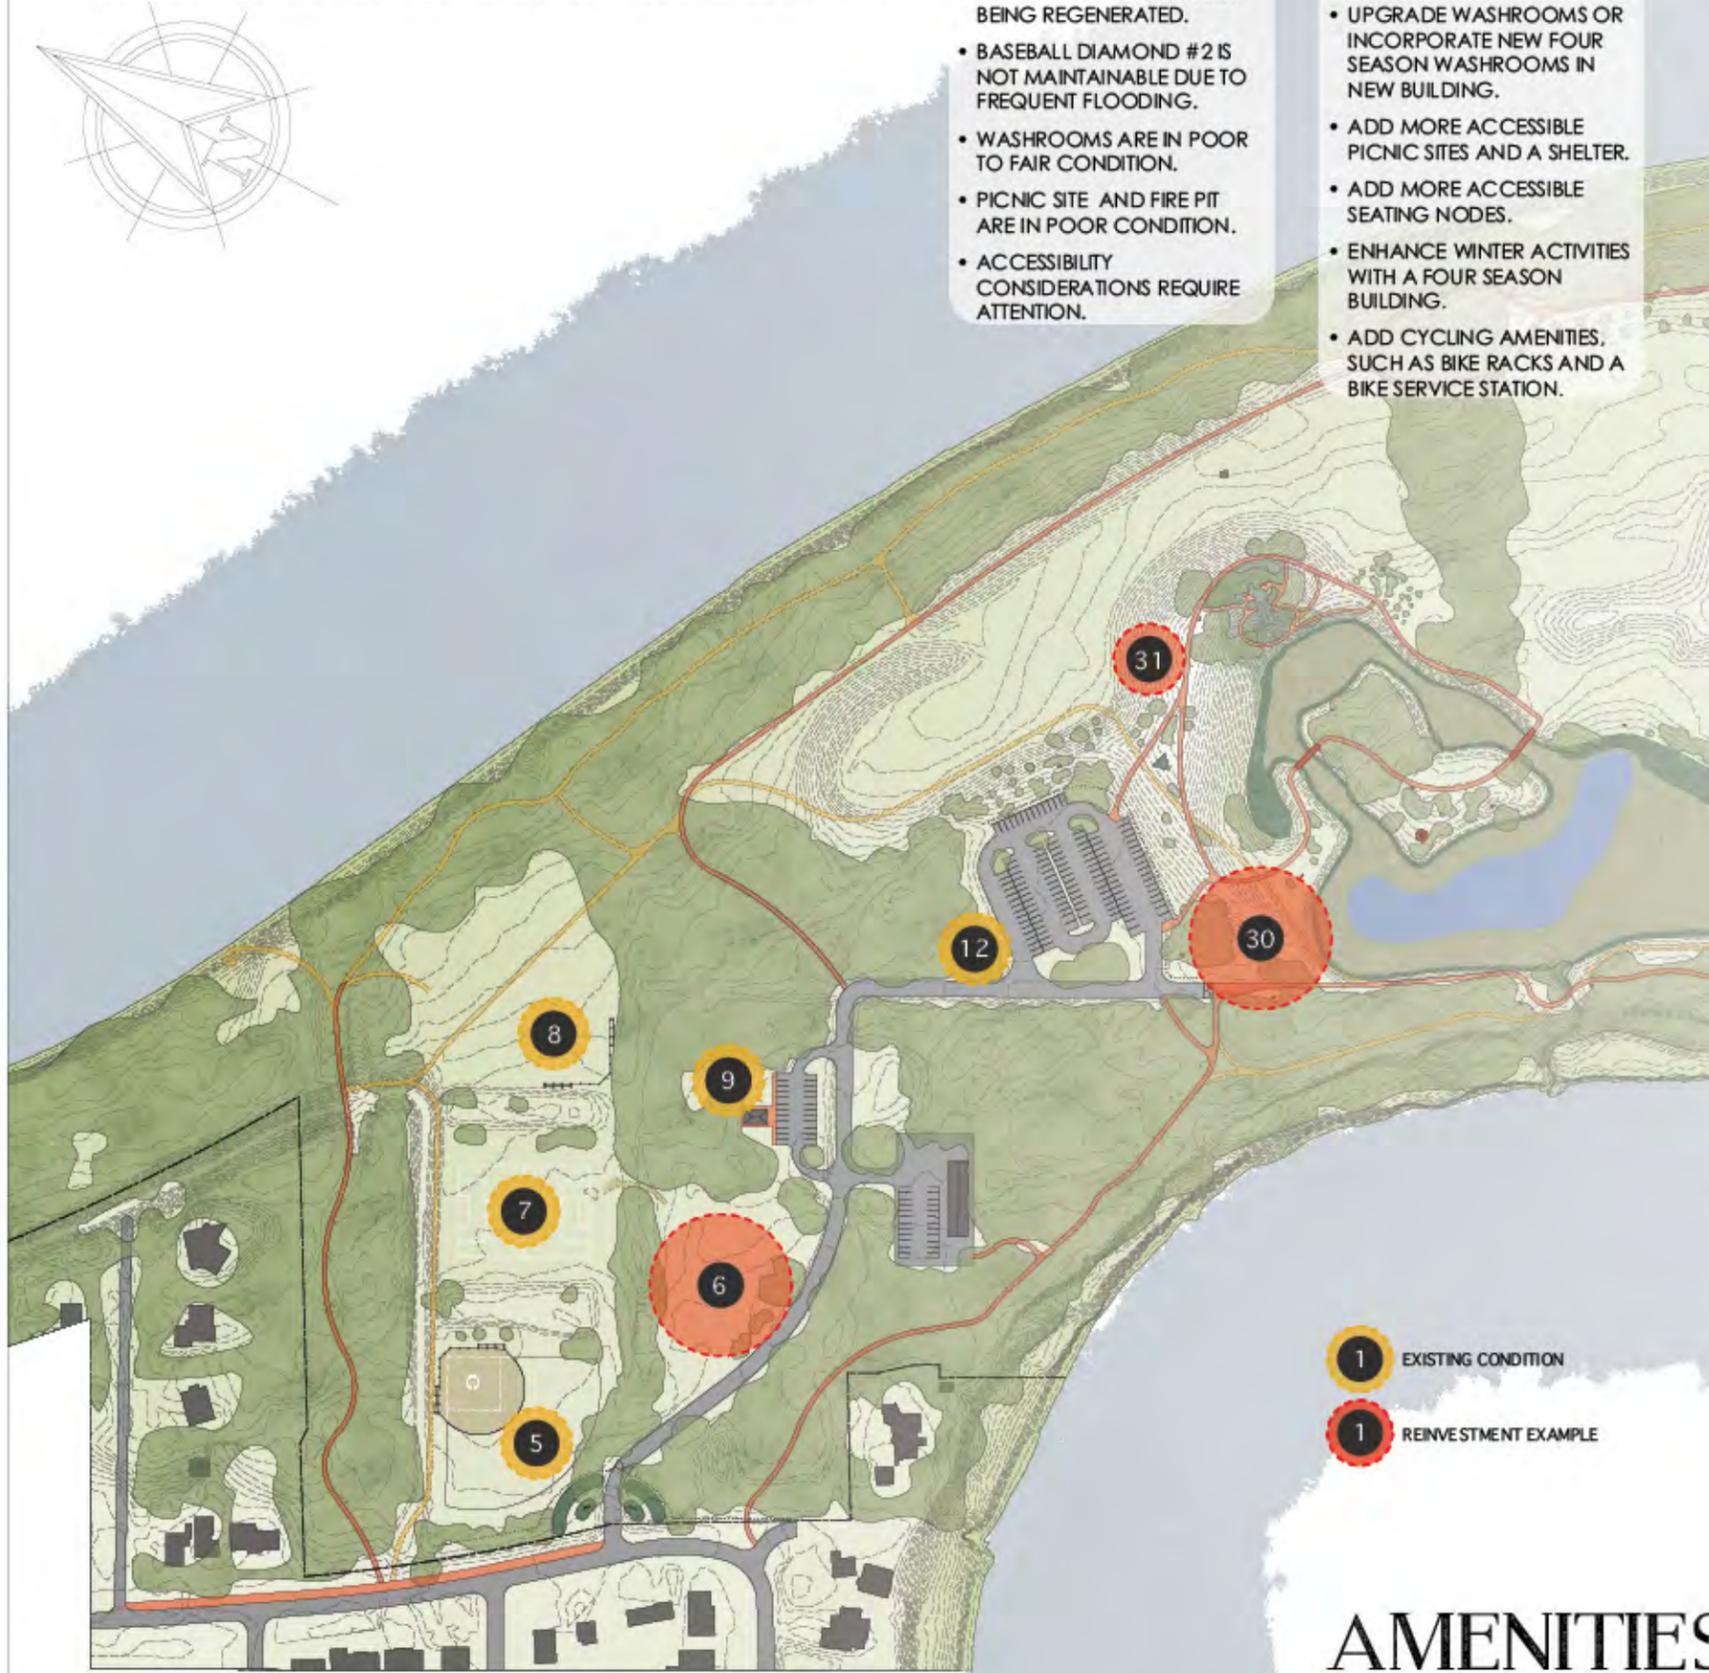
AMENITIES AND FEATURES

- 1 EXISTING CONDITION
- 1 REINVESTMENT EXAMPLE
