**SEWPCC Upgrading/Expansion  
Conceptual Design Report**

**SECTION 21 - Building Envelope and Structural Assessment**

## 21.0 Building Envelope and Structural Assessment

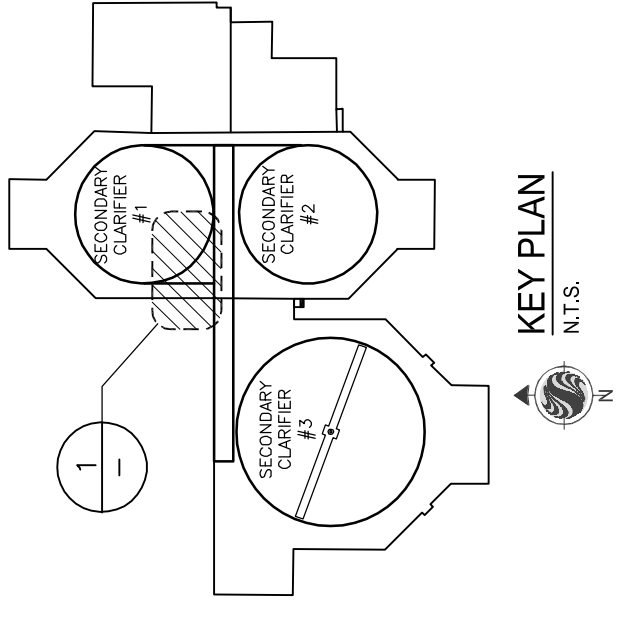
**TYP. CONCRETE REPAIR**  
A -  
1:10

**Comment:** Concrete has delaminated in the location noted. Delamination is likely due to insufficient concrete cover of the reinforcing steel. Moisture is allowed to reach the reinforcing steel surface causing it to rust and expand. The thin concrete cover does not have the strength to resist the expansive forces, resulting in concrete delamination. Loose and delaminated concrete in the area noted should be removed and repaired. Exposed reinforcing steel should be examined to confirm that rust is limited to the surface only. Reinforcing steel surfaces should be cleaned prior to replacing delaminated concrete. Subsequent investigation of the concrete at the other apron areas suggest that the delamination is limited to the area noted in the report. The aprons were checked for delamination by hammer “sounding”. See Figure 21.1.

**Action:** Remove loose and delaminated concrete, examine reinforcing steel, and repair concrete surfaces.
