APPENDIX C – OUTFALL SITE INVESTIGATIONS AND GEOTECHNICAL CONDITIONS

BISHOP GRANDIN OUTFALL – (S-MA70015994)

**800 MILLIMETER DIAMETER LAND DRAINAGE SEWER OUTFALL LOCATED EAST OF ST. ANNES
ROAD AT SEINE RIVER**

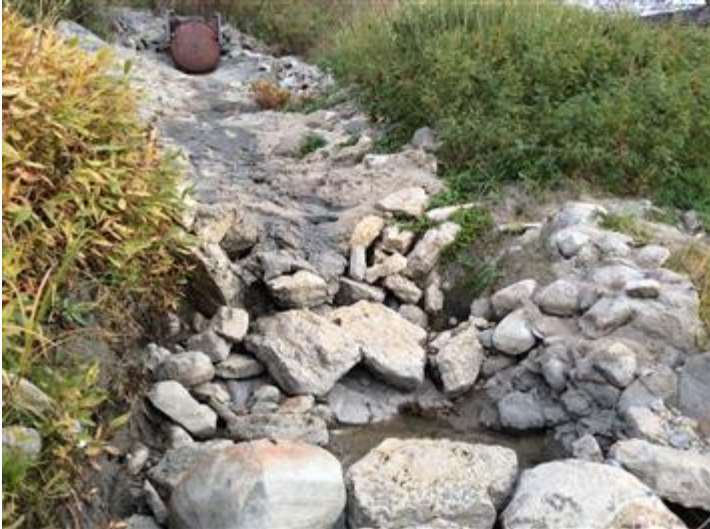
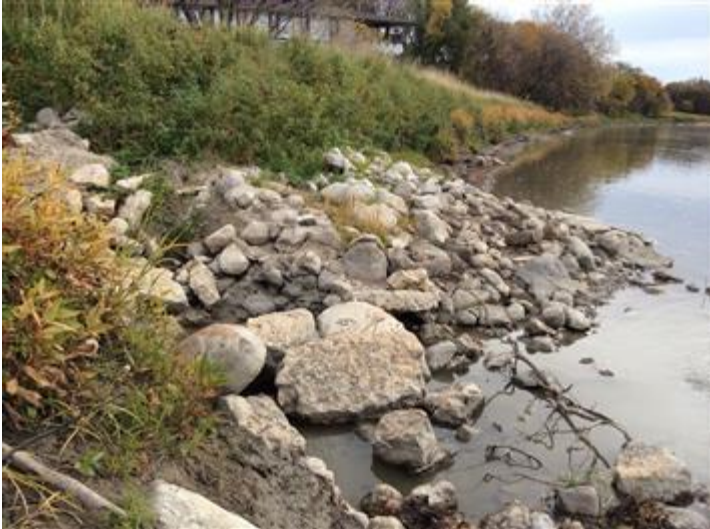
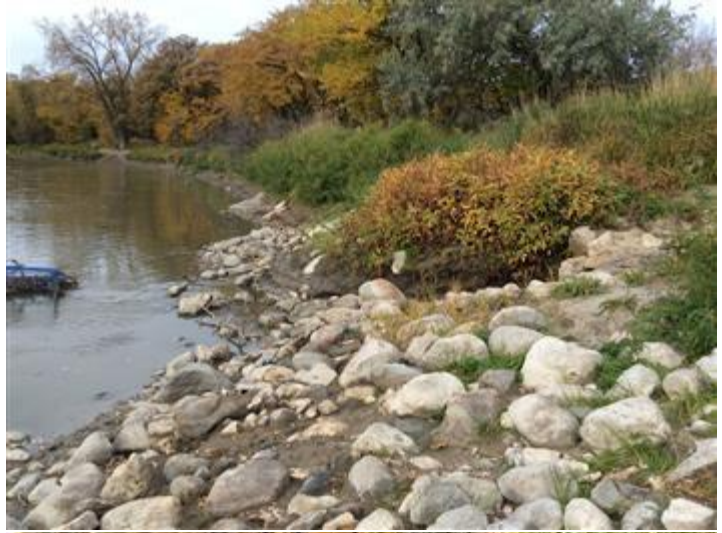
219-04

ID	Depth	Width	Location	Angle	Vegetation	Surface Soil
	218-04	700	2100	Toe	Moderate	Grass Natural	Clay

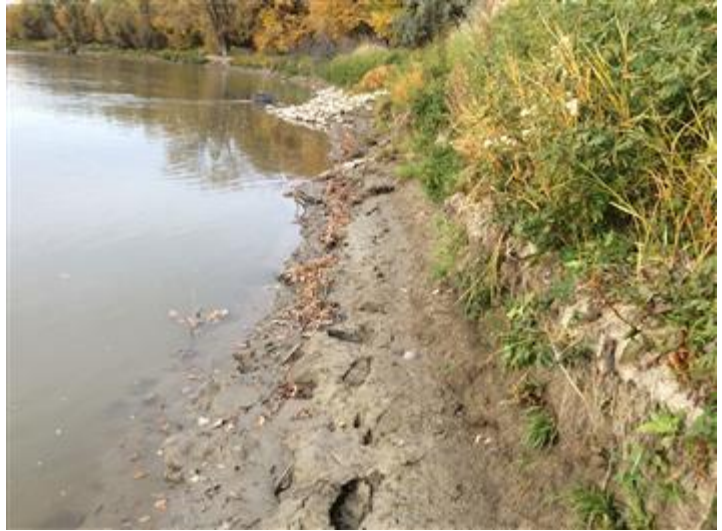
219-05

ID	Height	Location	Angle	Vegetation	Surface Soil
	218-05	1100	Toe	Vertical	Grass Natural	Clay
	218-06	1200	Toe	Vertical	Grass Natural	
	218-07	900	Mid Slope	Moderate	Grass Natural
