CITY OF WINNIPEG

WASTEWATER LIFT STATION CONDITION ASSESSMENT PHASE II - 2020

Document IV: Linden Lift Station Assessment

Date: 2021-01-25

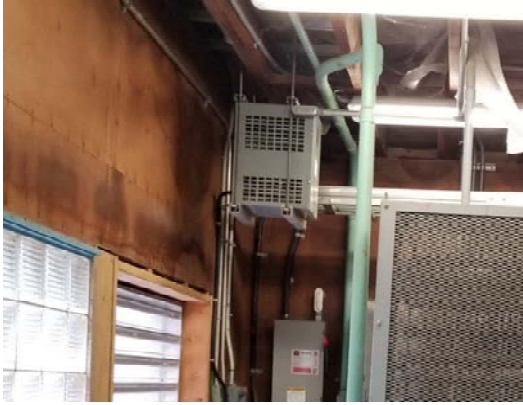
Wiring Terminations Visual Inspection: <i>Issues for Discussion:</i>	Rating 1 (Connections tight, labelled) Rating 2 (Missing Labels) Rating 3 (Loose / Disorganized wiring) Rating 4 (Inappropriate wiring) Rating 5 (Combination of above)	1	0.1				
		Occurrences of Maintenance Issues: <i>Issues for Discussion:</i>	Rating 1 (None) Rating 2 (Intermittent) Rating 3 (Consistent but occasional) Rating 4 (Frequent) Rating 5 (Constant)	2	0.4				
		Meets City Electrical Design Standards: <i>Issues for Discussion:</i>	Rating 1 (Yes) Rating 3 (No - current standards) Rating 5 (No - legacy standards)	1	0.2				
		Current Physical Condition				RECOMMENDATIONS:			
		Fitness for Purpose				COST ESTIMATE			
	Has the Capacity been Reached? <i>Issues for Discussion:</i>	Rating 1 (<75%) Rating 2 (<85%) Rating 3 (<95%) Rating 4 (At capacity) Rating 5 (Above capacity)	1	0.4					
	Equipment Remaining Service Life: <i>Issues for Discussion:</i>	Rating 1 (> 90% lifecycle remain) Rating 2 (> 75% lifecycle remain) Rating 3 (> 50% lifecycle remain) Rating 4 (> 25% lifecycle remain) Rating 5 (obsolete)	4	0.4

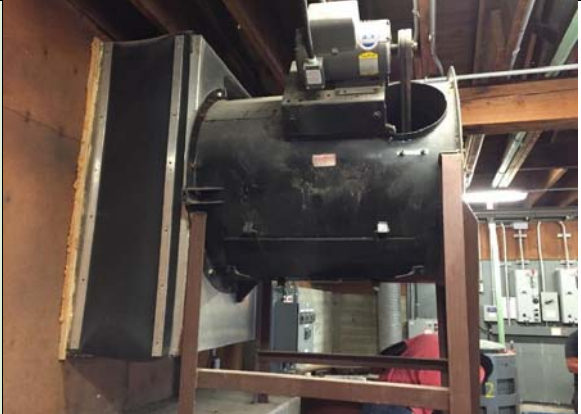
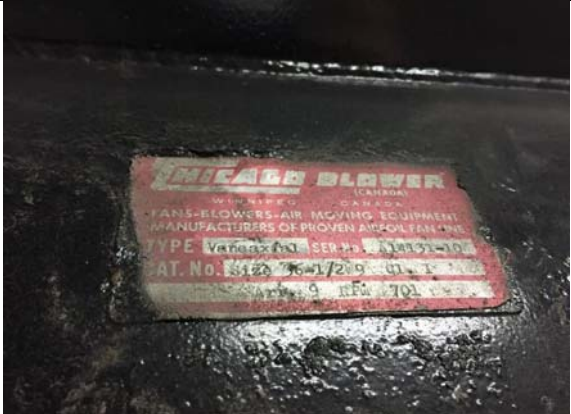
Canadian Electrical Code Issues Identified: <i>Issues for Discussion:</i> Rating 1 (No issues) Rating 3 (Non compliant - current code) Rating 5 (Non compliant - legacy code)	5	0.4					
		Wiring Terminations Visual Inspection: <i>Issues for Discussion:</i> Rating 1 (Connections tight, labelled) Rating 2 (Missing Labels) Rating 3 (Loose / Disorganized wiring) Rating 4 (Inappropriate wiring) Rating 5 (Combination of above)	1	0.1					
		Occurrences of Maintenance Issues: <i>Issues for Discussion:</i> Rating 1 (None) Rating 2 (Intermittent) Rating 3 (Consistent but occasional) Rating 4 (Frequent) Rating 5 (Constant)	2	0.4					
	Fitness for Purpose	Meets City Electrical Design Standards: <i>Issues for Discussion:</i> Rating 1 (Yes) Rating 3 (No - current standards) Rating 5 (No - legacy standards)	1	0.25	RECOMMENDATIONS: COST ESTIMATE				
		Has the Capacity been Reached? <i>Issues for Discussion:</i> Rating 1 (Below service factor) Rating 2 (Occasional within service factor) Rating 3 (Frequent within service factor) Rating 4 (Always Within Service Factor) Rating 5 (> Service Factor)	1	0.5

Equipment Remaining Service Life: <i>Issues for Discussion:</i> Rating 1 (> 90% lifecycle remain) Rating 2 (> 75% lifecycle remain) Rating 3 (> 50% lifecycle remain) Rating 4 (> 25% lifecycle remain) Rating 5 (obsolete)		4	0.25						
PHOTOGRAPHS

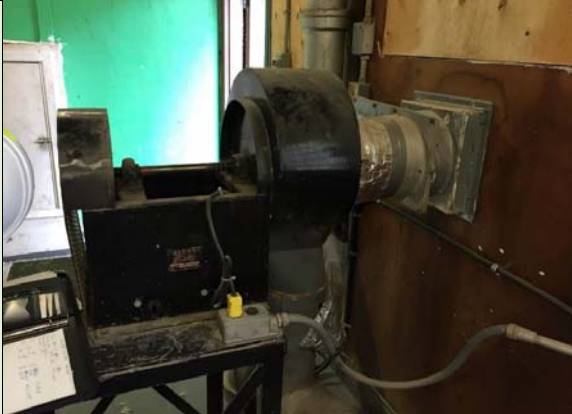
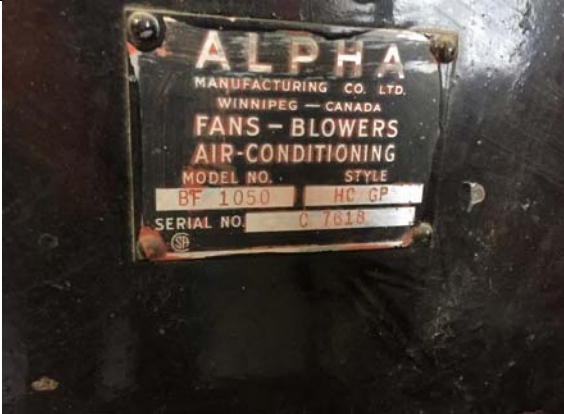
Canadian Electrical Code Issues Identified: <i>Issues for Discussion:</i> Rating 1 (No issues) Rating 3 (Non compliant - current code) Rating 5 (Non compliant - legacy code)	5	0.4					
		Wiring Terminations Visual Inspection: <i>Issues for Discussion:</i> Rating 1 (Connections tight, labelled) Rating 2 (Missing Labels) Rating 3 (Loose / Disorganized wiring) Rating 4 (Inappropriate wiring) Rating 5 (Combination of above)	2	0.1					
		Occurrences of Maintenance Issues: <i>Issues for Discussion:</i> Rating 1 (None) Rating 2 (Intermittent) Rating 3 (Consistent but occasional) Rating 4 (Frequent) Rating 5 (Constant)	2	0.4					
		Meets City Electrical Design Standards: <i>Issues for Discussion:</i> Rating 1 (Yes) Rating 3 (No - current standards) Rating 5 (No - legacy standards)	1	0.25					
	Fitness for Purpose	Has the Capacity been Reached? <i>Issues for Discussion:</i> Rating 1 (Below service factor) Rating 2 (Occasional within service factor) Rating 3 (Frequent within service factor) Rating 4 (Always Within Service Factor) Rating 5 (> Service Factor)	1	0.5	RECOMMENDATIONS: COST ESTIMATE

Equipment Remaining Service Life: <i>Issues for Discussion:</i> Rating 1 (> 90% lifecycle remain) Rating 2 (> 75% lifecycle remain) Rating 3 (> 50% lifecycle remain) Rating 4 (> 25% lifecycle remain) Rating 5 (obsolete)		4	0.25						
PHOTOGRAPHS

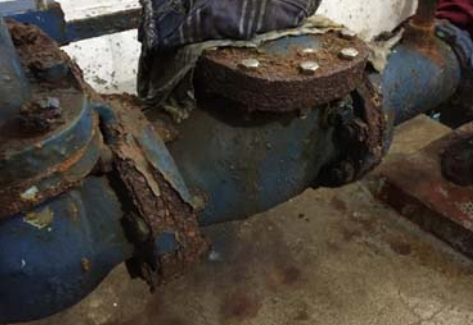
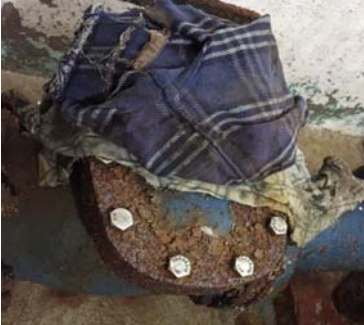
Valve Operation: Issues for Discussion:		Rating 1 (Yes - Valve functions) Rating 3 (Yes - Functions but with difficulty) Rating 5 (No - Valve inoperable)	5	0.3						
Occurrence of Maintenance Issues: Issues for Discussion:		Rating 1 (None) Rating 2 (Intermittent) Rating 3 (Consistent but Occasional) Rating 4 (Frequent) Rating 5 (Constant)	5	0.3						
Fitness For Purpose	Appropriate Valve Configuration: Issues for Discussion:	Rating 1 (Yes) Rating 3 (No - Station still functional) Rating 5 (No - Improper valve configuration for application. Risk of Critical Failure)	1	0.3	RECOMMENDATIONS: Replace Valve		COST ESTIMATE \$ 5,000.00			
	Valve Capacity: Issues for Discussion:	Rating 1 (Valve size sufficient for current and projected demand conditions) Rating 2 (Valve size sufficient for current demand conditions with minor surplus) Rating 3 (Valve size sufficient) Rating 4 (Valve size does not meet current demand condition) Rating 5 (Valve is critically undersized and likelihood of station backup is high)	3	0.7

Maintainability and Operability	Sufficient Access to Perform O&M Activities Safely: Issues for Discussion:	Rating 1 (Yes - No access restrictions) Rating 2 (Yes - Some minor access restrictions) Rating 3 (Yes - Access restrictions that cause minor alteration of work method) Rating 4 (No - Access restrictions cause significant alteration of work method) Rating 5 (No - Access restrictions prevent safe completion of O&M activities)	2	0.6						
	Sufficient Access to Exercise Valve: Issues for Discussion:	Rating 1 (Yes - No access restrictions) Rating 2 (Yes - Some minor access restrictions) Rating 3 (Yes - Access restrictions that cause minor alteration of valve operation) Rating 4 (No - Access restrictions cause significant alteration of valve operation) Rating 5 (No - Access restrictions prevent safe operation of valve)	1	0.4						
PHOTOGRAPHS

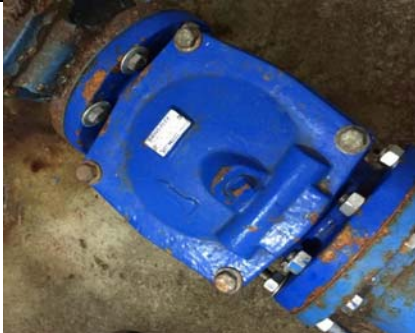
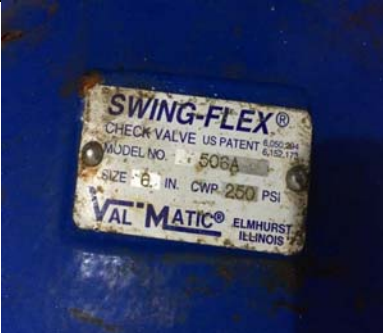
Project No.: 8400-001-02
 Tag: CHV_102
 Facility: Linden Lift Station
 Assessment Page 1 of 1

Valve Operation: Issues for Discussion:		Rating 1 (Yes - Valve functions) Rating 3 (Yes - Functions but with difficulty) Rating 5 (No - Valve inoperable)	2	0.3					
Occurrence of Maintenance Issues: Issues for Discussion:		Rating 1 (None) Rating 2 (Intermittent) Rating 3 (Consistent but Occasional) Rating 4 (Frequent) Rating 5 (Constant)	1	0.3					
Fitness For Purpose	Appropriate Valve Configuration: Issues for Discussion:	Rating 1 (Yes) Rating 3 (No - Station still functional) Rating 5 (No - Improper valve configuration for application. Risk of Critical Failure)	1	0.3	RECOMMENDATIONS:		COST ESTIMATE		
	Valve Capacity: Issues for Discussion:	Rating 1 (Valve size sufficient for current and projected demand conditions) Rating 2 (Valve size sufficient for current demand conditions with minor surplus) Rating 3 (Valve size sufficient) Rating 4 (Valve size does not meet current demand condition) Rating 5 (Valve is critically undersized and likelihood of station backup is high)	3	0.7

Maintainability and Operability	Sufficient Access to Perform O&M Activities Safely: Issues for Discussion:	Rating 1 (Yes - No access restrictions) Rating 2 (Yes - Some minor access restrictions) Rating 3 (Yes - Access restrictions that cause minor alteration of work method) Rating 4 (No - Access restrictions cause significant alteration of work method) Rating 5 (No - Access restrictions prevent safe completion of O&M activities)	2	0.6					
	Sufficient Access to Exercise Valve: Issues for Discussion:	Rating 1 (Yes - No access restrictions) Rating 2 (Yes - Some minor access restrictions) Rating 3 (Yes - Access restrictions that cause minor alteration of valve operation) Rating 4 (No - Access restrictions cause significant alteration of valve operation) Rating 5 (No - Access restrictions prevent safe operation of valve)	1	0.4					
PHOTOGRAPHS

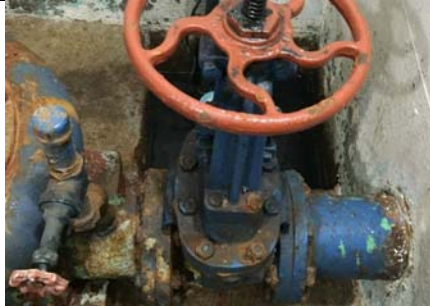
Appropriate Piping Configuration: <i>Issues for Discussion:</i> Rating 1 (Yes) Rating 3 (No - Station still functional) Rating 5 (No - Improper piping configuration for application. Risk of Critical Failure)	1	0.1								
		Piping Capacity: <i>Issues for Discussion:</i> Rating 1 (Piping has sufficient capacity for current and projected demand conditions) Rating 2 (Piping has sufficient capacity for current demand conditions with minor surplus) Rating 3 (Piping has sufficient capacity) Rating 4 (Piping does not meet current demand condition) Rating 5 (Piping is critically undersized and likelihood of station backup is high)	4	0.4								
	Maintainability and Operability	Sufficient Access to Perform O&M Activities Safely: <i>Issues for Discussion:</i> Rating 1 (Yes - No access restrictions) Rating 2 (Yes - Some minor access restrictions) Rating 3 (Yes - Access restrictions that cause minor alteration of work method) Rating 4 (No - Access restrictions cause significant alteration of work method) Rating 5 (No - Access restrictions prevent safe completion of O&M activities)	2	0.6

Isolation Valves Installed: <i>Issues for Discussion:</i> Rating 1 (Yes) Rating 5 (No)		1	0.4									
PHOTOGRAPHS

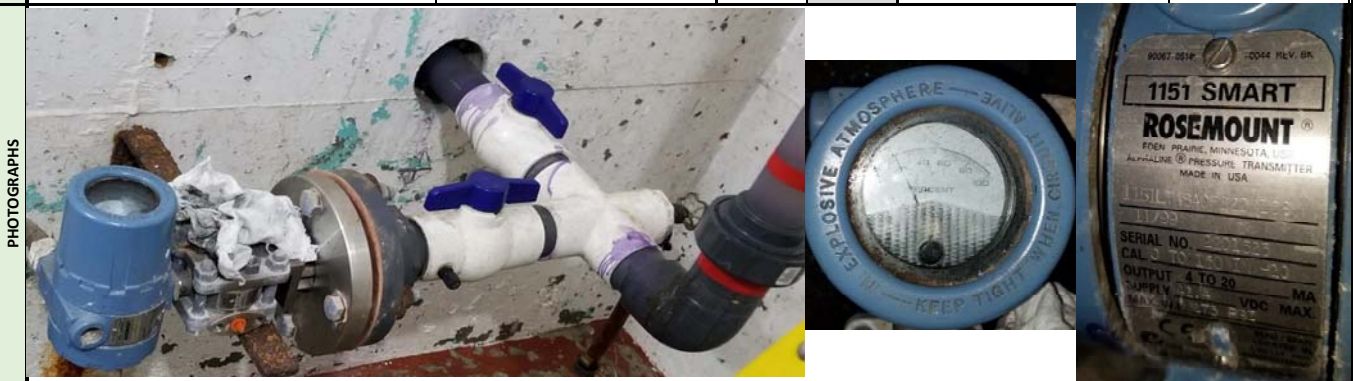
Canadian Electrical Code Issues Identified: <i>Issues for Discussion:</i> Rating 1 (No issues) Rating 3 (Non compliant - current code) Rating 5 (Non compliant - legacy code)	5	0.4					
Control Wiring Terminations Visual Inspection: <i>Issues for Discussion:</i> Rating 1 (Connections tight, labelled) Rating 2 (Missing Labels) Rating 3 (Loose / Disorganized wiring) Rating 4 (Inappropriate wiring) Rating 5 (Combination of above)		1	0.1						
Occurrences of Maintenance Issues: <i>Issues for Discussion:</i> Rating 1 (None) Rating 2 (Intermittent) Rating 3 (Consistent but occasional) Rating 4 (Frequent) Rating 5 (Constant)		2	0.4						
Instrument/Measurement is Designed Appropriately: <i>Issues for Discussion:</i> Rating 1 (Yes) Rating 3 (No - current standards) Rating 5 (No - legacy standards)		1	0.3						
Instrument Redundancy is Required/Installed: <i>Issues for Discussion:</i> Rating 1 (Yes or Not Required) Rating 3 (Required, non standard) Rating 5 (Required, not installed)		1	0.1

Fitness for Purpose	Instrument Range is Appropriate: <i>Issues for Discussion:</i> Rating 1 (Yes) Rating 3 (No - current standards) Rating 5 (No - legacy standards)	1	0.1						
	Instrument Remaining Service Life: <i>Issues for Discussion:</i> Rating 1 (> 90% lifecycle remain) Rating 2 (> 75% lifecycle remain) Rating 3 (> 50% lifecycle remain) Rating 4 (> 25% lifecycle remain) Rating 5 (obsolete)	5	0.5						
	RECOMMENDATIONS: Redundant Level Transmitter		COST ESTIMATE \$ 16,800.00
