**GEOTECHNICAL INVESTIGATION AND
RIVERBANK STABILTY ASSESSMENT
CRANE – WILLOW INTERCEPTOR
SEWER REPLACEMENT**

FINAL REPORT

NOVEMBER, 2007

**KGS
GROUP**

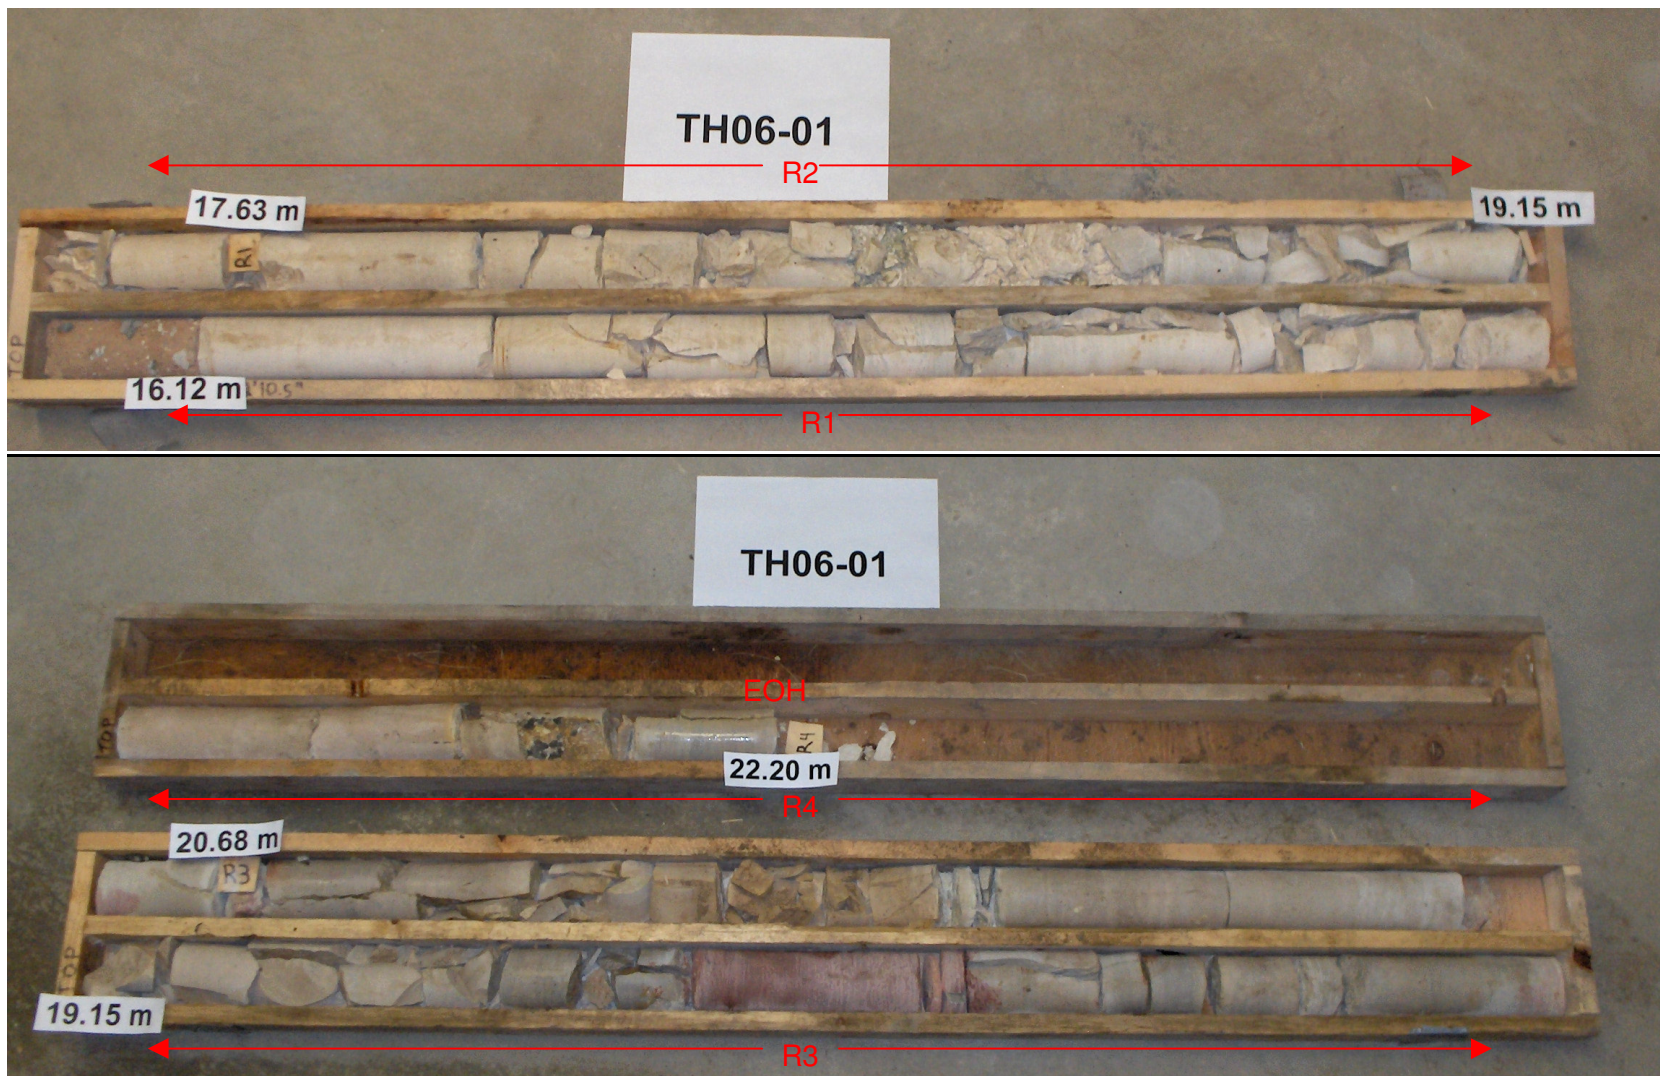
Refer to TH06-01 in Appendix A for detailed description of core

The silt till was underlain by limestone bedrock which extended at least to Elev. 206.9 m where coring was stopped. Detailed core logs are attached at the end of this report along with photos of each core run. The limestone was mottled tan to white in colour and contained some horizontal and vertical fractures. Core recovery was excellent with recoveries of 100% for each run in TH06-01. RQD values ranged from 31% to 60% resulting in a description of the bedrock quality as Poor to Fair.

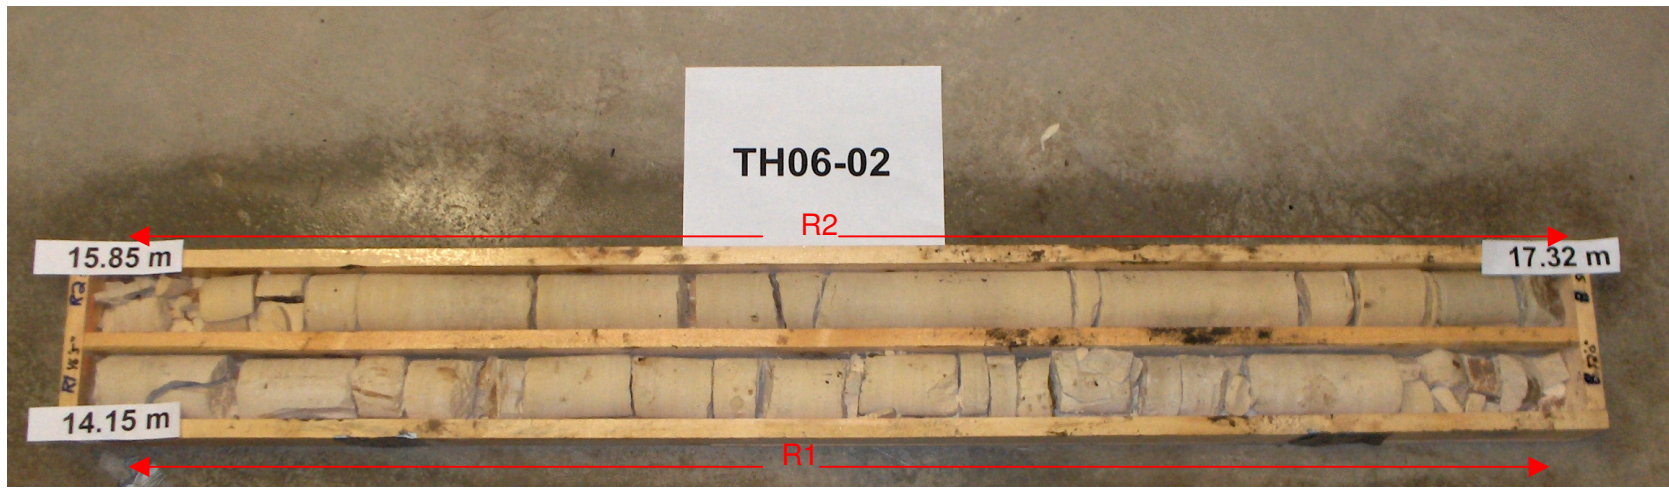
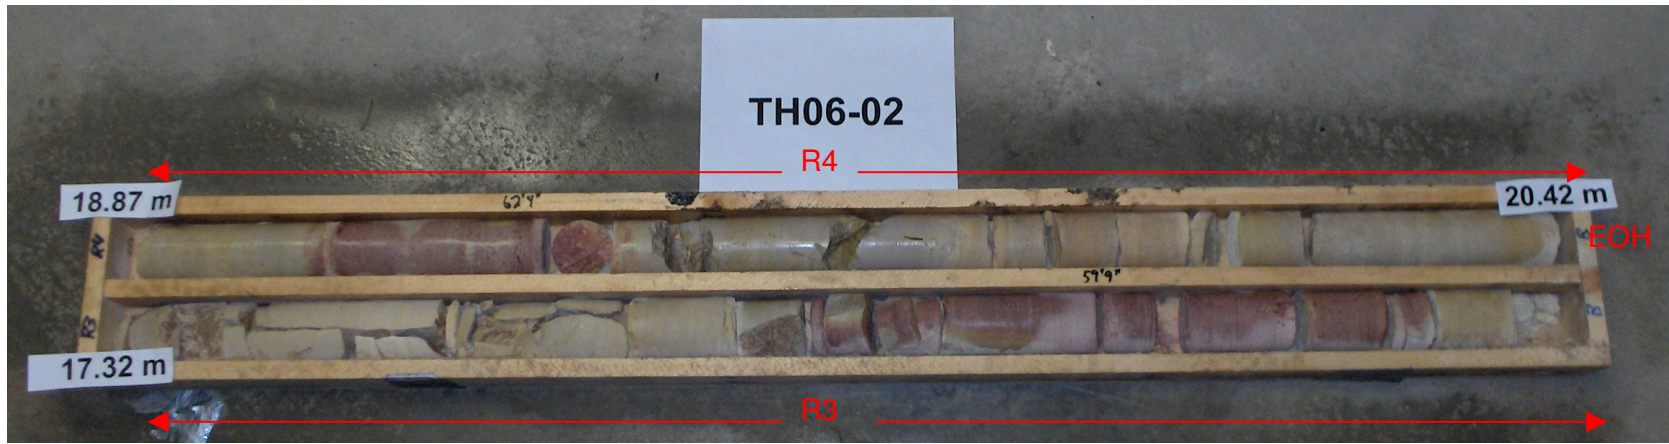
Refer to TH06-02 in Appendix A for detailed description of core

The silt till was underlain by limestone bedrock to at least Elev. 207.1 m where coring was stopped. The bedrock was mottled beige and yellow in colour and contained some horizontal and vertical fractures. Core recovery was excellent with recoveries ranging from 90% to 100% for each run in TH06-02. RQD values ranged from 37% to 67% resulting in a description of the bedrock quality as Poor to Fair.

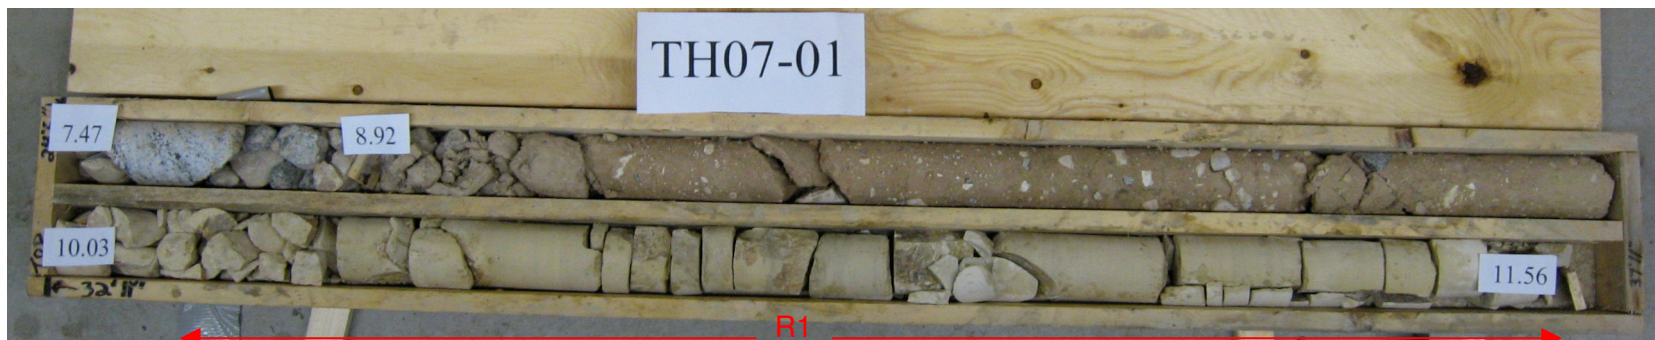
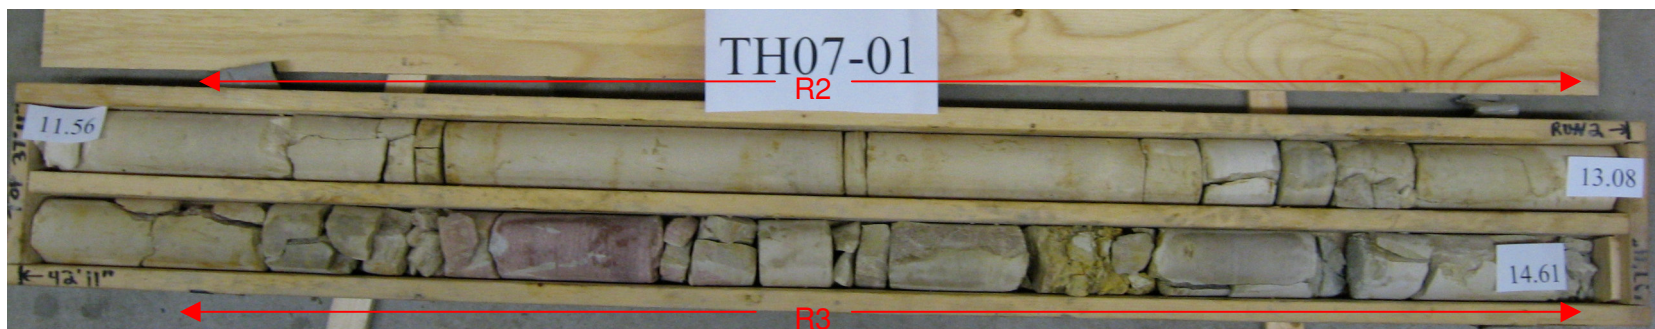
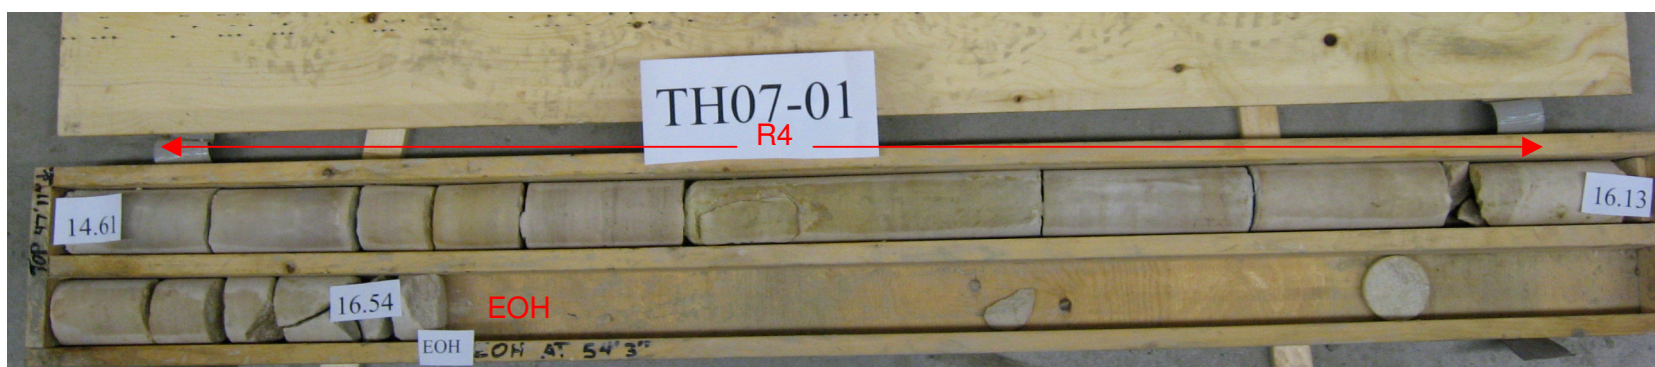
Refer to TH07-01 in Appendix A for detailed description of core

Till was underlain by limestone bedrock to at least Elev. 207.1 m where coring was stopped. Detailed core logs are attached at the end of this report along with photos of each core run. The bedrock was mottled tan to white in colour and contained some horizontal and vertical fractures.
