**THE CLOUTIER DRIVE OUTFALL (RR-7)
OUTFALL INSPECTION/CONDITION ASSESSMENT**

AUGUST, 2009

RE: 2009 Cloutier Drive Outfall (RR-7) Condition Assessment

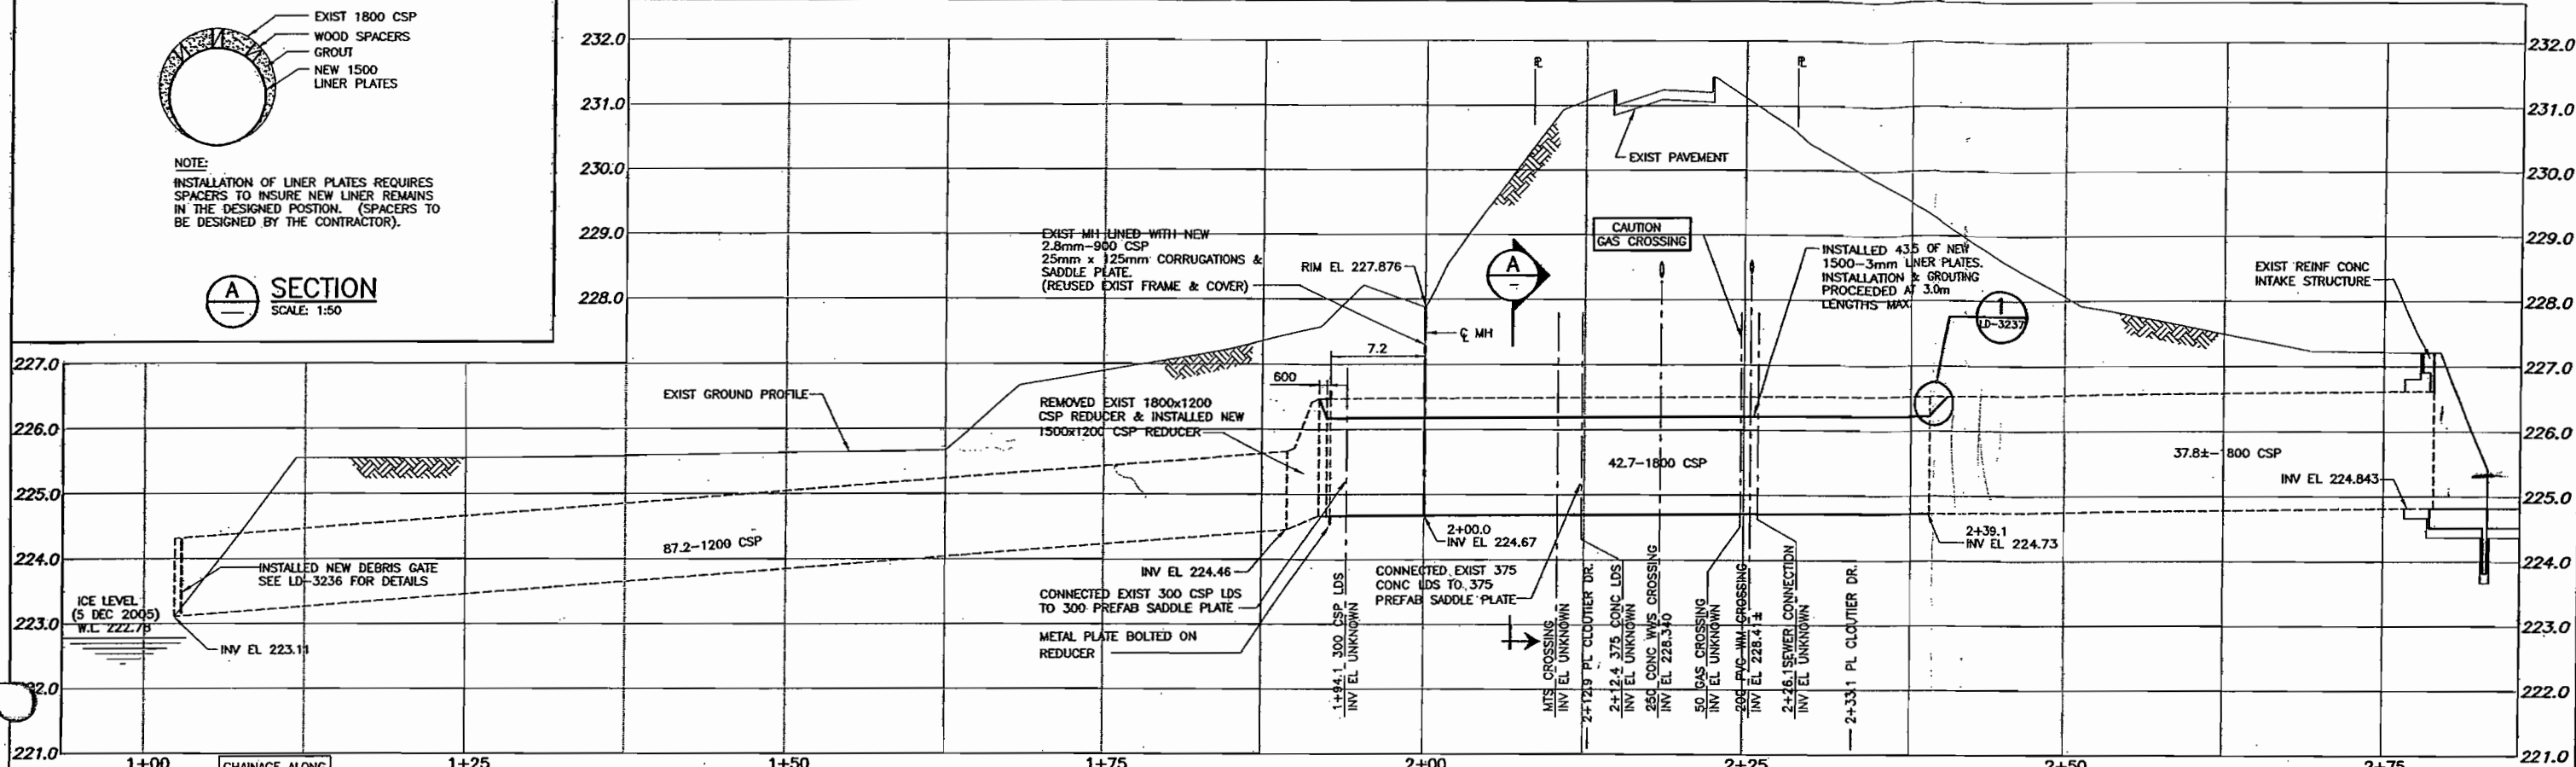
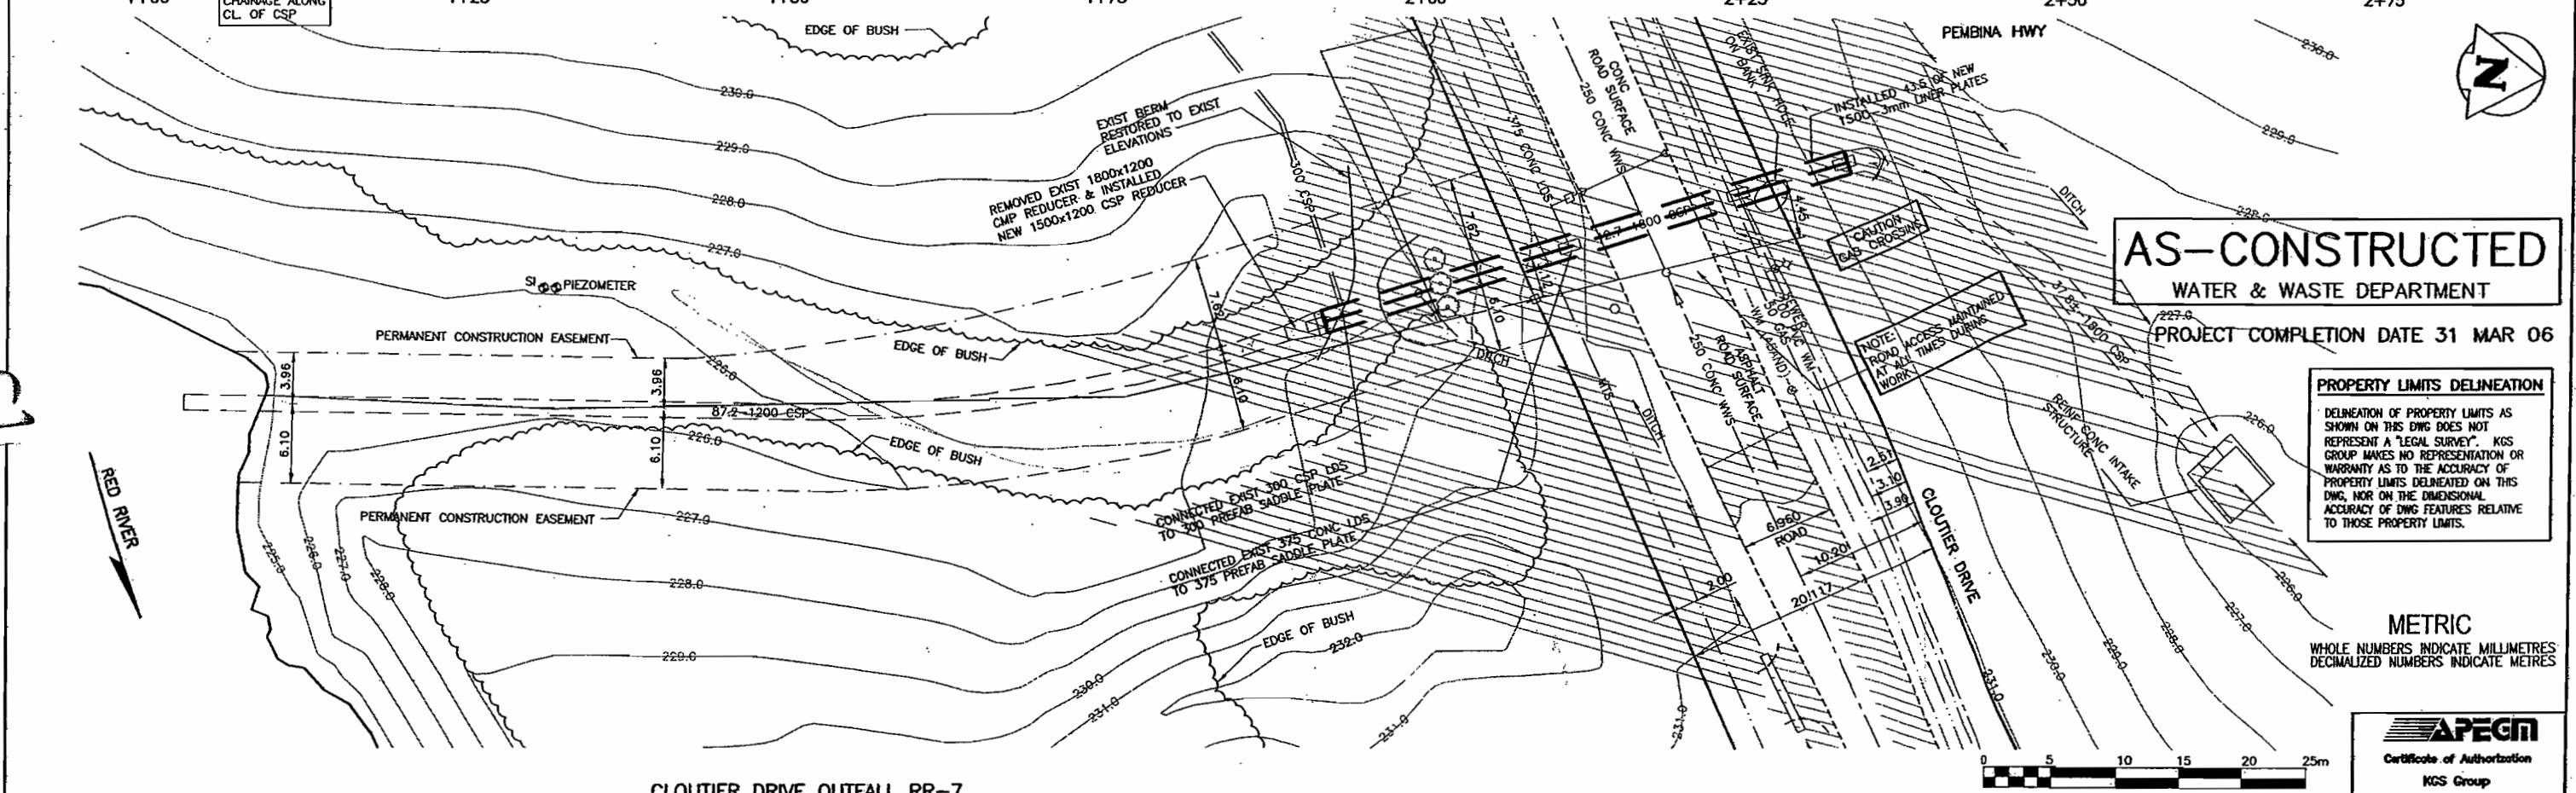
A SECTION
SCALE: 1:50

NOTE:
INSTALLATION OF LINER PLATES REQUIRES SPACERS TO INSURE NEW LINER REMAINS IN THE DESIGNED POSITION. (SPACERS TO BE DESIGNED BY THE CONTRACTOR).
