NEWPCC Secondary Clarifier #1
Examination
December 03, 2010

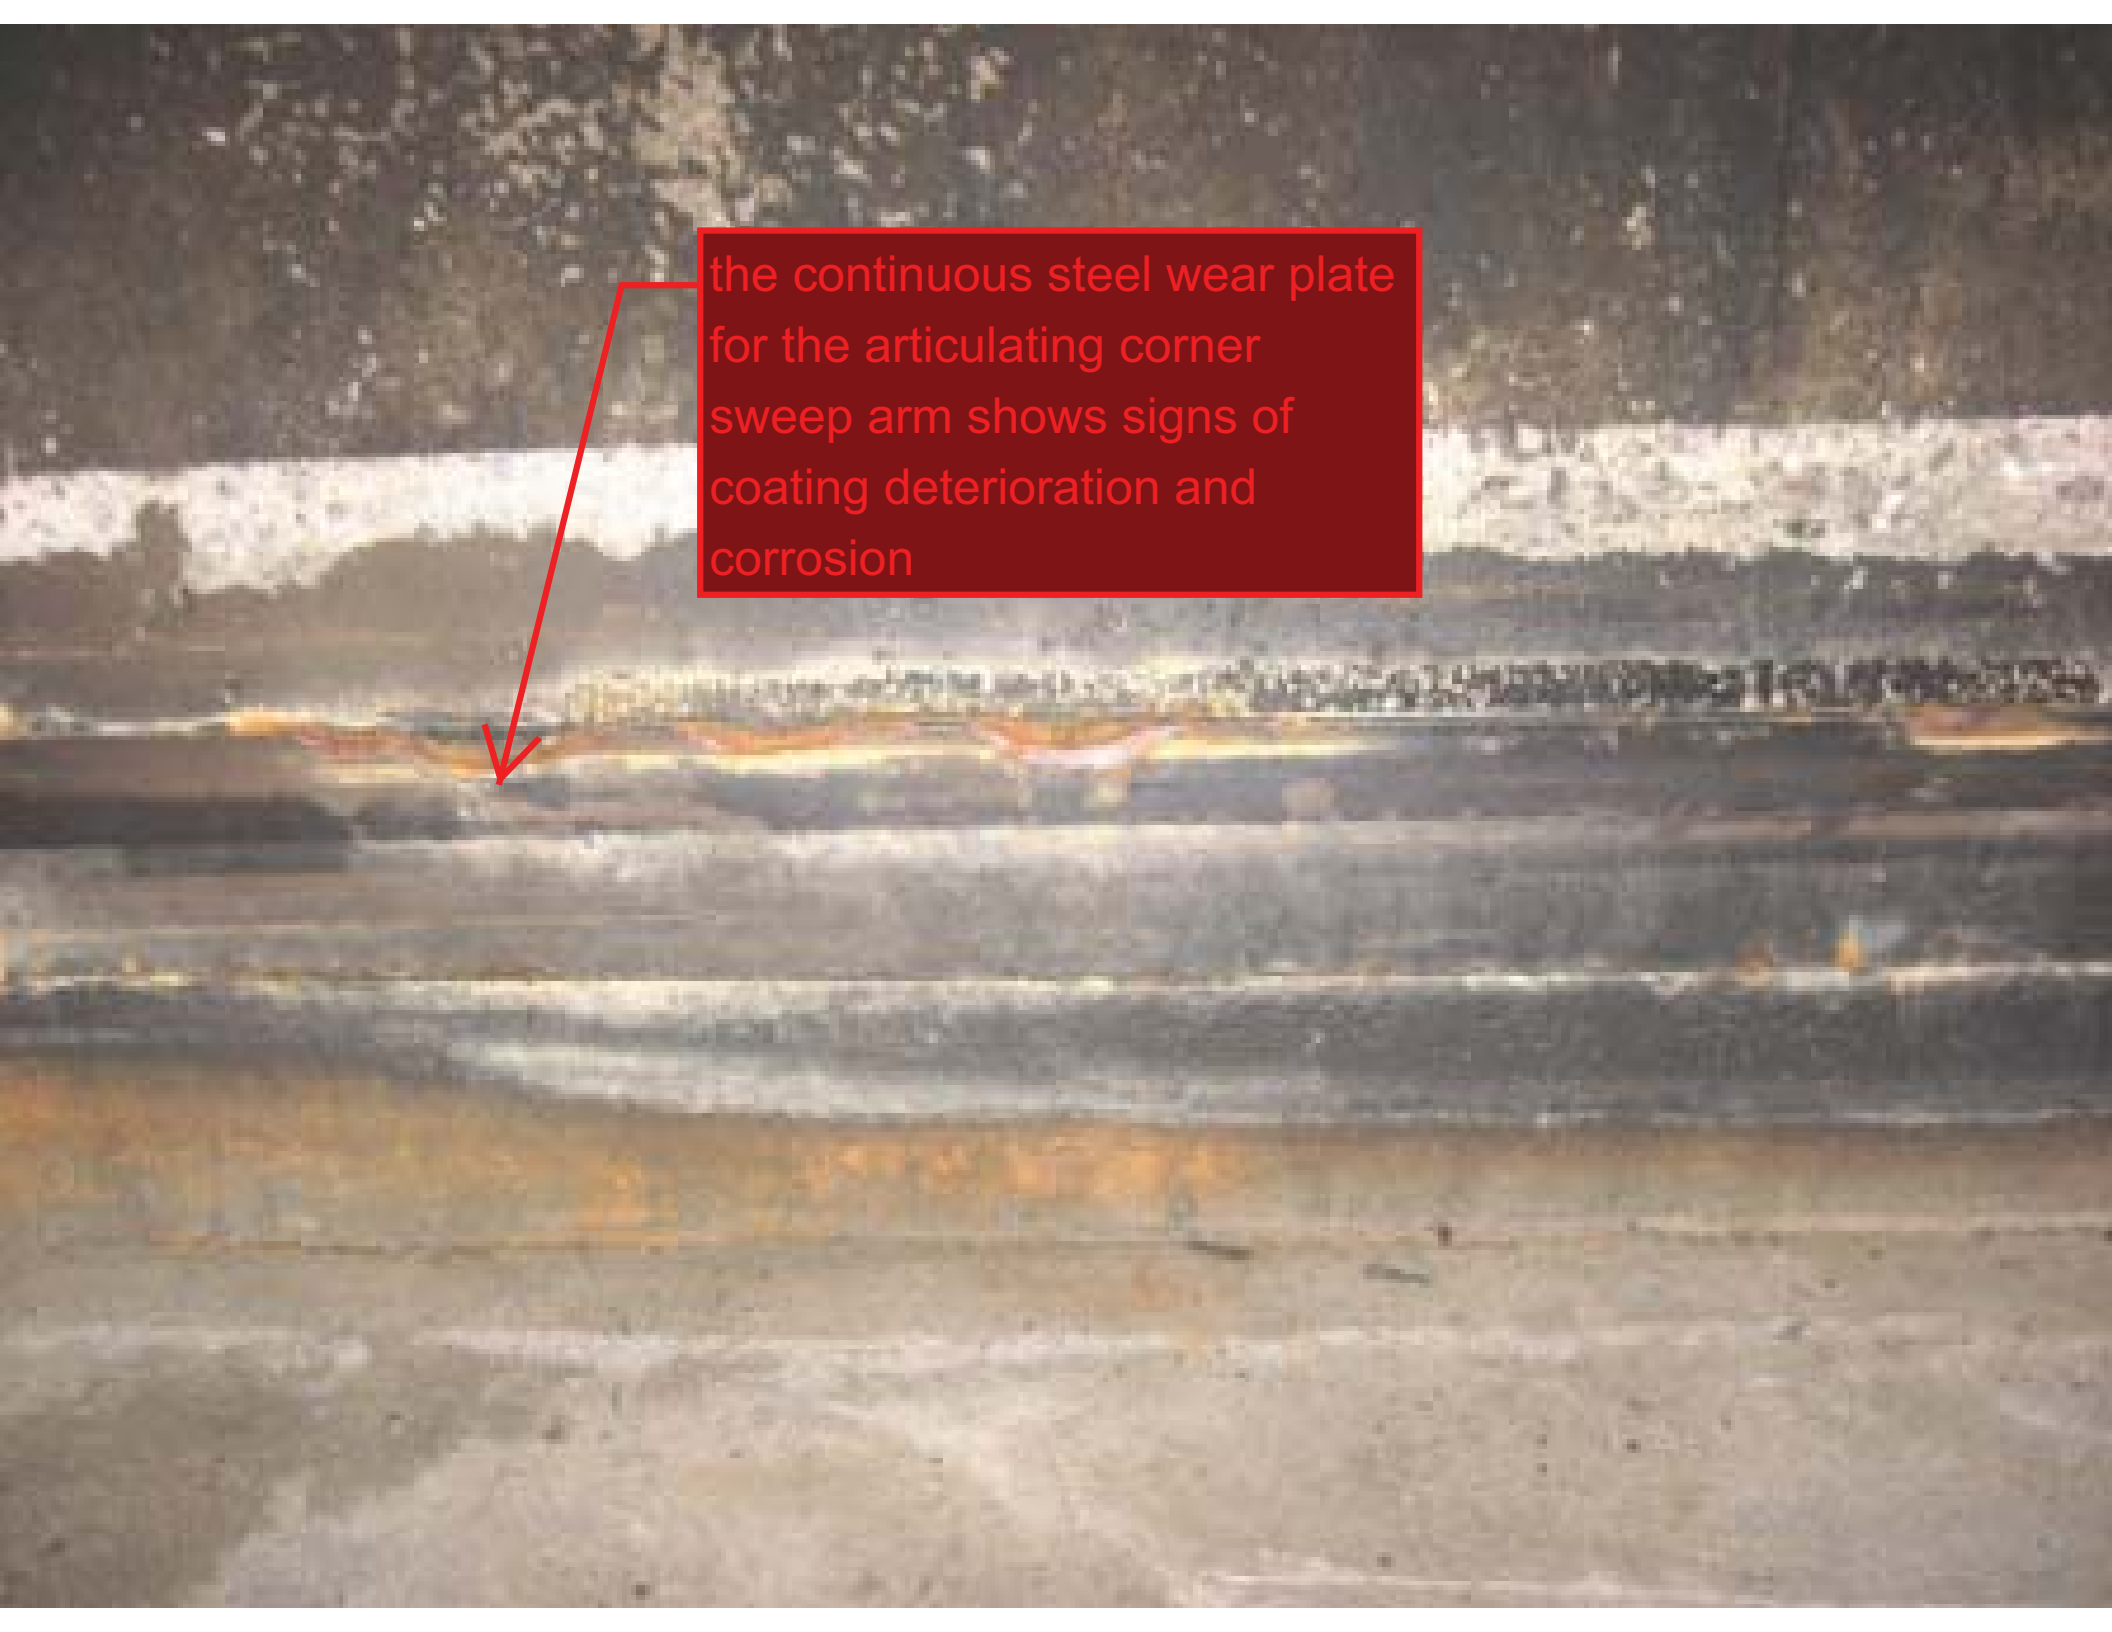
the continuous steel wear plate
for the articulating corner
sweep arm shows signs of
coating deterioration and
corrosion

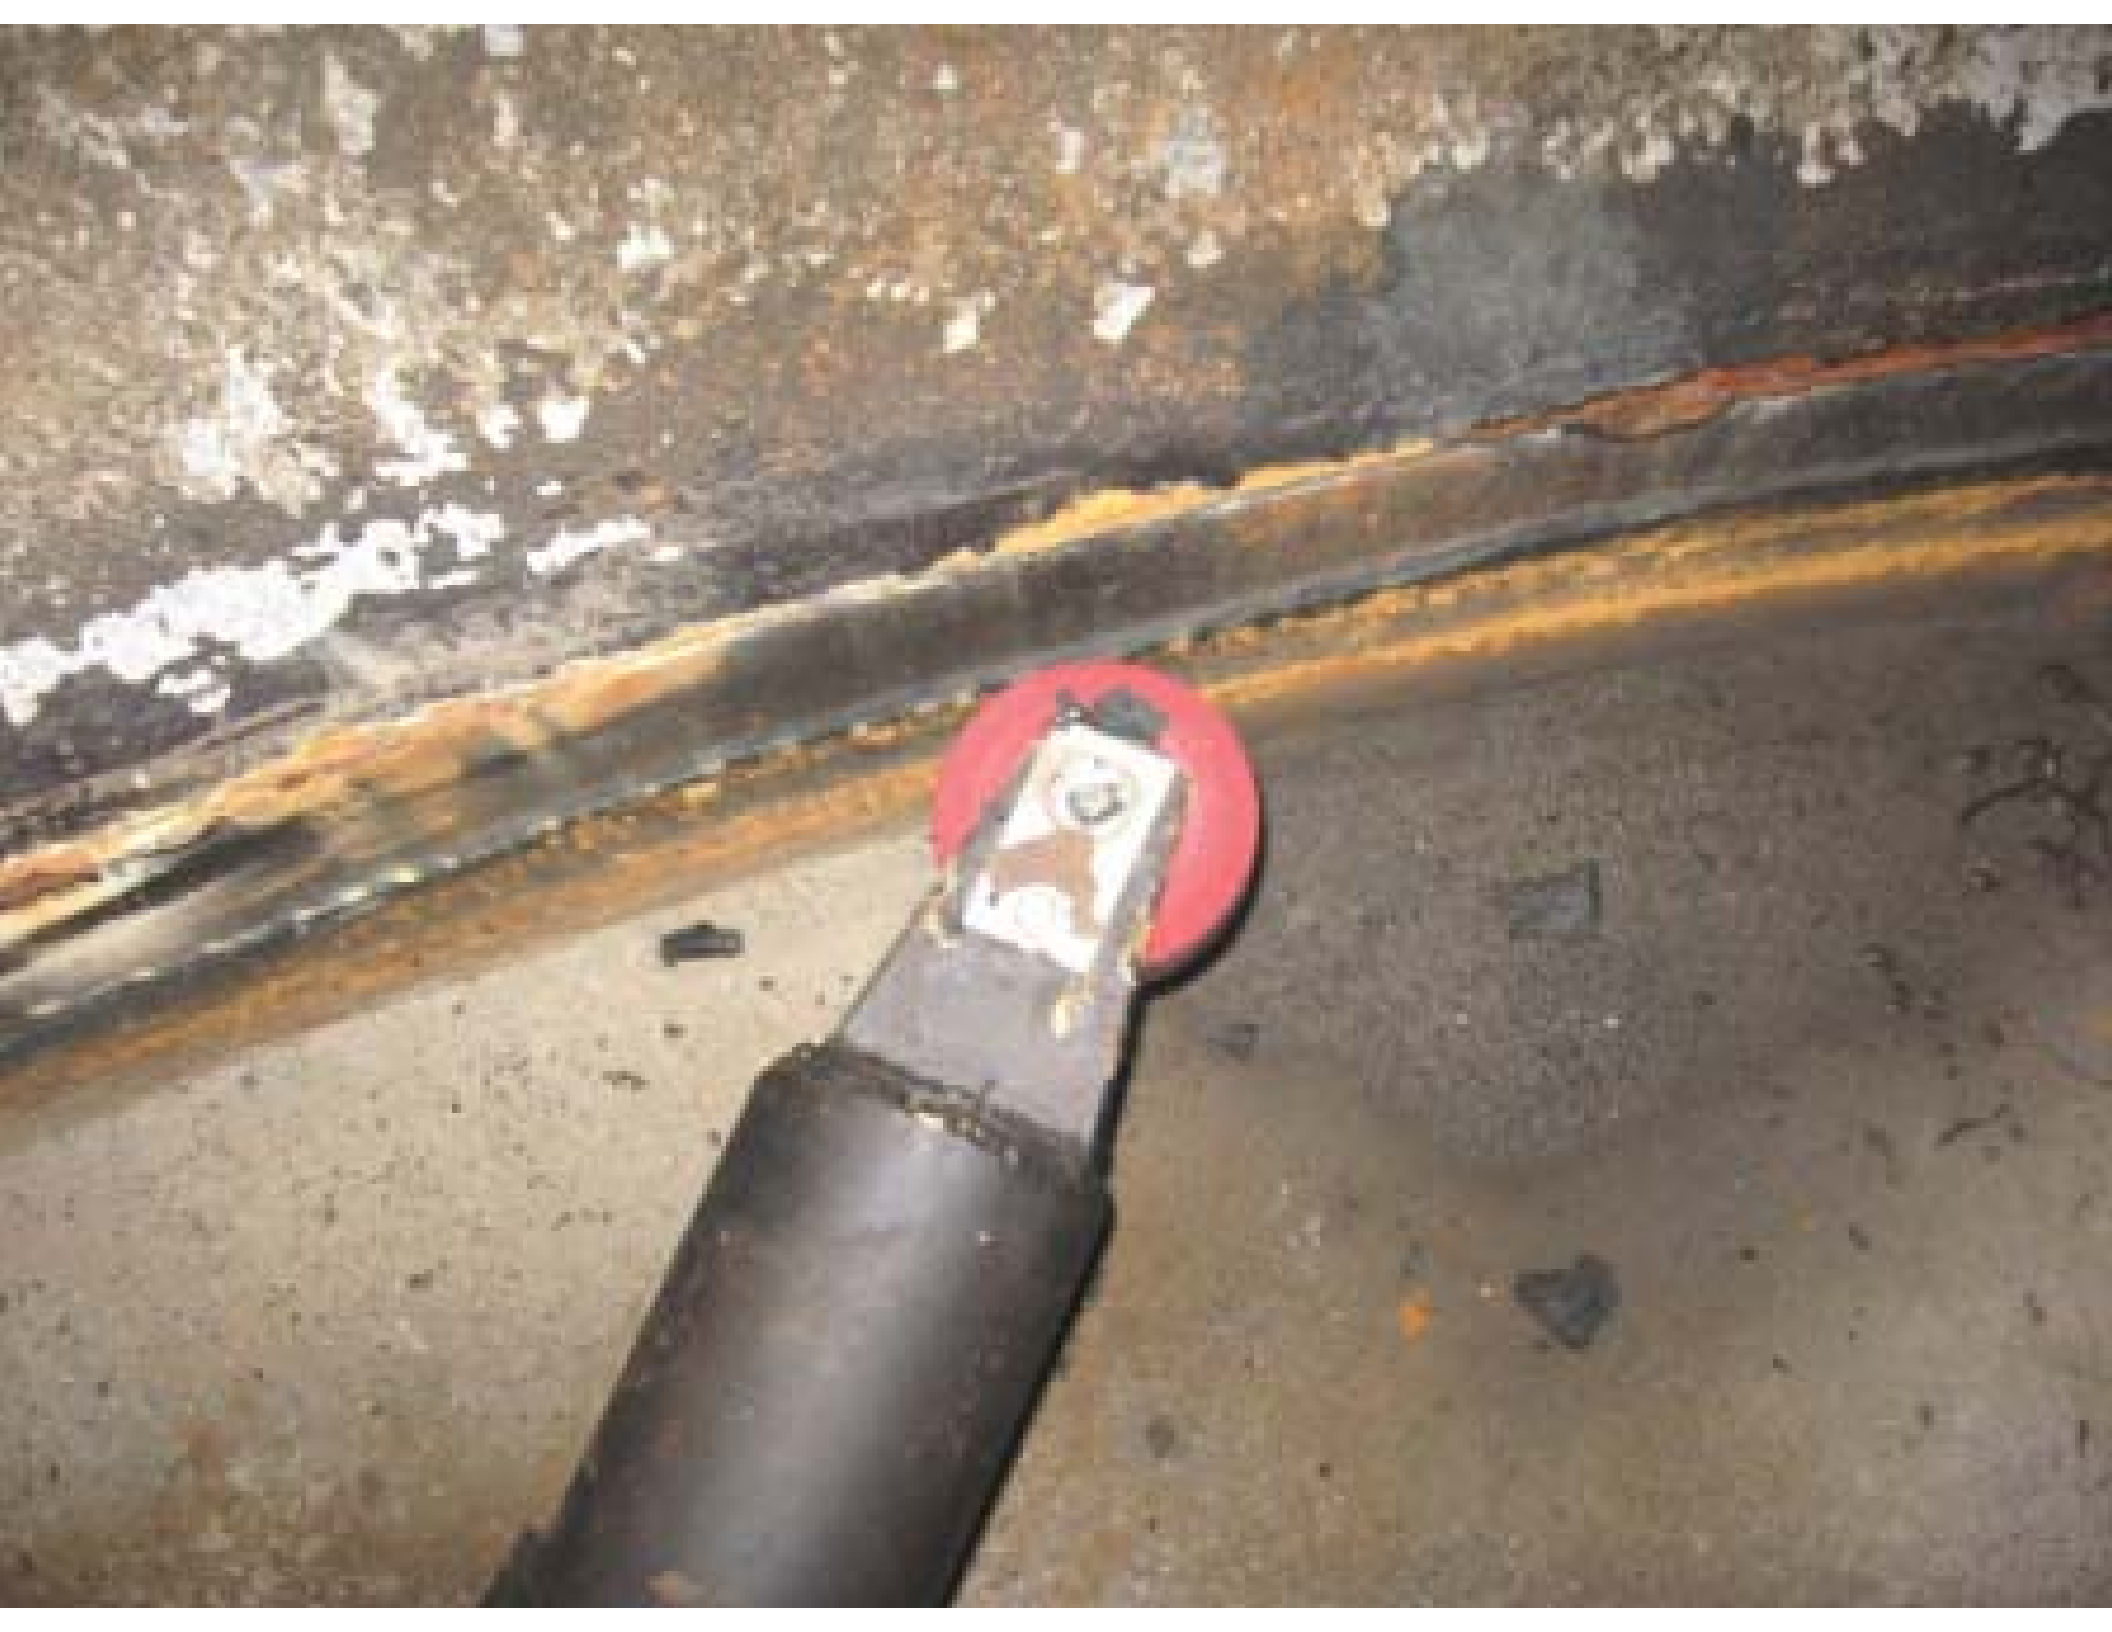
bent counterweight cable
attachment plate

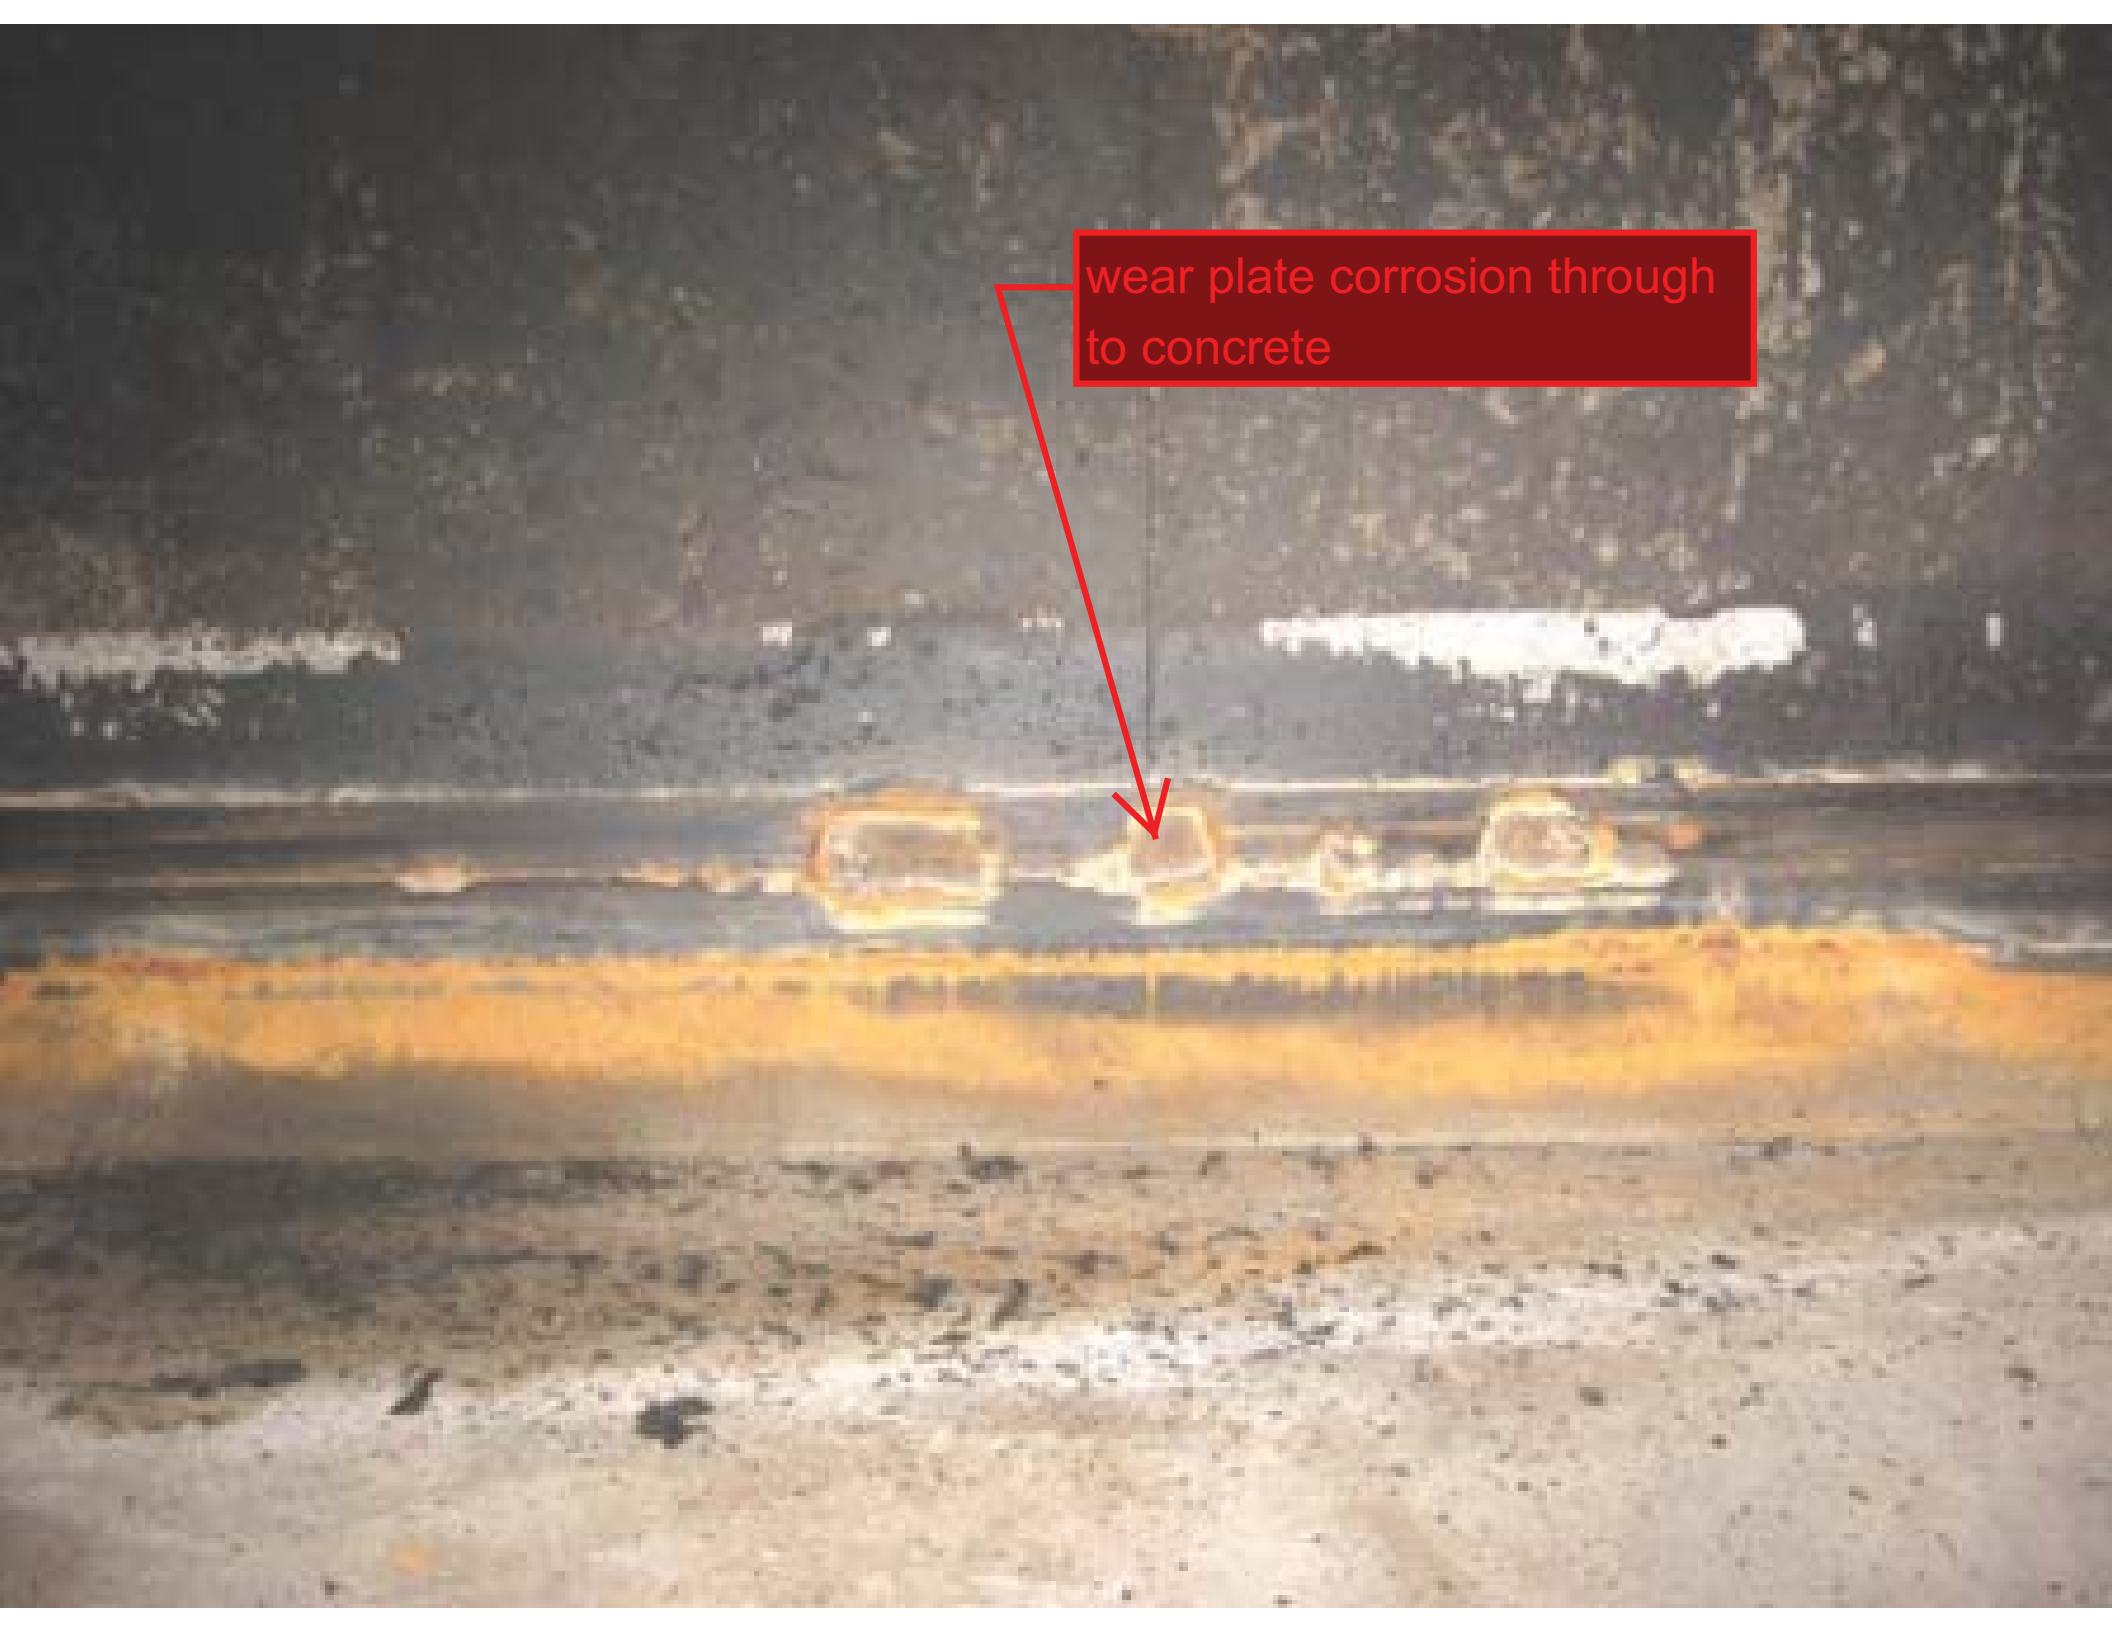
wear plate corrosion through to concrete

operators added the second wheel due to alignment issues
