SEWPCC Upgrading/Expansion Conceptual Design Report

SECTION 20 - Administration Building

20.0 Administration Building

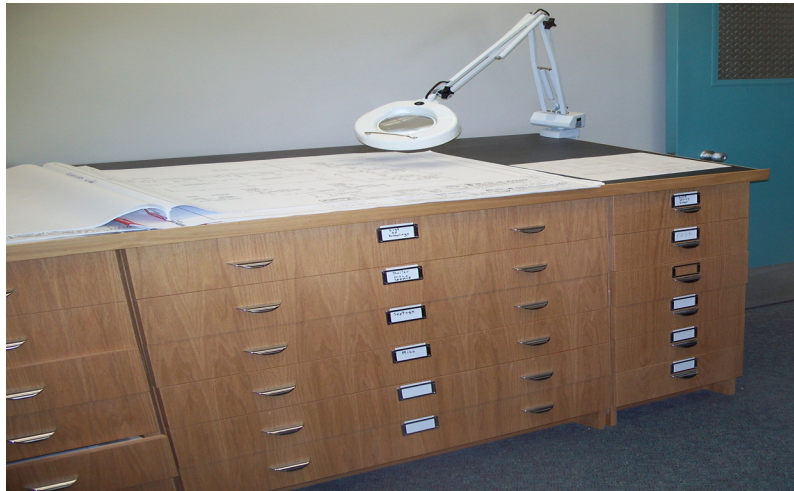
Figure 20.5: Clerical / Drawing Files Room - Files

This room appears to serve its desired function well as a drawing file and shared clerical office. No recommendations are made to modify the function or layout of this room.

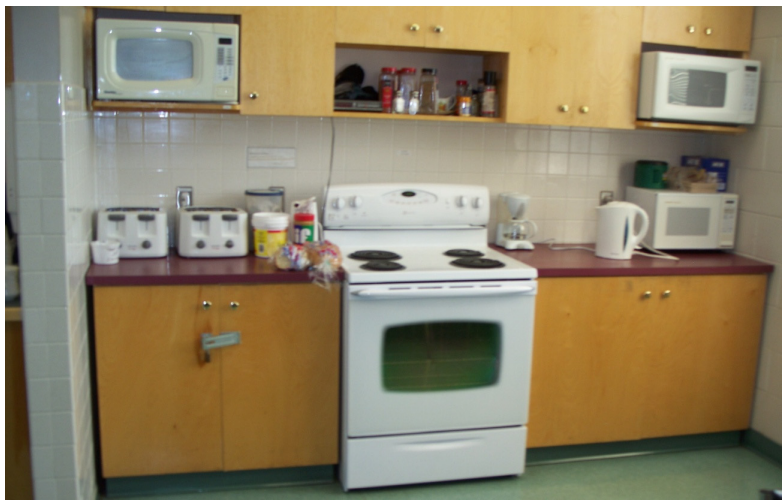
Figure 20.8: Lunch Room / Classroom - Kitchen Appliances

This room meets its intended functions well, and serves an important functional space for communication among staff personnel and for periodic rest breaks. Stantec recommends that the City upgrade the ceiling and wall treatment with light-colored paint or covering, except for the southern tile-covered wall which is currently satisfactory. Consideration should be given to installing wiring and a ceiling-mounted projector for classroom purposes.

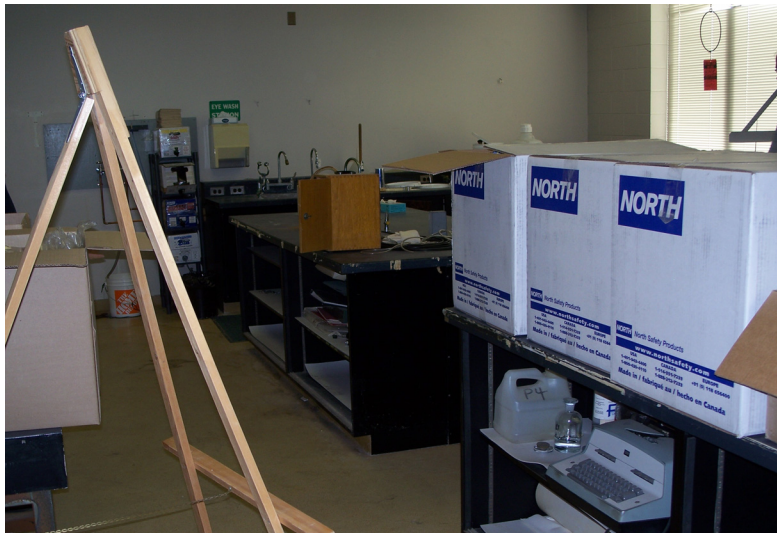
Figure 20.11: Laboratory Room Storage on Tables

The former analytical laboratory room which is on the main floor of the Administration Building is no longer used for any significant laboratory functions. The room is 9.70 m (31 feet 10 inches) long by 5.74 m (18 feet 10 inches) wide; inside clear dimensions. The room area is 55.7 m² (599 ft²). Photos showing the existing laboratory room are provided on Figures 20.10, 20.11, and 20.12. The space provided by the existing room far exceeds that currently needed for operable laboratory equipment. The room is presently used largely for storage of miscellaneous items. The existing lab room has a fume hood, gas lines, sinks, water, and counters in place. There is a muffle furnace in place, but the exact operational condition is unknown.

The items recommended above could fit in a space less than half the size of the present laboratory room. It is estimated that an area of approximately 20 m² would suffice for the future limited laboratory functions. Relocating the laboratory functions to another location outside the Administration Building would free up space for other purposes in this building. Stantec's discussions with City personnel have indicated that maintaining the laboratory equipment closer to the bioreactors would be more efficient. One potential new location for the future limited laboratory equipment is the present compressor building, which currently serves the high purity oxygen system. Based on the Conceptual Design concepts, there will be sufficient room in that building for a relocated laboratory space. Such relocation would require some minor architectural and plumbing work in the existing HPO compressor room.

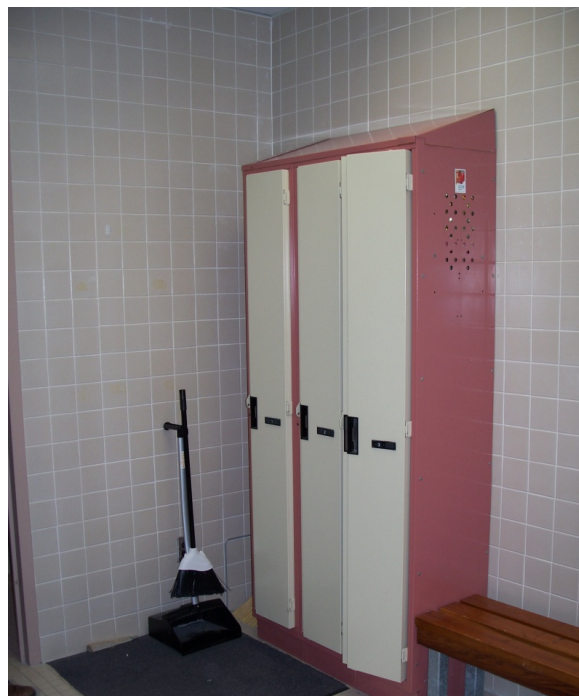
Figure 20.16: Women's Locker Room - Lockers

A review of dimensions indicated that Alternative A would significantly limit the capacity of the women's locker room, to an effective limit of two persons (assuming the same shift). This was considered to be an undesirable limitation. An initial review of the changes needed in the former Laboratory Room for conversion indicated that while there would be a cost associated with plumbing and other items, the alternative could be implemented feasibly because there is no longer a need to maintain laboratory facilities in the Administration Building. Therefore, Stantec recommends that the City implement Alternative B outlined above. This would involve the following:

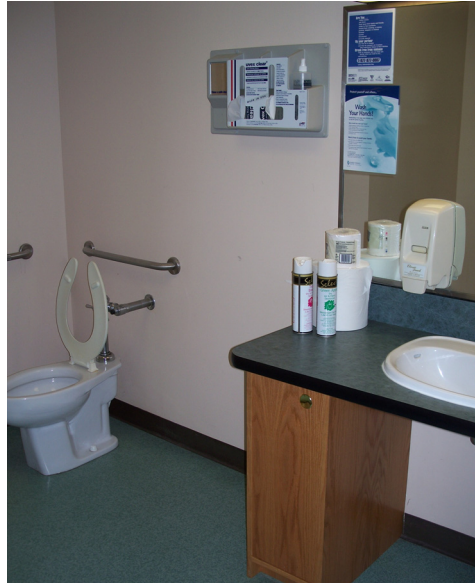
Figure 20.17: Existing Women's Washroom - Main Floor

Based on review of later plans and the August 2008 site visit, it appears that sometime prior to 1994, the southernmost room was re-designed to be the Men's Room, and the room just north of that was converted to be the Women's Room. The former coat closet room space was added to the new Women's Room, and the previous coat closet room door became the sole doorway entry into the new Women's Room.

The existing Men's Washroom is 1.52 m (5 feet) wide, and has an area of 6.0 m² (64 ft²). The existing Women's Washroom has an area of 7.4 m² (80 ft²).

Alternative 2 would involve less construction and is recommended for implementation. It is recommended that the remaining portion of the previous Laboratory Room space available after conversion for the new Women's Locker Room (13.7 m² remaining) be used to construct a new Women's Washroom. Implementing Alternative 2 would result in the following:

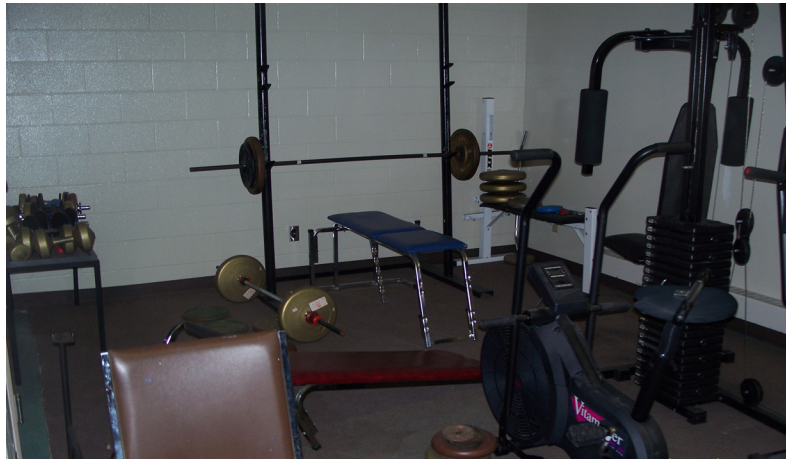
Figure 20.22: Exercise Room

All rooms and aspects of the Administration Building were reviewed. In addition to the rooms noted in preceding sections, the building includes several offices, storage rooms, and other function rooms. There is an exercise room located in the eastern section of the basement level, shown in Figure 20.22. This is an asset to the facility and the staff, and used judiciously will help maintain staff physical fitness and reduce the risk of workplace injuries.
