## **GEOTECHNICAL AND ENVIRONMENTAL REPORTS**

Morrison Hershfield  
**Polo Park Infrastructure Upgrades**

**Project Number:**  
0035 008 00

**RE: Sub-Surface Investigation Report for  
Polo Park Infrastructure Upgrades**

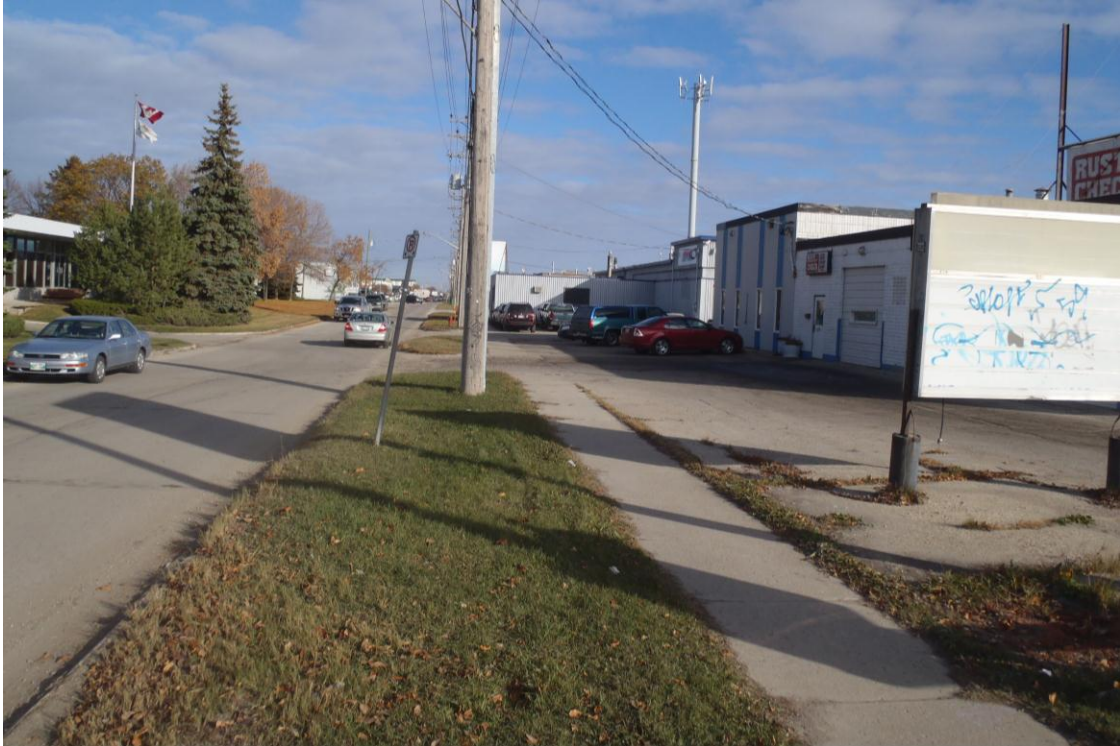
Photo 1: View looking north along Madison Street, north of St. Matthews Avenue showing the car wash operation.

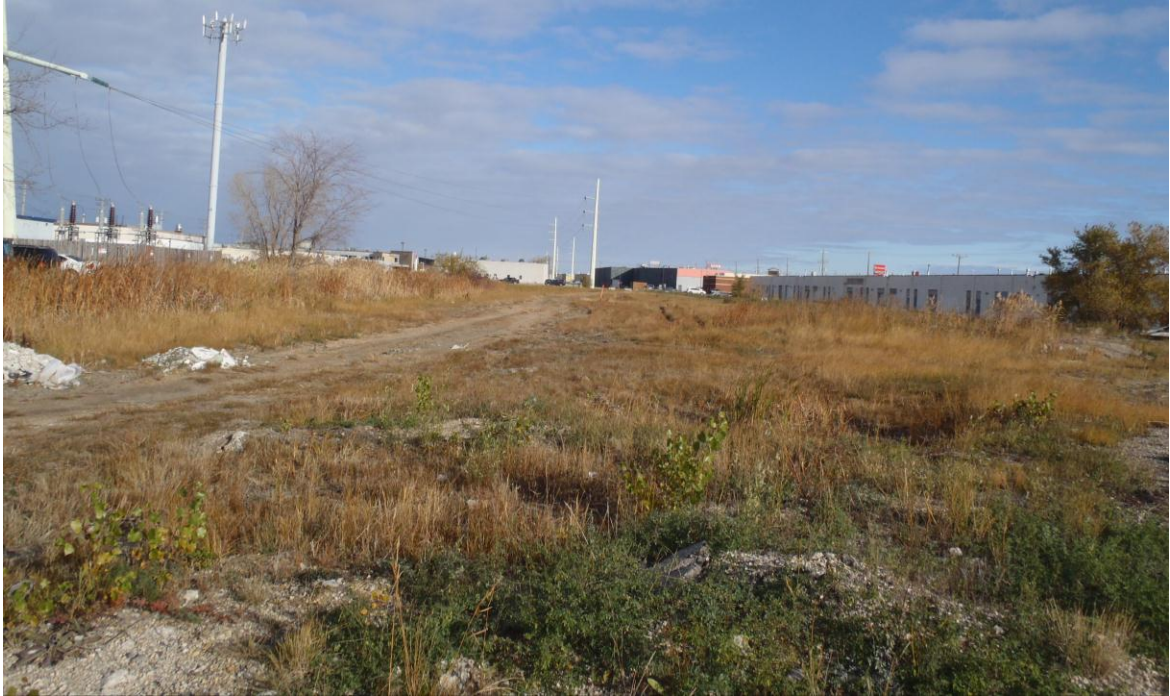
Photo 3: View looking north at former Oak Point Railway Branch right-of-way from proposed St. Matthews Avenue extension.

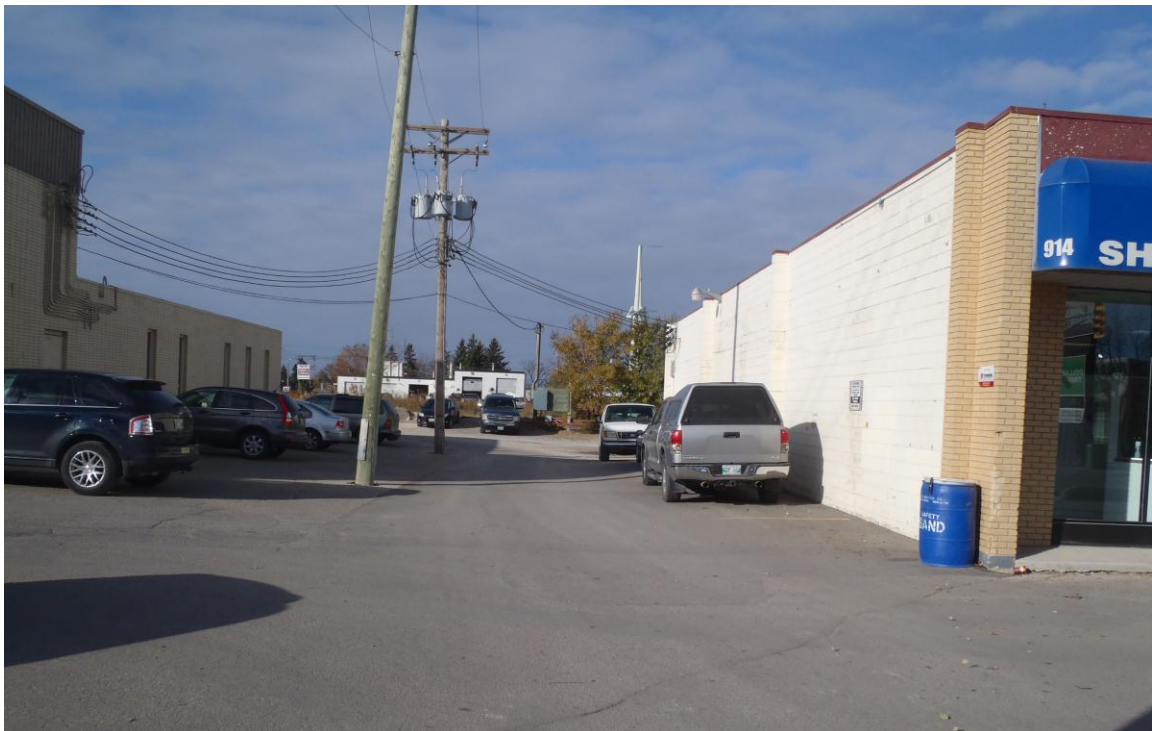
Photo 4: View looking west from St. James Street along proposed St. Matthews Avenue extension.

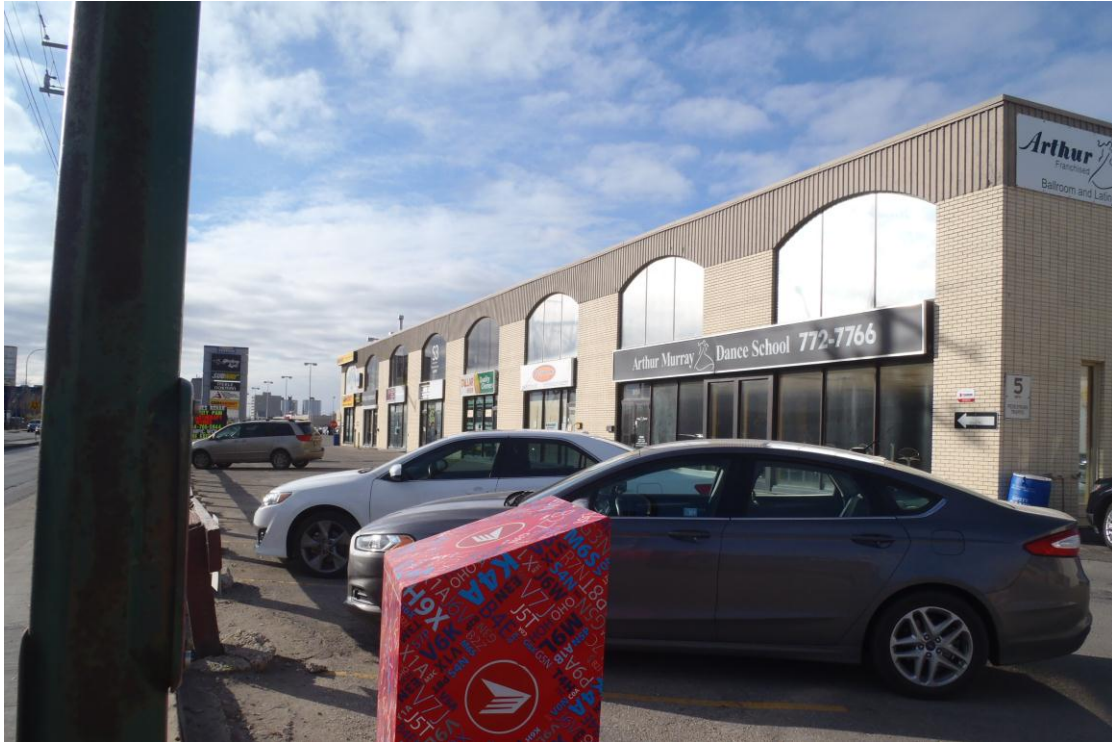
Photo 5: View looking south at commercial strip mall development on west side of St. James Street, south of St. Matthews Avenue.

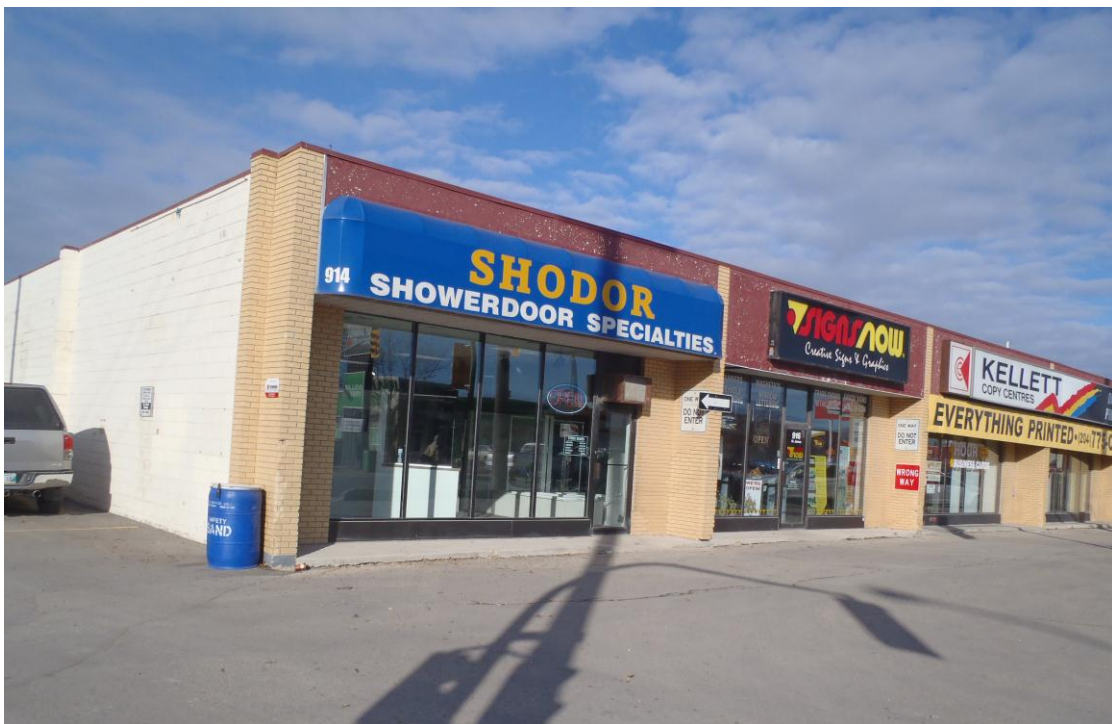
Photo 6: View looking northwest at commercial strip mall development on west side of St. James Street, north of St. Matthews Avenue.

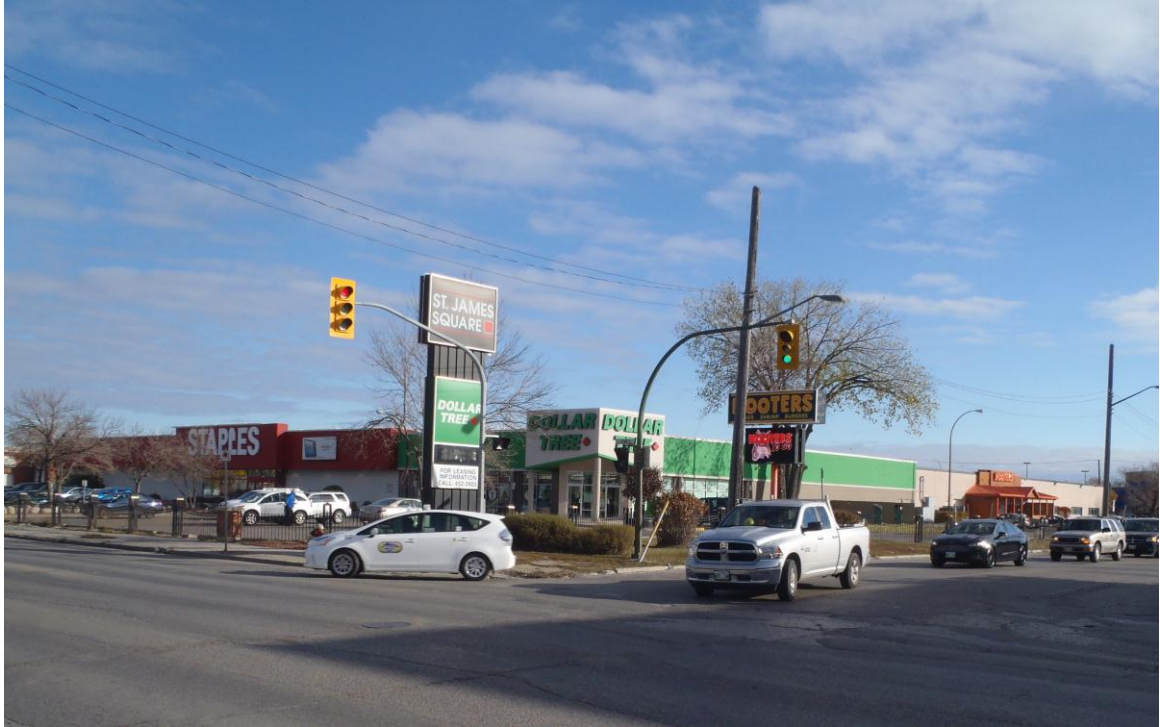
Fire maps showing the St. James Street and Ellice Avenue intersection identified a warehouse operated by Canadian Westinghouse Co. Ltd. in the southeast corner of the intersection as well as a warehouse operated by Security storage Co. Ltd. to the northeast. No indications of fuel or chemical storage were noted for these sites.

Photo 7: View looking northeast at commercial development on northeast corner of St. James Street and St. Matthews Avenue (former General Electric facility).

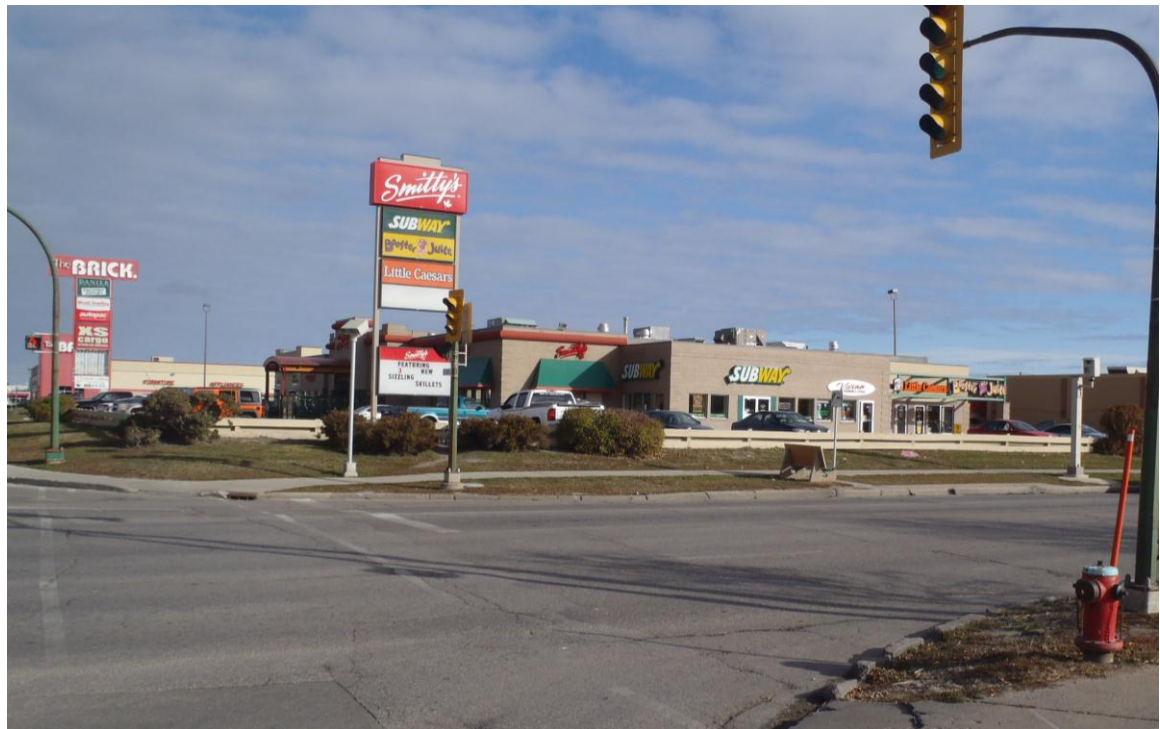
Photo 8: View looking northeast at commercial development on northeast corner of St. James Street and Ellice Avenue (former Security Storage site).
