APPENDIX C – “KING’S PARK RIVERBANK INVESTIGATION MONITORING AND ASSESSMENT” BY KGS GROUP, 2014

King's Park
Riverbank Investigation Monitoring and Assessment
FINAL

KGS Group 13-0107-008
September 2014

RE: Riverbank Investigation, Monitoring and Assessment – King's Park
Final Report

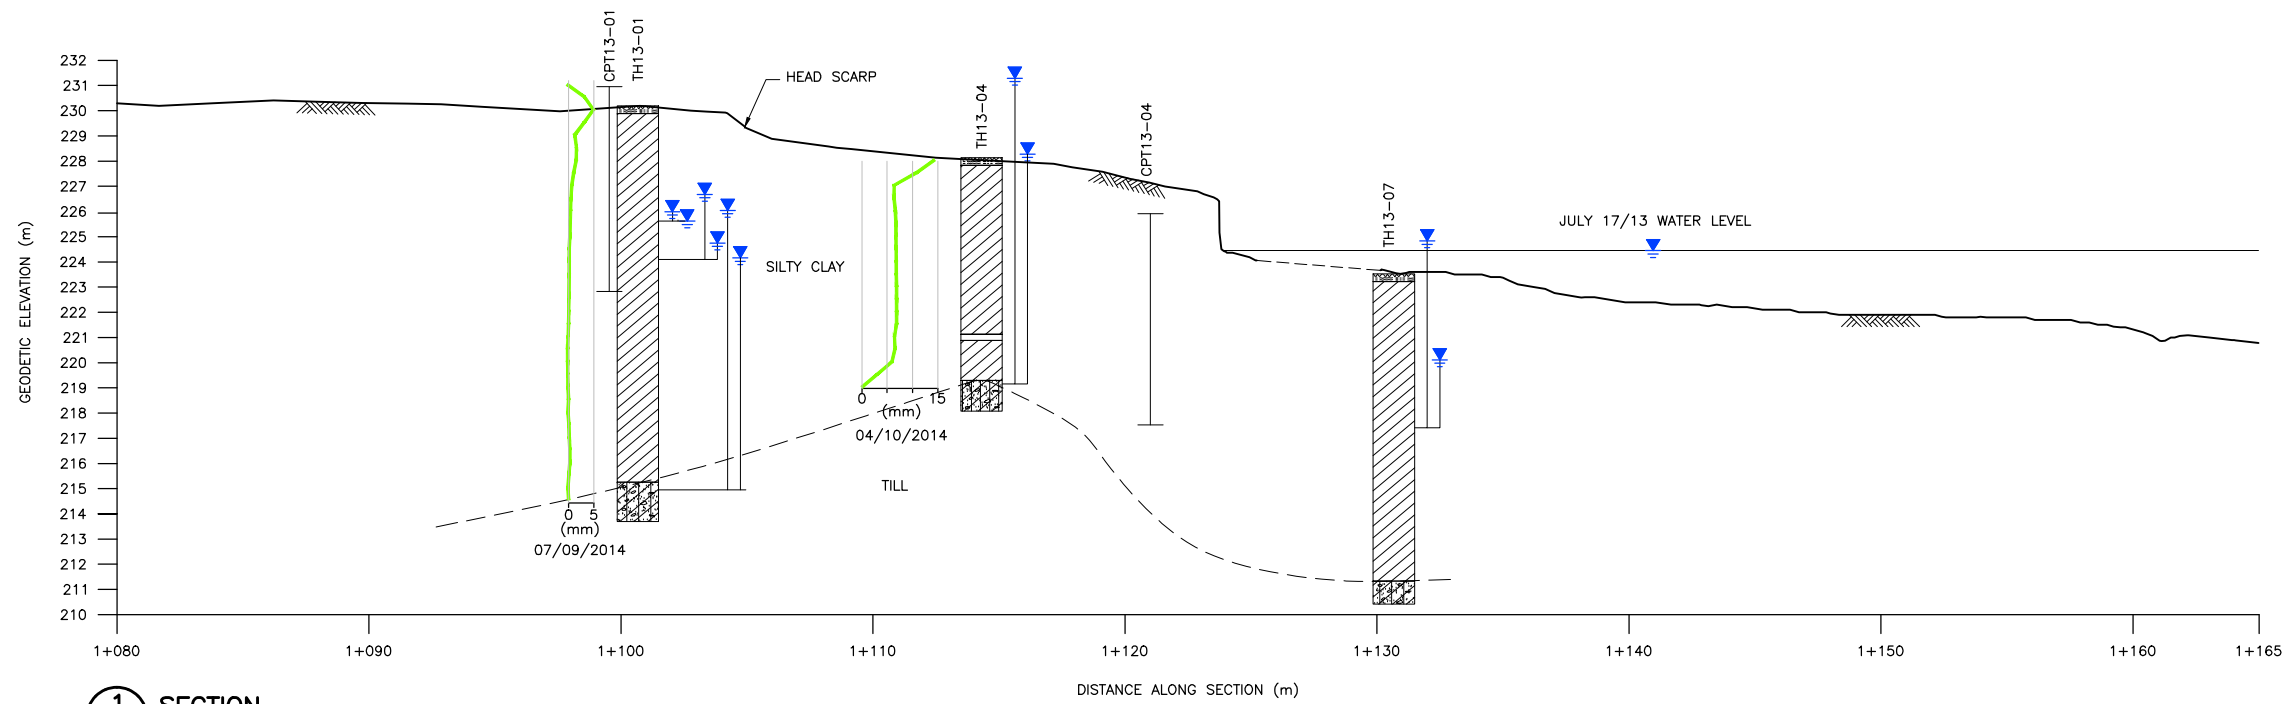
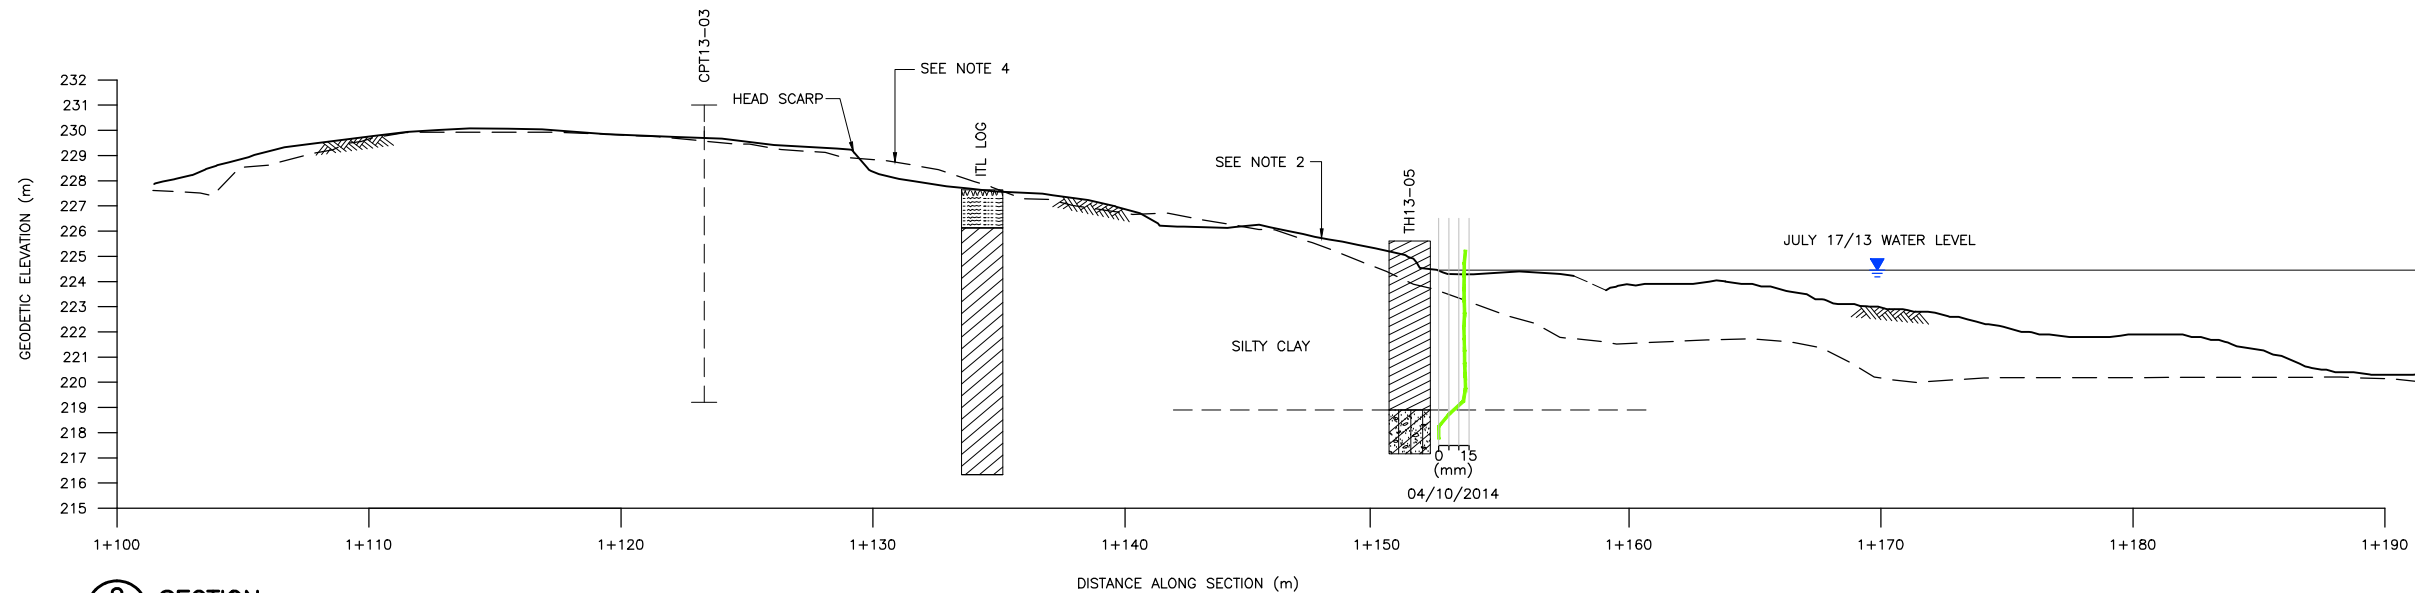
SEPTEMBER 2014 **FIGURE 02** REV: 0

In general, the overall geometry of Sections 1, 2, and 3 is characteristic hummocky of retrogressive, slump block topography where erosion at the river's edge triggers deep seated and retrogressive bank failures. Note that 1989 ITL profile (Section A-A) was superimposed on Section 2 (see Figure 02). The results indicated that there were only minor changes of the upper and mid bank profiles in the last 25 years. However, major changes were detected at the lower bank area. These changes could be due to the remedial work of the existing outfall. The very steep geometry of Section 4 is consistent with an alluvial bank on an inside bend.

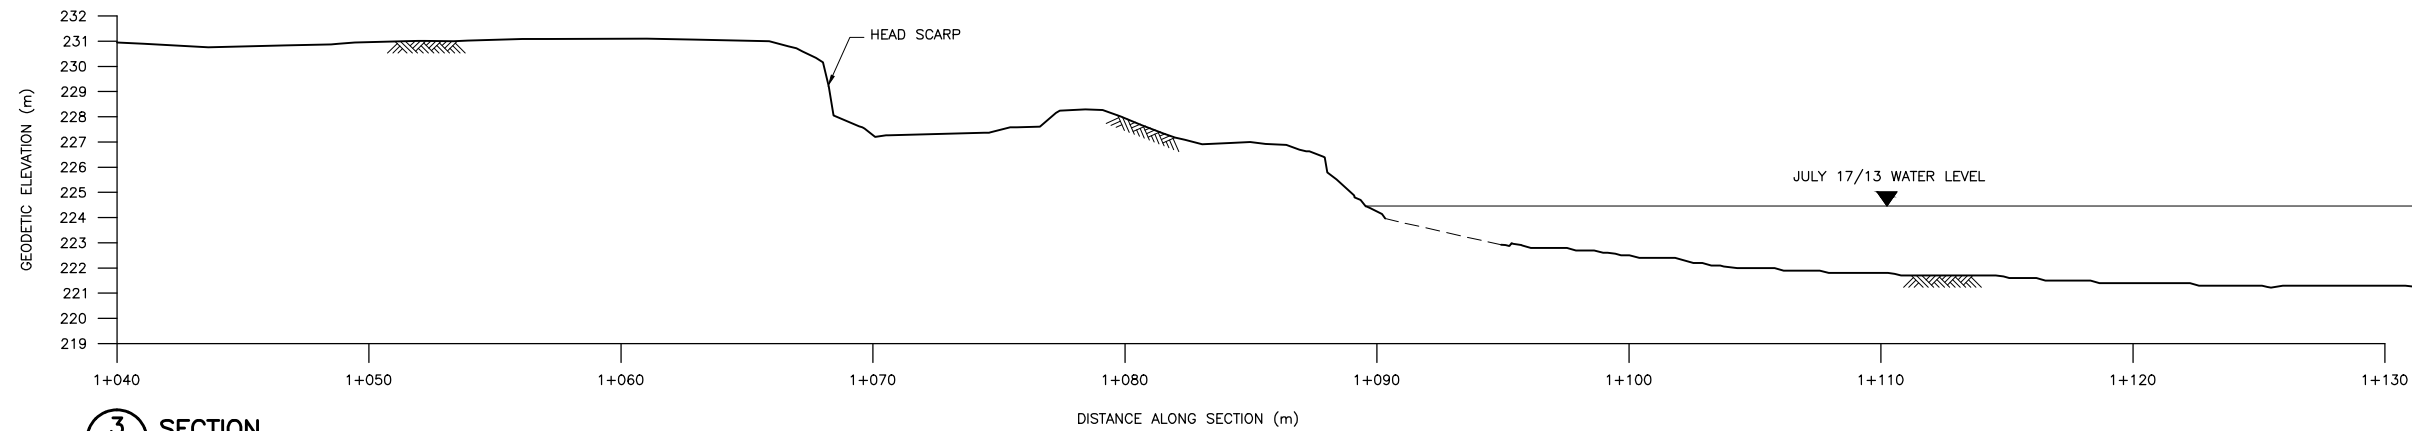
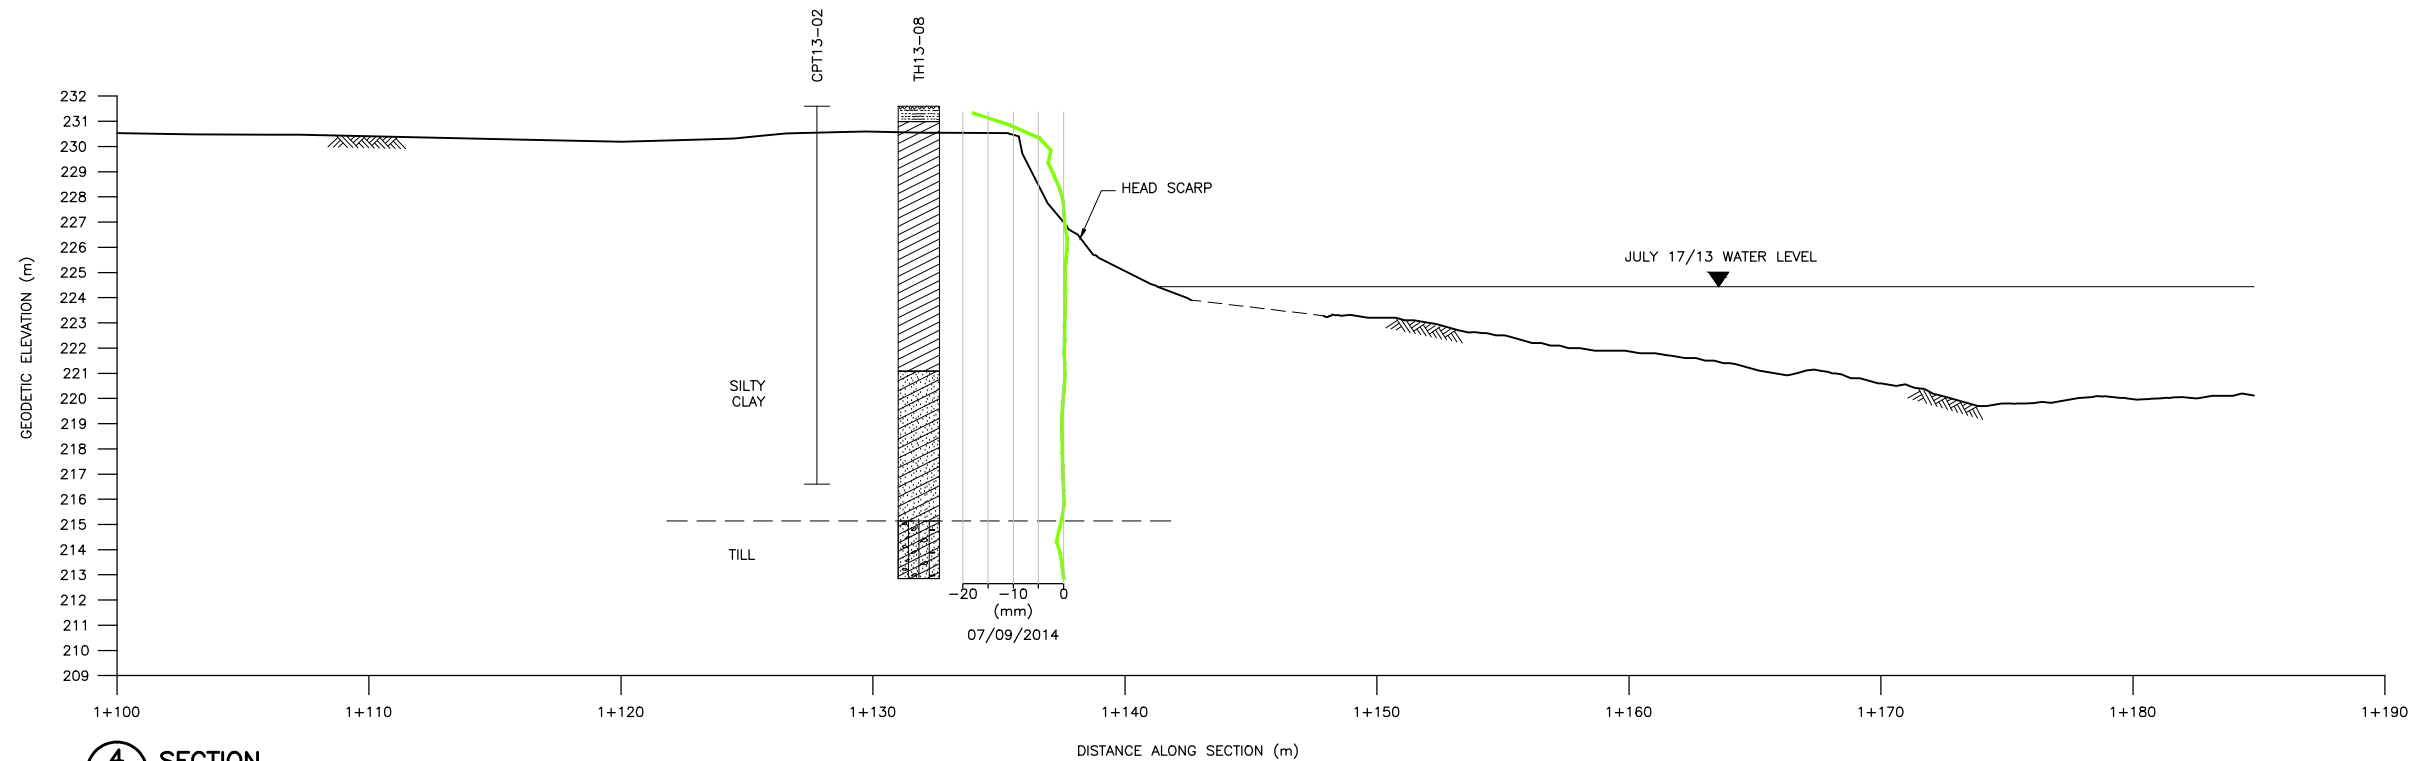
SEPTEMBER 2014	FIGURE 03	REV: 0
----------------	-----------	--------

The existing riverbank geometry of the study area is shown in plan on Figure 01 and in section on Figures 02 and 03 (Cross Sections 1, 2, 3 and 4). Section 1-1 shows a typical cross section of the outside bend areas. In Section 1-1, an upper bank area extends from Elev. 230.5 to 230.0 m± and is followed by a 1.0 to 1.5 m± drop, which is interpreted to be probably a headscrap. From there, it slopes down along a broad mid-bank bench at about 7.5H±:1V, again followed by a nearly vertical drop of 2.0 m± to the lower bank areas. The river bottom slopes down at about 10H±:1V. This provides approximately an effective slope of 3.5H±:1V from top of the bank to the Regulated Summer River Level (RSRL).

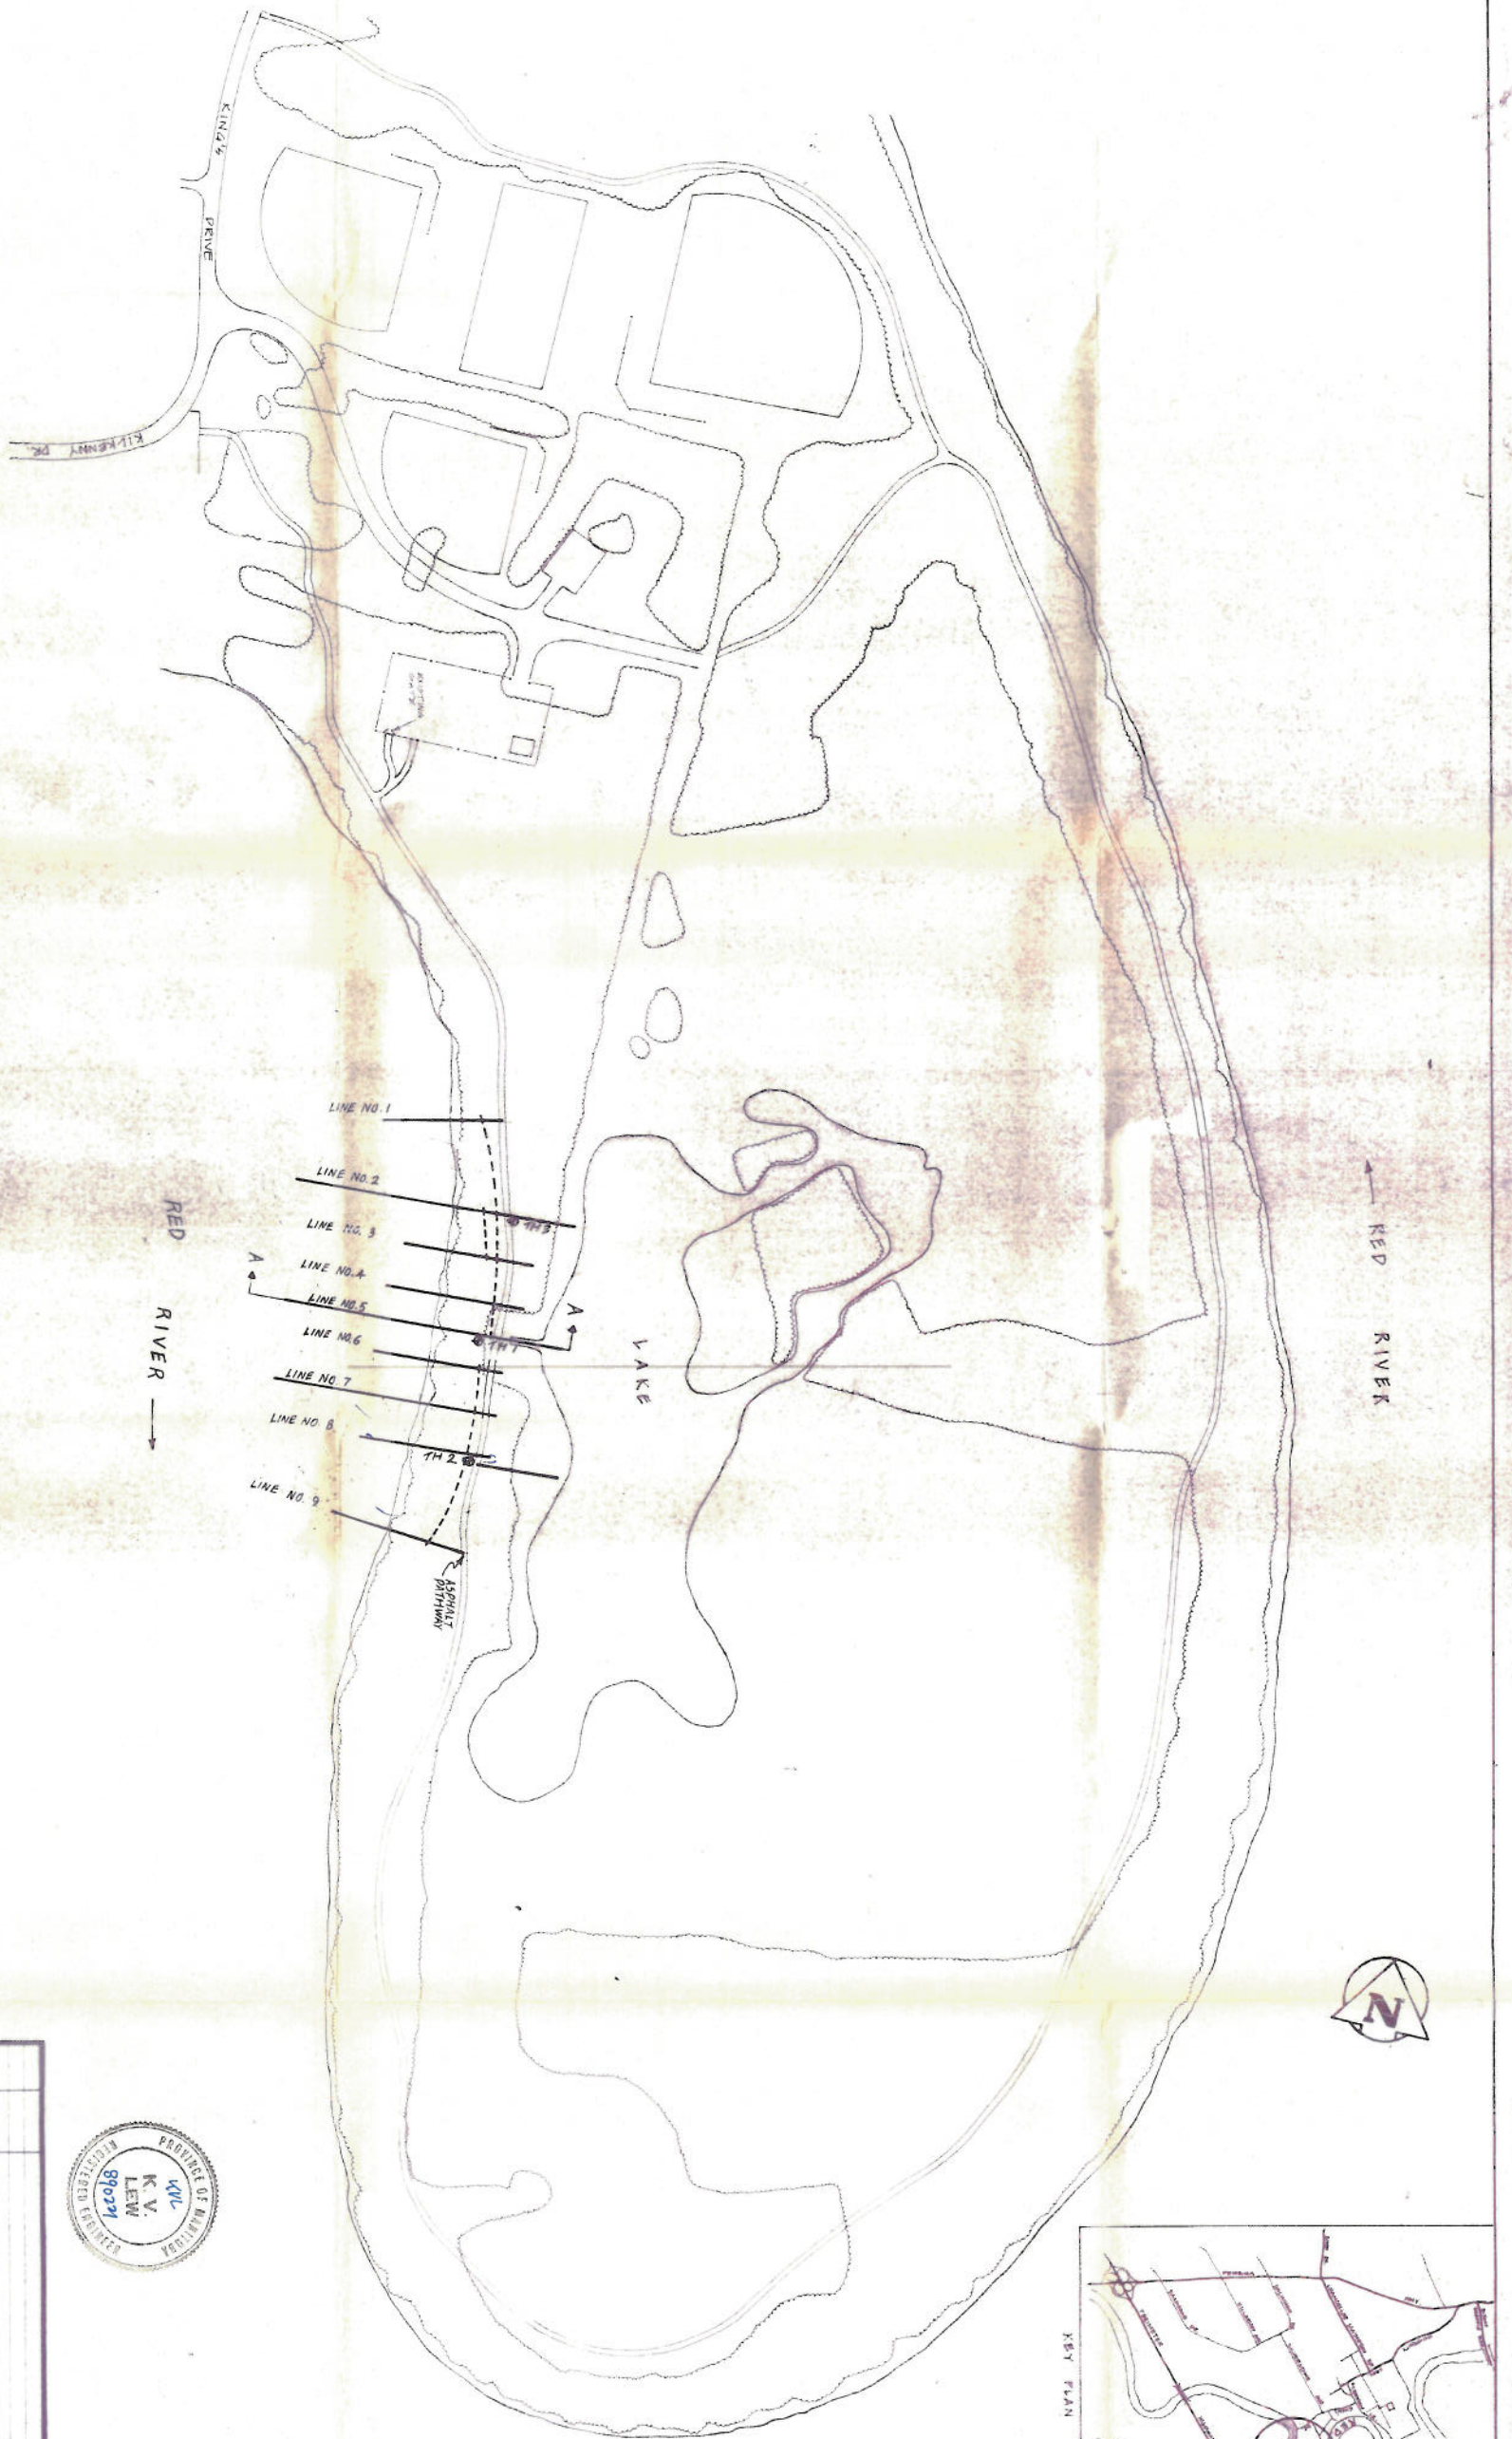
THE CITY OF WINNIPEG,
 PARKS AND RECREATION DEPARTMENT
 KING'S PARK
 RIVERBANK STABILITY ANALYSIS
 LOCATION PLAN

LEGEND
 - - - - - FAILURE SCARP OR CRACK

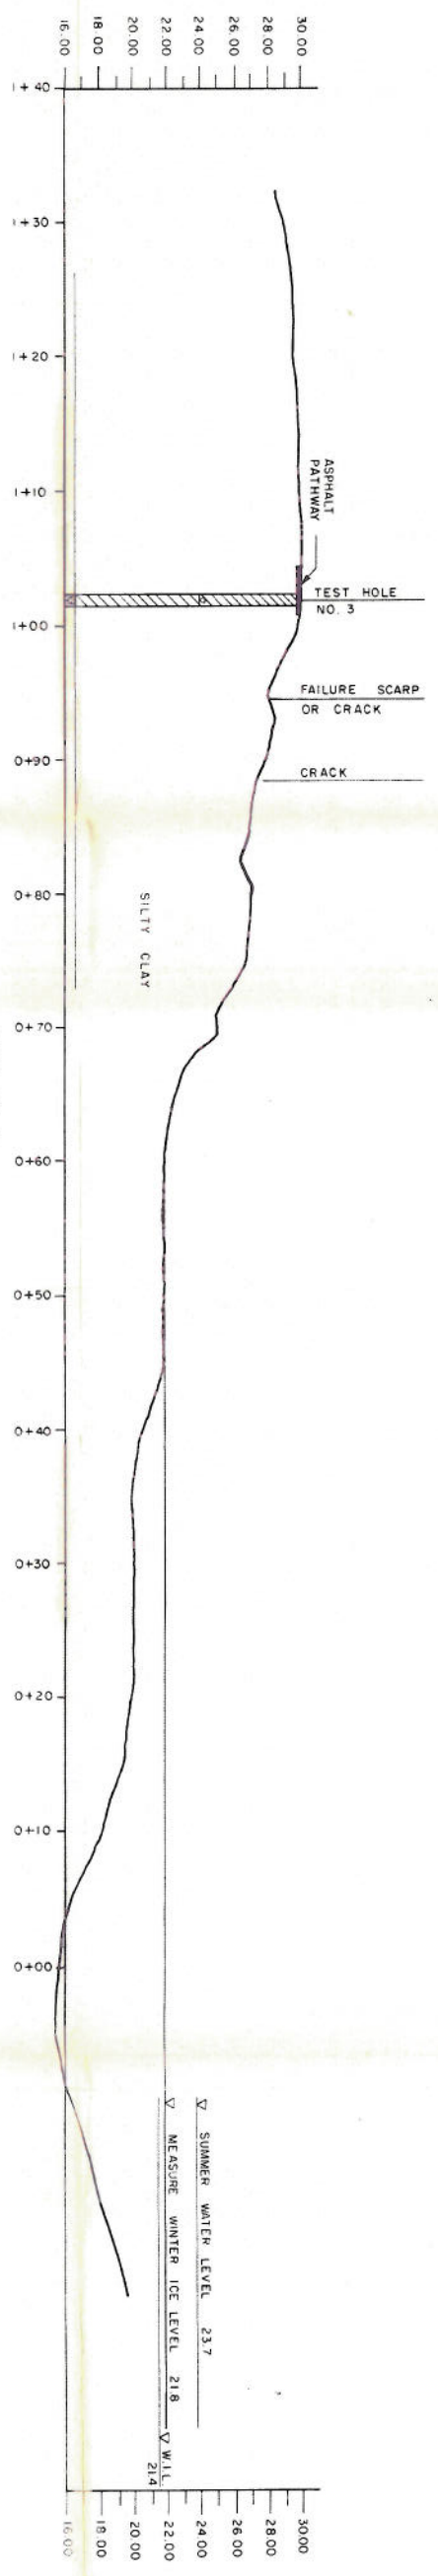
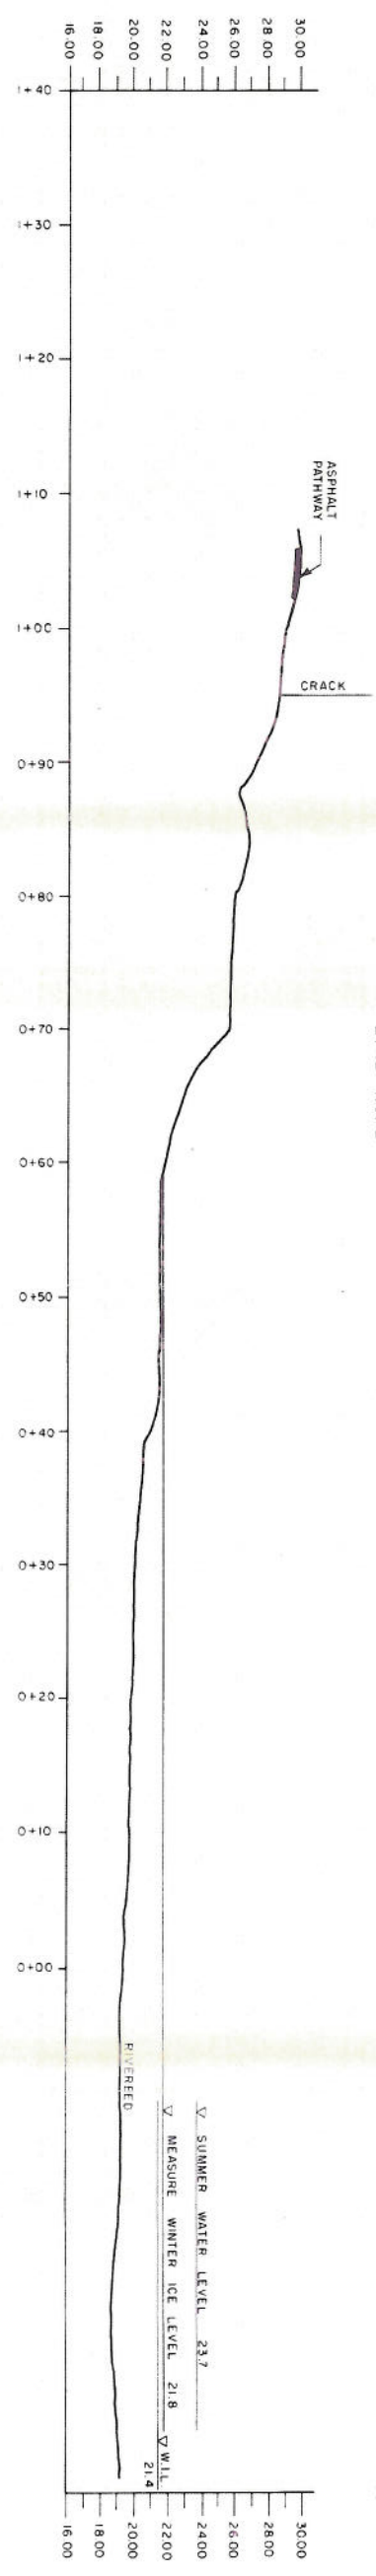
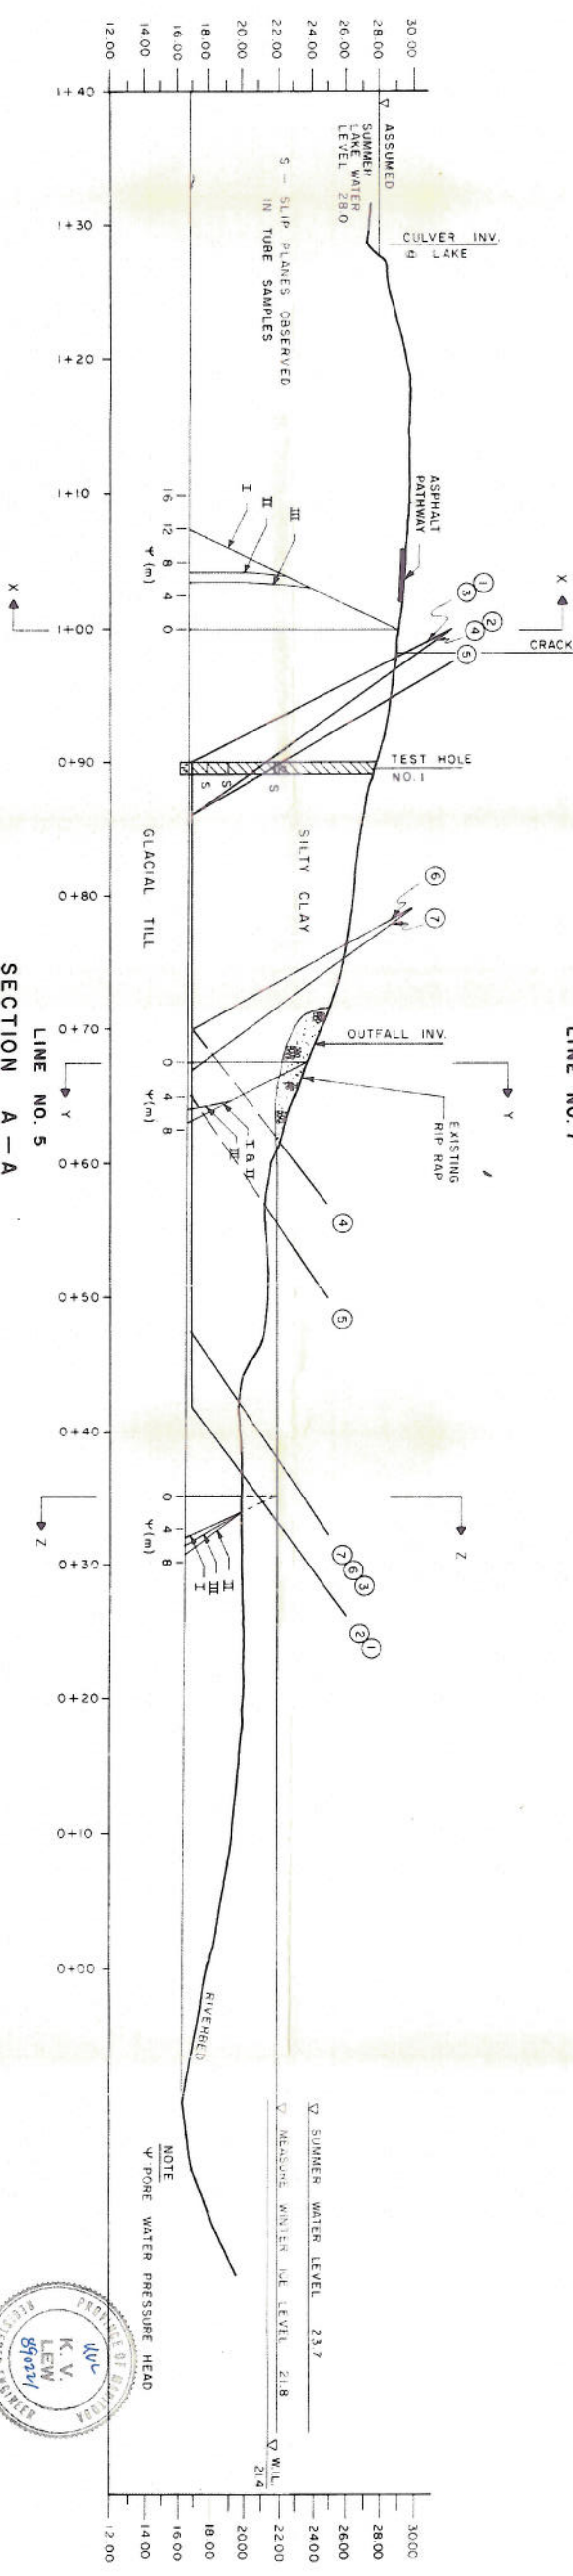
SECTION A-A

Based upon the bank profile and riverbottom sounding surveys, cross-section A-A along the centerline of the outfall pipe, as shown on Drawing 030-406, was selected for analysis as it is most subject to sliding in view of the existing slope and soil conditions encountered. Knowing that the riverbank has failed and from a theoretical standpoint, a proper stability analysis of an existing failure should give a computed factor of safety against sliding of 1.0. The stability back analysis was therefore performed to compute the shear strength values (ϕ' and c') for the clay required to be mobilized along a potential slip surface for a factor a safety of unity when considering various different potential slip surfaces (See Drawing 030-406). The results of the stability back analysis are summarized as follows:
