Winnipeg Sewage Treatment Program

NEWPCC Fecal and E-Coli Compliance Investigation Report 2014

November 2014

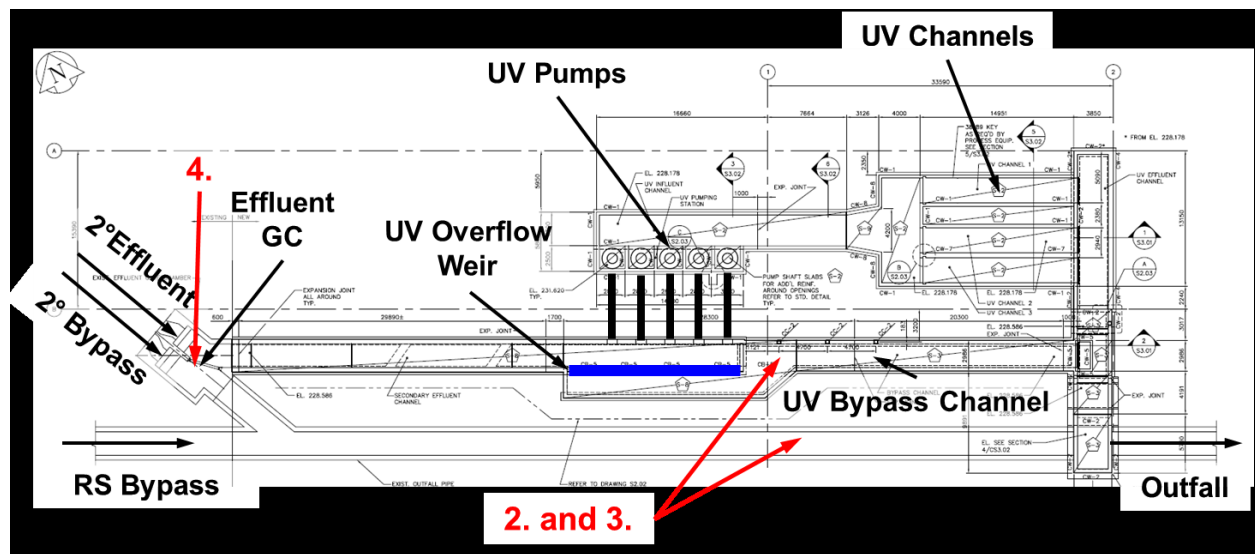
Figure 3 - NEWPCC Influent (Raw Sewage) Bypass

6. Occasional unintended raw sewage bypass or leakage at the raw sewage discharge well (Figure 1 and Figure 3).
7. Continuous leakage from gate YG11A and YG11B (both normally closed), which can provide secondary treatment bypass if required

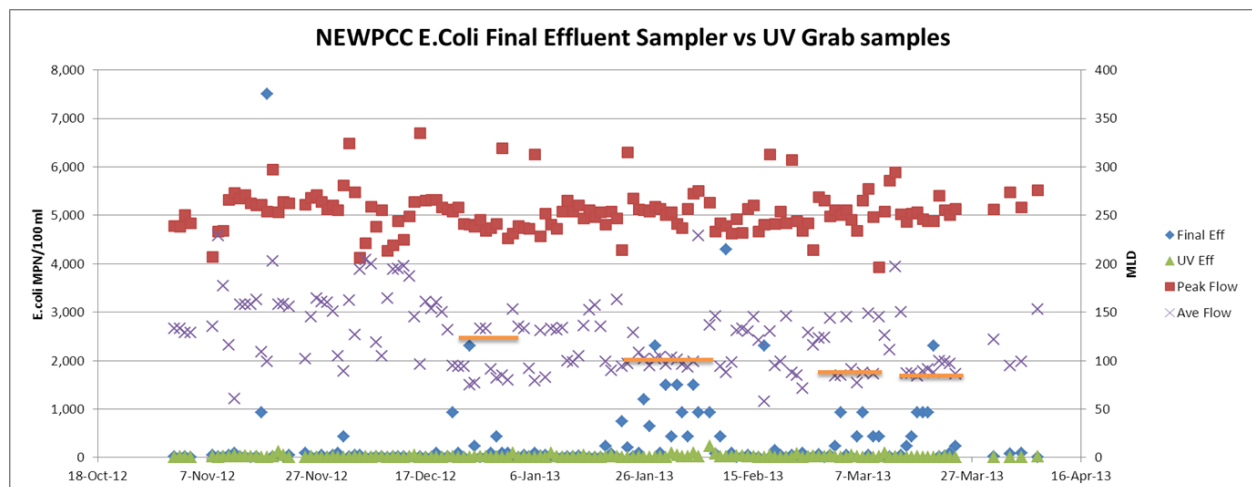
Figure 1 - Correlation of flow and effluent quality

In 2012 and 2013 sampling was carried out to compare results of regulatory samples of final effluent against effluent from the UV facility, Appendix 1. Results indicate the UV facility performs well with the UV effluent having a much lower MPN index than the final effluent, and that high E-coli levels at the final effluent sampler correspond with low flows.

The conclusion from this analysis is that high E-coli levels in the final effluent are coming from the UV by-pass culvert which is causing contamination of UV effluent. The source of the contamination cannot be deduced from the data.

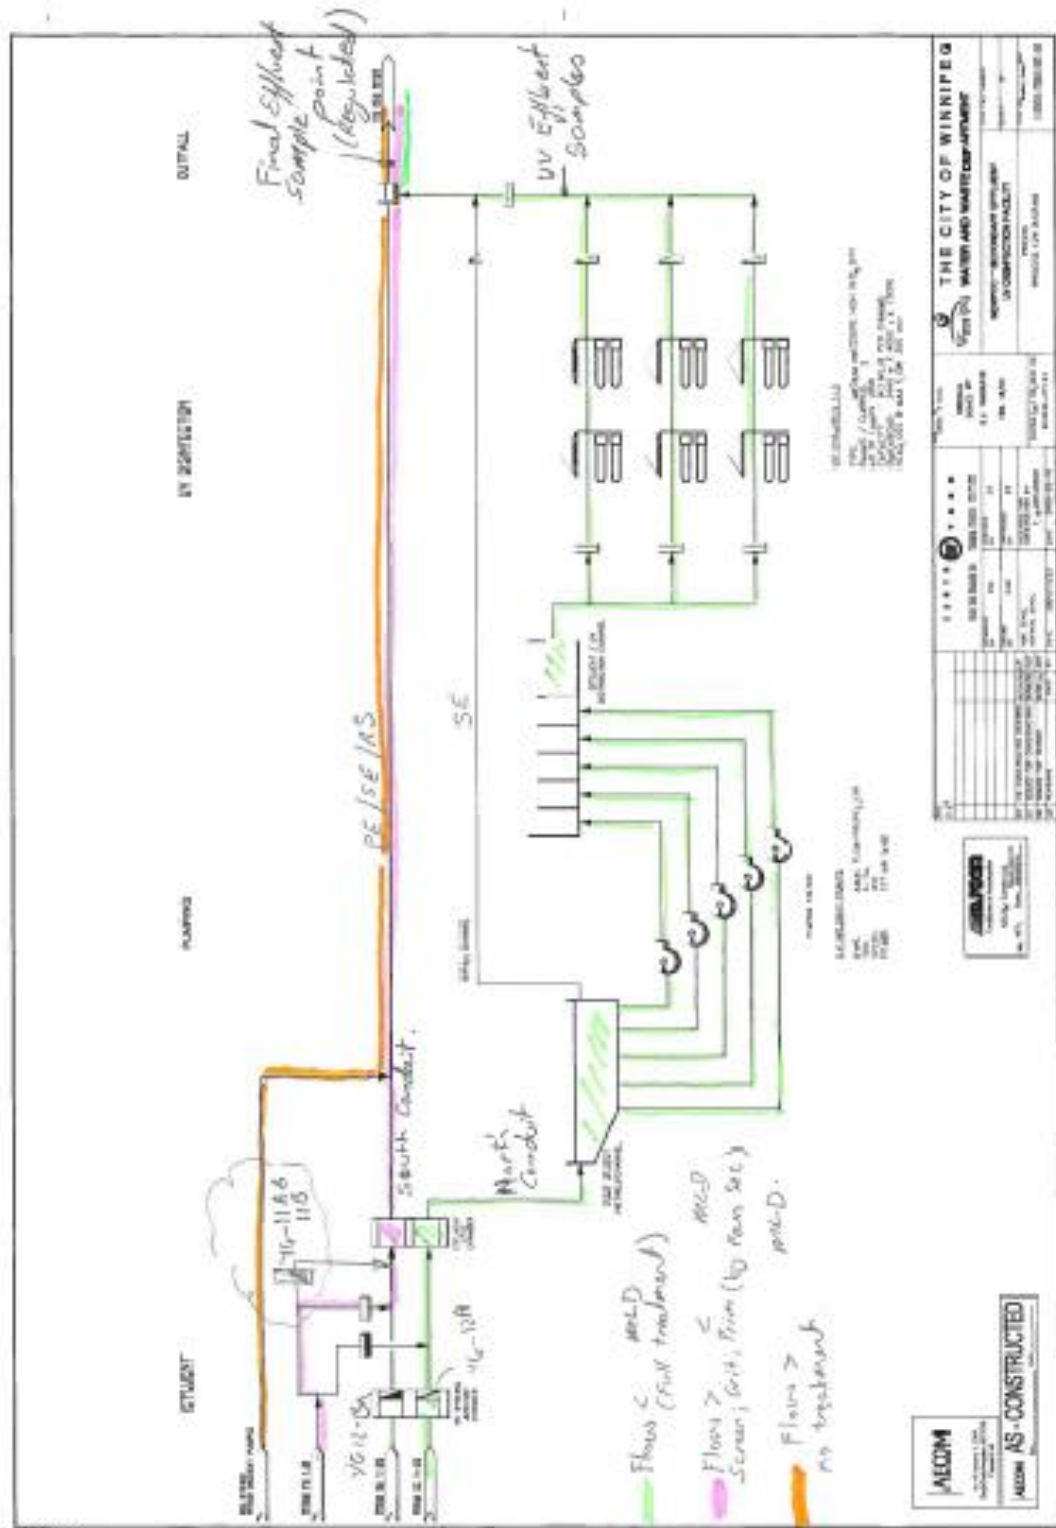
Figure 2 - Flow diagram

The abandoned investigation left the condition of the patch as unknown. It is not known why the water level slowly dropped down and caused the ultrasonic level sensor went out of calibrated range, and eventually led to the restart of UV pumps and observed backwater effect?

The following diagram shows flow conditions through the secondary effluent conduits and location of flow control structures.

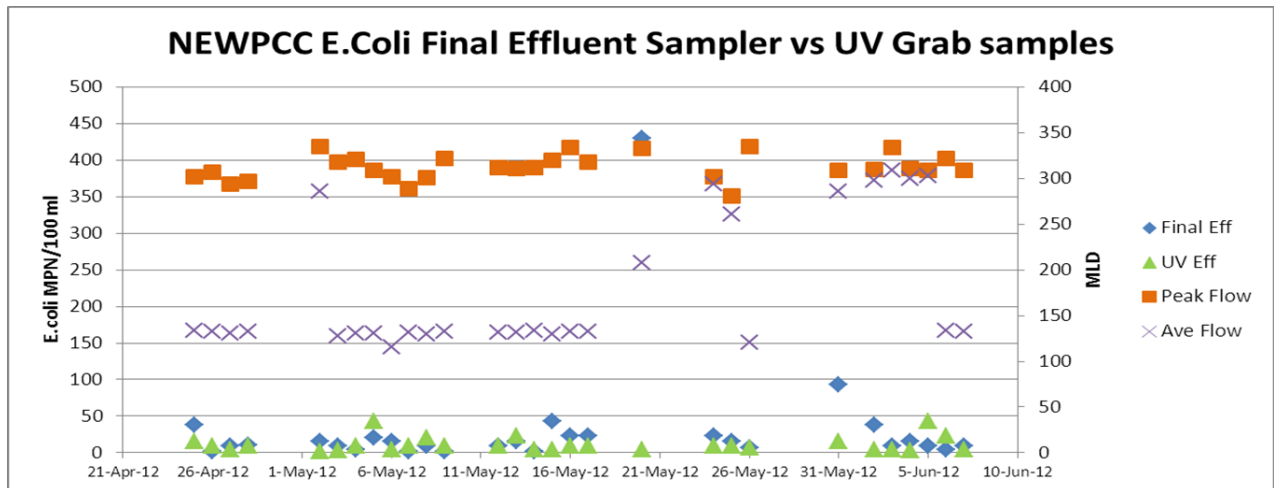
Figure 3

Figures 3 to 5 show that the UV facility is producing a good quality tertiary treated effluent and it is unlikely that the Fecal and E-coli violations are related to the UV facility performance.

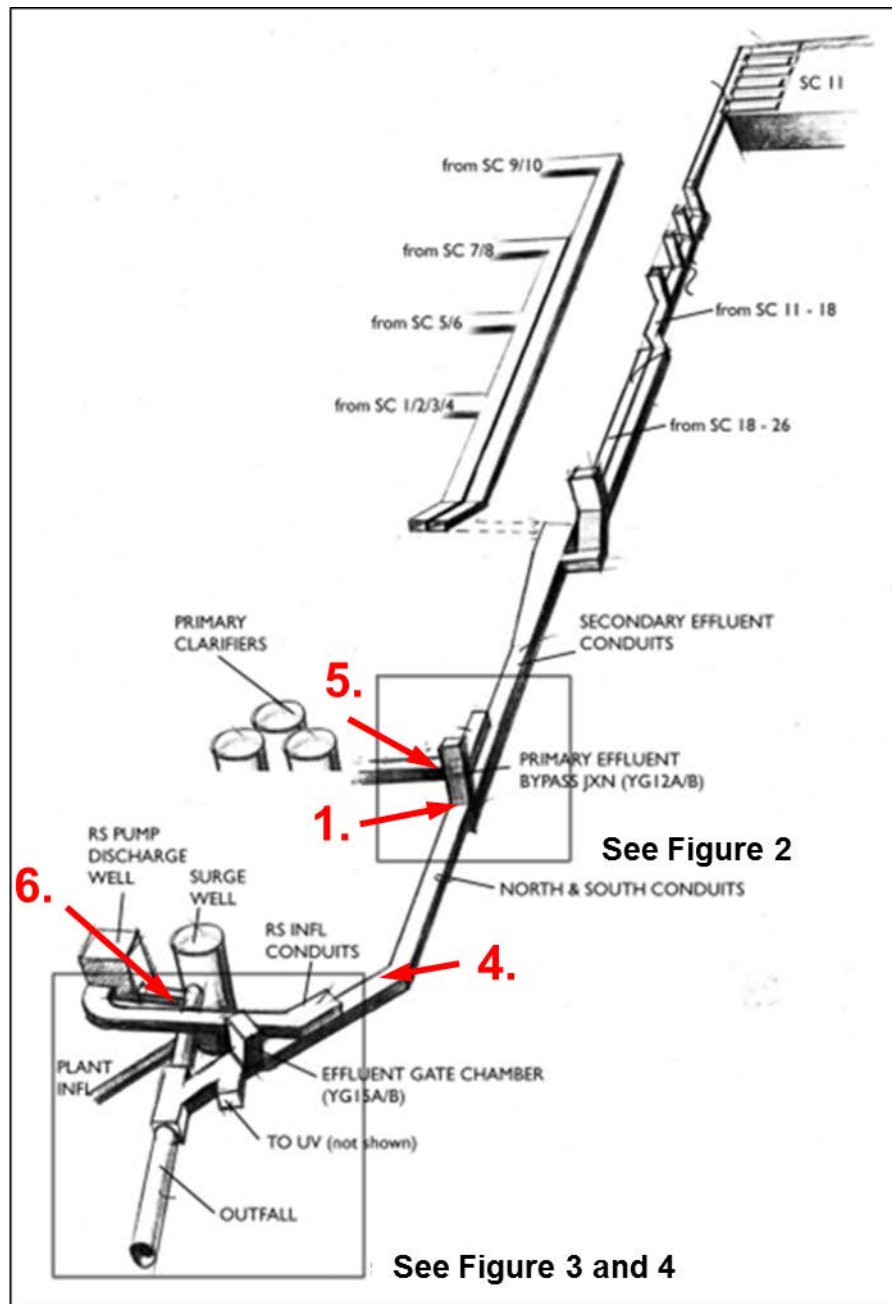
Figure 1 - NEWPCC Effluent Conduit System Overview

1. Continuous leakage from gate YG12B (normally closed), which isolates the south secondary effluent conduit at the junction chamber located near the west end of the grit building (Figure 1 and Figure 2).

4. Continuous leakage between the North and South secondary effluent conduits (Figure 1, Figure 2, and Figure 4).
5. Occasional unintended primary effluent overflow at the junction chamber at the junction chamber when a raw sewage pump starts (Figure 1 and Figure 2).

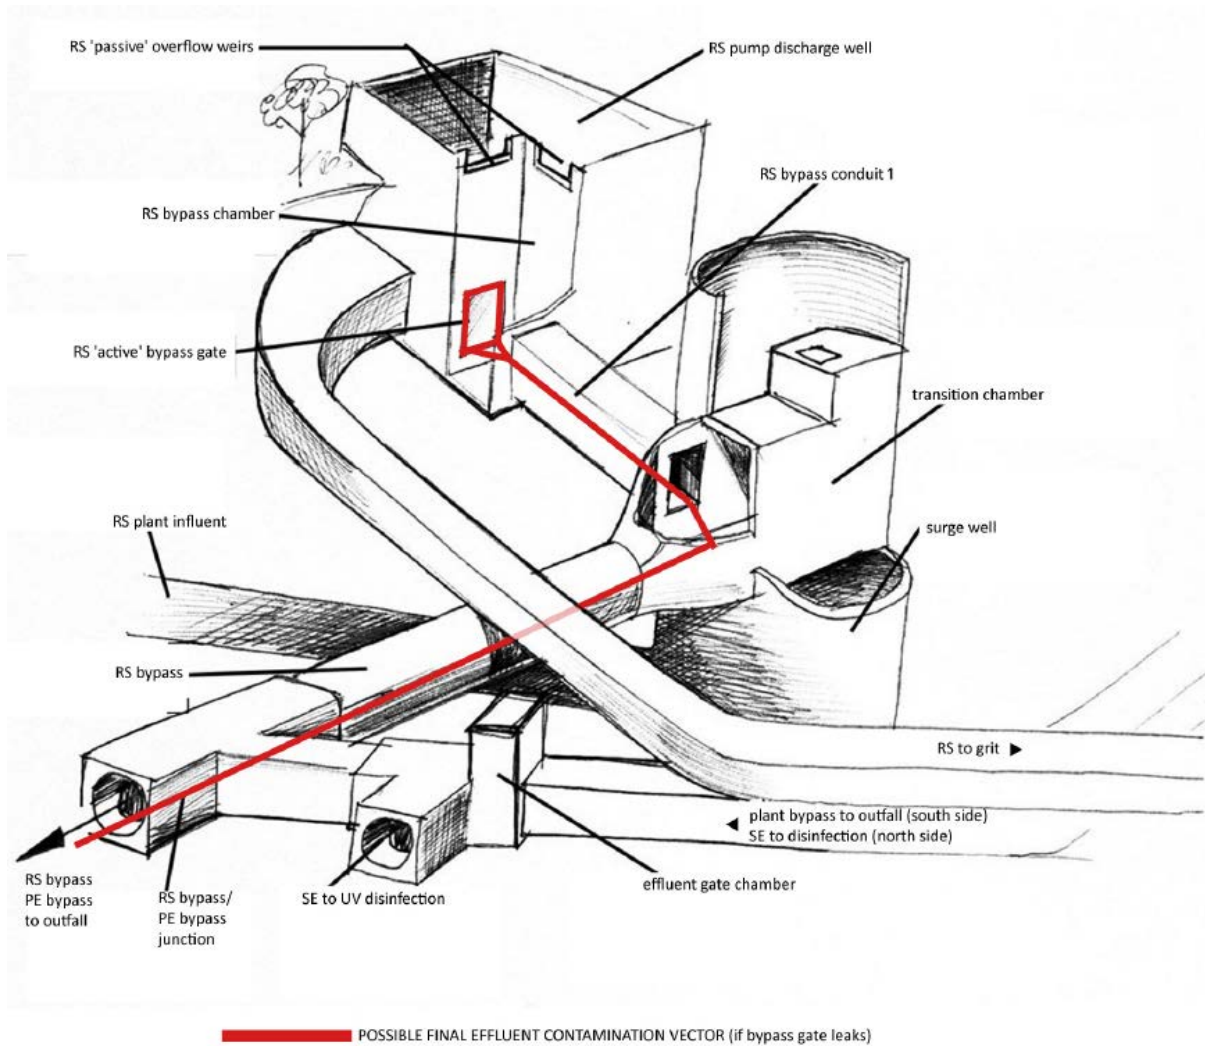
Figure 3 - NEWPCC Influent (Raw Sewage) Bypass

6. Occasional unintended raw sewage bypass or leakage at the raw sewage discharge well (Figure 1 and Figure 3).

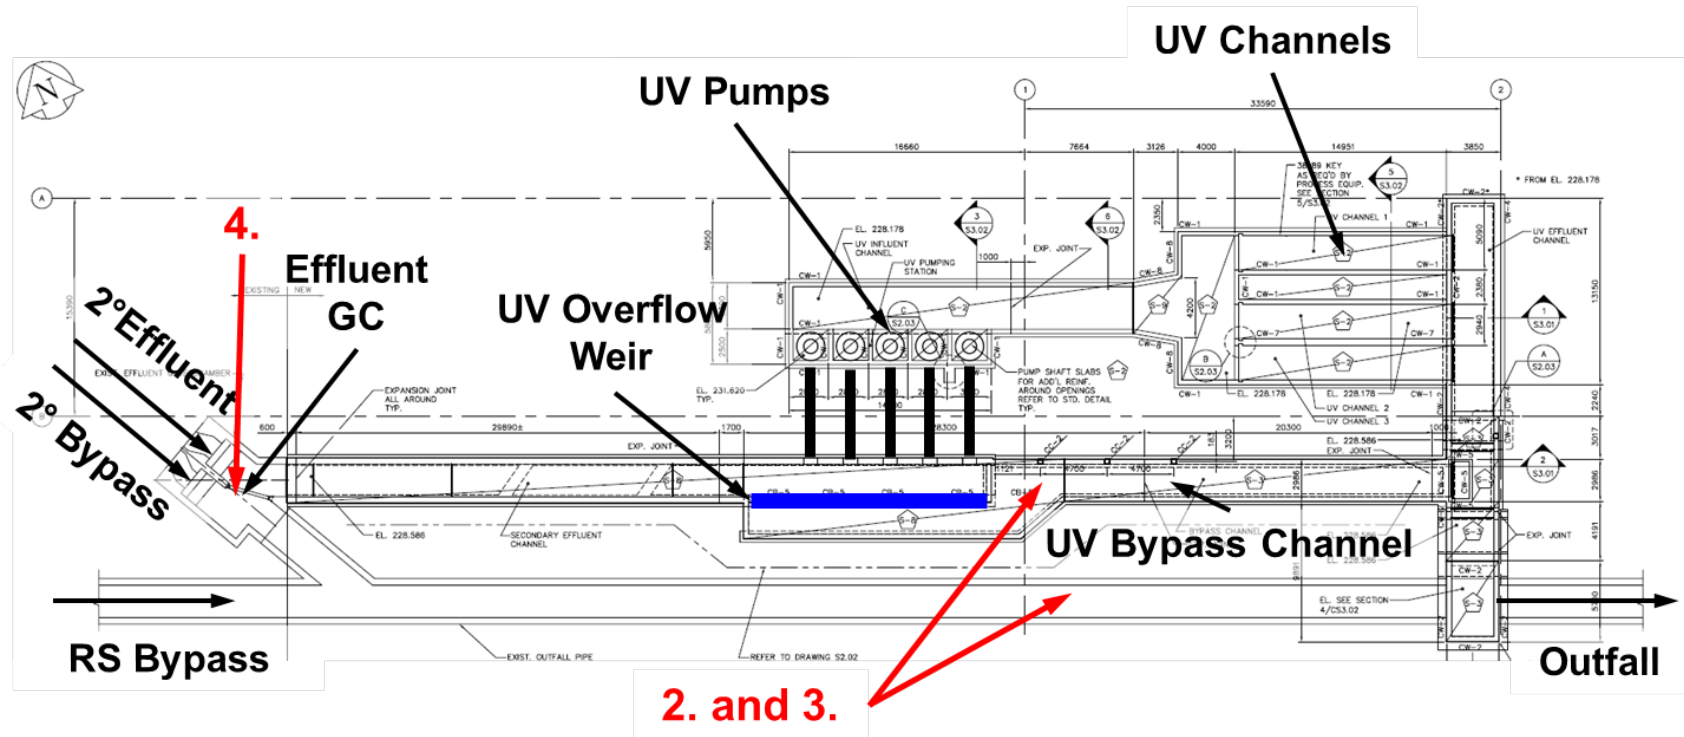
Figure 4 - Effluent Gate Chamber, UV and Outfall Interface

2. Stagnated (trapped) flow in the UV, secondary and raw sewage (RS) bypass channels from previous permitted bypass operations washing out and contaminating treated UV effluent (Figure 4).

3. Flow from UV effluent discharge flowing backwards along the UV, secondary and raw sewage bypass channels, stagnating and allowing regrowth of fecal coliform and E.coli which eventually washes out and contaminates the treated UV effluent at low flows (Figure 4).

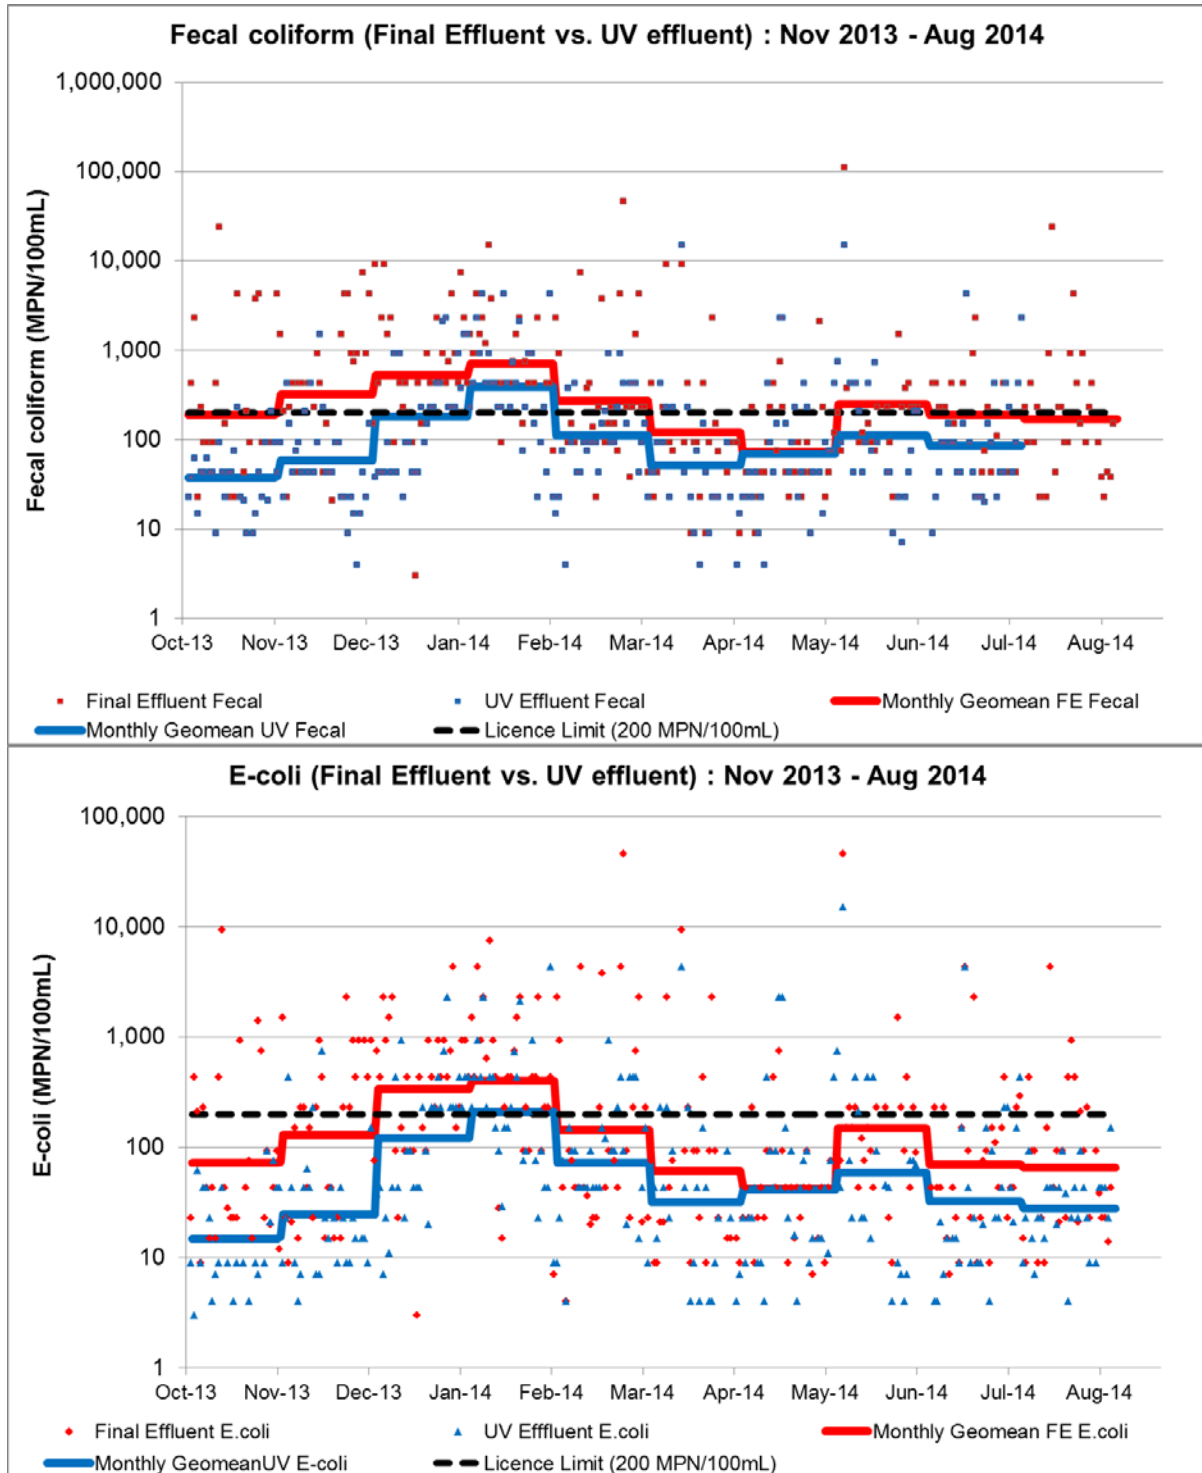
Figure 5 - Fecal Coliform and E.coli in UV and Final Effluent (November 2013 to August 2014)

Effluent sampling data for fecal coliform and E.coli were provided for the period of November 1, 2013 to August 31, 2014 for effluent collected at two locations downstream of the UV disinfection facility. The 'final effluent' samples are collected in the sampling chamber which was installed on the outfall piping as part of the construction of the UV facility in 2006. These are the samples used for regulatory reporting. UV effluent was collected as 'grab samples' within the UV facility, i.e. upstream of the UV bypass and outfall channels, and were used to compare against the final effluent (Figure 5).

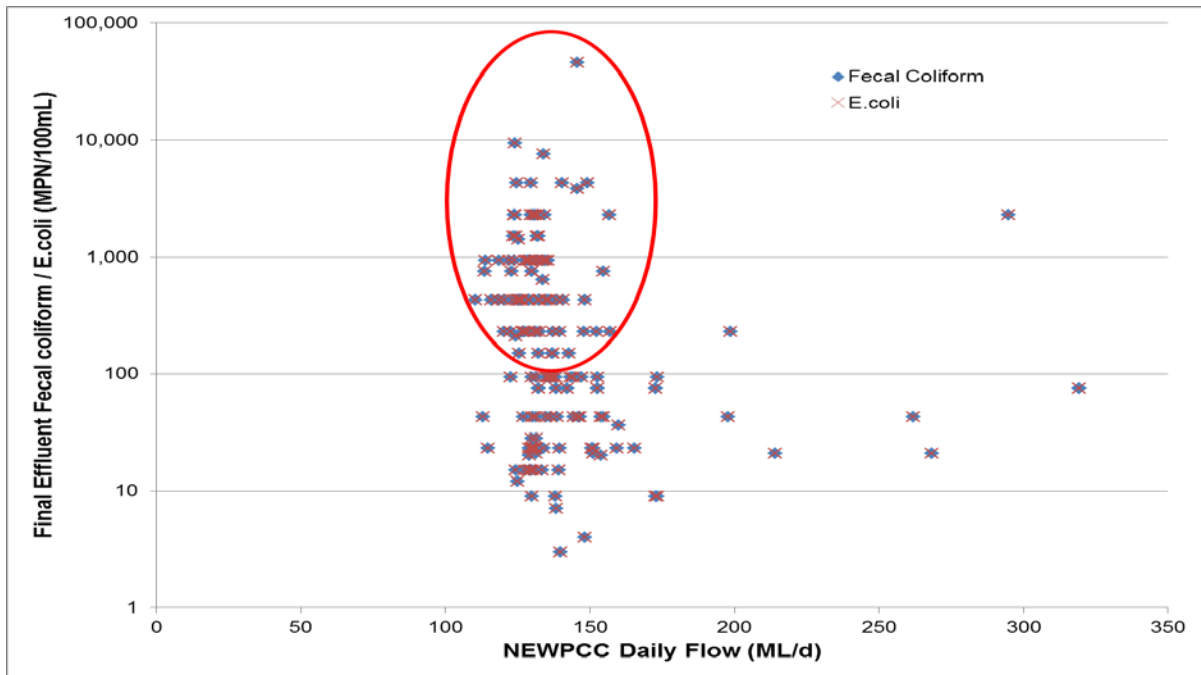
Figure 6 - Final Effluent Fecal Coliform and E.coli vs Plant Daily Flow

The data also appeared to suggest a higher frequency of elevated fecal coliform and E.coli levels in the final effluent during periods of low flows through the NEWPCC. In order to further examine this hypothesis, final effluent fecal coliform and E.coli data were plotted against daily flow at the NEWPCC (Figure 6). The data suggests that the overwhelming majority of instances where fecal coliform and E.coli exceeded the license limit in the final effluent were during periods of dry weather flow (DWF), i.e. when flows were a maximum of approximately 150 ML/d.

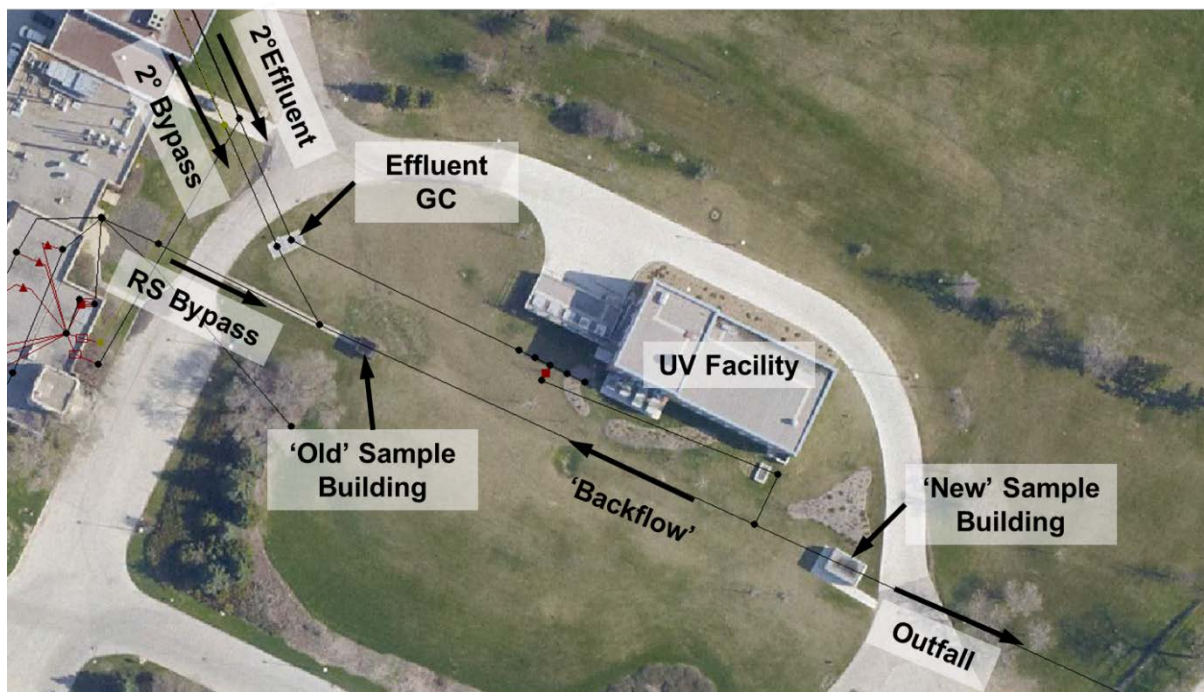
Figure 8 - Site Plan of Effluent Conduit Inspection

In November, 2006, an inspection of the effluent conduit took place and was documented by Terry Holding. Civil Maintenance was to inspect a previously installed patch in the effluent conduit at a location 3 metres west of the old sampling building (Figure 8). Based on this description, the patch would appear to be located in the original outfall pipe, i.e. not in the parallel secondary effluent and secondary bypass conduits upstream of the effluent gate chamber.

Flow through the treatment plant was interrupted to allow the man entry inspection to take place which also included shutting down the UV facility and its pumps. However, it appears that while the crew was preparing to complete the inspection that the UV pumps accidentally restarted. This resulted in a rapid backflow up the bypass piping and south (secondary bypass) channel towards the effluent gate chamber. During the initial surge of the backflow event, the level rose to a maximum level of approximately 2 metres. The pumps were subsequently shutdown and the inspection abandoned.

These observations confirm backflow into the UV, secondary and raw sewage bypasses can occur when the rate of discharge from the UV facility increases.

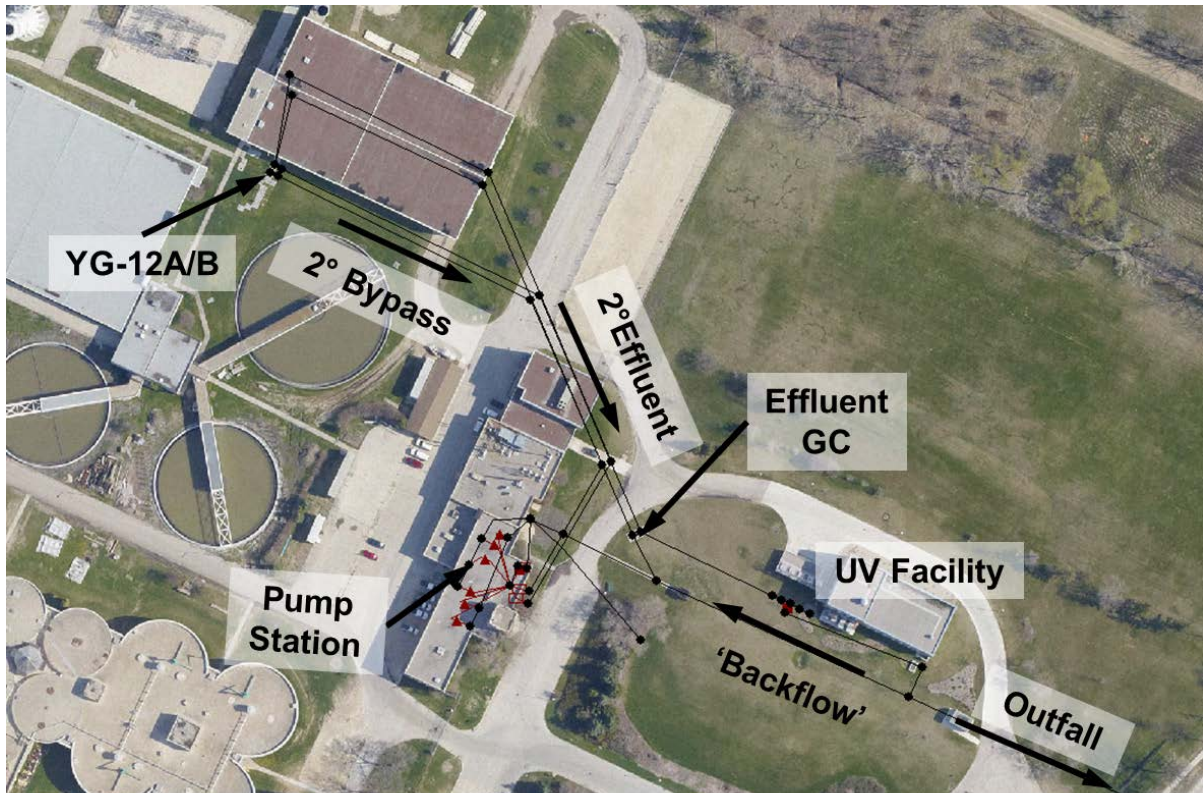
Figure 10 - InfoWorks CS Model of NEWPCC Outfall and Bypass Conduits

A hydraulic model of the outfall conduits was created in InfoWorks CS to more closely examine the flow conditions in the UV, secondary and raw sewage bypass conduits as shown in Figure 10. A typical diurnal inflow pattern (data from March 2011) was applied to the model and the response in the outfall examined.

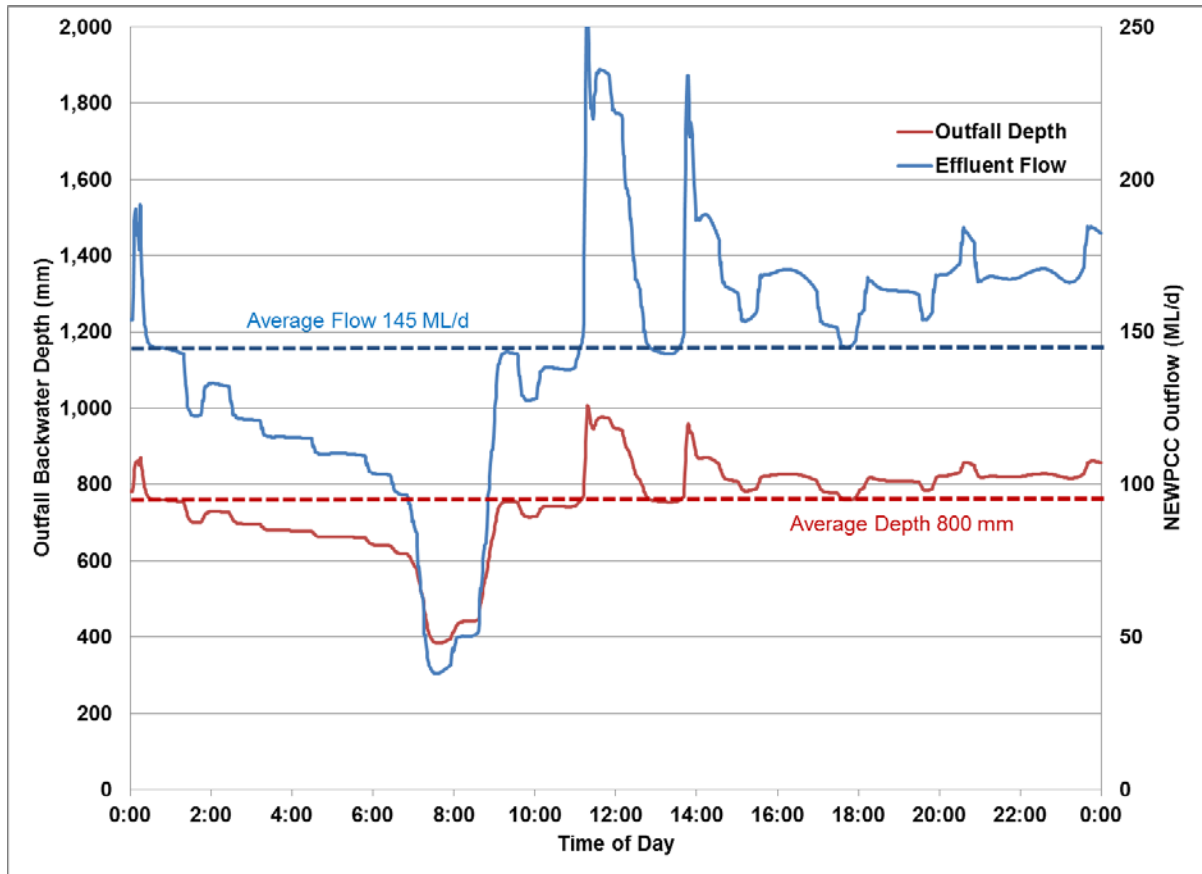
Figure 11 - Diurnal Fluctuation in Outflow and Outfall Backwater Depth

The model indicates that over the course of a typical day, levels in the outfall, and consequently in the bypass conduits, will fluctuate as a result of the diurnal variation in flow (Figure 11). When flow decreases, there would be outflow from the conduits bypassing the UV facility, potentially contaminating effluent flow. Conversely, when flow increases, there is backflow into the 'dead storage' of the bypass conduits. The ebb and flow in the bypass conduits is likely to be more significant during periods of low flow which coincides with the observed elevated levels of fecal coliform and E.coli.

This analysis also suggests that the timing of the collection of the final effluent grab samples could affect the results. Based on the diurnal pattern shown in Figure 11, collecting the samples at roughly 7:00AM could yield the worst results in terms of the bacteriological analysis if contamination from the bypass channel is in fact occurring. Conversely, collecting the samples at peak flow, which appears to occur at roughly 11:30AM, could yield lower fecal coliform and E.coli counts in the final effluent.

Sampling at a point where the outflow is relatively stable and approximately equivalent to ADWF would likely yield the most representative results. Based on the diurnal pattern shown in Figure 11, this would correspond to a time in the late afternoon (i.e. between 16:00 and 18:00).

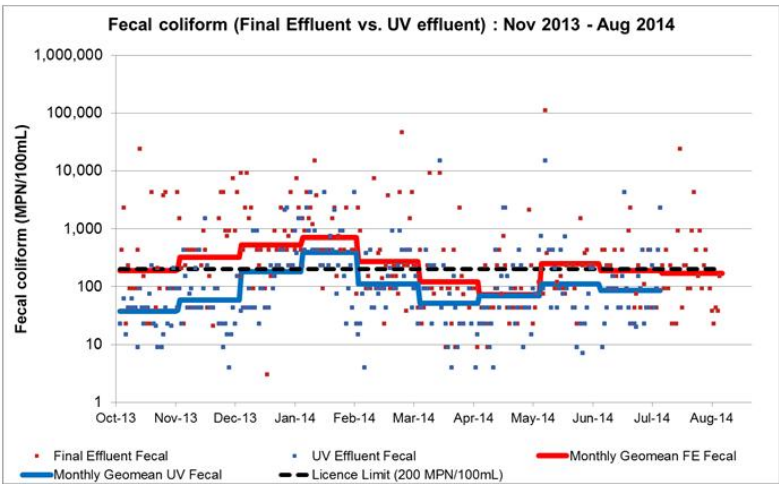
- Highest values during periods of dry weather (Nov – Feb)
- Fecal and E.coli generally higher in final vs UV effluent

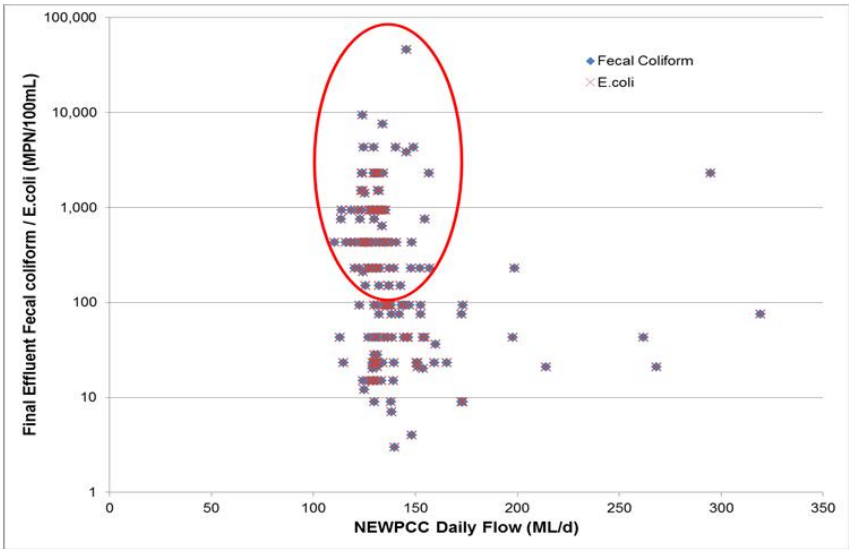
- Largest fecal and E.coli counts in final effluent at low flows (<150ML/d)

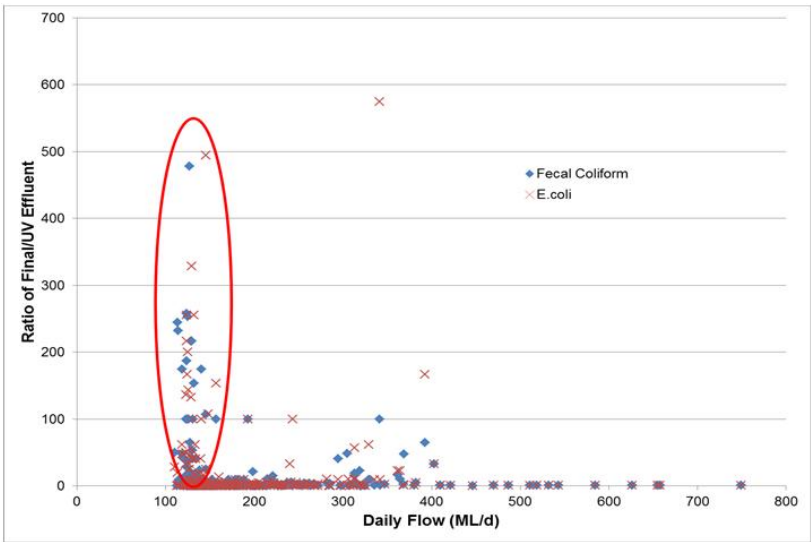
- Largest ratio of final to UV effluent also at low flows (<150ML/d)

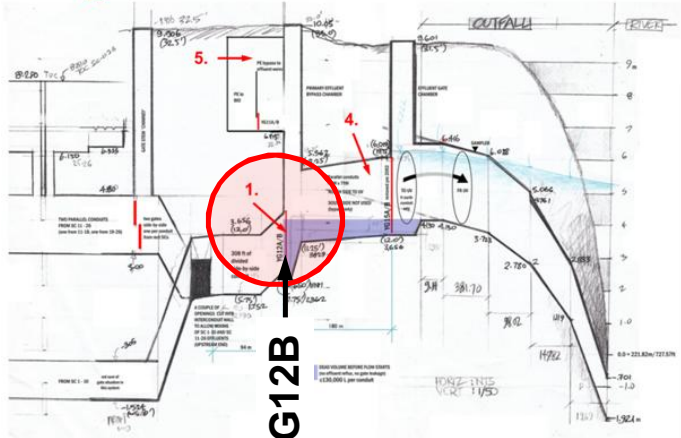
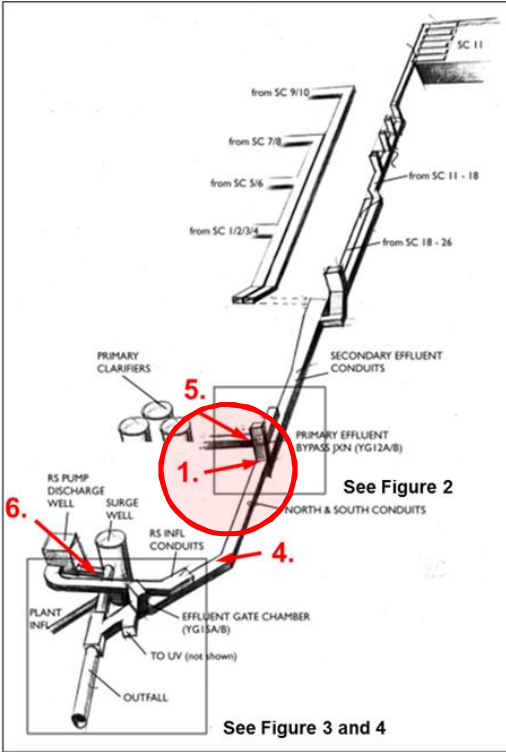
1. Continuous leakage from gate YG12B

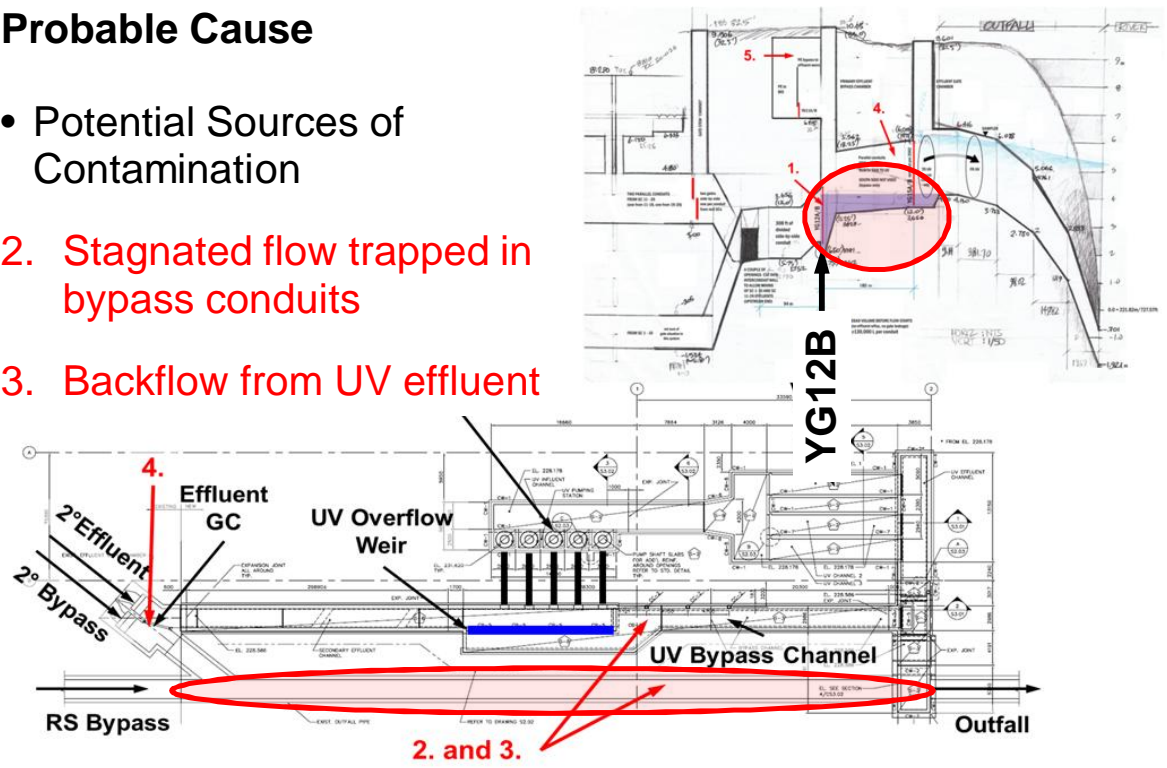
- Potential Sources of Contamination
- 2. Stagnated flow trapped in bypass conduits
- 3. Backflow from UV effluent

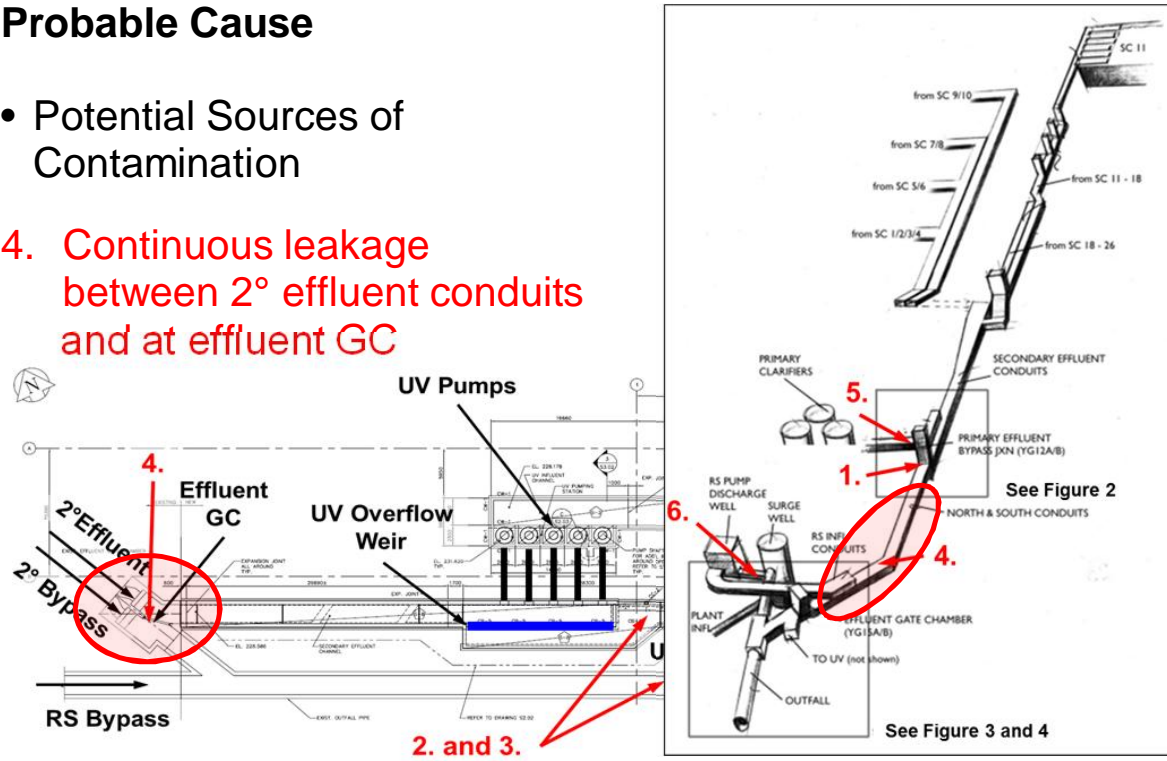
- Potential Sources of Contamination
- 4. Continuous leakage between 2° effluent conduits and at effluent GC

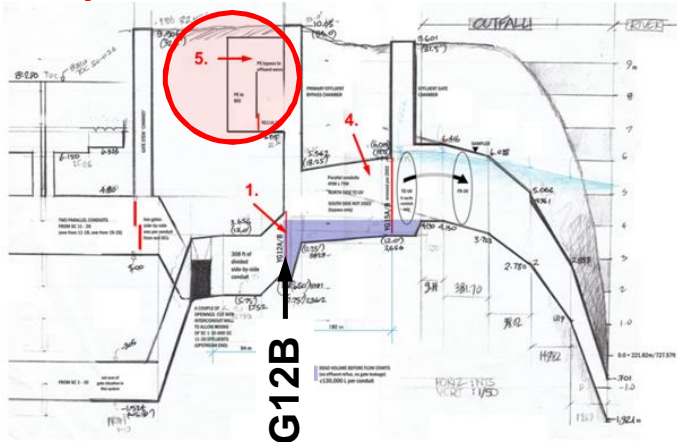
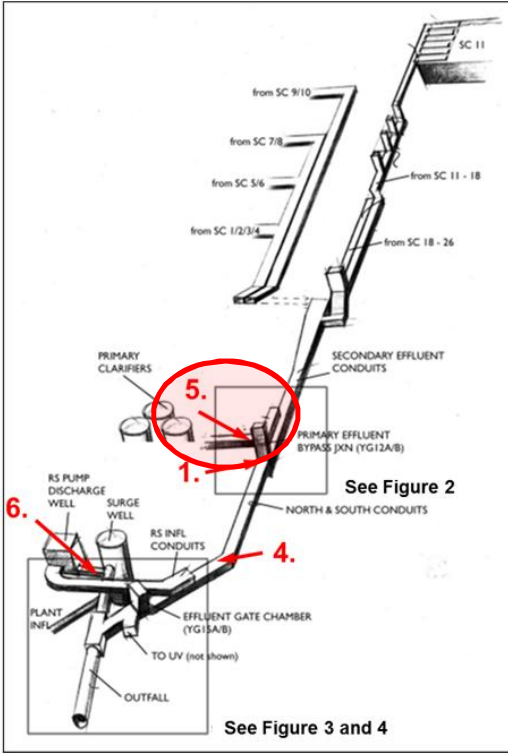
5. 1° effluent overflow at junction chamber

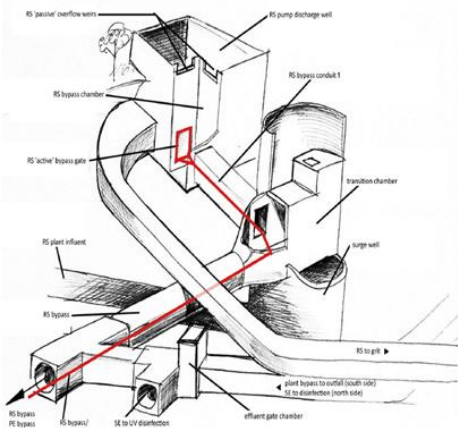
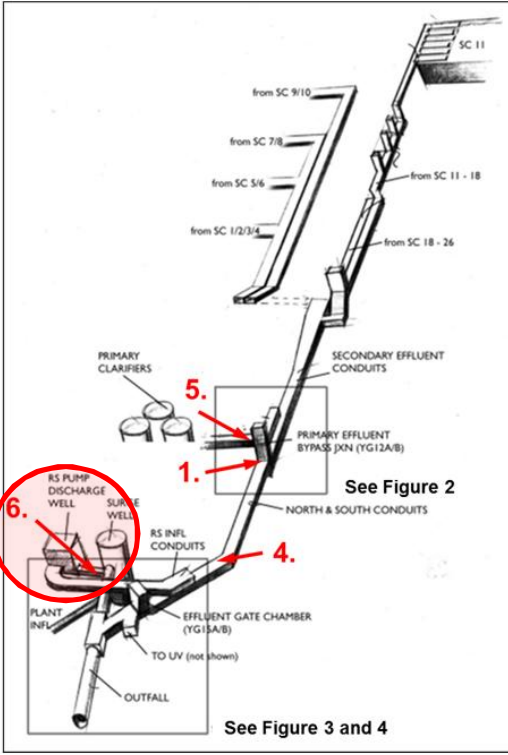
6. Occasional raw sewage bypass

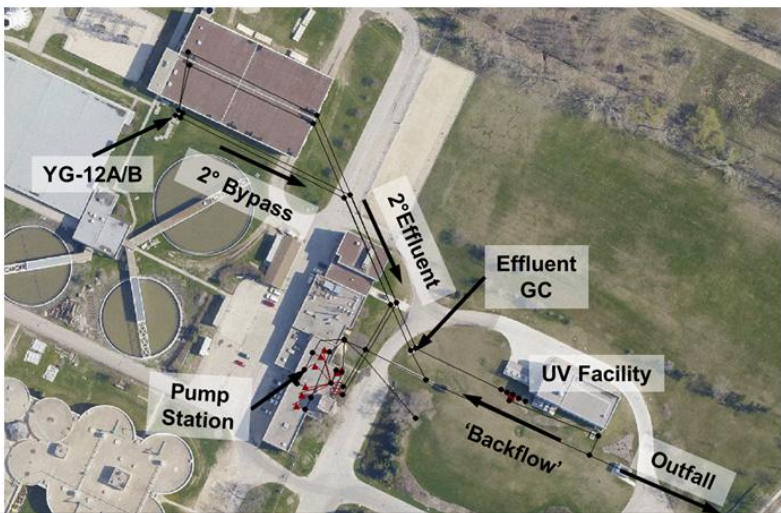
- Hydraulic Analysis
 - Hydraulic model of effluent conduits and outfall created to analyze conditions during DWF
 - Applied typical NEWPCC DWF data (March 2011)

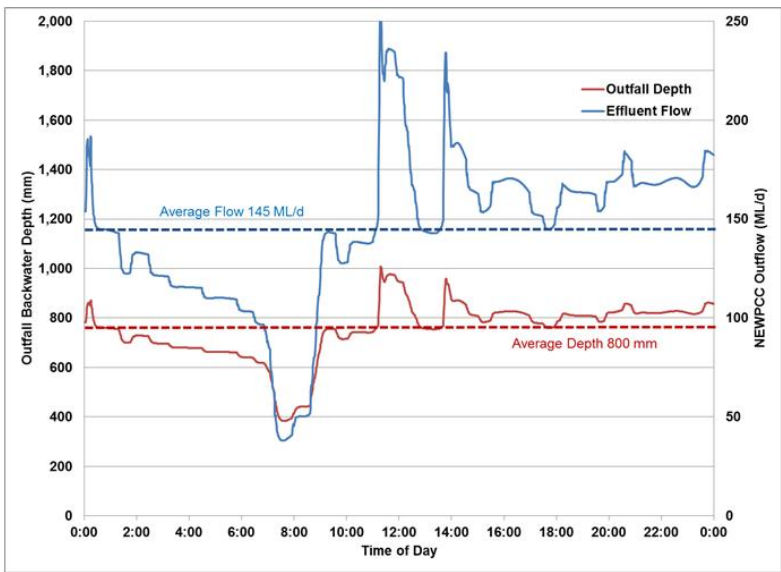
- Hydraulic Analysis
 - Over course of typical day, level in outfall and bypass conduits fluctuate in response to changing flows

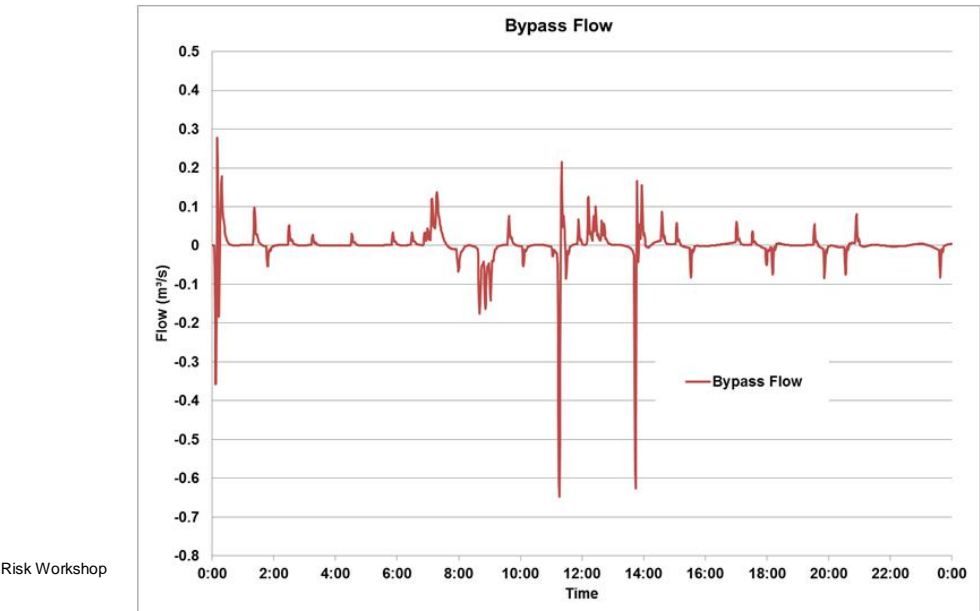
- Hydraulic Analysis
 - Ebb and flow in and out of bypass conduit -0.6 (in) to 0.2 m³/s (out)

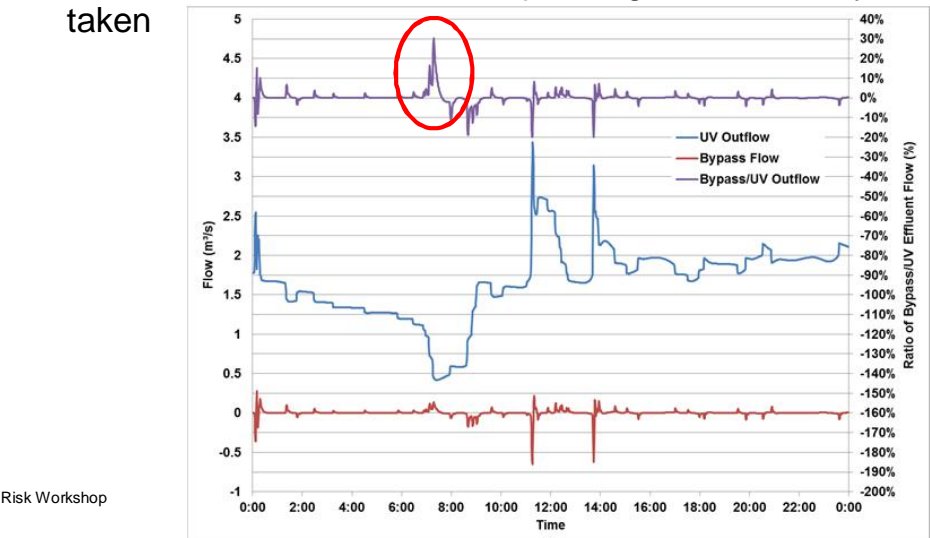
- Hydraulic Analysis
 - Ratio of 'bypass flow' to UV flow potentially as high as 30% at ~7:30AM
 - Potential for contamination depending on time of day sample is taken
