Winnipeg Sewage Treatment Program

NEWPCC Fecal and E-Coli Compliance Investigation Report 2014

November 2014

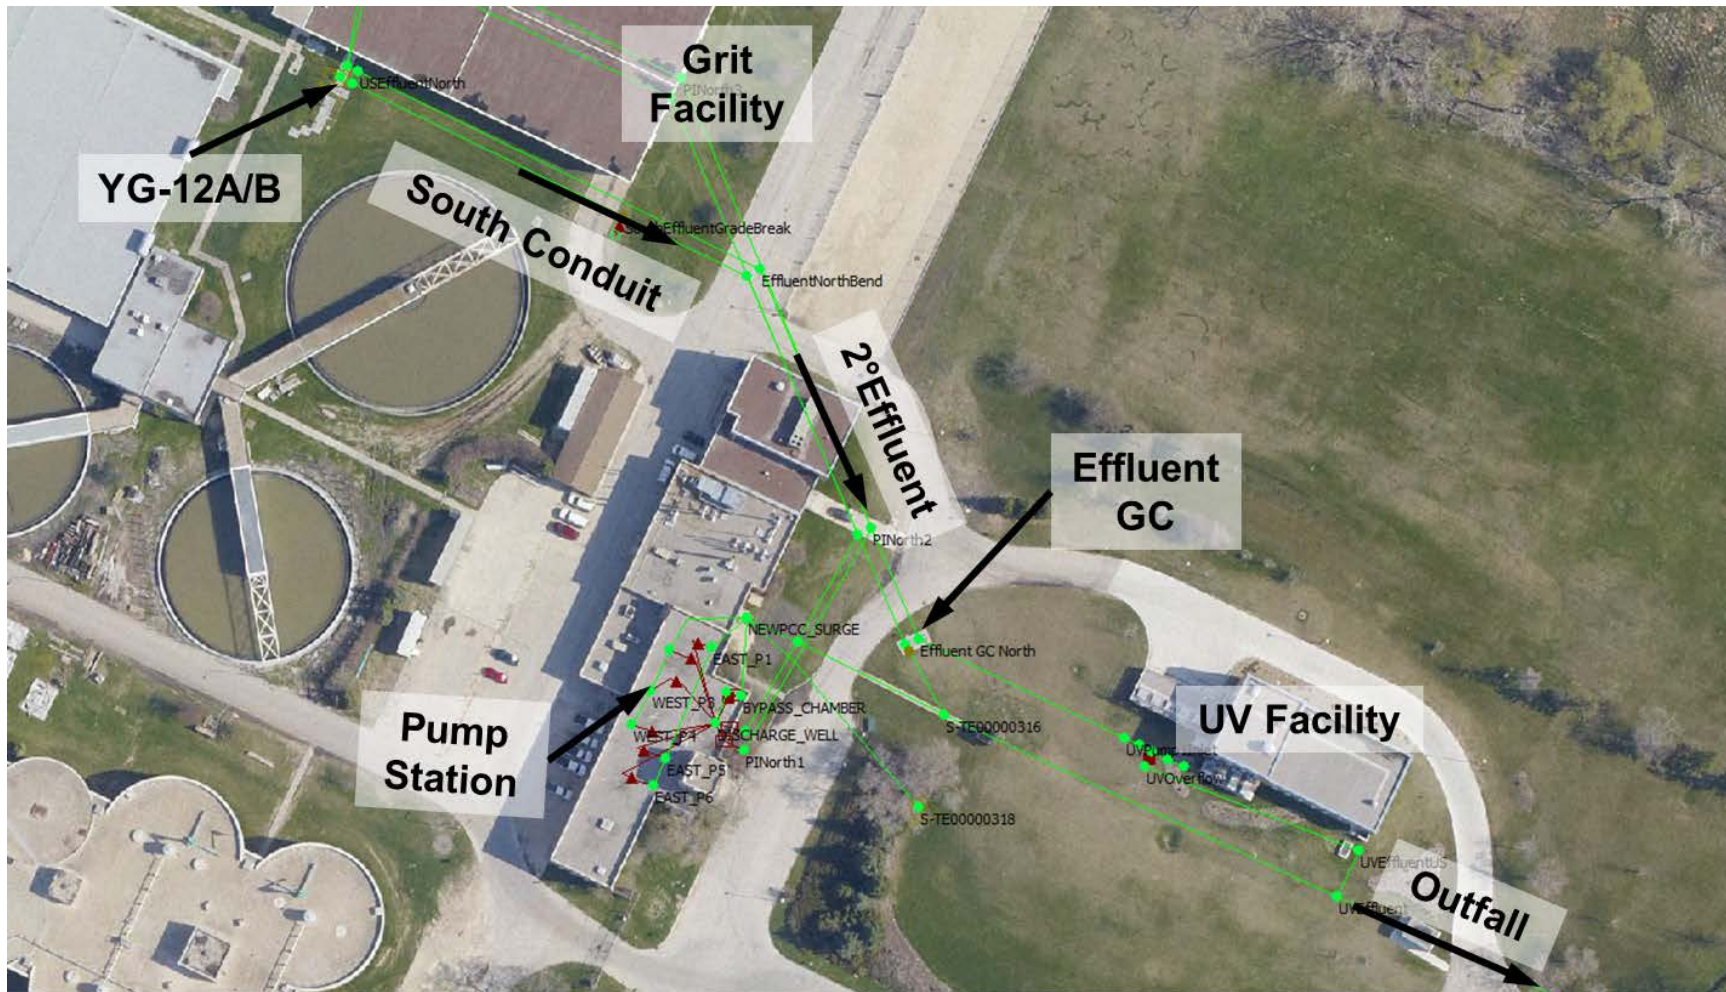
Figure 2.1 – InfoWorks CS Model of NEWPCC Outfall and Bypass Conduits

In order to evaluate the potential effectiveness of these options, the InfoWorks CS hydraulic model of the outfall conduits (Figure 2.1) was utilized. The water quality modelling feature available in InfoWorks CS was used to assess the potential effectiveness of the alternatives on the coliform levels in the final effluent. The following assumptions were made in the analysis:

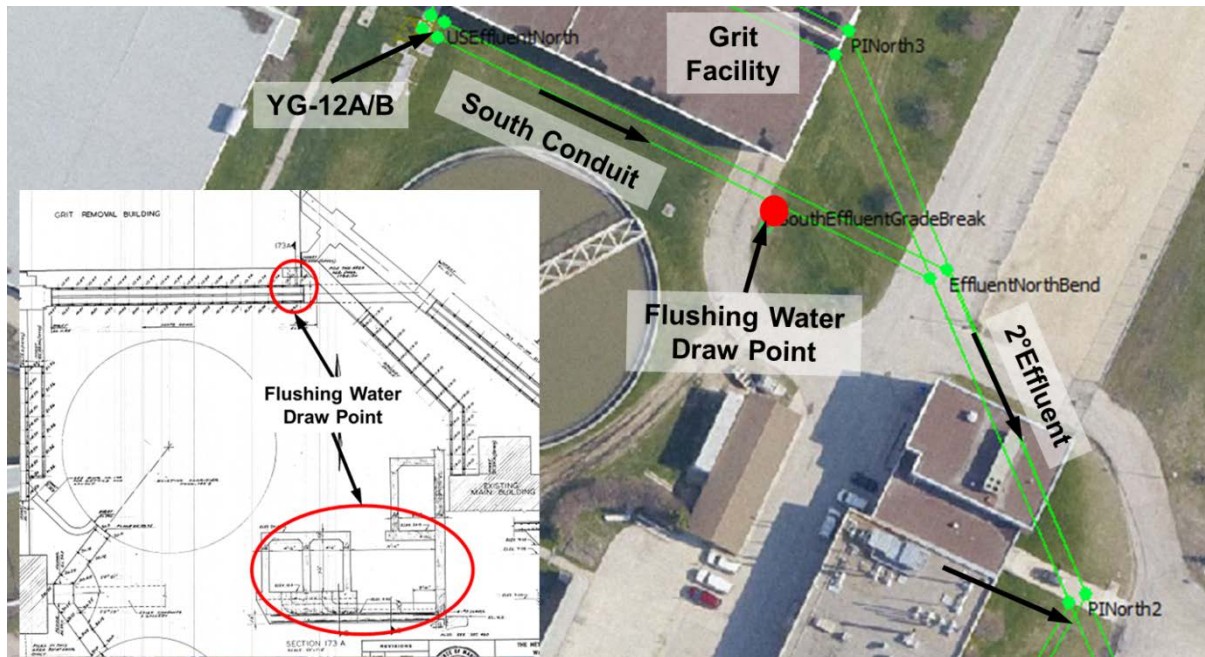
Figure 2.5 – Dewater South Effluent Conduit via Flushing Water Offtake

To simulate this alternative, a small pump was added to the model which would draw from the south conduit at the same point as the flushing water pumps in the Grit Facility as shown in Figure 2.5. A constant dewatering rate of 6 L/s (equivalent to the estimated combined leakage from gate YG12B and from the stop logs in the EGC) was assumed for the analysis.

- 1) Dewatering of the south conduit using the flushing water offtake is recommended as the first approach to be implemented.
 - a. This approach has the lowest cost, introduces little operational complexity or risk and is anticipated to provide significant improvement in effluent quality.

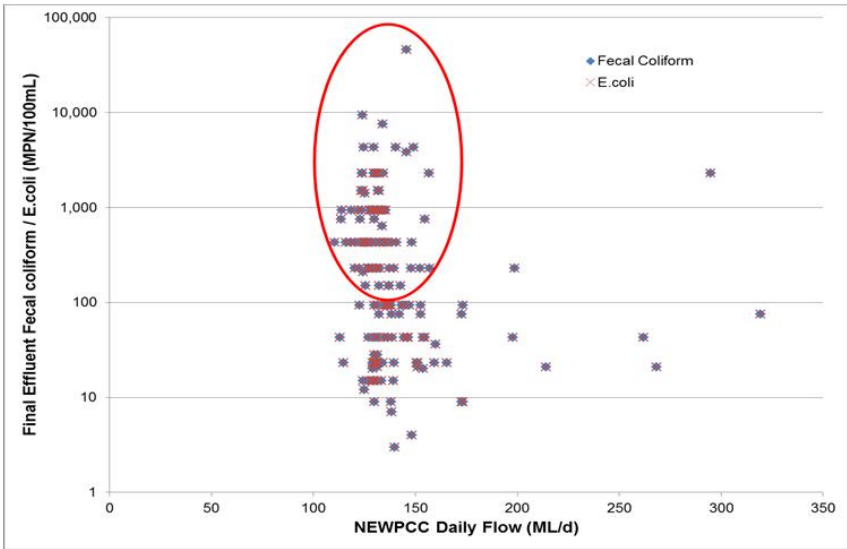
- Largest fecal and E.coli counts in final effluent at low flows (<150ML/d)

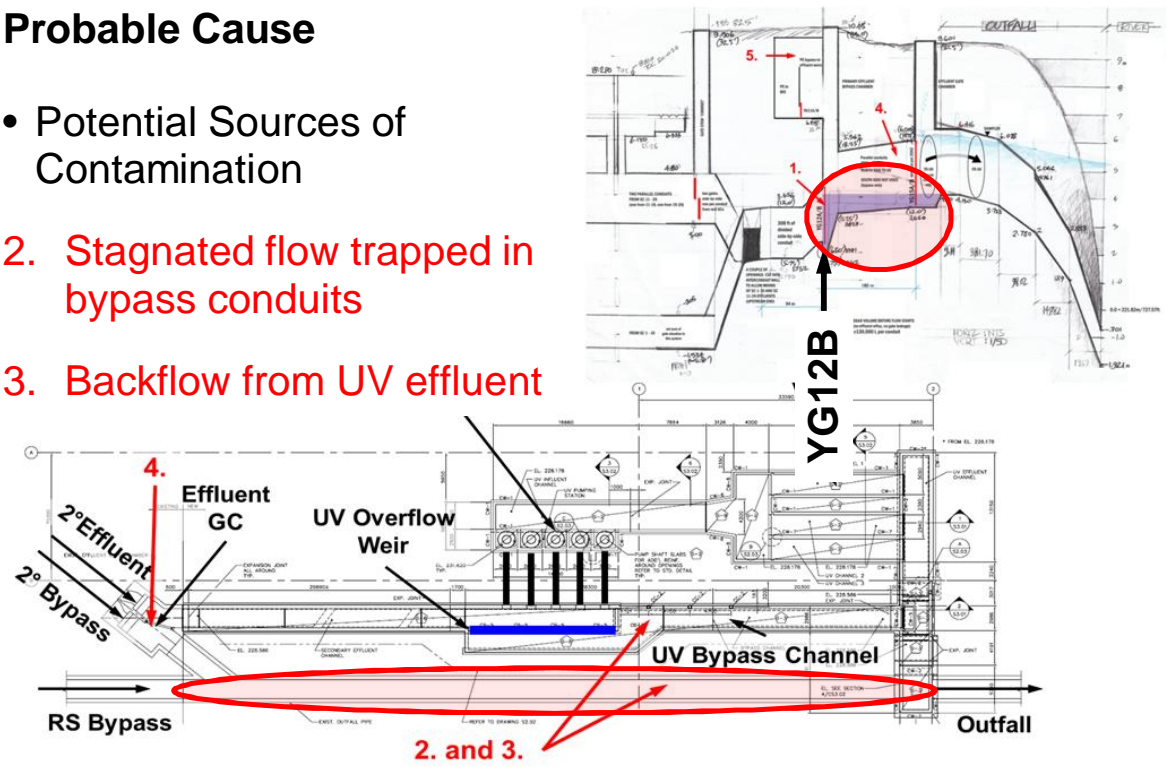
- Potential Sources of Contamination
- 2. Stagnated flow trapped in bypass conduits
- 3. Backflow from UV effluent

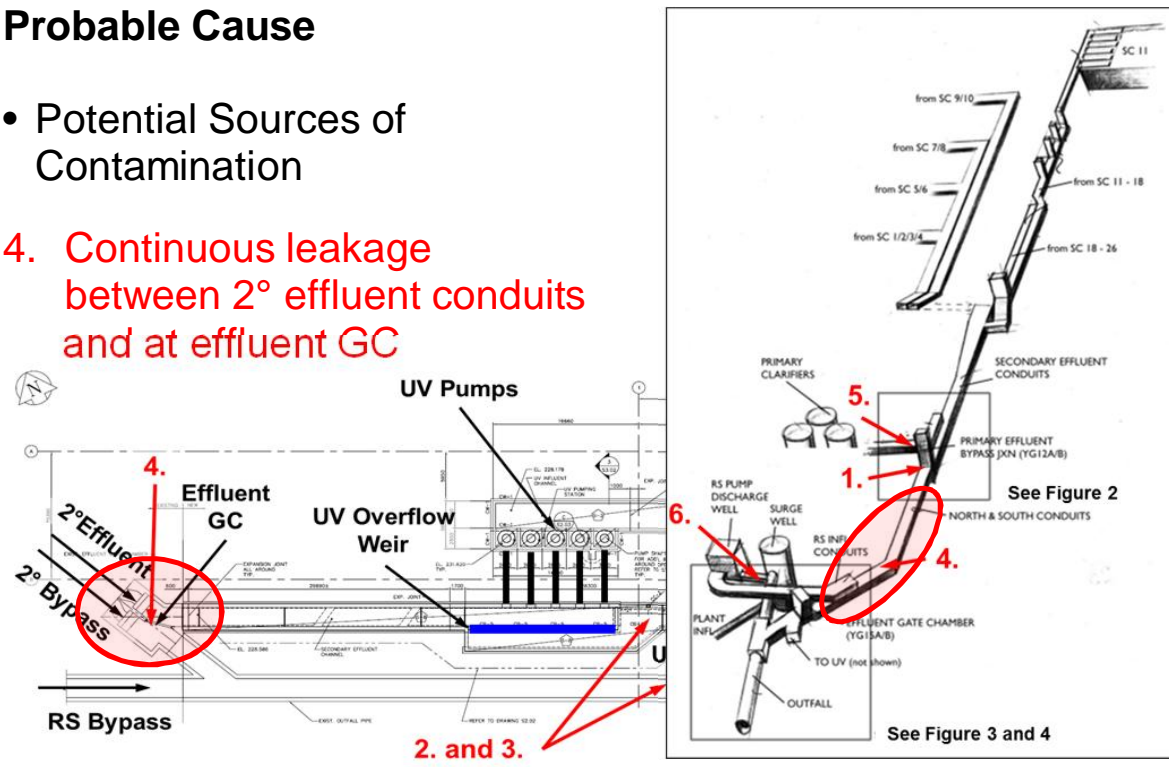
- Potential Sources of Contamination
- 4. Continuous leakage between 2° effluent conduits and at effluent GC

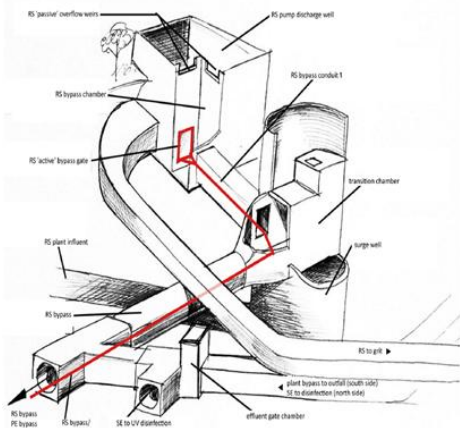
6. Occasional raw sewage bypass

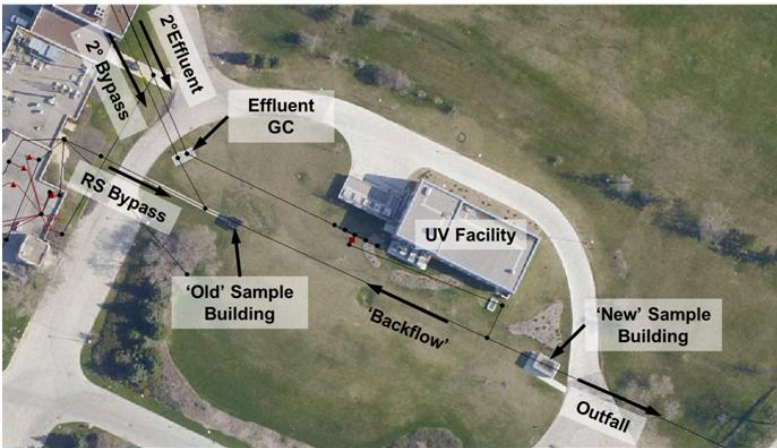
- Observation of Backflow (November, 2006)
 - During inspection of effluent conduit by Civil Maintenance
 - UV pumps accidentally restarted, rapid backflow up bypass conduits
 - Physical observation of backflow confirmed

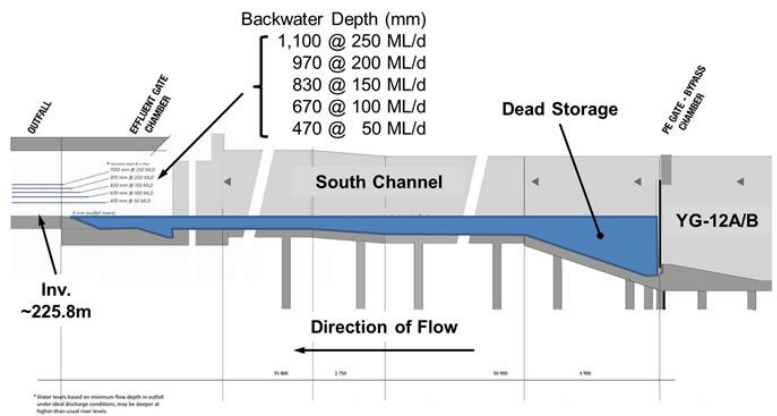
- Hydraulic Analysis
 - Depth of backwater in South Channel a function of flow rate in outfall
 - Even under no flow, effluent trapped as dead storage in South Channel between YG12B and Effluent GC

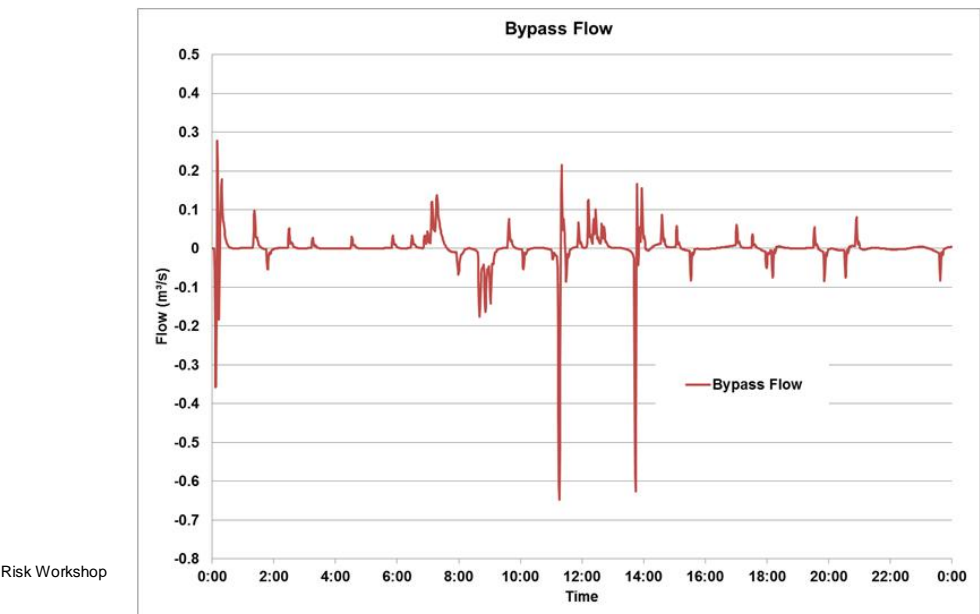
- Hydraulic Analysis
 - Ebb and flow in and out of bypass conduit -0.6 (in) to 0.2 m³/s (out)
