Olive Wastewater Pumping Station Upgrades Preliminary Design Report

City RFP No. 1100-2014

KGS Group No. 14-0107-043

March 2015

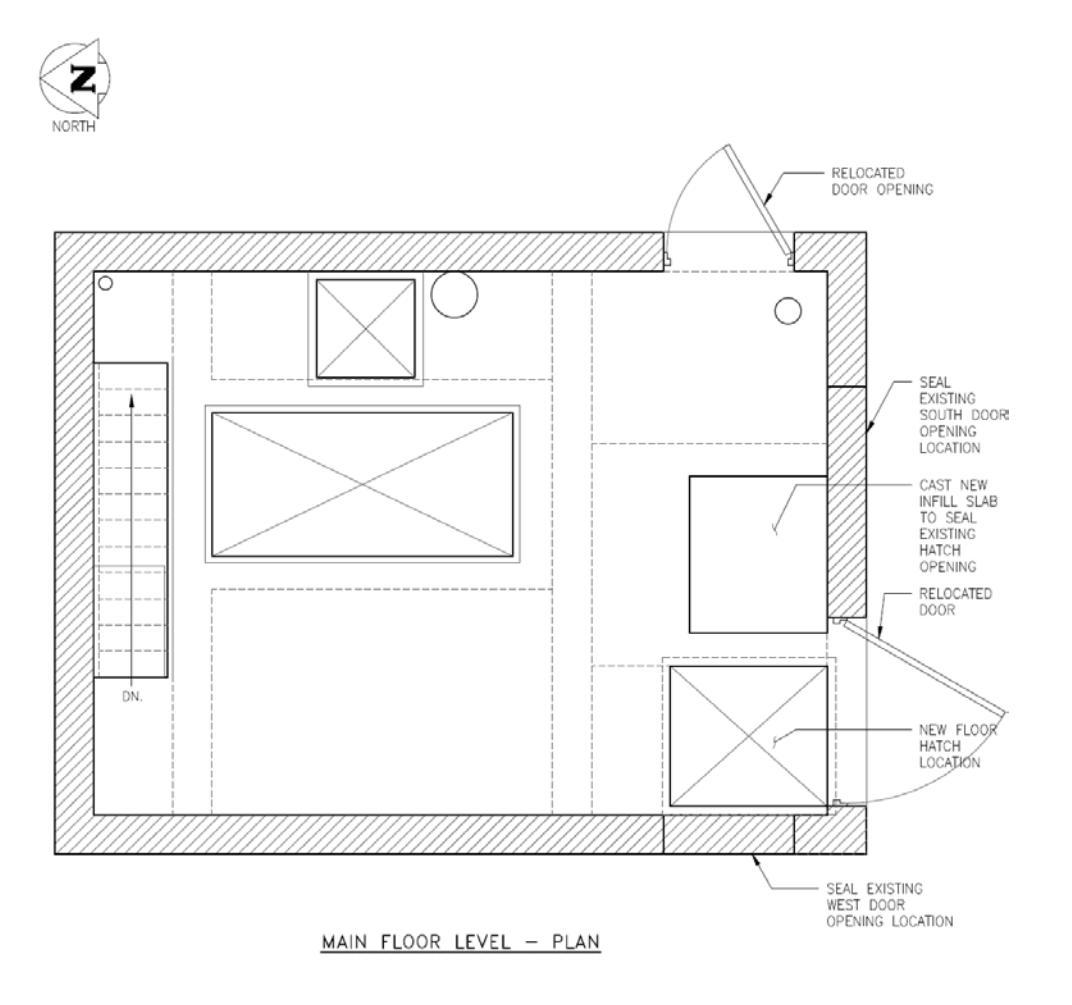
The exterior doors appear to be in good condition with no corrosion. However, the location of the doors will not be functional for the new proposed relocation of the motor and pump room access hatch to the southwest corner of the structure as outlined below and in the mechanical review section.

The exterior doors will require relocation for the proposed hatch relocations. The current large door on the south face would have to be shifted westward approximately 1400mm (4'-7") to align with the new access hatch to the motor and pump room. The secondary door on the west side of the structure will require relocation to the east wall as the new hatch location will prevent emergency access in the event that the hatch is removed. The existing openings will be sealed by matching the existing wall system. The proposed new door and hatch layout is shown below in Figure 3.1.

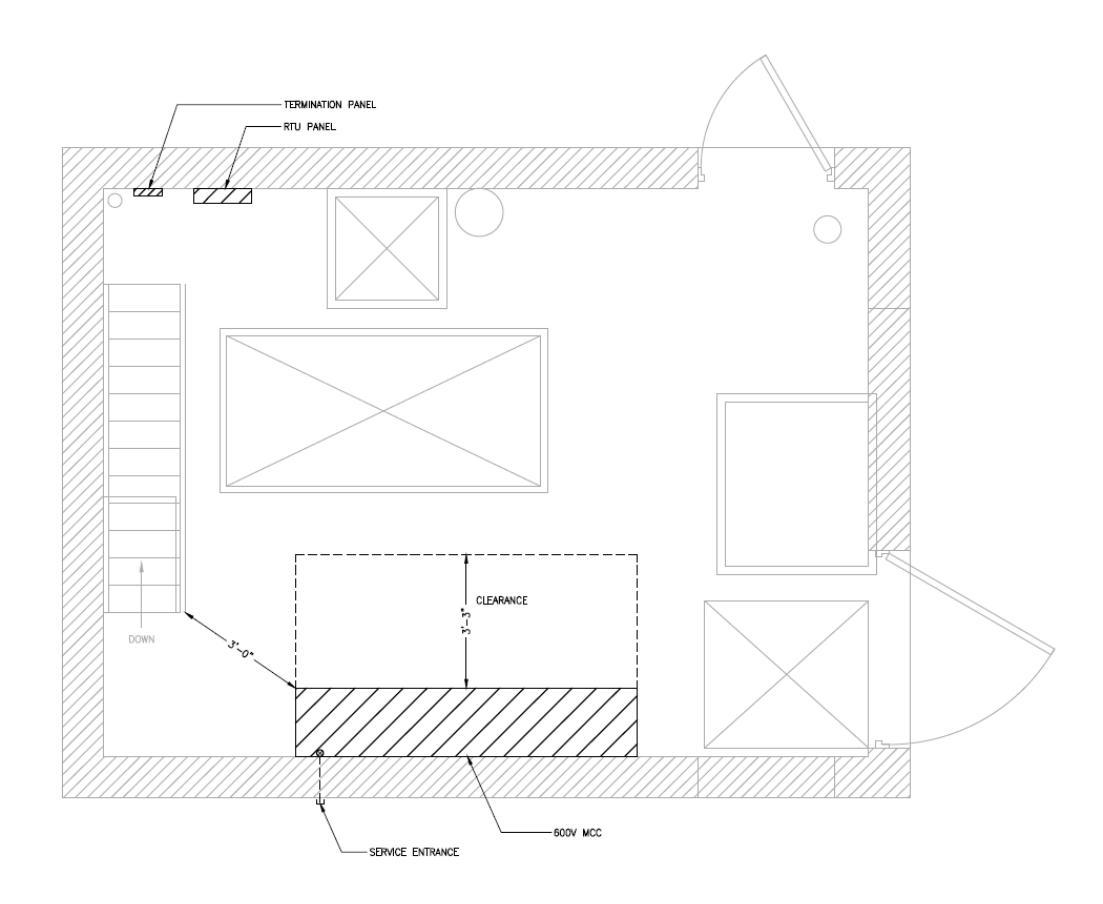
Figure 7 – Main Floor Electrical Equipment Layout

The proposed MCC would house the main breakers, soft starters for each pump, breakers for the 600V feeds, surge protection device, transformer and a 120/208V panel. The proposed MCC would have five sections. The estimated footprint of the MCC is 8'-4" in length and 20" deep. There is not sufficient space to place the MCC in the location of the current distribution, however it is recommended to place this proposed MCC along the west wall of the station. As the service is to be upgraded at the time of construction, it is recommended to relocate the service termination point to the west wall at the proposed MCC location. Refer to Figure 7 for details. To achieve this, the RTU panel and associated connections would have to be relocated; this is discussed further in section 7.1.
