APPENDIX B – MMM GROUP LTD. CONCEPTUAL GATE CHAMBER DESIGN EXISTING CONDITION ASSESSMENTS REPORT

Re: RFP No. 818-2014 - Professional Consulting Services for Developing Conceptual Concepts for Gate Chamber Designs for Storm Relief Sewer Systems

CONCEPTUAL GATE CHAMBER DESIGN EXISTING CONDITION ASSESSMENTS

Prepared for:
The City of Winnipeg

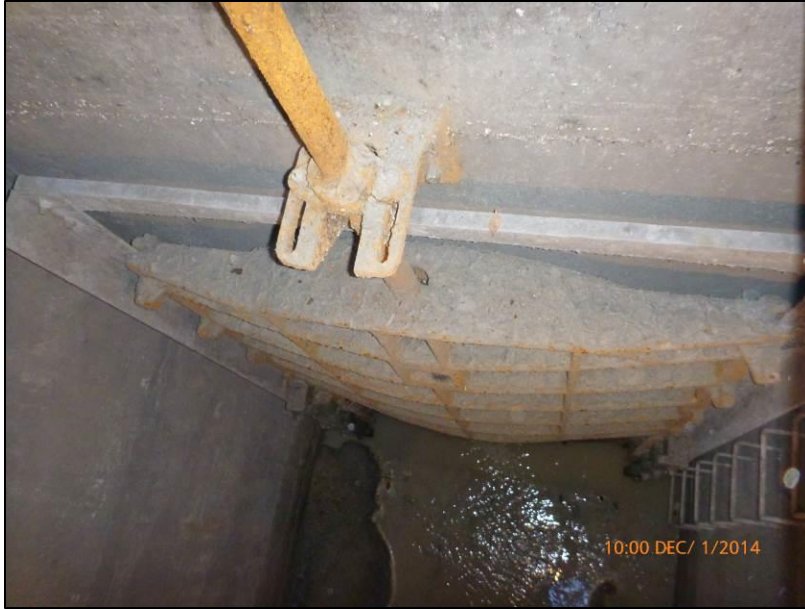
Photograph No. 9
Positive sluice gate
