## **APPENDIX C – FEBRUARY 2015 MONITORING REPORT**

File No. 0015 008 00

**RE Lyndale Drive –Ave. Taché to Gauvin St.  
2014 Riverbank Monitoring Results**

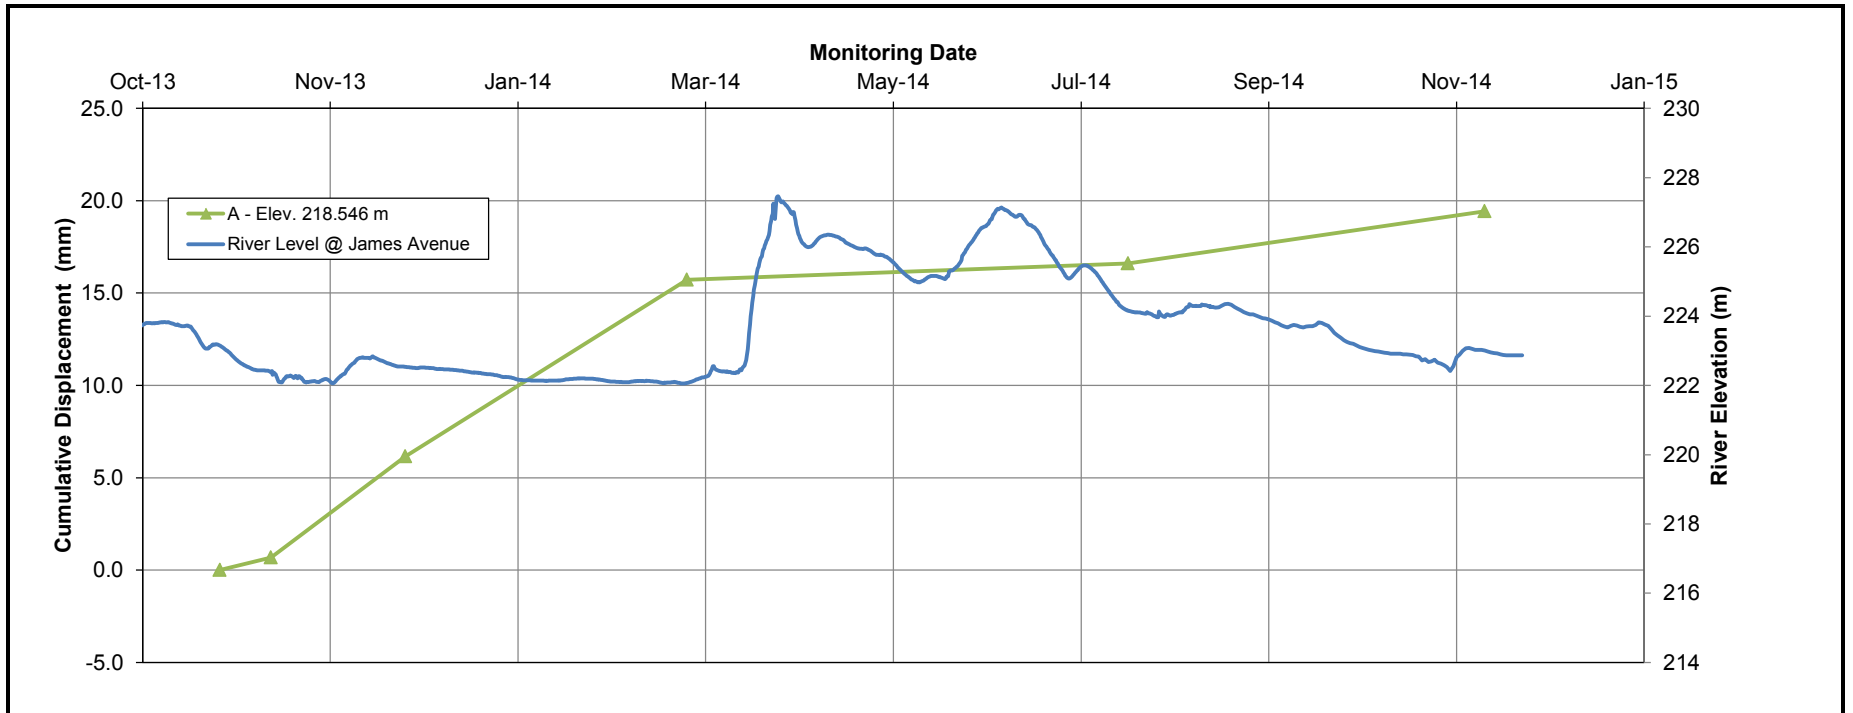
Project No. 0015 008 00  
 Project Title Lyndale Drive Retaining Wall Assessment  
 Client City of Winnipeg  
 Slope Inclinator No. SI-4

Elevation Range (m)		Axis	Cumulative Displacement (mm) vs. Monitoring Date							
218.5			25-Oct-13	11-Nov-13	24-Dec-13	24-Mar-14	12-Aug-14	4-Dec-14		
Mid	218.5	A	0.0	0.7	6.2	15.7	16.6	19.4		
		B	0.0	0.4	0.4	1.8	1.6	1.8		
		Resultant	0.0	0.8	6.2	15.8	16.7	19.5

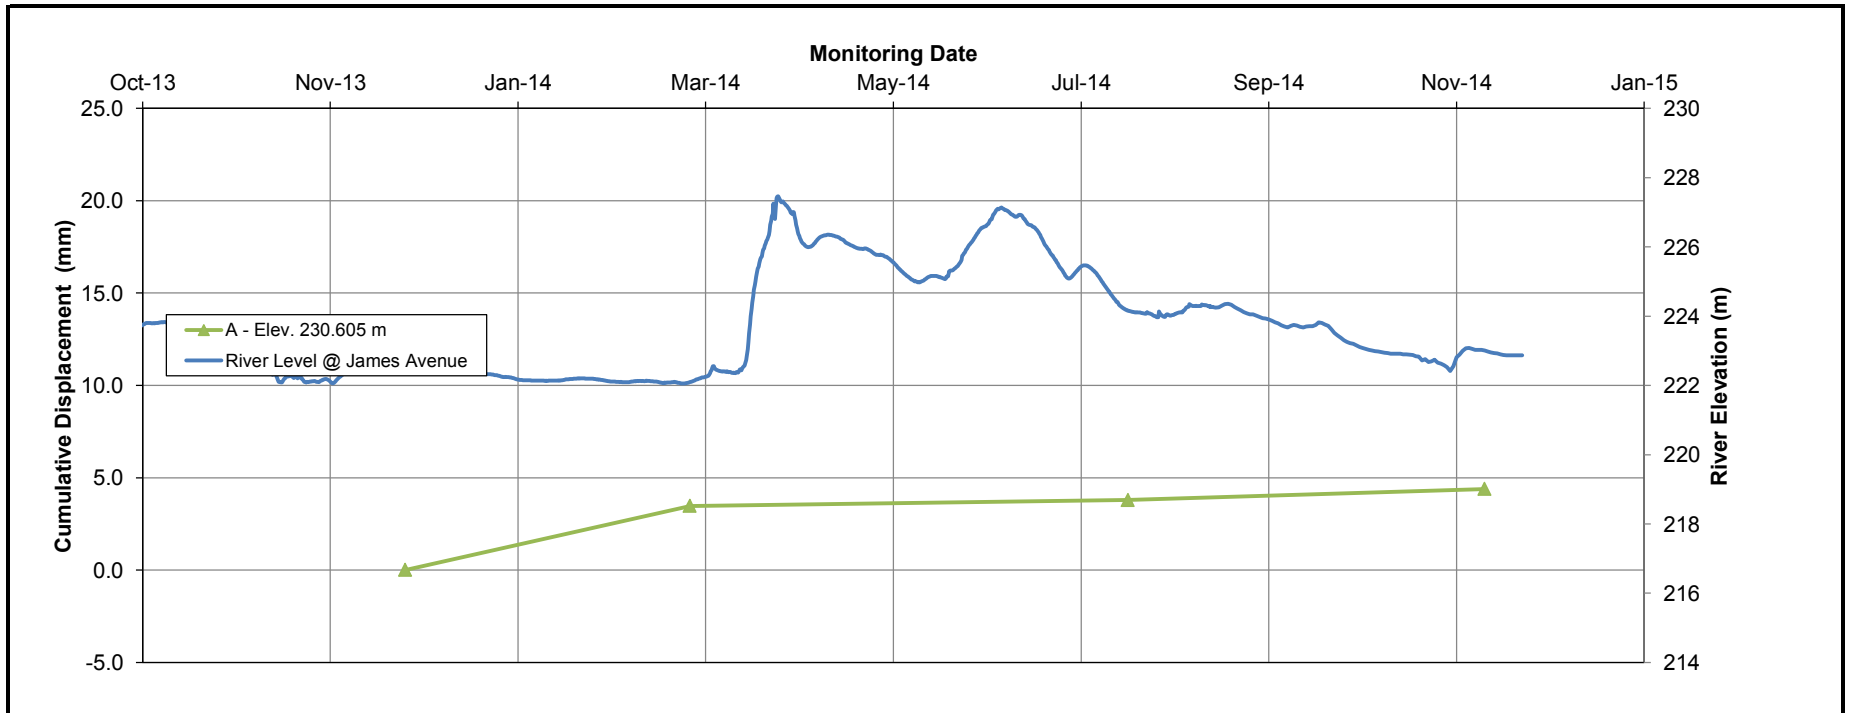
Project No. 0015 008 00  
 Project Title Lyndale Drive Retaining Wall Assessment  
 Client City of Winnipeg  
 Slope Inclinator No. SI-5

Elevation Range (m)		Axis	24-Dec-13	25-Mar-14	12-Aug-14	4-Dec-14							
Top	230.6	A	0.0	3.5	3.8	4.4							
		B	0.0	0.4	1.4	0.3							
		Resultant	0.0	3.5	4.0	4.4

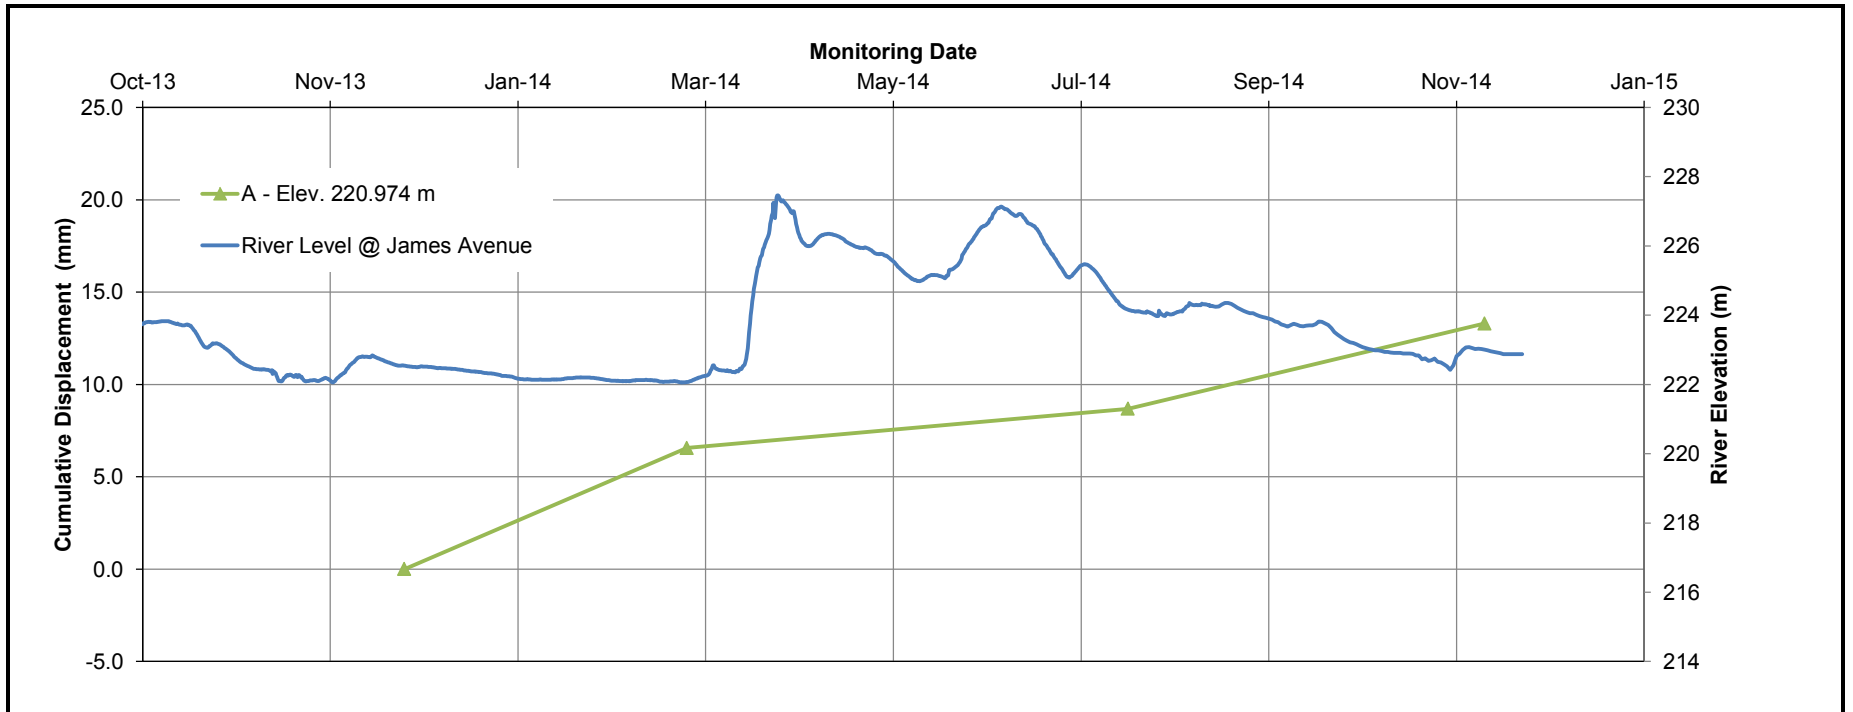
Project No. 0015 008 00  
 Project Title Lyndale Drive Retaining Wall Assessment  
 Client City of Winnipeg  
 Slope Inclinator No. SI-7

Elevation Range (m)		Cumulative Displacement (mm) vs. Monitoring Date										
221.0	Axis	23-Dec-13	24-Mar-14	12-Aug-14	4-Dec-14							
	A	0.0	6.6	8.7	13.3							
	Resultant	0.0	6.6	8.8	13.3

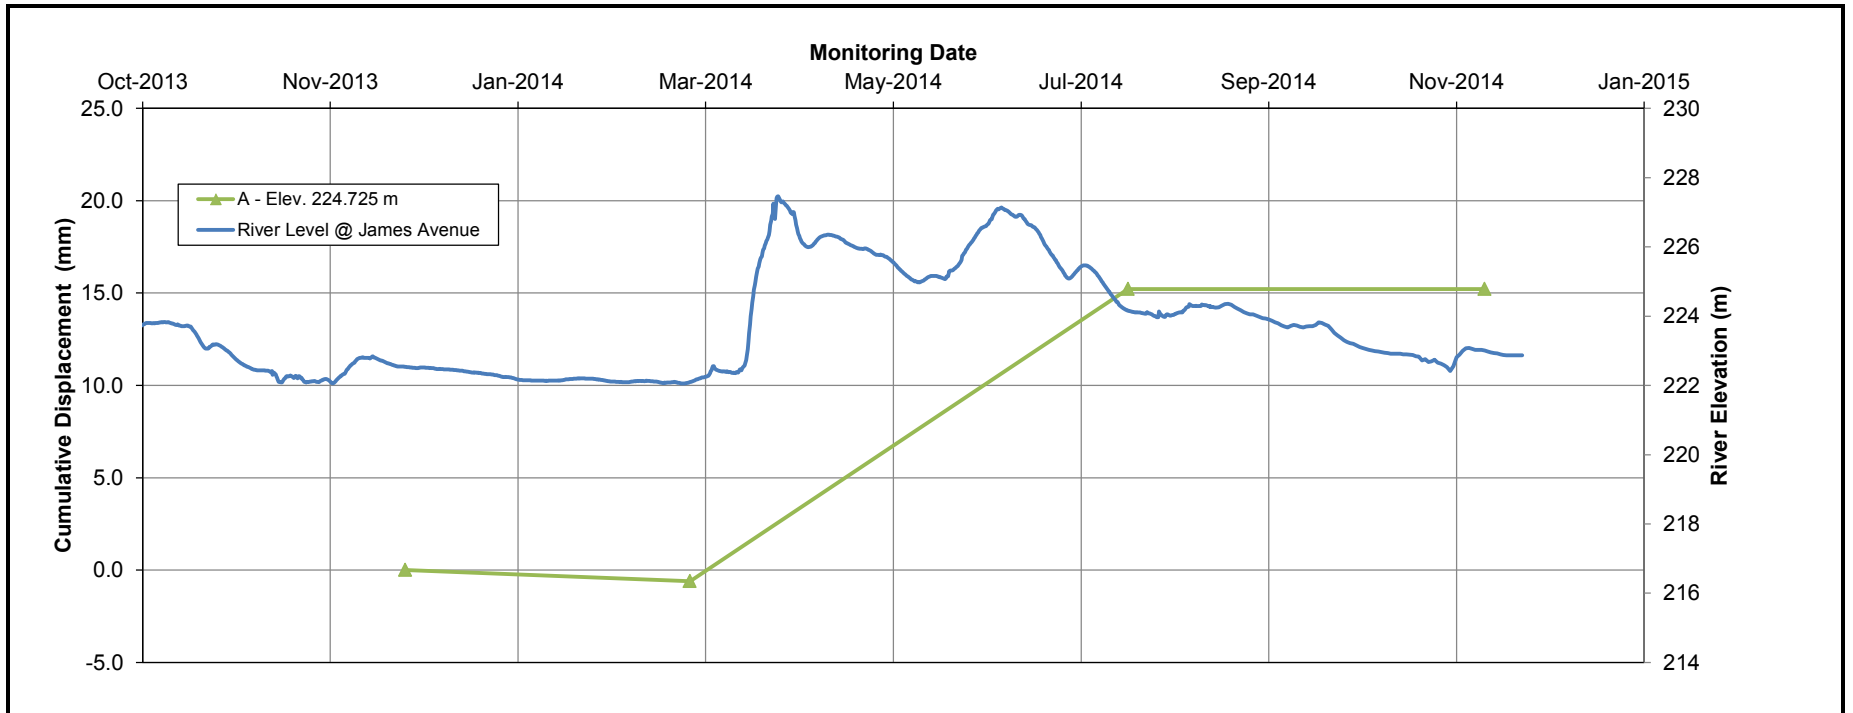
Project No. 0015 008 00  
 Project Title Lyndale Drive Retaining Wall Assessment  
 Client City of Winnipeg  
 Slope Inclinator No. SI-9

Elevation Range (m)		Axis	24-Dec-13	25-Mar-14	12-Aug-14	4-Dec-14						
Top	224.7	A	0.0	-0.6	15.2	15.2						
		B	0.0	0.4	5.5	3.6						
		Resultant	0.0	0.7	16.2	15.7
