## **AJP Engineering Services**

**Subject: *Structural Condition Assessment of Primary Clarifier Travelling Bridge Collector No. 3 at the South End Sewage Treatment Plant, Revision 0***

## INSPECTION REPORT

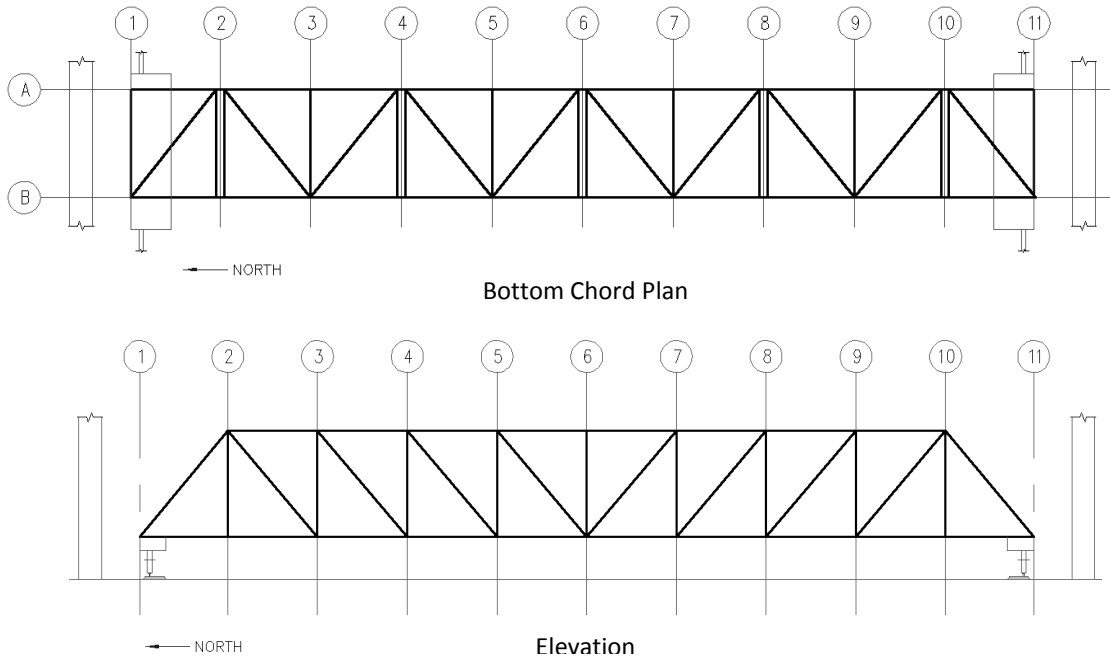
Figure 1: Bridge Collector Plan & Elevation

The grid system shown in Figure 1 was created to cross-reference between the AJP report and CQI weld inspection report. Several photos are labelled with this grid system as well.

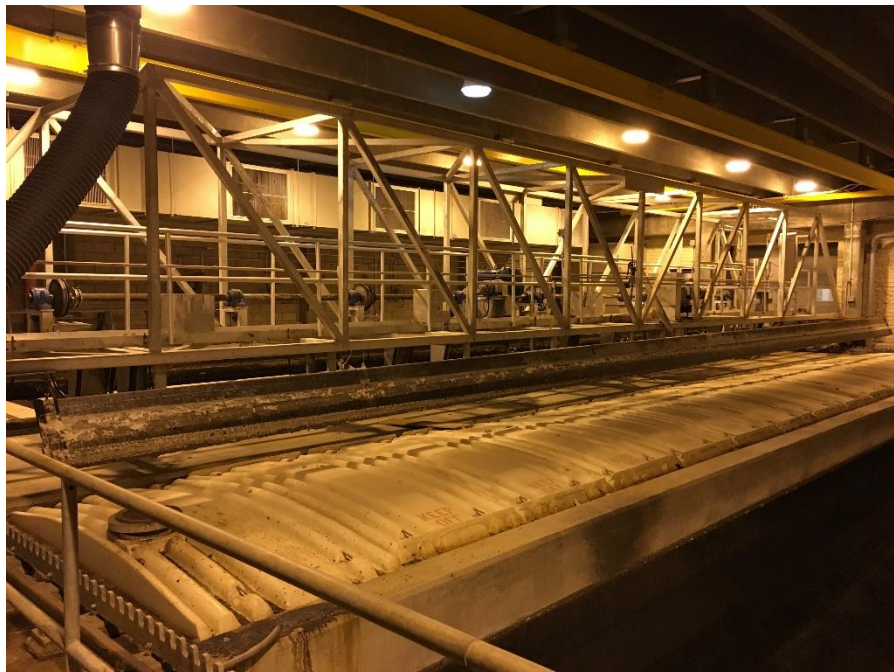
*Overall view of Clarifier Bridge No.3*

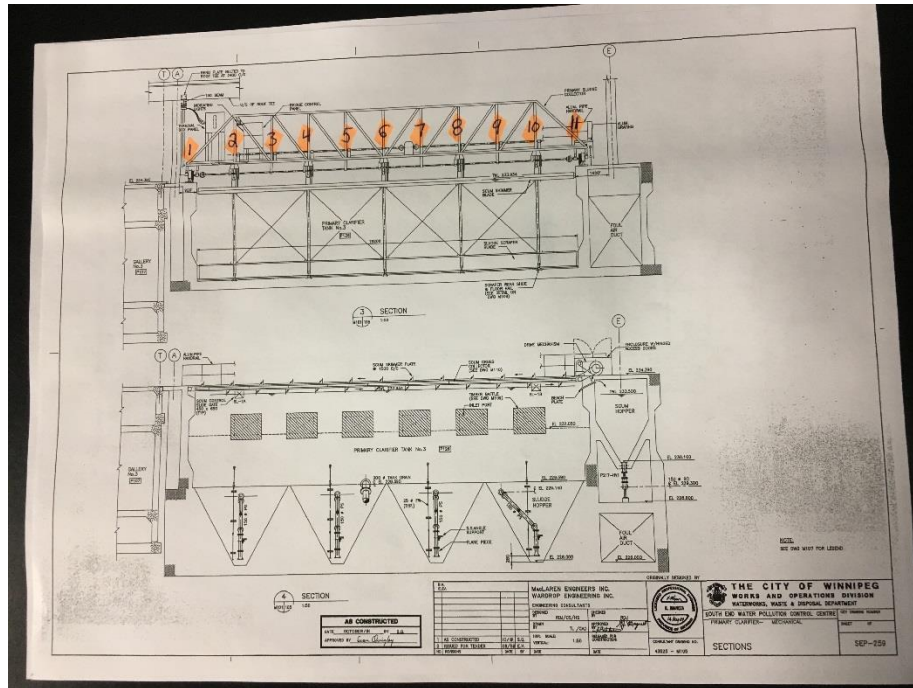
Annotated Drawing with Inspection Locations  
 With location 1 to 11 from north to south

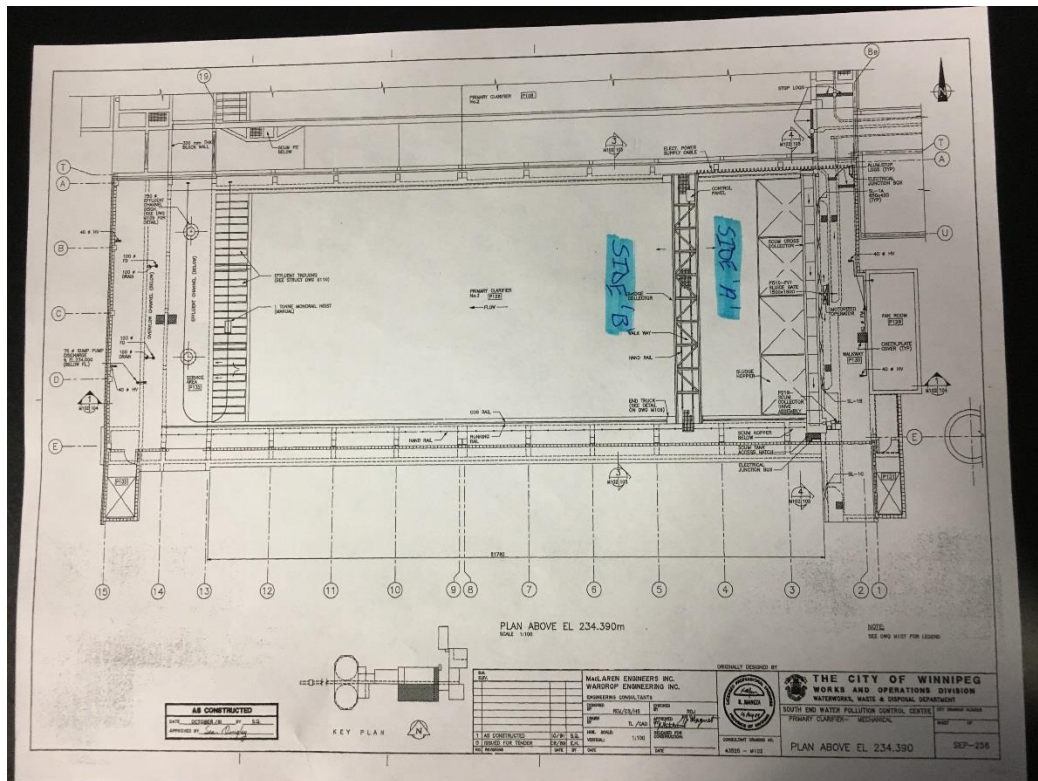
Annotated drawing showing side "A" as east side and Side "B" as west side

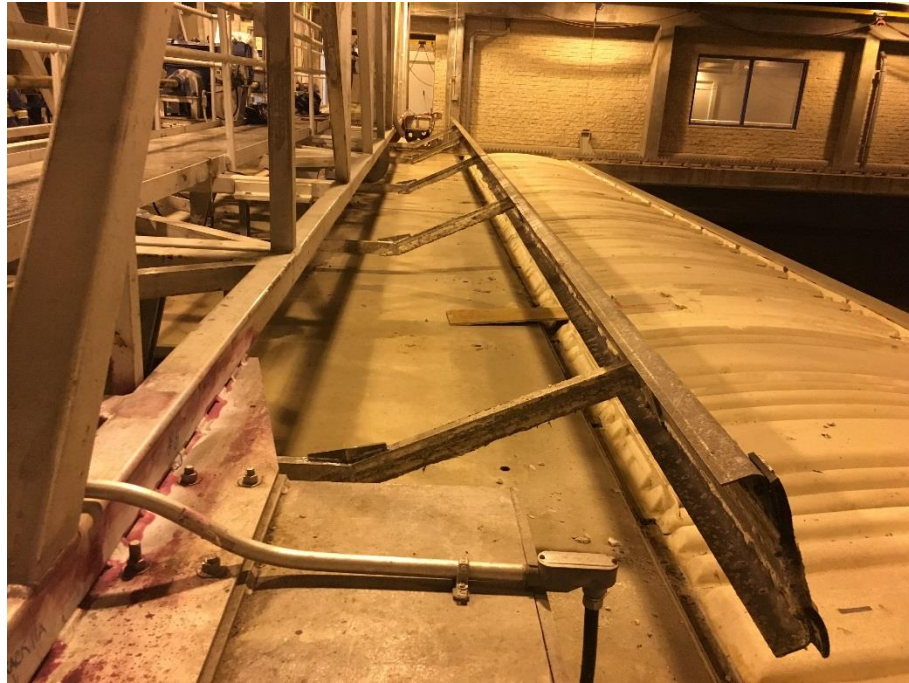
The front and rear skimmer arms have undergone extensive corrosion, affecting the main members and the welds at the elbow joint and the connection to the skimmer blade (Figure 2).

**Photo of east side Skimmer Arm and Scum Paddle**

Due to the extensive corrosion, both front and rear skimmer arms should be replaced. This is not an immediate concern, but should be addressed within the next 3-5 years.

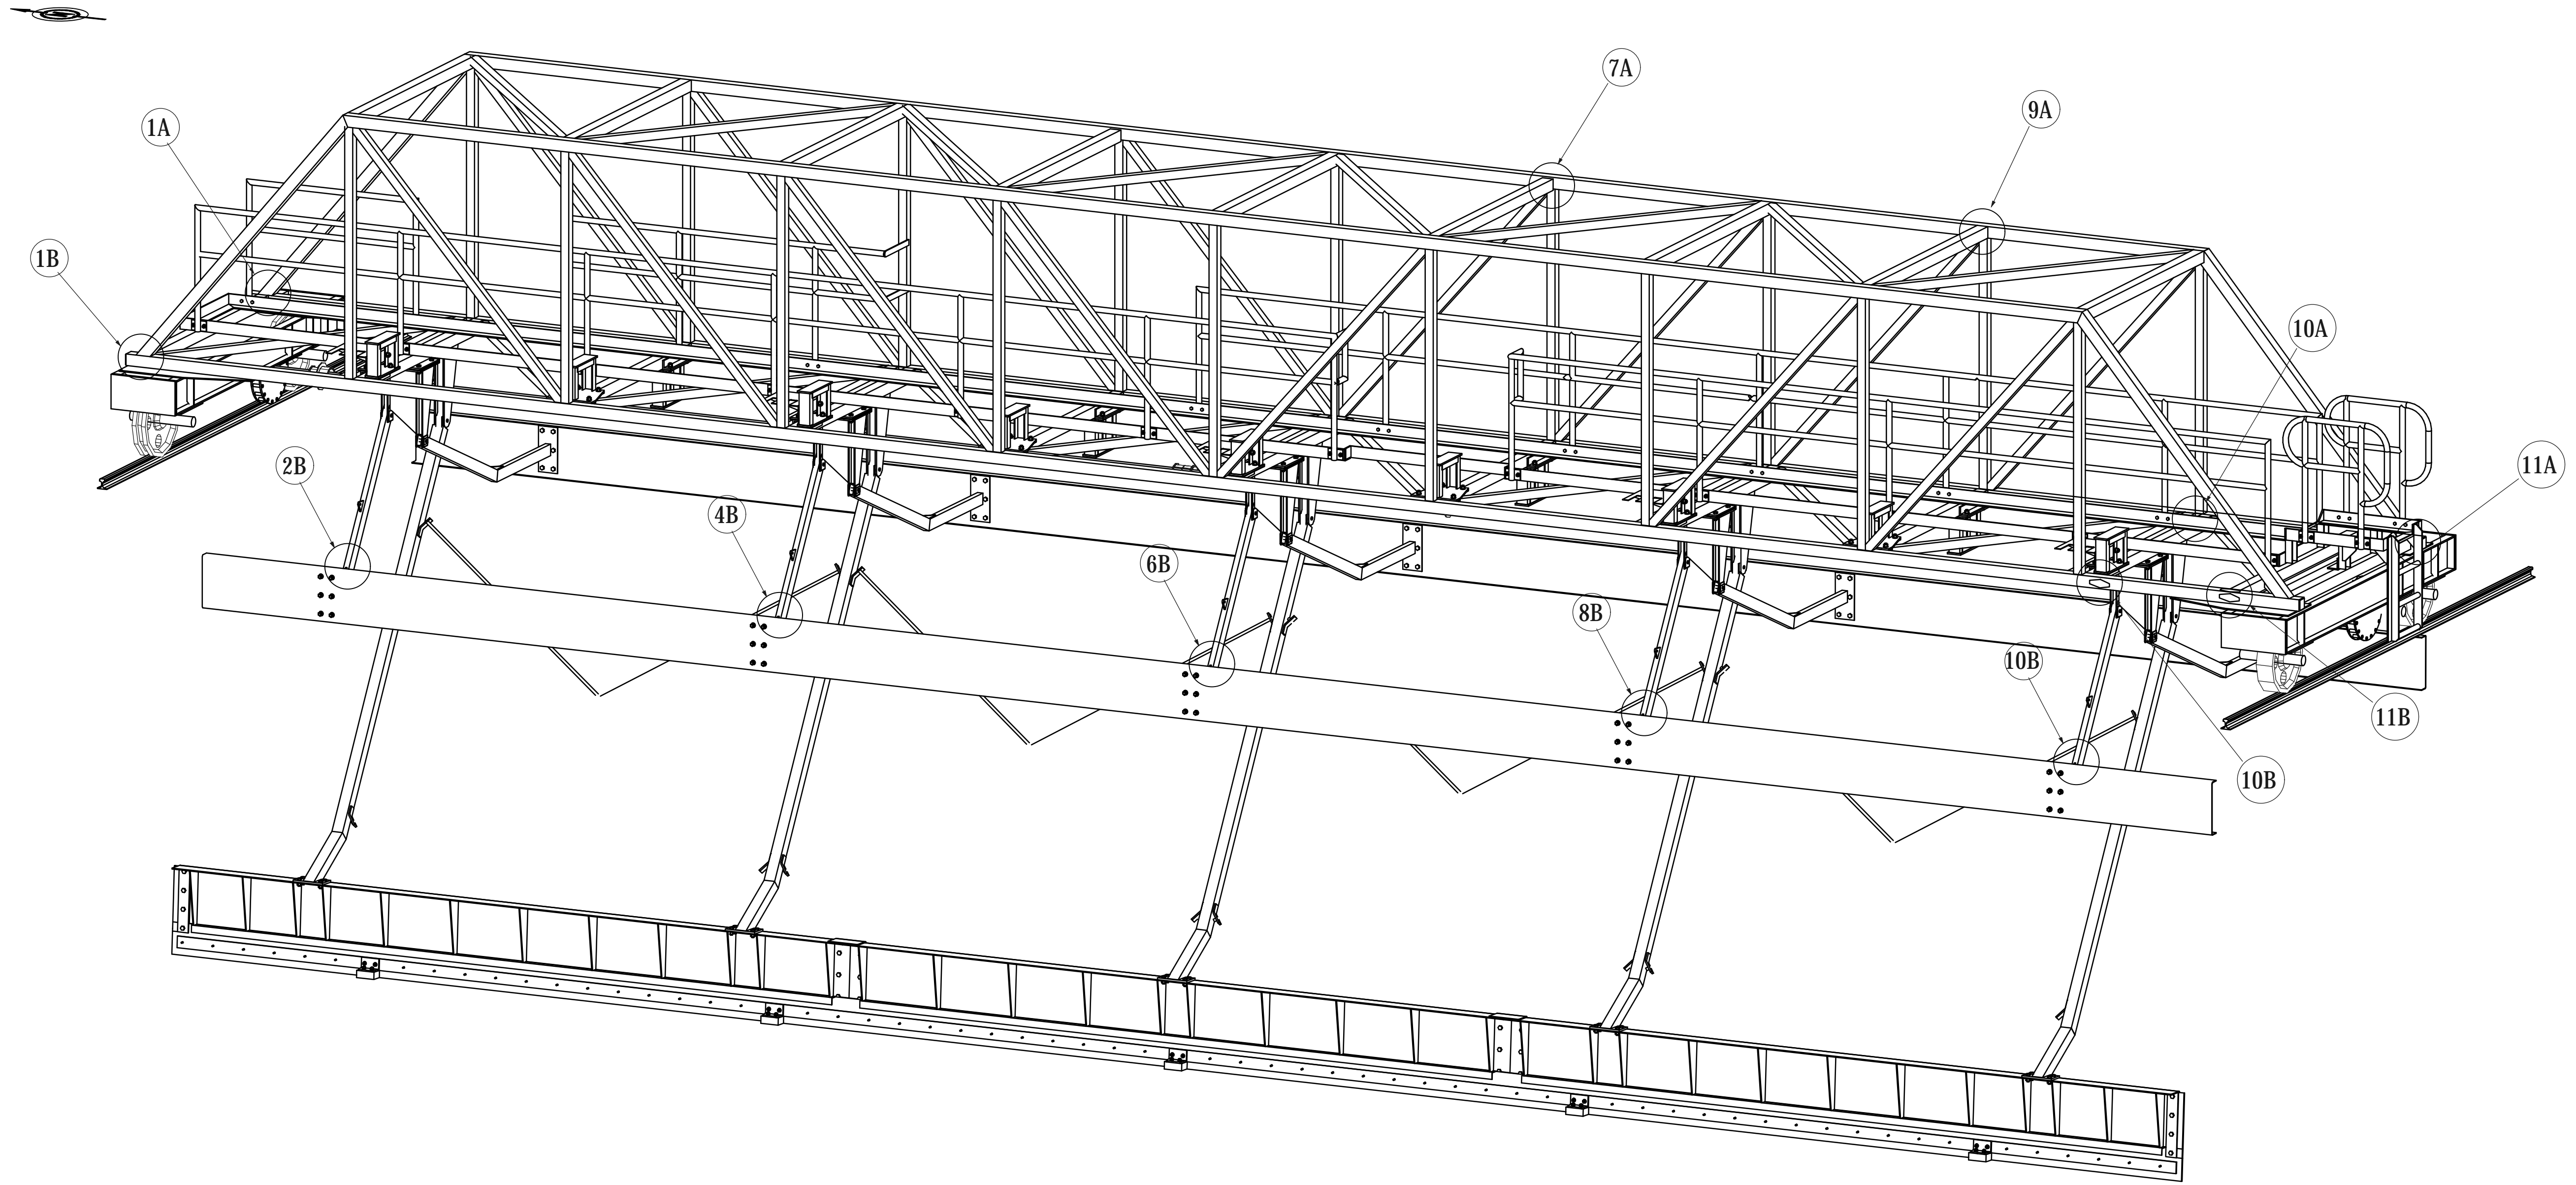
**PERSPECTIVE VIEW**

1. Location 1B – Cracked weld on both sides of lower horizontal tube.
2. Location 1B – Cracked weld on end truck bearing mount weld.
3. Location 1B – Lack of fusion on reinforcement plate weld.
4. Location 1A – Cracked weld on lower horizontal weld.
5. Location 2B, 4B, 6B, 8B, 10B – Aluminum skimmer arm weld and material is corroded and pitted.
6. Location 7A – Porosity on upper horizontal tube weld
7. Location 9A – Missing weld on upper horizontal tube
8. Location 10A – Cracked welds on lower diagonal and horizontal tube.
9. Location 10B – Fish plate weld quality is unacceptable
10. Location 11B -- Crack in parent material perpetrating from fish plate.
11. Location 11B – Lack of fusion on fish plate weld.
12. Location 11B – Cracked weld on lower horizontal tube.
13. Location 11A – Cracked weld on lower horizontal tube.

LEGENDS:	
1.	LOCATION 1B - CRACKED WELD ON BOTH SIDES OF LOWER HORIZONTAL TUBE.
2.	LOCATION 1B - CRACKED WELD ON END TRUCK BEARING MOUNT WELD.
3.	LOCATION 1B - LACK OF FUSION ON REINFORCEMENT PLATE WELD.
4.	LOCATION 1A - CRACKED WELD ON LOWER HORIZONTAL WELD.
5.	LOCATION 2B, 4B, 6B, 8B, 10B - ALUMINUM SKIMMER ARM WELD AND MATERIAL IS CORRODED AND PITTED.
6.	LOCATION 7A - POROSITY ON UPPER HORIZONTAL TUBE WELD.
7.	LOCATION 9A - MISSING WELD ON UPPER HORIZONTAL TUBE.
8.	LOCATION 10A - CRACKED WELDS ON LOWER DIAGONAL AND HORIZONTAL TUBE.
9.	LOCATION 10B - FISH PLATE WELD QUALITY IS UNACCEPTABLE.
10.	LOCATION 11B - CRACK IN PARENT MATERIAL PERPETRATING FROM FISH PLATE.
11.	LOCATION 11B - LACK OF FUSION ON FISH PLATE WELD.
12.	LOCATION 11B - CRACKED WELD ON LOWER HORIZONTAL TUBE.
13.	LOCATION 11A - CRACKED WELD ON LOWER HORIZONTAL TUBE.

All issues identified in the CQI report should be addressed. Welds should be repaired by a CWB certified welder with appropriate credentials for aluminum welding. The missing weld on grid 9A on the upper tube should be added.
