GEOTECHNICAL REPORT

Regional Streets Renewal Projects – 2018 Program Geotechnical Report

0022-061-00

November 2, 2017

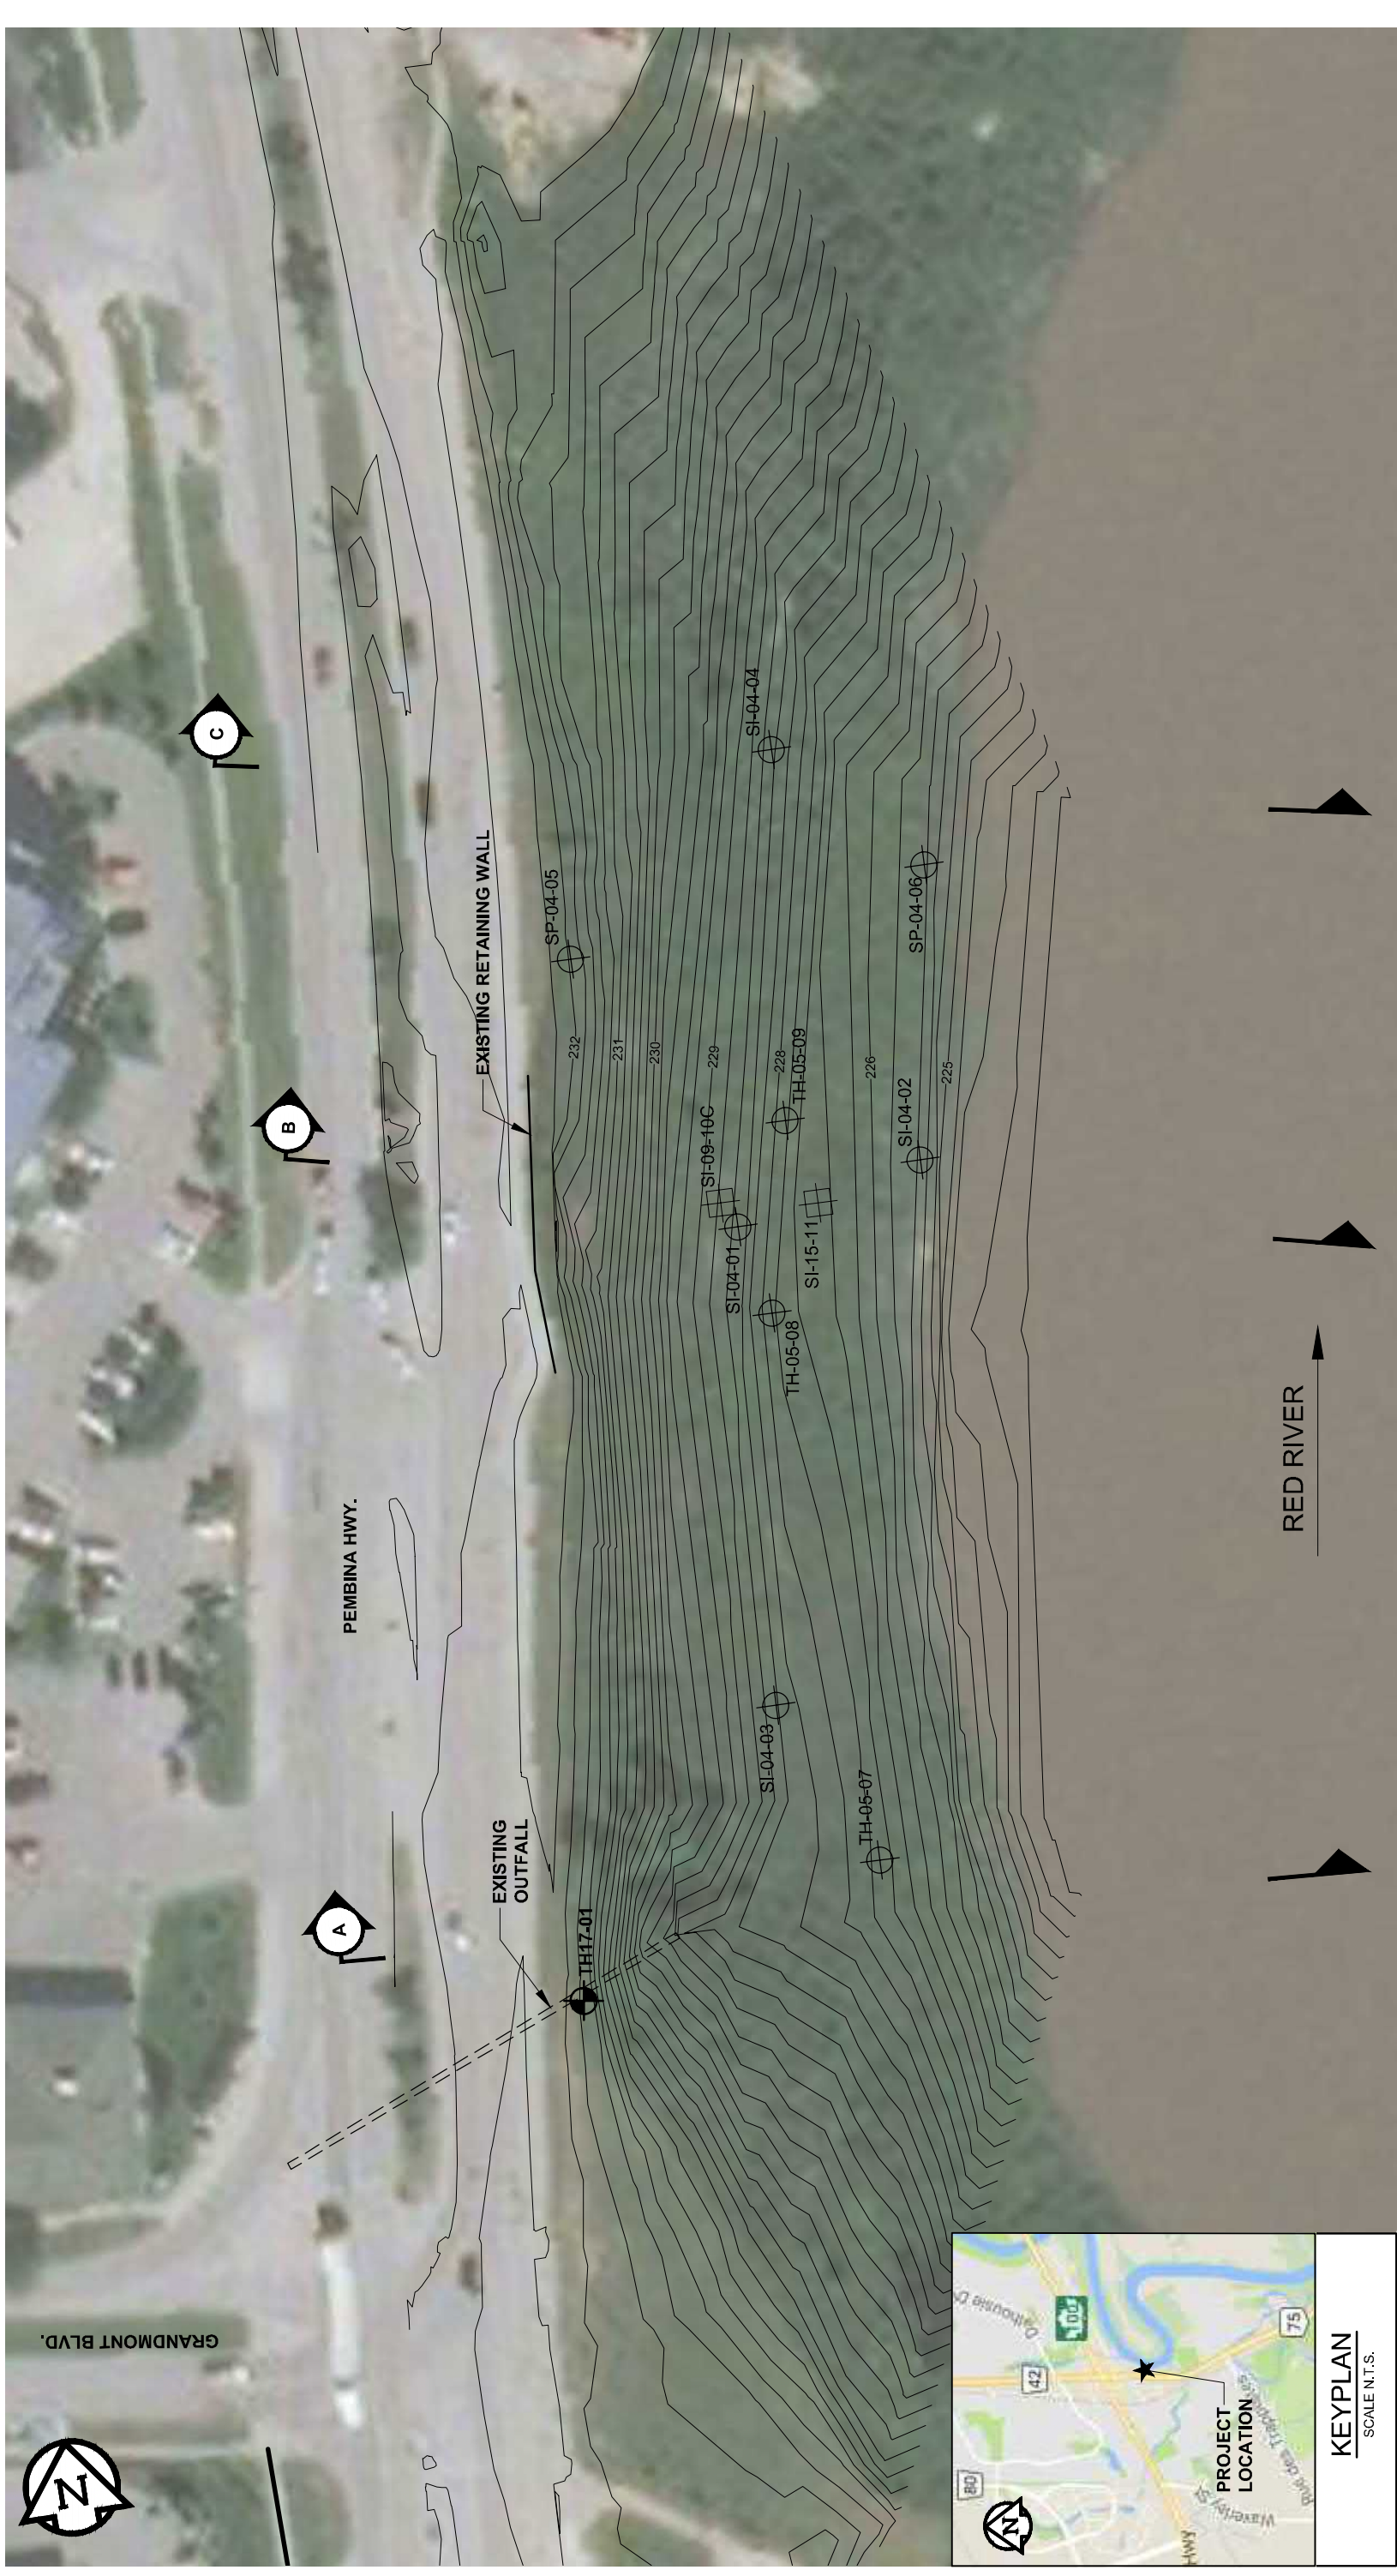
Cross sections (A, B, and C) through representative areas of the bank were surveyed by Dillon for use in our stability analyses. The locations of the cross-sections are shown in plan view on the attached Site Plan and the cross-sections are shown on the slope stability outputs. Cross-section A was developed to assess the steep slope at the outfall pipe, Cross-section B was developed to assess the critical area of the pre-existing failure zone at the retaining wall, and Cross-section C represents the general grade of the north area of the site.
