Sodium Hypochlorite Tank, TK-J520A Inspection

Inspection Date: **November 22, 2017**

Prepared by: **Structural Composite Technologies Ltd.**

Inspector: **Bon Bacani, CCT-C, C.Tech.**

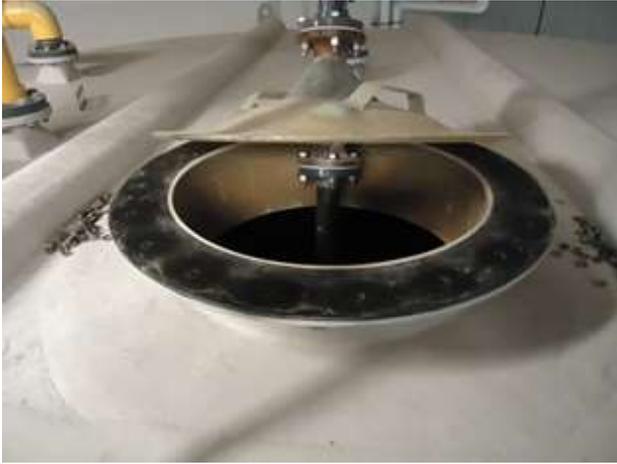
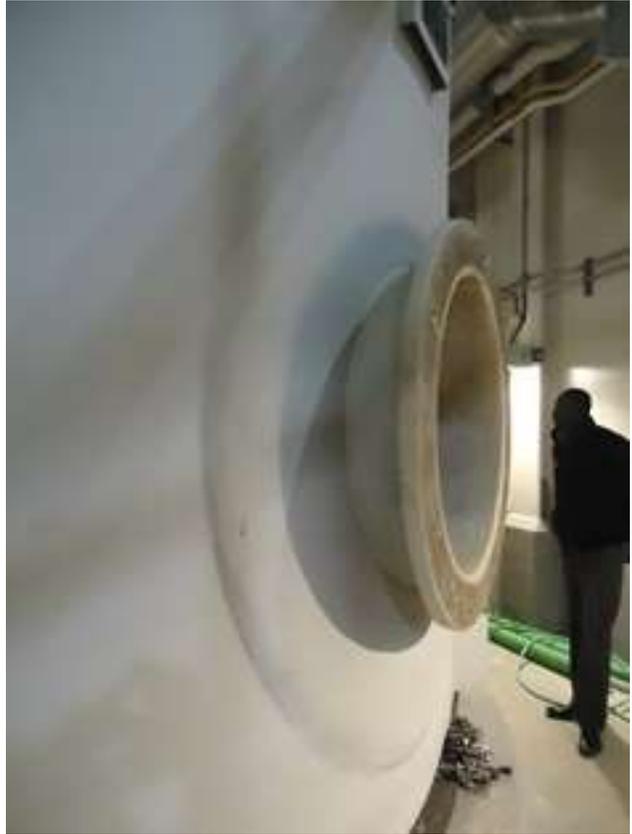
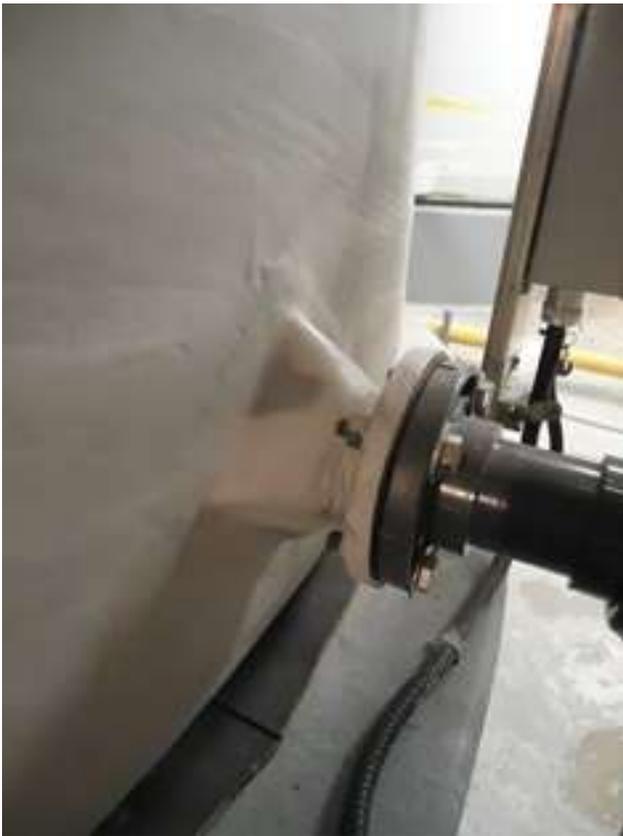
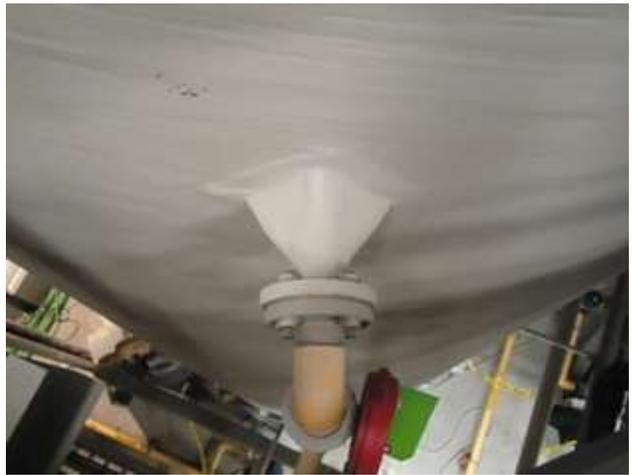
Photo Set 4: Tank Appurtenances – Flanged Nozzles (outside view)

1. There was no sign of leaking nor cracks from the tank;
2. Flanges don't have any sign of cracks nor leaks;
3. No significant corrosion observed on the flange fasteners, lugs and other metal parts on the tank.

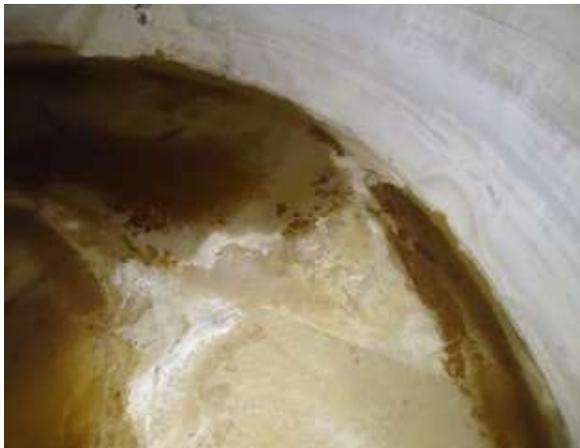
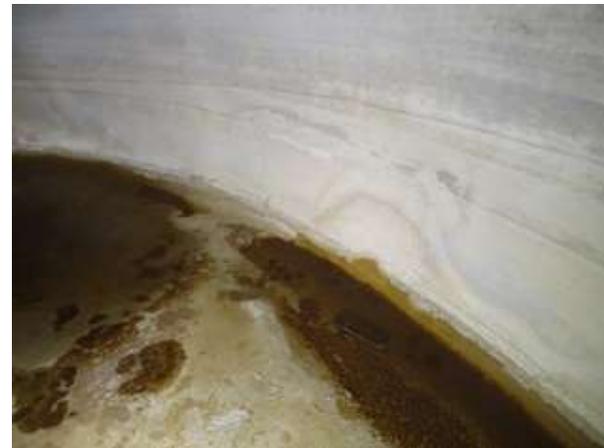
Photo Set 9: Close up view of the dryness and roughness of the compromised tank liner

1. **Tank wall and floor (inside)** - Sandblast to remove compromised liner;
2. **Nozzles and Appurtenances (inside)** - Repair or replace nozzles on bottom half of tank; manway needs to be relined as well;

4. **Tank wall and floor (inside)** - Reline the whole tank inside wall and floor after sandblasting, recommended laminate construction is 2 plies of 1.5 oz mat and 2 plies of Nexus synthetic veil using Vipel K022-ACA vinyl ester resin which is suitable for the 12% Sodium Hypochlorite service;
