## **APPENDIX B – MMM GROUP LTD. CONCEPTUAL GATE CHAMBER DESIGN EXISTING CONDITION ASSESSMENTS REPORT**

**Re: RFP No. 818-2014 - Professional Consulting Services for Developing Conceptual Concepts for Gate Chamber Designs for Storm Relief Sewer Systems**

# CONCEPTUAL GATE CHAMBER DESIGN EXISTING CONDITION ASSESSMENTS

Prepared for:  
**The City of Winnipeg**

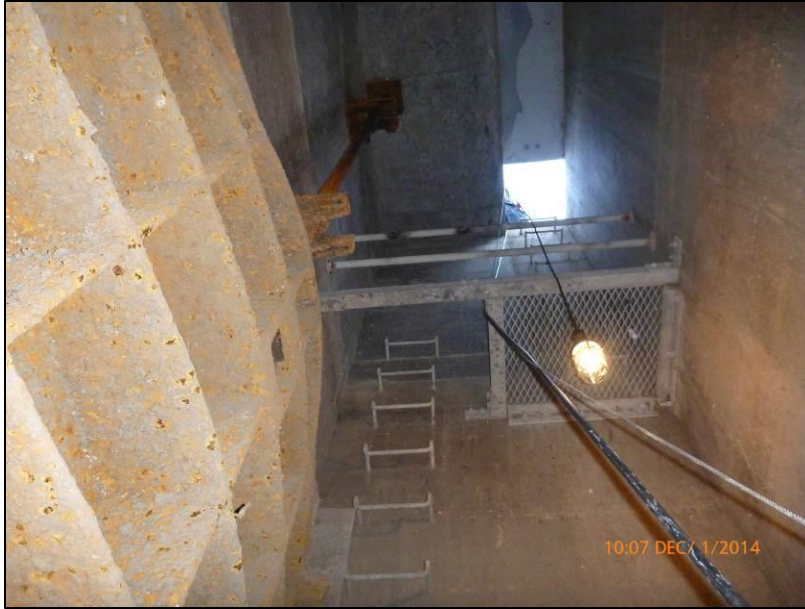
**Photograph No. 7**  
Ladder and intermediate landing

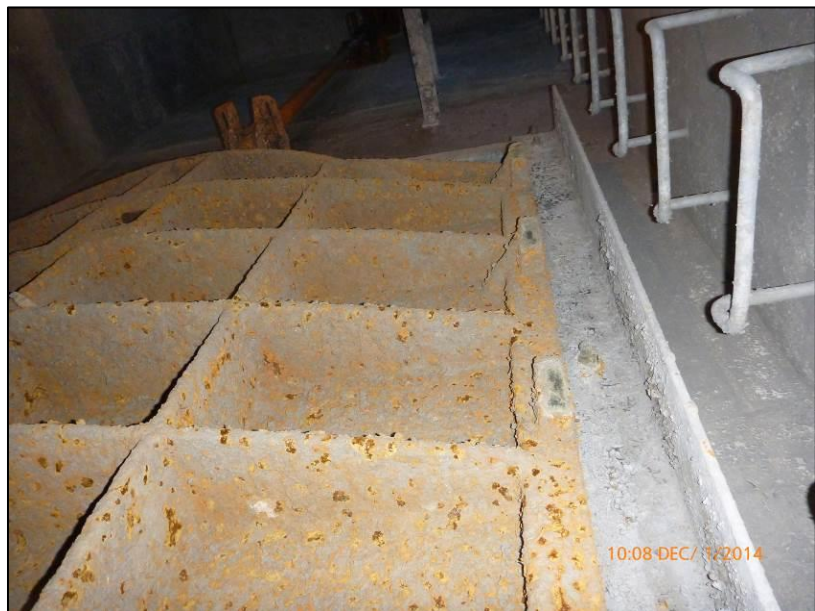
**Photograph No. 8**  
Existing sluice and gate guide
