CONCEPTUAL GATE CHAMBER DESIGN EXISTING CONDITION ASSESSMENTS

Prepared for:
The City of Winnipeg

Submitted by:
MMM Group Limited

March 2015

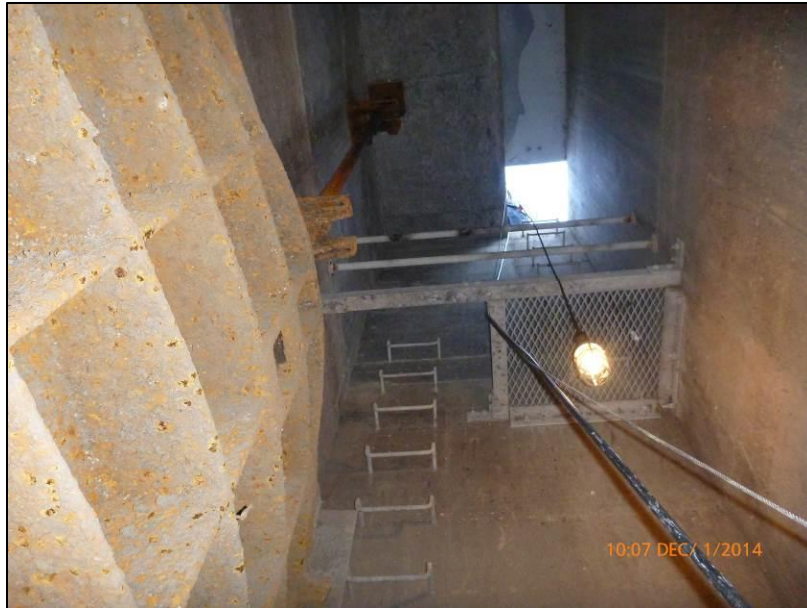
Photograph No. 7
Ladder and intermediate landing

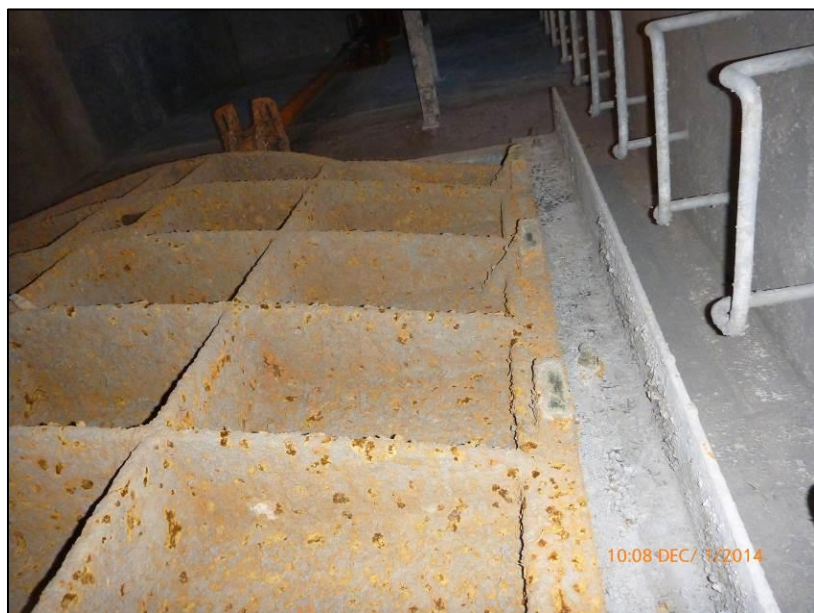
Photograph No. 8
Existing sluice and gate guide
