Bonivital Pool; 1215 Archibald Street Building Condition Assessment

Submitted to: City of Winnipeg
Planning, Property, and Development Department
Accommodation Services

Date: April 4, 2019

Submitted by: Crosier Kilgour & Partners Ltd.
300-275 Carlton Street
Winnipeg, Manitoba R3C 5R6
Phone: 204.943.7501 Fax: 204.943.7507
Website: www.ckpeng.com

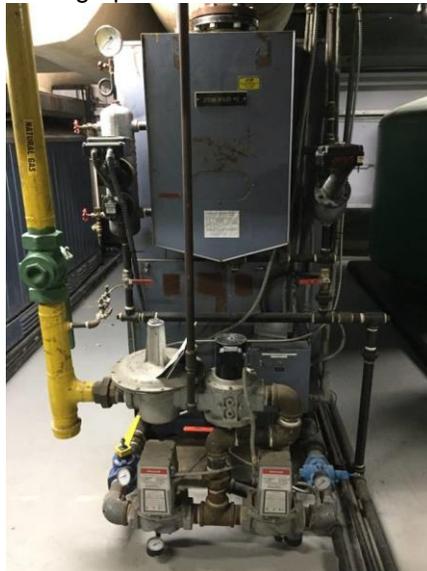
Photograph 2.5.1-1: One of two low pressure steam boilers

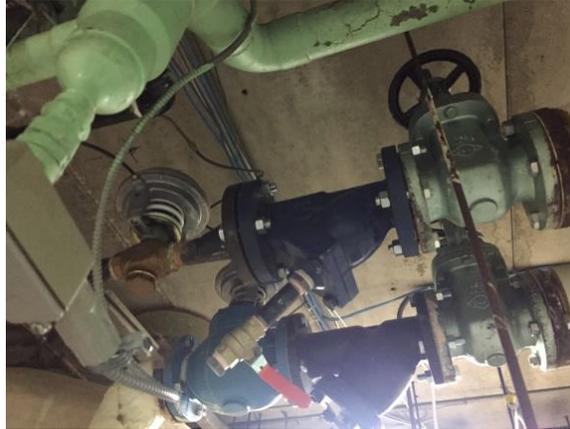
Photograph 2.5.1-2: Control valves serving steam-water and steam-glycol heat exchangers

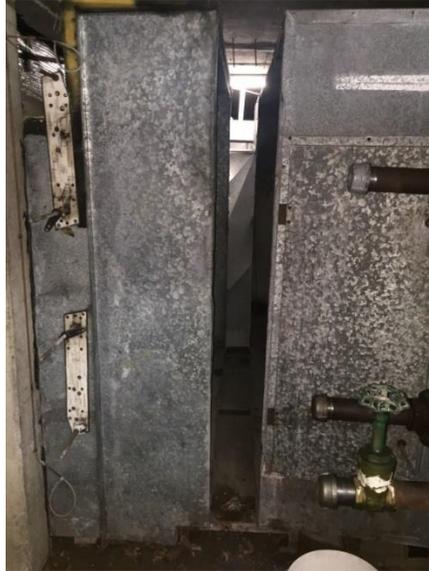
AHU-1 (Photograph 2.5.3.1-1) is responsible for zone control of the pool deck area. The heating coil of AHU-1 is a glycol coil (undergoing replacement at time of site review)

Photograph 2.5.3.1-1: AHU-1 serving pool deck; glycol loop down for repairs

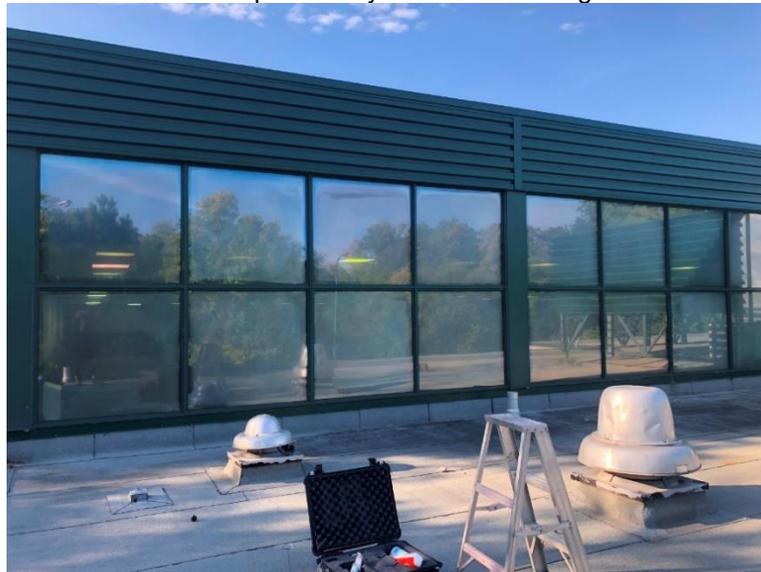
- .1 The clerestory windows on the north elevation are aluminum framed interior glazed ribbon windows consisting of triple pane argon filled sealed units with PVC spacers. Glass thickness could not be determined. Individual ribbon units consist of four glazing panels separated by a horizontal rail and vertical mullion. Individual ribbon units are installed in banks of two, vertically butt jointed together at the center and separated by structural framing on either end of the bank, for a total of eight glazing panels per bank. All windows are fixed and have no operable components. The sealed glazing units are dated 1997, 22 years old, and as such are nearing their expected service life of 25 years.

Photograph 3.3.2.1-1: Partial view of east end of north elevation showing first two banks of ribbon windows separated by structural framing.

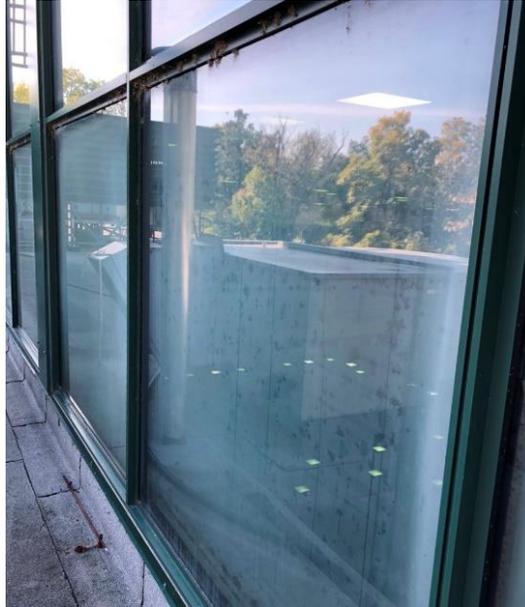
Photograph 3.3.2.1-2: Partial view of bank of ribbon window, showing center butt joint between individual ribbon units, and end structural framing separating banks.

All sealed units exhibited evidence of seal failure including fogging, condensation, streaking, and accumulation of desiccant residue on interior surfaces of lites. Four of the 62 sealed clerestory units underwent frost point testing, which confirmed failed seals in all instances.

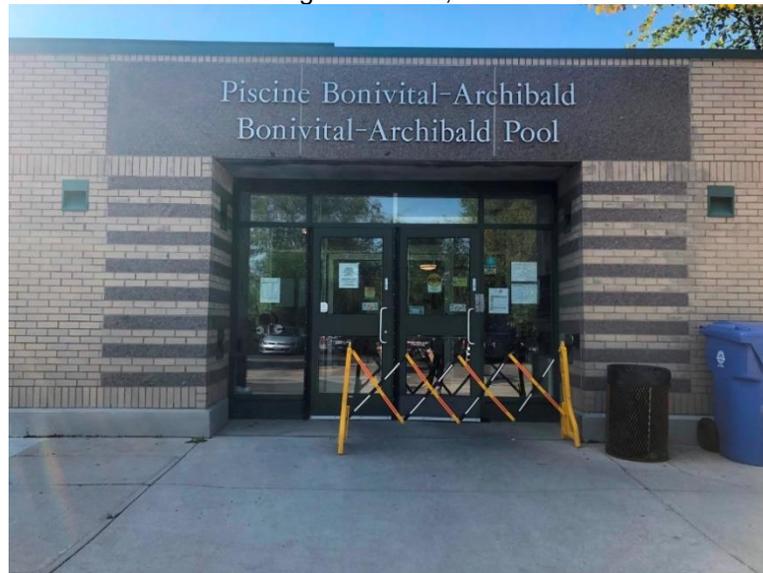
Photograph 3.3.2.2-1: North elevation entrance consisting of two aluminum doors, two curtain wall framed sidelight windows, and three curtain wall framed transom windows.

Though the sealed units did not exhibit visible evidence of seal failure, frost point testing of one of the five window units revealed seal failure.

No visible cracks were observed in any of the sealed units. Being situated below the entrance canopy and somewhat protected from the elements, the exterior gaskets of these units were intact.

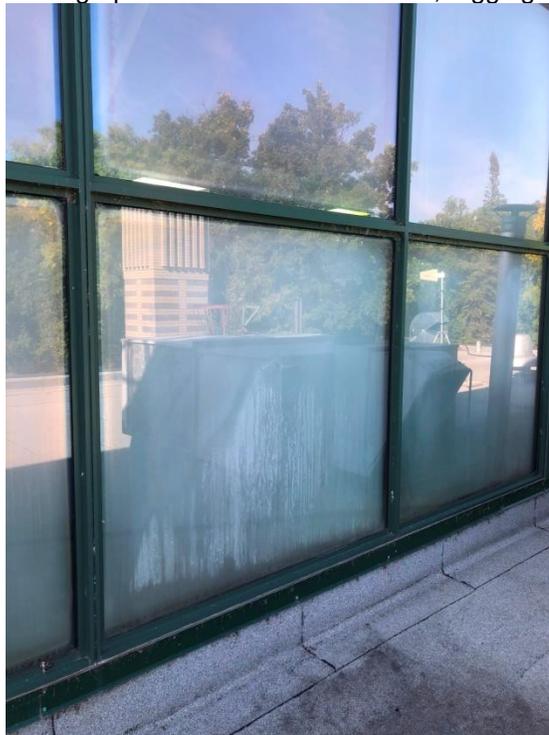
- .2 The high level windows on the north side of the pool area exhibited signs of seal failure with significant condensation, fogging, and streaking (Photographs 3.4.1.2-1 and -2).

Photograph 3.4.1.2-2: Condensation, fogging of pool north side windows

Recommendation 3.4.1.2-1: Condensation in a high humidity pool environment is difficult to manage during the winter months due to the extreme temperature differential between indoors and ambient. Recommissioning, servicing and/or replacing the steam finned tube along the high level glazing on the north side of the pool area can help eliminate or minimize the condensation (Photograph 3.4.1.2-1).

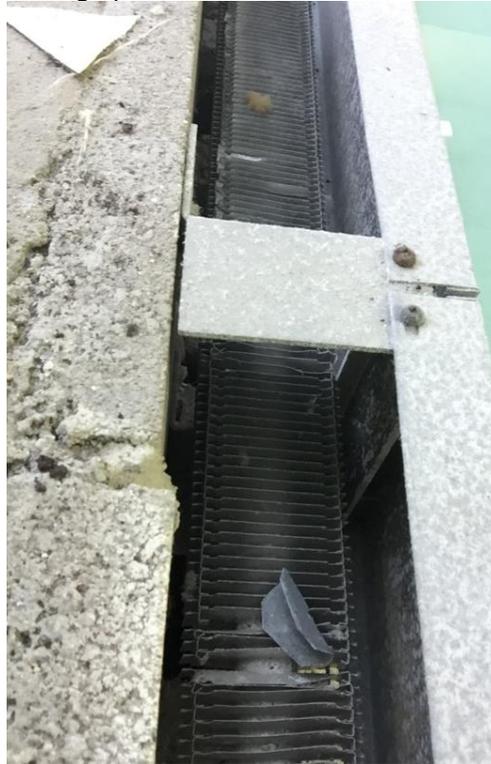
Photograph 3.4.1.2-2 Fin tube radiators serving pool north side walls

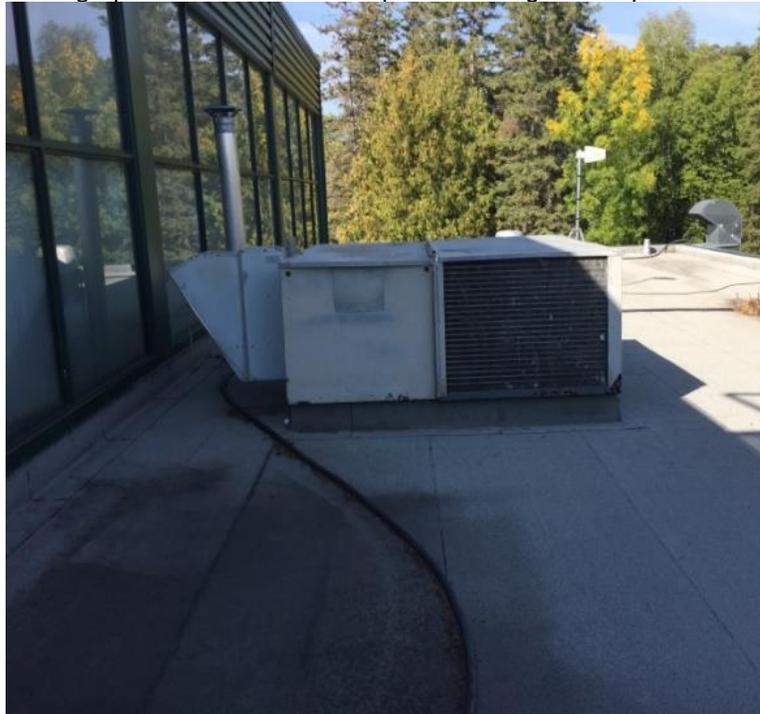
- .5 The roof top D/X units serving the office and observation areas are only ventilating the spaces during the summer months, and therefore, the air being supplied in the winter months is not providing any ventilation to the spaces which does not meet current ventilation code requirements. The units are also nearing the end of their useable service life.

Photograph 3.4.1.5-1:D/X rooftop unit serving office space- east side

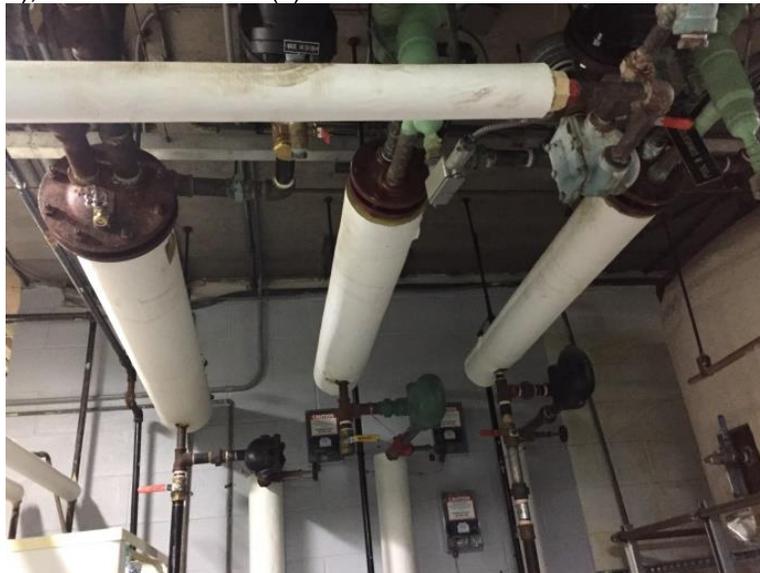
- .6 The shell and tube heat exchangers serving the pool water systems and administration unit/combustion air units are original and nearing the end of their useable service life.

Photograph 3.4.1.6-1: Shell-and-tube heat exchangers serving pool water systems (1 & 2), AHU-2 and AHU-3 (3)

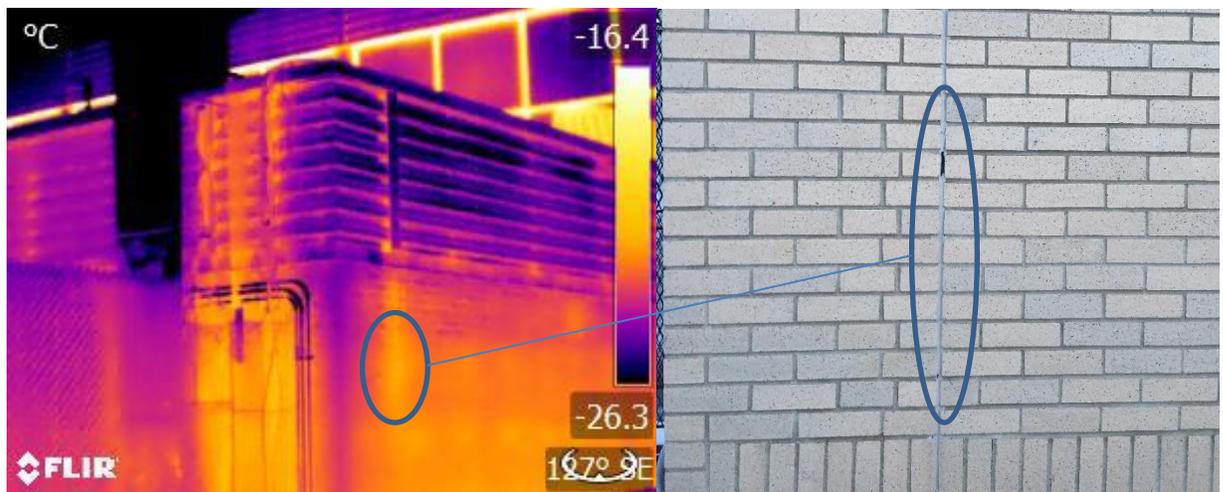
Figure 2: Air leakage at masonry control joint at West elevation (refer to Photograph #17). Air leakage at masonry control joints is a result of discontinuous and debonded sealant at the joints. The sealant at many of the control joints is debonded or discontinuous. Warm, moist air from within the pool building leaking through the control joints will cause condensation when in contact with cold outdoor air or colder building materials. The condensation created can cause deterioration of the masonry over the long term.

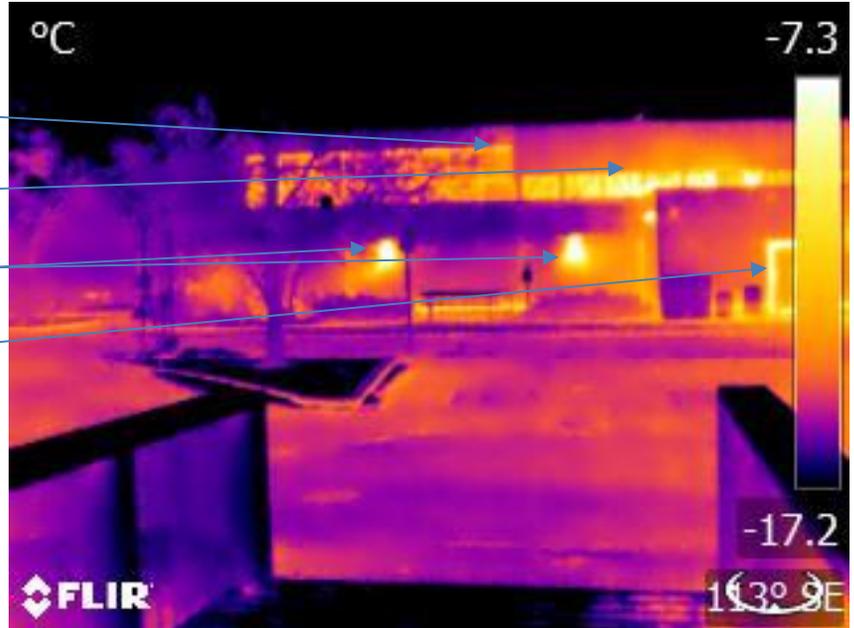
Photograph #1:

- Thermal bridge at window frames.
- Thermal anomaly caused by discharge of roof-top air handling unit.
- Thermal anomaly caused by air discharge at exhaust vents.
- Air leakage around door.

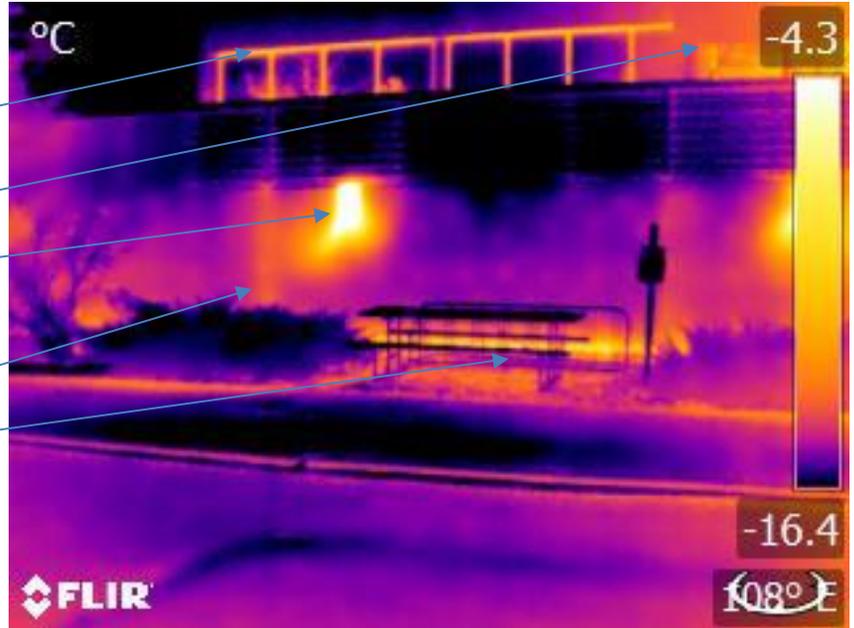
Photograph #3:

- Thermal bridge at window frames.
- Thermal anomaly caused by discharge of roof-top air handling unit.
- Thermal anomaly caused by air discharge at exhaust vents.
- Thermal bridge at masonry control joint.
- Thermal anomaly at foundation wall.

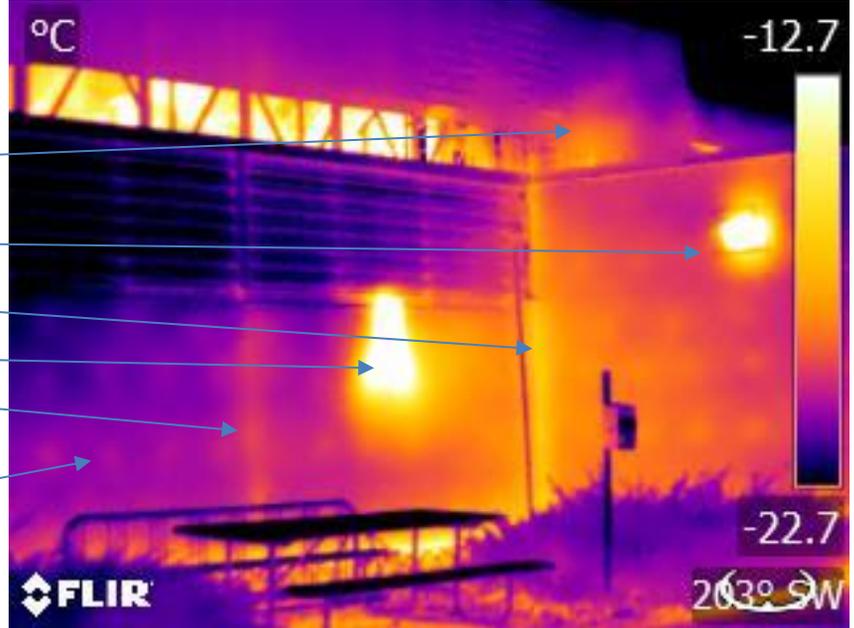
Photograph #5:

Figure 7: Thermal bridge at inside corner of North elevation wall intersection at entrance (refer to Photograph #5). Direct path for heat flow from mass of masonry at the corner causes elevated temperatures on the exterior surface during colder weather.

- Thermal anomaly caused by discharge of roof-top air handling unit.
- Thermal anomaly at light fixture.
- Thermal bridge at inside corner walls.
- Thermal anomaly at exhaust vent.
- Thermal bridge at masonry control joint.
- Thermal bridge at masonry wall ties.

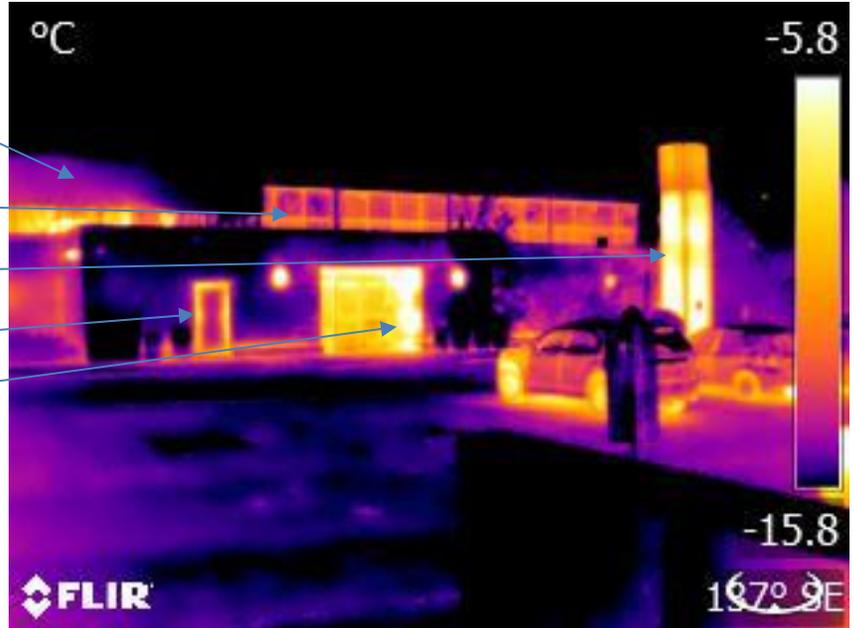
Photograph #7:

- Thermal anomaly caused by discharge of roof-top air handling unit.
- Thermal bridge at window frames.
- Thermal anomaly at chimney.
- Air leakage at door.
- Thermal anomaly in door alcove caused by light fixtures.

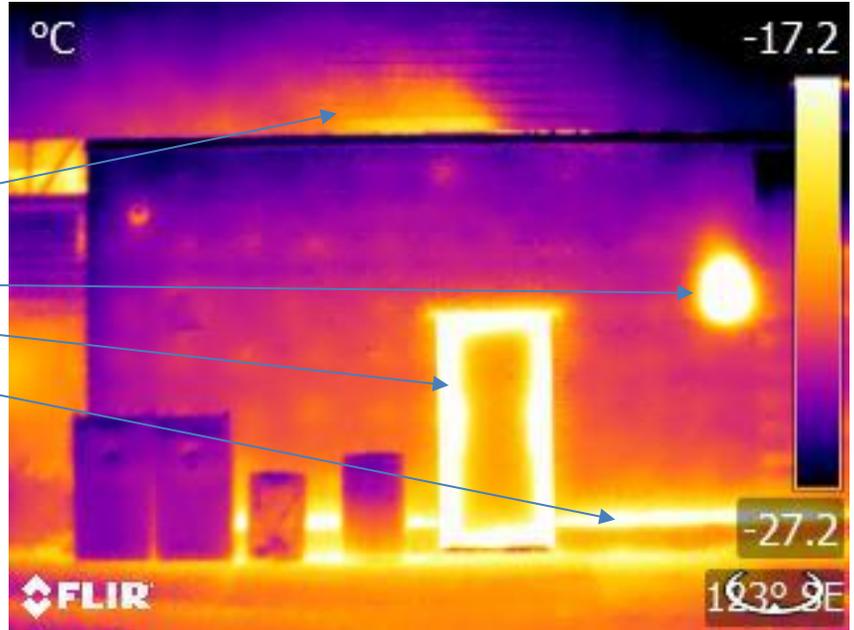
Photograph #9:

- Thermal anomaly caused by discharge of roof-top air handling unit.
- Thermal anomaly at light fixture.
- Air leakage at door.
- Thermal anomaly at intersection of foundation wall and brick cladding.

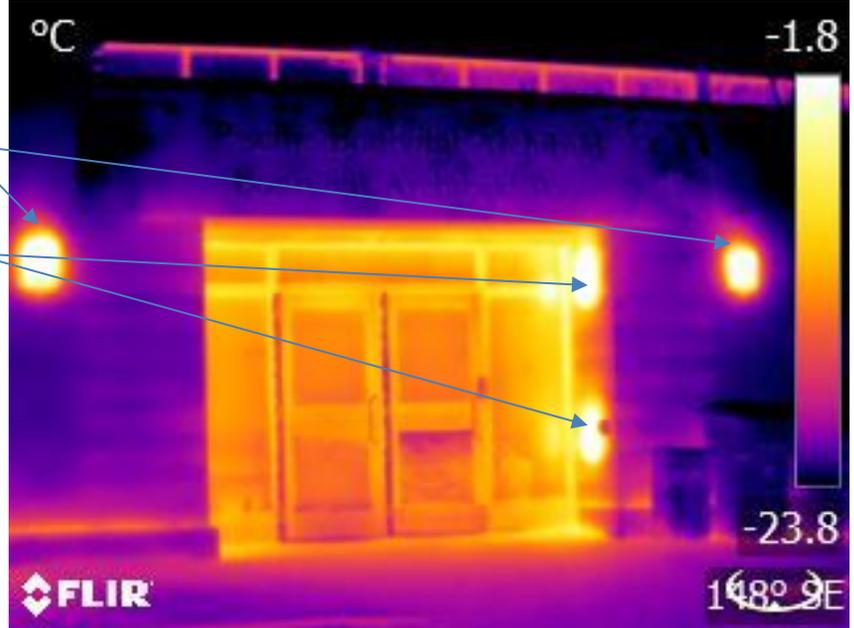
Photograph #11:

- Thermal anomaly caused by light fixture.
- Thermal anomaly caused by light fixture and intensified by stagnant air within entrance alcove.

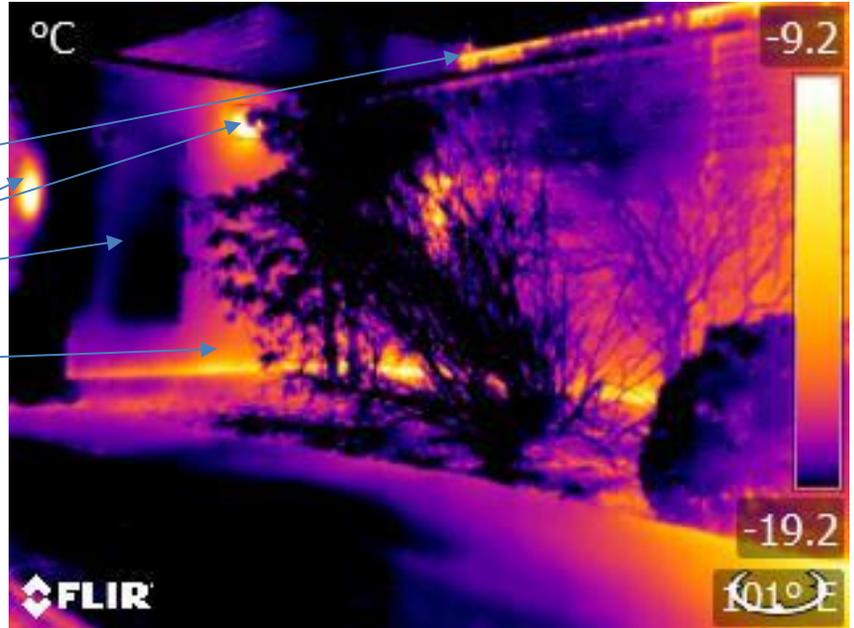
Photograph #13:

- Thermal bridge at window frames.
- Thermal anomaly at light fixtures.
- Thermal anomaly at intake grille.
- Thermal anomaly at intersection of foundation wall and masonry cladding.

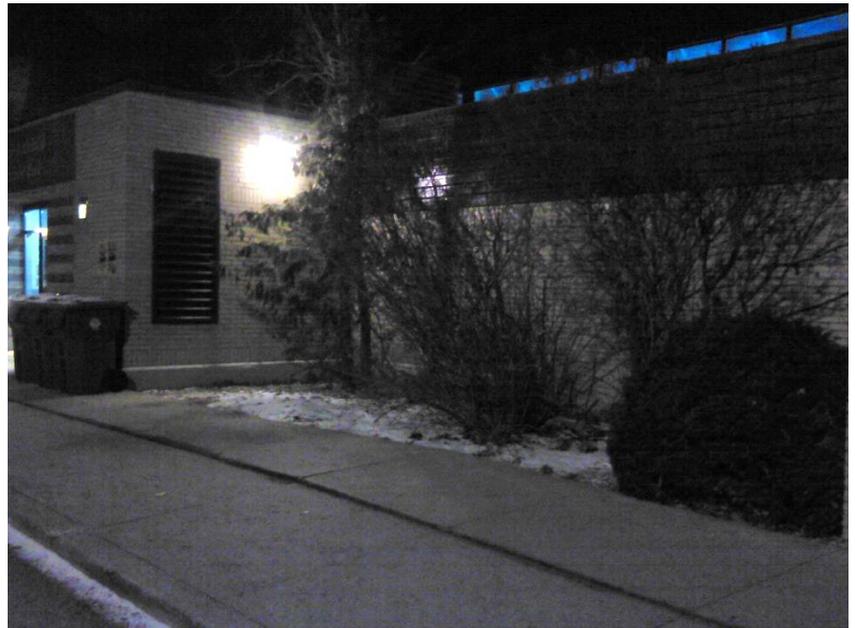
Photograph #14:

North elevation, west of entrance.

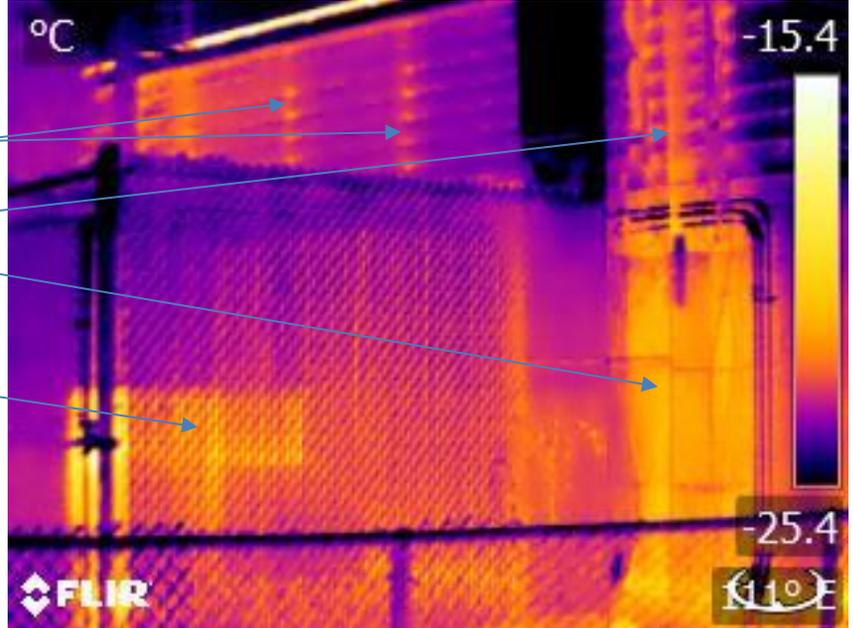
Photograph #15:

- Thermal bridge at metal siding fasteners.
- Thermal anomaly at electrical conduit.
- Thermal anomaly at ductwork due to reflectivity of metal ductwork.
- Thermal anomaly at transformer (behind slatted fence).

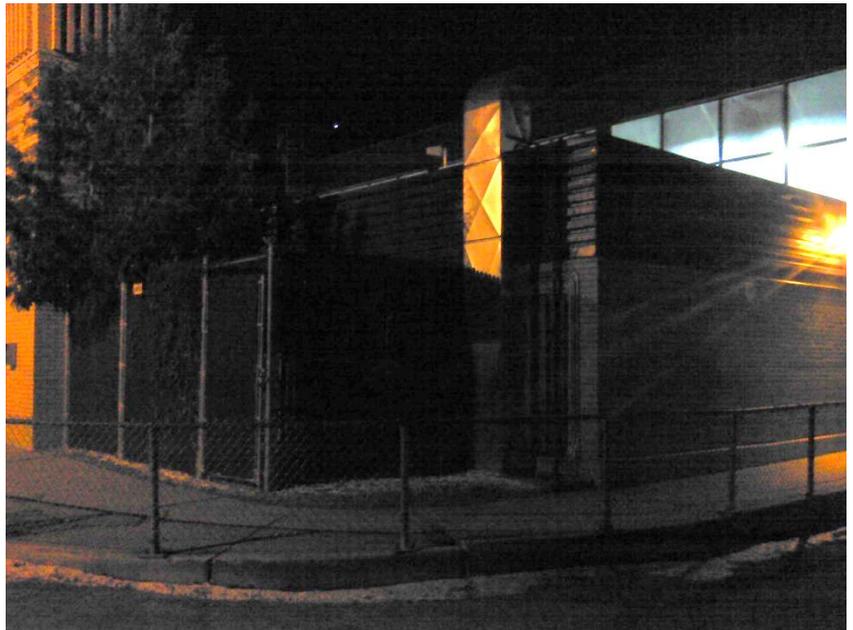
Photograph #16:

North elevation, west corner
at mechanical compound.

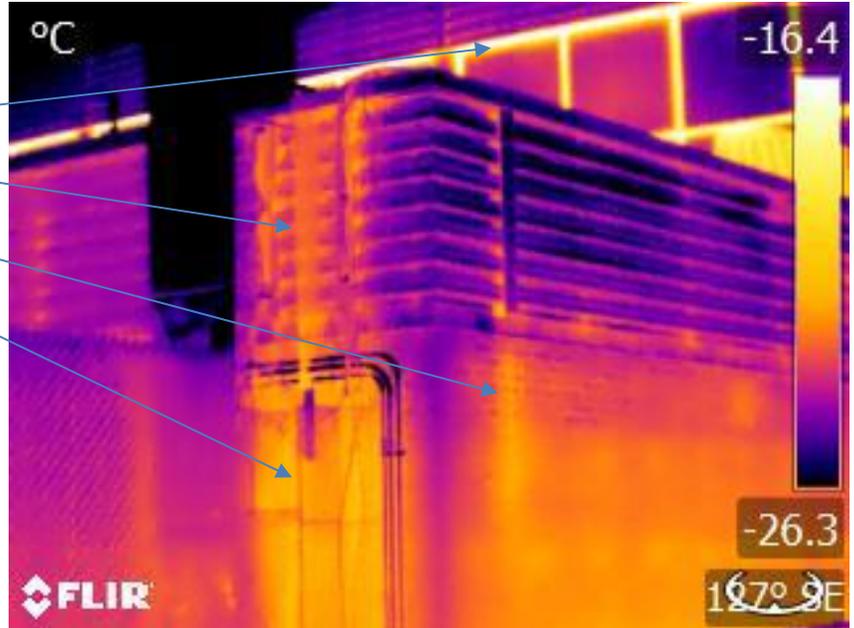
Photograph #17:

- Thermal bridge at windows.
- Thermal anomaly at electrical conduit.
- air leakage at masonry cladding control joint
- Thermal anomaly at metal ductwork caused by reflectivity of metal.

Generally, the thermographic scan did not identify significant deficiencies in the building envelope. Maintenance replacement of weather stripping and gaskets will address air leakage at doors. Maintenance replacement of sealant at masonry control joints will address air leakage at masonry control joints.

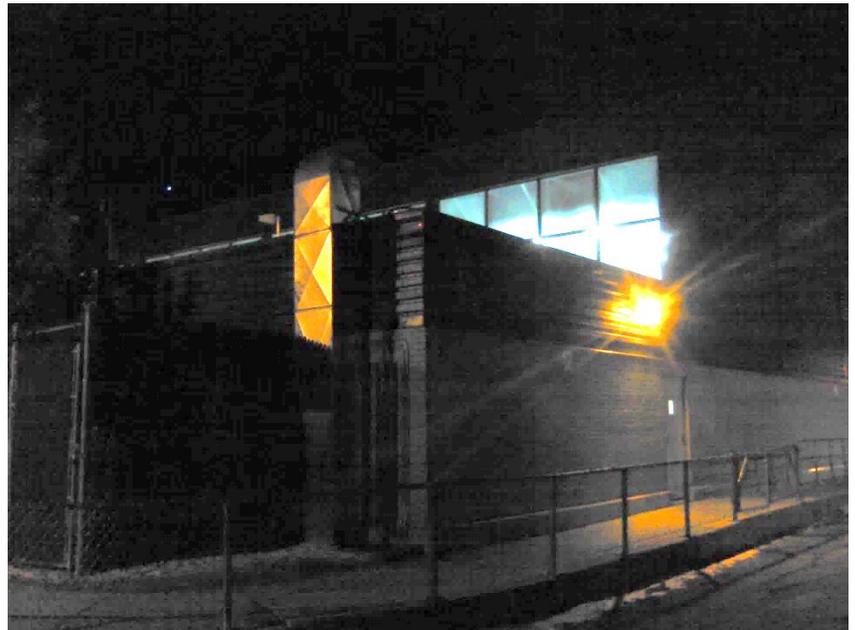
Photograph #18:

North-West corner.

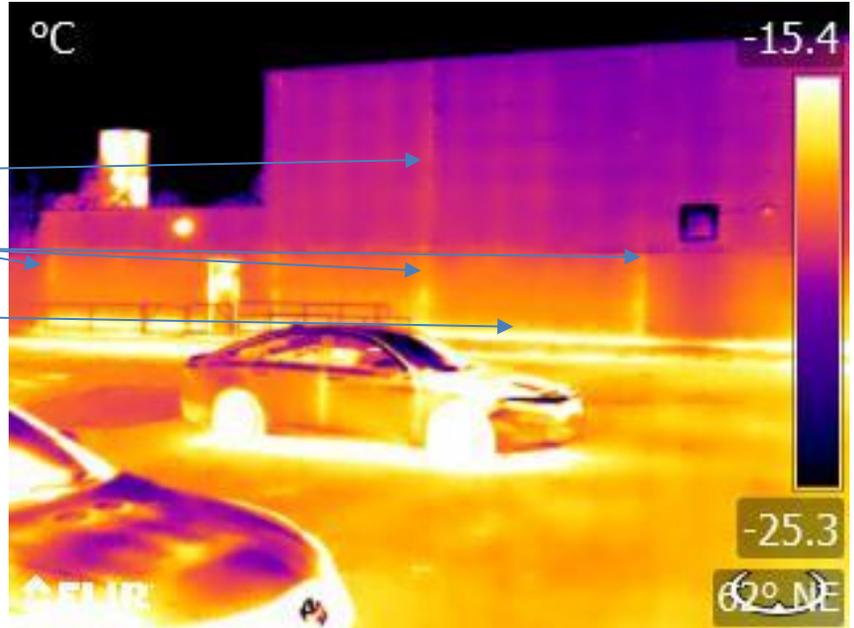
Photograph #19:

- Thermal anomaly at chimney.
- Thermal bridge at siding control joint.
- Air leakage at masonry cladding control joints.
- Thermal anomaly at intersection of foundation wall and masonry cladding.

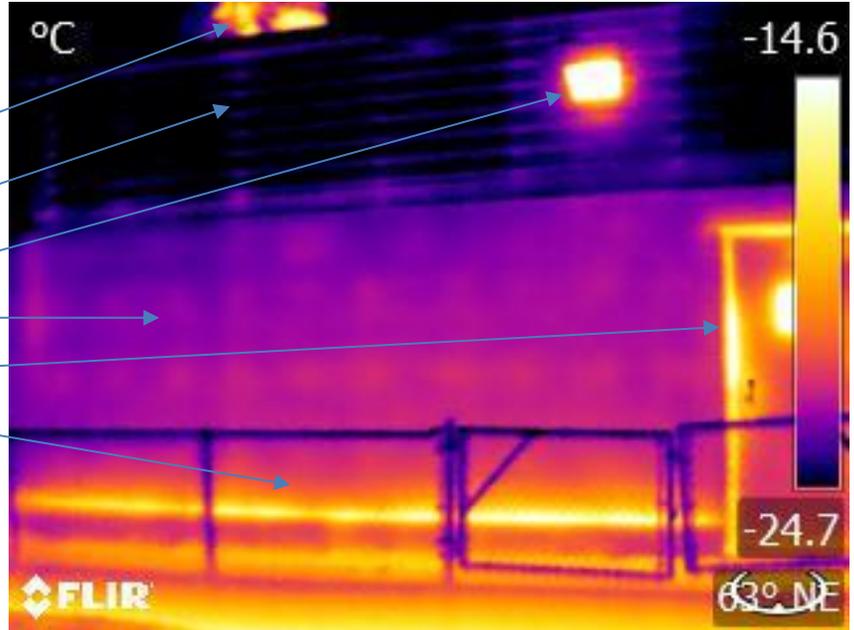
Photograph #21:

- Thermal anomaly at chimney.
- Thermal bridge at siding control joints.
- Thermal anomaly at light fixture.
- Thermal bridge at masonry wall tiles.
- Air leakage around door.
- Thermal anomaly at intersection of brick cladding and foundation wall.

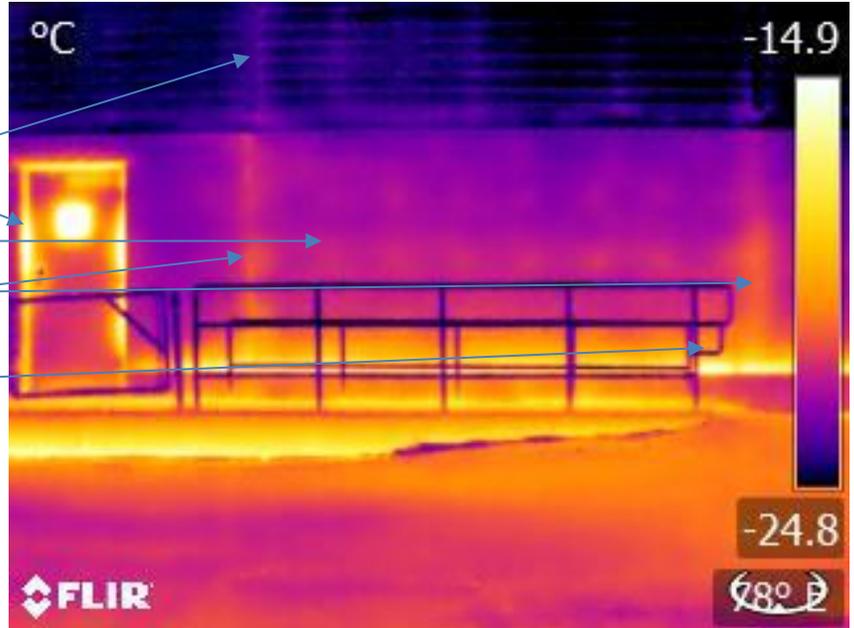
Photograph #23:

- Thermal bridge at siding control joints.
- Air leakage at door.
- Thermal bridge at masonry wall ties.
- Air leakage at masonry control joints.
- Thermal anomaly at intersection of masonry cladding and foundation wall.

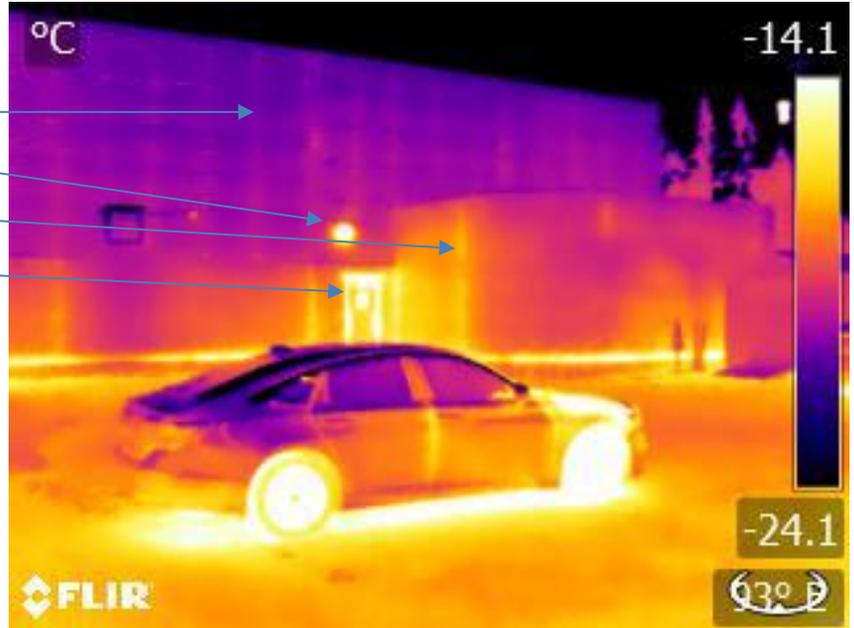
Photograph #25:

- Thermal bridge at siding control joints.
- Thermal anomaly at light fixture.
- Air leakage at masonry control joints.
- Air leakage at door.

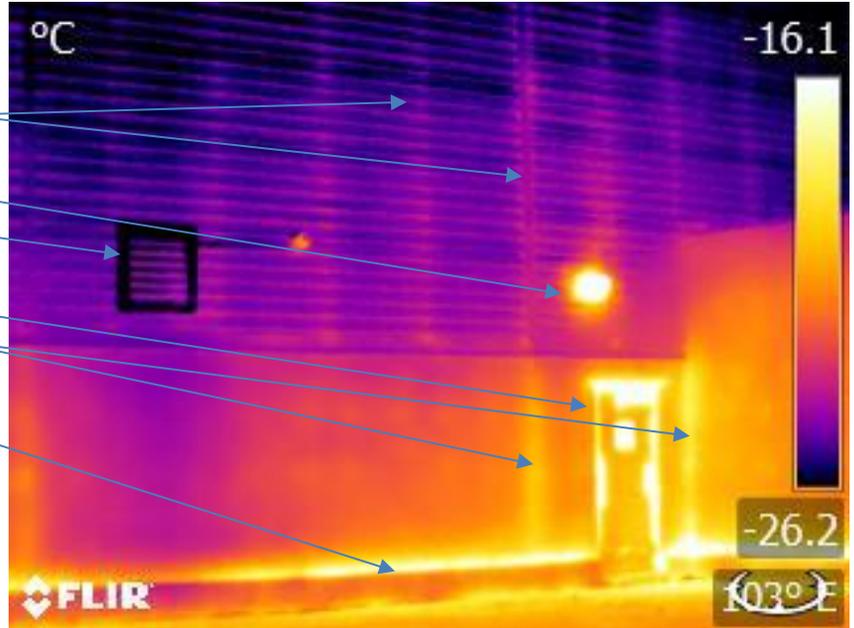
Photograph #27:

Figure 8: Metal siding control joints and supporting girts at West elevation (refer to Photograph #27). Heat transfer through steel girts supporting the siding (blue arrow) and at siding control joints (white arrow) and photograph to right).

- Thermal bridge at siding supports and control joint.
- Thermal anomaly at light fixture.
- Thermal anomaly at intake grille.
- Air leakage at door.
- Air leakage at masonry control joints.
- Thermal anomaly at intersection of masonry cladding and foundation wall.

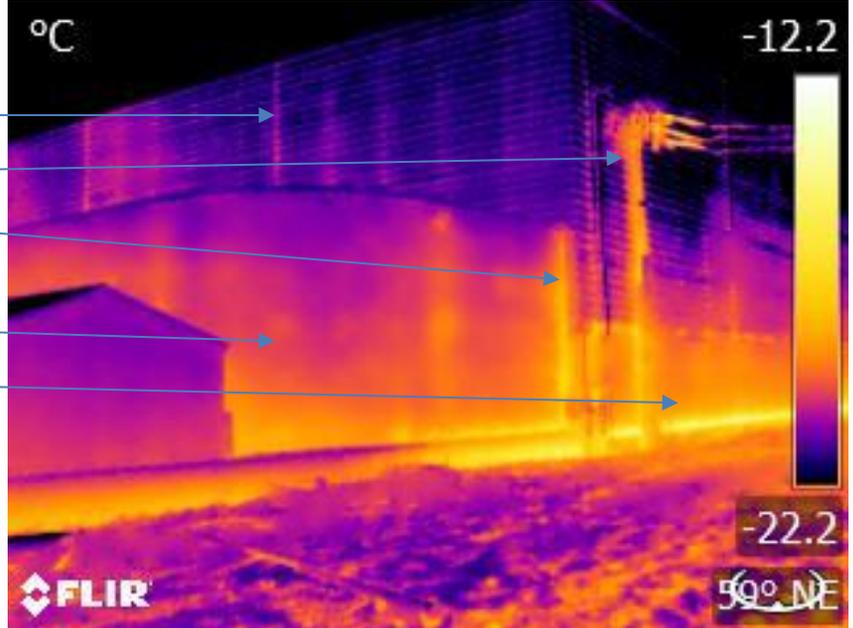
Photograph #29:

- Thermal bridge at siding control joints.
- Thermal anomaly at electrical connection.
- Air leakage at intersection of masonry and siding cladding.
- Thermal bridge at masonry wall ties.
- Thermal anomaly at intersection of siding cladding and foundation wall.

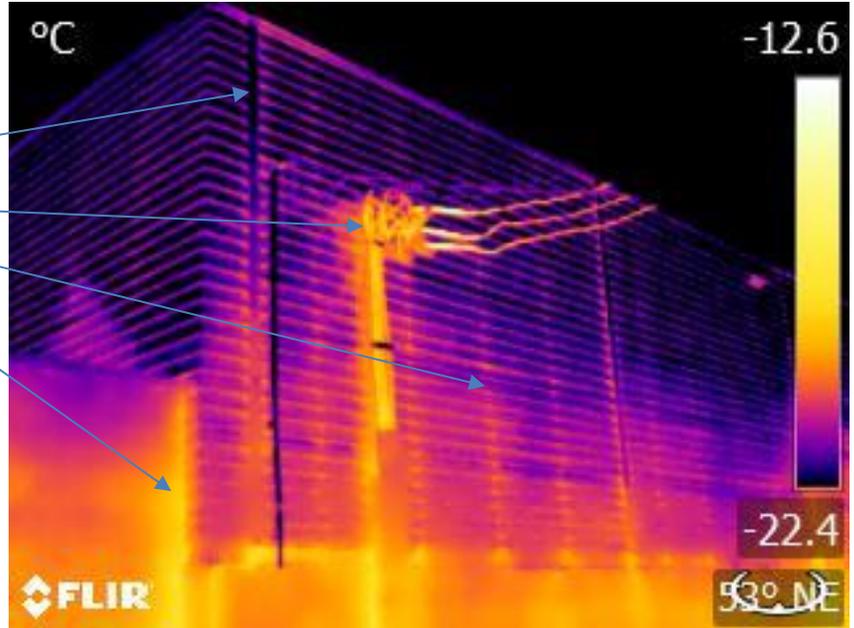
Photograph #31:

Figure 4: Air leakage vertical intersection of siding and brick cladding. South elevation at West end (refer to Photograph #31). Air leakage at this location is typically a result of discontinuous air barrier at the intersection of the cladding materials. Warm, moist air from within the pool building leaking through this location will create condensation when in contact with cold outdoor air or colder building materials. The condensation created can cause deterioration of the masonry over the long term.

- Thermal anomaly at siding control joint.
- Thermal anomaly at electrical connection.
- Thermal bridge at siding supports.
- Air leakage at intersection of siding and masonry cladding.

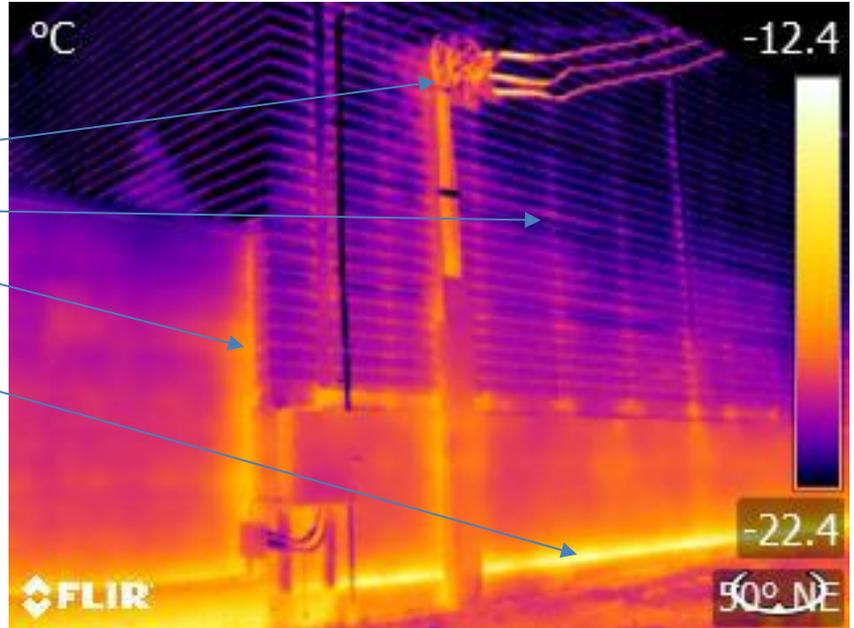
Photograph #33:

- Thermal anomaly at electrical connection.
- Thermal bridge at siding supports.
- Thermal anomaly at intersection of siding and masonry cladding.
- Thermal anomaly at intersection of masonry wall and foundation wall.

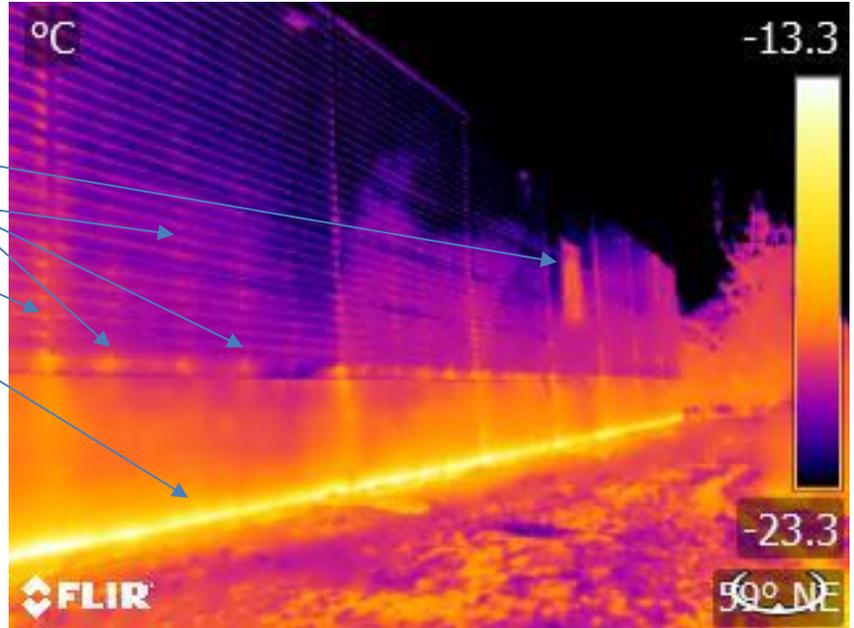
Photograph #35:

- Thermal anomaly at mechanical vent.
- Thermal bridge at siding supports.
- Thermal bridge at siding control joints.
- Thermal bridge at intersection of masonry cladding and foundation wall.

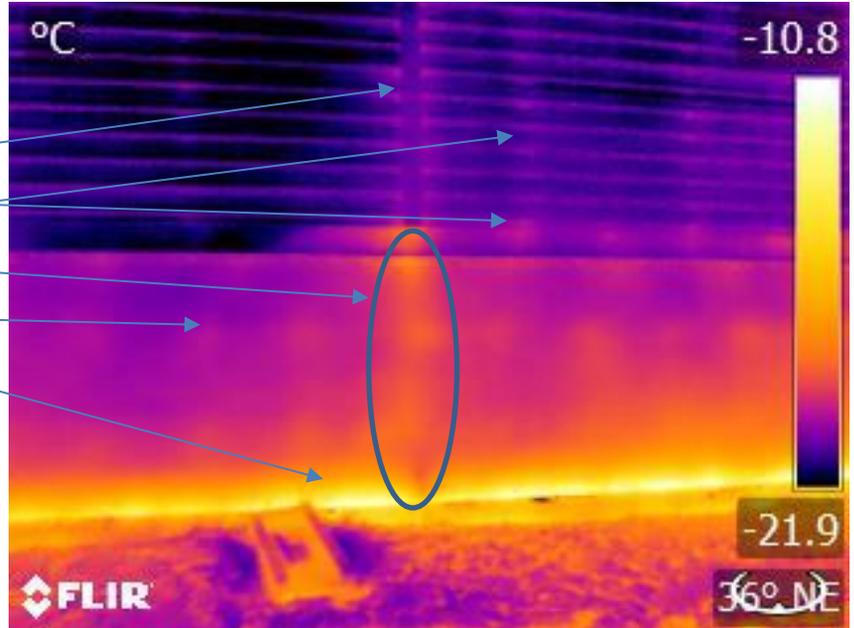
Photograph #37:

- Thermal bridge at siding control joint.
- Thermal bridge at siding supports.
- Thermal bridge at masonry control joint.
- Thermal bridge at masonry wall ties.
- Thermal anomaly at intersection of masonry cladding and foundation wall.

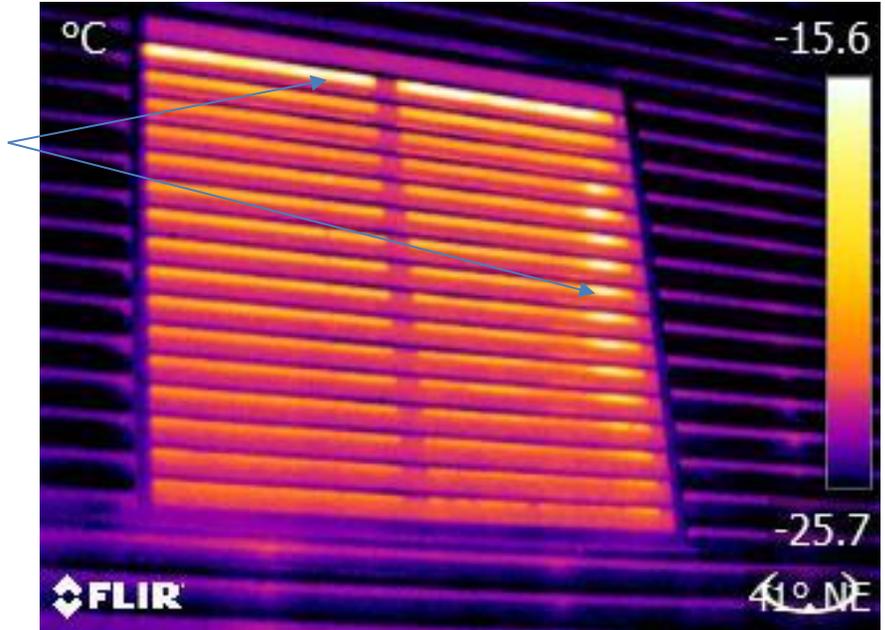
Photograph #39:

- Thermal anomaly at mechanical vent.

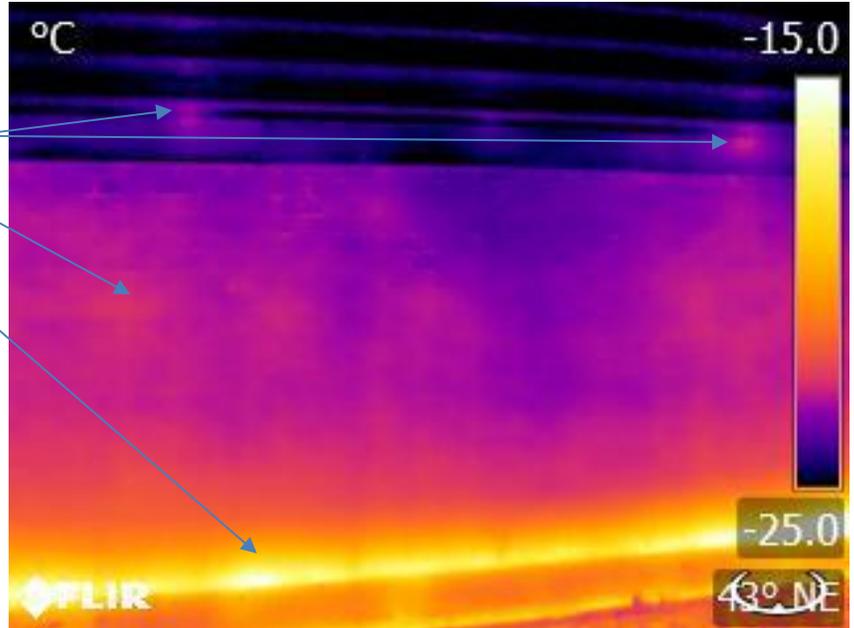
Photograph #41:

- Thermal bridge at siding supports.
- Thermal bridge at masonry wall ties.
- Thermal anomaly at intersection of masonry cladding and foundation wall.

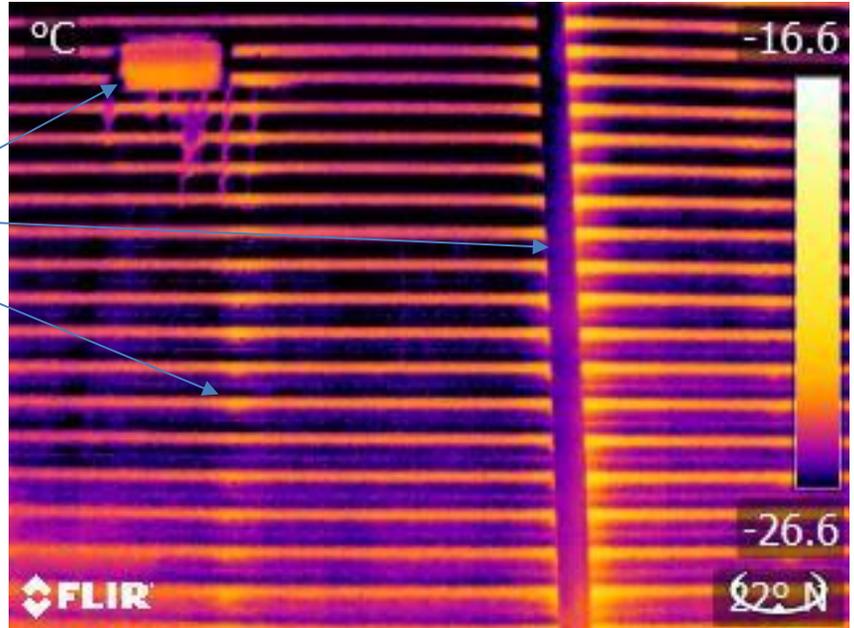
Photograph #43:

- Thermal anomaly at roof scupper.
- Thermal anomaly at siding control joints.
- Thermal bridge at siding supports.

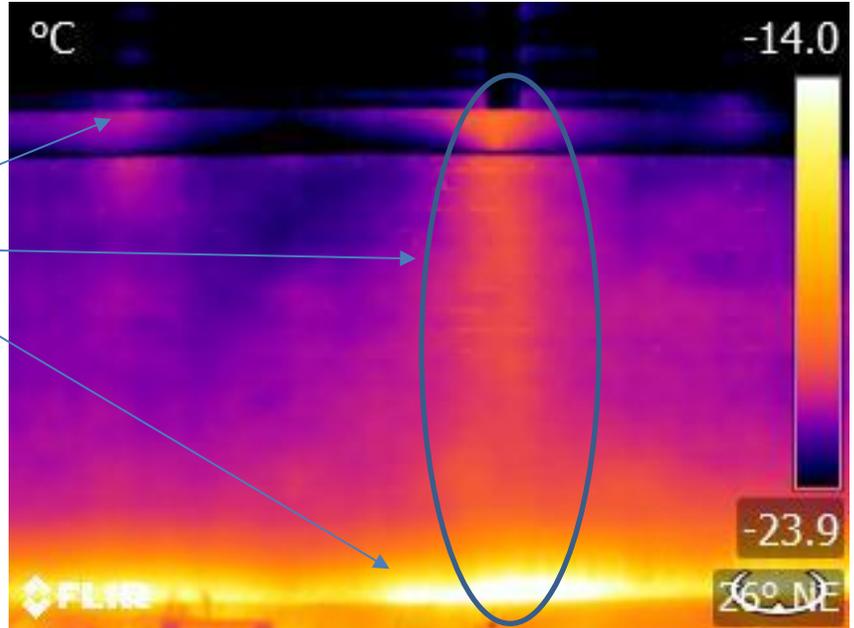
Photograph #45:

- Thermal anomaly at siding support.
- Thermal bridge at masonry control joint.
- Thermal anomaly at intersection of brick cladding and foundation wall.

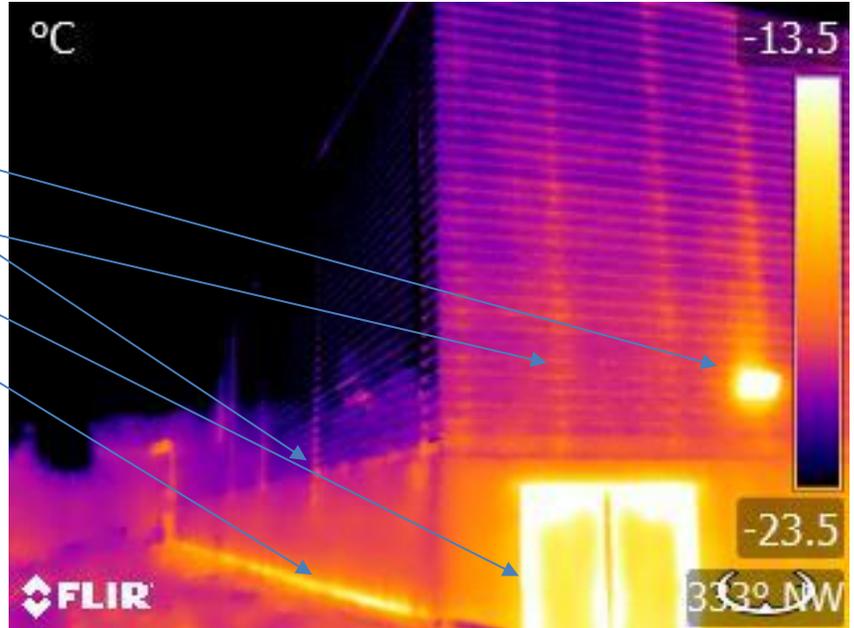
Photograph #47:

- Thermal anomaly at light fixture.
- Thermal bridge at siding supports.
- Air leakage at doors.
- Thermal anomaly at intersection of masonry cladding and foundation wall.

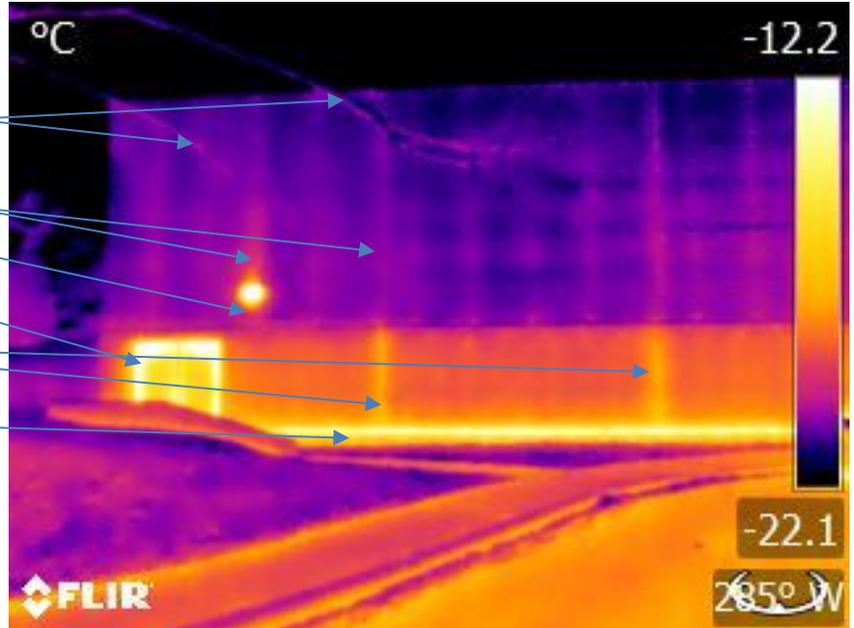
Photograph #49:

- Thermal anomaly at tree branch in front of building.
- Thermal bridge at siding supports.
- Thermal anomaly at light fixture.
- Air leakage at doors.
- Air leakage at masonry wall control joints.
- Thermal anomaly at intersection of masonry cladding and foundation wall.
