Bonivital Pool; 1215 Archibald Street Building Condition Assessment

Submitted to: City of Winnipeg
Planning, Property, and Development Department
Accommodation Services

Date: April 4, 2019

Submitted by: Crosier Kilgour & Partners Ltd.
300-275 Carlton Street
Winnipeg, Manitoba R3C 5R6
Phone: 204.943.7501 Fax: 204.943.7507
Website: www.ckpeng.com

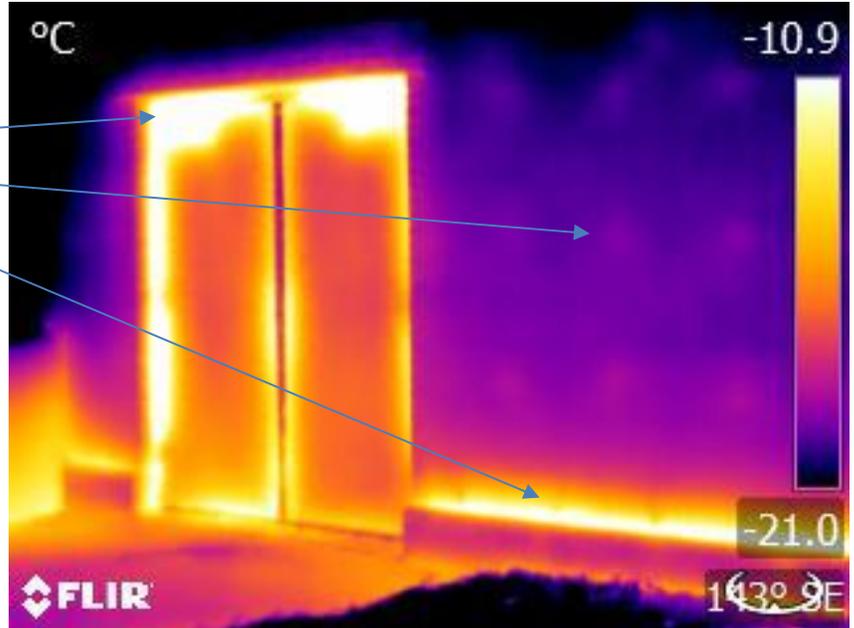
Photograph #51:

Figure 5: Air leakage at doors (refer to Photograph #51). Air leakage at doors is typically the result of worn gaskets and weather-stripping on door frames. Warm, moist air from within the pool building leaking through this location will create condensation when in contact with cold outdoor air or colder building materials. The condensation created can cause corrosion of the metal doors and frames.

- Air leakage at doors.
- Thermal bridge at masonry wall ties.
- Thermal anomaly at intersection of masonry cladding and foundation wall.

Generally, the thermographic scan did not identify significant deficiencies in the building envelope. Maintenance replacement of weather stripping and gaskets will address air leakage at doors. Maintenance replacement of sealant at masonry control joints will address air leakage at masonry control joints.

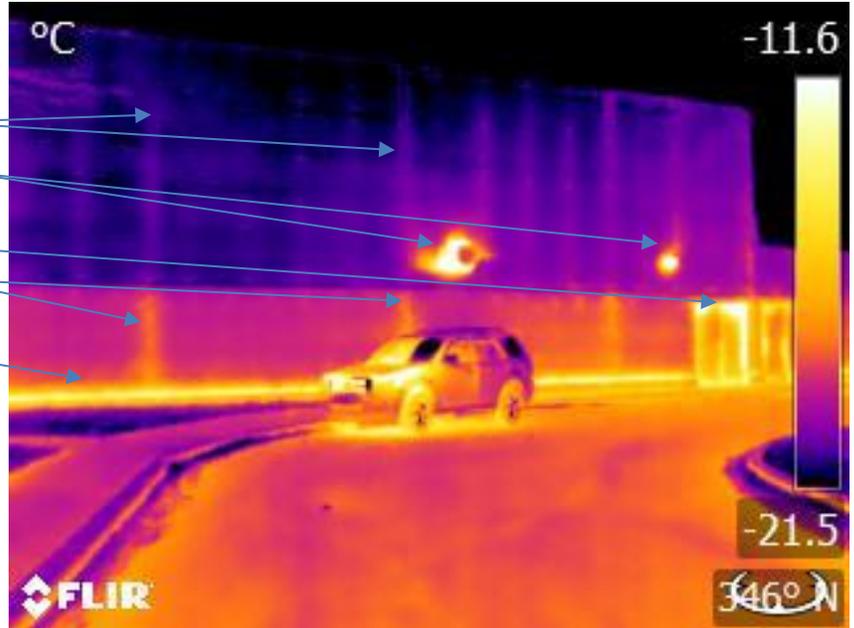
Photograph #53:

- Thermal bridge at siding supports.
- Thermal anomalies at exhaust vent and light fixture.
- Air leakage at doors.
- Air leakage at masonry control joints.
- Thermal anomaly at intersection of masonry cladding and foundation wall.

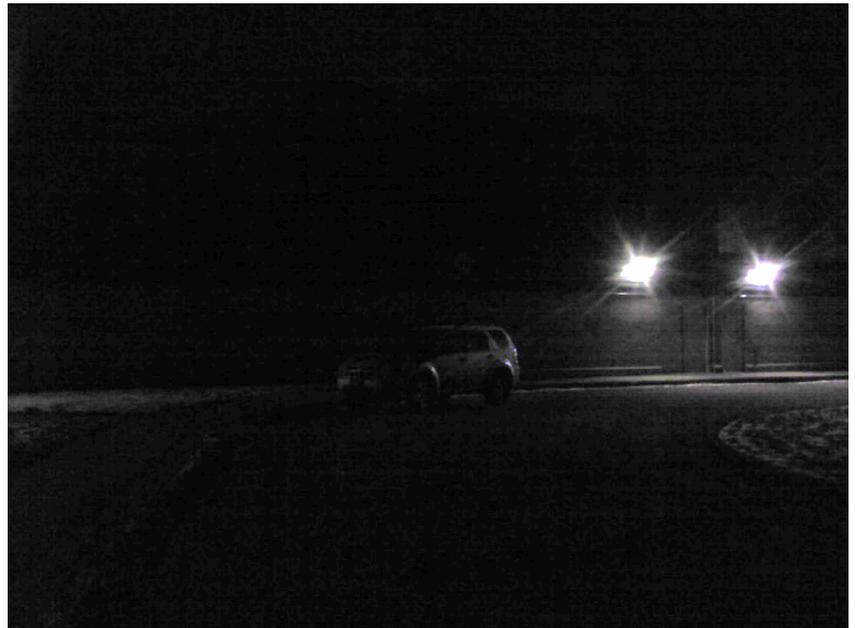
Photograph #54:

East elevation.

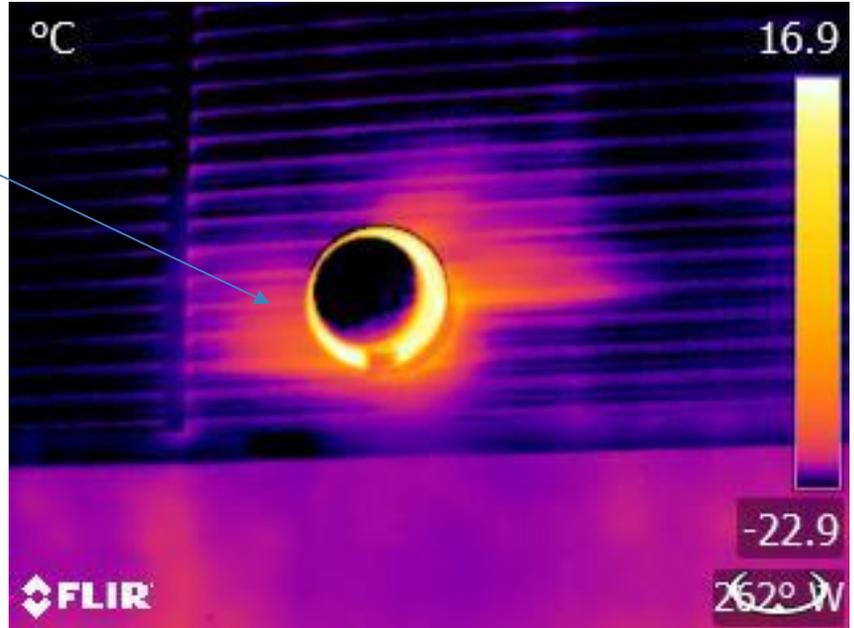
Photograph #55:

Figure 3: Air leakage at exhaust vent (refer to Photograph #55). Air leakage at this location is a controlled air leakage caused by mechanical exhaust fans.

- Air leakage at vent.

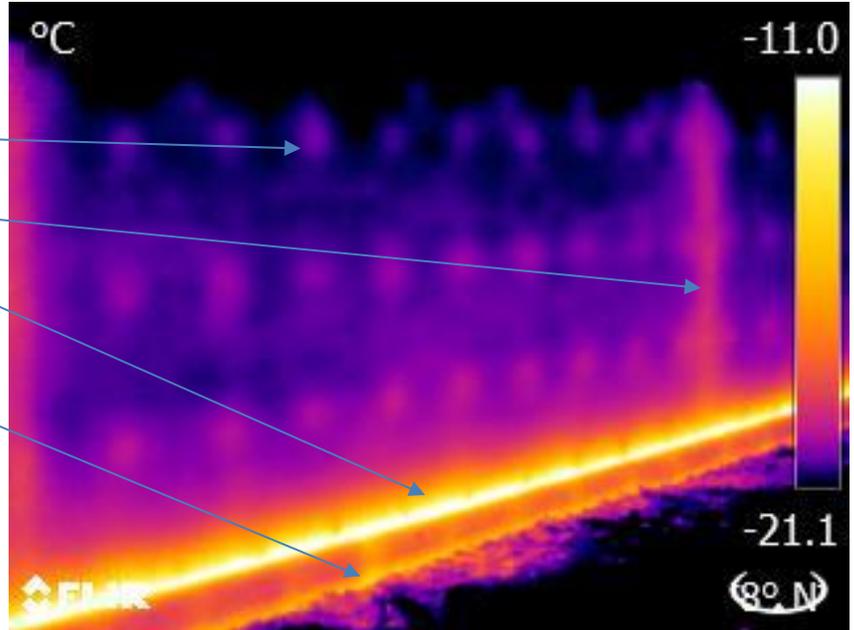
Photograph #57:

Figure 9: Masonry wall ties and foundation wall at grade at East elevation (refer to Photograph #57). Heat transfer through wall at ties supporting the clay brick veneer. Also, heat transfer through the foundation wall at grade.

- Thermal bridge at masonry wall ties.
- Air leakage at masonry control joints.
- Thermal anomaly at intersection of masonry cladding and foundation wall.
- Thermal bridge at intersection of foundation wall and grade.

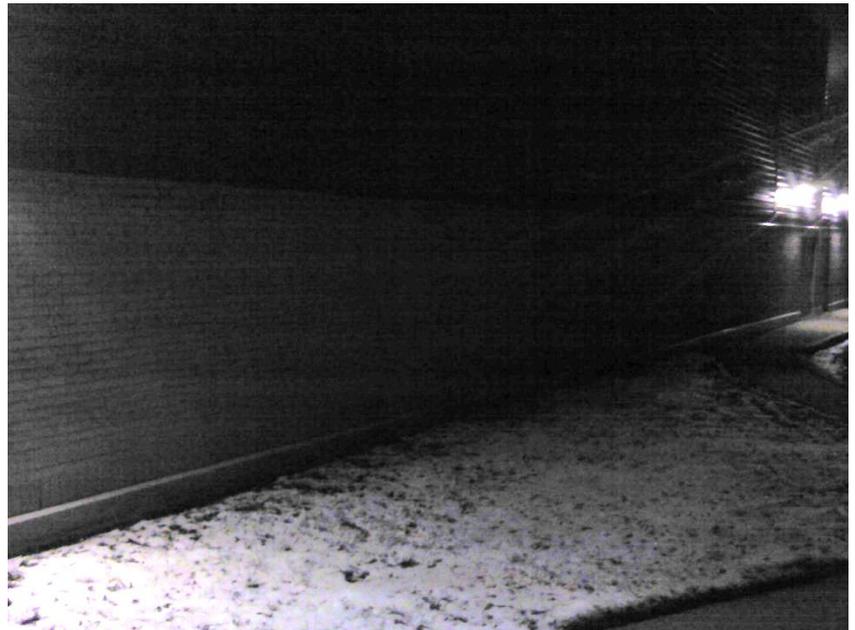
Photograph #58:

East elevation. Close-up view of base of wall.

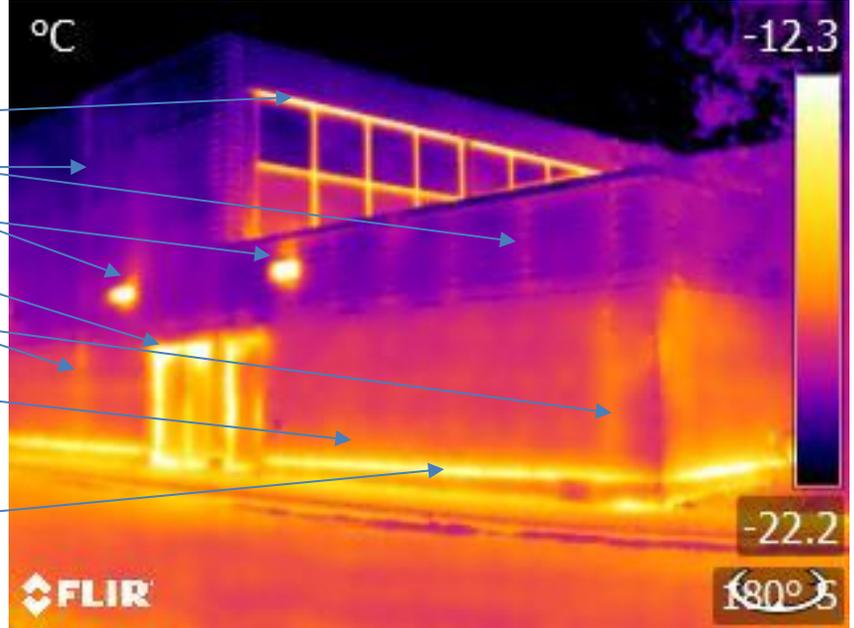
Photograph #59:

- Thermal bridge at window frames.
- Thermal bridge at siding supports.
- Thermal anomaly at light fixtures.
- Air leakage at doors.
- Air leakage at masonry wall control joints.
- Thermal anomaly at intersection of masonry cladding and foundation wall.
- Thermal bridge at intersection of foundation wall and grade.

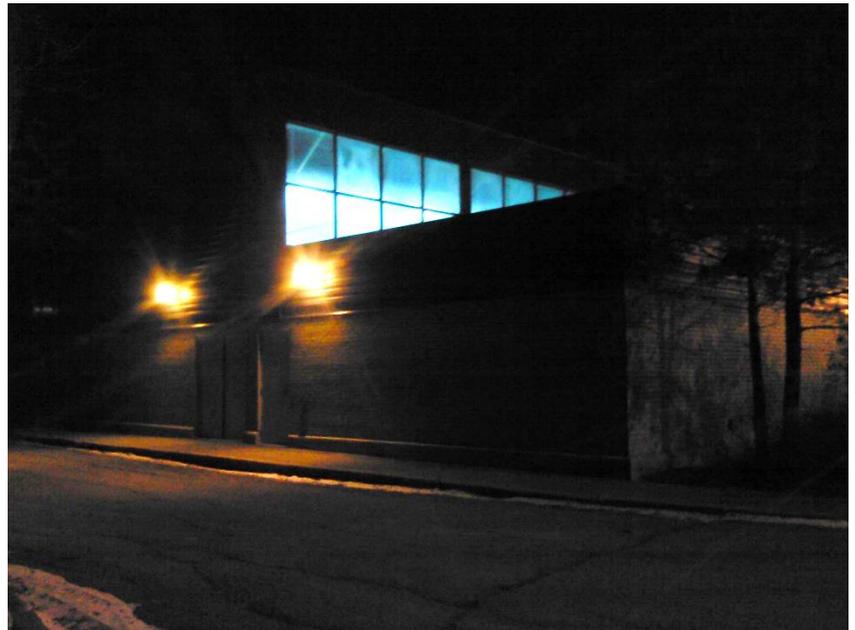
Photograph #60:

East elevation at north end.

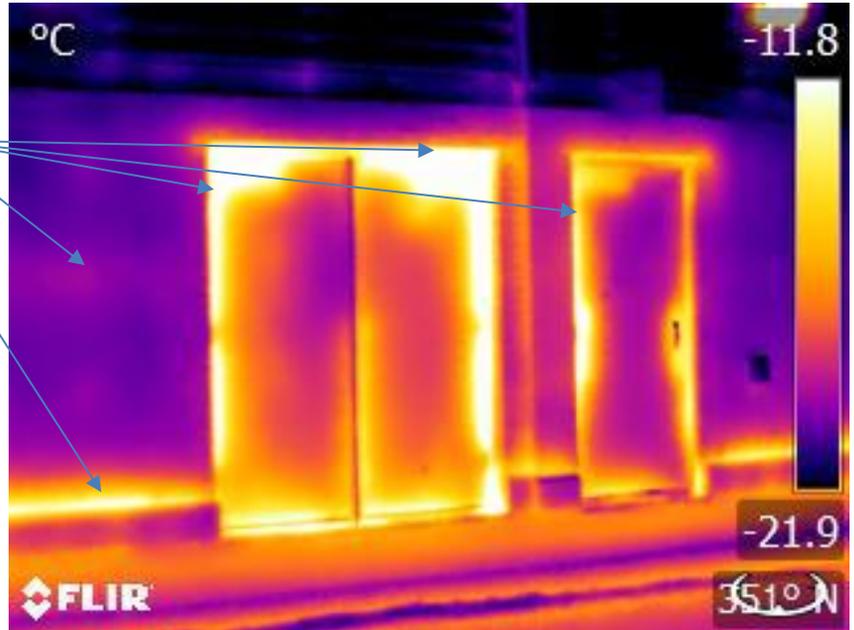
Photograph #61:

- Air leakage at doors.
- Thermal bridge at masonry wall ties.
- Thermal anomaly at intersection of masonry cladding and foundation wall.

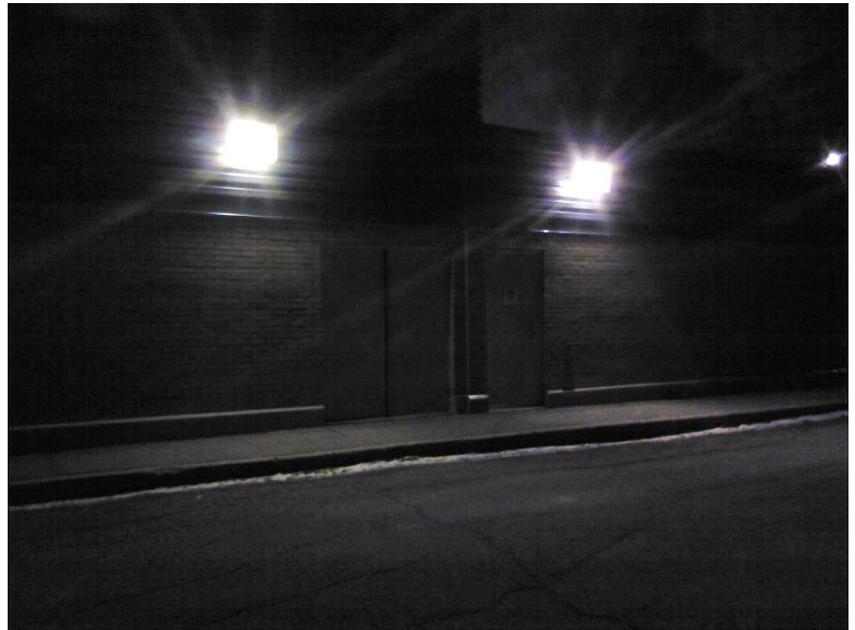
Photograph #62:

East elevation. Close-up view of doors at north end.

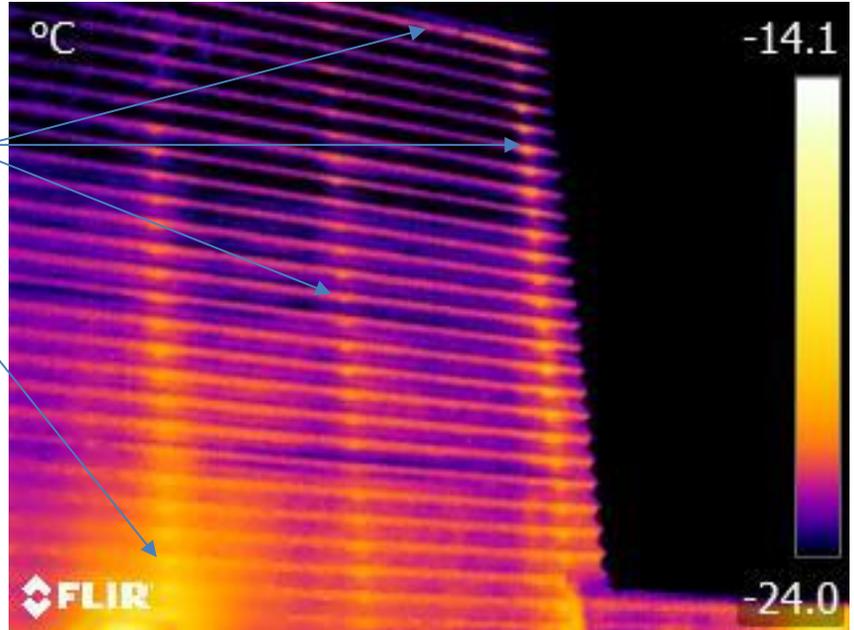
Photograph #63:

- Thermal bridge at siding supports.
- Thermal anomaly caused by light fixture.

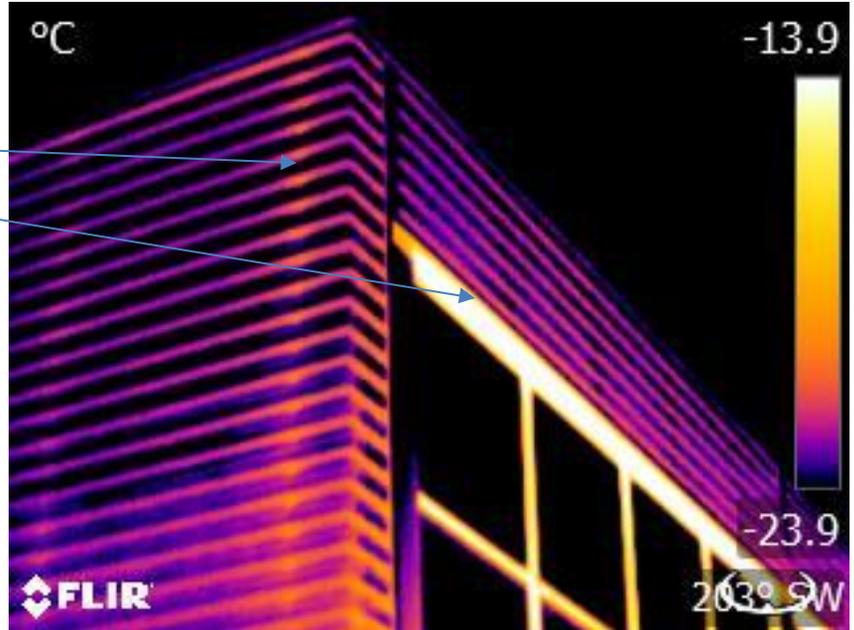
Photograph #65:

Figure 6: Thermal bridge at window frames at North elevation (refer to Photograph #65).

- Thermal bridge at siding supports.
- Thermal bridge at window frames.

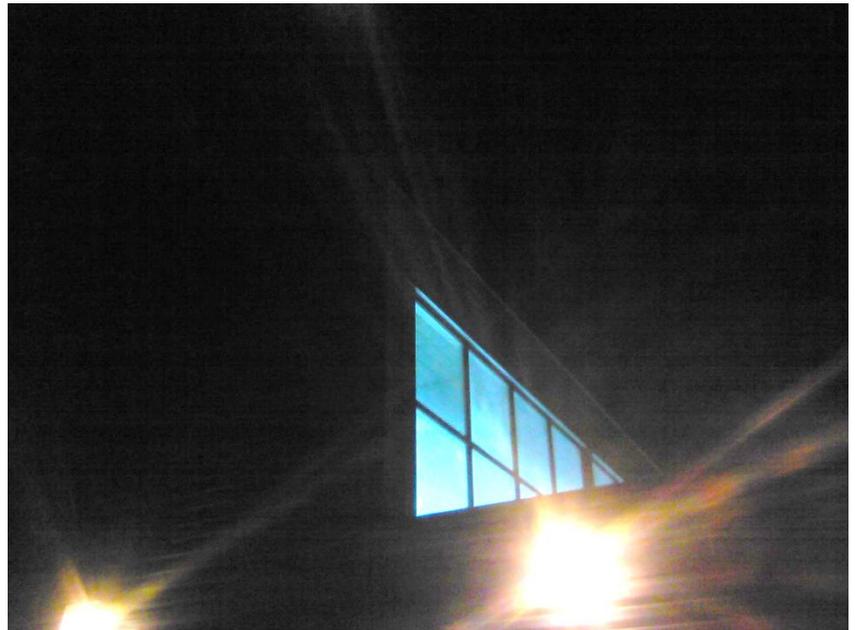
Photograph #66:

North-east corner. View of roof at pool section.
