APPENDIX F – 2019 CRANE INSPECTION REPORT
Hurst Pumping Station

A19-153 - COW - Pump Station Inspections

R.S.I.-A (Regulatory Safety Inspection - ANNUAL)

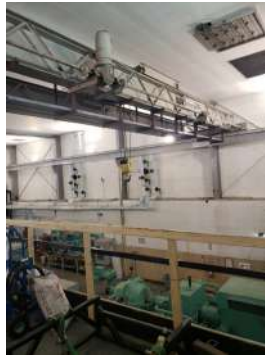
Hurst pumphouse

Whiting

8428

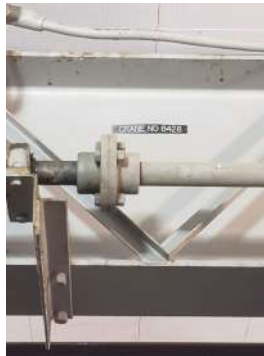
Picture of Make/Model/Serial Number

Whiting/8428

1- No directional sign on Bridge . Crane requires directional sign on bottom of bridge girder that corresponds to remote controller.

Greased all bridge drive line shaft bearings and drive wheel bearings. Checked oil level in gearbox, level is good.
*could not grease southeast bridge wheel bearings, inaccessible

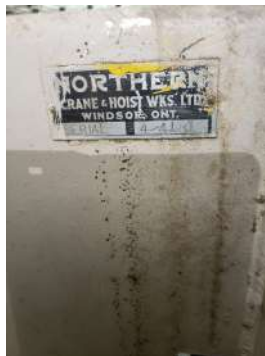
Picture of Make/Model/Serial Number

Northern 4/4181

1- load capacity on hook block is not clear . Hook block requires clear load capacity sign. (7.5 tons)

Greased hook block and upper sheaves. Checked oil level in hoist gearbox, level is good.

1- load capacity on hook block is not clear . Hook block requires clear load capacity sign. (7.5 tons) 1 tech/1hr for all repairs
