| Project: | <u>Kildonan-Redwood Feeder Main Pipe Inspection</u> | Date: | <u>March 29, 2019</u> |
| Contractor: | <u>J-Con Civil Ltd.</u> | Project #: | <u>60549028</u> |
| Owner: | <u>City of Winnipeg</u> | Weather: | <u>Snow, Blustery, -5° C</u> |

# Inspection Report

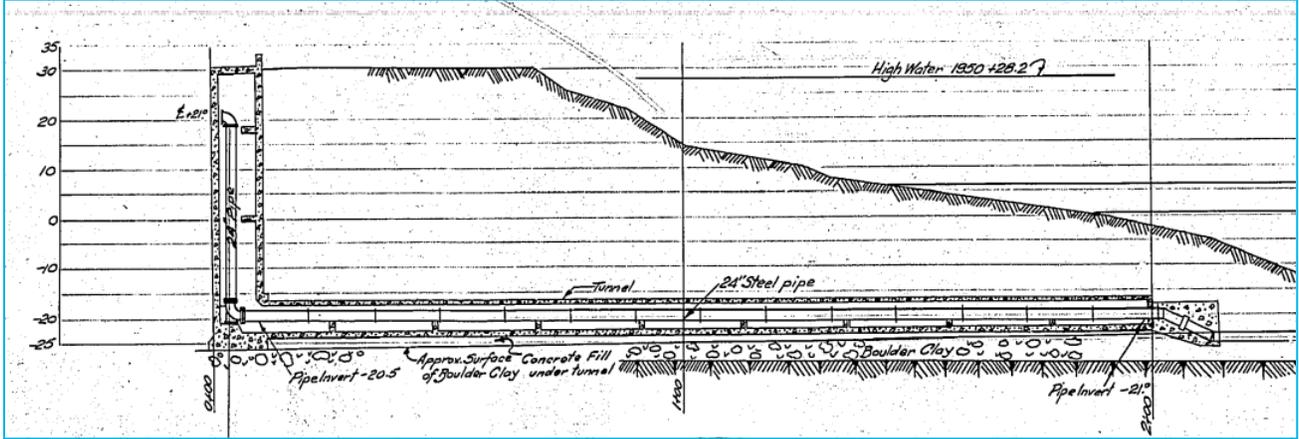
**Figure A 1 –Feeder Main and Tunnel on West Side of Red River, View Looking Northward.  
(From WWD Historic Drawing WA-12535).**

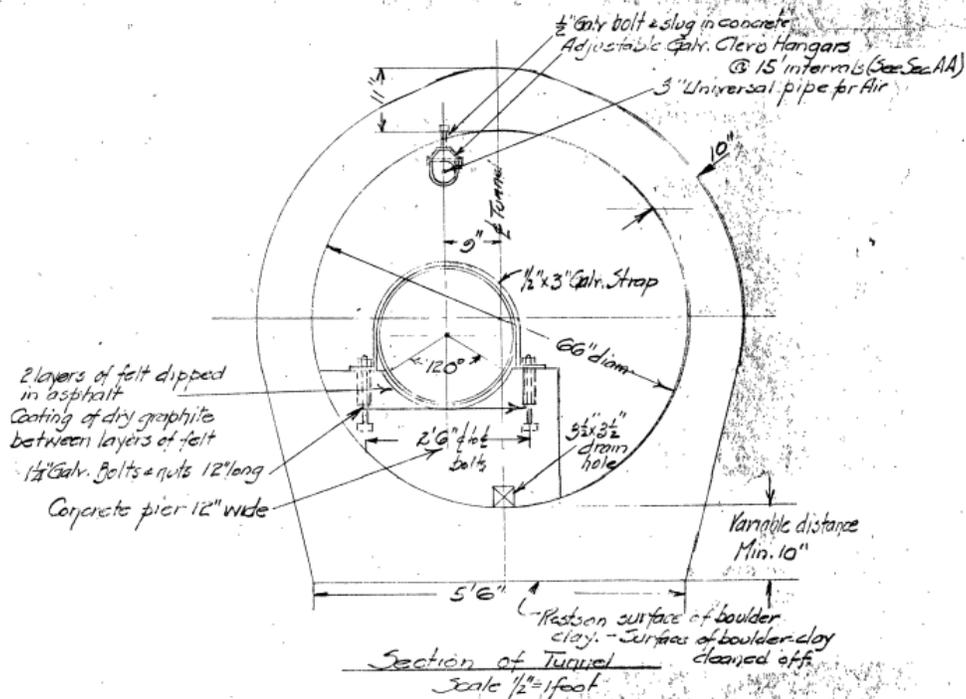
**Figure A 2 – Cross-Sectional View of Feeder Main and Tunnel, View Looking Westward.  
(From WWD Historic Drawing WA-12531).**

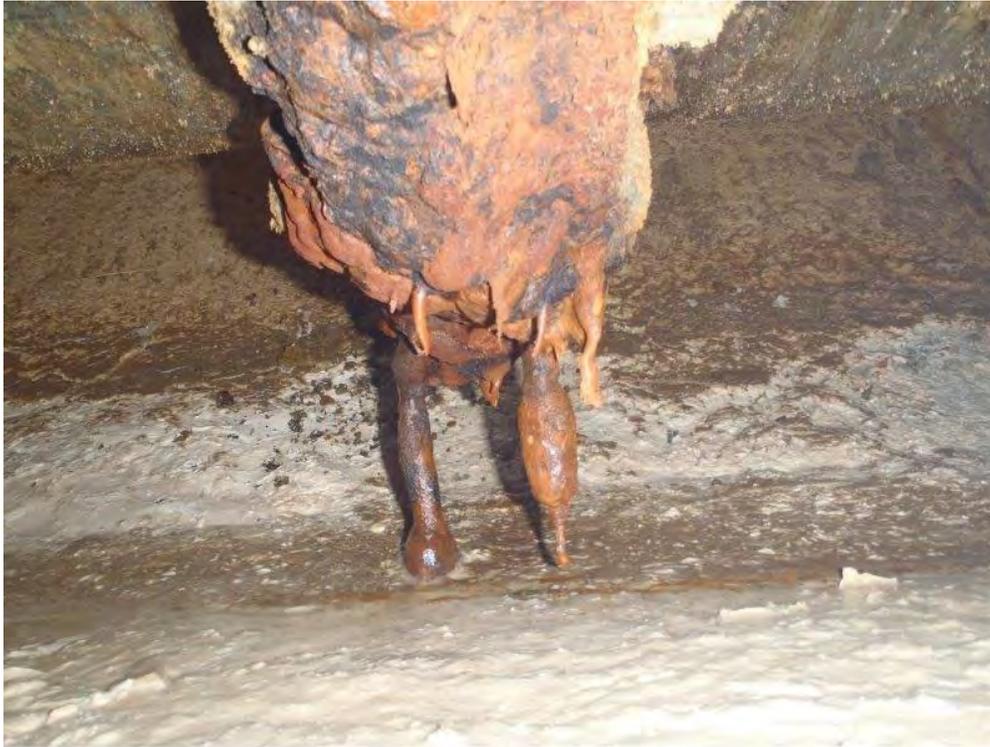
**Figure A 15 – Underside of Flange Connection at 46.78 m from Shaft.**

- Install petrolatum tape coating system over all flanged connections. Clean dirt and corrosion from flanges prior to coating and use profiling mastic to fill irregular spaces between flange fasteners, creating a smooth surface for tape wrapping.

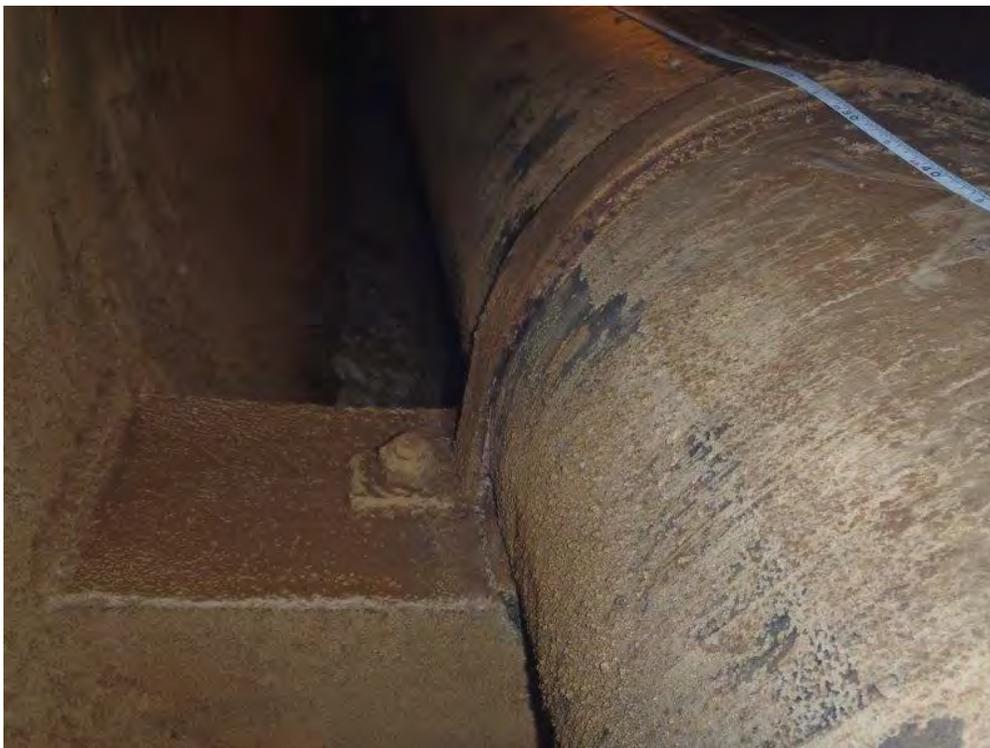
- Galvanized pipe straps at pedestals were in very good condition.
- Victaulic couplings were severely corroded and should be replaced. The bodies of the couplings were unevenly corroded with the appearance of grey cast iron, a brittle material. The underlying restraining rings

**Figure A 16 – Typical Galvanized Pipe Strap and Pedestal, 45.12 m From Shaft.**

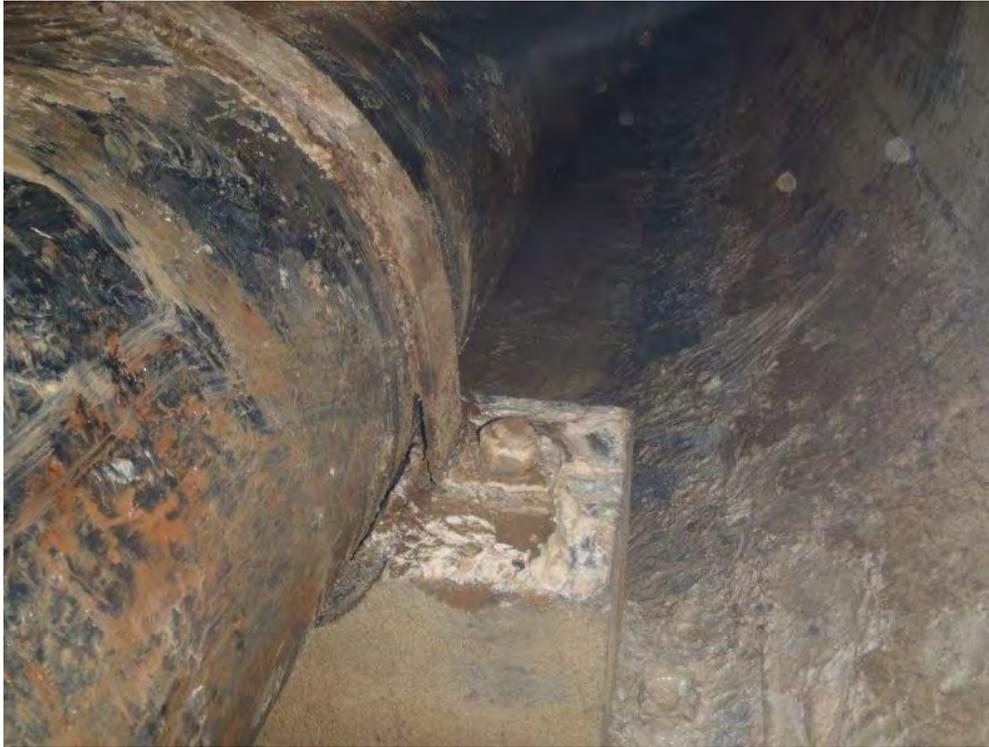
**Figure A 17 – Typical Galvanized Pipe Strap and Pedestal, 45.12 m From Shaft.**

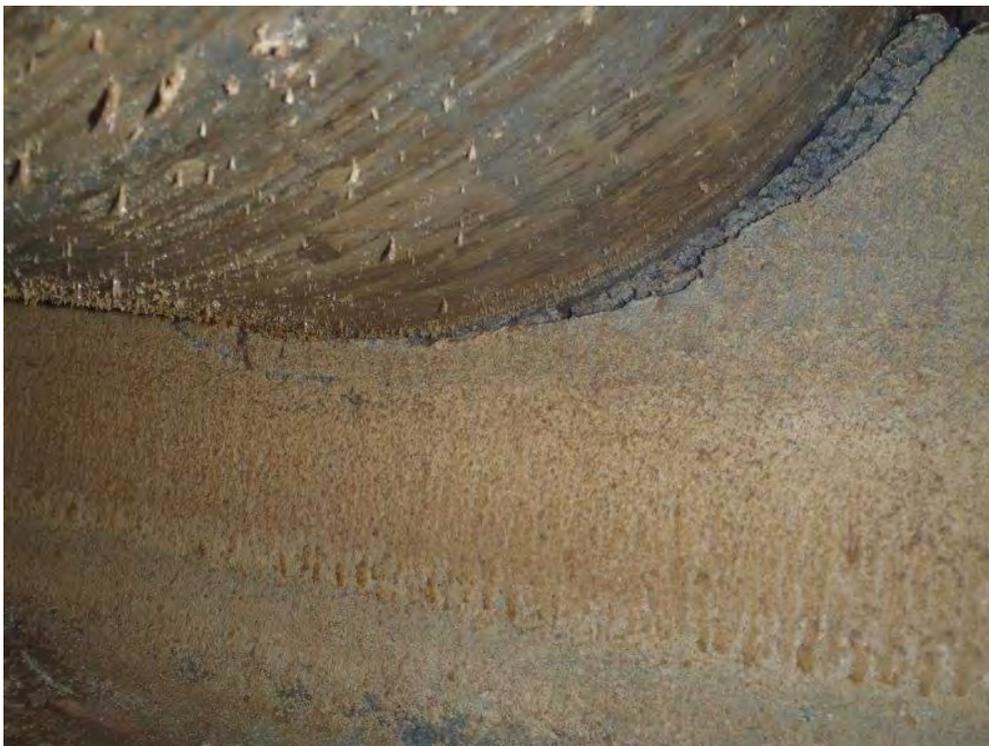
**Figure A 18 –Feeder Main on Pedestal at 6:00 o'clock, 45.12 m From Shaft.**

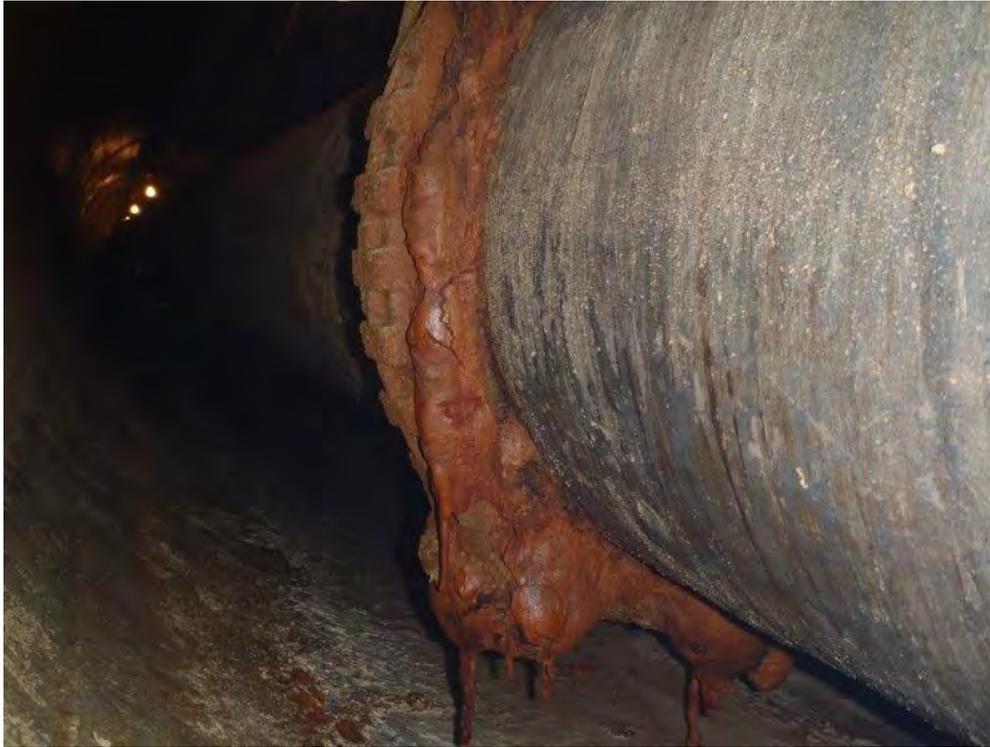
on the feeder main pipes, where visible, appeared in good condition and were smooth-surfaced with no pitting observed. The fasteners on the couplings also appeared in good condition.

**Figure A 25 – Underside of Victaulic Connection at 8:00 o'clock, 38.24 m from Shaft.**

- Replace the Victaulic couplings.
- Install a petrolatum tape coating repair (mastic and tape wrap) around the feeder main pipe at the coating break near the east tunnel wall. The repair should extend from the wall to 0.2 m from the wall.

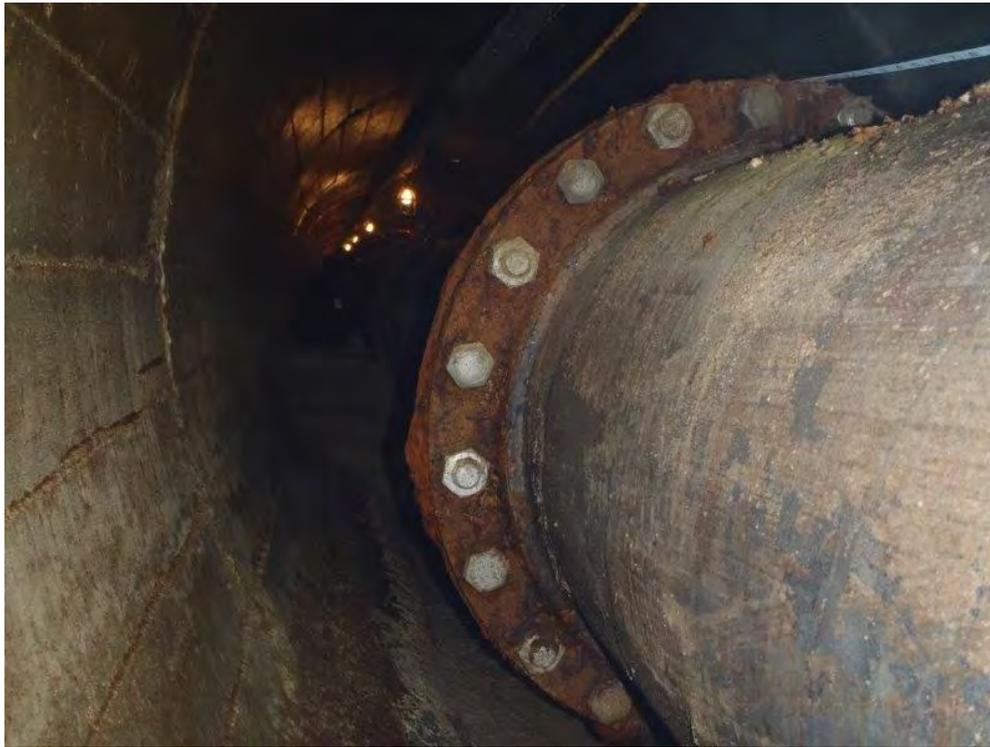
**Figure A 31 – Flange Connection at 9:00 o'clock, 33.96 m from Shaft.**

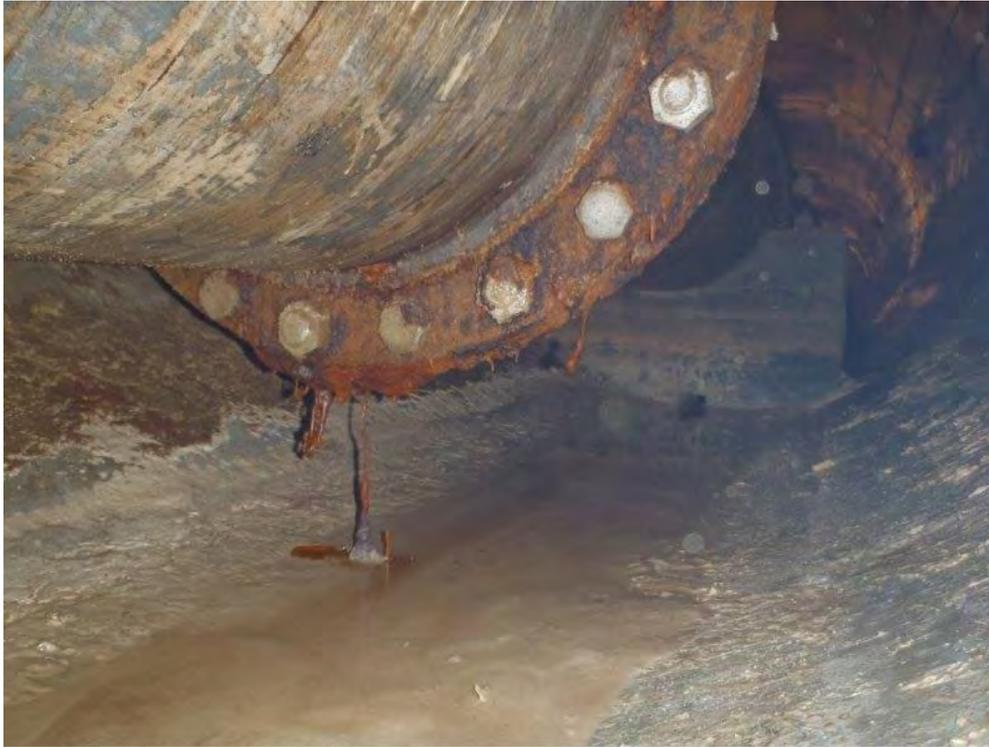
**Figure A 33 – Flange Connection at 5:00 o'clock, 33.96 m from Shaft.**
