REPORT FOR:

Seven Oaks Pool 444 Adsum Drive Building Condition Assessment

Submitted to: City of Winnipeg
Planning, Property, and Development Department
Accommodation Services

Date: April 4, 2019

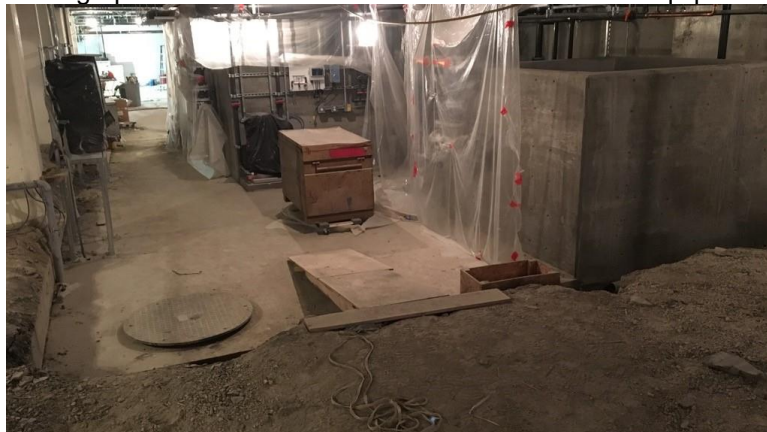
Portions of the original crawlspace were converted to service space to accommodate new equipment required for the addition (Photograph 3.2.1.1-2). Review of building components associated with the addition was not completed and beyond the scope of this assessment.

Photograph 3.2.1.1-2: Partial view of new mechanical equipment.

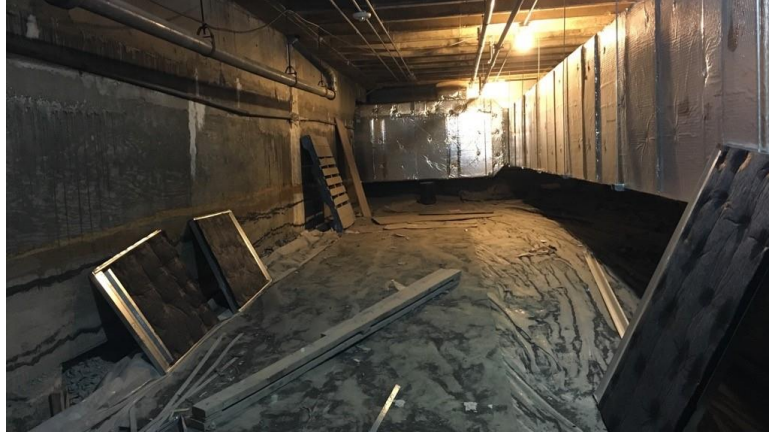
Photograph 3.2.1.1-3: Partial view of crawlspace below the west pool deck.

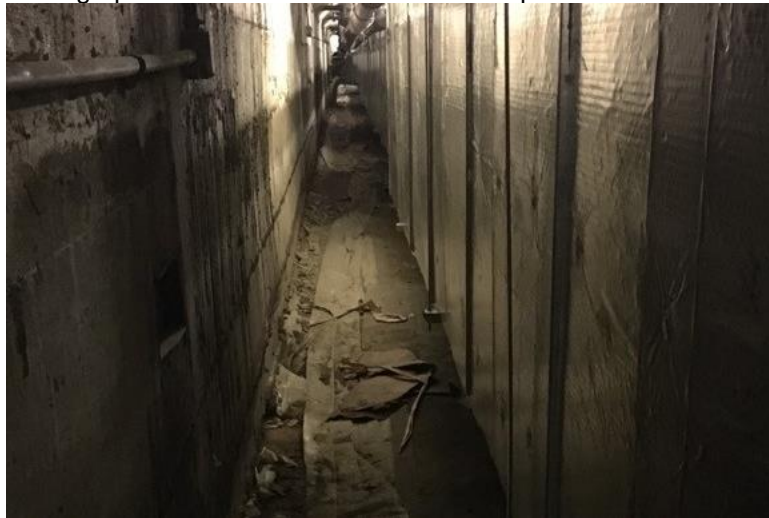
Photograph 3.2.1.1-4: Partial view of crawlspace below the west pool deck.

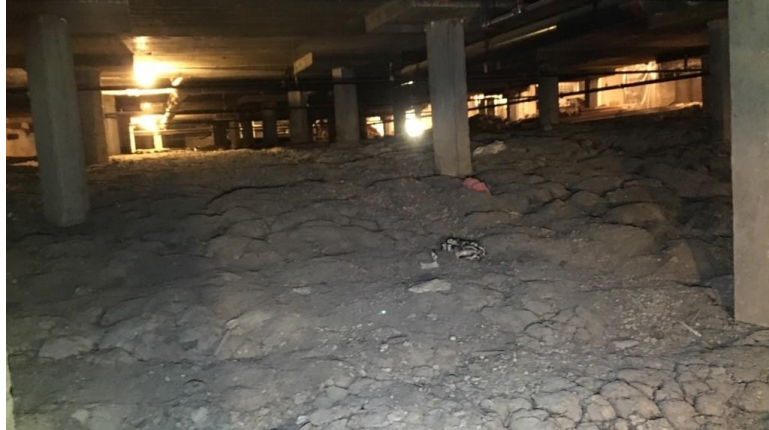
- .1 A crawlspace is located below the pool deck and tanks. The existing vapour retarder was not observed over large portions of the crawlspace including the north side (Photographs 3.2.1.1-1) and below the pool tank (Photograph 3.2.1.1-5 and 3.2.1.1-6). Where a polyethylene vapour retarder was visible, it was generally discontinuous and in poor condition (Photograph 3.2.1.1-1).

The elevation of the existing grade below the pool tank drops at the east end to accommodate the deep end of the pool (Photograph 3.2.1.1-5). The ground in below the deep end of the pool (east) was damp with evidence of crystal growth, possibly from sulphates, on the surface the soil

Photograph 3.2.1.1-5: Partial view of crawlspace below pool tank.

Recommendation 3.2.1.1-1: The crawlspace does not have a functioning vapour barrier. Remediation of the crawlspace is required including grading of the existing soil to direct water away from structural members, installation of a new drainage system and sump pits (if required, see mechanical), and installation of a vapour retarder and sand cover. Installation of new sub-surface drainage, vapour barrier, and sand cover is recommended within 5 years.

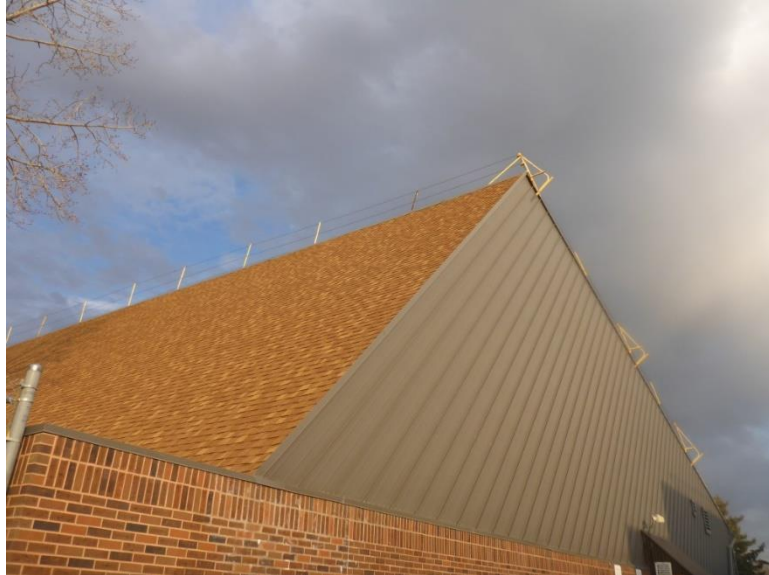
Photograph 3.3.1.4-3: General view of the existing metal cladding along the East elevation of the pool building.

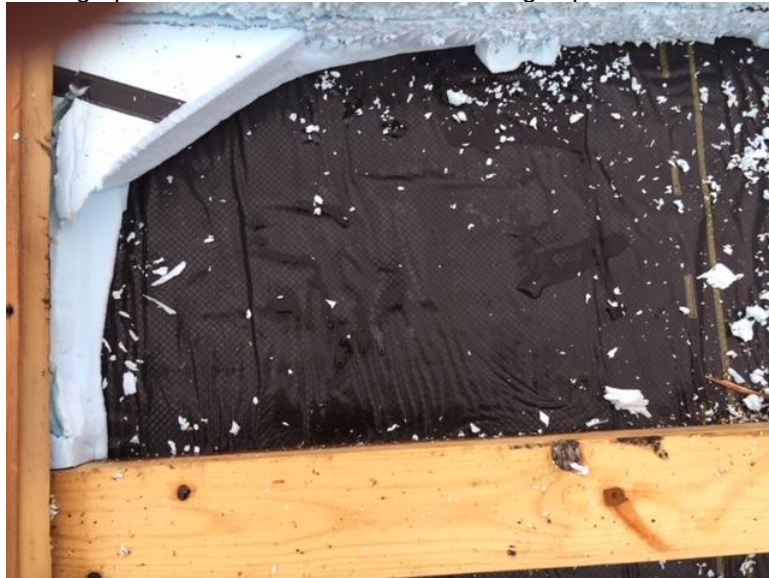
Photograph 3.3.3.1-2: View water on existing vapor barrier.
