# City of Winnipeg

## 600 mm Kildonan-Redwood Feeder Main

Condition Assessment Report, Standard Analysis

**PICA Project: 8054**

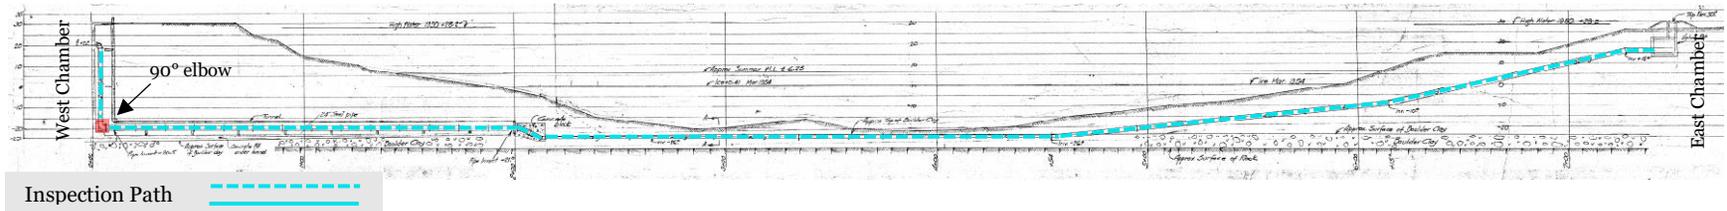
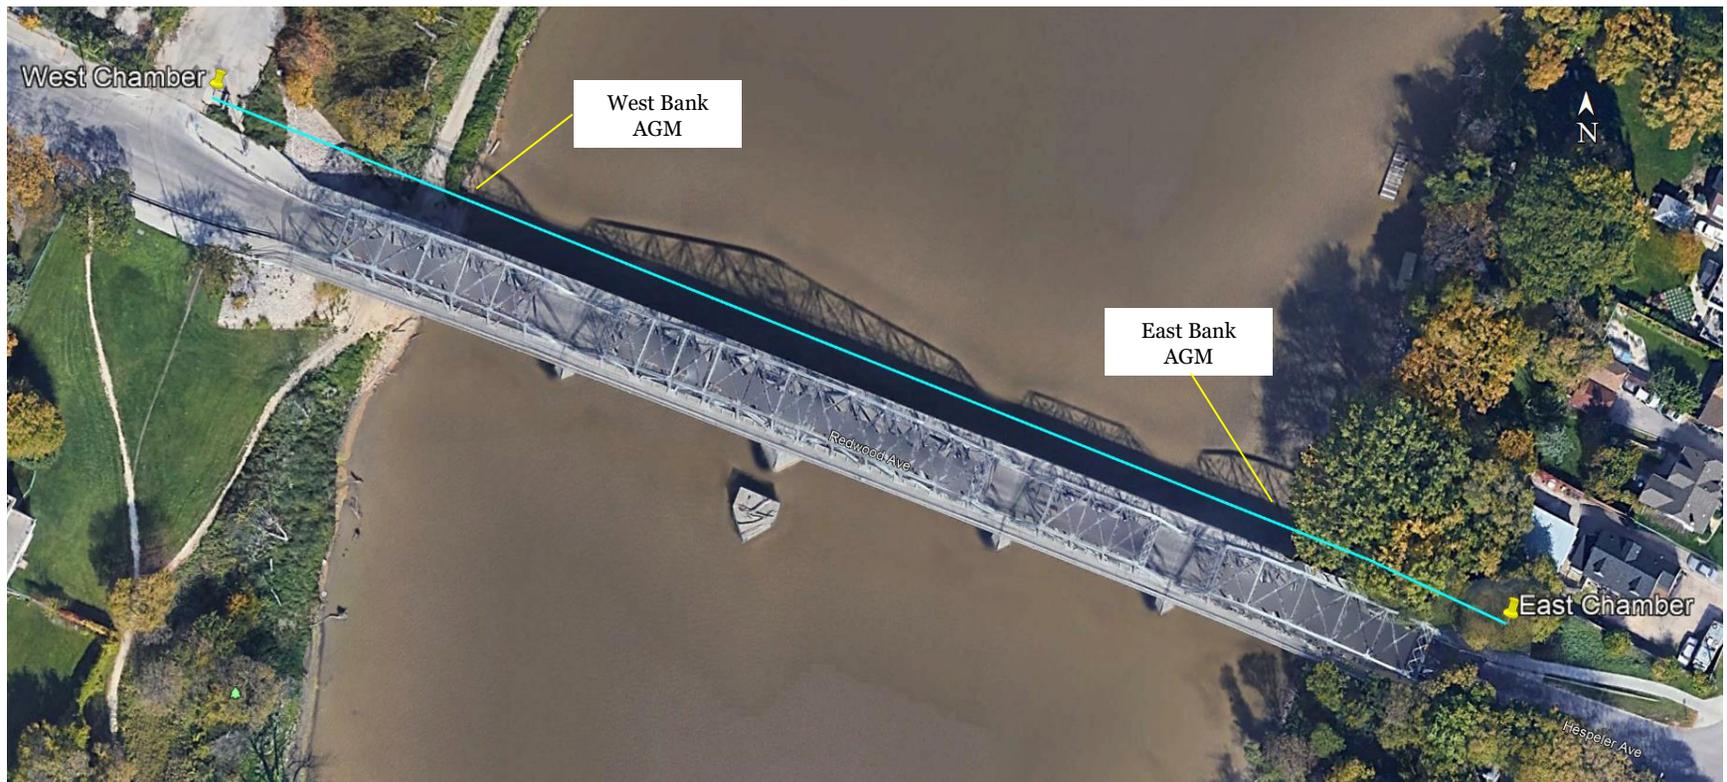
Figure 4. Profile drawing (Drawing No. 12529) and overview path map (Google Earth) of the Kildonan-Redwood Feeder Main that was inspected by PICA during the March 2019 mobilization, which crosses beneath the Red River (source: Google Earth)

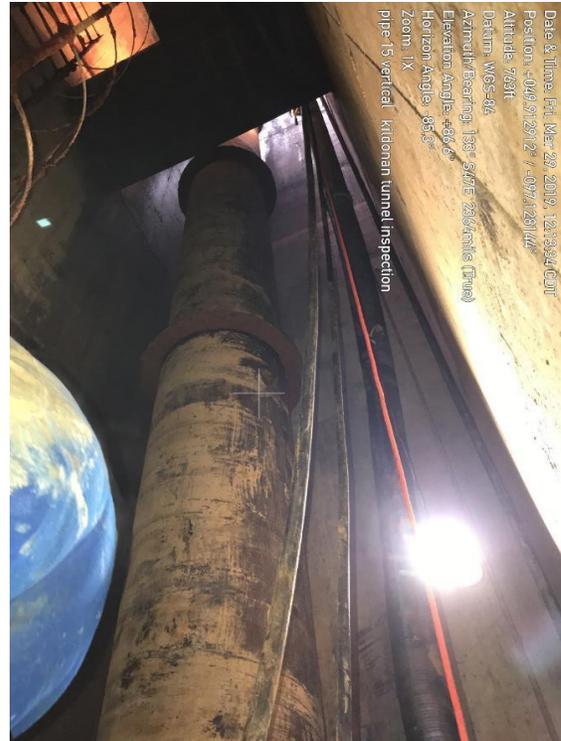
The total length of the vertical portion of the Main is documented as 10.91m, and was measured by the Chimera RFT tool's odometers as spanning 10.80 meters in length. Figure 10 shows an image taken from the tunnel showing the vertical piping extending from the tunnel up to the West Chamber.

Figure 10. Looking up vertical shaft from tunnel. Image shows the vertical steel pipe portion of the Kildonan-Redwood Feeder Main.

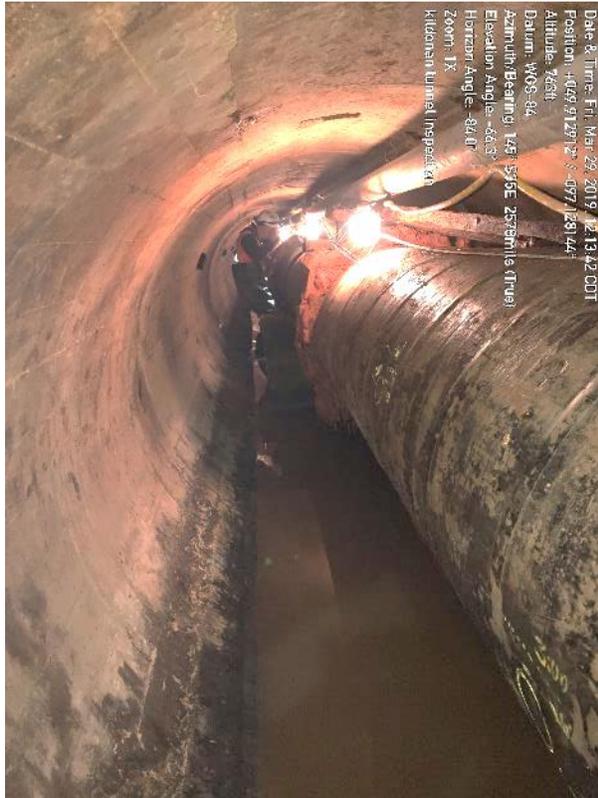
Following the completion of the RFT inspection, a visual inspection was conducted on the horizontal portion of the Main that runs through the tunnel (Figure 16) on the west side of the Red River. Measurements were taken of construction features such as the straps, Victaulic couplings and flange pair connections (Figure 17). Details about the visual investigation can be found in the section **Analysis Results – Visual Inspection**.

Figure 16. Visual investigation of the horizontal portion of the Kildonan-Redwood Feeder Main within the tunnel on the west side of the river.

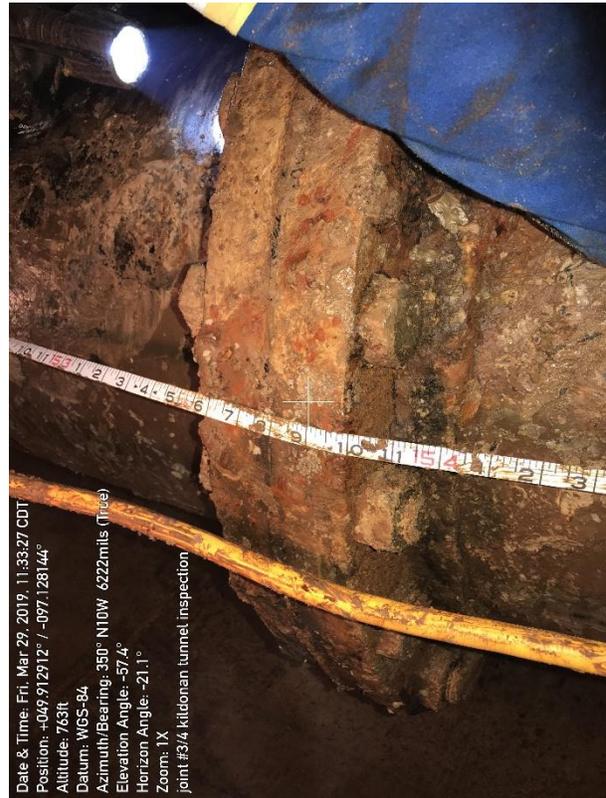
Figure 17. Measurements were taken of construction features within the horizontal portion of the pipe in the tunnel on the west side of the river.

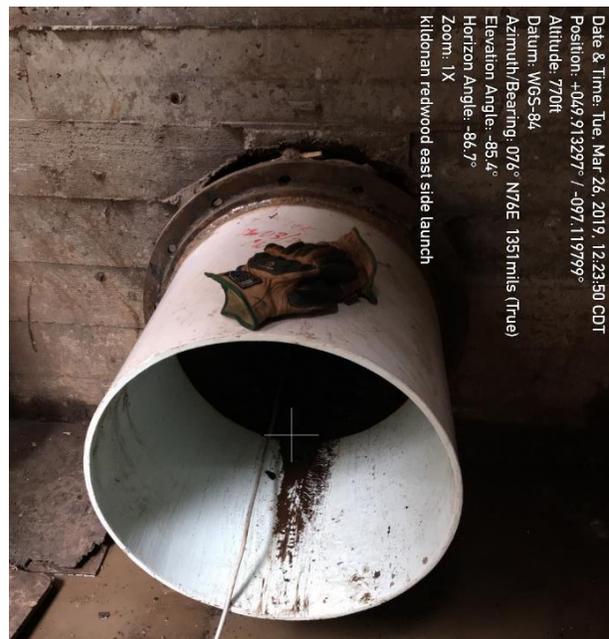
Two connections at the east side of the river crossing are thought to be welds, concurrent with suspected Dresser Style 63 connection rings. These two connections join pipe segments 0010 with 0020, and 0020 with 0030. Pipe 0010 is the white-painted pup piece that was welded to the main in the East Chamber. This pipe segment measures approximately 0.7m in length (please note that odometer data collected at the very beginning of the pipeline is poor in quality due to inconsistencies in the velocity of the RFT tool as it is brought up to the target inspection velocity). Figure 18 shows an image of the pup piece photographed in the East Chamber during one of the inspection runs.

Figure 18. Short segment of pipe in the East Chamber.

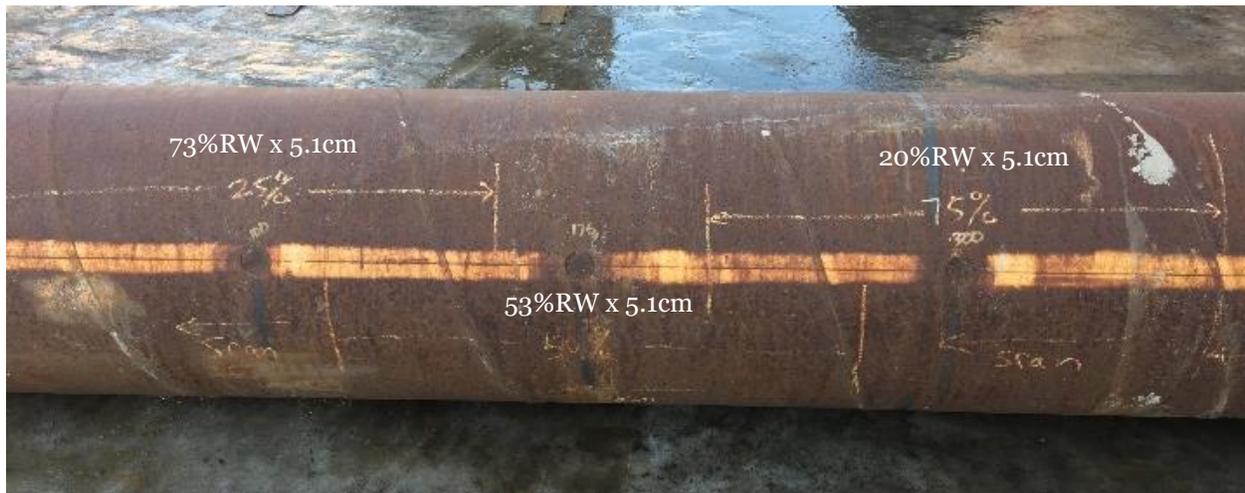
Figure 35 show the circular flat bottom defects, and Figure 37 shows the circular through hole defects machined into the calibration pipe. All defects were visible in the RFT scan of the calibration pipe, including the 1.3cm (0.5in) diameter through hole and the 5.1cm x 73%RW flat bottom defect. Figure 36 shows the RFT scan of the calibration pipe. It is important to note that the results of the calibration may not be directly comparable to the 6.4 mm (0.250in) CML pipe used to construct the Kildonan-Redwood Feeder Main due to the differences in nominal pipe wall thickness and steel grade.

Figure 35. Calibration pipe with 73% RW, 53% RW, and 20% RW 5.1cm diameter flat bottom defects.

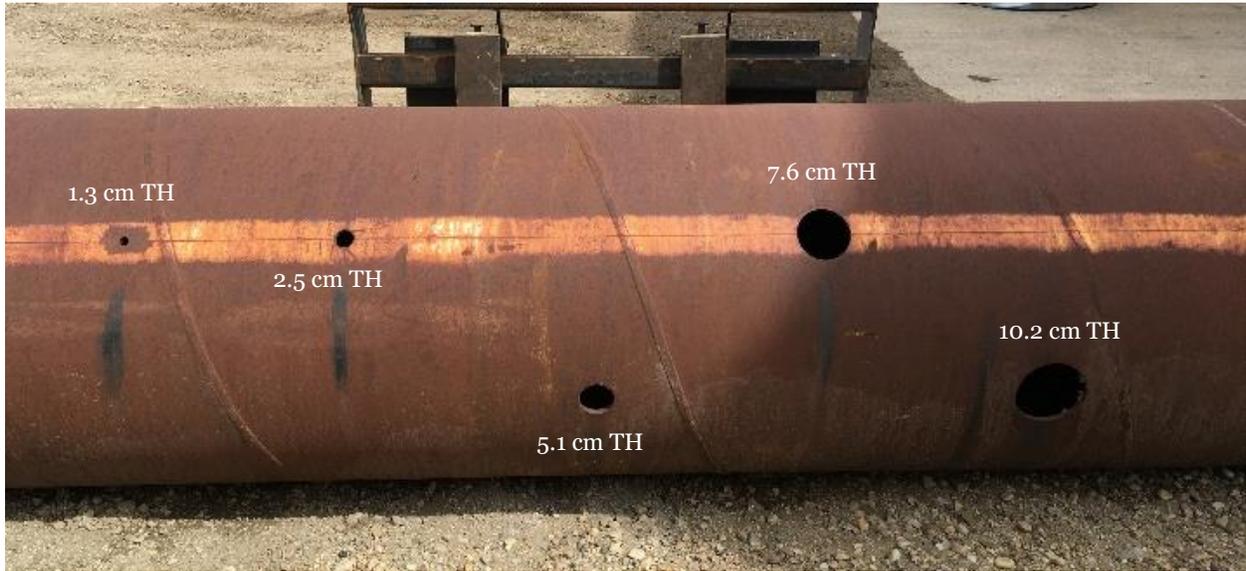
Figure 37. Through holes machined into the 24in calibration pipe. Defects measured 1.3 cm, 2.5 cm, 5.1 cm, 7.6 cm, and 10.2 cm (0.5in, 1.0in, 2.0in, 3.0in, and 4.0in) in diameter.

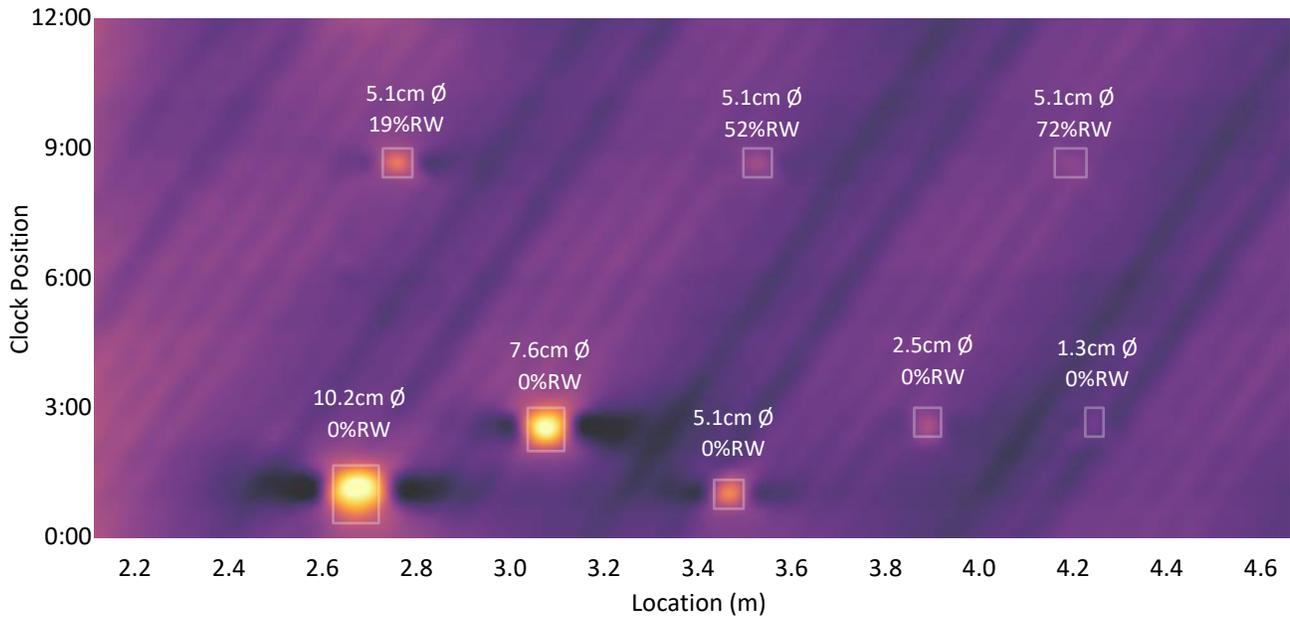
Figure 36. Colour map produced of scanned calibration pipe showing flat-bottom and through hole defects.
