## **CITY OF WINNIPEG**

**WASTEWATER LIFT STATION CONDITION ASSESSMENT PHASE II**

**Document III: Conway Lift Station Assessment**

Date: March 16, 2020

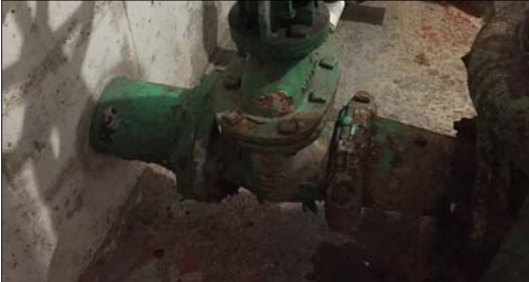
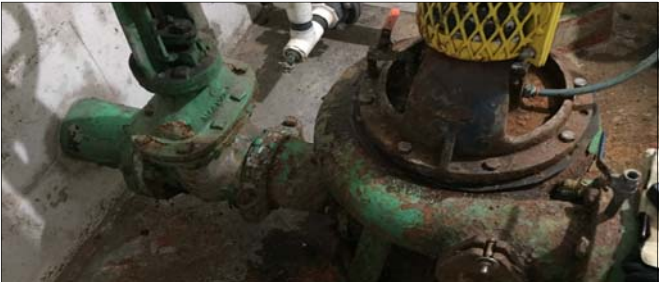
PHOTOGRAPHS

<b>Piping Capacity:</b> <i>Issues for Discussion:</i> Rating 1 (Piping has sufficient capacity for current and projected demand conditions) Rating 2 (Piping has sufficient capacity for current demand conditions with minor surplus) Rating 3 (Piping has sufficient capacity) Rating 4 (Piping does not meet current demand condition) Rating 5 (Piping is critically undersized and likelihood of station backup is high)	1	0.4								
Maintainability and Operability	<b>Sufficient Access to Perform O&amp;M Activities Safely:</b> <i>Issues for Discussion:</i> Rating 1 (Yes - No access restrictions) Rating 2 (Yes - Some minor access restrictions) Rating 3 (Yes - Access restrictions that cause minor alteration of work method) Rating 4 (No - Access restrictions cause significant alteration of work method) Rating 5 (No - Access restrictions prevent safe completion of O&M activities)	2	0.6							
	<b>Isolation Valves Installed:</b> <i>Issues for Discussion:</i> Rating 1 (Yes ) Rating 5 (No)	1	0.4
