The City of Winnipeg High Risk River Crossings – Phase Two Condition Assessment Report

April 2020

Project Number: 60549028

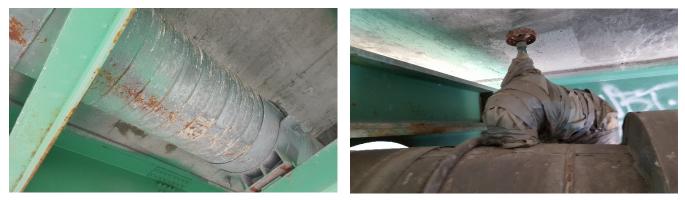
Figure 10: Site 3 - Preliminary External Inspection

AECOM completed a preliminary external inspection of the force main on February 8, 2018 with support from the City's under bridge inspection crane truck. The purpose of the inspection was to flag any obvious signs of external pipeline deterioration that would assist in the selection of inspection locations. Beyond some minor surficial corrosion and remnants of previous works (see Figure 10) the pipe appeared to be in relatively good condition.

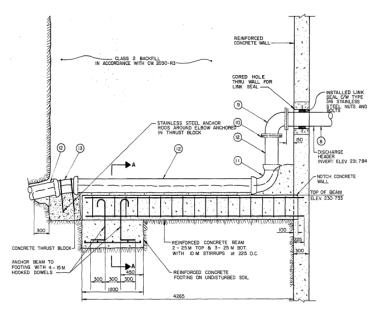
Figure 18: Site 5 - Pumping Station Connection

A review of the force main alignment revealed the presence several 90 deg elbows along the alignment making a complete inspection of the force main impossible due to the inability of most SONAR platforms to traverse sharp bends in smaller diameters. The 90 degree elbows included two immediately outside of the pumping station (see Figure 18), precluding launching an inline tool from within the station. Ultimately the preliminary structural assessment (see Section 3.3) concluded a SONAR inspection wasn't required due to the conservative nature of the original design versus the external loading conditions present.

- Inspection utilizing an internal SONAR platform is not practical.
- Sampling and testing to confirm material properties would be sufficient to confirm the condition of the force main:
 - o Sampling to occur adjacent to the pump station to avoid other utility conflicts.

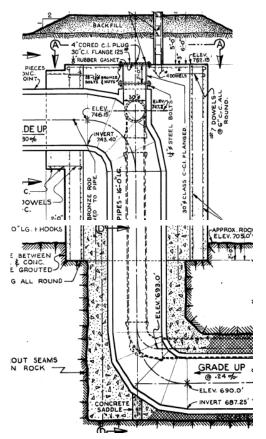
Figure 21: Site 6 - Drop Pipe Configuration

To navigate the tunnel shaft and tunnel, the original designers included a series of 90 deg elbows (Figure 21). At the top of the tunnel shaft the feeder main runs north on both sides of the river to adjacent valve/drain chambers. As discussed in Section 5, there are platforms that can traverse 90 degree bends, however, it does increase the risk associated with inspection, especially when there are multiple bends on a single deployment. In addition to 90 degree bends, the adjacent valve chambers contain butterfly valves, which greatly increase the risk of deployment in inline EM Platforms.

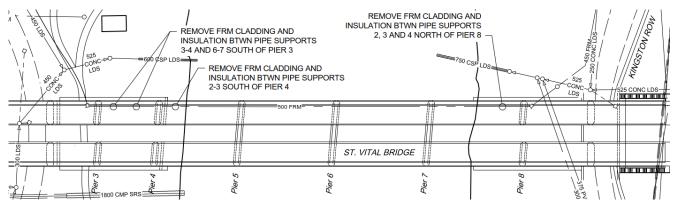
Figure 31: Site 3 - Proposed Inspection Locations

Through the information and preliminary investigations completed by AECOM (see Section 3.2.3), five discrete locations were recommended, all approximately 2.7 m long (Figure 31).

Based on the discussion in Section 3 and above, AECOM recommended the use of an external RFT EM inspection bracelet for spot inspections on the St. Vital Bridge Force Main crossing. To facilitate inspection utilizing an external RFT tool the pipeline cladding and insulation would be removed at discrete, select locations. The discrete inspection locations were used to infer the condition of the crossing as a whole.

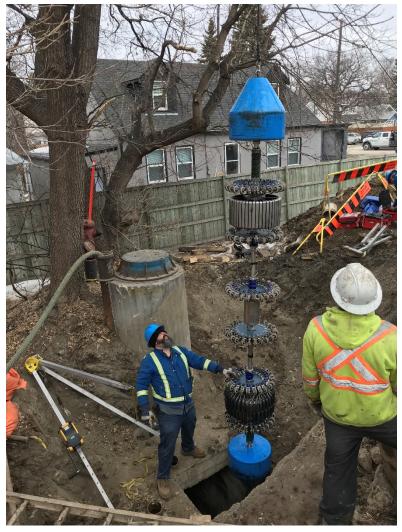
Figure 32: Site 1 - RFT Tool Insertion

The EM inspections occurred between March 26th and 28th, 2019 without major issues. Figure 32 depicts insertion of the tool at Site 1, through the existing east valve chamber. PICA's inspection reports can be found in Appendix H. On March 27, 2019, after completion of the inline inspection on the Kildonan-Redwood feeder main, PICA and AECOM completed an inspection of the feeder main piping within the drop shaft and tunnel supported by J-Con. AECOM's inspection report can be found in Appendix G.

- Nine pipes were identified to have localized wall loss with a total of 18 discrete defect locations. The worst corrosion related defect identified had 40% remaining pipe wall, with a majority of the defects having 65% remaining pipe wall. Defects appear to be relatively evenly spread along the length and circumference of the pipe outside of the tunnelled section.
- The tunnel inspection found the existing pipe and coatings were in relatively good condition. No noted corrosion of the pipe itself and only several blemishes in the coating were observed. The tunnel inspection did note that the existing Victaulic couplings and ventilation piping components were severely corroded.

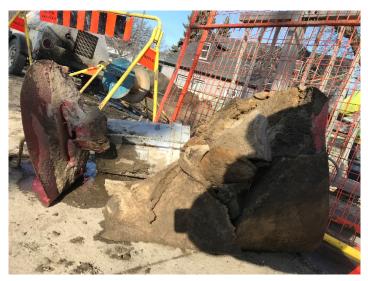
Figure 33: Site 1 - Shredded Foam Cleaning Pig

- Inadequate measurements prior to procuring the new steel pipe components within the east valve chamber resulted in modifications to how the 600 mm welded spool piece was installed. It was ultimately, fit inside a portion of the existing slip coupling and welded externally to the existing coupling.
- The contractor shredded a foam cleaning pig within the line and had to complete additional cleaning efforts to retrieve the foam components of the pig, (Figure 33)

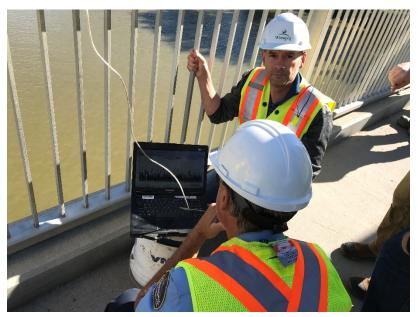
Figure 34: Site 1 - 2nd Correlator Inspection

Subsequent to the low head leakage tests on the Kildonan-Redwood Feeder Main crossing the City of Winnipeg's Water Services Branch completed two correlator inspections of the crossing with the intent of locating the leak. Unfortunately, the first test, completed on April 18, 2019 was inconclusive due to equipment error. Based on subsequent discussions with the Water Services staff the cause of the error was lack of connectivity between the wireless sensors and the base unit. Water Services completed a second correlator inspection on September 6, 2019 with longer lead cables on the pipe sensors and the base unit located in the middle of the Harry Lazarenko Bridge (see Figure 34). While no equipment errors were noted, the test was still inconclusive as no discrete leak location was identified. While the reason not detecting leak locations during the second correlator inspection is unknown, it is suspected that multiple small leaks may be present resulting in no single large detectable leak.

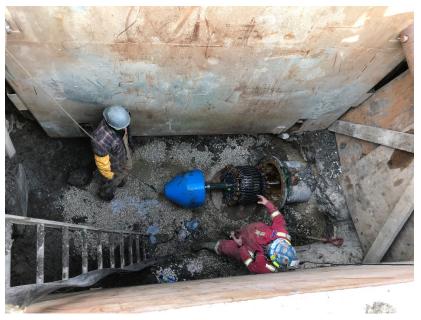
Figure 35: Site 2 - FRT Tool Removal

The EM inspections occurred between March 26th and 28th, 2019 without major issues. Figure 35 depicts removal of the tool at Site 2, through the existing east valve chamber. PICA's inspection reports can be found in Appendix H.

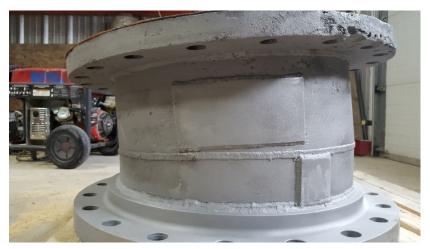
Figure 36: Site 2 - Repaired Spool Piece Prior to Coating

- Changes in the feeder main pipe layout from that depicted on the record drawings and the contractor's shoring system resulted in the launch wyes being installed further from the existing chambers than show in the tendered design.
- Coating failures and corrosion of the existing feeder main piping resulted in the need for some patching and coating repairs. Figure 36 depicts steel patches welded to an existing flanged spool piece (bend) uncovered and reused on the south side of the crossing.

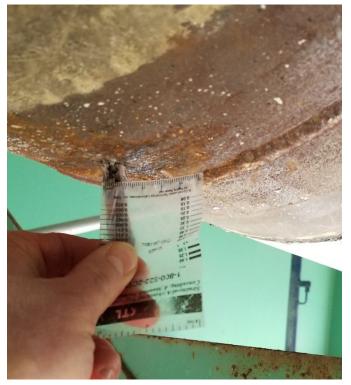
Figure 37: Hole in St. Vital Bridge Force Main

Preparation work for the external inspection at Site 3 – St. Vital Bridge Force Main commenced on October 15, 2018 with the stripping of external cladding and insulation, see Drawing 11820. Unfortunately, the contractor uncovered a leak in the force main between supports 5 and 6 north of Pier 8. The hole was approximately 10 mm in diameter, see Figure 37. At the same time, another leak was noticed at the next pipe joint to the north, located over the river. Due to the discovery of two additional leaks, in addition to a leak which had occurred earlier in the year, further preparation work was suspended until AECOM could complete additional investigation into the condition of the pipe.

On October 26, 2018 AECOM completed an Ultrasonic Thickness (UT) wall thickness survey on the exposed sections of the force main. The survey found that the force main exhibited severe invert corrosion along the length of the pipe, with areas (outside of leak locations) registering wall thicknesses of less than 1 mm. The UT inspection report can be found in Appendix J.

As a result of the findings, it was concluded that the pipeline was exhibiting signs of severe invert corrosion and in need of immediate rehabilitation or replacement. Thus, the proposed external electromagnetic inspection was cancelled, and the WWD's Design and Construction Branch initiated a concept study for rehabilitation/replacement of the force main.

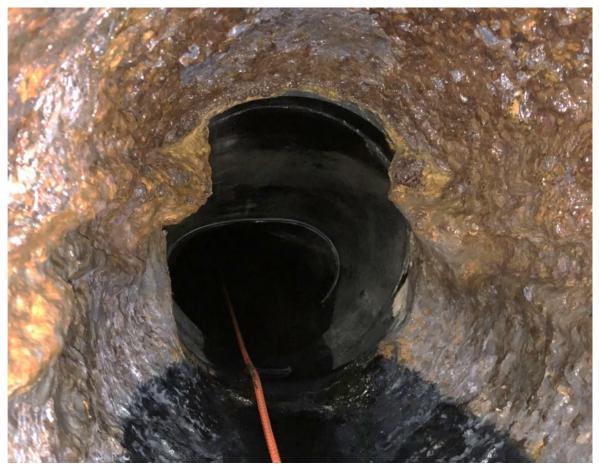
Figure 38: Site 4 - Deflection in HDPE Force Main

Upon commencement of the cleaning operations, the contractor noticed an approximate 30% deflection in the force main immediately adjacent to the west discharge chamber, see Figure 38. This resulted in a reduced cleaning effort with soft pigs only to ensure navigation through the heavily deflected pipe.

The CCTV inspection found that the HDPE pipe was split immediately adjacent to the HDPE/Cast iron connection to the west discharge chamber (Figure 42). This was likely attributable to the 30% deflection found immediately downstream (Figure 38). The City ultimately installed an internal ambient cure CIPP spot repair at the split location and the force main passed the subsequent leakage test.

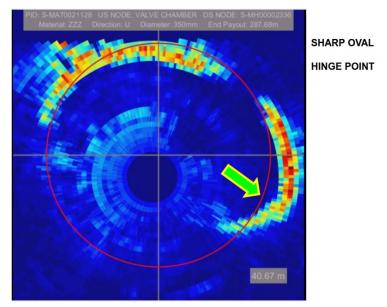
Figure 39: Site 4 - Sonar Inspection Results (Hinge Point)

The SONAR and CCTV inspection was completed on November 13, 2018 by AquaCoustic. Due to the known 30% deflection in the pipe, the SONAR tool was launched with a reduced centralizing setup to ensure passage through the pipe. This resulted in a reduction in the SONAR quality due to movement of the SONAR unit and increased assessment efforts. Nonetheless, results of the SONAR inspection indicate the pipe to be suffering from severe geometric defects along its length in the form of hinges, reverse curvature, and dents. Figure 39 depicts an example of the SONAR data with a sharp hinge point in the pipe wall. Figure 40 provides a summary of the pipe wall defects identified through the inspection.

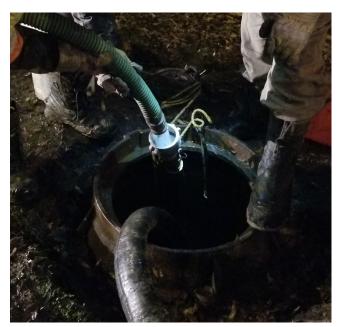
Figure 41: Site 4 - Low Head Leakage Test

Low head leakage tests were completed as part of the CA process. The low head leakage test was completed on the crossing at 49 kPa (7 psi), premised on the normal operating condition of the pipe, which roughly equated to static water level at grade at the valve chambers. The test pressures were intentionally kept as low as practically possible due to the sensitivity of the pipe to a heightened stress condition. To prevent over pressurization the test was carried out using stand pipes (rigid suction hose) and a water tank which was used to fill the line and maintain the static water level within the crossing (see Figure 41).

The first leakage test measured an apparent leak of approximately 800 L per hour. A subsequent test confirmed a leakage rates between 830 and 885 L per hour. Based on the level at which water within the crossing stabilized after the tests (566 mm above the pipe invert within the east valve chamber), the leak was believed to be located within the banks of the river. The City engaged Uni-Jet to complete a CCTV of the upper portions of the siphon, with particular attention being paid to the HDPE discharge chamber connection and the vertical/horizontal bends on the west side of the crossing.

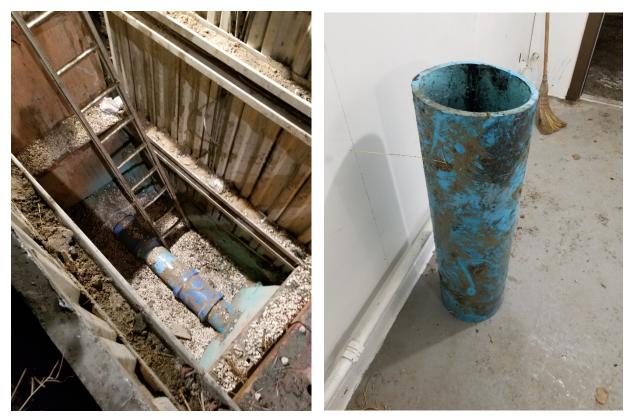
Figure 43: Site 5 - PVC Force Main Sample Retrieval

Sampling of the Heritage Park Force Main was completed by J-Con on November 22, 2018. An approximately 1 m long sample was obtained from the force main (Figure 43). A portion of the sample collected was sent to PSI labs in Colorado for material testing.

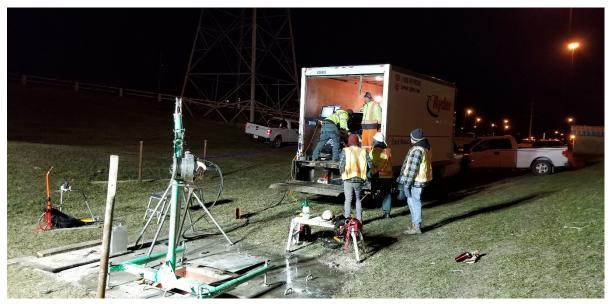
Figure 44: Site 6 - Sahara Inspection

The inspection occurred overnight between October 23rd and 24th, 2018. Figure 44 shows the inspection setup and tool launching apparatus.

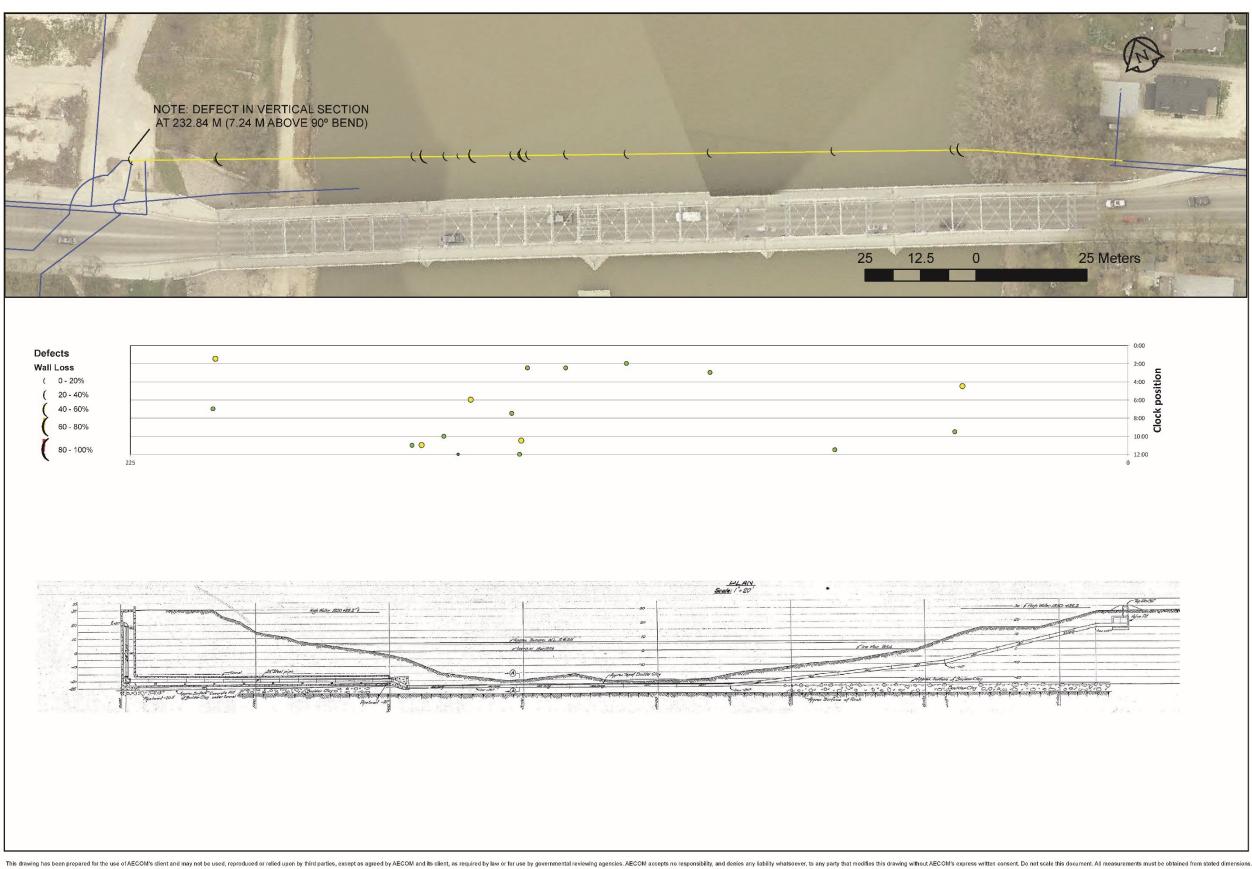
Figure 46: EM Inspection Results – Site 1 – Kildonan-Redwood Feeder Main

- Ten pipes were identified to have localized wall loss with a total of 111 discrete defect locations.
- The worst corrosion related defect identified had 16% remaining pipe wall, with a majority of the defects having between 40% and 65% remaining pipe wall.
- While there are defects spread along a majority of the pipe, a high percentage of those identified are located near the north bank of the river.

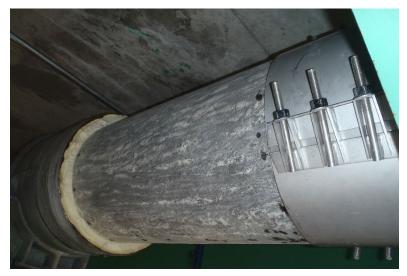
Figure 50: Site 3 - UT Inspection Locations

While originally slated for an external electromagnetic inspection by PICA, the St. Vital Bridge Force Main was inspected by AECOM using our UT wall thickness measurement instrument. Inspection at exposed areas of the pipe at both ends of the force main found the pipe was exhibiting severe invert loss along the length of the force main. Figure 50 depicts the pipe after UT measurements near the leak on the south river bank. The dark spots are the locations where UT measurements were taken. The UT measurements found wall thicknesses as low as 1 mm along the invert of the pipe. AECOM's inspection report can be found in Appendix J.

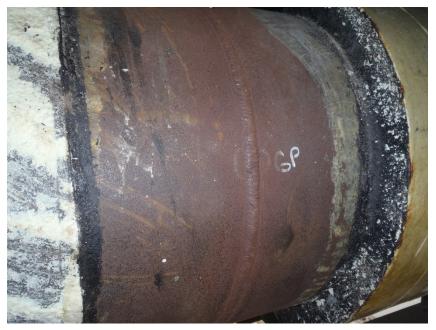
Figure 51: Site 3 - Exterior Pipe Corrosion

Exterior inspection of the pipe found minimal corrosion, compared to that measured by the UT tool (Figure 51). Thus, the cause of the wall loss is believed to be a combination of corrosion and abrasion on the interior of the pipe

(commonly referred to as erosion corrosion). Based on a review of record drawings and the original specifications, the pipe was installed without any interior coating. Typically, the corrosion process results in the formation of corrosion product which acts to reduce the corrosion rates. However, the configuration of the force main where it crosses the Red River will result in the transported sediments coming out of suspension causing the sediment to be deposited in the invert between pump runs. When the pumps start up again this sediment will be transported along the invert acting to abrade the formed corrosion product. This can greatly accelerate the corrosion process along this localized area of the pipe. Based on the condition of the pipeline the pipe was recommended for immediate rehabilitation or replacement.

The City installed a temporary bypass for the force main in 2019 and after additional leaks were found, put it into service. Further, the City is currently in the process of developing recommendations for rehabilitation or replacement of the crossing, consistent with AECOM's recommendations for the crossing.

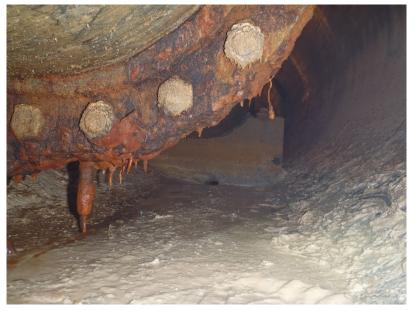
Figure 55: Site 1 - Bolts and Flange Within the Tunnel

- Based on record information, the pipes and joints for the buried sections of the crossing were coated prior to
 installation. Coatings within the tunnel section appear to be in good condition within the tunnel but the joints were
 noted to have not been coated after assembly. Figure 55 depicts the typical condition of the joints within the
 tunnel section. The pipe exposed on the Charleswood-Assiniboia Feeder Main showed extensive corrosion at
 field assembled flange joint and adjacent field welded joint where poor coating and stainless steel bolts were
 used (Figure 56). Based on the records for the Kildonan-Redwood Feeder Main it appears that stainless steel
 bolts were also used which could cause localized corrosion at the flanges similar to what was seen at Site 2.

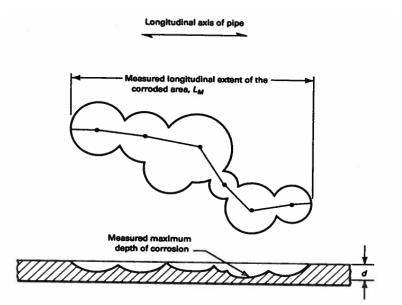
Figure 60: ASME B31G - Pressure Capacity Analysis of Corrosion Pitting

In addition to evaluating the hoop stress for reduced wall thicknesses, a Level 1 assessment was undertaken for all steel pressure pipe crossings to assess the effects of pitting on the internal pressure capacity as per ASME B31G. Using this methodology, a failure stress is estimated based on the axial length and maximum depth of pitting in a single corrosion feature (a string of corrosion pits). Figure 60 depicts the assumed condition for an ASME B31G analysis. The estimated failure stress is converted to a pressure and compared to the internal operating and surge pressures experienced by the pipe.

In the reports submitted by PICA, the depth of pitting and length of defect was provided. Further, AECOM UT measurements on the St. Vital Bridge Force Main indicate a strip of corrosion that extends from end to end of the pipe. To account for potential future progression of defects, a review of maximum allowable defect was undertaken. The sensitivity of the estimated failure stress to corrosion length decreases with greater lengths and eventually approaches a plateau. To provide a conservative look at the impact of corrosion, estimated failure stresses reflect the reduction in pressure capacity at the maximum extent of the potential corrosion defect string.

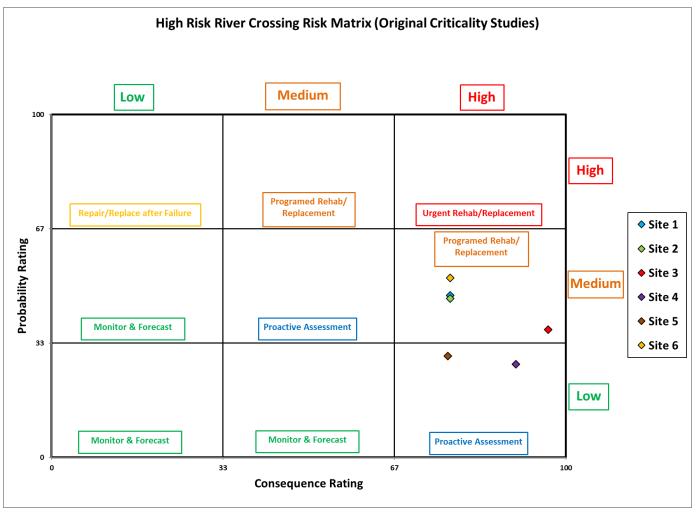
Figure 61: Risk Matrix – Original Criticality Studies

All assets in this program are considered to have varying degrees of high criticality. Through initial screening in the studies referenced earlier in this section, the risk of failure of these assets was considered to be the high end of low to medium. A plot of the probability of failure rating vs the consequence of failure rating for each crossing is provided in Figure 61. Without completing CA on the crossings, four of the crossings would have been identified for planned replacement in the near term (the crossings with medium probability and high consequence ratings).

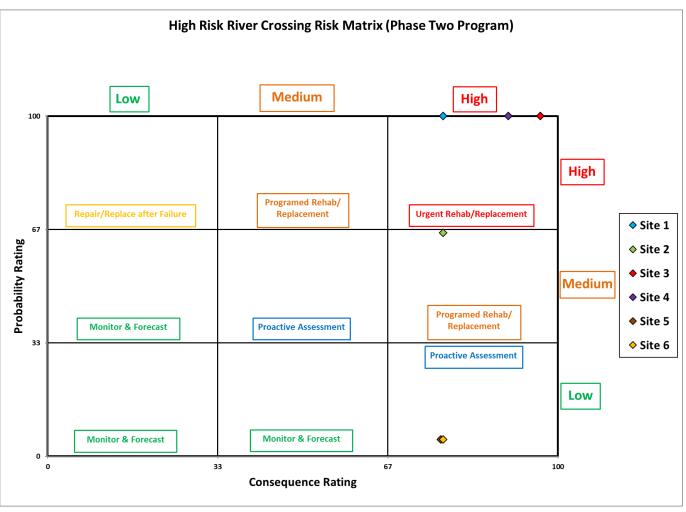
Figure 62: Current Pipe Failure Risk Rating

- Sites 1, 3, and 4 were elevated to a high probability of failure. In fact, they had failed and were actively leaking.
- Failure risk increased for Site 2 but it remained in the medium probability of failure classification.
- Site 5 and 6 were reduced to a low probability of failure.

Figure 62 displays current risk rating, based on assessed pipe condition and geotechnical conditions.

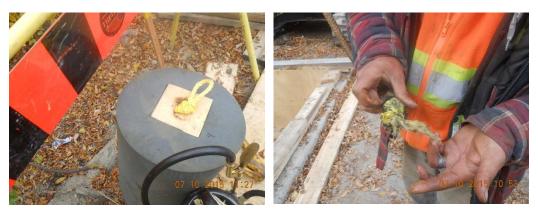
Figure 2 - Foam Pig with Nylon Pull Rope (left) and Broken Pull Rope (right)

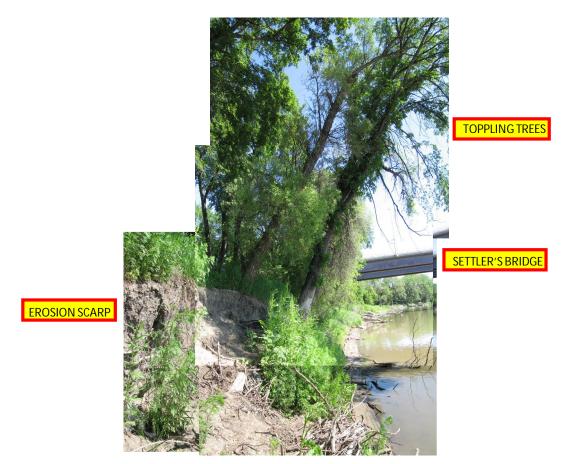
Figure 2 – Vertical erosion face and toppling trees at river edge.

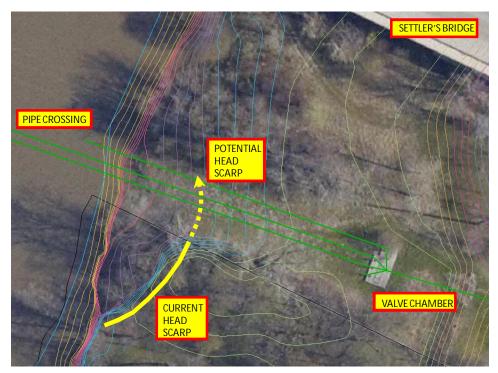
Figure 3 – Scarp south (upstream) of ROW on east bank from 1998 contour data.

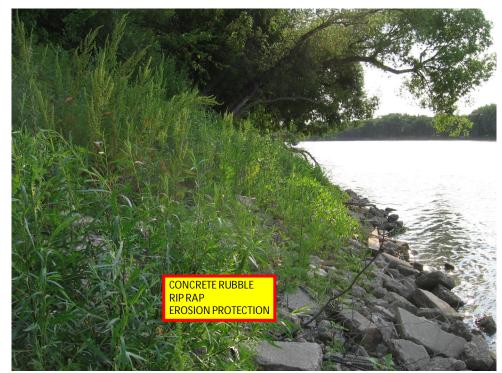
This site is located at the intersection of Scotia Street and Newton Avenue (469 Scotia Street), south of Kildonan Park. The upper bank is manicured lawn and sparse trees (some of large diameter near the top of the bank) surrounding the station. The lower bank is steep and armored with concrete rubble rip rap (Figure 4). Field stone rip rap is present surrounding the outfall pipe. There is no indication of structural distress at the station nor is there evidence of river bank instability. Property north (downstream) of the crossing has concrete stairs leading down the river bank to the river edge and are in good condition suggesting no evidence of bank displacement, though retaining walls have rotated into the river. Limestone rip rap extends to properties farther upstream.

Figure 4 – Concrete rubble used for rip rap as erosion protection.

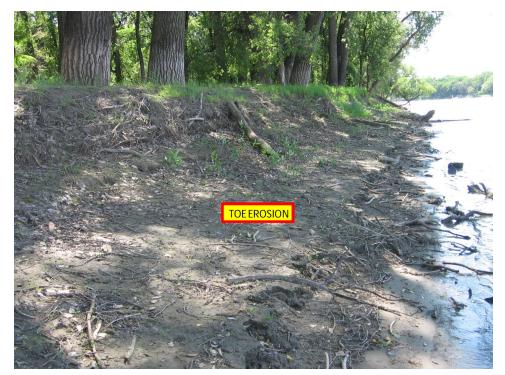
Located in Fraser's Grove Park, the site consists of a shallow long slope leading from a berm that carries a pedestrian / bicycle path (that also forms part of the City's primary dike system) to the river edge. The terrain is manicured grass with large trees and no significant underbrush except near the river edge. At the river edge there is evidence of toe erosion (Figure 5) but no bank instabilities. Runoff erosion channels have also formed at some locations. Wave action has carved 150mm steps in the alluvial soil at some locations. No erosion protection is present.

Figure 5 – Erosion at bank toe.

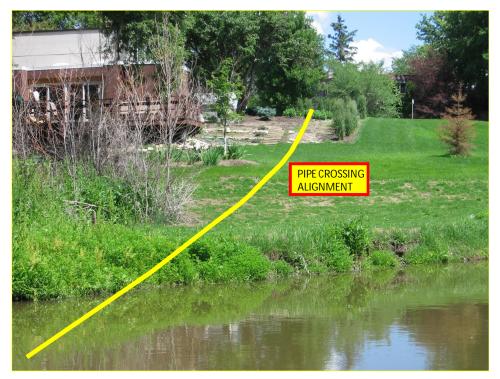
Figure 6 – Gentle slope on north bank with vertical edge of bank.

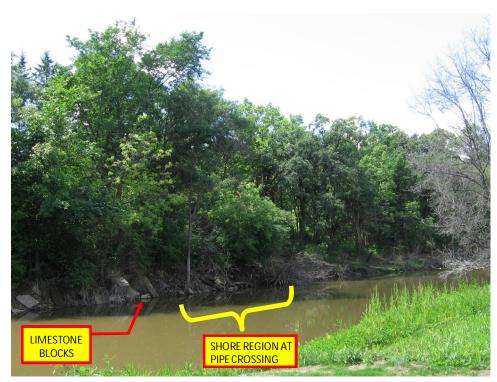
The interceptor alignment passes through the northwest corner of 147 Ashcroft Point. The site is heavily treed with both large trees and underbrush. There is no evidence of river bank instability or erosion. Though the bank can be categorized as alluvial soil, erosion remains in check due to armoring at the riverbank toe consisting of large concrete rubble and large carved limestone blocks (Figure 7).

Figure 7 – Steep south bank with sparse limestone blocks and rubble at river edge.

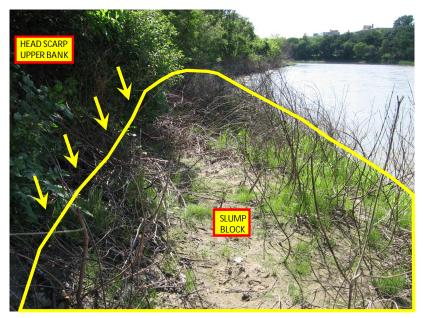
The south bank is located on Assiniboine Park Drive within Assiniboine Park and immediately north of the zoo. The bank is heavily treed with predominantly smaller trees and underbrush. A slump block (bank failure) extends across the pipe crossing alignment and is about 95m-long, parallel to the river, and about 6m wide at the crossing location (Figure 8 and Figure 9). The head scarp ranges from

1.2m to 2.1m in height. The soil at the scarp appeared fresh and may suggest relatively recent displacements. Erosion is not significant at the toe with the bank height at the river edge of 900mm. The river edge is near-vertical and well vegetated. Dead willows were present on the slump block.

Figure 8 – Top of slump block facing upstream (west) from location of pipe crossing.

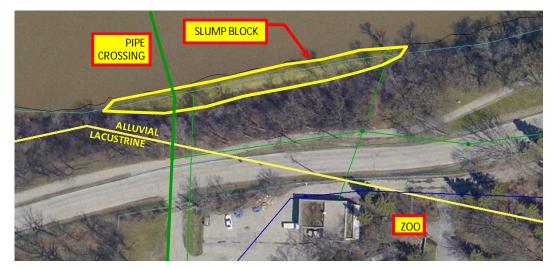
Figure 9 – Extent of slump block relative to pipe crossing.

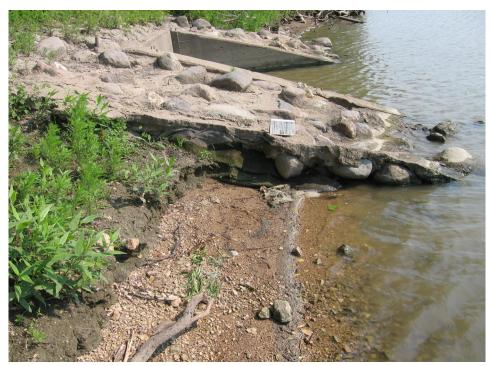
This site is located at 75 Scotia Street at the intersection of Scotia Street at Polson Avenue. The ROW consists of manicured lawn and no significant tree vegetation. There is no evidence of river bank instability. The outfall pipe at the river toe is encased as a monolithic structure with concrete headwall and wing walls. Grouted rip rap is located immediately upstream and downstream of the wing walls with no adjoining loose rip rap. Erosion has occurred on the bank adjoining the grouted rip rap and resulted in the bank toe receding upland. The vertical difference between the top edge of the grouted rip rap and the existing shoreline surface is 400mm which translates to about 1.2m of horizontal bank recession (Figure 10).

Sparse rocks are located at the toe but in insufficient quantity to be considered as a concerted effort at rip rap armoring. Erosion at the shoreline has produced a 300mm to 600mm erosion scarp. North (downstream) of the ROW there is a 2.1m high scarp (79 Scotia Street). Limestone rip rap is present at the first property south (upstream) of the station (71 Scotia Street) and at the second property north (89 Scotia Street).

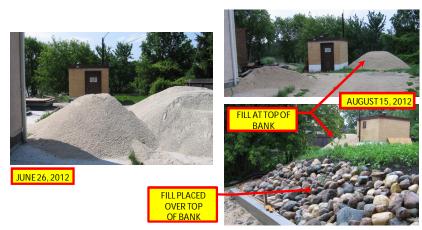
adjacent to the chamber building along with construction of a concrete pad near the south edge of the property and rock landscape feature with concrete grade beam over the top of the bank (Figure 11). Placement of additional fill material at the top of a river bank has a destabilizing effect and is to be avoided.

Figure 11 – Fill placed at and over top of bank on ROW by neighbouring property owner.

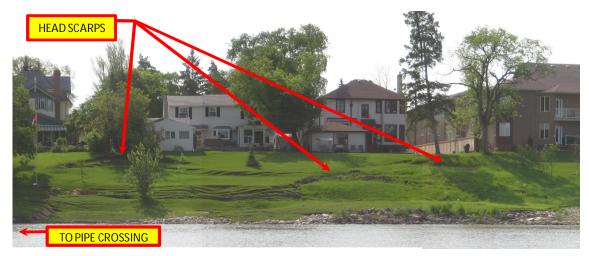
Properties located south (upstream) of the ROW at 518, 502, and 500 Henderson Highway present current river bank failures with multiple scarps and evidence of retrogressive bank failure (Figure 13). These properties no longer have large trees on the property and had been landscaped to form manicured lawns. Aerial photographs from 2007 show large trees present at 500 Henderson Highway that were removed in the 2009 aerial photographs. In 2009, a head scarp and rolling terrain, indicative of bank failure, is present at 500 Henderson Highway. The large building at 488 Henderson Highway is not present in the 2007 and 2009 photos and large trees are present at the river bank toe. This toe vegetation was since removed to become the present condition.

Figure 13 – Neighbouring river bank failures upstream of ROW.

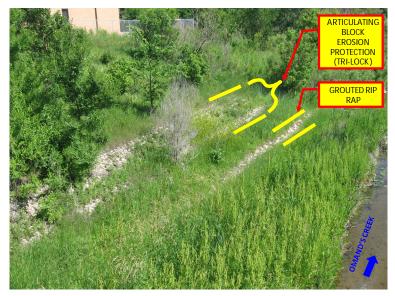
Site 7 is located on Omand's Creek immediately south of the Portage Avenue bridge crossing. It's also located west of 1420 Portage Avenue. Since the site is contained within a small area it is treated here in its entirety. The slopes on both banks have been graded and protected with concrete articulating blocks (Tri-Lock) and grouted rip rap (Figure 14). The erosion protection is located at discrete locations on the bank surface and appears to coincide with specific water elevation events. The articulating blocks are about 3m wide and located on a higher portion of the bank. The grouted rip rap contains about 300mm diameter limestone and is about 600mm wide and is closest to the creek edge. Both types of erosion protection extend parallel along the creek for a distance of 30m south of the bridge abutment.

Figure 14 – Articulating block erosion protection (Tri-Lock) and grouted rip rap on east bank. Photograph taken from bridge at Portage Avenue.

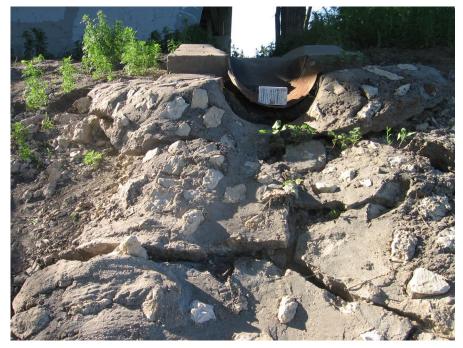
The north bank is located on Osborne Street at Churchill Drive. The pipe enters the ground upslope of the second pier from the river edge (43m from river edge). There is no evidence of river bank instability at the site. Riverbank toe is armored with loose rip rap with no erosion present. Rip rap appears to have deposition in void spaces. The rip rap extends 45m upstream and 30m downstream of the nearest edge of the bridge. Outside of this protected area the river banks are steep with evidence of bank failure due to undercutting erosion on alluvial banks. Concrete drains show no sign of structural distress. Separation of grouted rip rap at drain outlet does not appear to be related to underlying bank stability issue and may be caused by post construction settlement, freeze-thaw action, or ice floe action (Figure 15).

Figure 15 – Cracking of grouted rip rap and separation from bridge drain outlet.

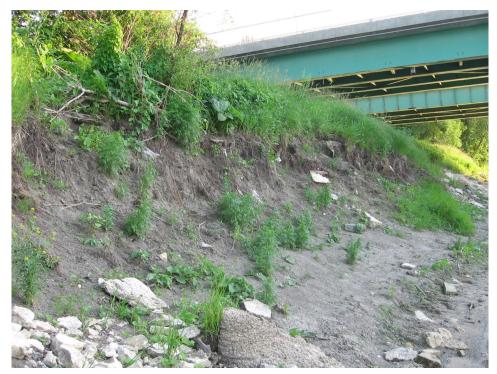
Rip rap coverage is limited to 16m west (upstream) and 10m east (downstream) of the bridge. To the west, between a distance of 16m to 28m upstream, the rip rap becomes sparsely distributed and there is evidence of surficial displacements in the upper bank. In the downstream direction (east), beyond the 10m rip rap limit the upper bank is steep (2.4m high) and overhanging which is indicative of surficial displacements (Figure 16). This oversteepened section is concerning since there are several pieces of sewer infrastructure upslope of this bank that may be engaged by these displacements in the future. This oversteepened bank also lacks consistent armoring at the bank toe that could lead to further erosive effects.

Figure 16 – Erosion and potential surficial bank displacements downstream (east) of bridge downslope of other pipe infrastructure.

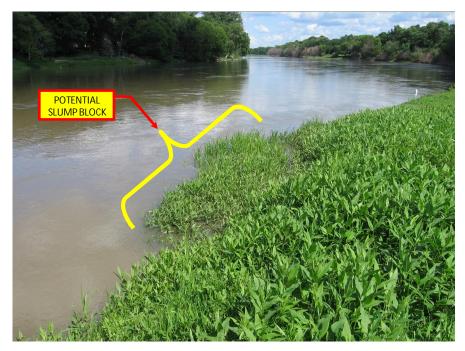
The south bank is located at Southboine Drive at the end of Berkley Street with a ROW between 6161 Southboine Drive and 385 Berkley Street. The ROW is a graded bank. Manicured lawns exist on the ROW and adjacent properties. Trees are present on the adjacent properties. The lower bank on the adjacent properties consists of a small berm about 1.5m to 2.4m high and a gulley upslope of the berm which is part of the river morphology. There is no evidence of bank instabilities on the upper bank. The bank toe shows possible evidence of a small slump block but this feature was partially submerged at the time of our inspection and may only be an erosion feature. No erosion protection is present at the bank toe.

Figure 17 – Partially submerged potential slump block at river bank toe at crossing location.

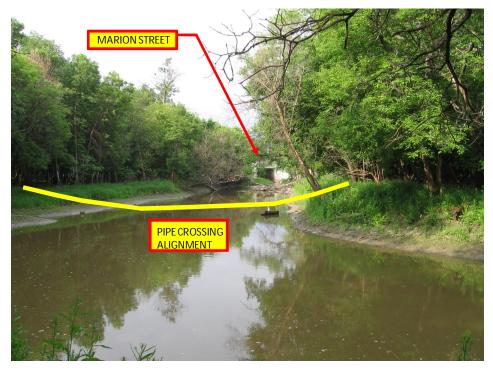
The east bank is located at the end of Goulet Street off Youville Street. The bank has a steeper upper bank at the end of the street that leads down to a broad floodplain that extends to the edge of the present river channel proper (Figure 18). Some fill has been placed at the upper bank. Based on measurements from the current geographic information system (GIS) the location of the bend in the pipe alignment is located on the flood plain. The location of the elbow and potentially the pipe alignment is marked by a low berm (less than 300mm high) that is likely the mounded trench backfill. The lower bank is vegetated with mature trees and low underbrush (less than 300mm tall). There is no evidence of river bank instability. Minor erosion is present at the river edge with a 900mm high erosion scarp. Grasses offer the only form of erosion protection with no other hard armoring.

Figure 18 – Flood plain at crossing location.

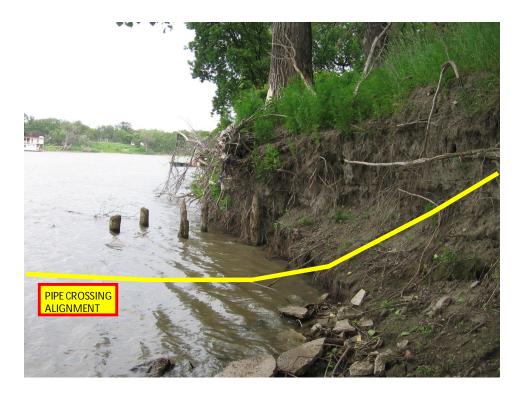
This site is located on Hespeler Avenue at Glenwood Crescent. Steep unstable banks are located on the pipe crossing alignment on the north (downstream) side of the Redwood Bridge (Figure 19). Unlike the west bank that was constructed in a shaft and tunnel, the east bank pipe was buried and therefore is located within the river bank. With no erosion protection present, the bank has eroded (2.4m height) and receded upslope. Large trees are presently anchoring the uplands. There is no evidence of bank instabilities beneath and south (upstream) of the bridge but erosion and bank recession has also occurred south of the bridge. Two large marine cables (75mm diameter protruding 700mm above the shore) are exposed and can be presumed to have been buried at the time of initial installation and provide an indication to the degree of erosion.

Figure 19 – River bank erosion on pipe crossing alignment immediately downstream of Redwood Bridge.

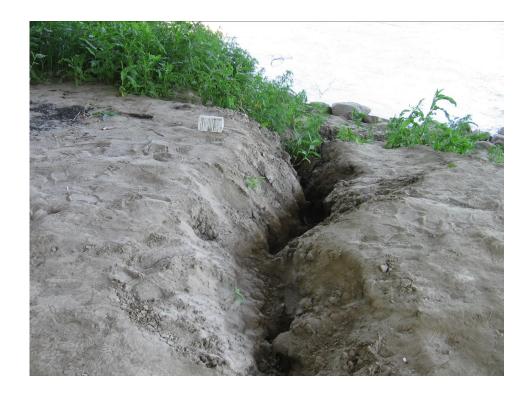
The north bank is located south of Misericordia Hospital at Cornish Avenue and the south bank is located at the intersection of Academy Road at Wellington Crescent. Both banks have similar characteristics with a steepened upper bank leading downslope to a flat bench followed by a steep toe at the river edge. The riverbank toes are about 1.5m high. Drainage near the bridges and leading to the river flows without erosion protection and as a result is producing deep erosion gulleys (600mm to 800mm deep) as shown in Figure 20. The exposed soils are silts and fine sands (alluvial deposits). The north bank is treed with low standing willows at the pipe crossing and the south bank consists of young trees and grass vegetation. There is no evidence of rip rap at the toe of either bank though occasional boulders are present. Dessication cracks were present in the soil on the lower bench but there is no evidence of tension cracks related to bank instability.

Figure 20 – Gulley erosion near bridge pier without erosion protection on lower bank.

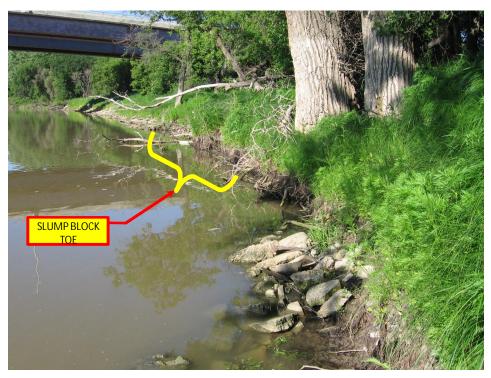
Figure 21 – Toe erosion and toe of slump block upstream (south) of pipe crossing alignment. Photograph taken from pipe crossing.

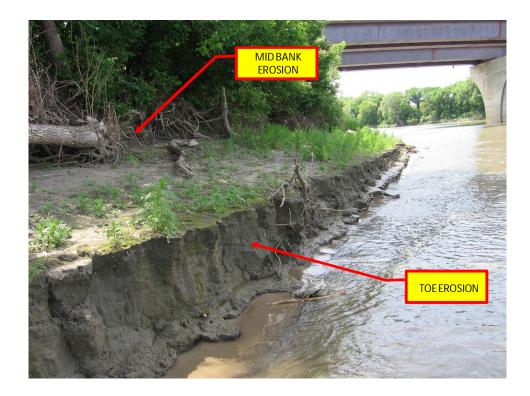
Located immediately north of Settler's Bridge, this site is located east of Henderson Highway and consists of a forested bank on the inside bend of the river. The upper bank is a flat tree-covered plain with no evidence of river bank instability. The active area affected by river currents at the bank toe is eroding with a 900mm scarp at the high water level and a 600mm scarp at the shoreline at the river edge. There is no evidence of further instability issues. Exposed soils are alluvial silt. Rip rap is present near the bridge location but no erosion protection is at the crossing location.

Figure 22 – Toe and mid bank erosion on east bank facing (upstream) south.

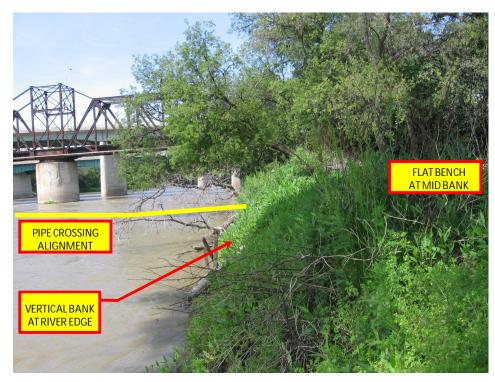
Active erosion occurs at the bank face at the river edge. No erosion protection is present east of the railway bridge. There is no evidence instability on the upper bank or the bench leading to the river edge.

Figure 23 – Toe erosion with vertical bank at river edge at pipe crossing alignment.

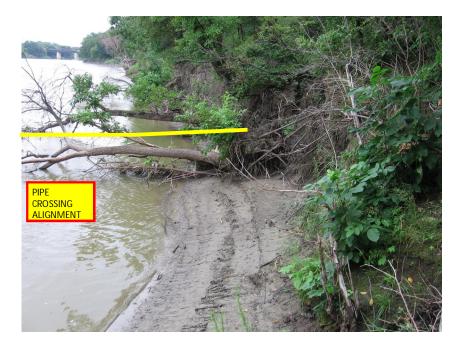
The river level in June obscured the lower bank and did not afford a view of the mechanism underlying the toppling failures. In August, and upon viewing a new section of bank toppling, it is apparent that the bank is being undermined by the river current through erosion processes. Once the

overlying root mat and soil is sufficiently undercut the mass topples as a unit. As a result these failures are shallow-seated.

Figure 24 – Eroded bank with toppling blocks of overhanging soil with root mat and trees.

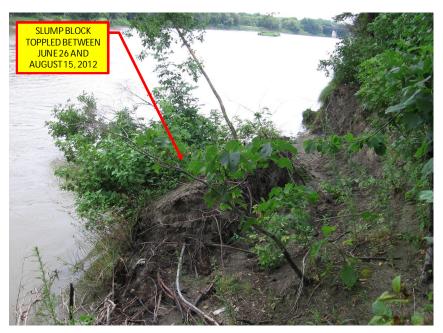
Figure 25 – Fresh slump block toppled between June 26 and August 15, 2012 indicative of active failure pattern.

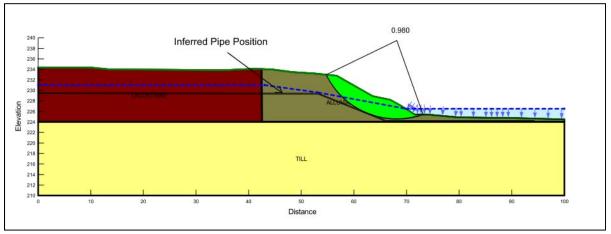
Figure 5: Site 5 Global Slip Surface Engaging the Pipe (GS+P)

While a number of slip surfaces have FS values slightly lower than 0.8, in reality the actual FS are likely higher considering the stabilizing effect of the extensive vegetation growth. A stability output model illustrating the position of the global slip surface engaging the pipe at the lowest FS is shown in Figure 5, determined at a river elevation of 226.5 m.

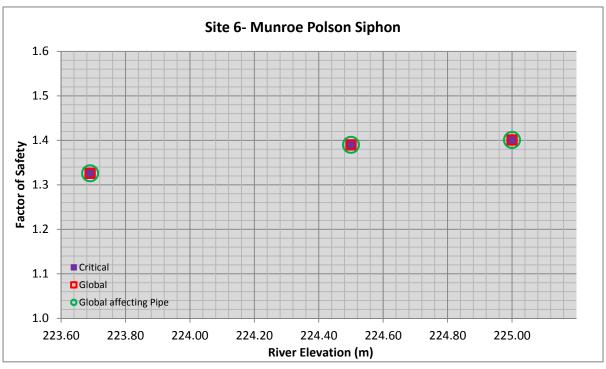
Figure 6: Slope Stability Factor of Safety Relating to the Current Condition to Site 5

The results of the slope stability analysis presented in Figure 6 indicate that the calculated FS lies typically between 1.3 to 1.4. These values are considered an acceptable level of stability. The reported FS values are for the theoretical slip surfaces which represent CS, TS, GS and GS+P.

The field inspection largely supports the results of the slope stability where there was an absence of observations relating to instability within the immediate vicinity of the pipe crossing. Nevertheless, visual inspection of adjacent properties upstream of the Right of Way (ROW) have shown significant evidence of movement which has included head scarps, trees dislocation and topsoil creep which are not present along the riverbank slope of the pipe crossing. This is believed to be related to the recent removal of tree growth allowing for surficial movement within the upper riverbank materials.

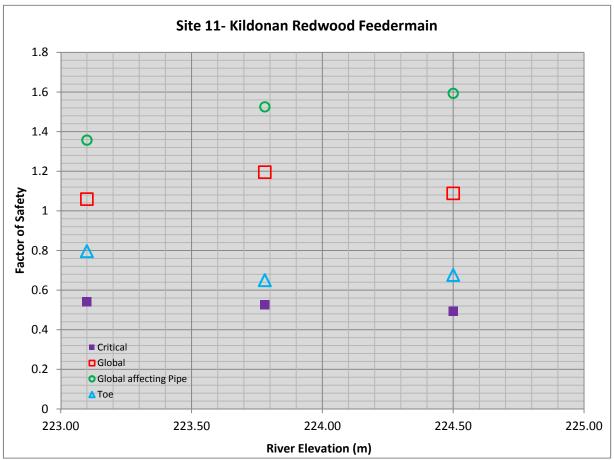
Figure 8: Slope Stability Factor of Safety Relating to the Current Conditions of Site 11

The results of the slope stability assessment appear to confirm observations made during the field inspections in regard to the overall stability of the riverbank slope. Limited or no evidence of instability along the upper and mid slope portion of the riverbank was noted, however a large percentage of observations regarding instability were concentrated at the toe of the riverbank. The calculated FS for instability at the toe of the slope has been calculated at less than 0.8, whereas the FS for global instability has been calculated between 1.0 and 1.2. This is largely due to the near vertical face at the toe of the riverbank created through erosion. The calculated FS for slip surfaces engaging the pipe has been calculated between 1.3 and 1.6. The FS for critical slip surfaces largely mirror values associated with toe instability of the riverbank slope. The results of the analysis are presented graphically in Figure 8.

Reduction in overall global stability of the riverbank may occur should retrogressive failure at the toe extend further upslope and potentially engage the pipe. Placement of rock (rip-rap) and reshaping at the toe of the riverbank slope may control toe erosion, and thus reduce the potential for continued or retrogressive slips.

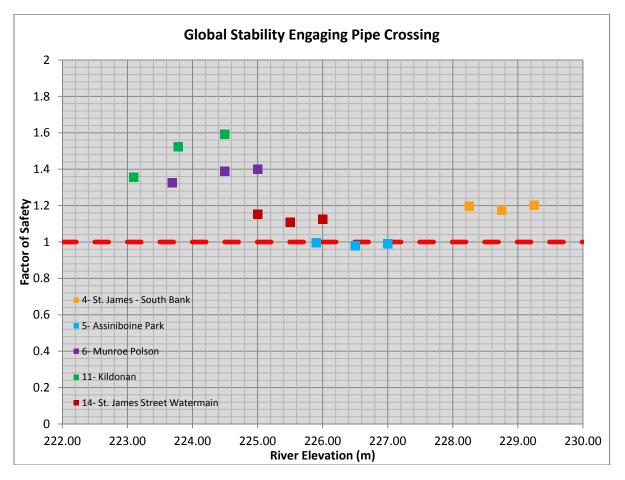
Figure 12: Global Stability Engaging Pipe Crossing

The calculated stability results from each pipe crossing discussed in previous sections has been presented graphically in Figure 12 and summarized in Table 4. Table 4 presents the sites according to a relative ranking system considering the reported site observations, slope geometries and the calculated FS for GS and GS+P slip surfaces. The relative ranking system is structured as No.1 is the relatively higher risk site and No.5 is the relatively lower risk site among the considered five sites.

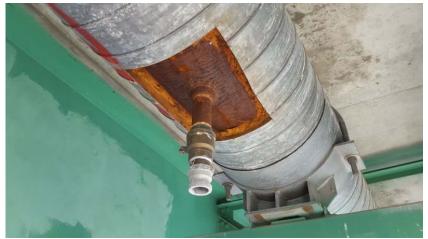
Figure 1: Under Bridge Inspection

Figure 1 depicts one of the points of interest on the force main, where a drain port was installed without restoration of the exterior cladding.

Stage two will involve representative detailed inspection of the pipe, based on results of the preliminary inspection and a review of the force main's operational and environmental exposure to identify locations at a higher risk of experiencing internal and external corrosion. Recommendations for inspection locations will be provided with the draft support tender package. Inspection of 3 to 4 representative locations will provide adequate information to infer the condition of the crossing as a whole.

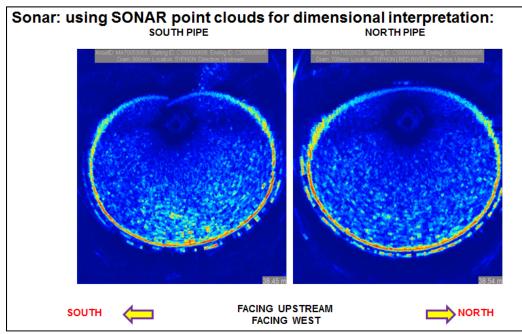
Figure A 10 - Sonar Imagery Depicting Reverse Curvature and Longitudinal Fracture of Plastic Pipe.

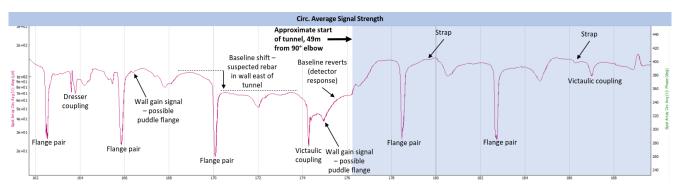
- Regarding the water stop shown within the east tunnel wall on drawing 12531, two wall-gain signals associated with possible water stop locations were identified. However, the signals are quite different from each other so if they are both puddle flanges, the actual flange make-up is different for each.

- In the EM data, PICA can distinguish between flanged and Victaulic connections. The connection just beyond the east tunnel wall appears to be a Victaulic, as is shown on drawing 12531. However, the pipe strap and pedestal shown further east does not appear to be present, though it is possible that the wall gain signal marked as a possible puddle flange is in fact the strap support at a relocated position.

Figure 1 - Electromagnetic Inspection Data for the Feeder Main at the East Tunnel Wall. (East is left; vertical bends are on left side; tunnel area is shown grey)

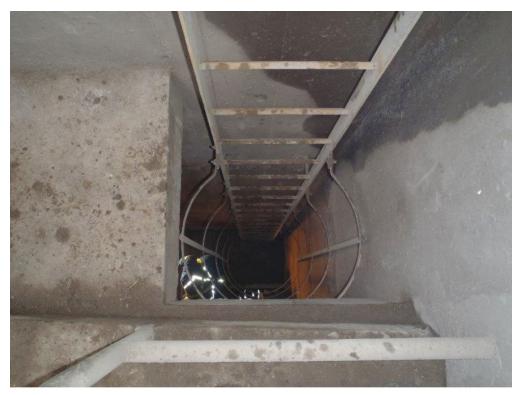
Figure A 5 – View Into Base of Shaft Showing Condition of Galvanized Ladder.

- Monitor the condition of the ladders in the tunnel shaft.
- Seal cracks and / or joints in the tunnel structure from water infiltration by injecting them with hydrophilic polyurethane grout. Similar repairs have been made throughout the Shoal Lake Aqueduct.

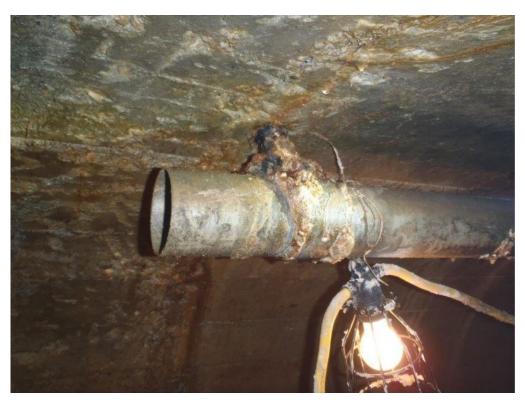
Figure A 8 – End of Aluminum Air Pipe at East End of Tunnel.

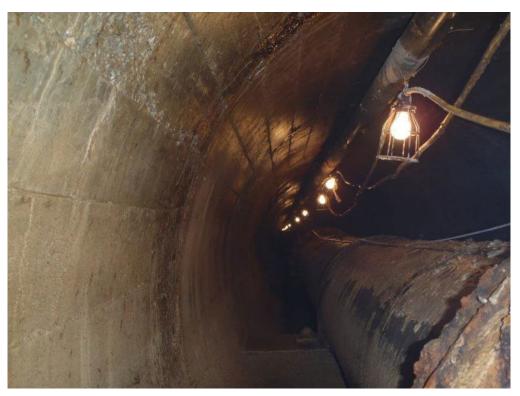
Figure A 11 – Water Infiltrating at Concrete Cold Pour Joint 4.5 m from Tunnel End.

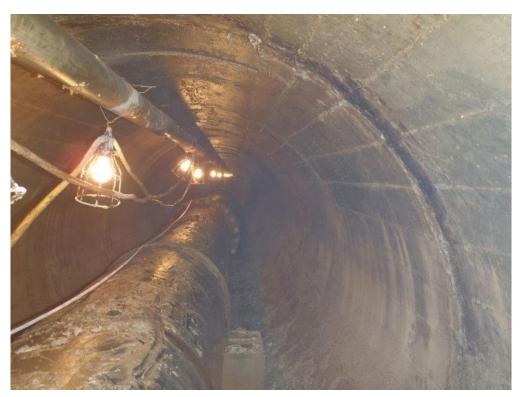
Figure A 12 – Water Infiltrating at Concrete Cold Pour Joint 4.5 m from Tunnel End.

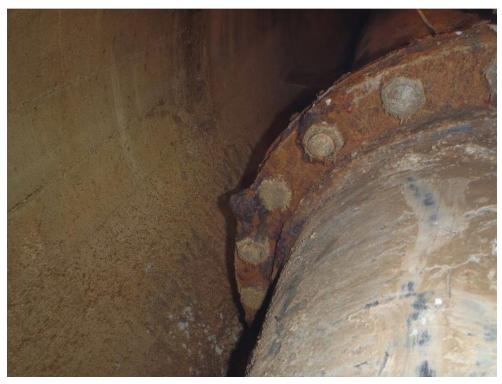
- Flanged connections were in good condition, exhibiting only slight general corrosion. Fasteners, which appeared to be galvanized or stainless steel, also were in good condition.

Figure A 13 – Flange Connection at 10:00 o'clock, 46.78 m from Shaft. Note Corrosion Tubercle Between Bolt Heads at 9:30 o'clock.

- Install petrolatum tape coating system over all flanged connections. Clean dirt and corrosion from flanges
 prior to coating and use profiling mastic to fill irregular spaces between flange fasteners, creating a smooth
 surface for tape wrapping.

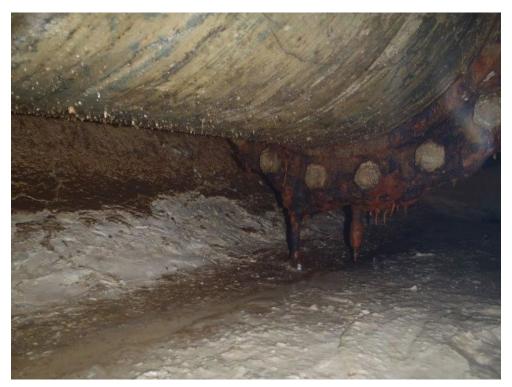
Figure A 14 – Flange Connection at 6:00 o'clock, 46.78 m from Shaft.

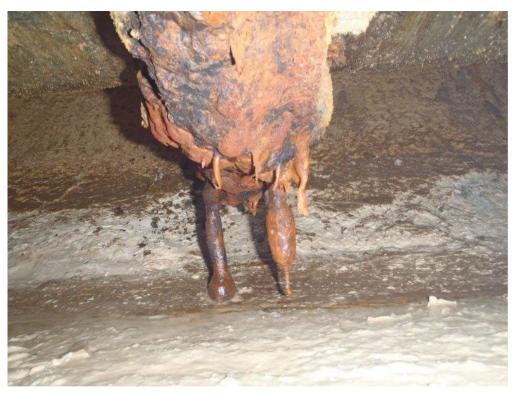
Figure A 15 – Underside of Flange Connection at 46.78 m from Shaft.

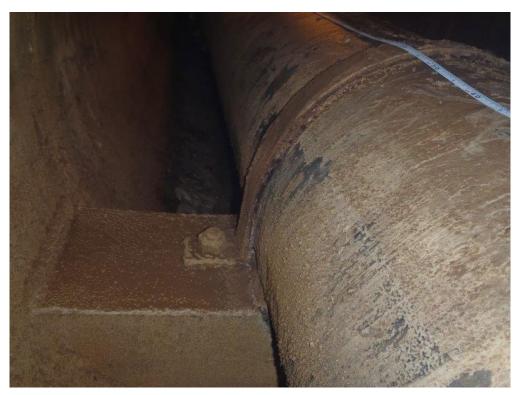
- Galvanized pipe straps at pedestals were in very good condition.
- Victaulic couplings were severely corroded and should be replaced. The bodies of the couplings were unevenly corroded with the appearance of grey cast iron, a brittle material. The underlying restraining rings

Figure A 16 – Typical Galvanized Pipe Strap and Pedestal, 45.12 m From Shaft.
