The City of Winnipeg High Risk River Crossings – Phase Two Condition Assessment Report

April 2020

Project Number: 60549028

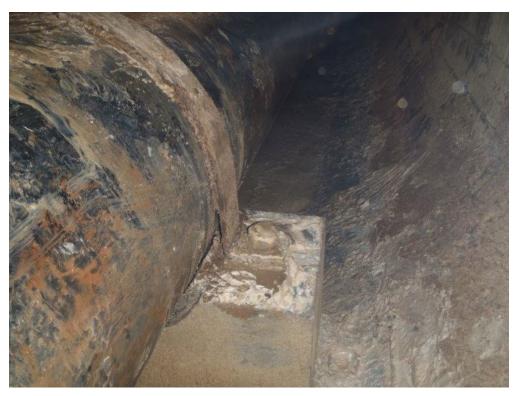
- Galvanized pipe straps at pedestals were in very good condition.
- Victaulic couplings were severely corroded and should be replaced. The bodies of the couplings were unevenly corroded with the appearance of grey cast iron, a brittle material. The underlying restraining rings

Figure A 17 – Typical Galvanized Pipe Strap and Pedestal, 45.12 m From Shaft.

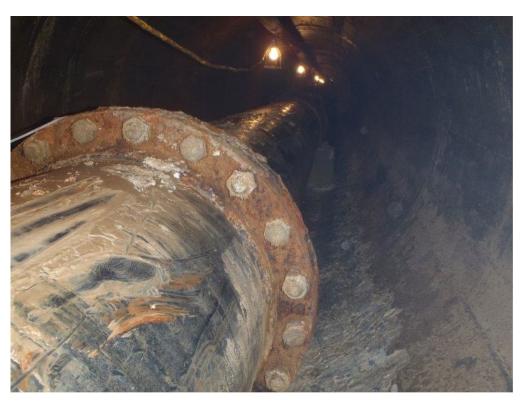
- Flanged connections were in good condition, exhibiting only slight general corrosion. Fasteners, which appeared to be galvanized or stainless steel, also were in good condition.

Figure A 19 – Flange Connection at 2:00 o'clock, 42.50 m from Shaft.

- Install petrolatum tape coating system over all flanged connections. Clean dirt and corrosion from flanges
 prior to coating and use profiling mastic to fill irregular spaces between flange fasteners, creating a smooth
 surface for tape wrapping.

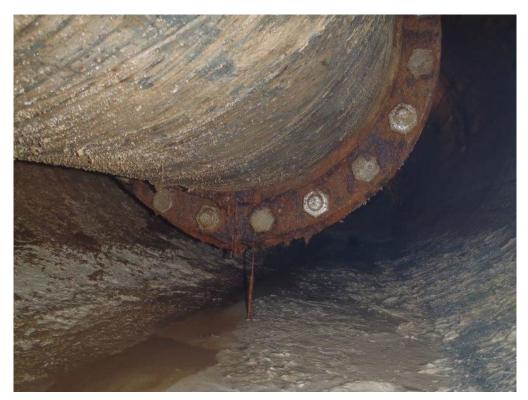
Figure A 20 – Flange Connection at 6:00 o'clock, 42.50 m from Shaft.

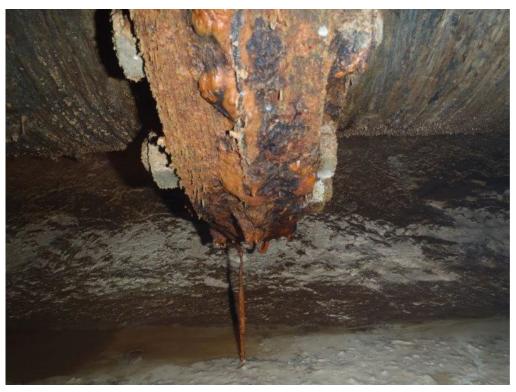
Figure A 21 – Underside of Flange Connection at 42.50 m from Shaft.

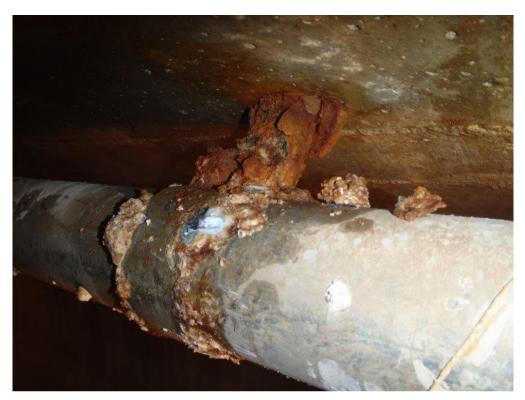
Figure A 22 – Typical Corrosion of Aluminum Air Pipe at Anchor Point, ~40.0m From Shaft.

- Repair or replace the deteriorated tunnel ventilation pipe. Options include:
 - Replace the existing aluminum piping with plastic piping (PVC or CPVC) that will not undergo galvanic corrosion on contact with the ferrous metal pipe anchors and will not corrode in the humid tunnel environment. Piping could be socketed for joining by solvent welding.

- Wrap a neoprene sheet gasket around the air pipe at the hanger points to isolate the aluminum from the steel / iron hangers (eliminate galvanic corrosion) and seal the perforations through the pipe.
 Gaskets may be held in place by plastic zip ties.

- Repair or replace the corroded aluminum piping at the anchor locations and secure the piping to the hangers with non-metallic anchors (for example, FRP anchor system).

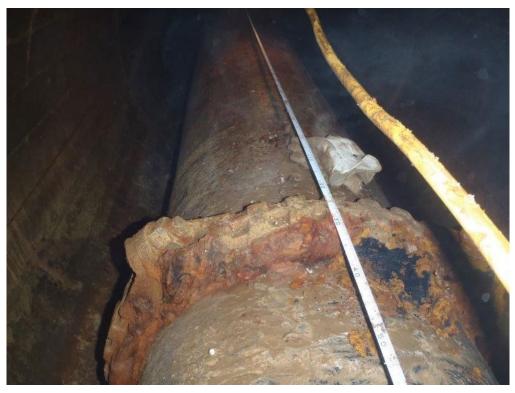
Figure A 23 – Victaulic Connection at 12:00 o'clock, 38.24 m from Shaft.

- Replace the Victaulic couplings.
- Install a petrolatum tape coating repair (mastic and tape wrap) around the feeder main pipe at the coating break near the east tunnel wall. The repair should extend from the wall to 0.2 m from the wall.

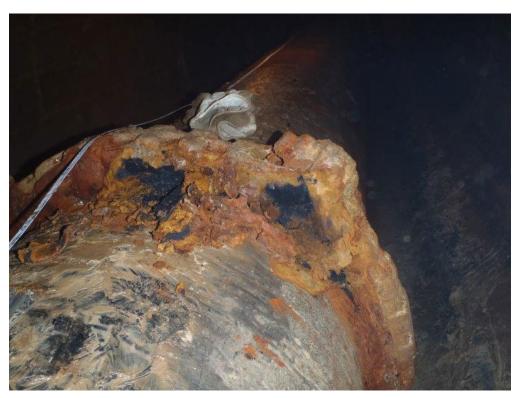
Figure A 24 – Victaulic Connection at 2:00 o'clock, 38.24 m from Shaft.

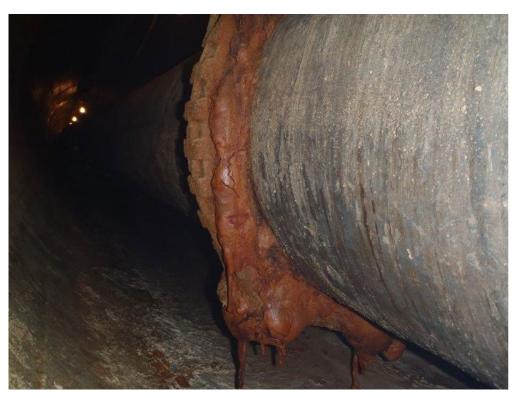
Figure A 25 – Underside of Victaulic Connection at 8:00 o'clock, 38.24 m from Shaft.

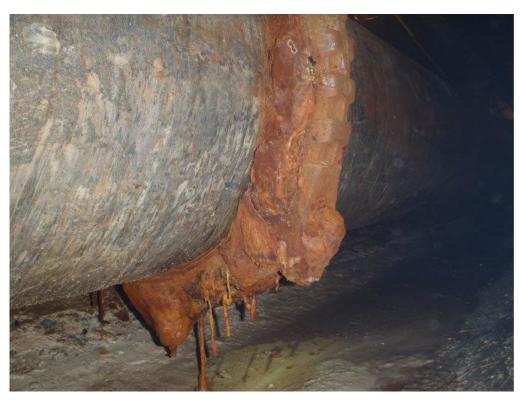
Figure A 26 – Underside of Victaulic Connection at 4:00 o'clock, 38.24 m from Shaft.

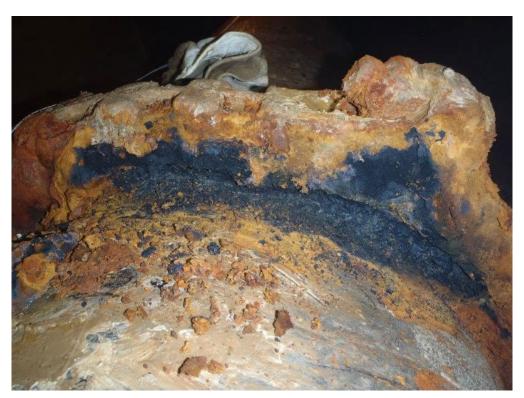
Figure A 27 – Corroded Body of Victaulic Connection at 1:00 o'clock, 38.24 m from Shaft.

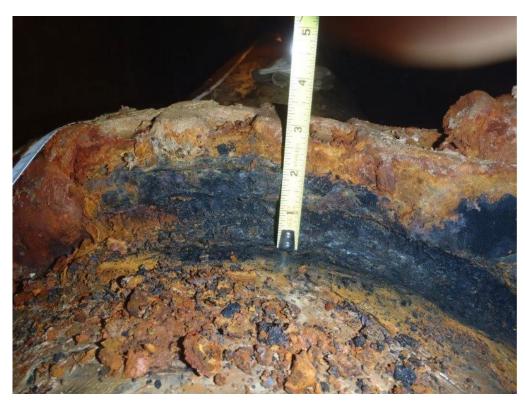
Figure A 28 – Corroded Body of Victaulic Connection at 1:00 o'clock, 38.24 m from Shaft.

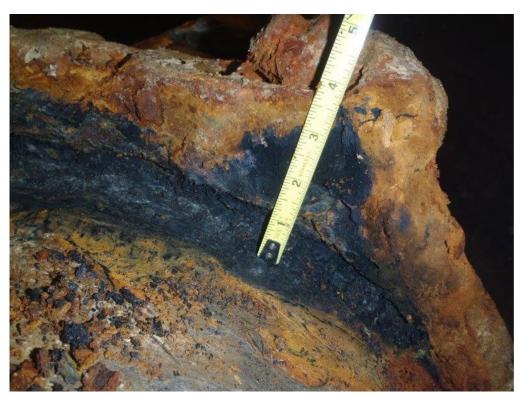
Figure A 29 – Corroded Body of Victaulic Connection at 1:30 o'clock, 38.24 m from Shaft.

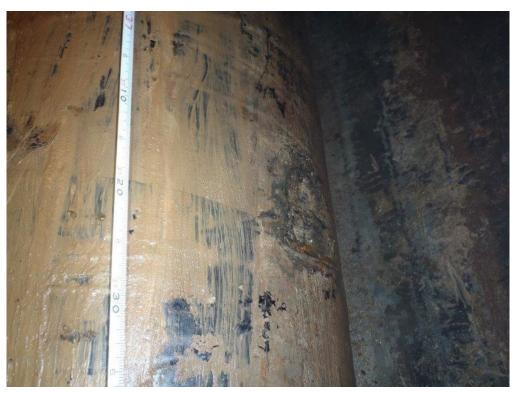
- Several blemishes in the coating as may be caused by lifting the pipe with straps or forks while the coating was soft.
 - Dents or gouges in the steel pipe and coating caused by mechanical forces, which required the coatings to be repaired. PICA advised that such damage may be detected by their EM tool because it causes stress-related changes in the steel.

Figure A 30 – 125 mm-square Dimple in Coating at 2:30 o'clock, 37.20 m From Shaft.

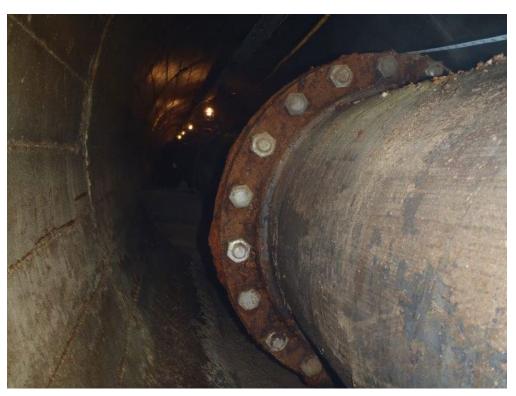
Figure A 31 – Flange Connection at 9:00 o'clock, 33.96 m from Shaft.

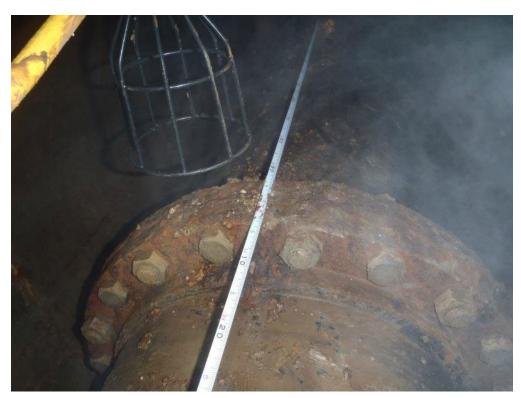
Figure A 32 – Flange Connection at 12:00 o'clock, 33.96 m from Shaft.

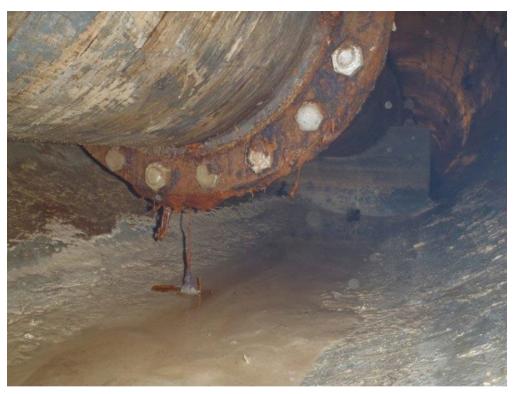
Figure A 33 – Flange Connection at 5:00 o'clock, 33.96 m from Shaft.

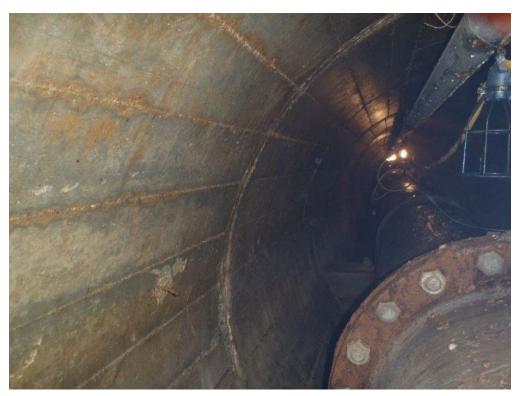
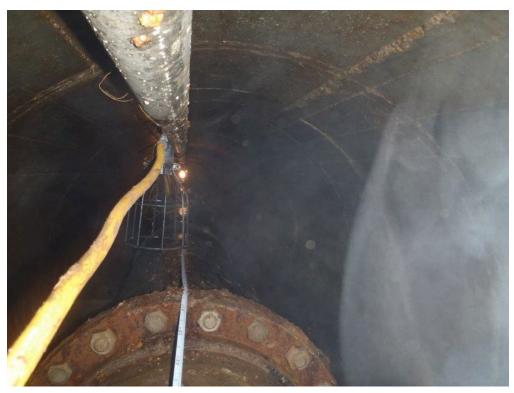
Figure A 34 – View of Tunnel, Looking Westward at 33.96 m From Shaft.

Figure A 35 – View of Tunnel, Looking Westward at 33.96 m From Shaft.

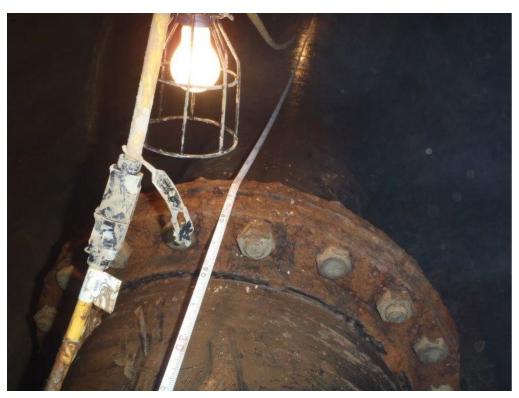
Figure A 36 – Flange Connection at 12:00 o'clock, 29.68 m from Shaft.

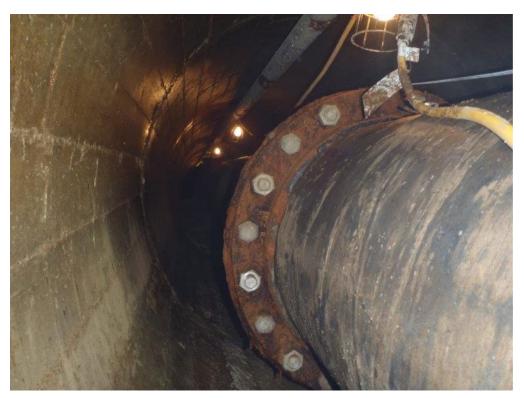
Figure A 37 – Flange Connection at 9:00 o'clock, 29.68 m from Shaft.

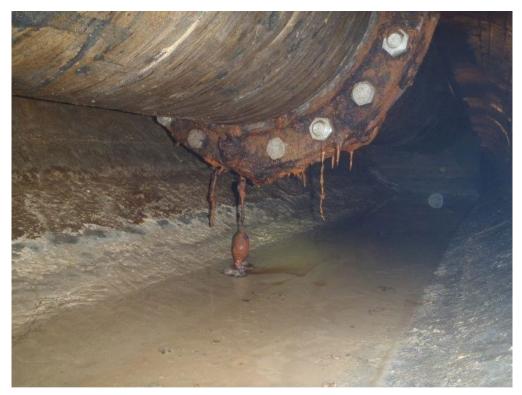
Figure A 38 – Flange Connection at 6:00 o'clock, 29.68 m from Shaft.

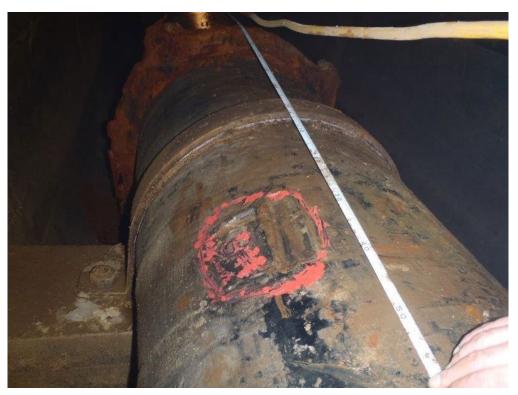
Figure A 39 – Coating Dimple at 11:00 o'clock, 26.30 m From Shaft. Possible Dent in Pipe.

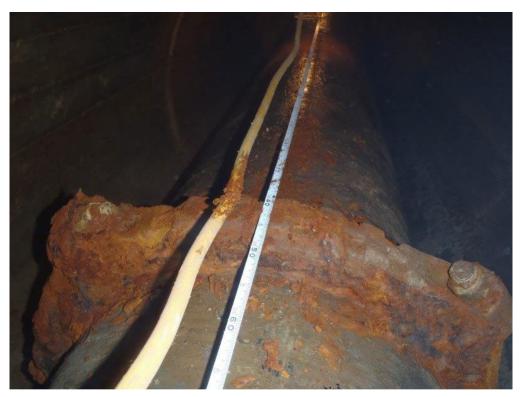
Figure A 40 – Victaulic Connection at 12:30 o'clock, 25.42 m from Shaft.

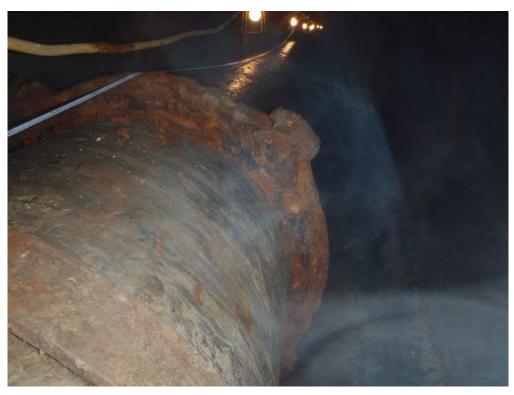
Figure A 41 – Victaulic Connection at 2:00 o'clock, 25.42 m from Shaft.

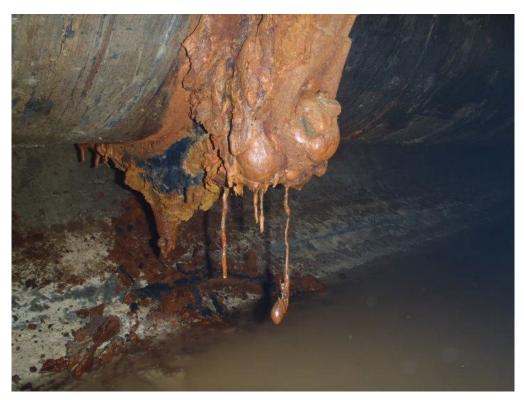
Figure A 42 –Victaulic Connection at 6:00 o'clock, 25.42 m from Shaft.

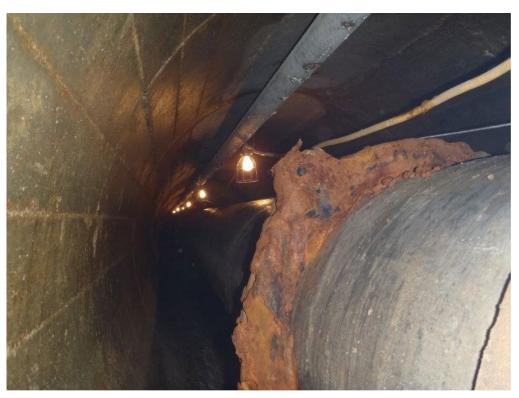
Figure A 43 –Victaulic Connection at 10:00 o'clock, 25.42 m from Shaft.

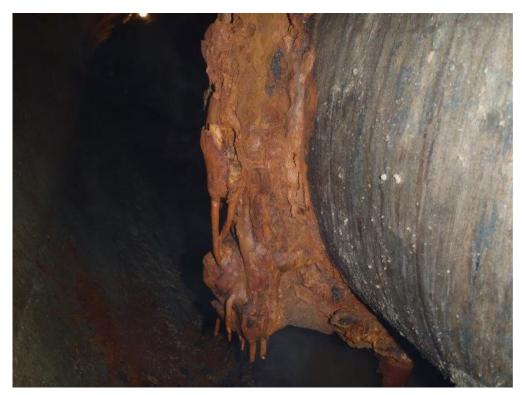
Figure A 44 – Underside of Victaulic Connection at 8:00 o'clock, 25.42 m from Shaft.

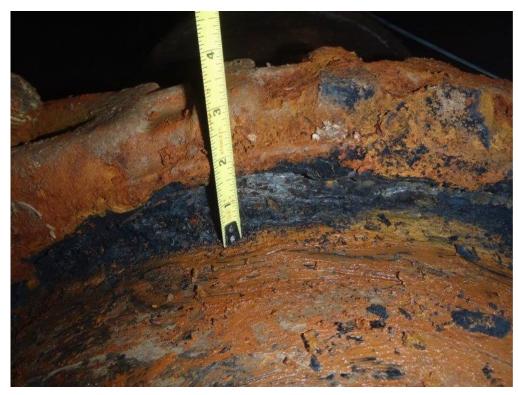
Figure A 45 – Corroded Body of Victaulic Connection at 1:00 o'clock, 25.42 m from Shaft.

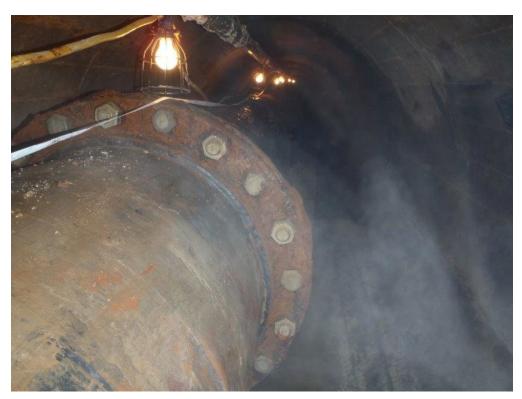
Figure A 46 – Flange Connection at 2:00 o'clock, 21.14 m from Shaft.

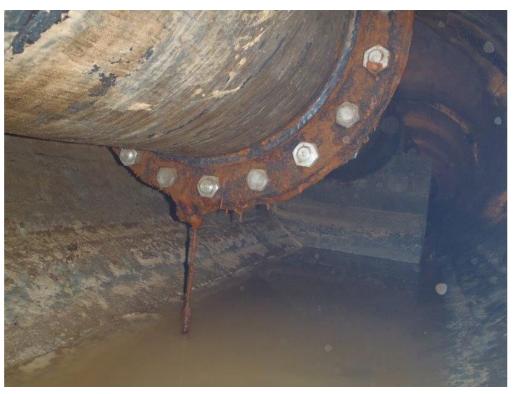
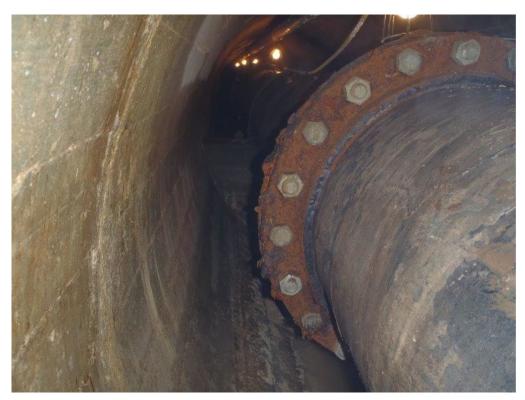
Figure A 47 – Flange Connection at 5:00 o'clock, 21.14 m from Shaft.

Figure A 48 – Flange Connection at 5:00 o'clock, 21.14 m from Shaft.

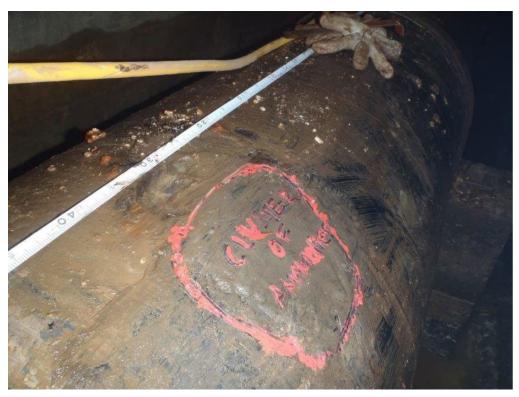
Figure A 49 – Coating Dimple at 12:30 to 2:30 o'clock, 20.30 m From Shaft. Possible Dent in Pipe.

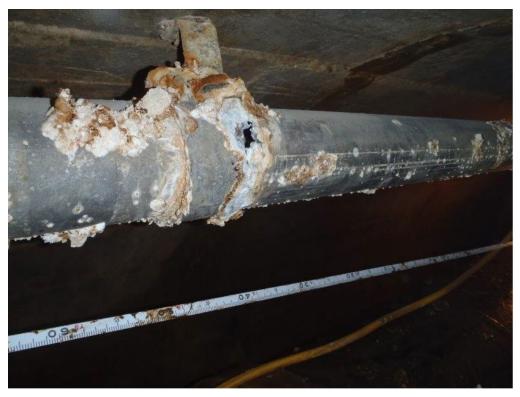
Figure A 50 – Corrosion / Perforation of Aluminum Air Pipe, 19.50 m From Shaft.

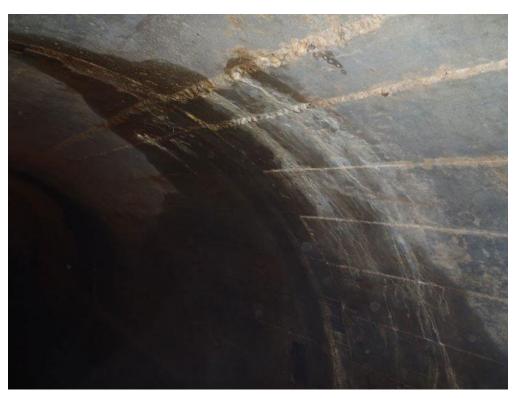
Figure A 52 – Water Infiltrating (Slow Run) at Concrete Pour Joint, and at 100 mm-diameter honeycomb pocket at 1:00 o'clock, 19.10 m From Shaft.

- Monitor the condition of the ladders in the tunnel shaft.
- Seal cracks and / or joints in the tunnel structure from water infiltration by injecting them with hydrophilic polyurethane grout. Similar repairs have been made throughout the Shoal Lake Aqueduct.

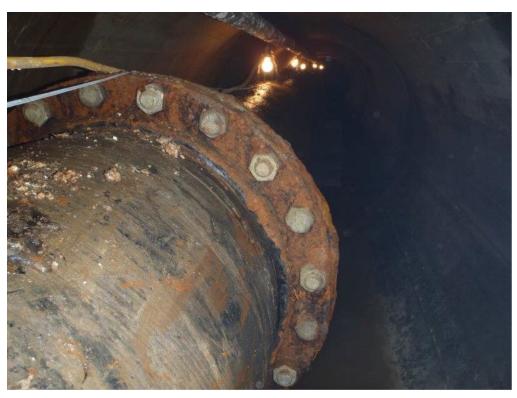
Figure A 53 – Flange Connection at 1:30 o'clock, 16.86 m from Shaft.

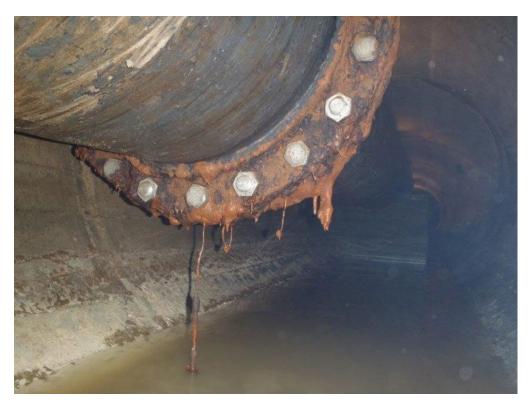
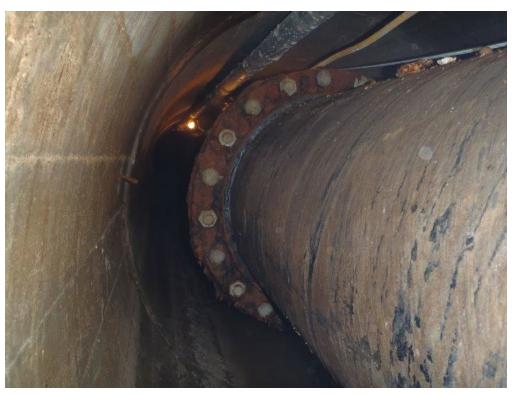
Figure A 54 – Flange Connection at 9:00 o'clock, 16.86 m from Shaft.

Figure A 55 – Flange Connection at 9:00 o'clock, 16.86 m from Shaft.

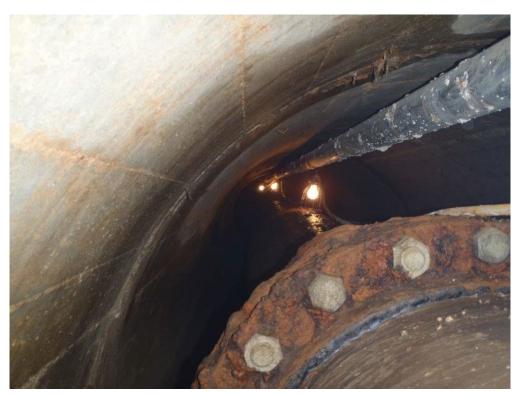
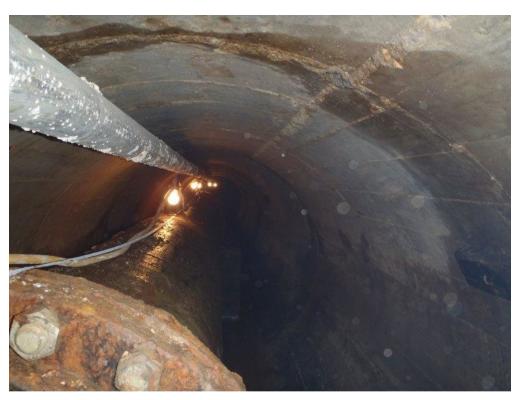
Figure A 56 – View of Tunnel, Looking Westward, 16.86 m From Shaft.

Figure A 57 – View of Tunnel, Looking Westward, 16.86 m From Shaft.

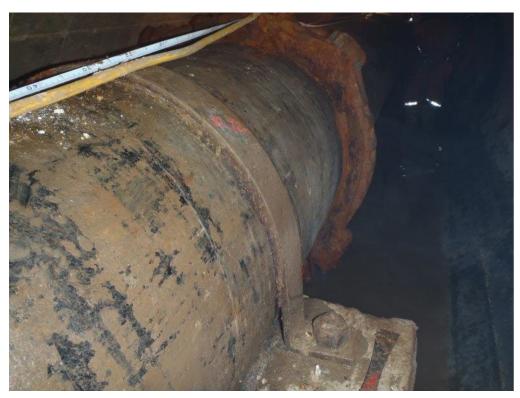
Figure A 58 – Galvanized Pipe Strap and Pedestal, 13.58 m From Shaft.

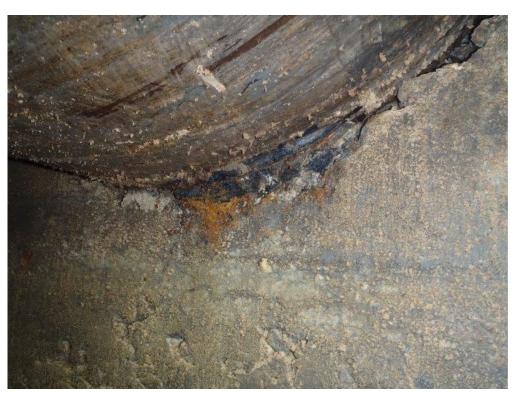
Figure A 59 – Feeder Main Pipe on Pedestal, 13.58 m From Shaft. Suspect rust staining is from pedestal reinforcing.

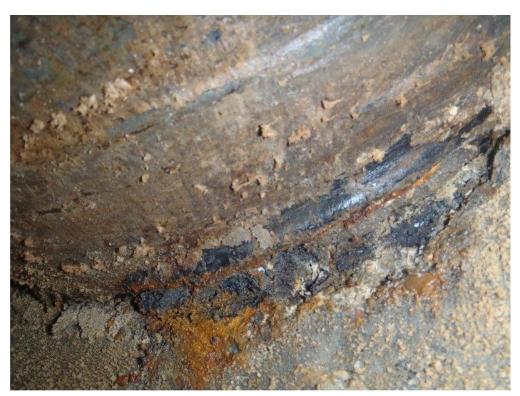
Figure A 60 – Feeder Main Pipe on Pedestal, 13.58 m From Shaft. Note graphite paste pipe cushion along surface of coating.

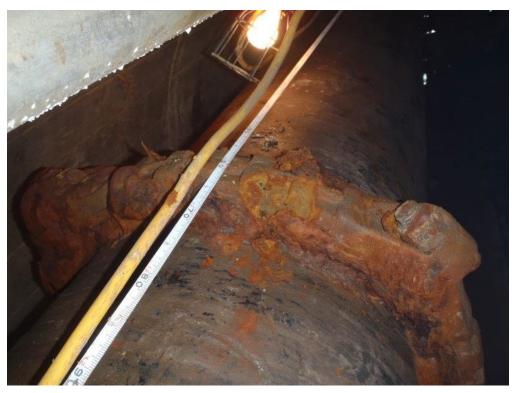
Figure A 61 – Victaulic Connection at 12:30 o'clock, 12.59 m from Shaft.

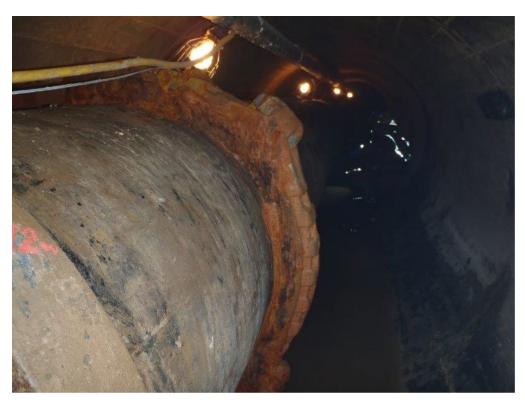
Figure A 62 – Victaulic Connection at 2:00 o'clock, 12.59 m from Shaft.

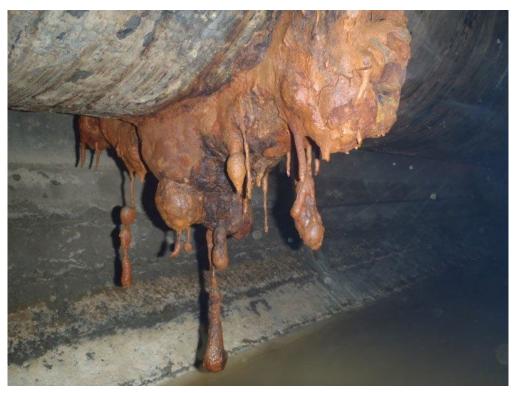
Figure A 63 –Victaulic Connection at 6:00 o'clock, 12.59 m from Shaft.

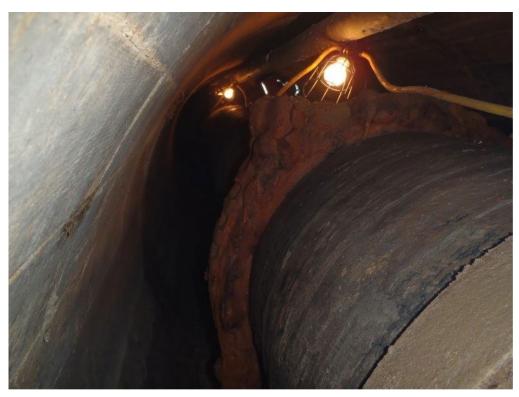
Figure A 64 – Victaulic Connection at 10:00 o'clock, 12.59 m from Shaft.

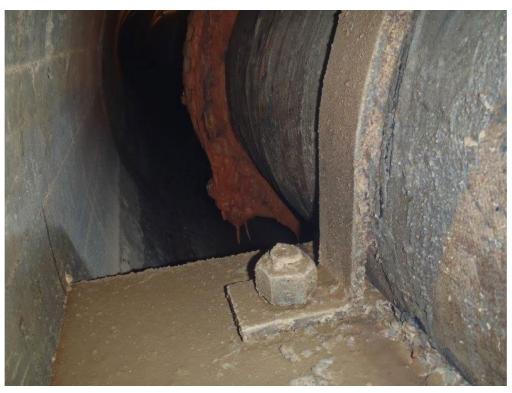
Figure A 65 –Victaulic Connection at 8:00 o'clock, 12.59 m from Shaft.

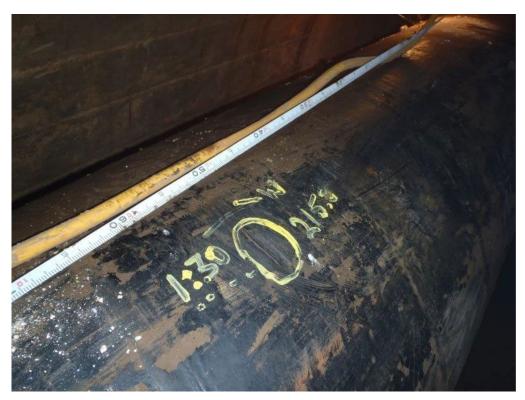
Figure A 66 – Coating Dimple at 1:00 o'clock, 10.50 m From Shaft. Possible dent in pipe.

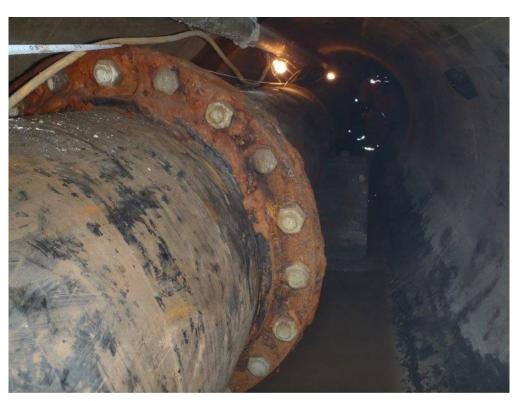
Figure A 67 – Flange Connection at 2:00 o'clock, 8.32 m from Shaft.

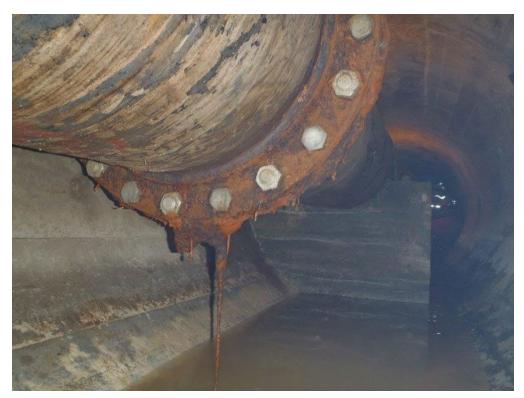
Figure A 68 – Flange Connection at 5:00 o'clock, 8.32 m from Shaft.

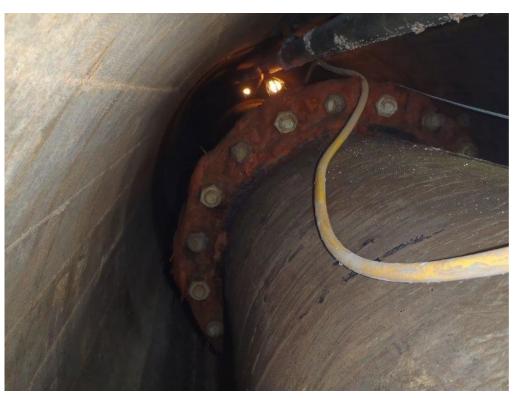
Figure A 69 – Flange Connection at 10:00 o'clock, 8.32 m from Shaft.

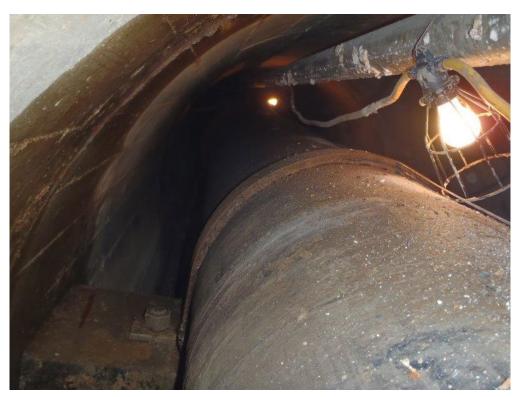
Figure A 70 – Galvanized Pipe Strap and Pedestal, 6.48 m From Shaft.

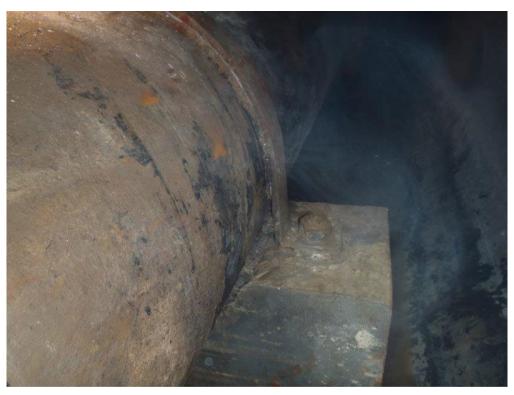
Figure A 71 – Galvanized Pipe Strap and Pedestal, 6.48 m From Shaft.

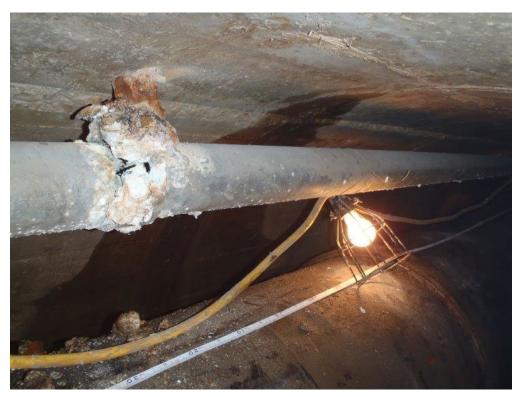
Figure A 72 – Corrosion / Perforation of Aluminum Air Pipe, 7.30 m From Shaft. Water infiltrating tunnel at concrete pour joint near 6.48m from shaft.

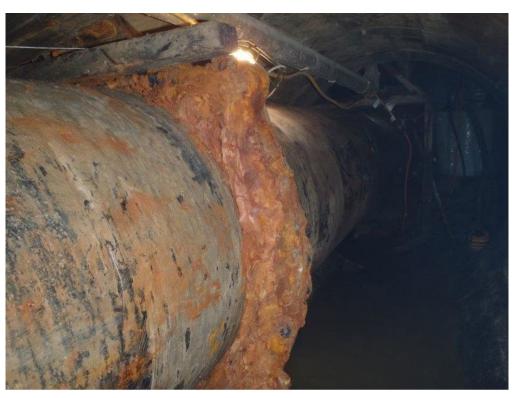
Figure A 73 – Victaulic Connection at 2:30 o'clock, 4.60 m from Shaft.

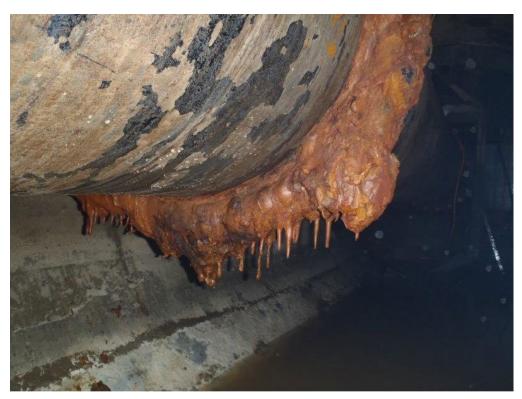
Figure A 74 – Victaulic Connection at 5:30 o'clock, 4.60 m from Shaft.

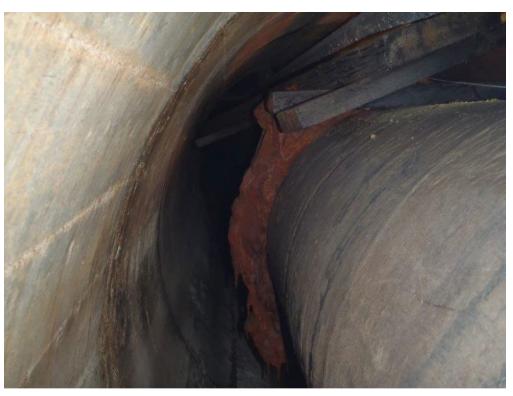
Figure A 75 – Victaulic Connection at 9:30 o'clock, 4.60 m from Shaft.

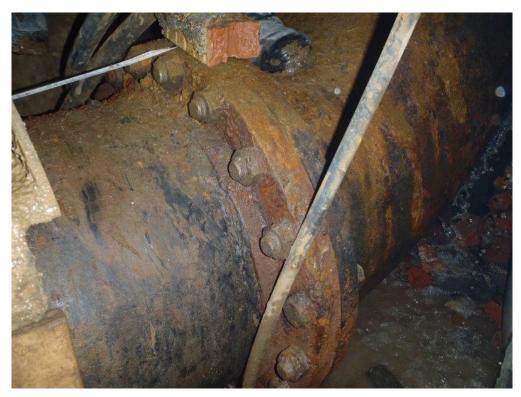
Figure A 76 – Base Elbow at Shaft, 2:00 o'clock.

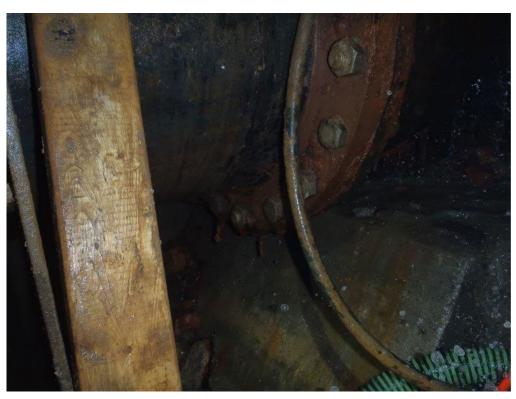
Figure A 77 – Underside of Lower Flange Connection on Base Elbow at Shaft, 4:00 o'clock.

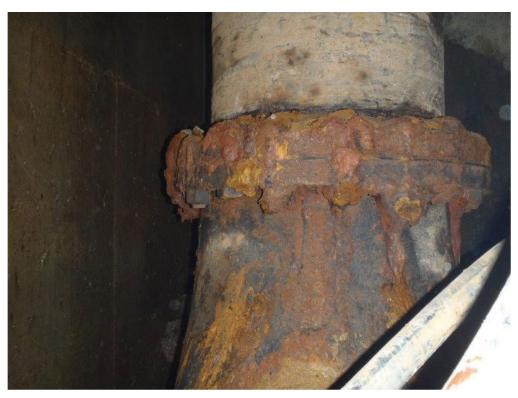
Figure A 78 – Upper Flange Connection on Base Elbow at Shaft, 4:00 o'clock.

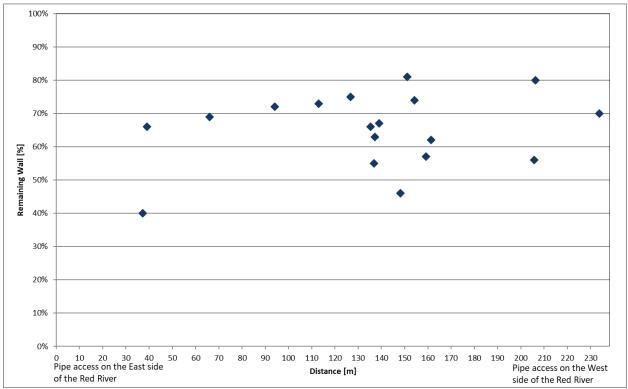
In general, the feeder main was found to be in good condition. Nine (9) pipes were found to show evidence of pitting corrosion with a total of 18 localized pitting indications reported. Of these 18 indications, 11 indications measured to be "shallow" ($\geq 65\%$ RW), and 7 indications measured to be "medium" (40-64% RW).

Figure 1. Axial distribution of defect indications and remaining wall (%) within the scanned length of the Kildonan-Redwood Feeder Main

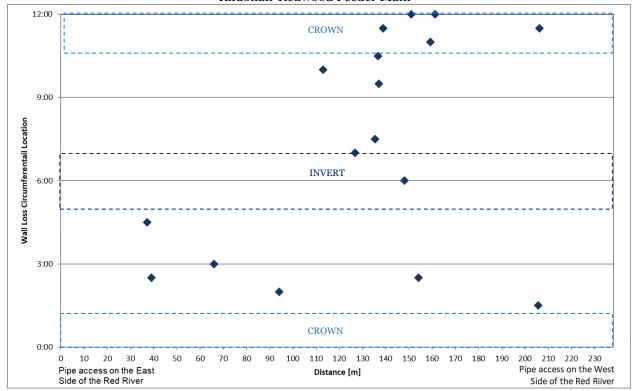
Figure 2. Circumferential distribution of pitting regions along the Kildonan-Redwood Feeder Main, described with clock positions referenced by looking from east to west. Note that the defect reported in pipe 0340 is not included in chart as clock position information is not available for this pipe.

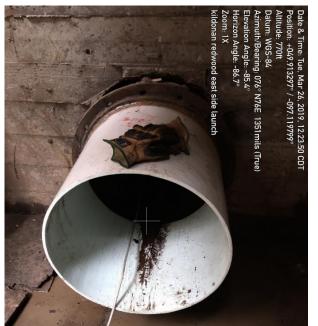
Two connections at the east side of the river crossing are thought to be welds, concurrent with suspected Dresser Style 63 connection rings. These two connections join pipe segments 0010 with 0020, and 0020 with 0030. Pipe 0010 is the white-painted pup piece that was welded to the main in the East Chamber. This pipe segment measures approximately 0.7m in length (please note that odometer data collected at the very beginning of the pipeline is poor in quality due to inconsistencies in the velocity of the RFT tool as it is brought up to the target inspection velocity). Figure 18 shows an image of the pup piece photographed in the East Chamber during one of the inspection runs.

Figure 18. Short segment of pipe in the East Chamber.

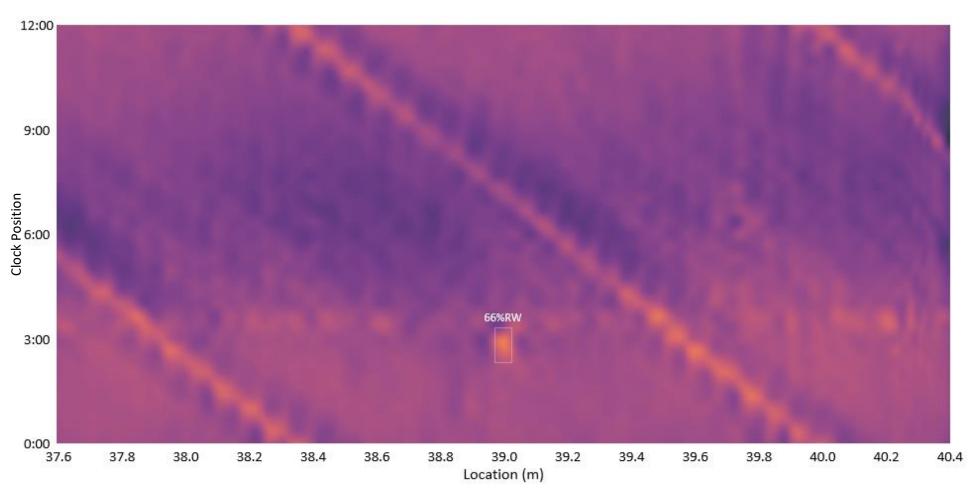
Figure 24. Pipe 0070 colour map showing 66% remaining wall indication, 39.00 meters from the ZRD.

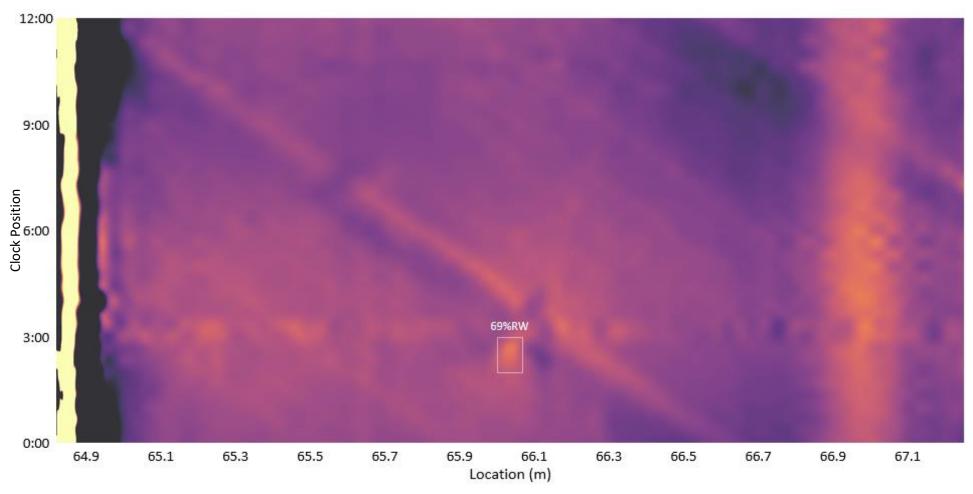
Figure 25. Pipe number 0100 colour map showing 69% RW indication, 66.03 meters from the ZRD.

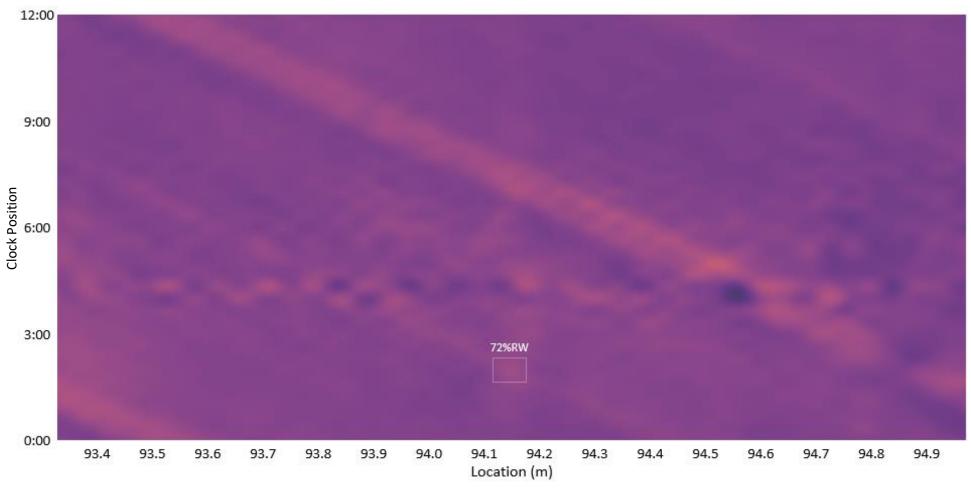
Figure 26. Pipe 0120 colour map of 72% RW indication, 94.15 meters from the ZRD.

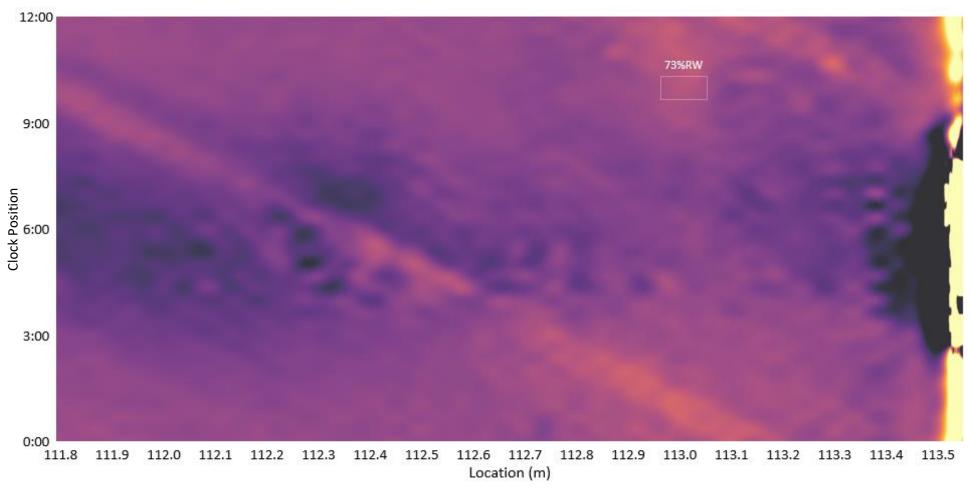
Figure 27. Pipe 0130 colour map showing 73% RW indication at 113.01 meters from the ZRD.

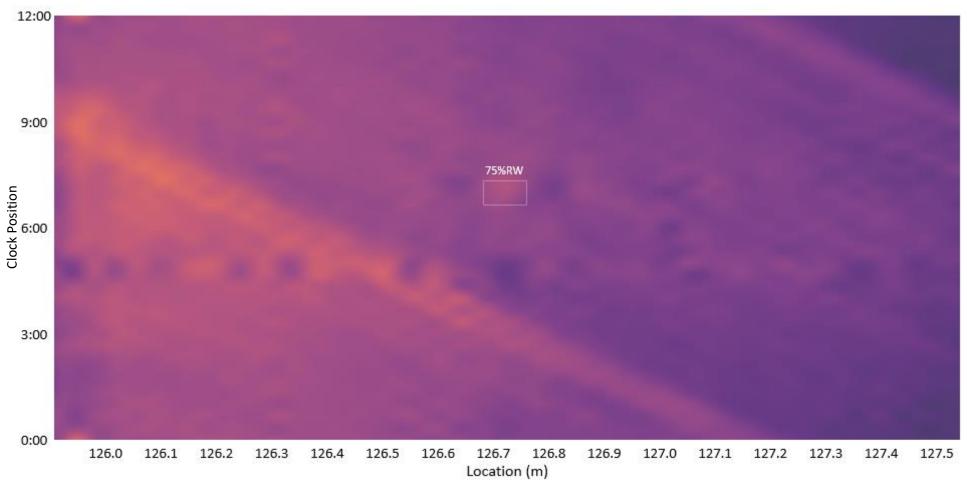
Figure 28. Pipe 0150 colour map showing 75% RW indication, 126.73 meters from the ZRD.

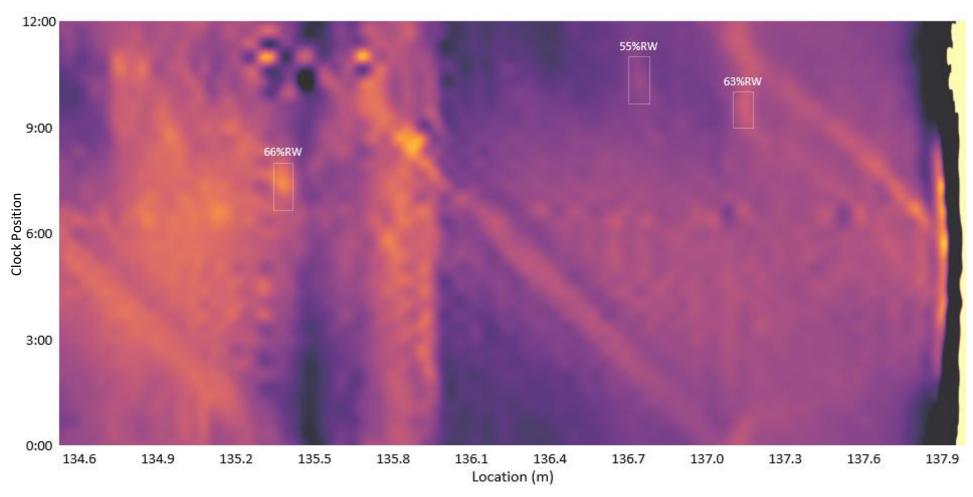
Figure 29. Pipe 0150 colour map showing the 66% RW, 55% RW, and 63% RW indications.

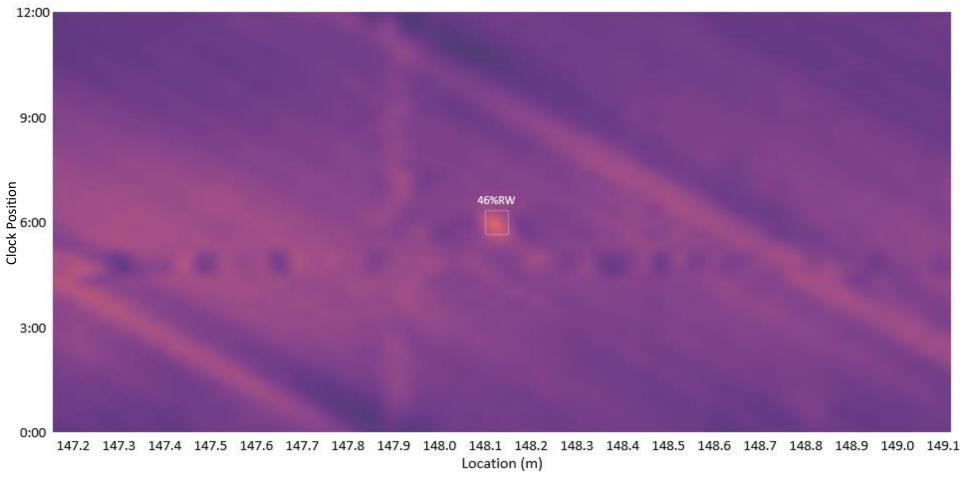
Figure 30. Pipe number 0160 showing the 46% RW indication, 148.13m from the ZRD.

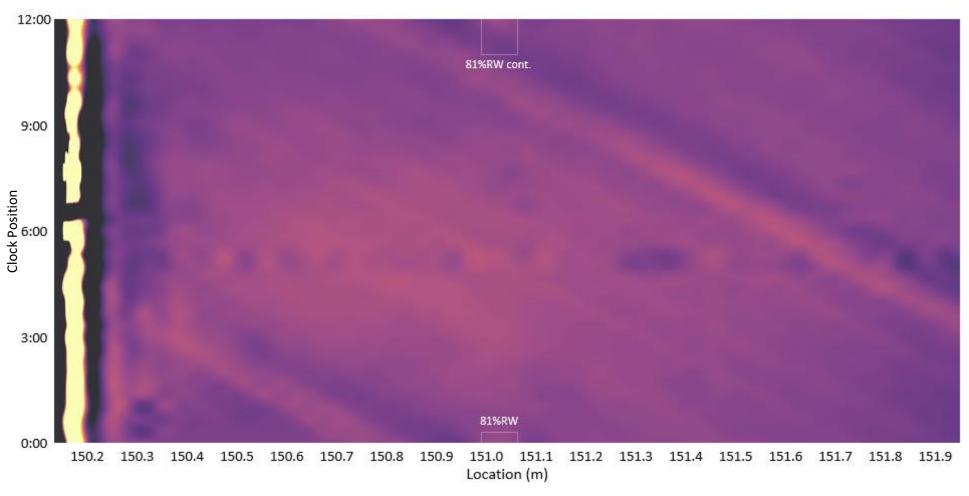
Figure 31. Pipe 0170 colour map showing 81% RW indication at 151.03m from the ZRD.

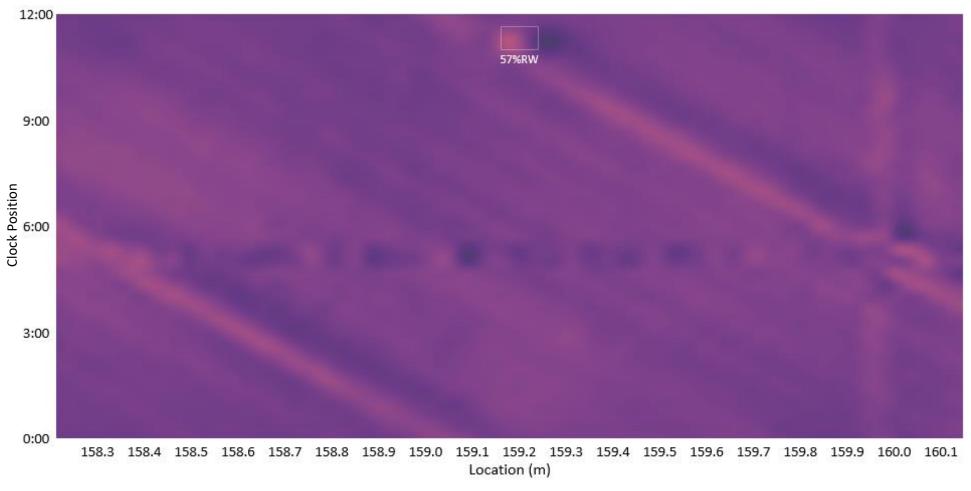
Figure 32. Pipe 0170 colour map showing the 57% RW indication, 159.19m from the ZRD.

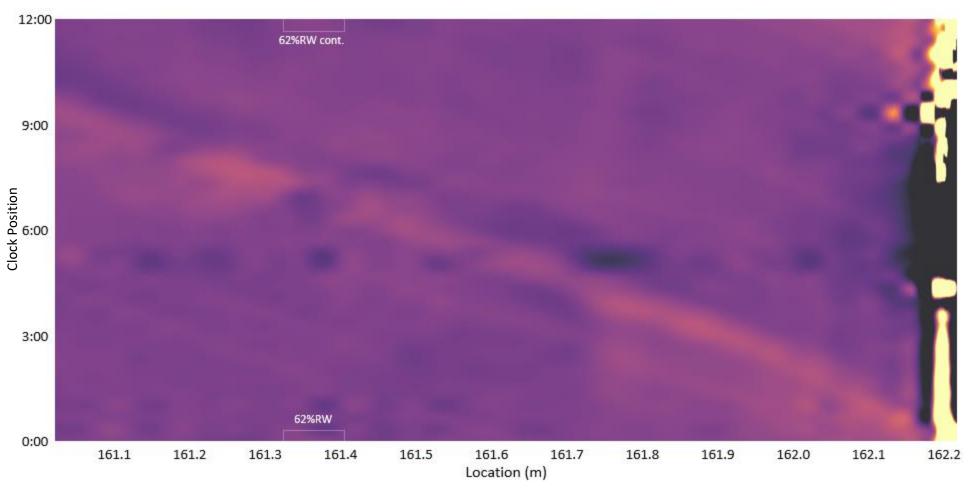
Figure 33. Pipe 0170 colour map showing the 62% RW indication, 161.37m from the ZRD.

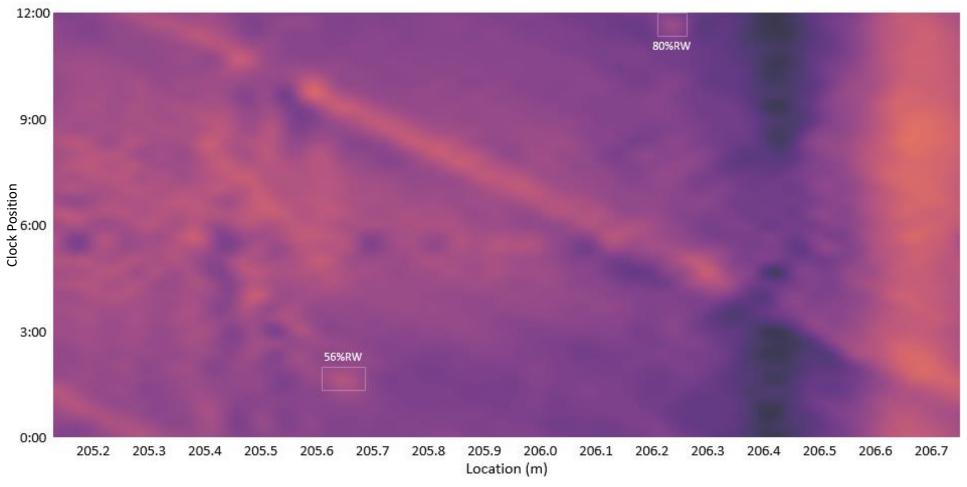
Figure 34. Pipe 0290 colour map with 56% RW and 80% RW indications shown.

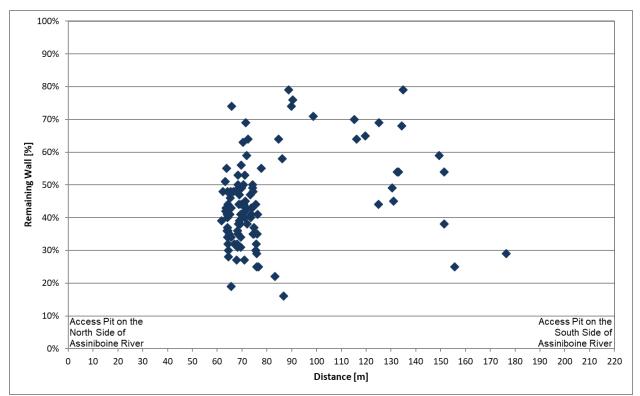
Figure 1. Axial distribution of defect indications and remaining wall (%) within the scanned length of the Charleswood-Assiniboia Feeder Main

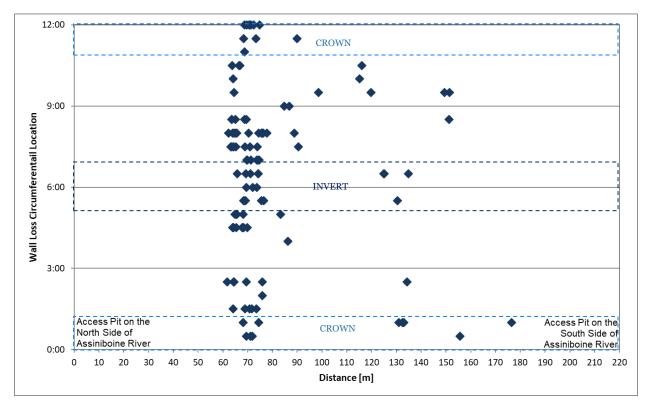
Figure 2. Circumferential distribution of pitting regions along the Charleswood-Assiniboia Feeder Main, described with clock positions referenced by looking from north to south

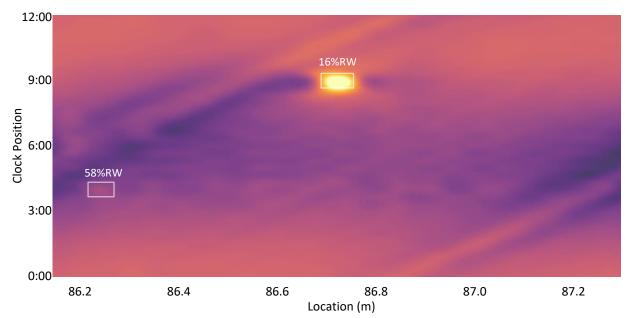
A colour map of the area with the smallest remaining wall indication recorded (16% RW in pipe 0130), located at 86.75m from the ZRD, is shown in Figure 12. Colour maps can highlight wall loss, wall gain, and material stresses within the pipe. Figure 13 to Figure 24 in Appendix 1 show additional colour maps of the data for all sections of pipe with reported wall loss indications, with defect indications annotated. Defect indications are highlighted in the figures with bounding boxes.

Figure 12. Colour map showing a close up of the 16% RW indication detected in pipe 0130, 86.75m from the ZRD on the north side of the river crossing

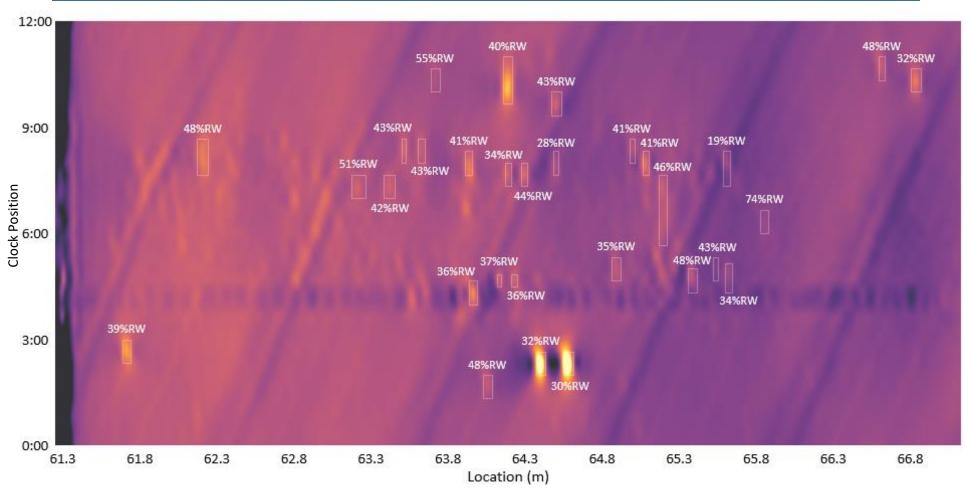
Figure 13. Colour map showing locations of defect indications reported within pipe number 0100 (Client pipe segment P10). A total of 66 indications have been reported in this pipe segment, continued in Figure 14. One deep defect (19% RW) was reported in this pipe segment, located 65.85m from the ZRD. Flange connection at beginning of pipe (61.29m) shown on left of colour map.

If AECOM and the City decide to perform verification and repair work on the onshore portions of the feeder main crossing (for example for pipe 0100), please let your PICA representative know. PICA can assist by providing dig sheets for the selected areas.

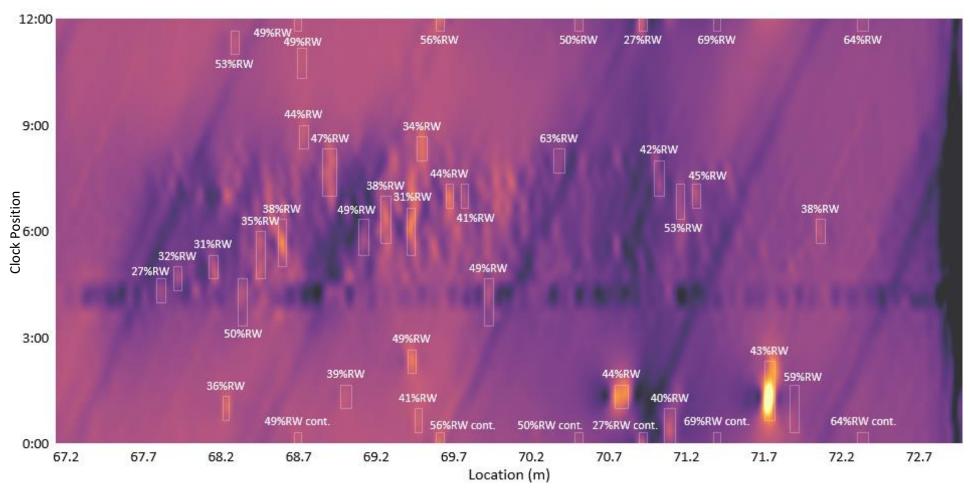
Figure 14. Continuation of pipe number 0100 colour map with defect indication locations shown. Flange connection at end of pipe (72.95m) shown on right of colour map.
