The City of Winnipeg High Risk River Crossings – Phase Two Condition Assessment Report

April 2020

Project Number: 60549028

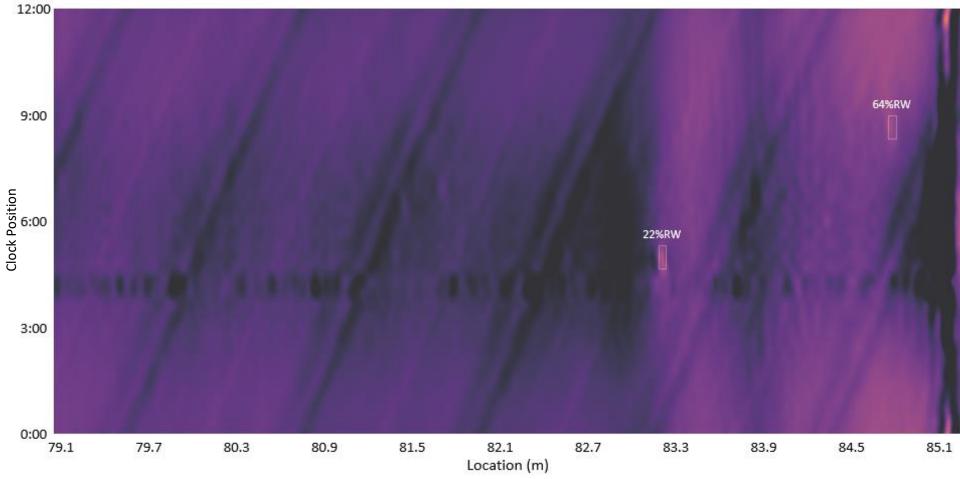
Figure 16. Continuation of pipe number 0110. Flange connection at end of pipe (85.15m) shown on right of colour map.

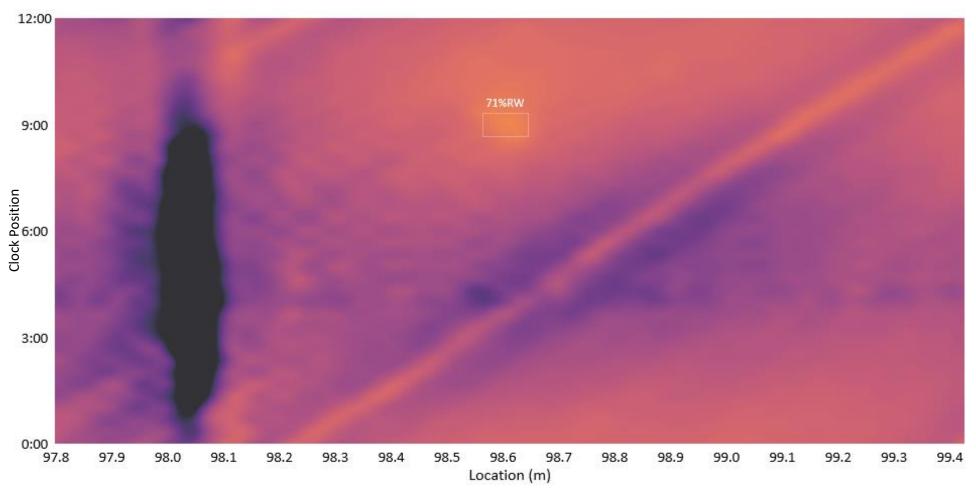
Figure 18. Pipe number 0140 colour map showing the single defect indication reported in this segment. A flange connection is visible beginning at 98.03m.

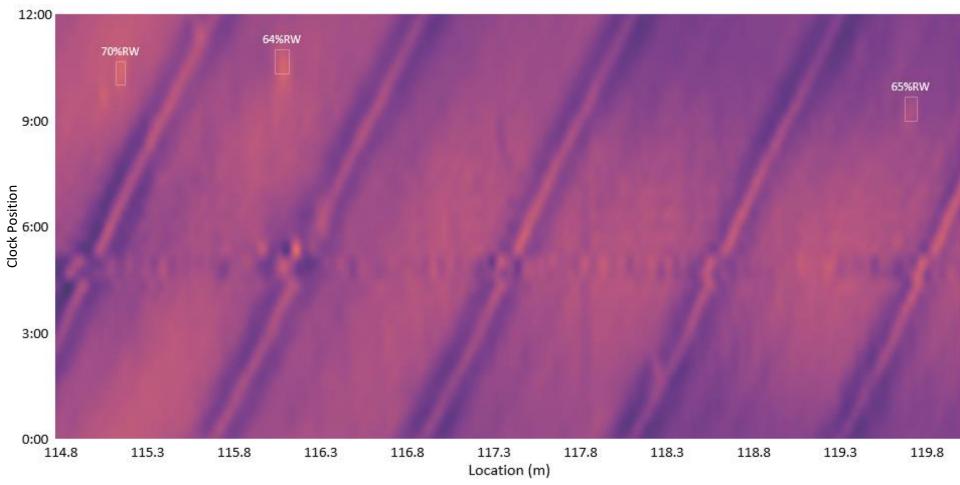
Figure 19. Pipe number 0150 colour map with three reported indications.

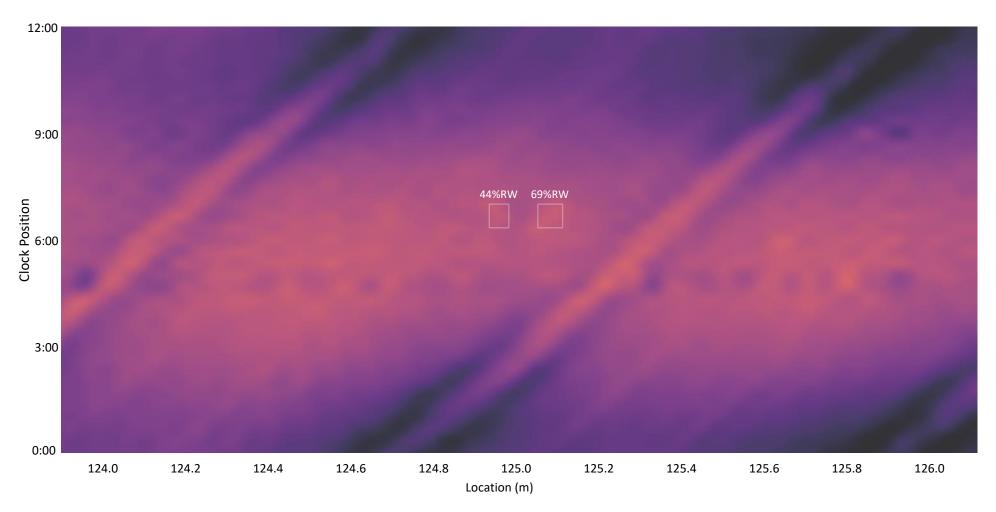
Figure 20. Pipe number 0160 showing locations of two of the seven defects reported within this pipe segment. Continued in Figure 21.

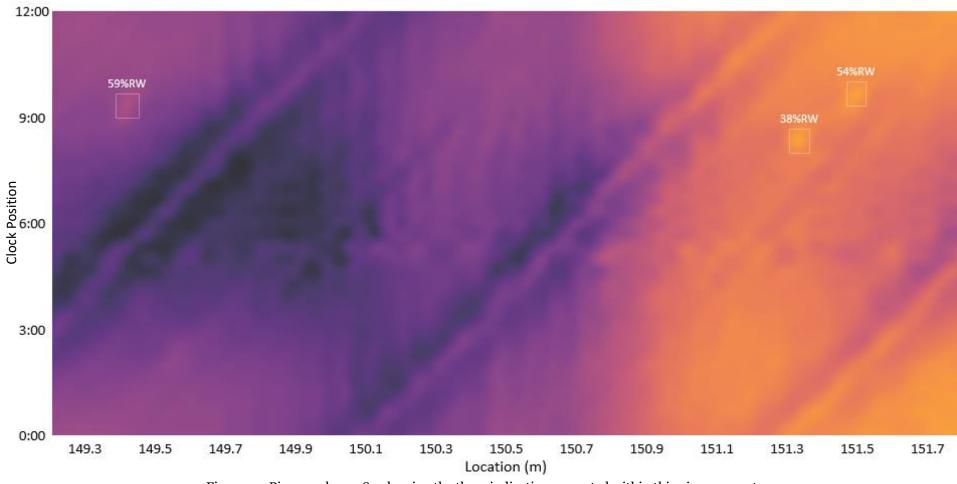
Figure 22. Pipe number 0180 showing the three indications reported within this pipe segment.

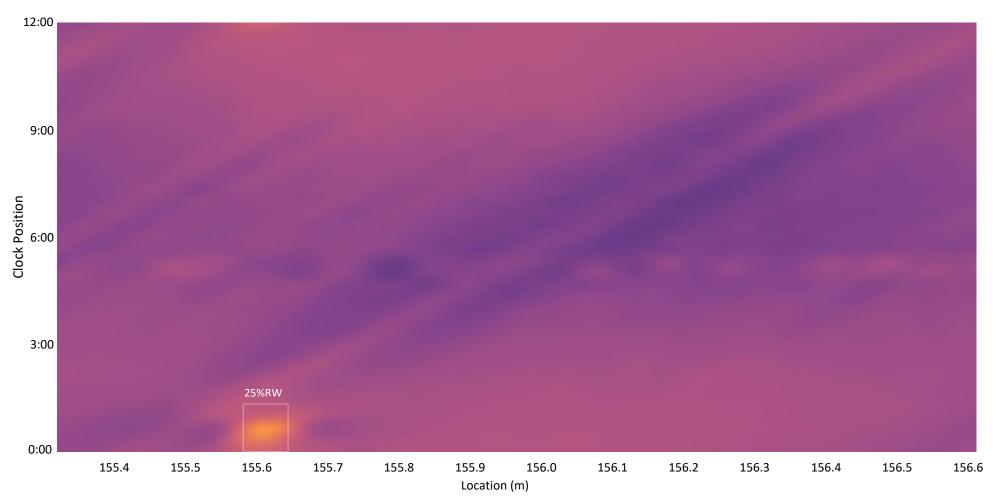
Figure 23. Pipe number 0200 colour map showing the single reported defect indication location within this pipe segment

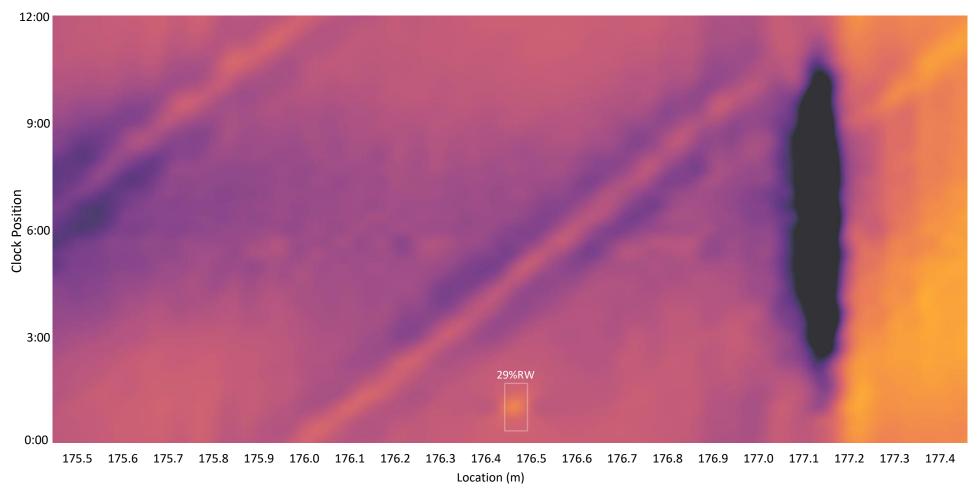
Figure 24. Pipe number 0240 colour map showing the single defect indication reported in this segment, along with a flange connection at 177.14m. This flange connection was noted to be leaking during installation on drawing 7183/64B in 1965. During analysis, special attention was given to this area near the flange connection, though no other wall loss indications were detected.

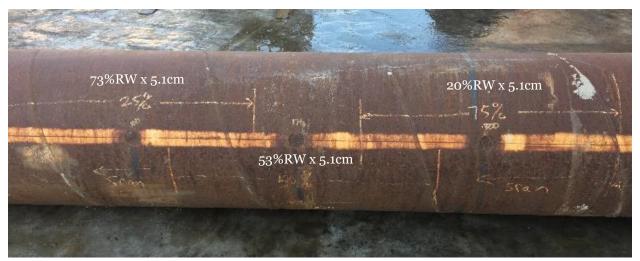
Figure 25. Calibration pipe with 73% RW, 53% RW, and 20% RW 5.1cm diameter flat bottom defects.

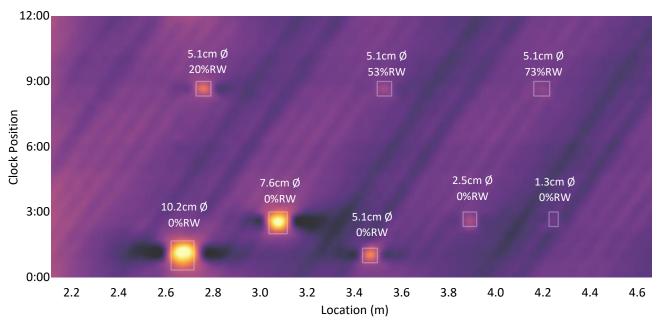
Figure 25 show the circular flat bottom defects, and Figure 27 shows the circular through hole defects machined into the calibration pipe. All defects were visible in the RFT scan of the calibration pipe, including the 1.3cm (0.5in) diameter through hole and the 5.1cm x 73%RW flat bottom defect. Figure 26 shows the RFT scan of the calibration pipe. It is important to note that the results of the calibration may not be directly comparable to the 6.4 mm (0.250in) CML pipe used to construct the Charleswood-Assiniboia Feeder Main due to the differences in the grade and magnetic permeability of the steel pipe material.

Figure 26. Colour map produced of scanned calibration pipe showing flat-bottom and through hole defects.

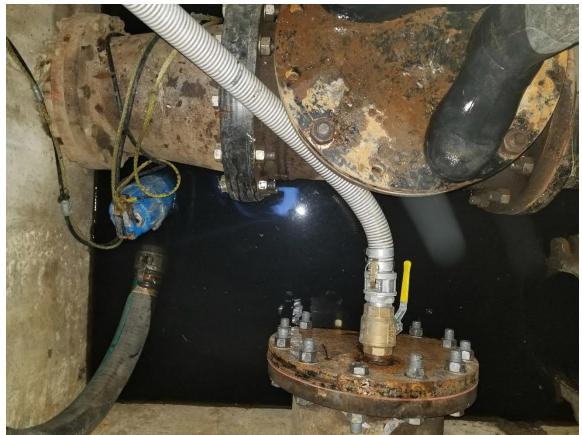
Figure 2: Top down view of the standpipe assembly. Black line made with marker shows water level after water was left to stabilize overnight.

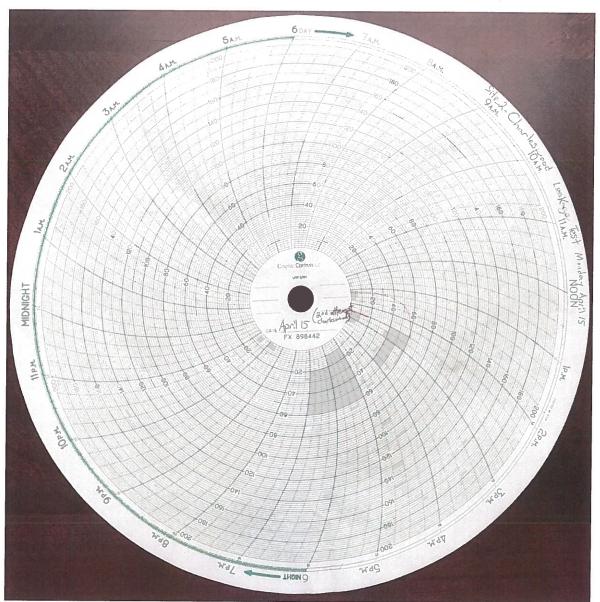
- Hose connected to hydrant to fill McDougall's water tank. Trailer connected to crossing pipe via hose to 50 mm blow-off on the feeder main in the south chamber. At approximately 13:15 the pressure in the feeder main crossing was bled off to zero and observed to gradually rise back to approximately 62 psi over the course of approximately 1.5 hours. (See Photo 2)

- Results:
 - The south main line feeder main valve is bypassing slightly.
 - No apparent leaks on the feeder main crossing.

Photo 2 - McDougall's Enterprise pressure test chart

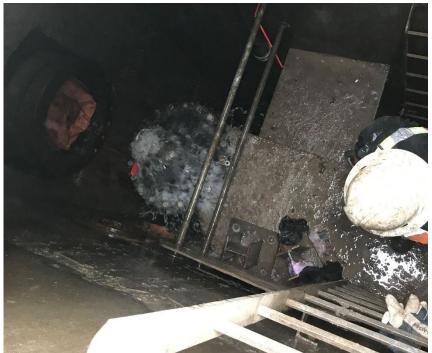
Photo 3 - Water observed flowing from blind flange with ball valve after flushing out air in west chamber

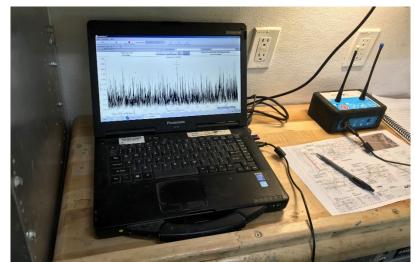
- Apparent leak of 400 L/hr based on leakage test.
- Visual inspection indicates that the leak is not present within the tunnel or tunnel shaft.
- Correlator inspection indicates leak is present on the feeder main crossing itself (between the valve chambers) and possibly 10 to 20 m west of the east valve chamber (towards the river).

Photo 6 - Acoustic correlator read-out during first setup on April 18

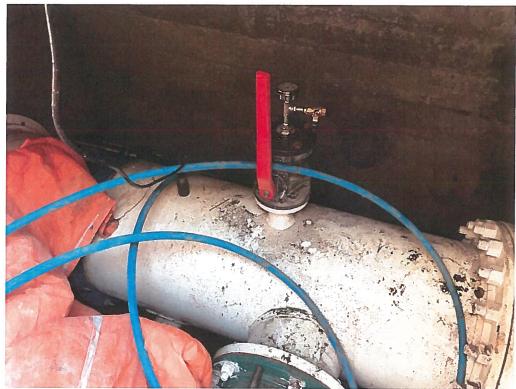
Photo 7 - Acoustic correlator set up on 300 mm gate valve during second setup on April 18

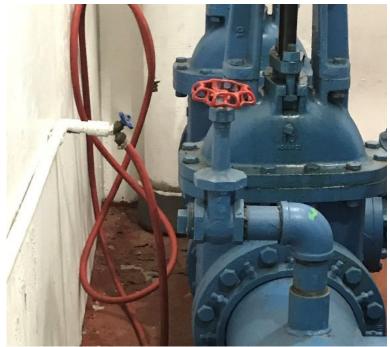
Photo 1 - 50 mm threaded port for flushing / connecting leakage testing equipment

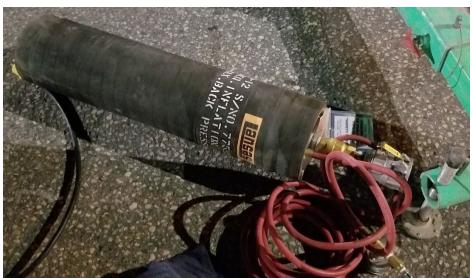
Photo 2 - Incorrect inflatable plug, rated for 20 psi, 25 mm port

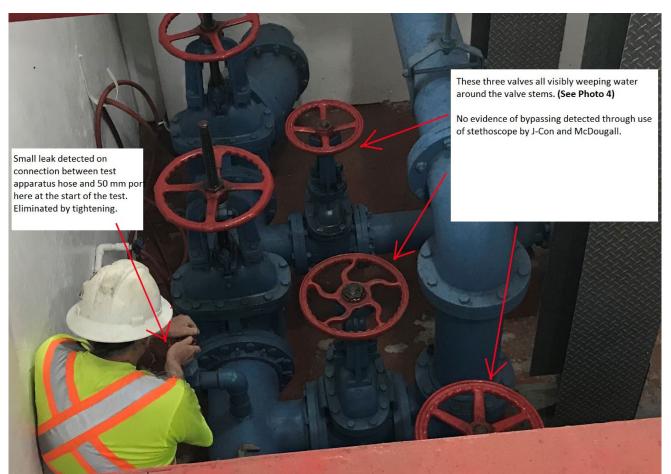
- 01:00 Pressure dropped to 40 psi. J-Con and McDougall inspecting valves and 50 mm port connection in
 pumping station for leaks. A small drip was found at the connection between the 50 mm port and the hose
 running to McDougall's test apparatus. This was quickly eliminated by additional tightening of the fitting. It was
 also observed at this time that three of the closed valves had a very small amount of water weeping up around
 the spindles. A stethoscope was used to sound the valves but J-Con and McDougall were both unable to hear
 any evidence of bypassing in any of the valves. Since no bypassing was heard using the stethoscope, City
 personnel recommended not attempting to reseat or tighten the valves further due to their unknown and
 possibly deteriorated condition (see Photo 3 and Photo 4).

Photo 3 - Eliminating potential sources of leakage at the beginning of the test

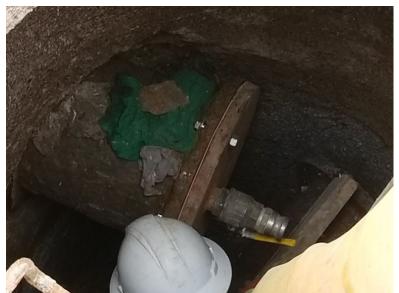
Figure 1 - Installation of blind flange with 2" port at downstream manhole.

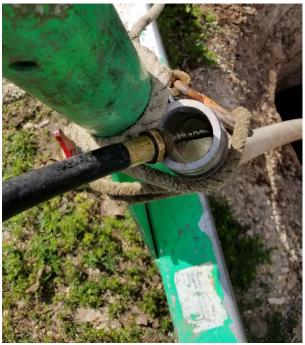
Figure 2 - J-Con filling the standpipe with water.

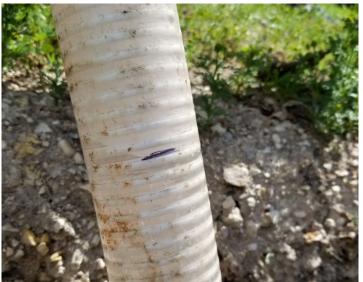
• 11:14 a.m. – The water level in the standpipe was observed to have stabilized approximately 9 inches above the rim of the manhole and marked using a felt pen.

Figure 3 - Mark made on the standpipe at the start of the leakage test.

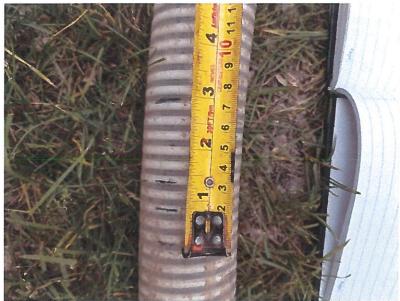
- 11:15 a.m. The leakage test was initiated.
- 11:45 a.m. The water level in the standpipe was marked. It was measured that the water level had dropped approximately 4.13 cm since the start of the test.
- 12:00 p.m. The water level in the standpipe was marked. It was measured that the water level had dropped an additional 1.53 cm for a total drop of 5.66 cm.
- 12:15 p.m. The leakage test was concluded. The final level in the standpipe was marked. It was measured that the level had dropped by an additional 2.01 cm for a total drop of 7.67 cm.

Figure 4 - Measurement of markings on standpipe after removal.

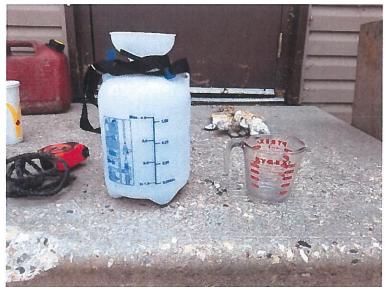
12:17 p.m. – J-Con poured water into the standpipe using a measuring cup until the water level stabilized at the starting elevation. 5.05 L of water was required to bring the water level back to where it started prior to the 1-hour leakage test.

Figure 5 - Water container and measuring cup used to fill the standpipe after completion of leakage test.

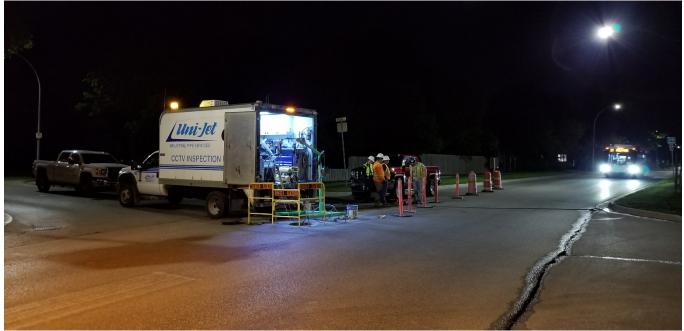
Figure 1: Setup at Discharge Manhole

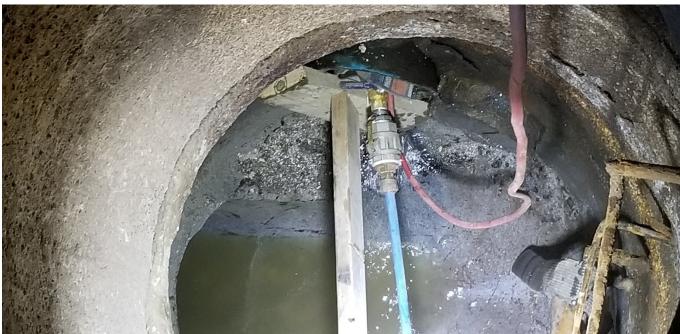
- Gerry Jones and J-Con were unaware of the modified testing procedure and were not prepared to induce pressure from the downstream plug location. J-Con managed to find appropriate fittings to test through the bleed port on the plug vs. the testing port as requested.
- McDougal did not bring full trailer setup as discussed with J-Con and thus did not have a water tank for testing. McDougal opted to utilize a hydrant for the water feed at the corner of Ness Ave and School Road.
- For the first two plug setup's J-Con utilized an insufficient blocking configuration which allowed the plug to move. For the third attempt they employed blocking consistent with the first test which held.

Figure 2: Pressure Plug and Blocking

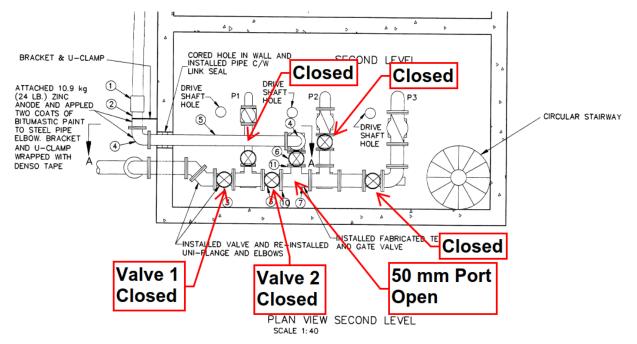
Figure 3: Valve Configuration in Station

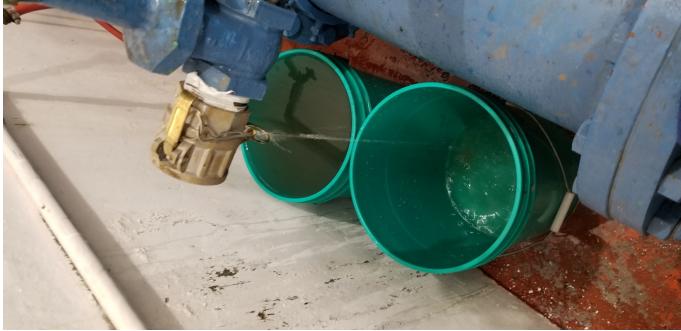
Figure 4: Bypassing Measurement in Station

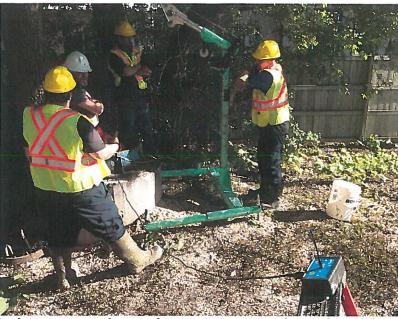
Photo 1: City of Winnipeg personnel preparing to connect correlator wires to feeder main in the east chamber

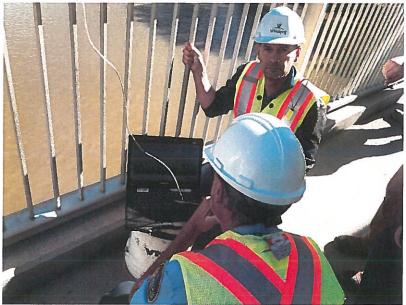
Photo 2: Observing results of correlator test on the Harry Lazarenko Bridge

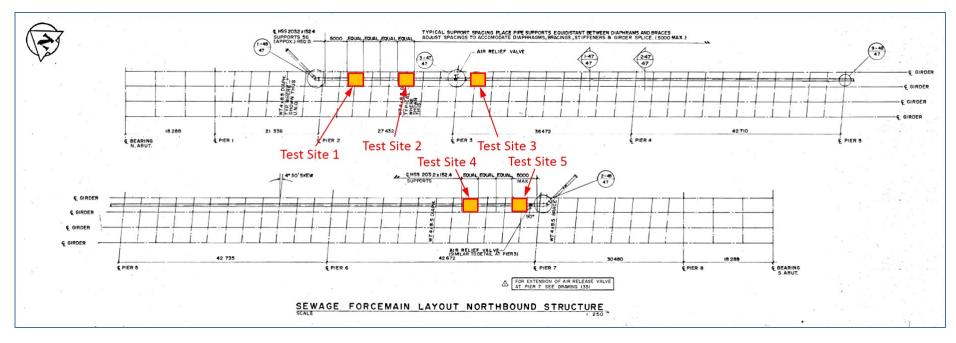
Figure A 1 – Approximate Locations of Ultrasonic Test Sites along Baltimore Force Main Bridge Pipe.

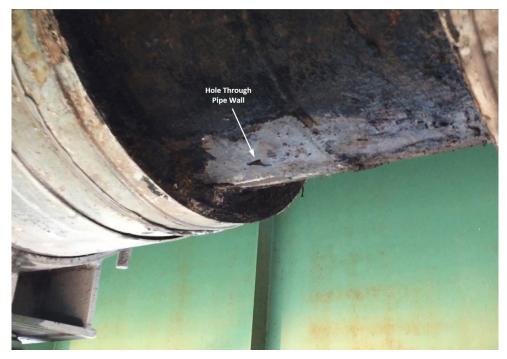
While observations of very little exterior face corrosion are consistent with the manner in which the system was built (i.e. as a pre-insulated pipe) significant internal corrosion processes are present. As nearly all wall thickness measurements were less than 8.5mm it is high likely that a protective lining was not installed (if one was installed, it has completely failed). This suggests the observations of preferential invert corrosion in the pipe are likely widespread due to a combination of natural pitting and erosion corrosion processes. The severity of the pitting is also extreme and remediation plans should be rationalized for the pipe in the short term.

Figure A 2 - Leak Site in Baltimore Force Main, August 10, 2018. Triangular hole through patch welded to the bottom of the pipe.

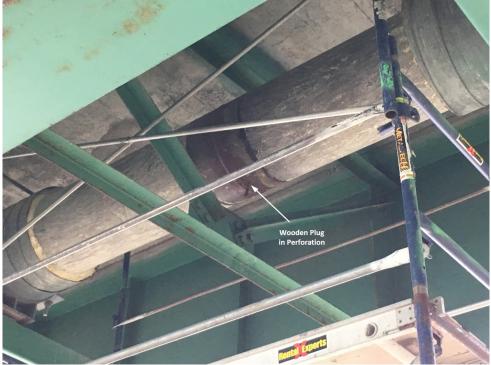
Figure A 3 – Leak Site in Baltimore Force Main, October, 2018.

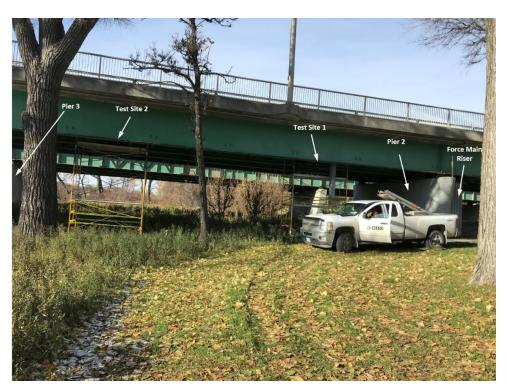
Figure A 4 – Test Sites 1 and 2 between Piers 2 and 3 on north side of Red River.

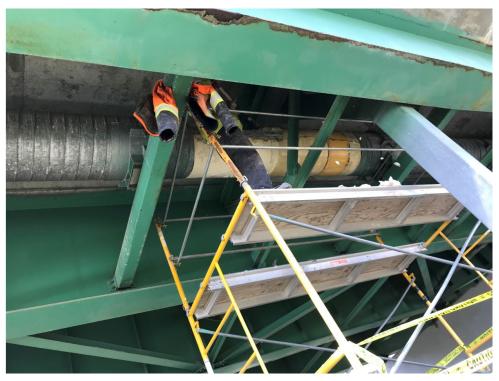
Figure A 5 – Test Site 1 on north side of Red River. Girth weld location on right (darker band of insulation near bridge drainage chute).

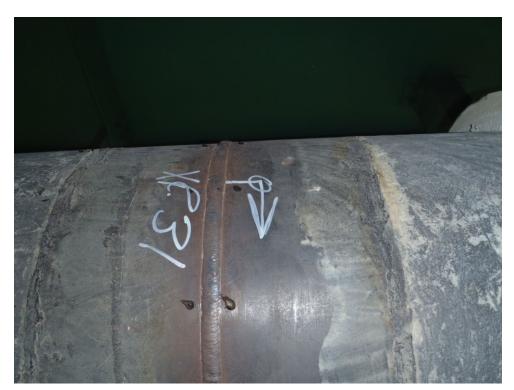
Figure A 6 – Test Site 1 on north side of Red River. Top of pipe showing minor surface corrosion at girth weld (X-ray 31) and ultrasonic test points on each side of girth weld.

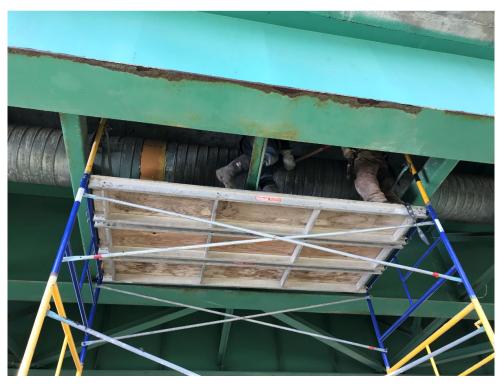
Figure A 7 – Test Site 2 on north side of Red River. Girth weld location on left, at exposed insulation.

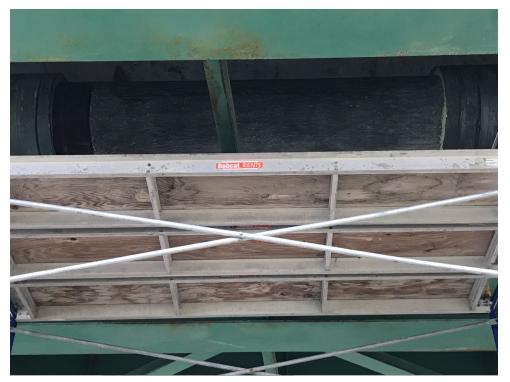
Figure A 8 – Test Site 2 on north side of Red River. Girth weld location on left.

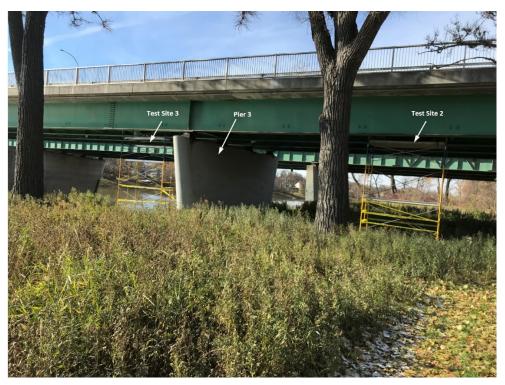
Figure A 9 - Test Sites 2 and 3 near Pier 3 on north side of Red River.

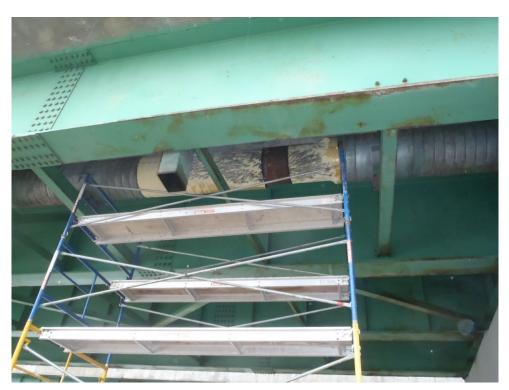
Figure A 10 – Test Site 3 south of Pier 3 on north side of Red River.

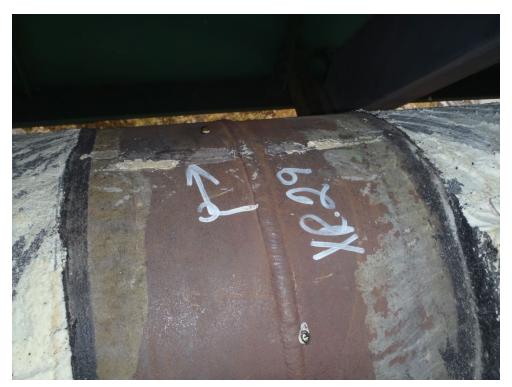
Figure A 11 – Test Site 3 south of Pier 3 on north side of Red River. Top of pipe showing minor surface corrosion at girth weld (X-ray 29).

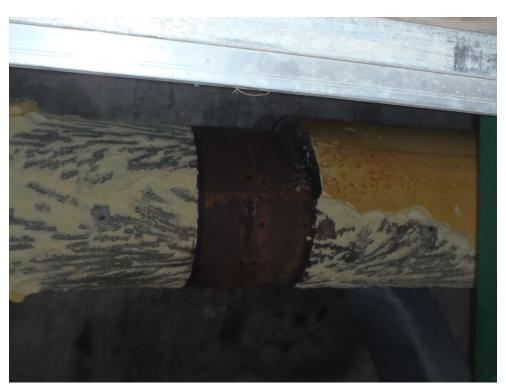
Figure A 12 – Test Site 3 south of Pier 3 on north side of Red River. Bottom of pipe showing test locations at girth weld and on invert.

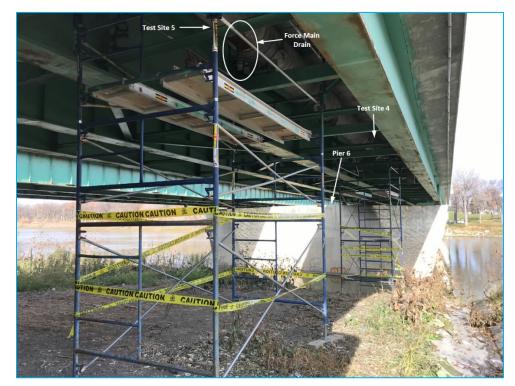
Figure A 13 - Test Sites 4 and 5 between Piers 6 and 7 on south side of Red River.

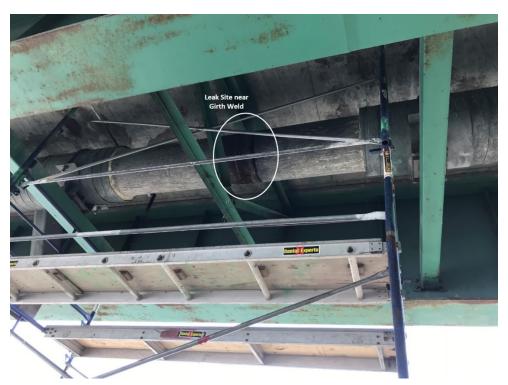
Figure A 14 - Test Site 4 at October 2018 leak site on south side of Red River.

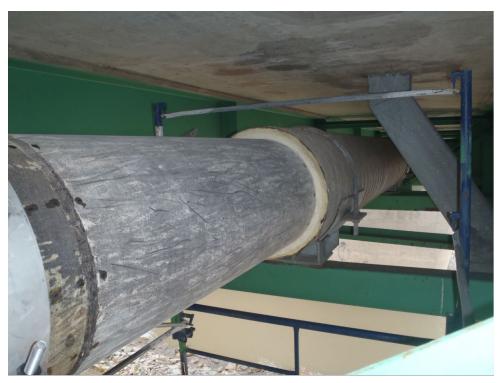
Figure A 15 – Test Site 4 north of leak repair on south side of Red River. Note ultrasonic test points near repair clamp at left edge of photo.

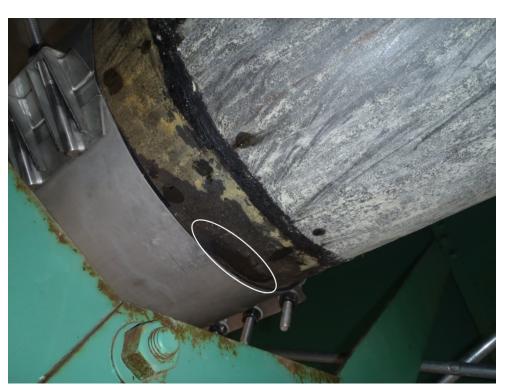
Figure A 16 – Test Site 4 north of leak repair on south side of Red River. Note ultrasonic test points along invert and around pipe circumference.

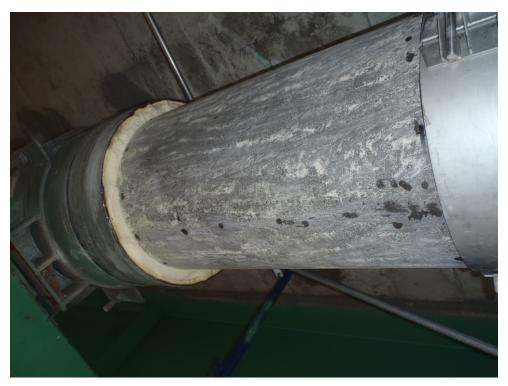
Figure A 17 – Test Site 4 south of leak repair on south side of Red River. Note ultrasonic test points along invert and around pipe circumference.

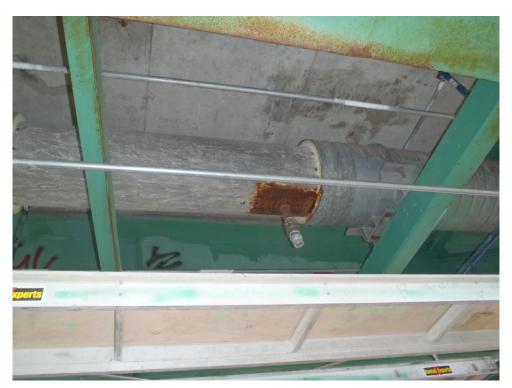
Figure A 18 - Test Site 5 at Force Main Drain on south side of Red River. Note ultrasonic test points around pipe circumference.

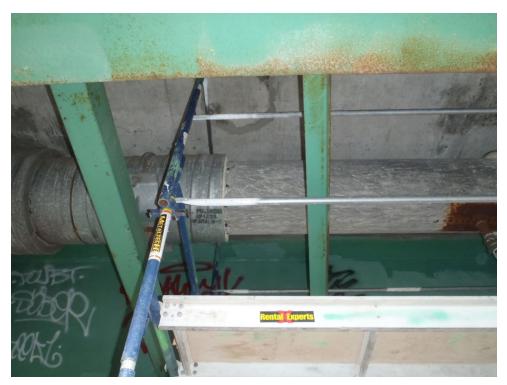
Figure A 19 - Test Site 5 at Force Main Drain on south side of Red River. Note ultrasonic test points around pipe circumference.

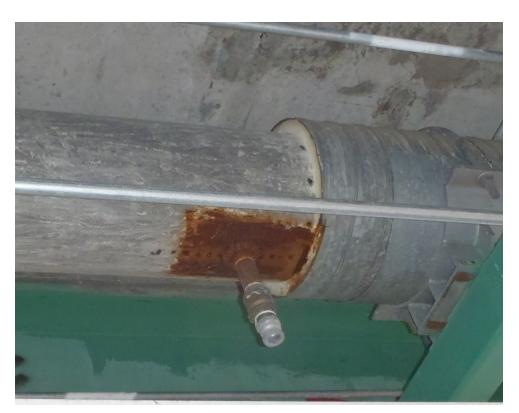
Figure A 20 – Test Site 5: Thickness Test Points on invert and circumference. Note ultrasonic test points along invert and around pipe circumference.

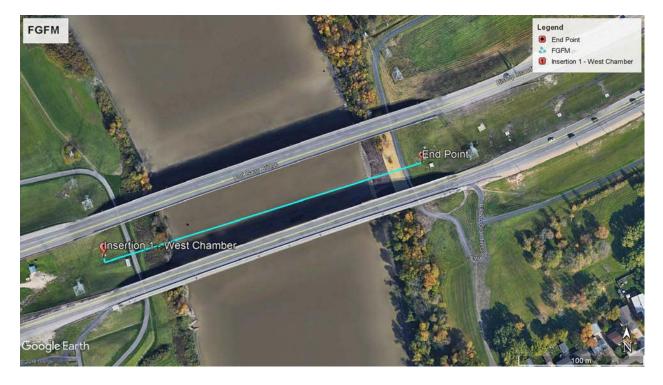
Figure 2.1: FGFM – West Chamber (307m)

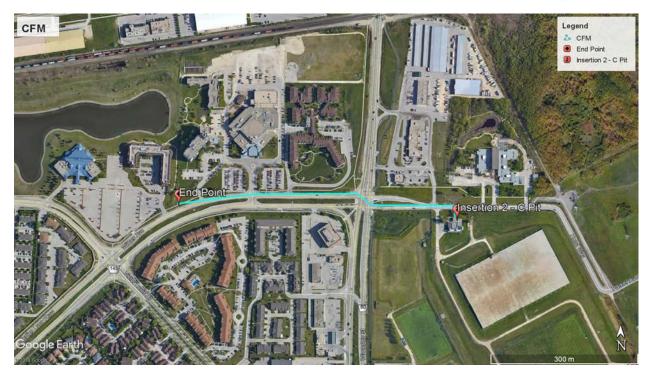
Figure 2.2: CFM – C Pit (568m)

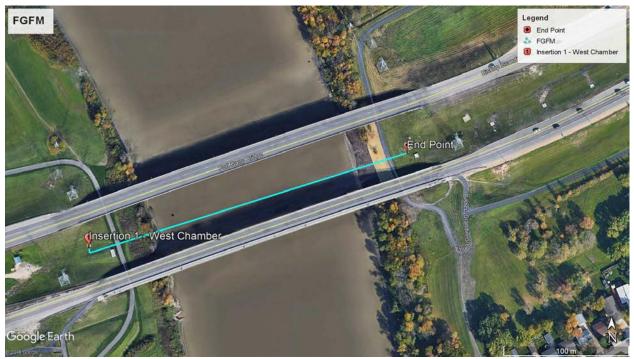
Figure 3.3: Aerial View of FGFM Inspection 1

The 600-mm diameter FGFM section between West Chamber and East Chamber was inspected on October 23-24, 2018. Figure 3.3 displays an aerial view of the FGFM Inspection 1 with the inspection scope highlighted in blue. A total inspection distance of 307m was completed. There were zero (0) leaks and zero (0) air pockets detected during the inspection. Table 3.2 provides details on the Inspection 1.

Tabl	Table 3.2: Aqueduct Sahara Inspection 1 Details							
Pipeline	FGFM							
Diameter	600-mm							
Material	Cast Iron							
Insertion Date	October 23-24, 2018							
Insertion Location	ARV 116							
Insertion Feature	4-inch valve with 2-inch NPT port							
Inspected Distance	307m							
Measured Flow	0.45m/s approximate							
Measured Pressure	3.10 bar (at insertion point)							
Survey Observations	0 visual defects located. No leaks or air pockets were detected.

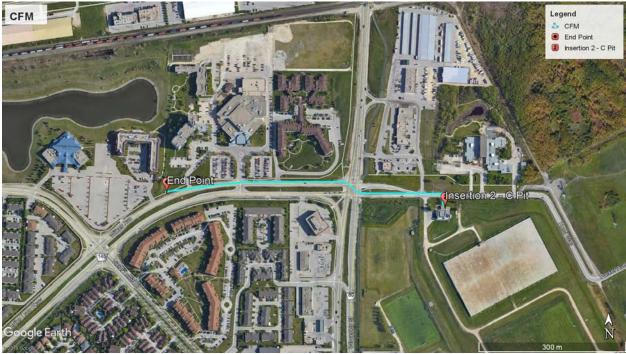
Figure 3.4: Aerial View of CFM Inspection 2

The 750-mm diameter CFM section was inspected on October 25, 2018. Figure 3.4 displays an aerial view of the CFM Inspection 2 with the inspection scope highlighted in blue. A total inspection distance of 568m was completed. There were zero (0) leaks and zero (0) air pockets detected during the inspection. Table 3.3 provides details on the Inspection 2.

Table 3.3: Aqueduct Sahara Inspection 2 Details							
Pipeline	CFM						
Diameter	750-mm						
Material	AC						
Insertion Date	October 25, 2018						
Insertion Location	C-Pit						
Insertion Feature	2-inch Valve						
Inspected Distance	568m						
Measured Flow	0.6m/s approximate						
Measured Pressure	4.82 bar (At insertion point)						
Survey Observations	0 visual defects located. No leaks or air pockets were detected.

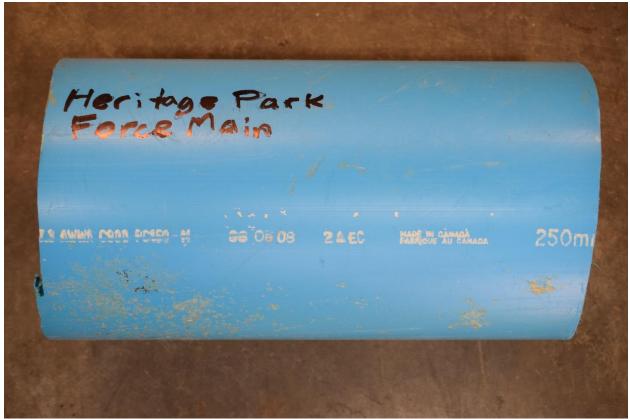
Figure 1. Sample #1: Heritage Park Force Main

Sample ID
<u>Properties</u>	Sample 1
Address	Heritage Park
IZOD Impact Resistance (ft-lb/in)	1.270
Tensile Strength @ Yield (psi)	7,168
Tensile Modulus (psi)	446,070
Color	Blue
Outside Diameter Ave. (in)	11.110
Minimum Wall Thickness (in)	0.6216
Heat Reversion	FAIL
Acetone Immersion	<1% / No Reaction
Ash Content (%)	6.04%

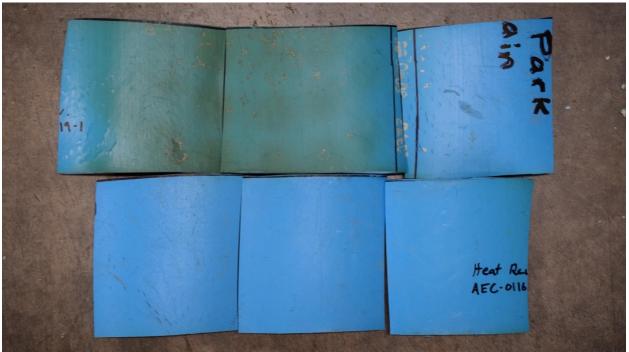
Figure 2. Post-test heat reversion test specimen from Sample #1: Note sun-bleached surface of the pipe which turns brown during heat reversion testing.

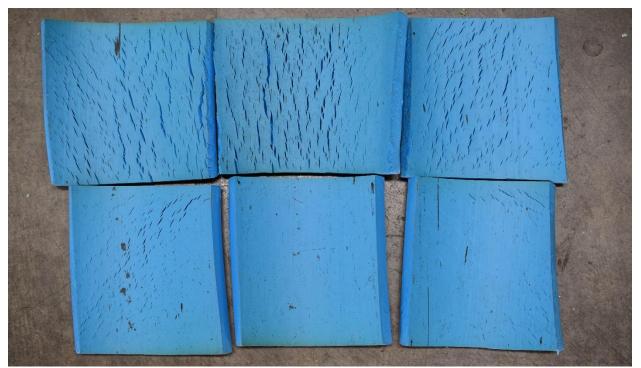
Figure 3. Post-test heat reversion test specimen from Sample #1: Note significant blistering and/or fish scaling.

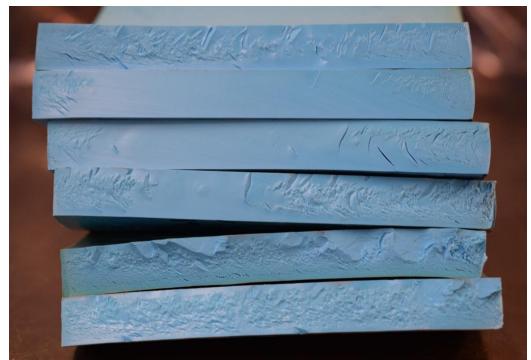
Figure 4. Post-test heat reversion test specimen from Sample #1: Note significant wall separation.
