GEOTECHNICAL REPORT

November 25, 2022

**Re: 2023 City of Winnipeg Local Street Renewal Program
Report of Geotechnical Investigation and Test Results**

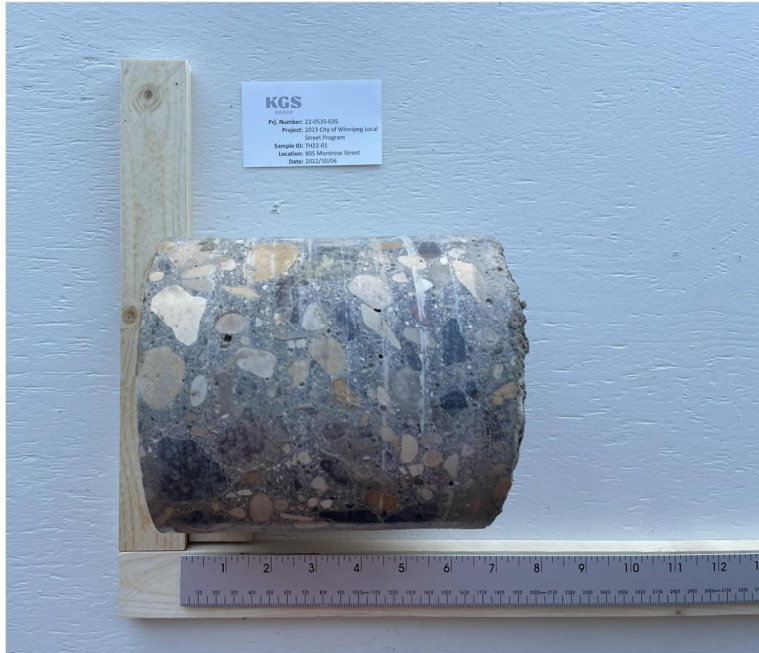
Photo 1: TH22-01

Four (4) cores were completed along Montrose Street; two (2) at joint locations (TH22-02 and TH22-04), and two (2) mid-slab (TH22-01 and TH22-03). The pavement surfacing consisted of concrete with a thickness of 159 to 203 mm (6.25 to 8 in.). Base material was only encountered in TH22-02 and consisted of 51 mm (2 in.) thick crushed limestone. Clay subgrade was encountered directly below pavement in the remaining test holes. Core hole locations are shown in Figure 1 attached.

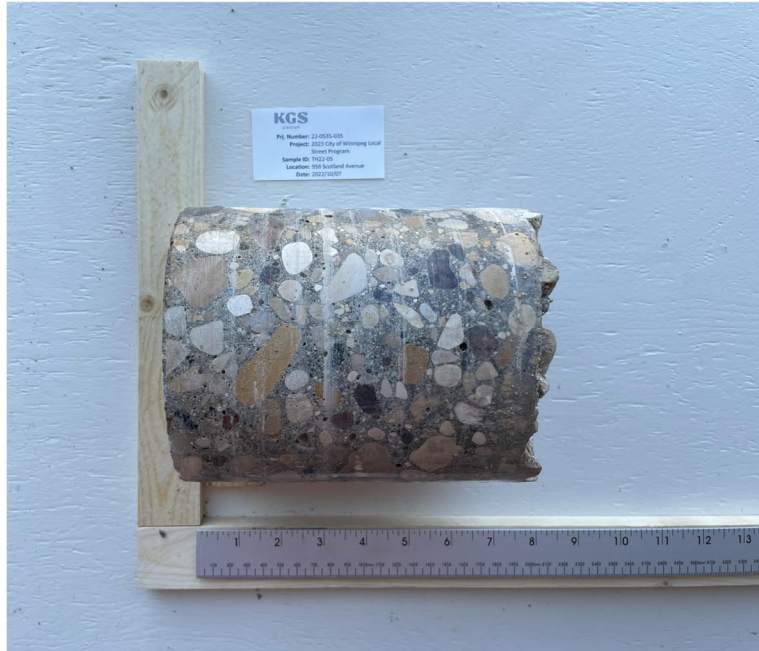
Photo 05: TH22-05

Five (5) cores were completed along Scotland Avenue; three (3) at joint locations (TH22-06, TH22-07 and TH22-09), and two (2) mid-slab (TH22-05 and TH22-08). Pavement surfacing consisted of concrete with a thickness of 171 to 222 mm (6.75 to 8.75 in.). Base material consisted of crushed limestone 25 mm (1 in.) thick in TH22-09, and granular 38 to 51 mm (1.5 to 2 in.) thick in TH22-07 and TH22-05. Clay subgrade was encountered directly below pavement in TH22-06 and TH22-08. Core hole locations are shown in Figure 2 attached.

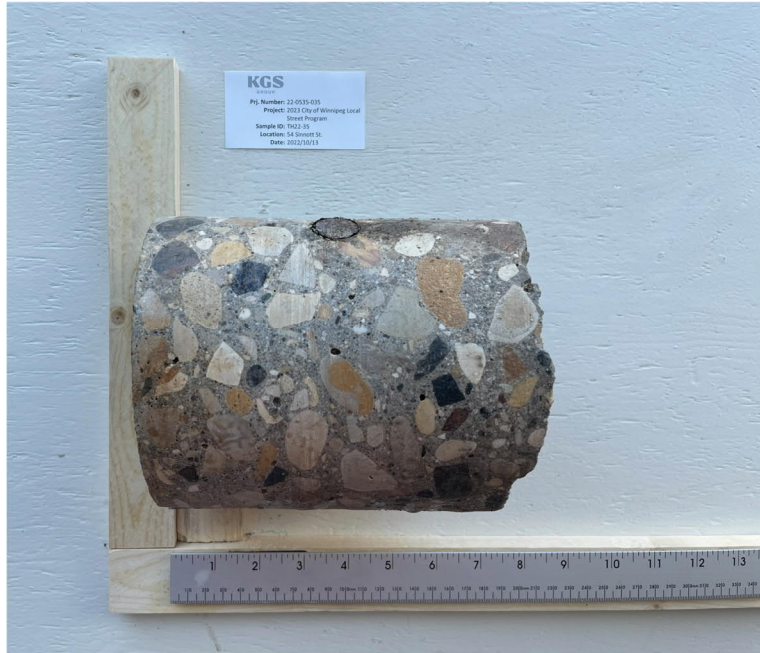
Photo 35: TH22-35

Three (3) cores were completed along Sinnott Street; two (2) at joint locations (TH22-35 and TH22-37), and one (1) mid-slab (TH22-36). The pavement surfacing consisted concrete with a thickness from 178 to 191 mm (7 to 7.5 in). Granular base material 76 mm (3 in) in thickness was encountered directly below pavement in TH22-35 and TH22-36. Clay subgrade was encountered immediately below pavement in TH22-37. Core locations are shown on the attached Figure 10.

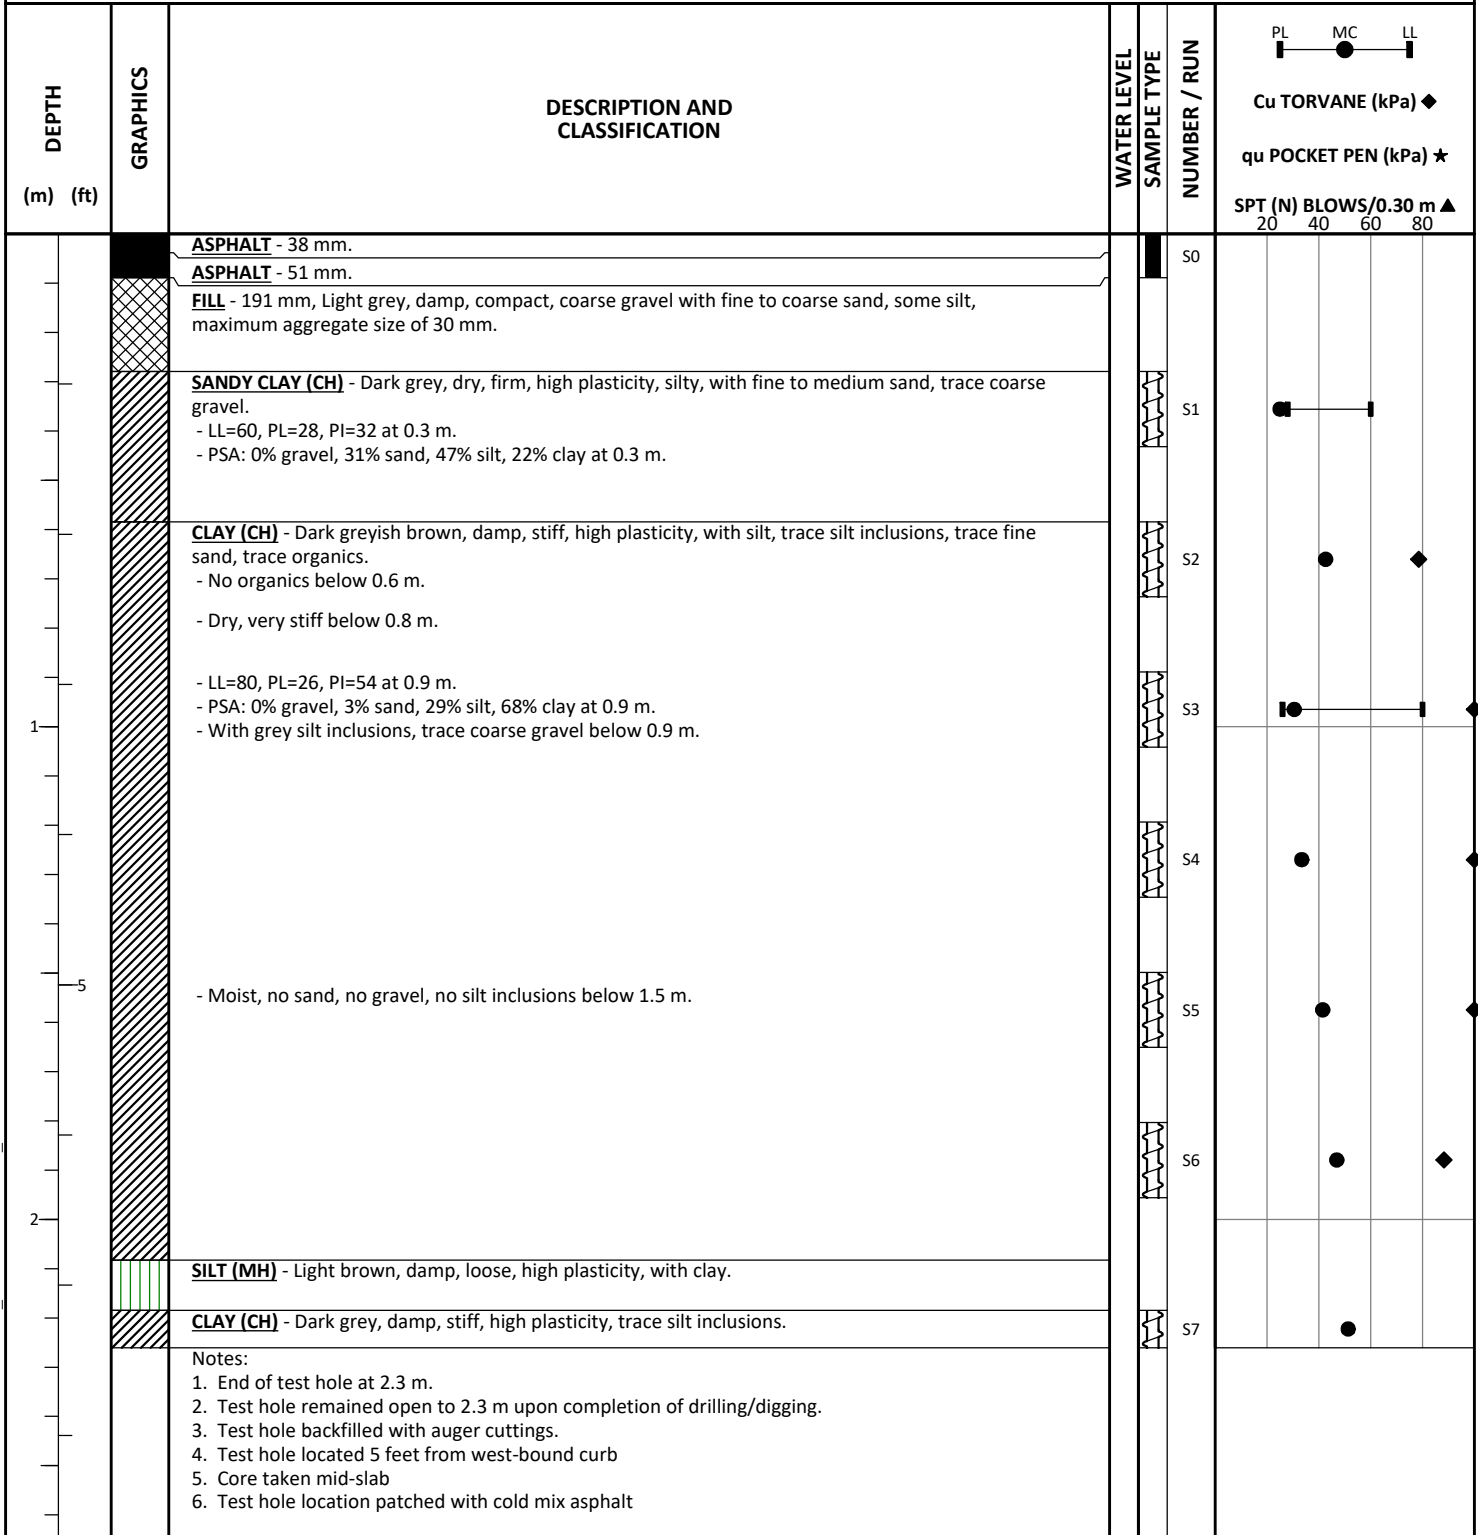
- Notes:
- End of test hole at 2.3 m.
 - Test hole remained open to 2.3 m upon completion of drilling/digging.
 - Test hole backfilled with auger cuttings.
 - Test hole located 5 feet from west-bound curb
 - Core taken mid-slab
 - Test hole location patched with cold mix asphalt

- Brown below 1.2 m.			S4				
5					S5				
		SILT (MH) - Light brownish grey, damp to moist, compact, high plasticity, with clay.			S6				
2		CLAY (CH) - Brown, damp to moist, stiff, high plasticity, trace silt inclusions, trace fine sand.			S7				
		Notes: 1. End of test hole at 2.3 m. 2. Test hole remained open to 2.3 m upon completion of drilling/digging. 3. Test hole backfilled with auger cuttings. 4. Test hole located 5 feet from west-bound curb 5. Core taken mid-slab 6. Test hole location patched with cold mix asphalt

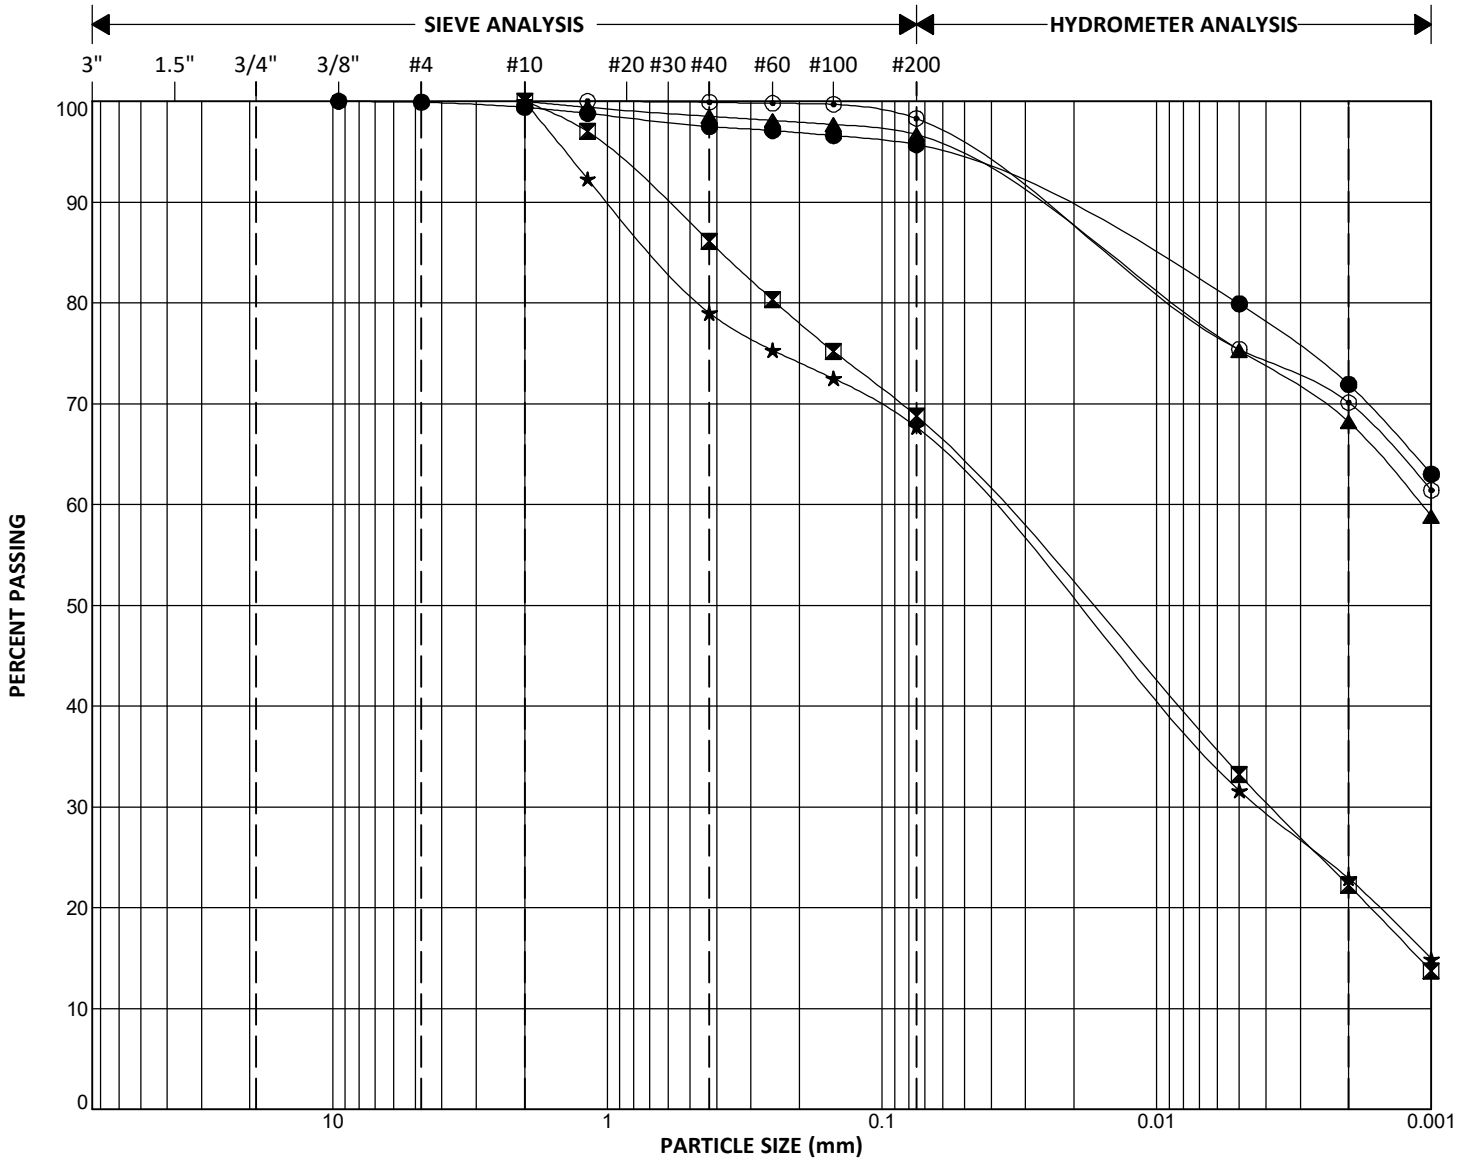
GRAIN SIZE DISTRIBUTION

HOLE	DEPTH (m)	SAMPLE #	GRAVEL (%)	SAND (%)	SILT (%)	CLAY (%)	SILT & CLAY (%)	Cu	Cc	CLASSIFICATION
●	Composite	0.0	S1	0	4	24	72	96			CH
■	TH22-41	0.3	S1	0	31	47	22	69			CH
▲	TH22-41	0.9	S3	0	3	29	68	97			CH
★	TH22-42	0.3	S1	0	32	45	23	68			CL
○	TH22-42	0.6	S2	0	2	28	70	98			CH

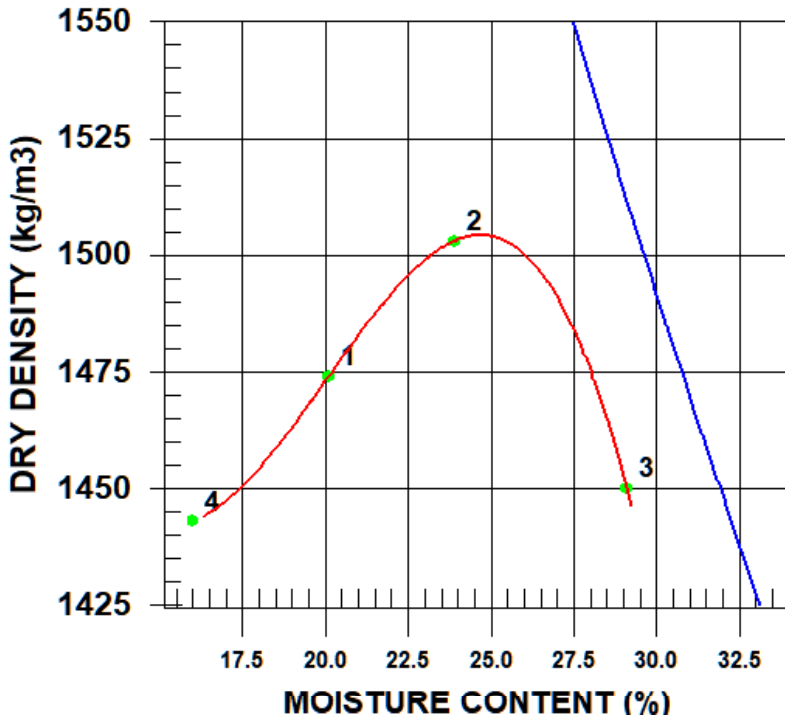
Additional Laboratory Testing - A moisture-density relationship test (standard Proctor) and a California Bearing Ratio (CBR) test were completed on a composite sample consisting of sandy clay and clay collected from the upper 1.5 m (5 ft) below base of fill material in all test holes. Results indicated a maximum dry density of 1500 kg/m³, an optimum moisture content of 24.5%, and a CBR of 3.6 at 2.54 mm penetration. Atterberg limit and

MAXIMUM DRY DENSITY (kg/m ³)	OPTIMUM MOISTURE CONTENT (%)
CALCULATED	1500	24.5
OVERSIZE CORRECTED

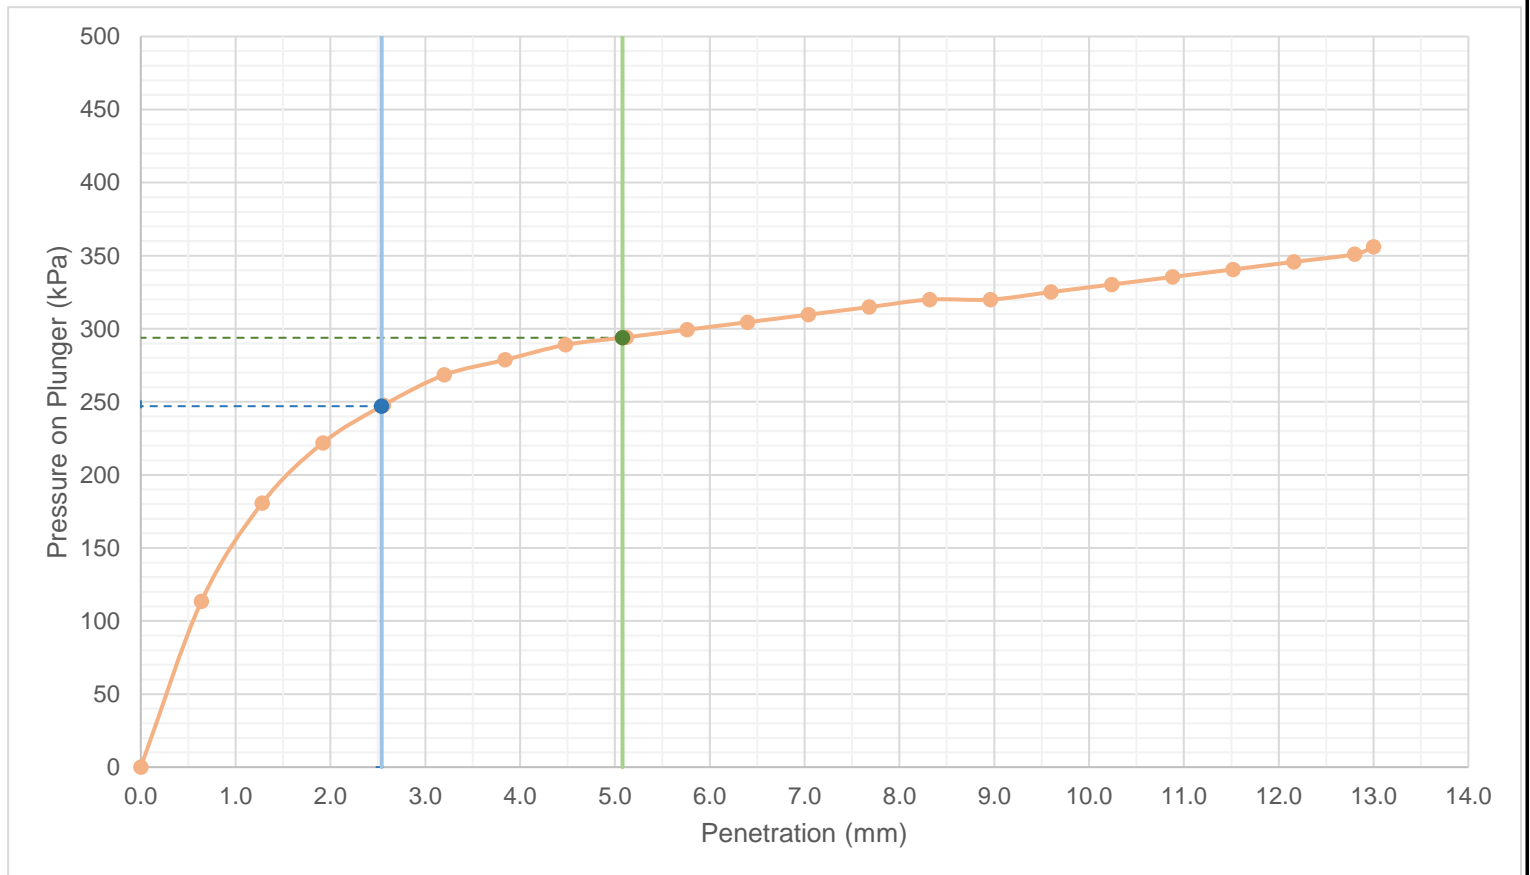
LOAD PENETRATION CURVE

IMMERSION PERIOD	96 ± 2 hr	TARGET MAX. DRY DENSITY	1500 kg/m ³
CONDITION OF SAMPLE	Soaked	TARGET OPTIMUM MOISTURE	24.5 %
SURCHARGE MASS	4.54 kg	AS-COMPACTED MAX. DRY DENSITY	1425 kg/m ³
SWELL OF SAMPLE	7.0%	AS-COMPACTED MOISTURE CONTENT	24.6 %
		POST-TEST MOISTURE CONTENT (TOP 25 mm)	37.6 %
