CITY OF WINNIPEG

WASTEWATER LIFT STATION CONDITION ASSESSMENT PHASE II

Document IV: Windsor Park Lift Station Assessment

Date: March 16, 2020

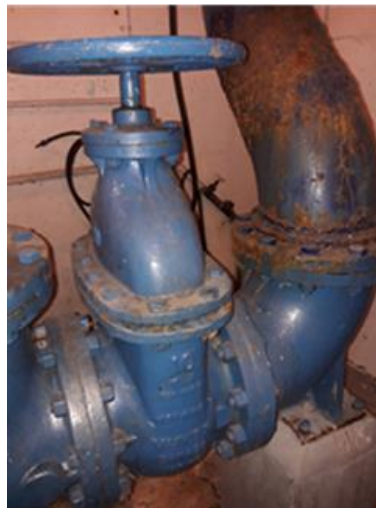
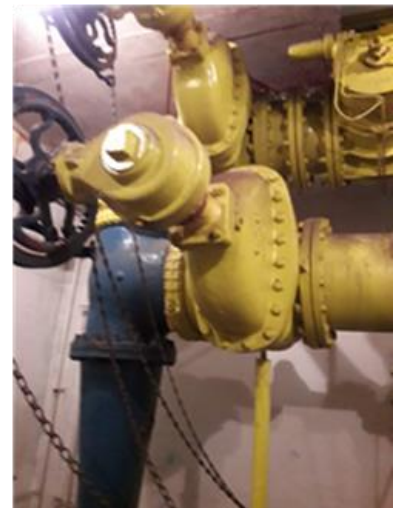
The majority of the valves were installed in 1998, with the exception of the force main isolation valves and the storm pump discharge valve which were installed in 1976. The manual and pneumatic force main isolation valves are regularly exercised. Operational staff noted that the force main isolation valves are not seating completely. The manually actuated gate valves that are used for isolation of equipment for maintenance and are not regularly exercised. The check valves are critical to the operation of the lift station and are exercised regularly through operation. In general, valves are in “Fair” to “Poor” condition. Table 7.5 provides a summary of the condition of the valves at the station.

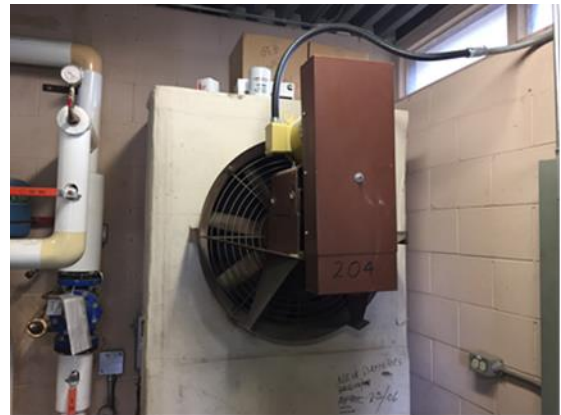
- The dry well continuous ventilation system is undersized for the dry well fresh air requirements.
- There is no exhaust ducting in place in the dry well.
- There is no wet well ventilation system in place.

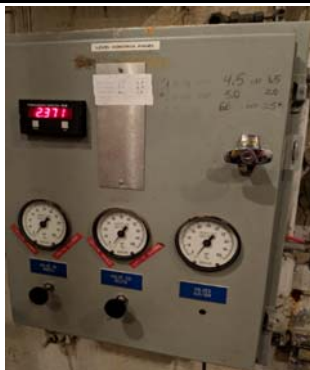
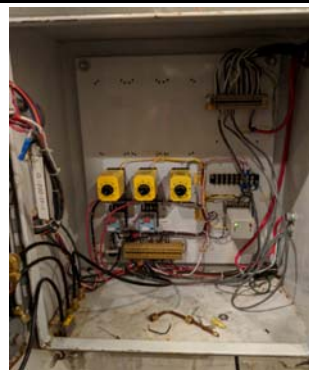
Project No.: 8400-001-00
 Tag: IC_103_Panel
 Facility: Windsor Park Lift Station
 Assessment Page 1 of 1

Control Logic is Appropriate for Installation: <i>Issues for Discussion:</i> Rating 1 (Yes) Rating 3 (No - current standards) Rating 5 (No - legacy standards)	1	0.3					
	Fitness for Purpose	Communications Equipment is Appropriate: <i>Issues for Discussion:</i> Rating 1 (Yes) Rating 3 (No - current standards) Rating 5 (No - legacy standards)	1	0.1	RECOMMENDATIONS: Incorporate new panel as part of the overall control panel upgrade and design.		COST ESTIMATE \$ 5,000.00		
		Equipment Remaining Service Life: <i>Issues for Discussion:</i> Rating 1 (> 90% lifecycle remain) Rating 2 (> 75% lifecycle remain) Rating 3 (> 50% lifecycle remain) Rating 4 (> 25% lifecycle remain) Rating 5 (obsolete)	4	0.2

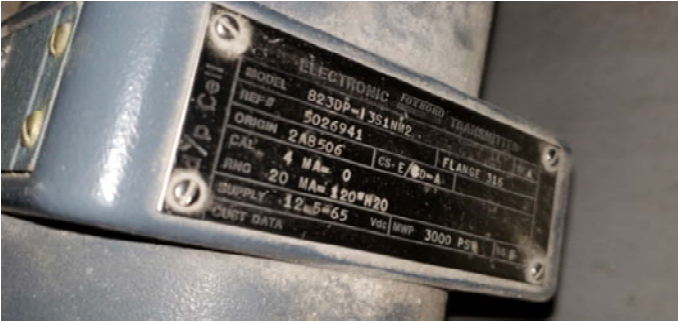
Canadian Electrical Code Issues Identified: <i>Issues for Discussion:</i>	Rating 1 (No issues) Rating 3 (Non compliant - current code) Rating 5 (Non compliant - legacy code)	1	0.4				
		Control Wiring Terminations Visual Inspection: <i>Issues for Discussion:</i>	Rating 1 (Connections tight, labelled) Rating 2 (Missing Labels) Rating 3 (Loose / Disorganized wiring) Rating 4 (Inappropriate wiring) Rating 5 (Combination of above)	1	0.1				
		Occurrences of Maintenance Issues: <i>Issues for Discussion:</i>	Rating 1 (None) Rating 2 (Intermittent) Rating 3 (Consistent but occasional) Rating 4 (Frequent) Rating 5 (Constant)	2	0.4				
		Instrument/Measurement is Designed Appropriately: <i>Issues for Discussion:</i>	Rating 1 (Yes) Rating 3 (No - current standards) Rating 5 (No - legacy standards)	1	0.3				
		Instrument Redundancy is Required/Installed: <i>Issues for Discussion:</i>	Rating 1 (Yes or Not Required) Rating 3 (Required, non standard) Rating 5 (Required, not installed)	5	0.1

Fitness for Purpose	Instrument Range is Appropriate: <i>Issues for Discussion:</i>	Rating 1 (Yes) Rating 3 (No - current standards) Rating 5 (No - legacy standards)	1	0.1	COST ESTIMATE \$ 5,000.00			
Instrument Remaining Service Life: <i>Issues for Discussion:</i>		Rating 1 (> 90% lifecycle remain) Rating 2 (> 75% lifecycle remain) Rating 3 (> 50% lifecycle remain) Rating 4 (> 25% lifecycle remain) Rating 5 (obsolete)	4	0.5					
PHOTOGRAPHS

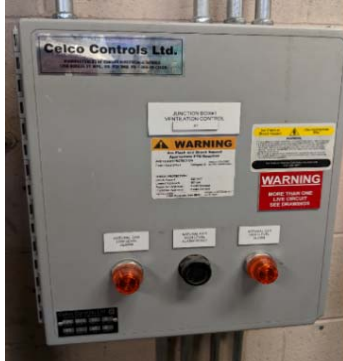
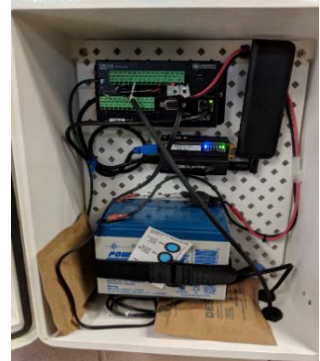
Canadian Electrical Code Issues Identified: <i>Issues for Discussion:</i>	Rating 1 (No issues) Rating 3 (Non compliant - current code) Rating 5 (Non compliant - legacy code)	1	0.4					
Control Wiring Terminations Visual Inspection: <i>Issues for Discussion:</i>		Rating 1 (Connections tight, labelled) Rating 2 (Missing Labels) Rating 3 (Loose / Disorganized wiring) Rating 4 (Inappropriate wiring) Rating 5 (Combination of above)	1	0.1						
Occurrences of Maintenance Issues: <i>Issues for Discussion:</i>		Rating 1 (None) Rating 2 (Intermittent) Rating 3 (Consistent but occasional) Rating 4 (Frequent) Rating 5 (Constant)	3	0.4						
Instrument/Measurement is Designed Appropriately: <i>Issues for Discussion:</i>		Rating 1 (Yes) Rating 3 (No - current standards) Rating 5 (No - legacy standards)	1	0.3						
Fitness for Purpose	Instrument Redundancy is Required/Installed: <i>Issues for Discussion:</i>	Rating 1 (Yes or Not Required) Rating 3 (Required, non standard) Rating 5 (Required, not installed)	1	0.1

Instrument Range is Appropriate: <i>Issues for Discussion:</i>	Rating 1 (Yes) Rating 3 (No - current standards) Rating 5 (No - legacy standards)	1	0.1						
	Instrument Remaining Service Life: <i>Issues for Discussion:</i>	Rating 1 (> 90% lifecycle remain) Rating 2 (> 75% lifecycle remain) Rating 3 (> 50% lifecycle remain) Rating 4 (> 25% lifecycle remain) Rating 5 (obsolete)	3	0.5						
PHOTOGRAPHS

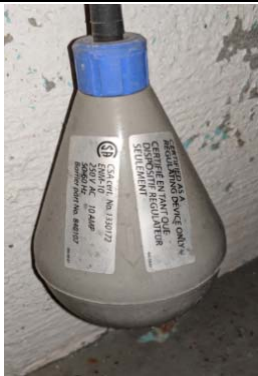
Canadian Electrical Code Issues Identified: <i>Issues for Discussion:</i> Rating 1 (No issues) Rating 3 (Non compliant - current code) Rating 5 (Non compliant - legacy code)	1	0.4					
Control Wiring Terminations Visual Inspection: <i>Issues for Discussion:</i> Rating 1 (Connections tight, labelled) Rating 2 (Missing Labels) Rating 3 (Loose / Disorganized wiring) Rating 4 (Inappropriate wiring) Rating 5 (Combination of above)		1	0.1						
Occurrences of Maintenance Issues: <i>Issues for Discussion:</i> Rating 1 (None) Rating 2 (Intermittent) Rating 3 (Consistent but occasional) Rating 4 (Frequent) Rating 5 (Constant)		2	0.4						
Instrument/Measurement is Designed Appropriately: <i>Issues for Discussion:</i> Rating 1 (Yes) Rating 3 (No - current standards) Rating 5 (No - legacy standards)		1	0.3						
Instrument Redundancy is Required/Installed: <i>Issues for Discussion:</i> Rating 1 (Yes or Not Required) Rating 3 (Required, non standard) Rating 5 (Required, not installed)		1	0.1

Fitness for Purpose	Instrument Range is Appropriate: <i>Issues for Discussion:</i> Rating 1 (Yes) Rating 3 (No - current standards) Rating 5 (No - legacy standards)	1	0.1						
	Instrument Remaining Service Life: <i>Issues for Discussion:</i> Rating 1 (> 90% lifecycle remain) Rating 2 (> 75% lifecycle remain) Rating 3 (> 50% lifecycle remain) Rating 4 (> 25% lifecycle remain) Rating 5 (obsolete)	1	0.5						
PHOTOGRAPHS

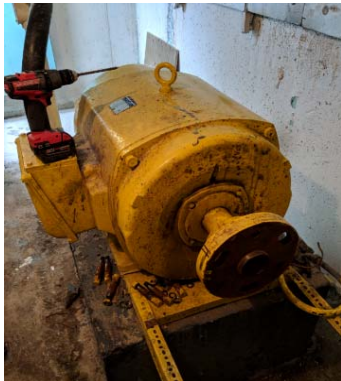
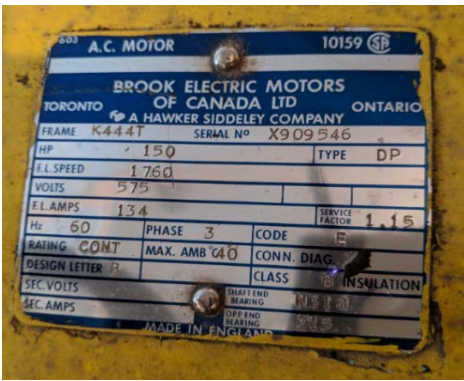
Canadian Electrical Code Issues Identified: <i>Issues for Discussion:</i> Rating 1 (No issues) Rating 3 (Non compliant - current code) Rating 5 (Non compliant - legacy code)		5	0.4										
Wiring Terminations Visual Inspection: <i>Issues for Discussion:</i> Rating 1 (Connections tight, labelled) Rating 2 (Missing Labels) Rating 3 (Loose / Disorganized wiring) Rating 4 (Inappropriate wiring) Rating 5 (Combination of above)		1	0.1										
Occurrences of Maintenance Issues: <i>Issues for Discussion:</i> Rating 1 (None) Rating 2 (Intermittent) Rating 3 (Consistent but occasional) Rating 4 (Frequent) Rating 5 (Constant)		2	0.4										
Meets City Electrical Design Standards: <i>Issues for Discussion:</i> Rating 1 (Yes) Rating 3 (No - current standards) Rating 5 (No - legacy standards)		1	0.25										
Fitness for Purpose	Has the Capacity been Reached? <i>Issues for Discussion:</i> Rating 1 (Below service factor) Rating 2 (Occasional within service factor) Rating 3 (Frequent within service factor) Rating 4 (Always Within Service Factor) Rating 5 (> Service Factor)	2	0.5	RECOMMENDATIONS: Replace Motor during electrical upgrades.

Equipment Remaining Service Life: <i>Issues for Discussion:</i> Rating 1 (> 90% lifecycle remain) Rating 2 (> 75% lifecycle remain) Rating 3 (> 50% lifecycle remain) Rating 4 (> 25% lifecycle remain) Rating 5 (obsolete)	4	0.25						COST ESTIMATE \$ 20,000.00				
	PHOTOGRAPHS

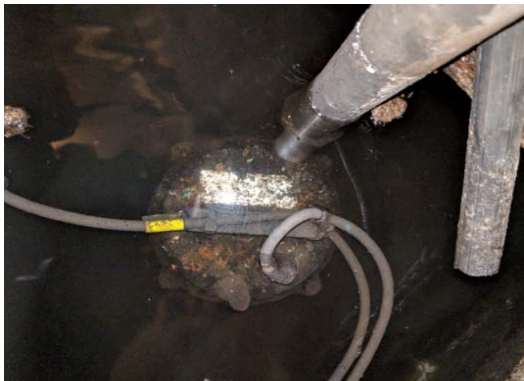
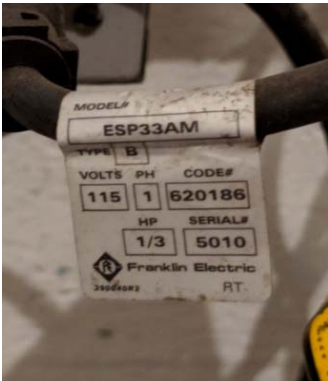
Canadian Electrical Code Issues Identified: <i>Issues for Discussion:</i> Rating 1 (No issues) Rating 3 (Non compliant - current code) Rating 5 (Non compliant - legacy code)	1	0.4						
	Wiring Terminations Visual Inspection: <i>Issues for Discussion:</i> Rating 1 (Connections tight, labelled) Rating 2 (Missing Labels) Rating 3 (Loose / Disorganized wiring) Rating 4 (Inappropriate wiring) Rating 5 (Combination of above)	1	0.1						
	Occurrences of Maintenance Issues: <i>Issues for Discussion:</i> Rating 1 (None) Rating 2 (Intermittent) Rating 3 (Consistent but occasional) Rating 4 (Frequent) Rating 5 (Constant)	2	0.4						
Fitness for Purpose	Meets City Electrical Design Standards: <i>Issues for Discussion:</i> Rating 1 (Yes) Rating 3 (No - current standards) Rating 5 (No - legacy standards)	1	0.25						
	Has the Capacity been Reached? <i>Issues for Discussion:</i> Rating 1 (Below service factor) Rating 2 (Occasional within service factor) Rating 3 (Frequent within service factor) Rating 4 (Always Within Service Factor) Rating 5 (> Service Factor)	2	0.5

Equipment Remaining Service Life: <i>Issues for Discussion:</i> Rating 1 (> 90% lifecycle remain) Rating 2 (> 75% lifecycle remain) Rating 3 (> 50% lifecycle remain) Rating 4 (> 25% lifecycle remain) Rating 5 (obsolete)	3	0.25						
PHOTOGRAPHS

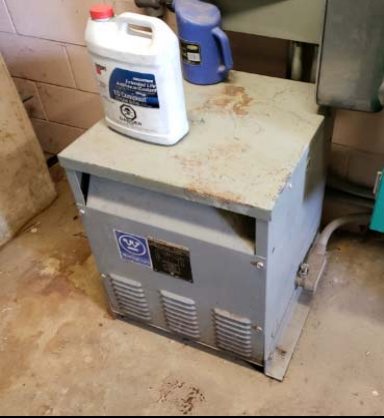
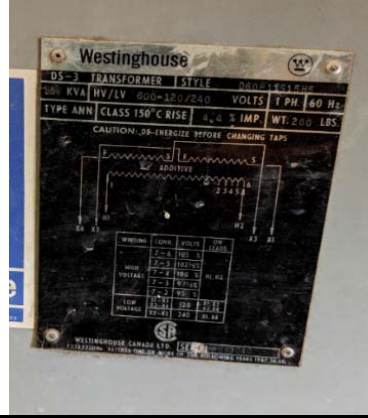
Canadian Electrical Code Issues Identified: Issues for Discussion:	Rating 1 (No issues) Rating 3 (Non compliant - current code) Rating 5 (Non compliant - legacy code)	1	0.4					
Wiring Terminations Visual Inspection: Issues for Discussion:		Rating 1 (Connections tight, labelled) Rating 2 (Missing Labels) Rating 3 (Loose / Disorganized wiring) Rating 4 (Inappropriate wiring) Rating 5 (Combination of above)	1	0.1						
Occurrences of Maintenance Issues: Issues for Discussion:		Rating 1 (None) Rating 2 (Intermittent) Rating 3 (Consistent but occasional) Rating 4 (Frequent) Rating 5 (Constant)	1	0.4						
Meets City Electrical Design Standards: Issues for Discussion:		Rating 1 (Yes) Rating 3 (No - current standards) Rating 5 (No - legacy standards)	1	0.2						
Fitness for Purpose	Has the Capacity been Reached? Issues for Discussion:	Rating 1 (<75%) Rating 2 (<85%) Rating 3 (<95%) Rating 4 (At capacity) Rating 5 (Above capacity)	1	0.4	RECOMMENDATIONS: Install a new transformer as part of the electrical upgrade. Install transformer on a housekeeping pad. Locate new transformer in an alternate location to allow unobstructed access to the distribution panel.

Equipment Remaining Service Life: Issues for Discussion:	Rating 1 (> 90% lifecycle remain) Rating 2 (> 75% lifecycle remain) Rating 3 (> 50% lifecycle remain) Rating 4 (> 25% lifecycle remain) Rating 5 (obsolete)	4	0.4						
PHOTOGRAPHS

COST ESTIMATE \$ 10,000.00
