## **APPENDIX 'A' – GEOTECHNICAL REPORT**

## Hartford Avenue - McGregor St / Salter St.

ATTENTION:  
PROJECT: Local Streets Package 24-R-05 (751-2023.5)  
Sanford, Winnipeg, MB

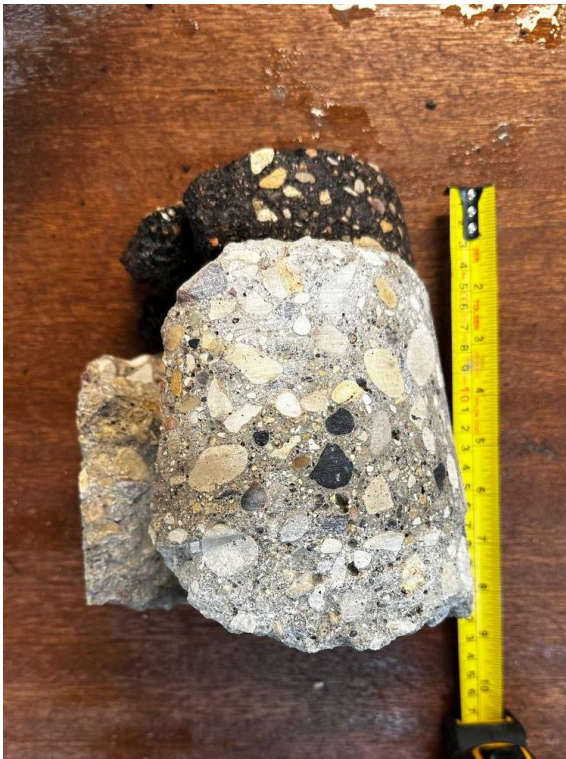
**Core 1 – Sanford (SBL)**

Figure 1. Core 1 pavement surface showing void existed between pavement and subsurface

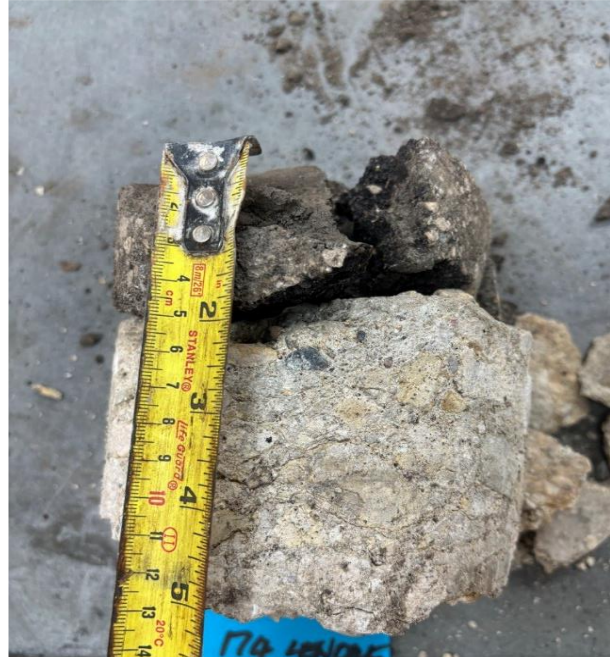
Ruby St - Lenore St Backlane, NBL, Core 38  
(Asphalt Thk 51mm; Conc Thk 102)
