# **GEOTECHNICAL REPORT**

June 10, 2024

**Re: 2024 City of Winnipeg Local Street Renewal Program  
Report of Geotechnical Investigations and Test Results – Rev 1**

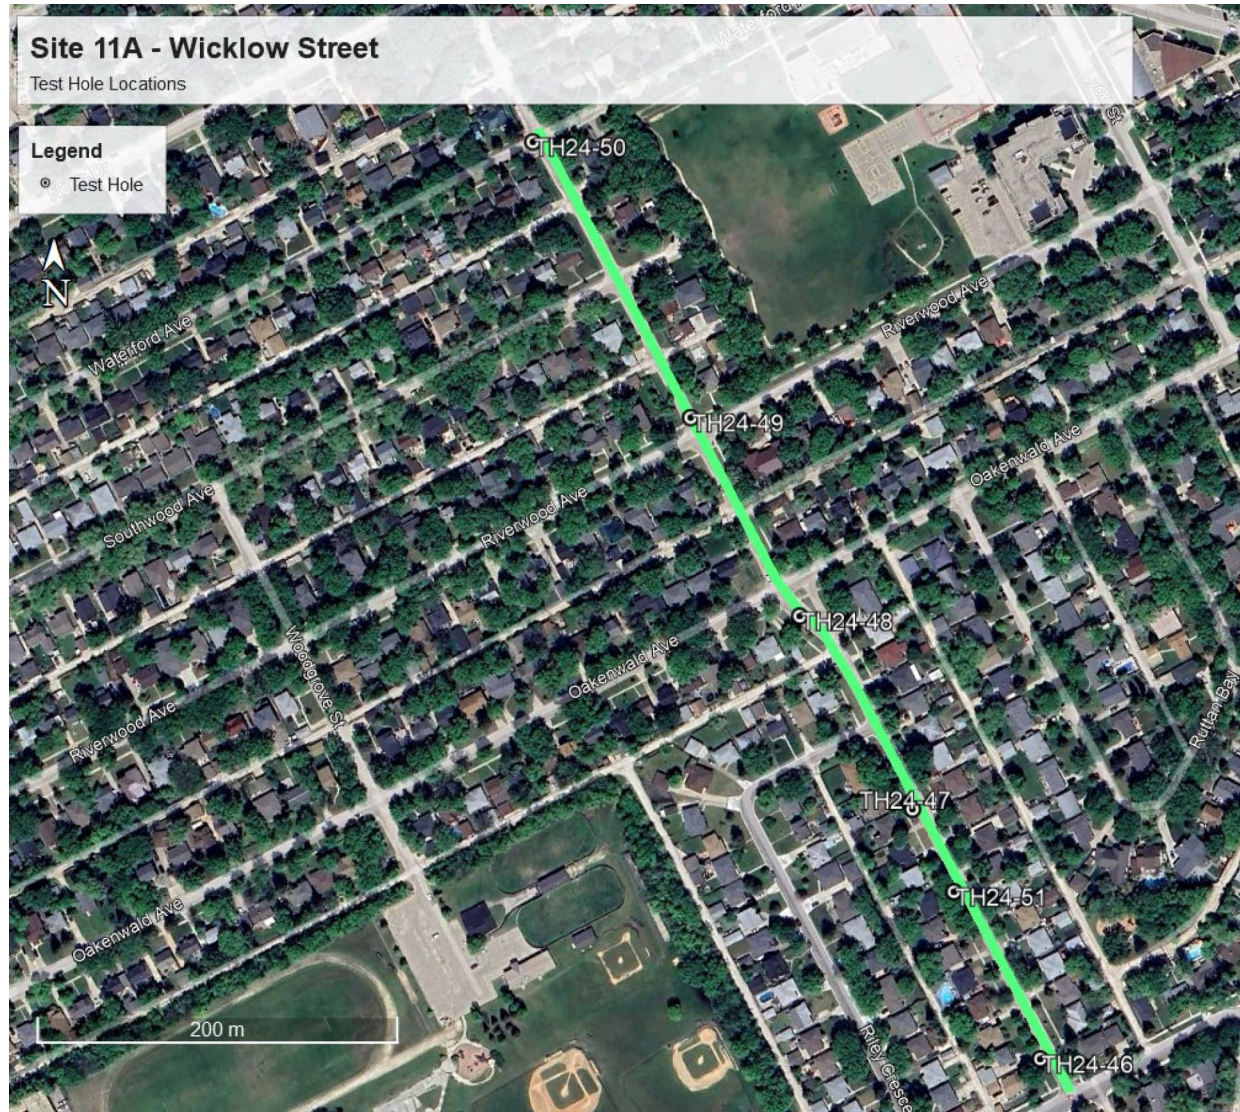
FIGURE 11: TEST HOLE LOCATIONS FOR WICKLOW STREET (REHAB)

A core investigation was conducted along Wicklow Street, involving the extraction of six (6) core from exclusively mid-slab locations. The pavement surface was composed of asphalt with thicknesses ranging from 60 to 195 mm. Granular base was identified at all the core locations, with thicknesses varying between 40 and 120 mm overlying sandy subgrade material. Detailed core locations are illustrated in Figure 11.

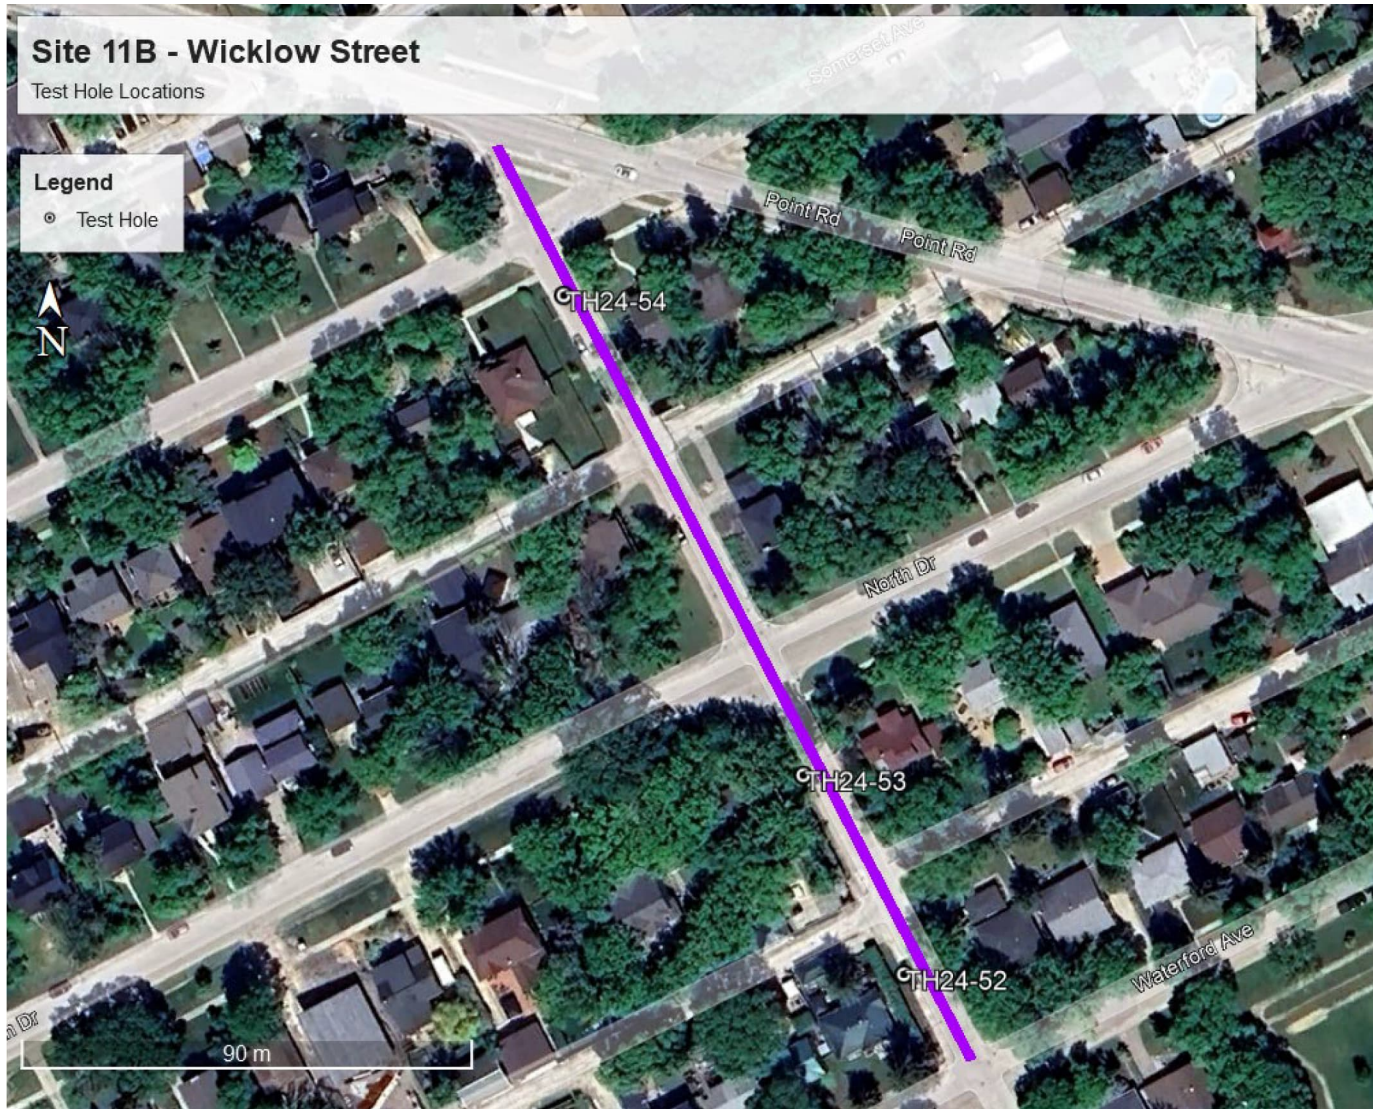
FIGURE 12: TEST HOLE LOCATIONS FOR WICKLOW STREET (RECONSTRUCTION)

A core investigation was conducted along Wicklow Street, involving the extraction of three (3) core: two (2) from mid-slab locations and one (1) from a joint location. Additional soil drilling was conducted within each of the three (3) test holes and were advanced to a depth of 3.0 m (10 ft) below pavement surface using a track mounted drill rig equipped with 125 mm solid stem augers. In general, site stratigraphy consisted of asphalt pavement over granular base, overlying clay. A further description of each layer is provided below, with test hole logs provided in Appendix B and test hole locations shown in Figure 10.

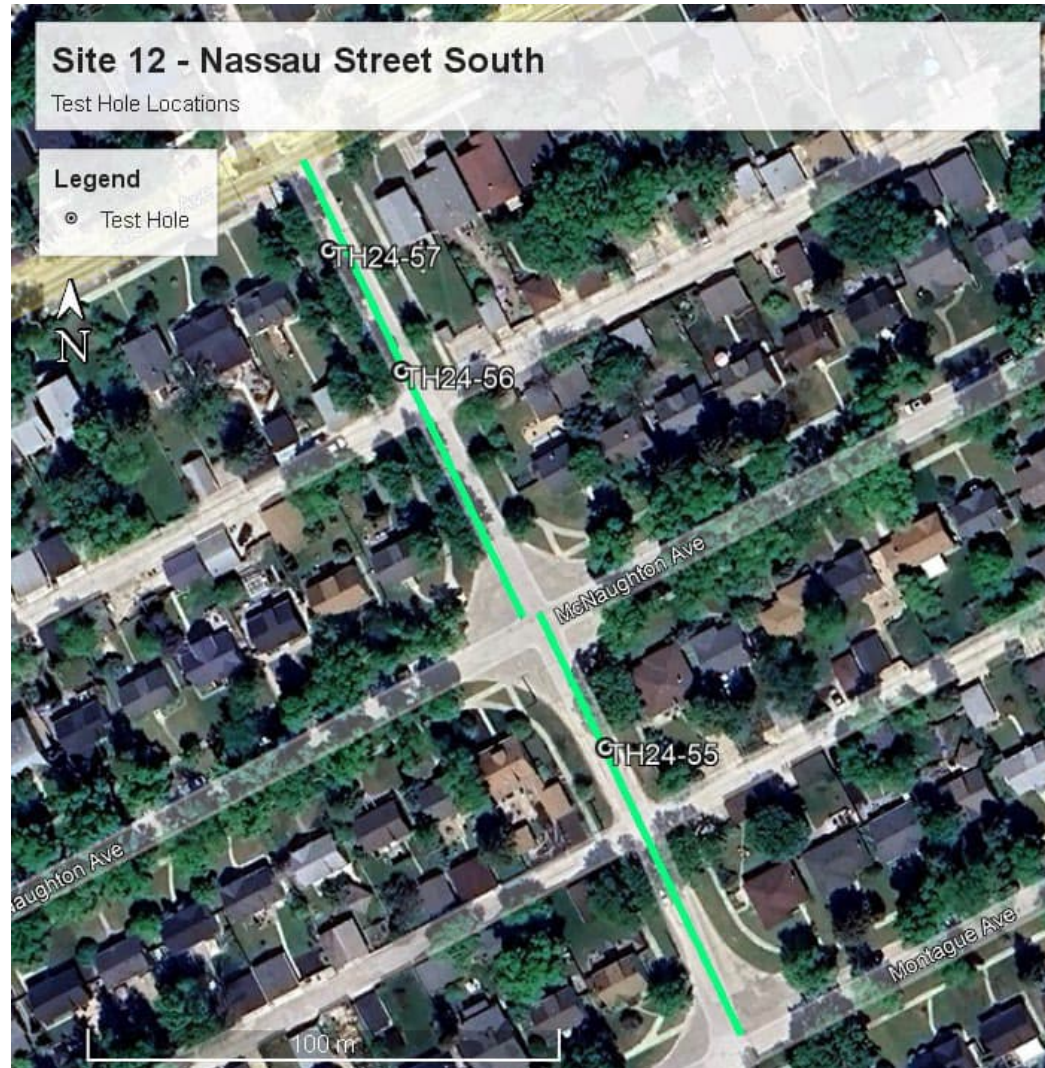
FIGURE 13: TEST HOLE LOCATIONS FOR NASSAU STREET SOUTH

A core investigation was conducted along Nassau Street South, involving the extraction of three (3) core: two (2) from mid-slab locations and one (1) from a joint location. The pavement surface was composed of concrete with thicknesses ranging from 165 to 185 mm. No base was identified at any of the core locations, exposing a clay subbase beneath the pavement. Detailed core locations are illustrated in Figure 13.

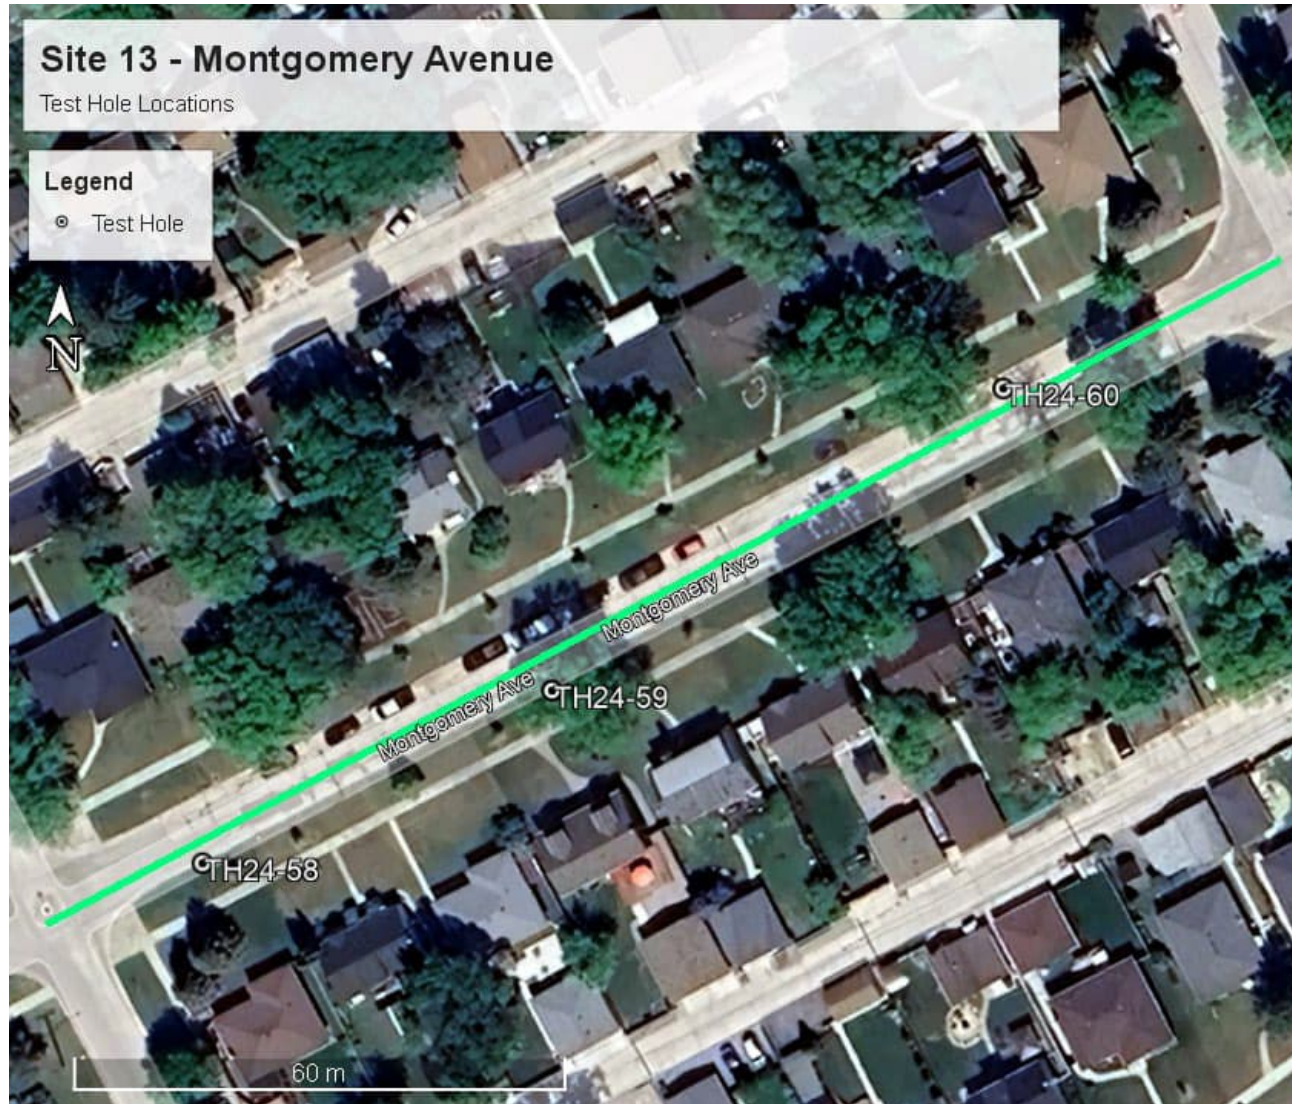
FIGURE 14: TEST HOLE LOCATIONS FOR MONTGOMERY AVENUE

A core investigation was conducted along Montgomery Avenue, involving the extraction of three (3) core: two (2) from mid-slab locations and one (1) from a joint location. The pavement surface was composed of concrete with thicknesses ranging from 180 to 195 mm. Crushed limestone base was identified at TH24-58 and TH24-59 with thicknesses of 55 and 90 mm, while the remaining core revealed no base material, exposing a clay subbase beneath the pavement. Detailed core locations are illustrated in Figure 14.
