Millennium Library Parkade – 251 Donald St. Parkade Condition Assessment

Submitted to: City of Winnipeg
Attention: Mr. Jason Wiebe C.E.T.
Date: April 1, 2021 (Revised April 8, 2021)
Submitted by: Crosier Kilgour & Partners Ltd.
300-275 Carlton Street
Winnipeg, Manitoba R3C 5R6
Phone: 204.943.7501 Fax: 204.943.7507
Website: www.ckpeng.com
Contact: Derek J. Mizak, P.Eng.
Our File No. 2020-1183

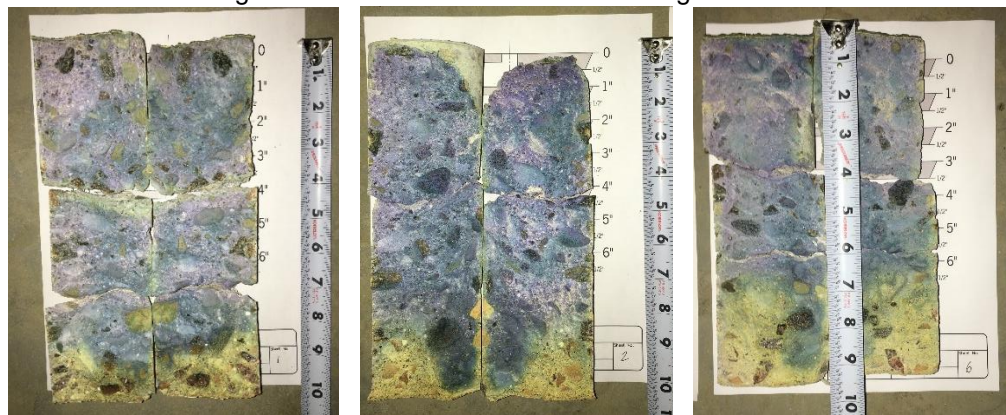
Figure 1: Results of Carbonation Testing

For this investigation, the cores were extracted full depth to provide results at the top surface and soffit of the structural slab. The results of the carbonation testing indicated a pH ranging from 7 to 9 on the bottom of the structural slab core samples. The depth ranges from 1 ¼” to 2” which suggests the carbonation has reached the bottom reinforcing steel and the protective film is no longer present. The pH at the top surface generally appears to be above 9. The results of the carbonation testing confirm that the passive protective film provided by a high pH is no longer present at the bottom reinforcing and the reinforcing steel is vulnerable to corrosion in the presence of moisture and oxygen.

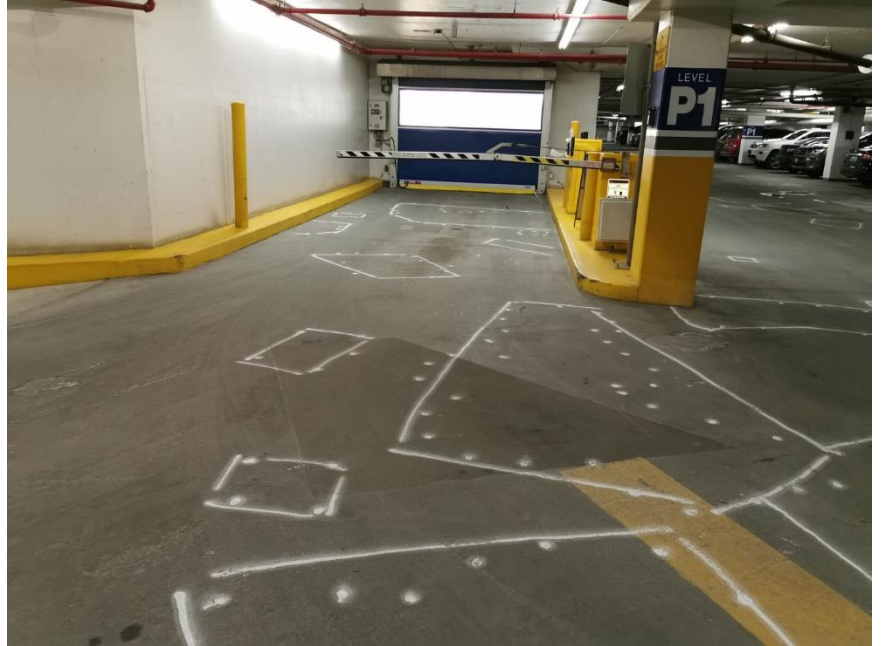
Photograph #3:

Approximate extents of apparent concrete delamination marked onsite.

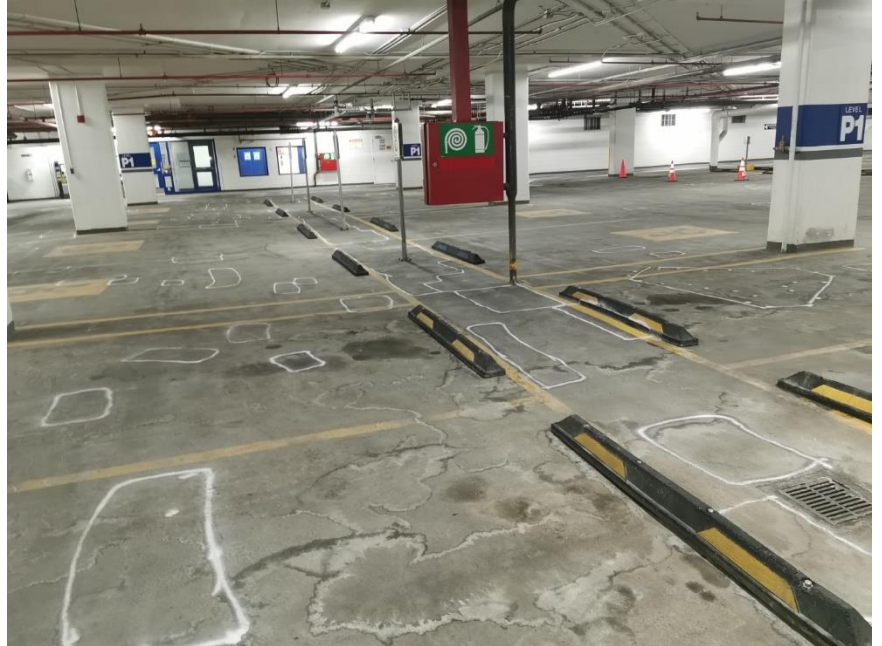
Photograph #5:

Approximate extents of apparent concrete delamination marked onsite.

Note variation in location and size.

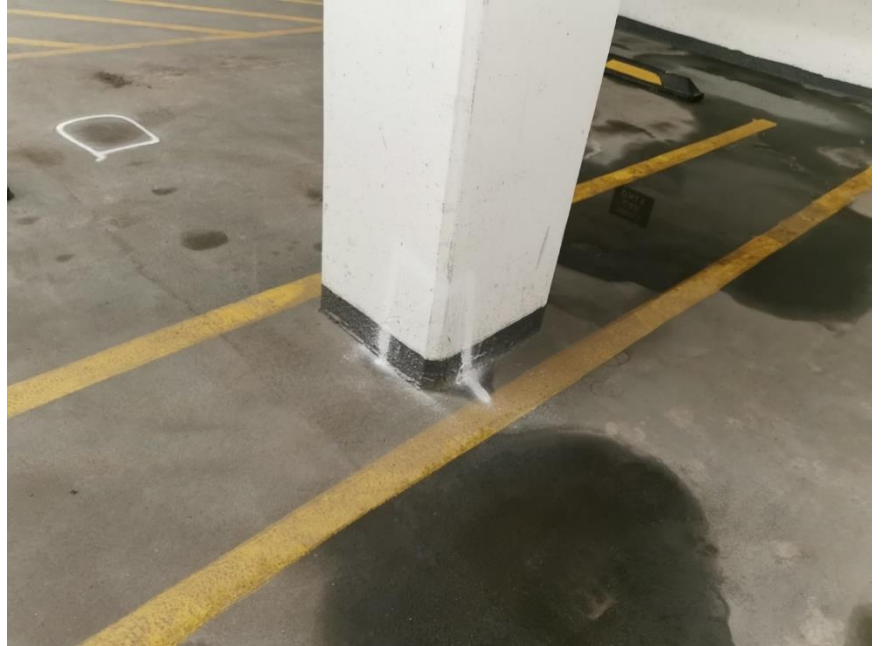
Photograph #7:

Approximate extents of apparent concrete delamination marked on column.

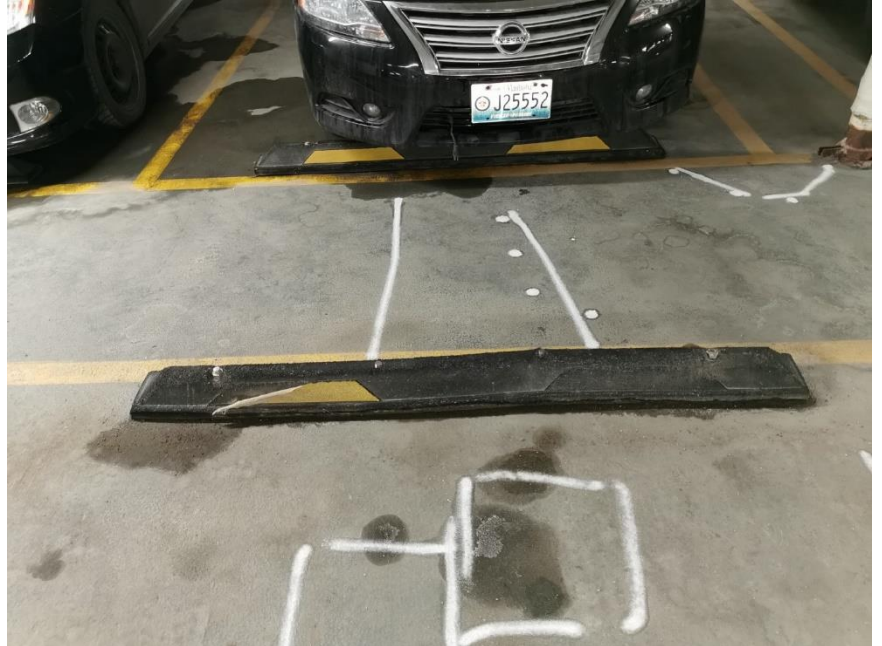
Photograph #9:

Typical condition of existing asphalt curbs.

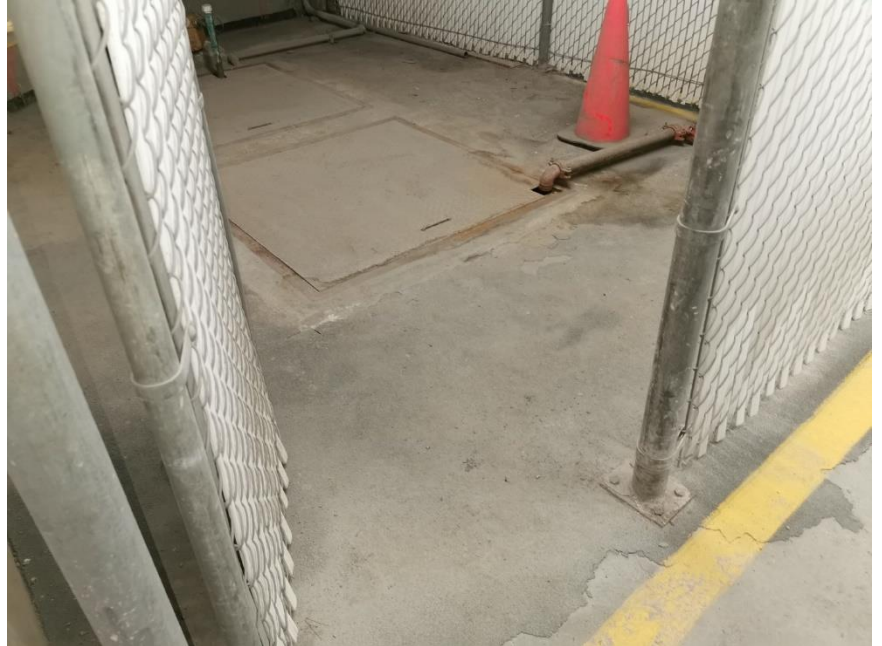
Photograph #11:

Existing waterproofing in Level P2 mechanical pit enclosure in poor condition.

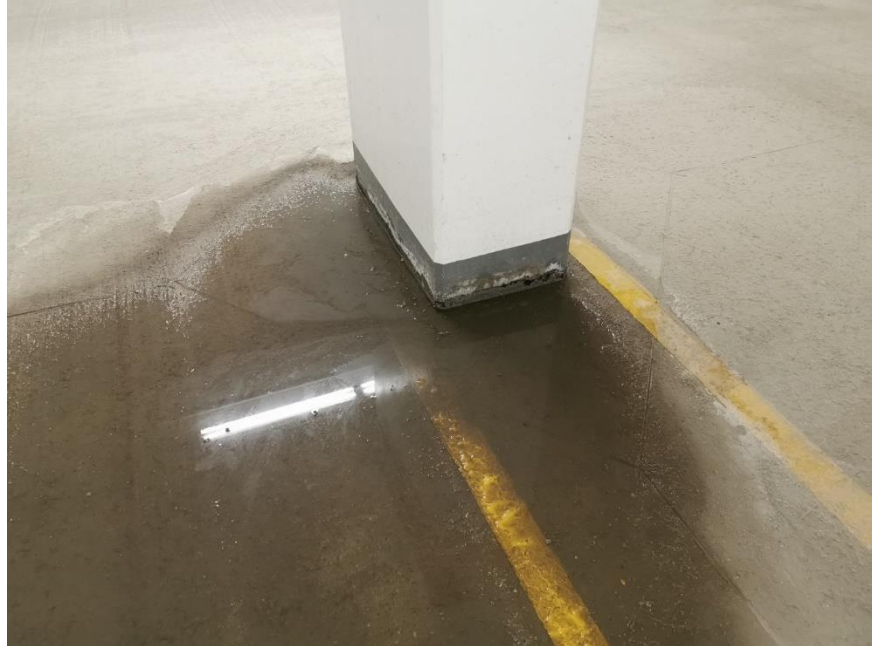
Photograph #13:

Water ponding against base of column on Level P2.

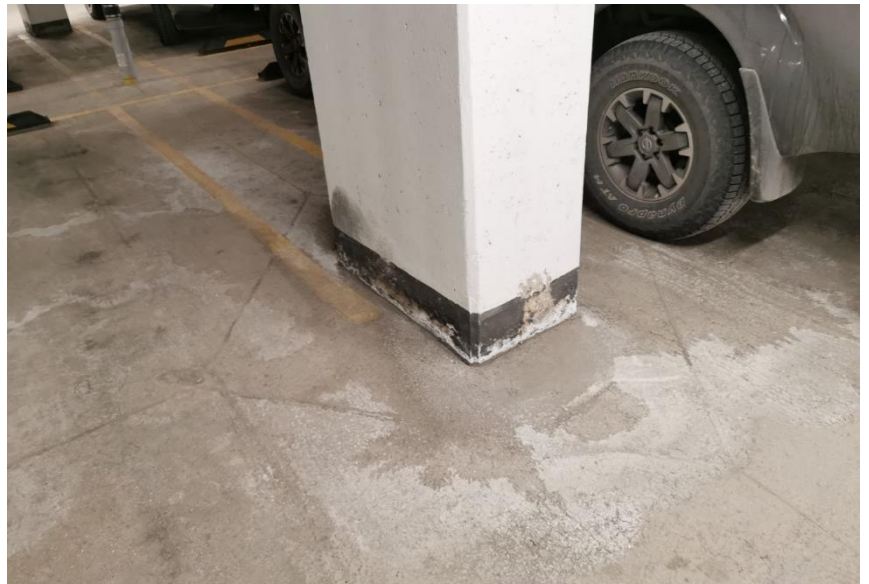
Photograph #14:

Visible scaling and efflorescence along base of column on Level P2.

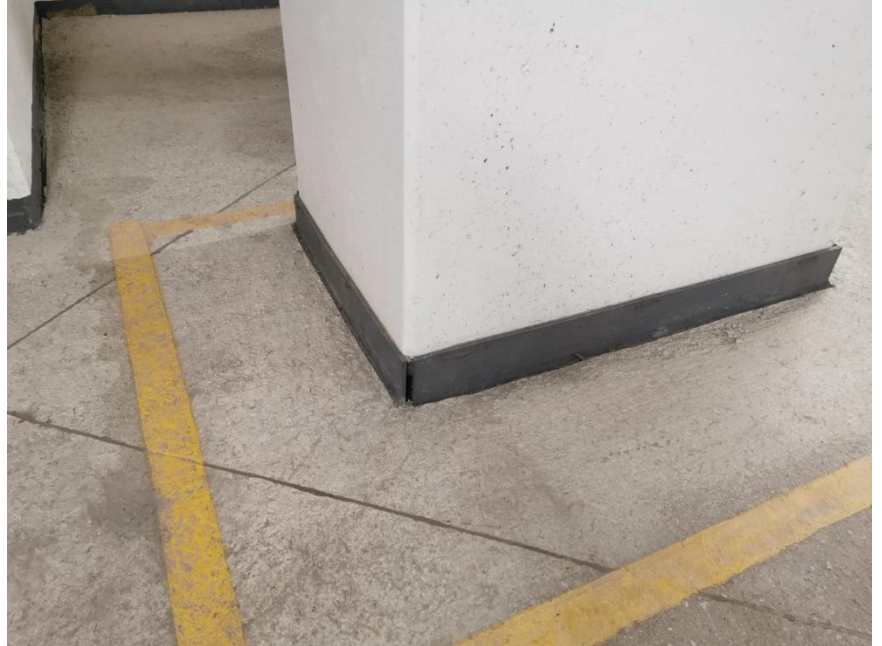
Photograph #15:

It was also noted that the concrete column jackets at 5 locations did not extend down to the pile caps. As a result, the new slab-on-grade elevation has caused a gap between the slab-on-grade and bottom of the pile cap (Photograph #15). Although the gap itself is not a structural concern, its presence allows moisture to flow into the cut-out and pond against the column and pile cap. The gap has been partially closed with plywood formwork; however, this is not an effective protective measure against moisture. It is recommended that concrete swales be installed at these locations in the short term.

Plywood formwork installed to cover gap between existing concrete column jacket and slab-on-grade.

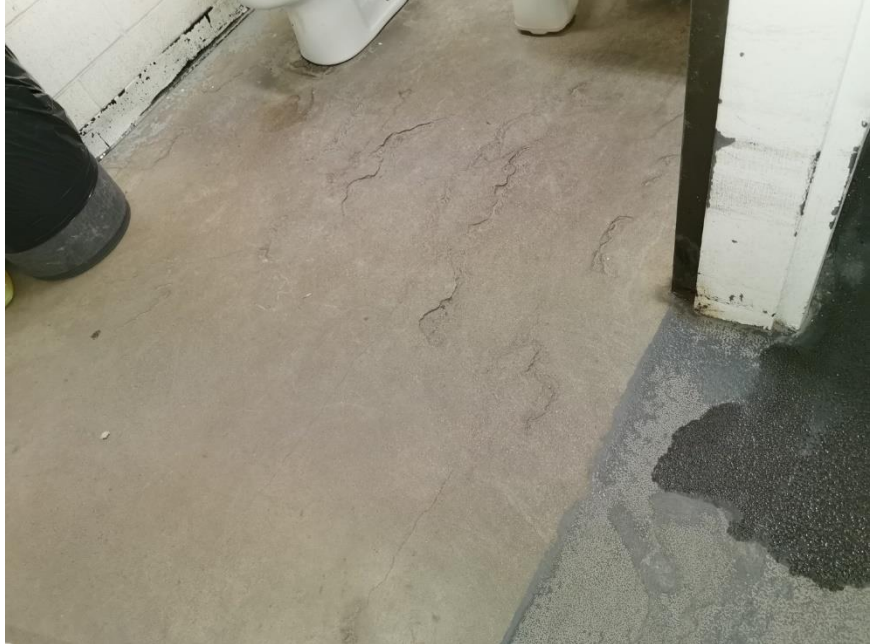
Photograph #17:

In general, the mechanical rooms are in fair condition. Although not sounded, localized top surface deterioration, was apparent in the mechanical rooms (Photograph #17). Locations of concrete deterioration were also noted on the walls, ramps, columns, soffits, and curbs (Photograph #18). It is recommended that localized concrete repairs be completed in the short term.

Visible concrete delamination in washroom.

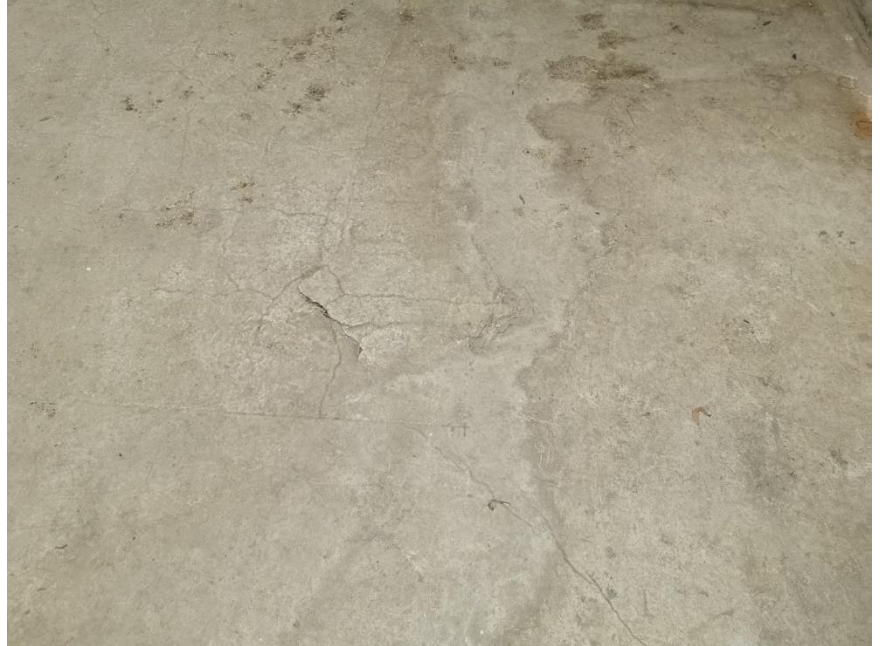
Typical condition of existing coating in mechanical rooms.

Note apparent concrete delamination beneath coating.

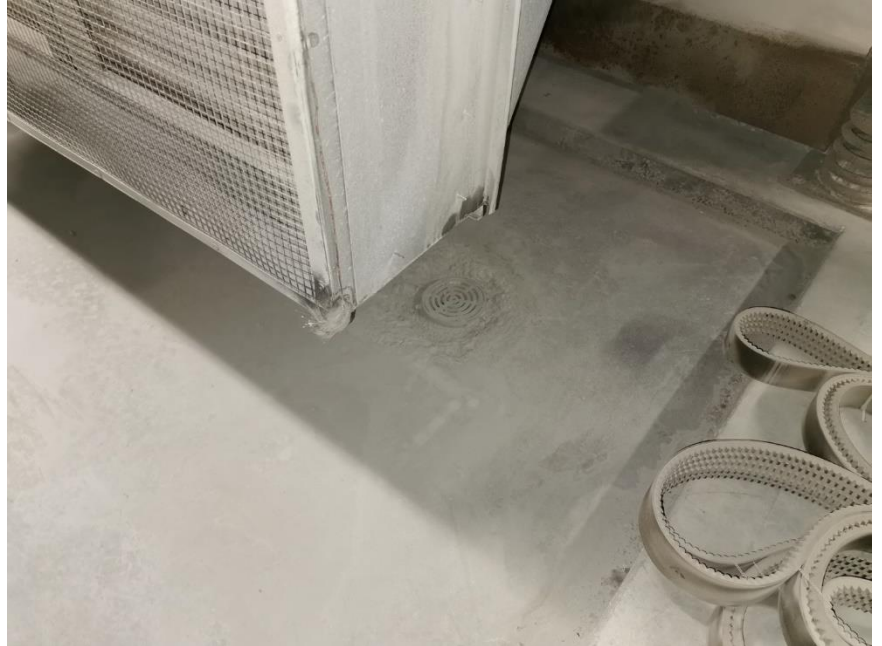
Photograph #21:

Typical observed condition of drains in mechanical rooms.

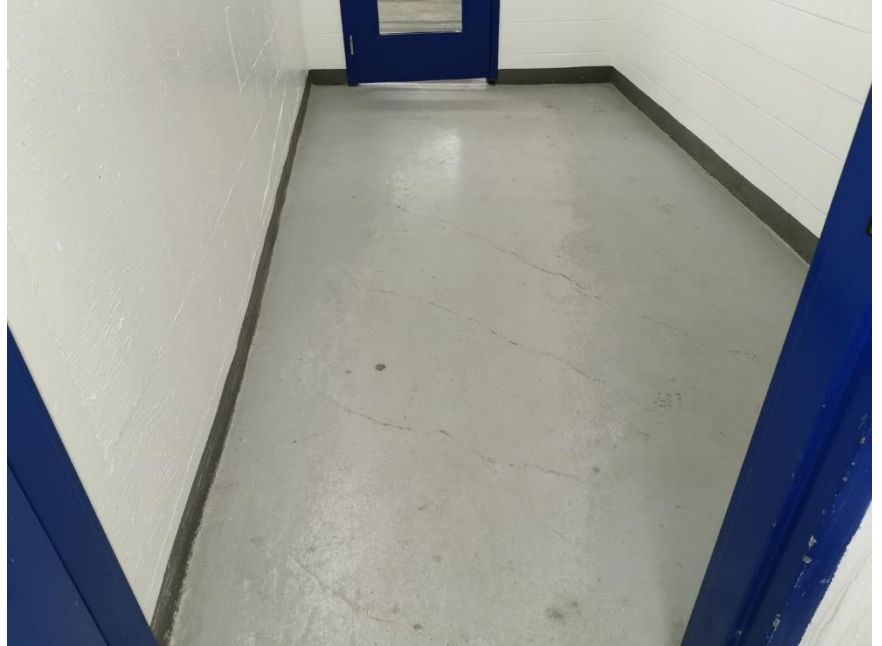
Photograph #23:

Existing coating in stairwell vestibule. Note cracking and apparent concrete delamination visible beneath coating.

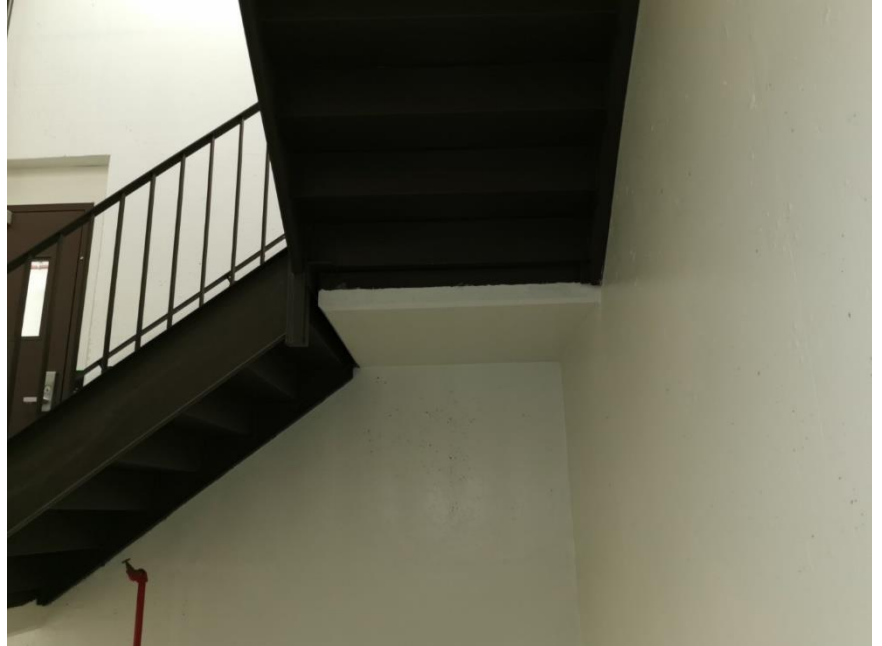
Photograph #25:

Typical condition of structural steel and steel stair pans.

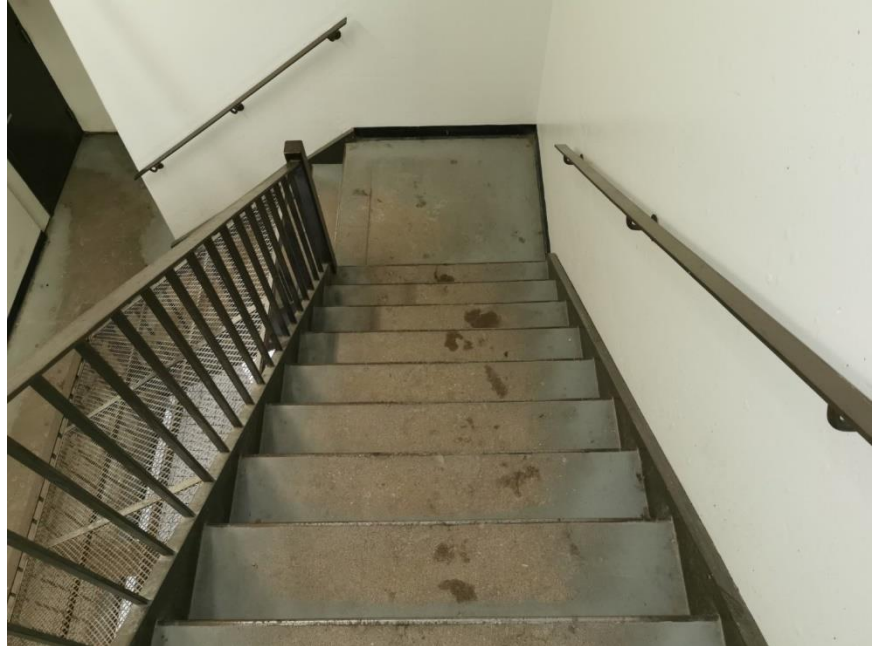
Photograph #27:

Cracking and minor deterioration of treads.

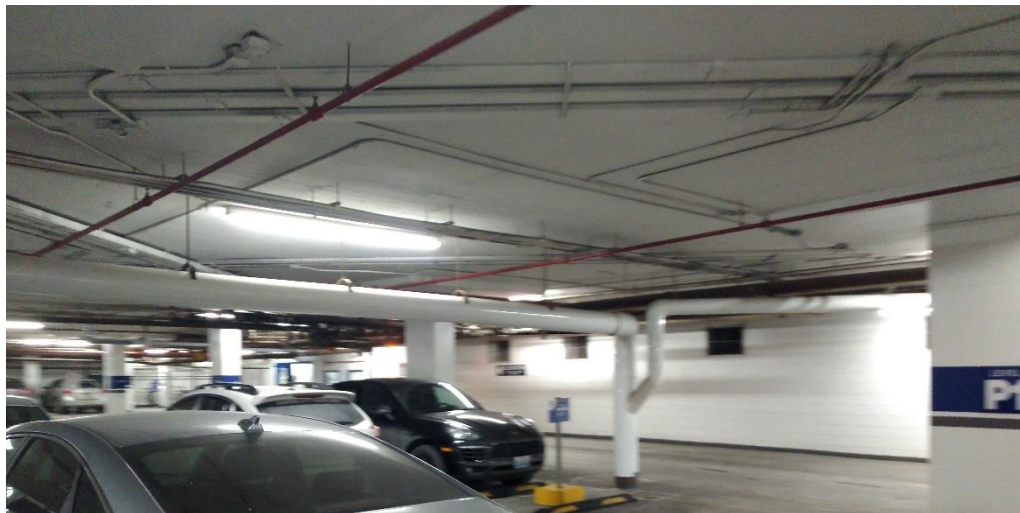
- .1 There is storm drainage piping which serves the plaza above. The condition is unknown as the piping is mostly insulated and re-covered with PVC jacketing. Most of the piping connected to the drains serving the plaza level were replaced when the plaza was redeveloped but the mains and branch piping is believed to be original. The new piping is within the expected service life but any original piping would be nearing the expected service life of 50 years. The storm drainage piping runs to the south end of the parkade where it is connected to the municipal main on the lower level.

Figure 1: Storm drainage piping fully insulated.

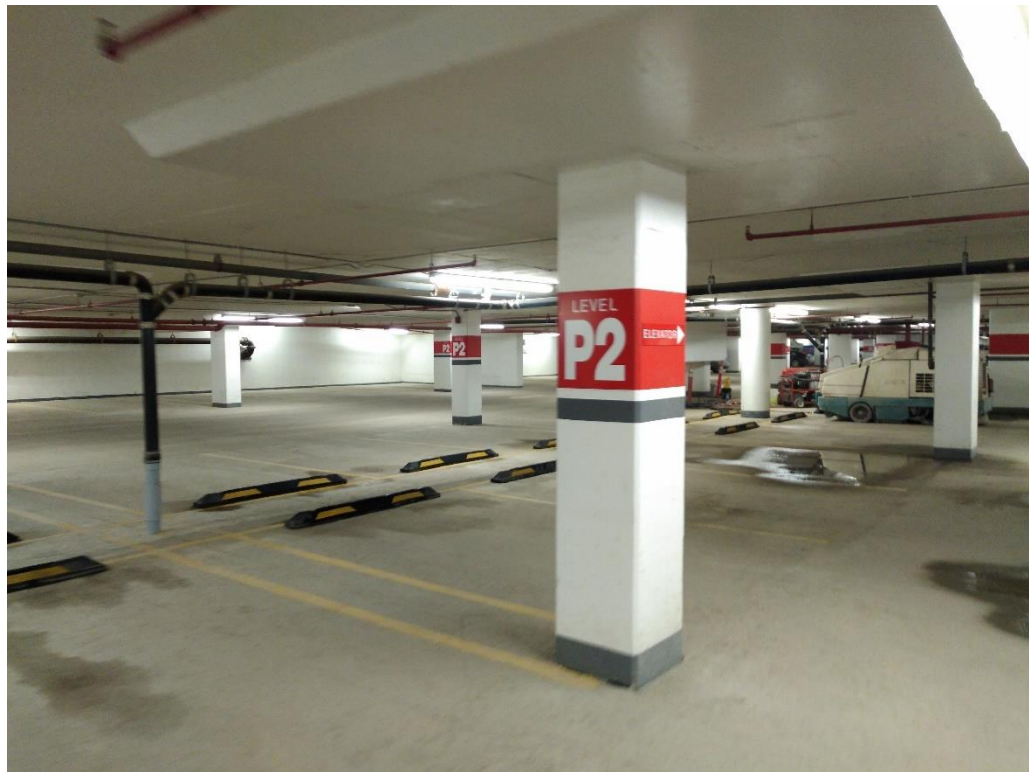
- .4 There is a grit interceptor on the lower level for the carwash. The interceptor is in fair condition and is required by code. No further recommendation.
- .5 The piping below the slab on grade section below appears to be plastic and is expected to have been replaced during the parkade renovation based on record information and section of visible plastic piping extending below the slab. All plastic piping as it passes below the slab is equipped with expansion joints as required by current plumbing code.

Figure 6: Lower level sanitary piping serving the parkade drainage with plastic piping passing below grade.

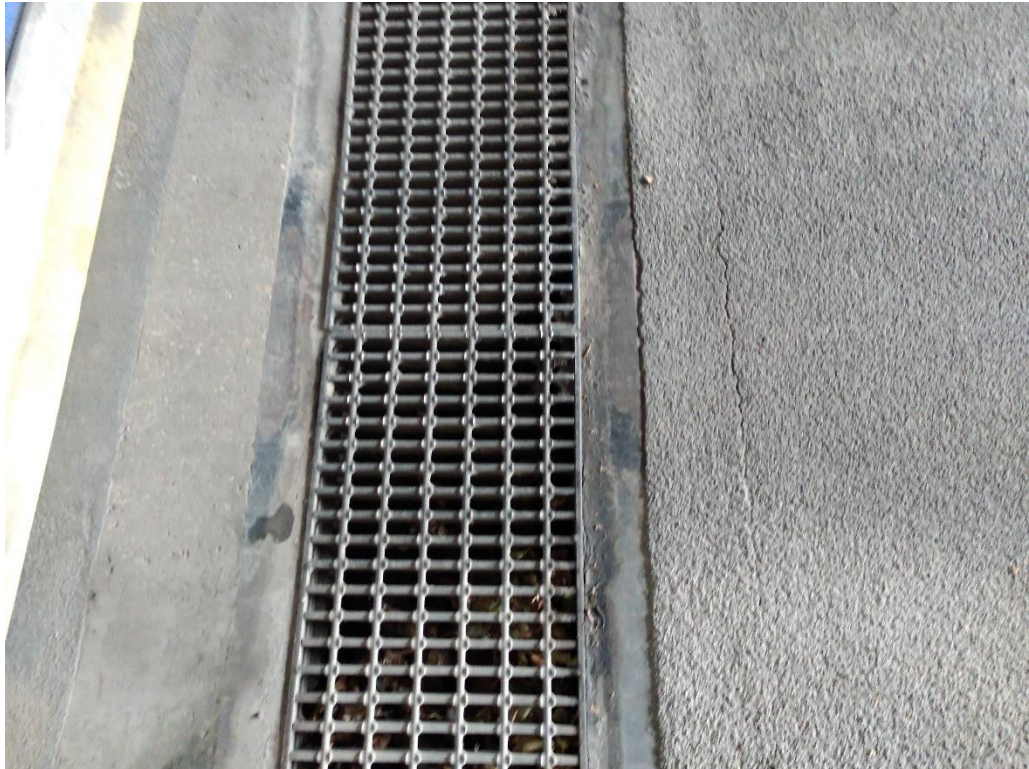
- .6 There are two sanitary services on Donald and one on Smith street. Both appear to be original and would fall into the same category for replacement as the original piping in the parkade.
- .7 The trench drains for the ramps were replaced as part of the ramp replacement. They are only a few years old and are in good condition.

Figure 7: Trench drain on one of the four entrance ramps.

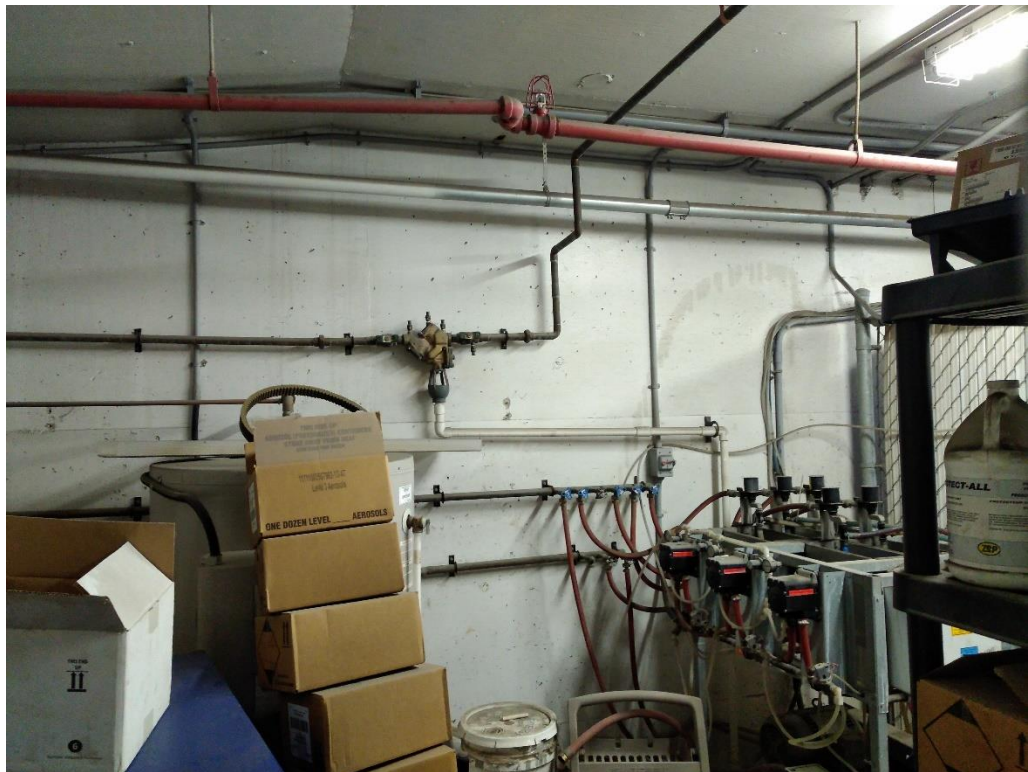
Figure 8: High pressure car wash pumps and dedicated hot water tank.

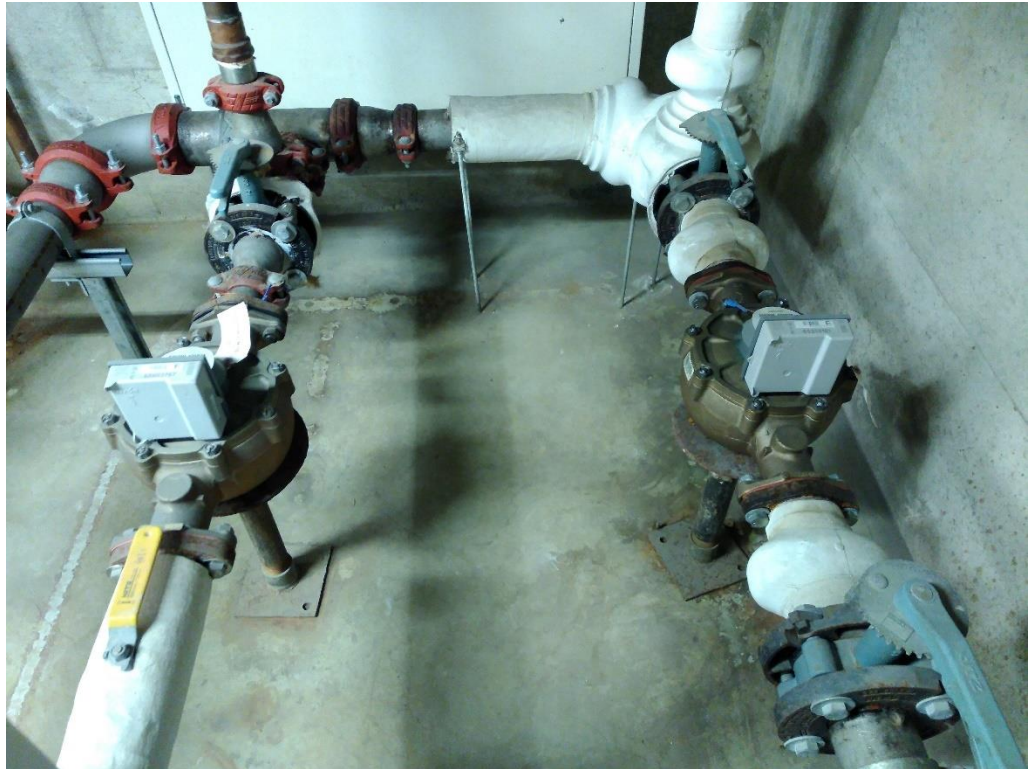
Figure 9: Separate meters for the library and parkade.

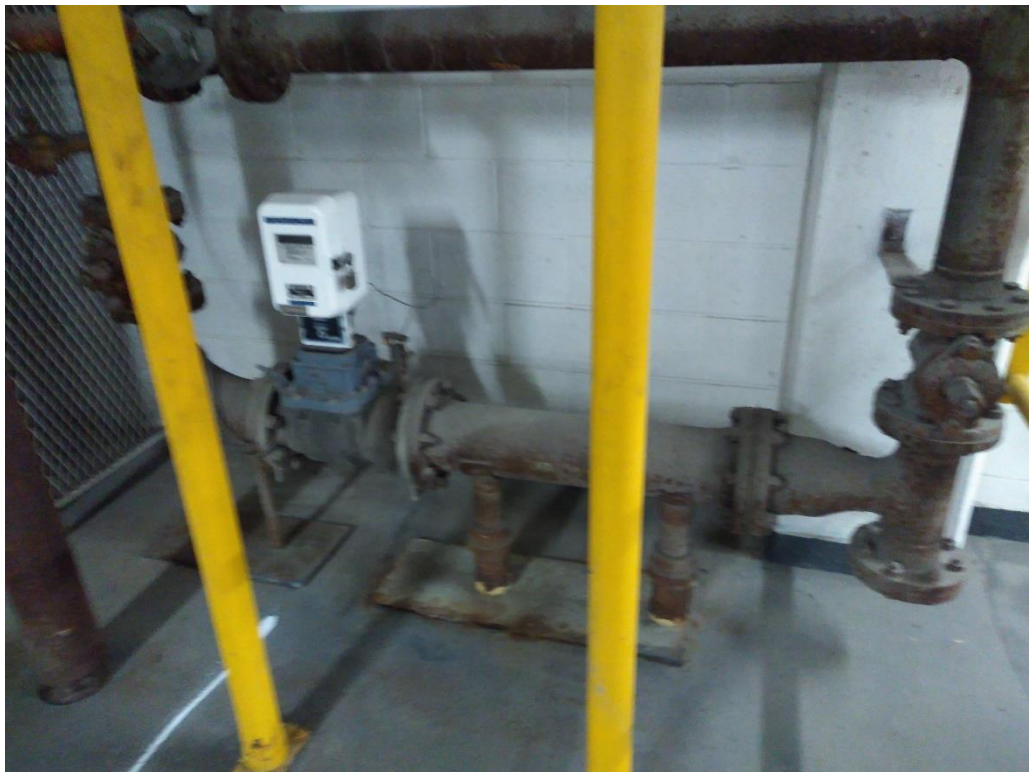
- .1 The natural gas piping in the facility comes in on the West wall of the lower parkade and is routed over to the South wall of the upper parkade. It is protected by metal posts connected to the floor and ceiling. The natural gas piping appears to be original to the facility but has a new meter upgrade by MB Hydro. The piping is in fair condition with sections that are painted and expected to be within the service life. Localized corrosion was noticed and should be painted, or the pipe section replaced in the near future. Long term recommendations would be to replace the entire natural gas piping systems but this would be outside the window of review for this report.

Figure 10: Natural Gas Main.

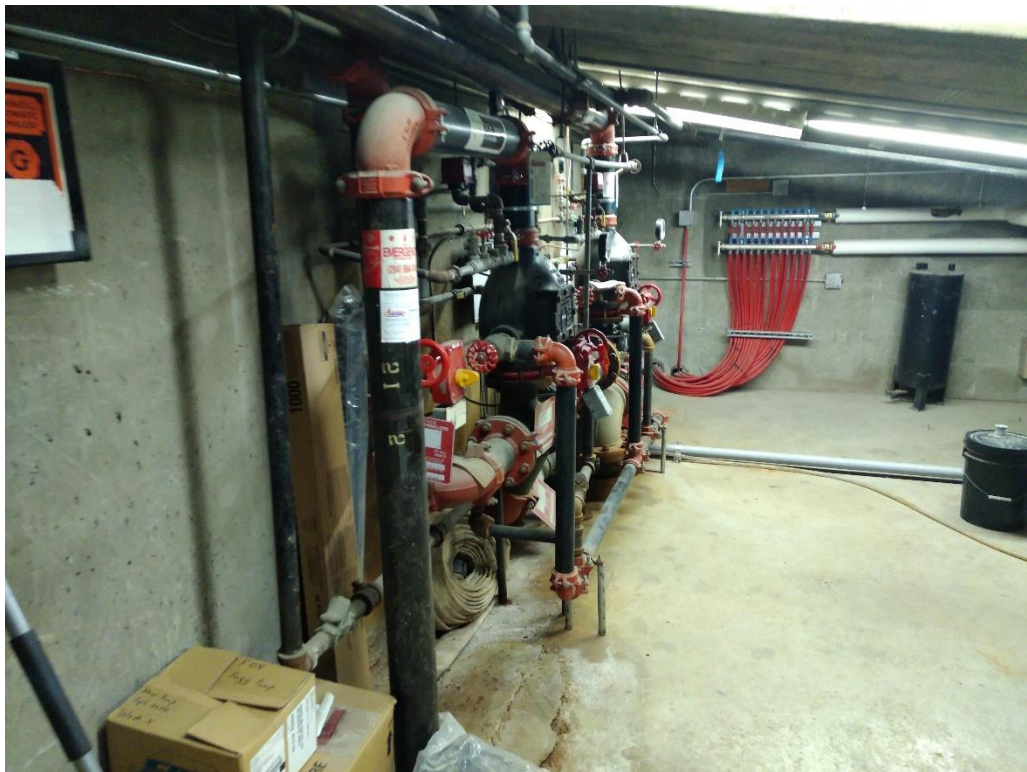
Figure 12: Sprinkler header in the Southwest corner of the upper parkade.

- .5 The exact age of the sprinkler system is unknown, but it appears to have been modified recently. It is expected parts were updated as part of the renovation project. The valves are in fair condition with some signs of corrosion. It is expected parts of the piping system are nearing the expected service life of 25-30 years for black steel pipe as part of a dry sprinkler system. It is recommended to monitor the piping systems and schedule replacement of sections annually once leaks become a larger concern.

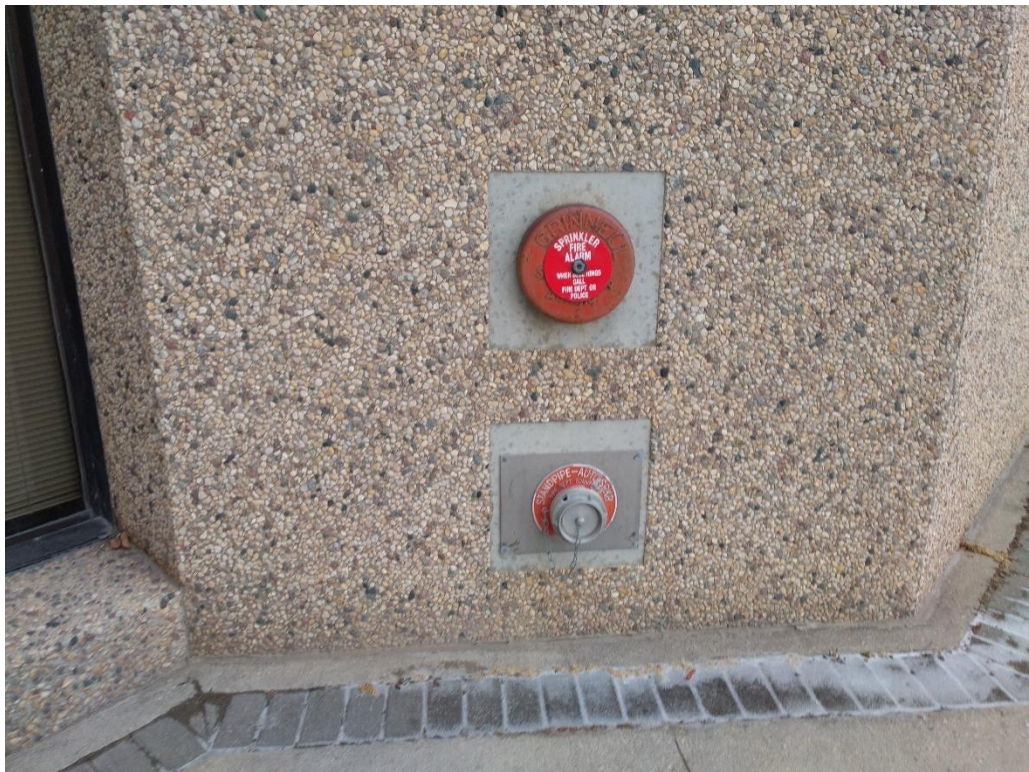
Figure 13: Fire department connection on building face.

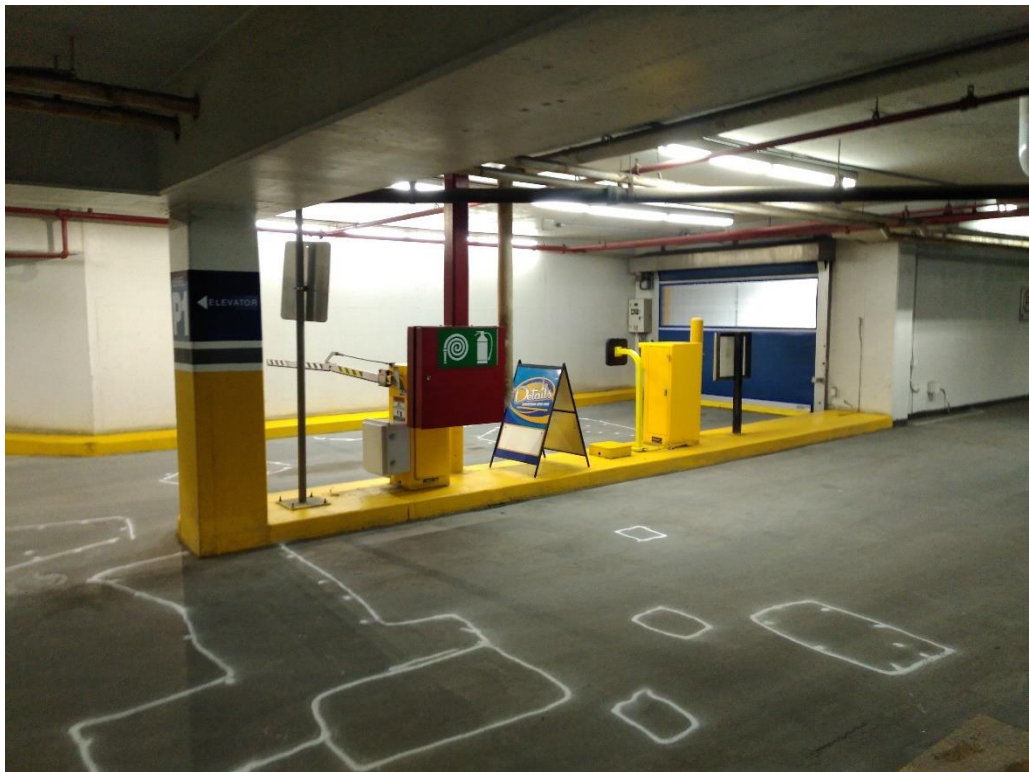
Figure 14: Hose cabinet and fire extinguisher installed as part of renovation project for Library

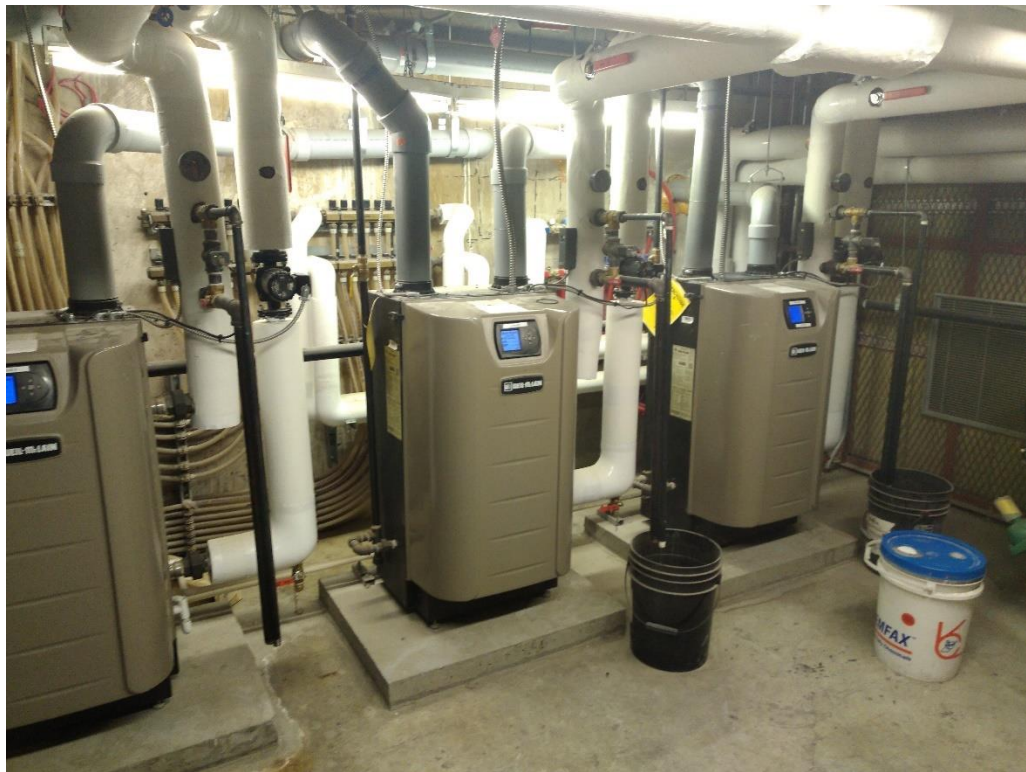
- .2 The boiler systems were replaced in 2018 and consists of three Weil-McLean Evergreen 299 MBH high-efficiency boilers per system. The combined output for all three boilers is 807 MBH for both snow melt systems, based on name plate data. The system type is identical between the two boiler plants and they were installed at the same time. The boilers are all equipped with a condensate neutralizer on the drain line as required by code. The boilers all have injection pumps to feed hot water into the secondary heating loop. The boilers are within the expected service life of 19 years and are in good condition.

Figure 15: Boiler plant on Smith Street side of parkade.

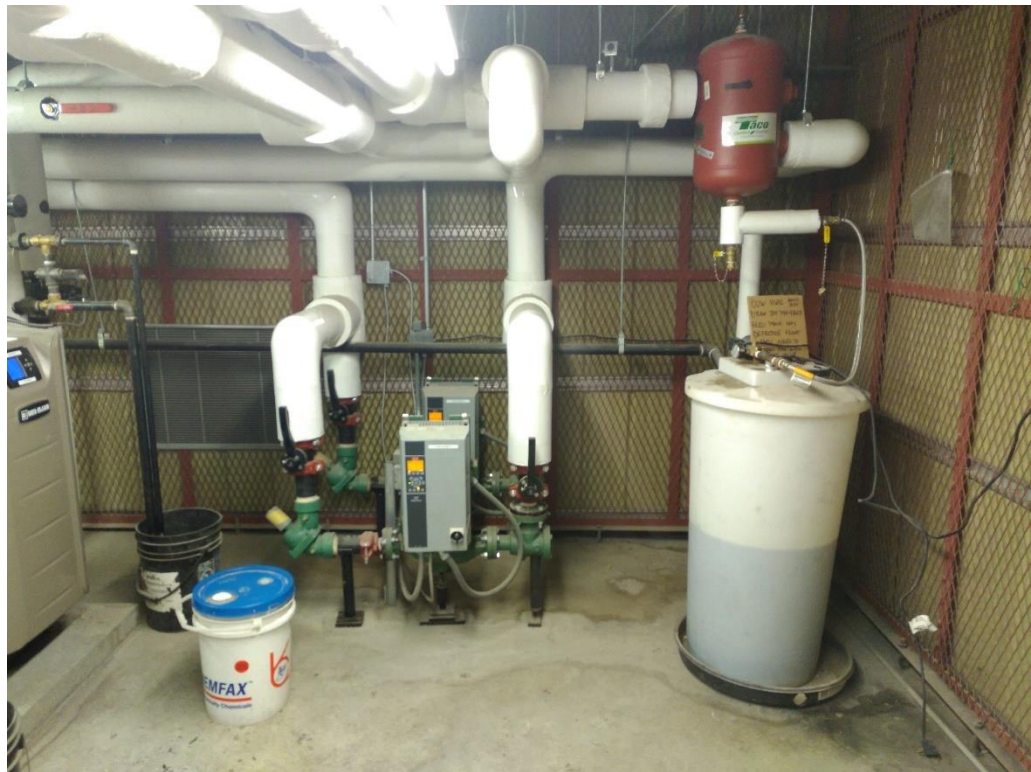
- .3 The boilers are manifolded together with a common circulating pump system and operate in a primary-secondary loop arrangement, the pumps are inline vertical style pumps with sensorless VFD drives. The pumps were installed as part of the modification in 2018, are within the expected service life of 19 years for hydronic pumps, and in good condition.

Figure 16: VFD driven pumps on hydronic system, in-line separator and glycol fill tank

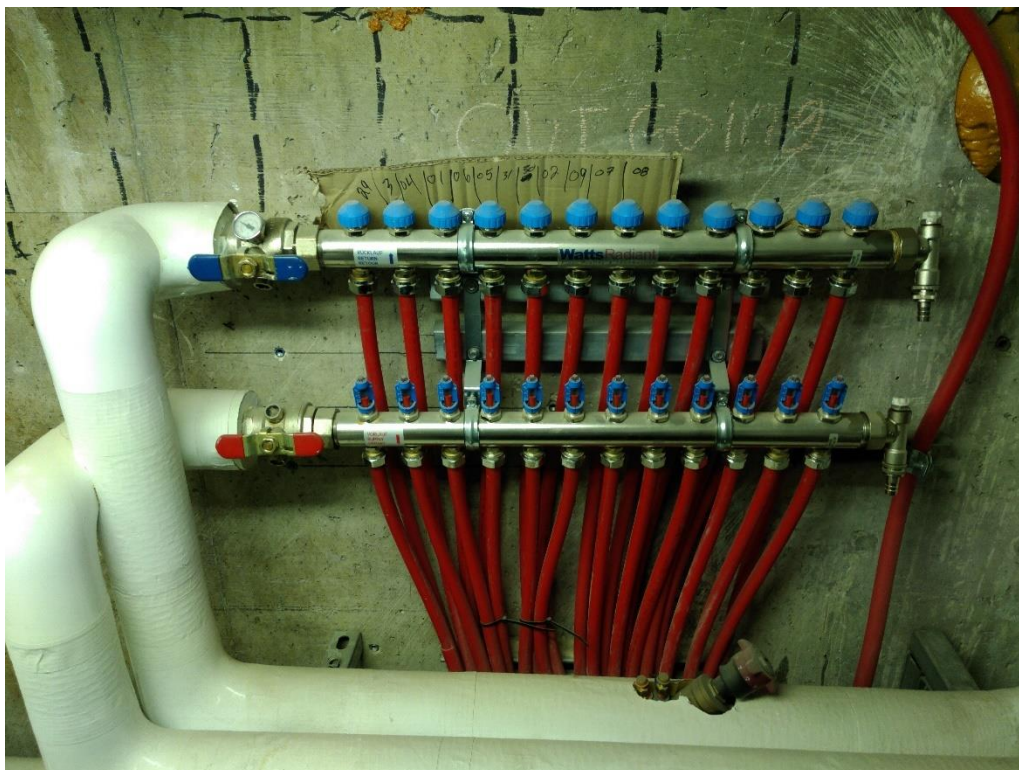
Figure 17: Stainless steel snow melt manifold installed in 2018.

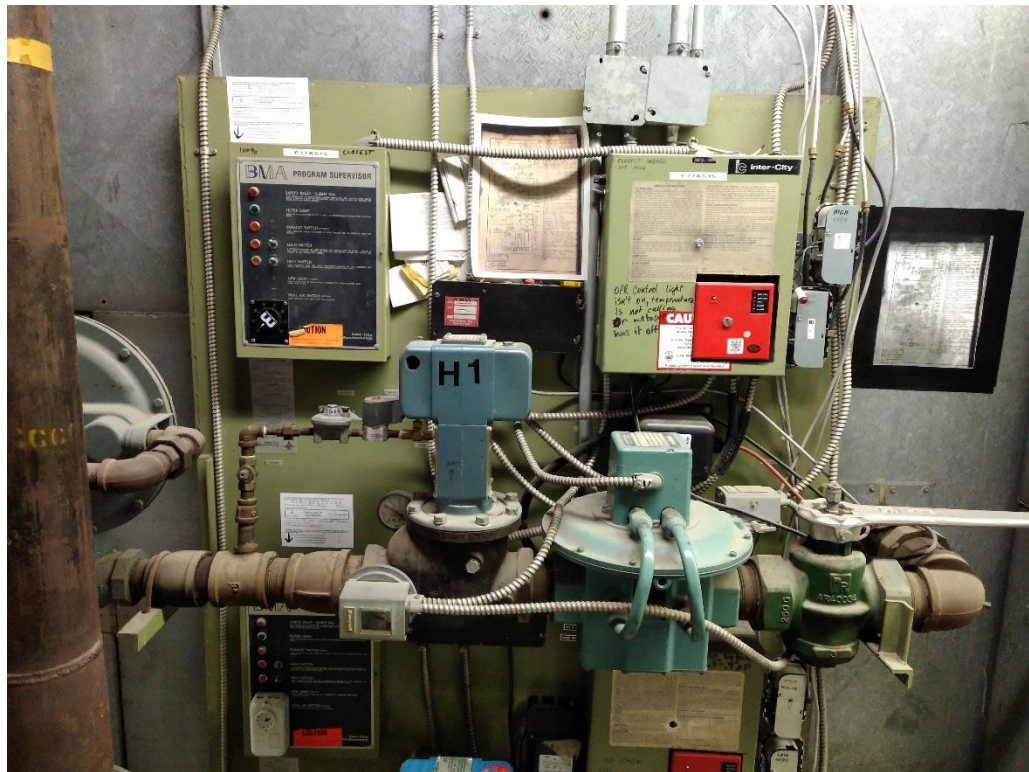
Figure 20: Natural gas manifold for direct fired burner on make-up air unit

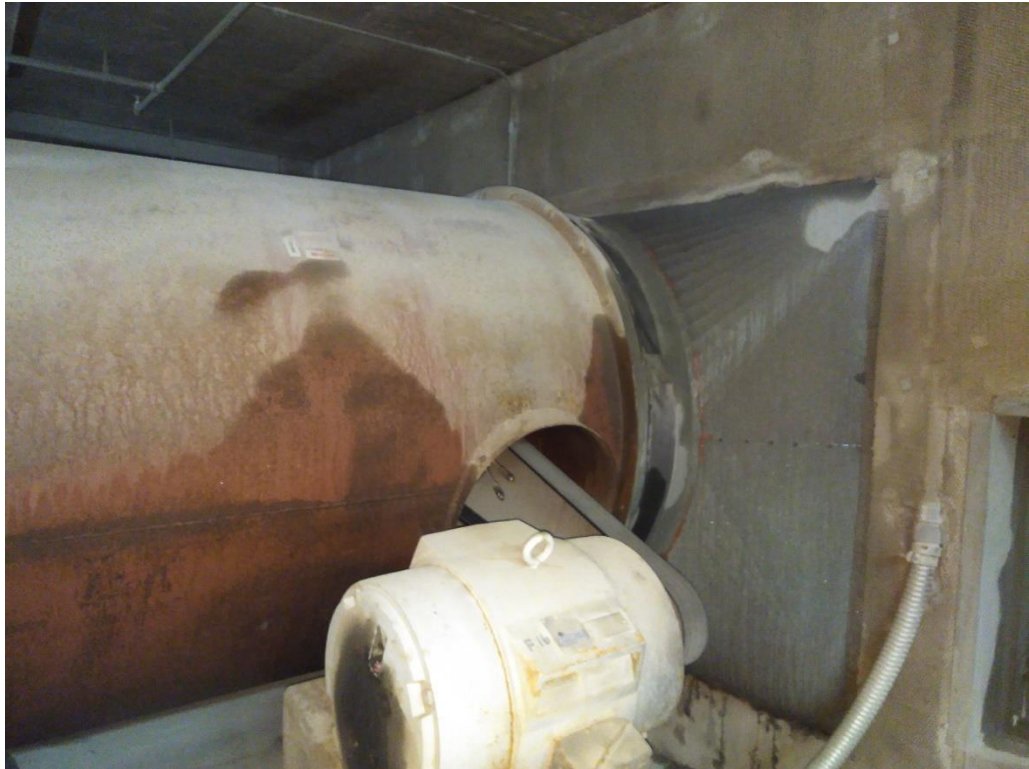
- .1 The make-up air is interlocked to two exhaust fans located on the upper level of the parkade. The exhaust fans are staged similar to the make-up air unit and can be controlled for upper and lower levels. The glycol run-around loop is disconnected similar to the make-up air unit. The fans are installed in a sealed room which acts as a negative air plenum with ductwork connections for the lower level and two branches for the upper level. The exhaust fans are original to the facility and appear to be in fair to poor condition. The fans are undersized based on current code requirements for CO/NO₂ purge systems. The capacity would need to be upgraded. Replacement is recommended.

Figure 22: Exhaust fan serving parkade ventilation system.

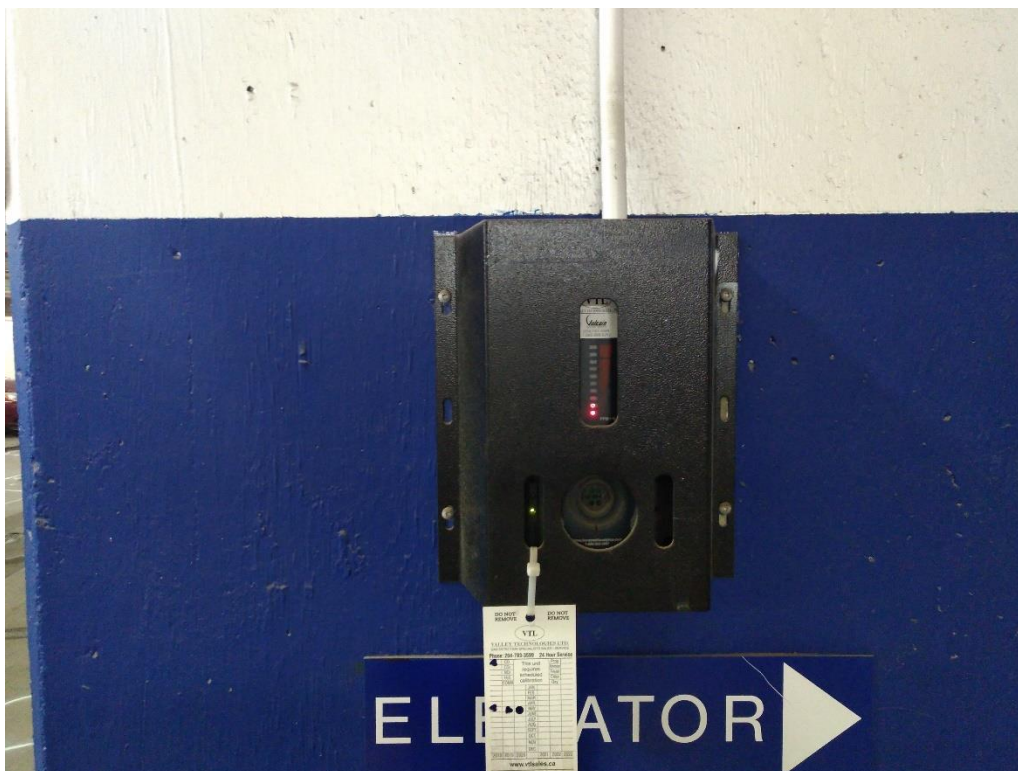
- .1 The entire parkade utilizes a CO detection system to control the make-up air unit and interlocked exhaust fans. It appears that the CO detection system is throughout the parkade and spaced in accordance with typical manufacturer requirements. The systems have been tested recently.
- .2 It was noted that there were lower and upper detection in some locations but not consistently throughout the parkade. Typically, CO detection is at the occupied breathing height with NO₂, another common hazardous gas generated by diesel vehicles located at high level. There

were high level detectors in only portions of the parkade and most detector inspection tags only indicated CO detection. It is recommended that NO₂ detectors be installed to align with proper spacing requirements per manufacturer recommendations.

Figure 25: CO detector located on column in parkade.
