Millennium Library Parkade – 251 Donald St. Parkade Condition Assessment

Submitted to: City of Winnipeg
Attention: Mr. Jason Wiebe C.E.T.
Date: April 1, 2021 (Revised April 8, 2021)
Submitted by: Crosier Kilgour & Partners Ltd.
300-275 Carlton Street
Winnipeg, Manitoba R3C 5R6
Phone: 204.943.7501 Fax: 204.943.7507
Website: www.ckpeng.com
Contact: Derek J. Mizak, P.Eng.
Our File No. 2020-1183

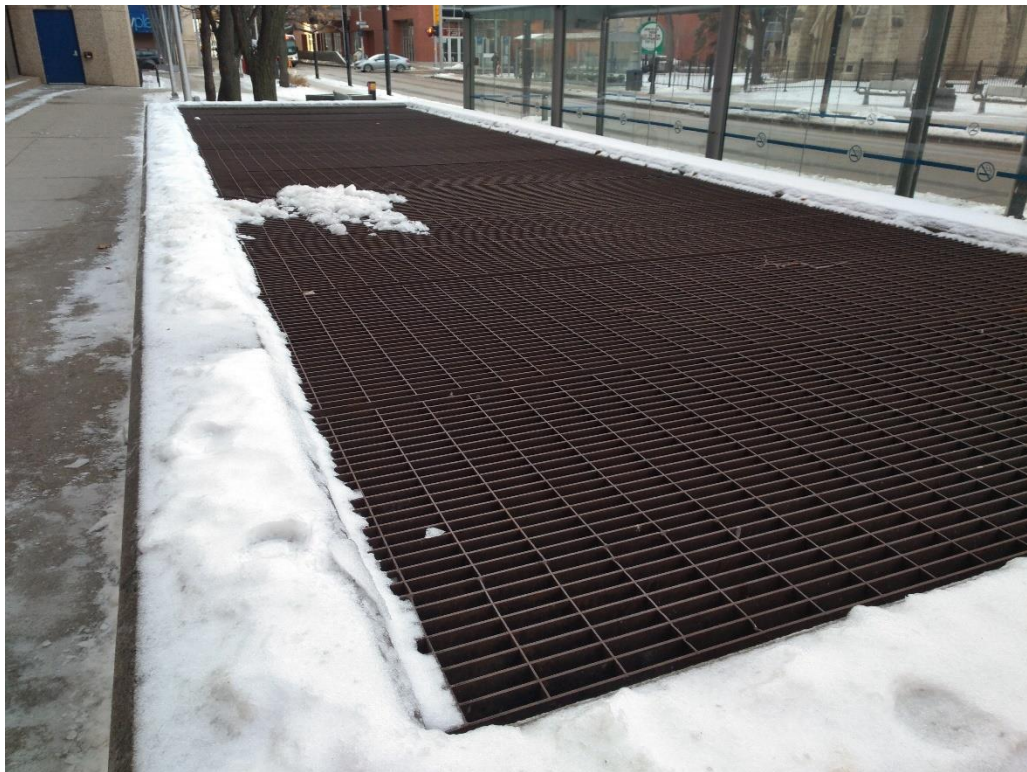
- .1 The intake louver for the make-up air serving the parkade is in an area well on Graham Avenue. The intake is approximately 10 feet from the street and therefore is not an ideal location to pull ventilation air from due the consistent bus traffic on Graham Avenue. It is an existing condition which will remain.

Figure 26: Intake louver for parkade make-up air unit.

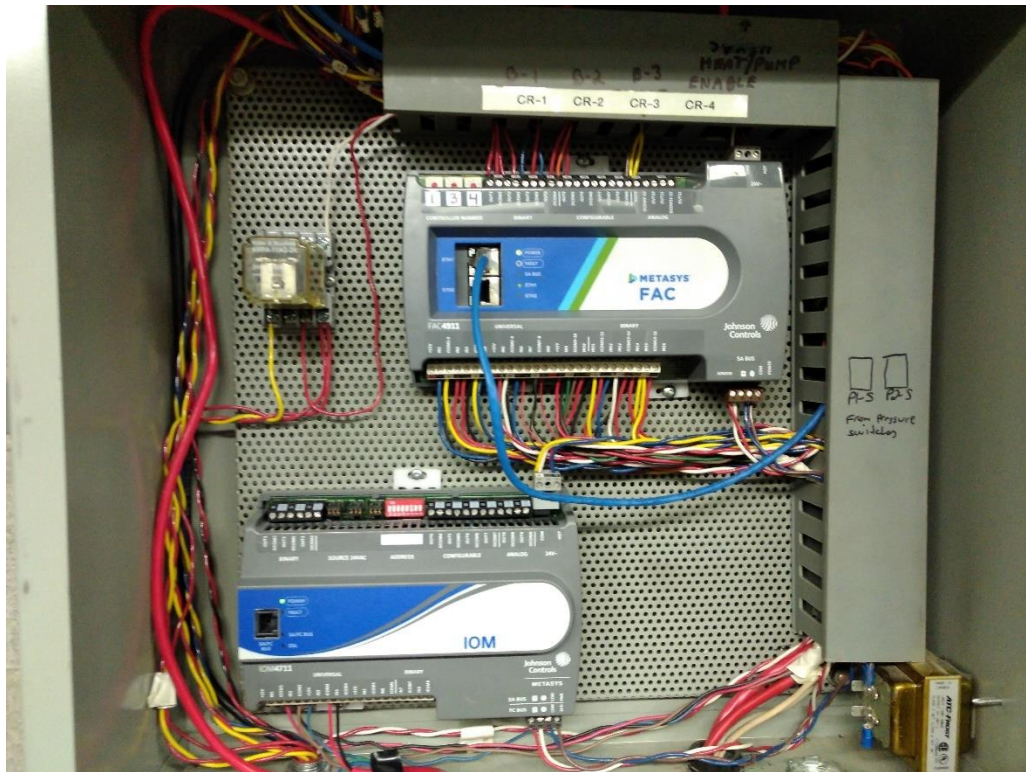
- .1 The majority of the building systems had pneumatic controls. The make-up air unit, the exhaust fans and several local items were on the pneumatic system. The existing pneumatic system is original to the facility and is recommended to be replaced with a DDC system.
- .2 There are two new panels located by the new boilers that serve the ramps on the upper levels. The control system is a DDC system installed by Johnson Controls and connects to the City of Winnipeg Remote Monitoring station. The control system was installed at the same time as the boiler and is in good condition.

Figure 27: New Johnson Controls system for ramp snow melt.

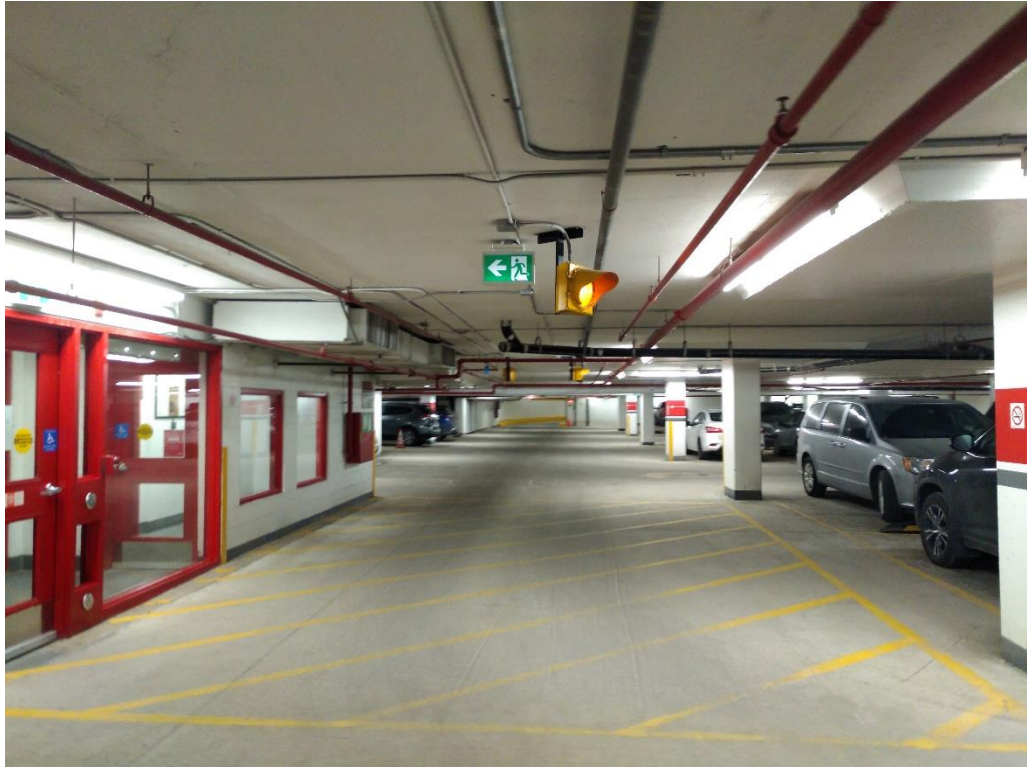
Lighting is mainly recessed surface mounted fluorescent fixtures with electronic ballasts and Led tubes. Stairwells ramps and general entrances all appear to be similar type fixtures.

Figure 28: Parkade Lighting

Lighting control in general parkade is on 24 hours a day, 7 days a week. Lighting appears to be maintained well throughout the parkade, but planning should be in place for potential replacement in the next 5 years.

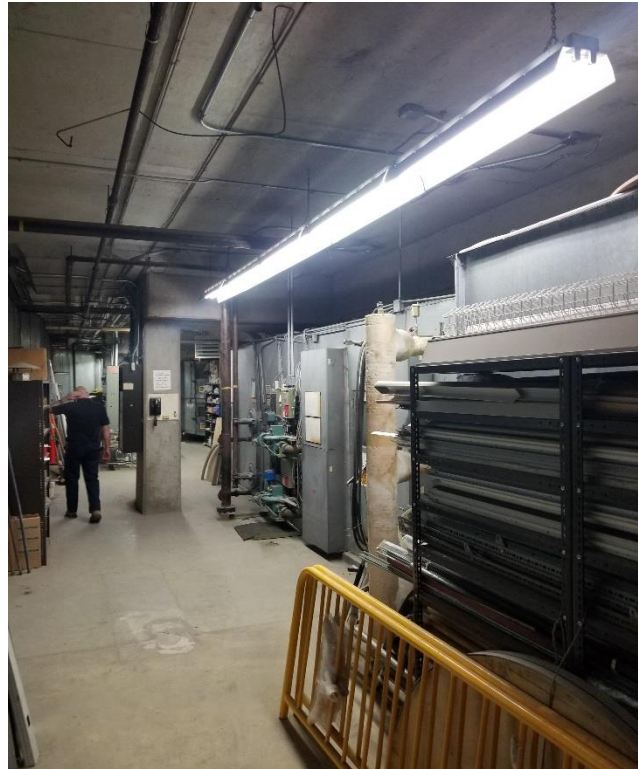
Back of house areas including service rooms are 2 lamp T8 fixtures with on/off switches.

Figure 29: Back of house lighting

All observed light fixtures were in fair to good condition.

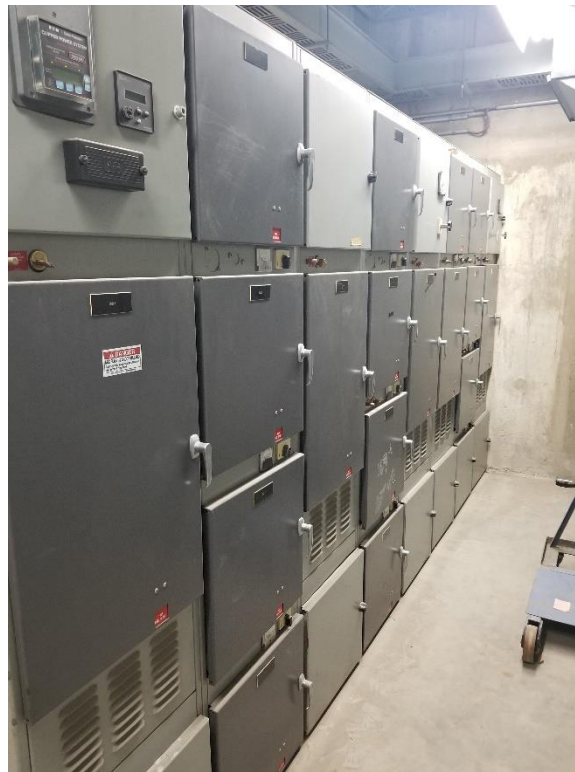
5.3.1 The main electrical distribution is located on level P2. The equipment appears original to the building but is still in fair working condition. Electrical equipment has a normal service life of 35 years. Although the equipment is still functioning, provisions should be made for replacement in the near future.

Figure 30: Part of the main distribution.

- 5.3.2 Additional labelling of equipment and the creation of a single distribution schematic is strongly recommended. The single line should be mounted in the main electrical room under a plexi-glass cover.
