Feasibility Study

MILLENNIUM LIBRARY PARKADE | 201 DONALD STREET

Millennium Library Parkade
201 Donald Street

April 22, 2024

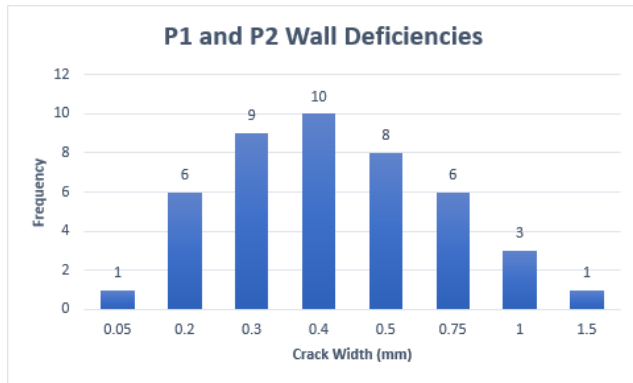
Figure 8: Wall crack Widths

Our team undertook a crack survey of the walls where it was found that, in general, there are limited cracks in the facility. The following figure summarizes the findings. As many of the cracks in the concrete are larger than 0.1mm, they could be prone to leaking and should be repaired to limit water ingress into the parking garage. The common approach to repair is to utilize crack injection.

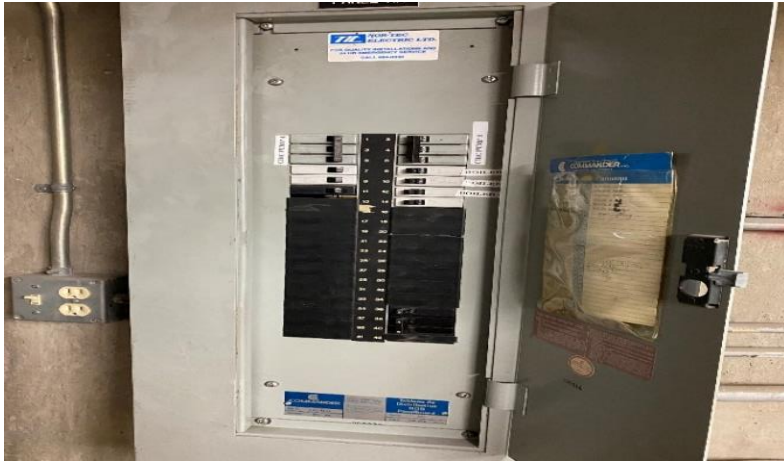
Figure 12: Indicate Essential Panelboard no longer used and obsolete Security Booth Panel

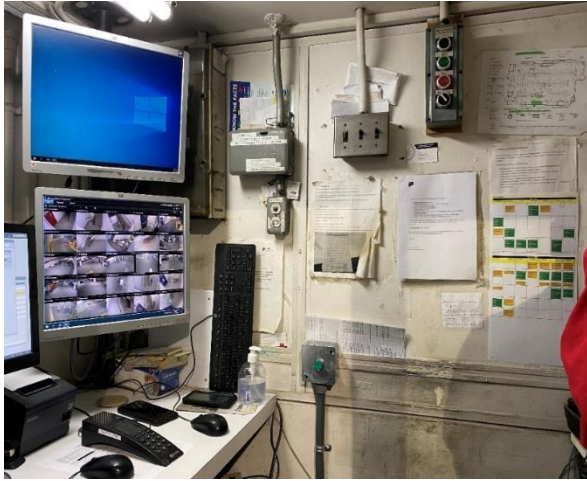
Figure 15: Security Cubicle

The Parkade security booth has a security alarm panel and keypad that are older, and the City has identified their intention to replace these. This would be recommended also as the booth is crowded with electrical and other control components and it would be beneficial to replace the system with new current equipment and provide secured conduit and wiring in a neat and easily identifiable fashion. Re-configuration of some of the existing wiring and devices would need to be coordinated to make an overall more efficient and professional workspace.

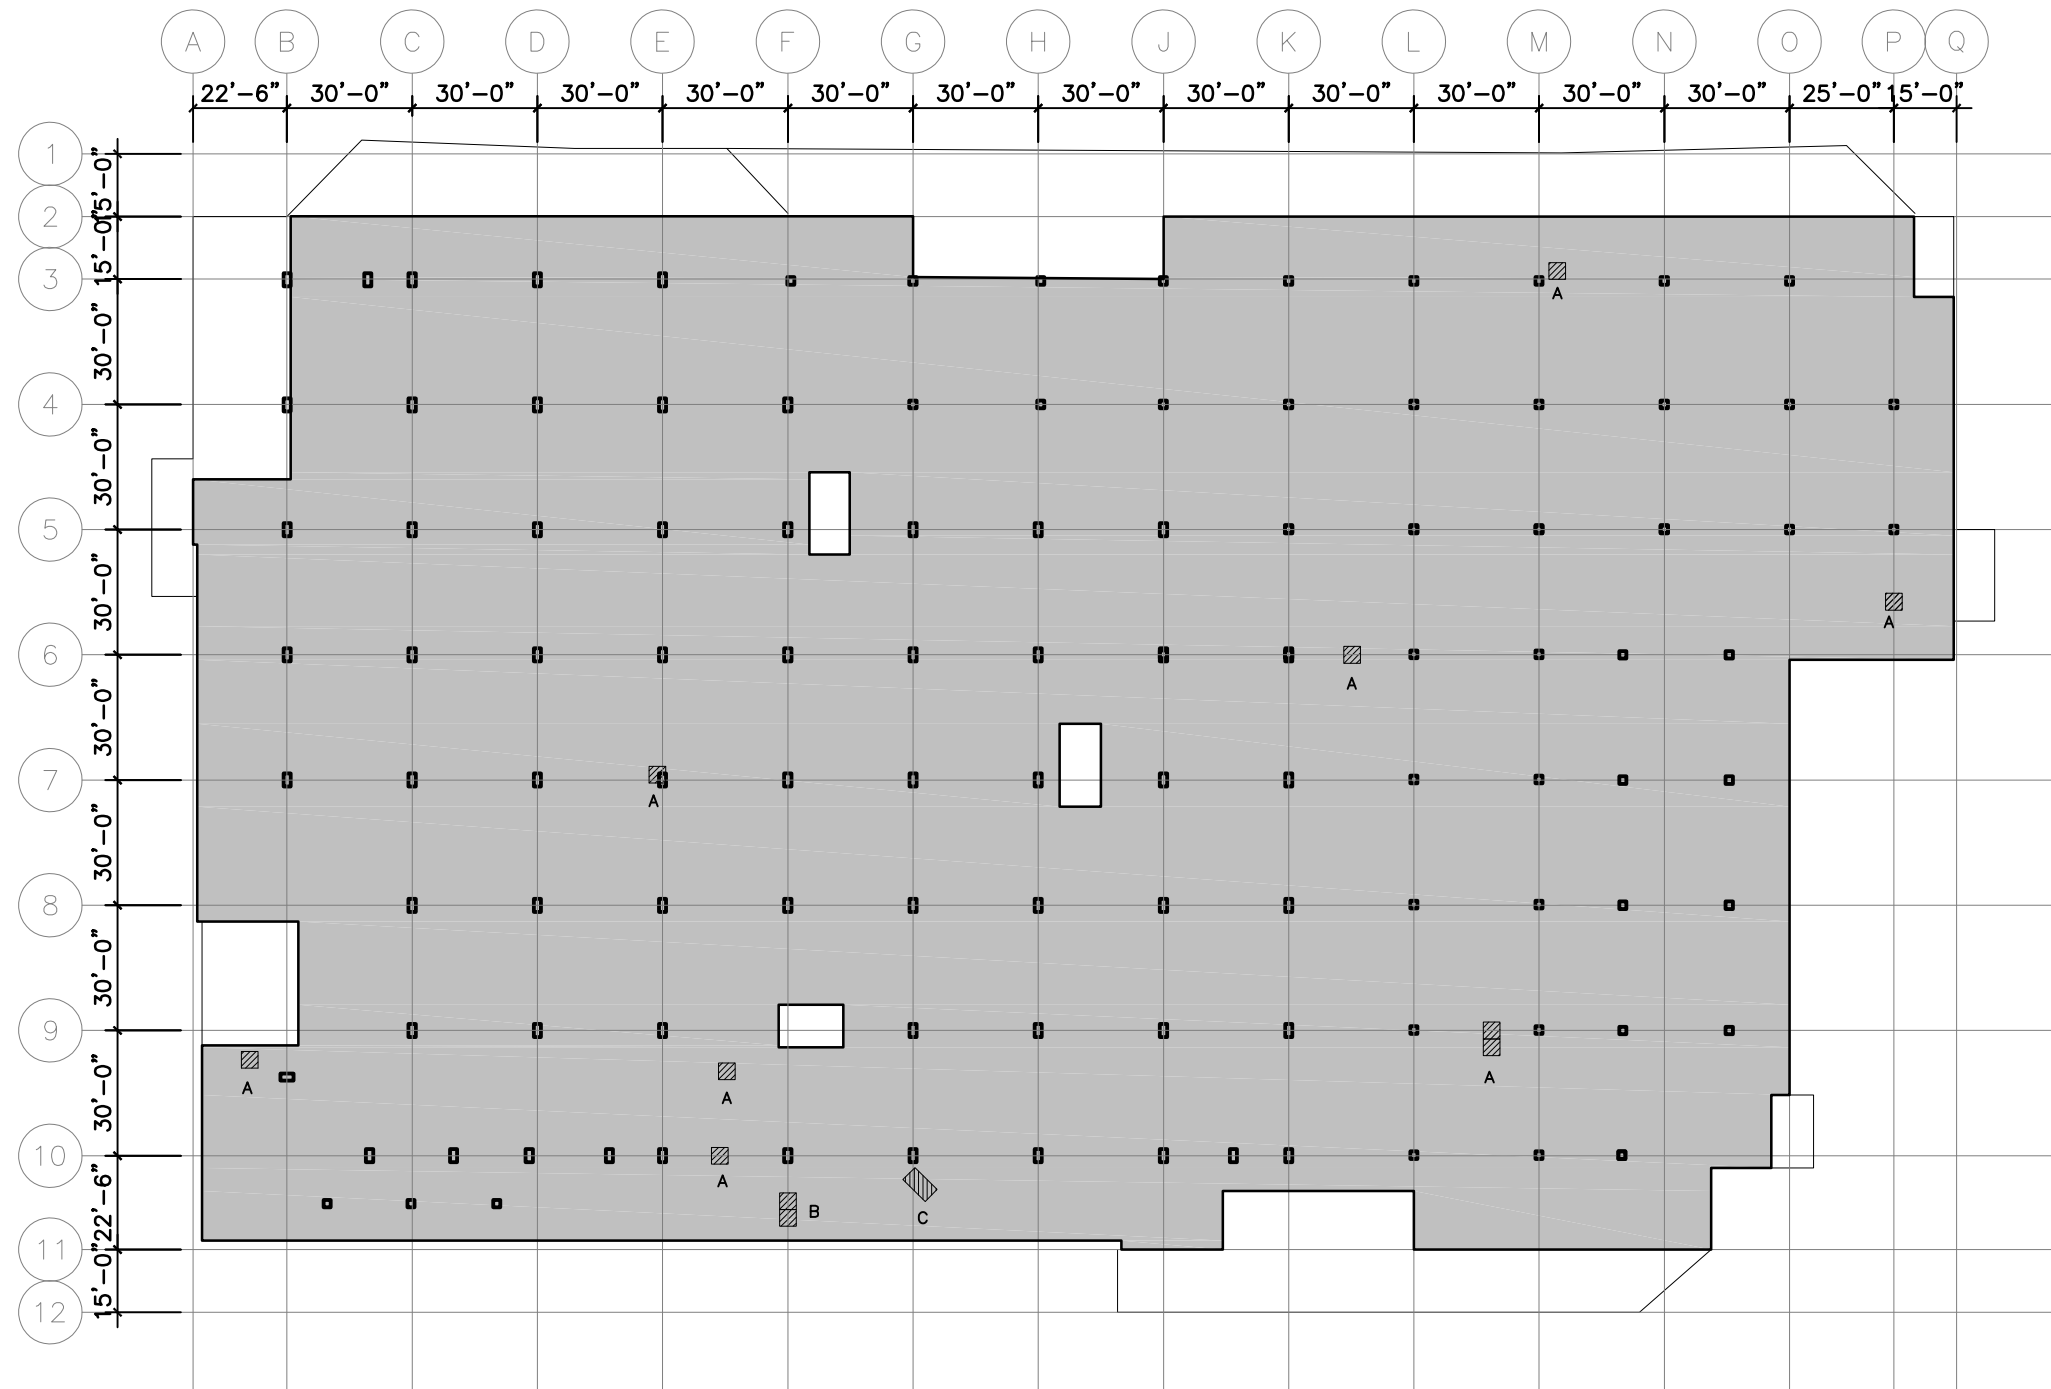
Figure No.
S-101

UNDERSIDE DEFICIENCY
APPROX. 2 SF EA

Title
SHORT TERM REPAIRS
UNDERSIDE ROOF SLAB

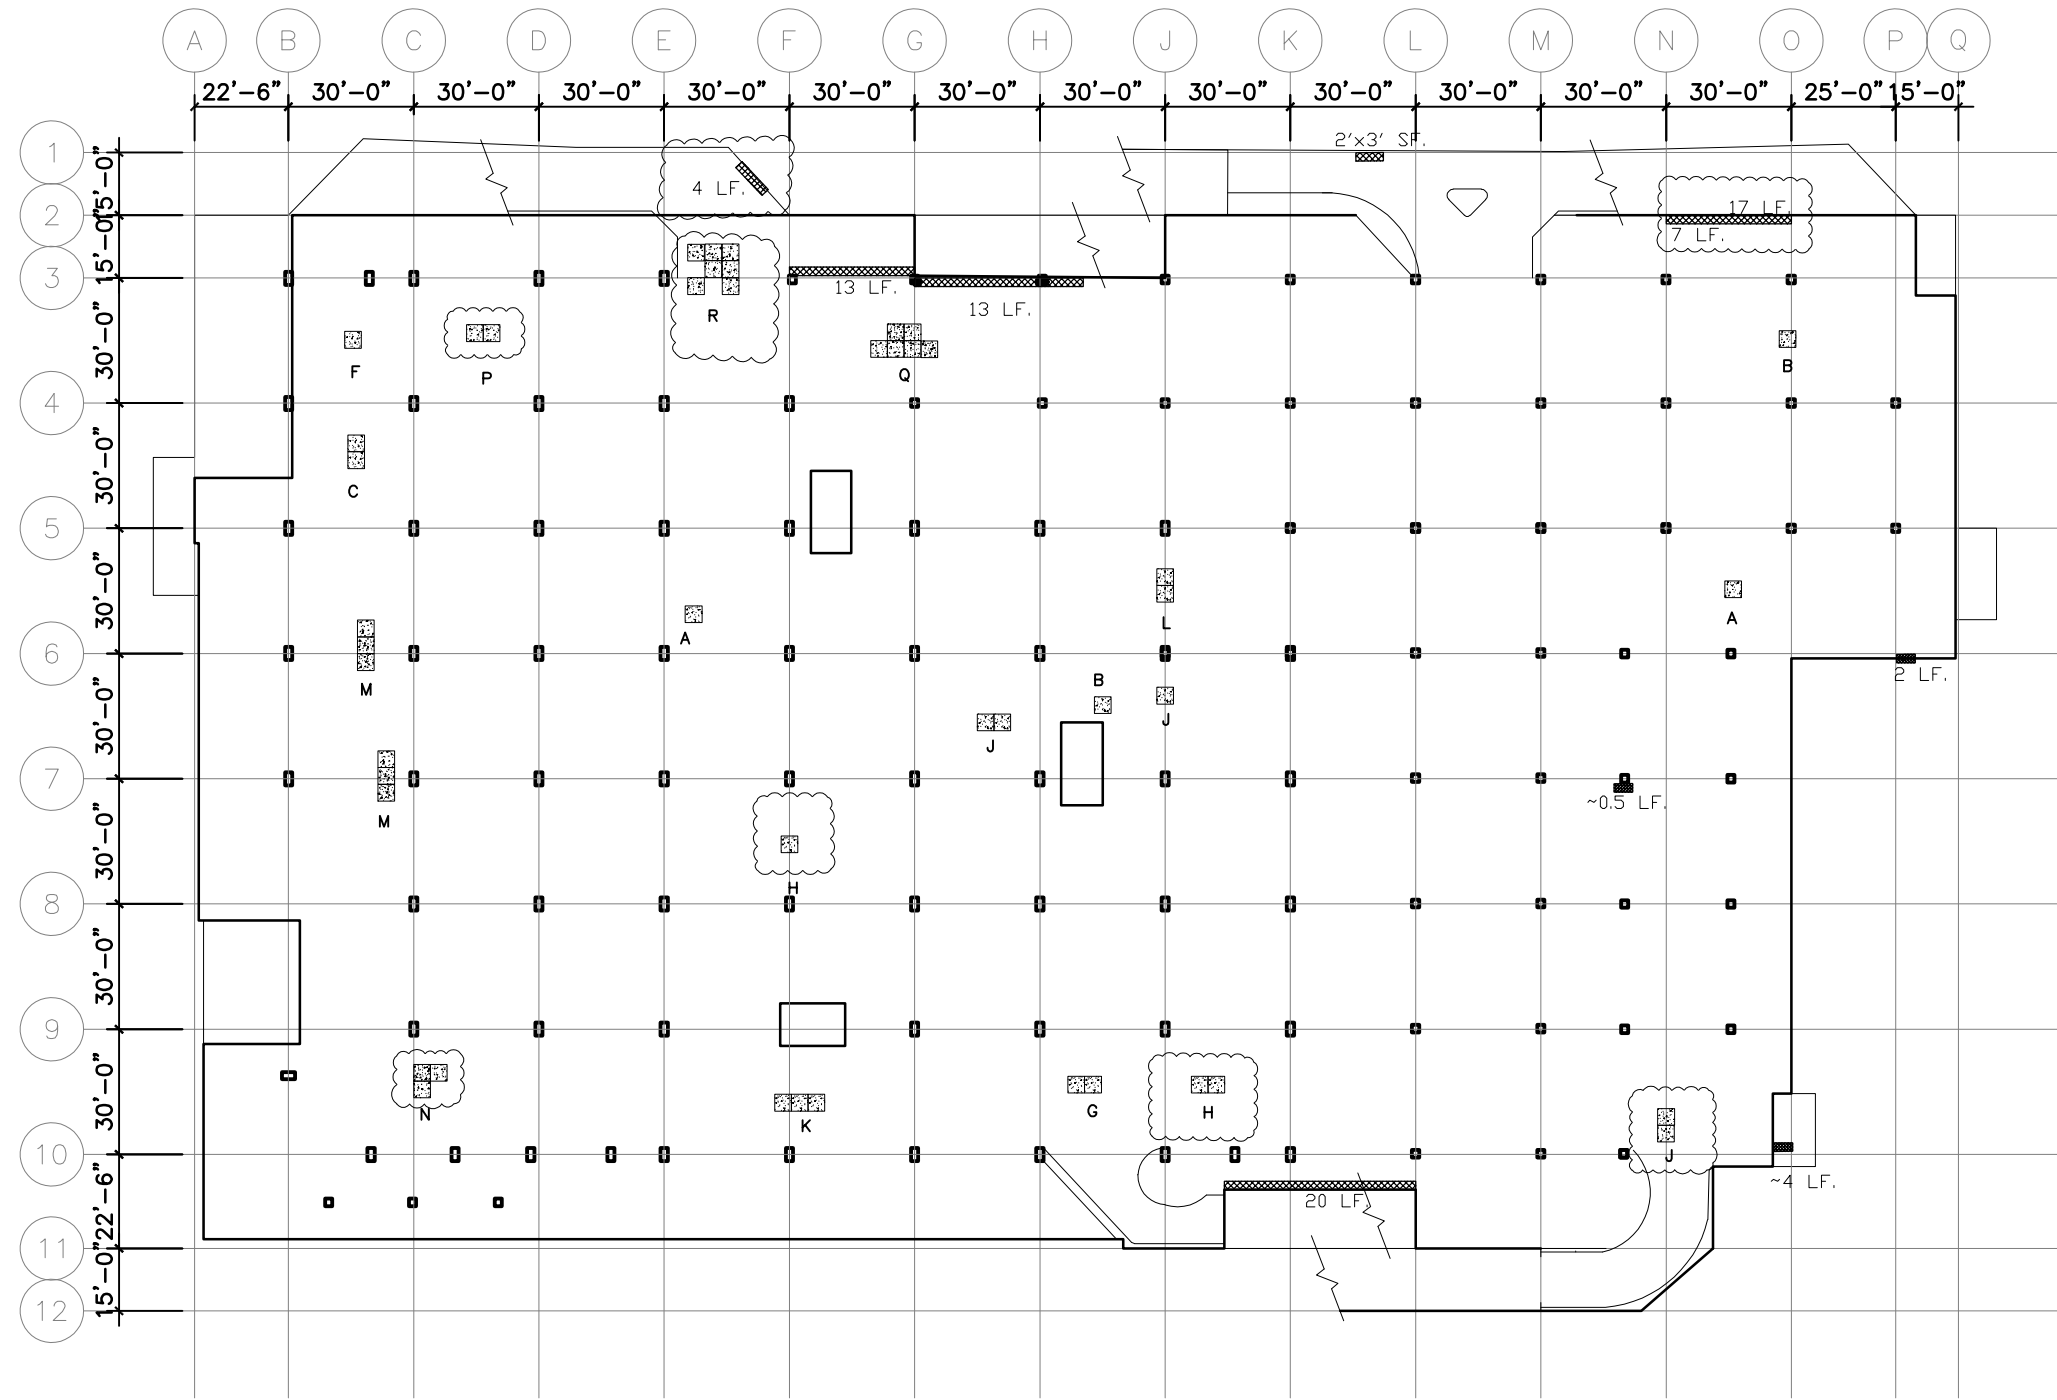
Figure No.
S-102

- MEMBRANE DEFICIENCY
- FULL DEPTH REPAIR APPROX. 170 SF
- P1 WALL DEFICIENCY APPROX. 86.5 LF

Title
**SHORT TERM REPAIRS
TOPSIDE P1 SLAB**

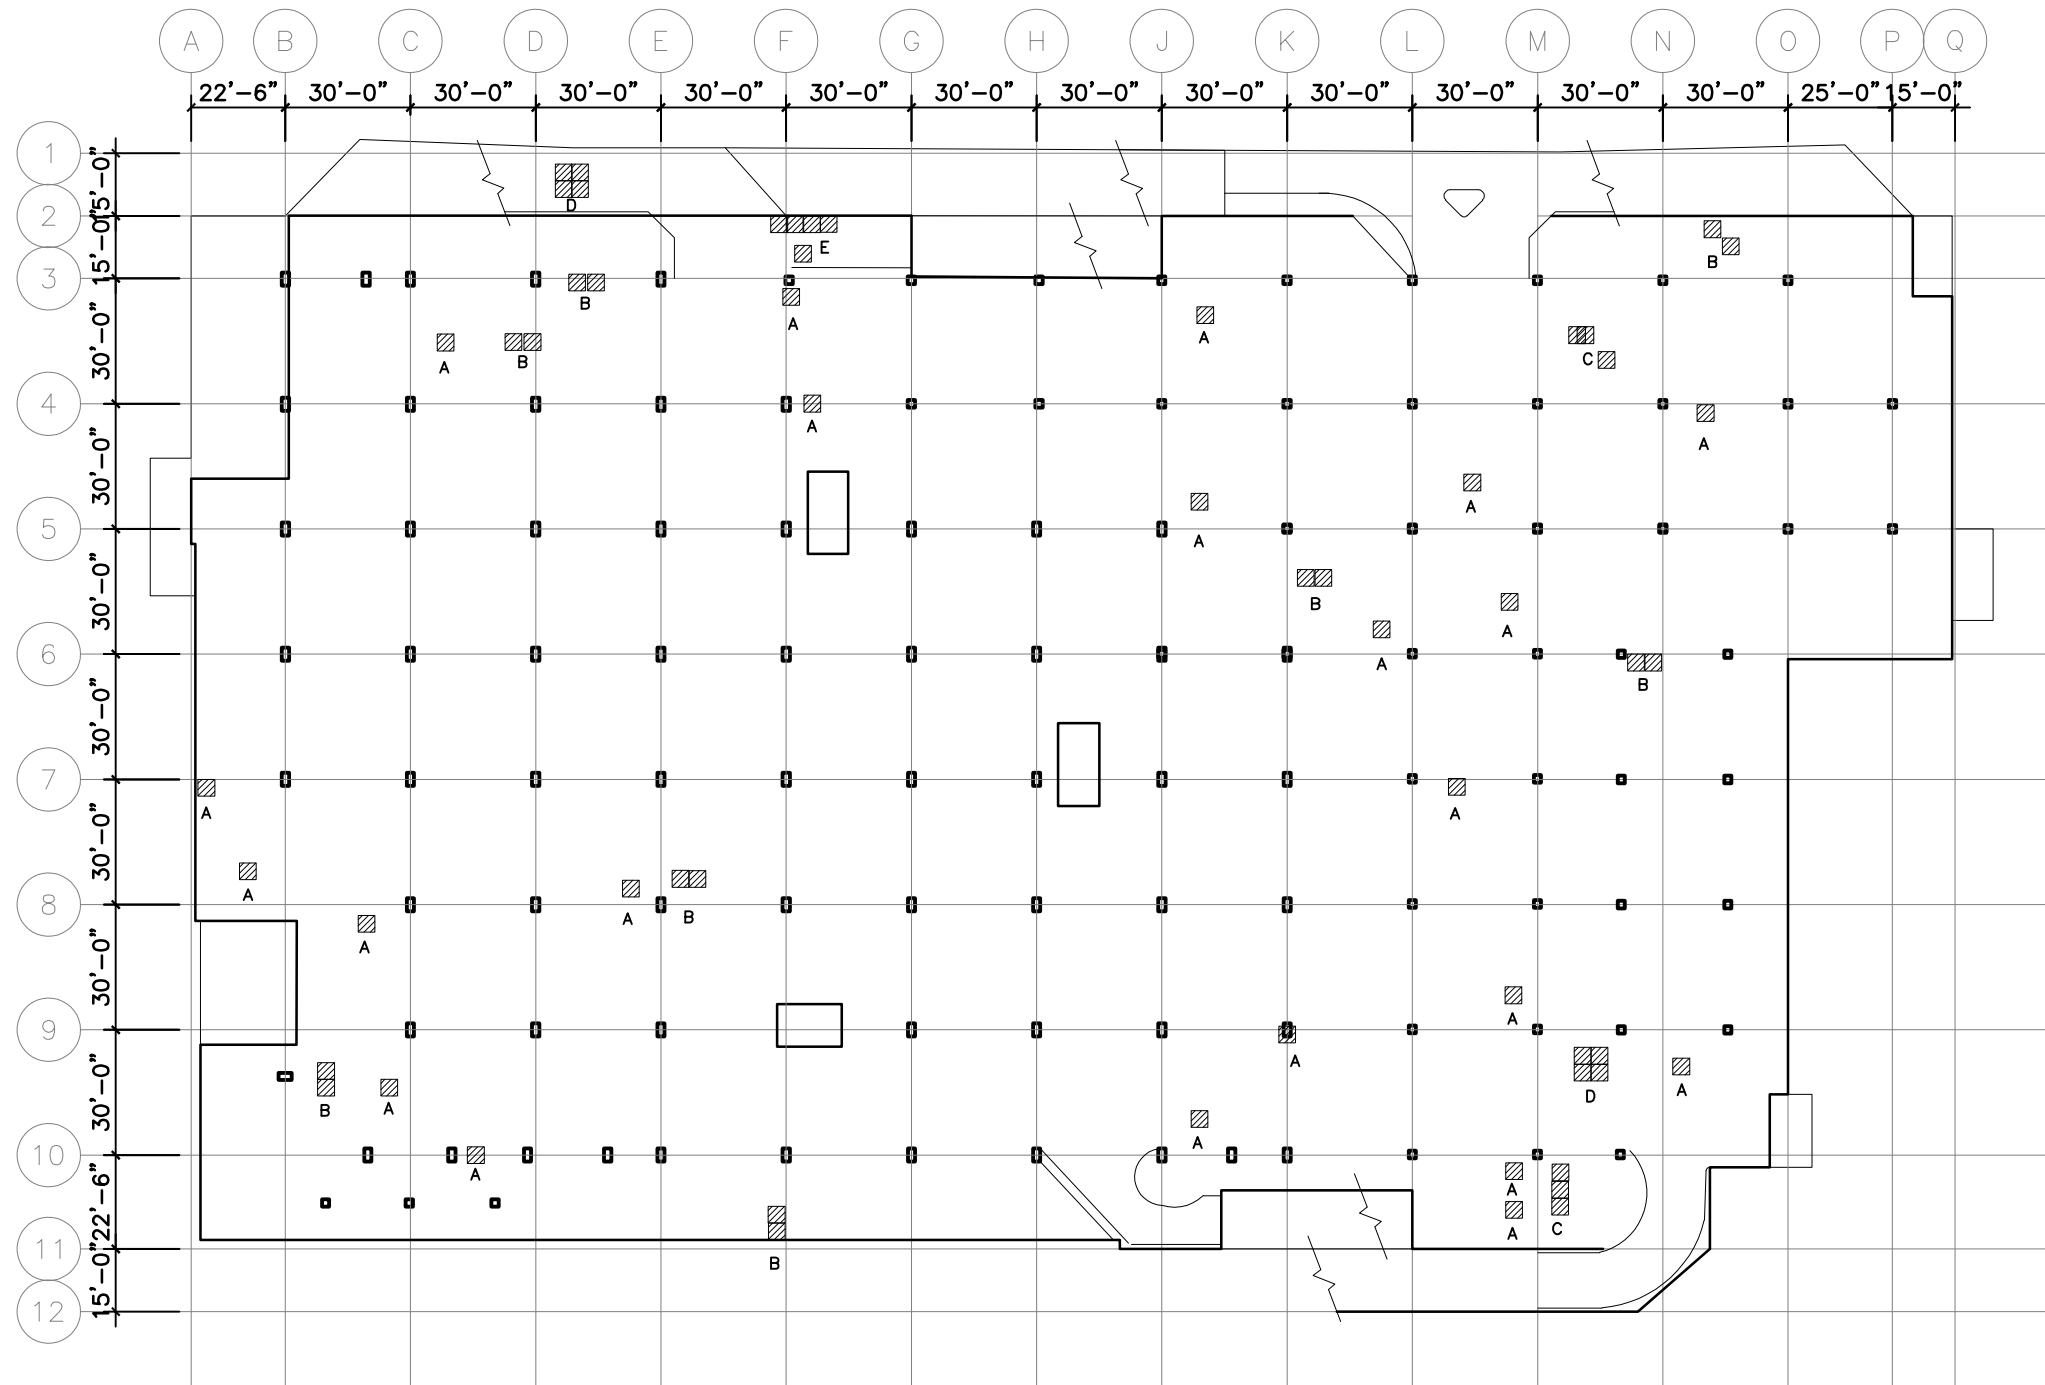
Figure No.
S-103

UNDERSIDE DEFICIENCY
APPROX. 2 SF EA

Title
SHORT TERM REPAIRS
UNDERSIDE P1 SLAB

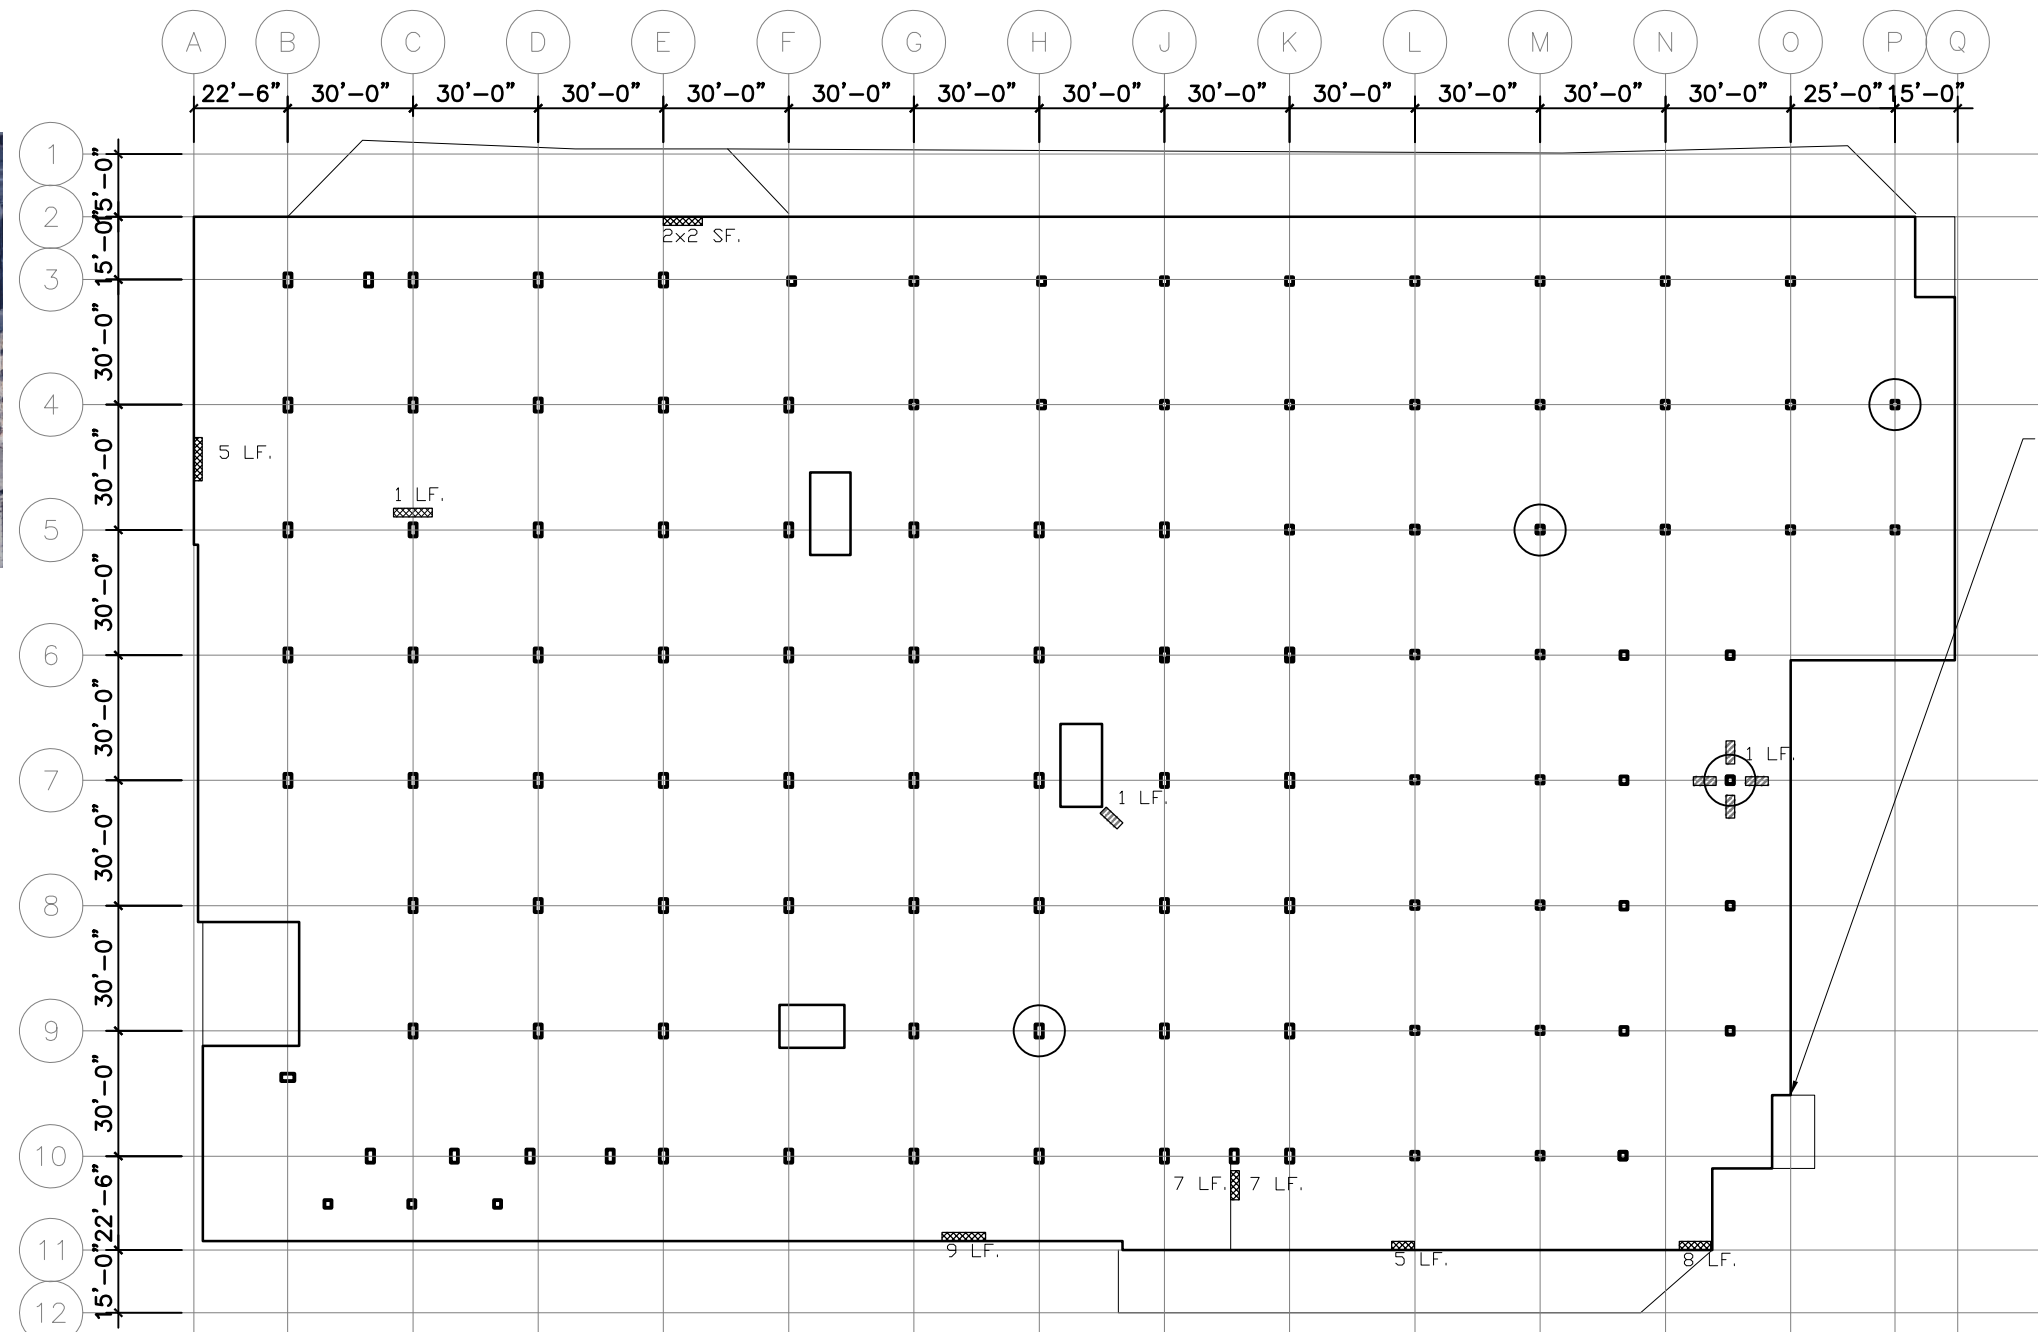
P2 SLAB DEFICIENCY
APPROX. 5 LF
-

P2 WALL DEFICIENCY
APPROX. 46 LF

1
**SHORT TERM REPAIRS
TOPSIDE P2 SLAB**
 S-104 1/46"=1'-0"

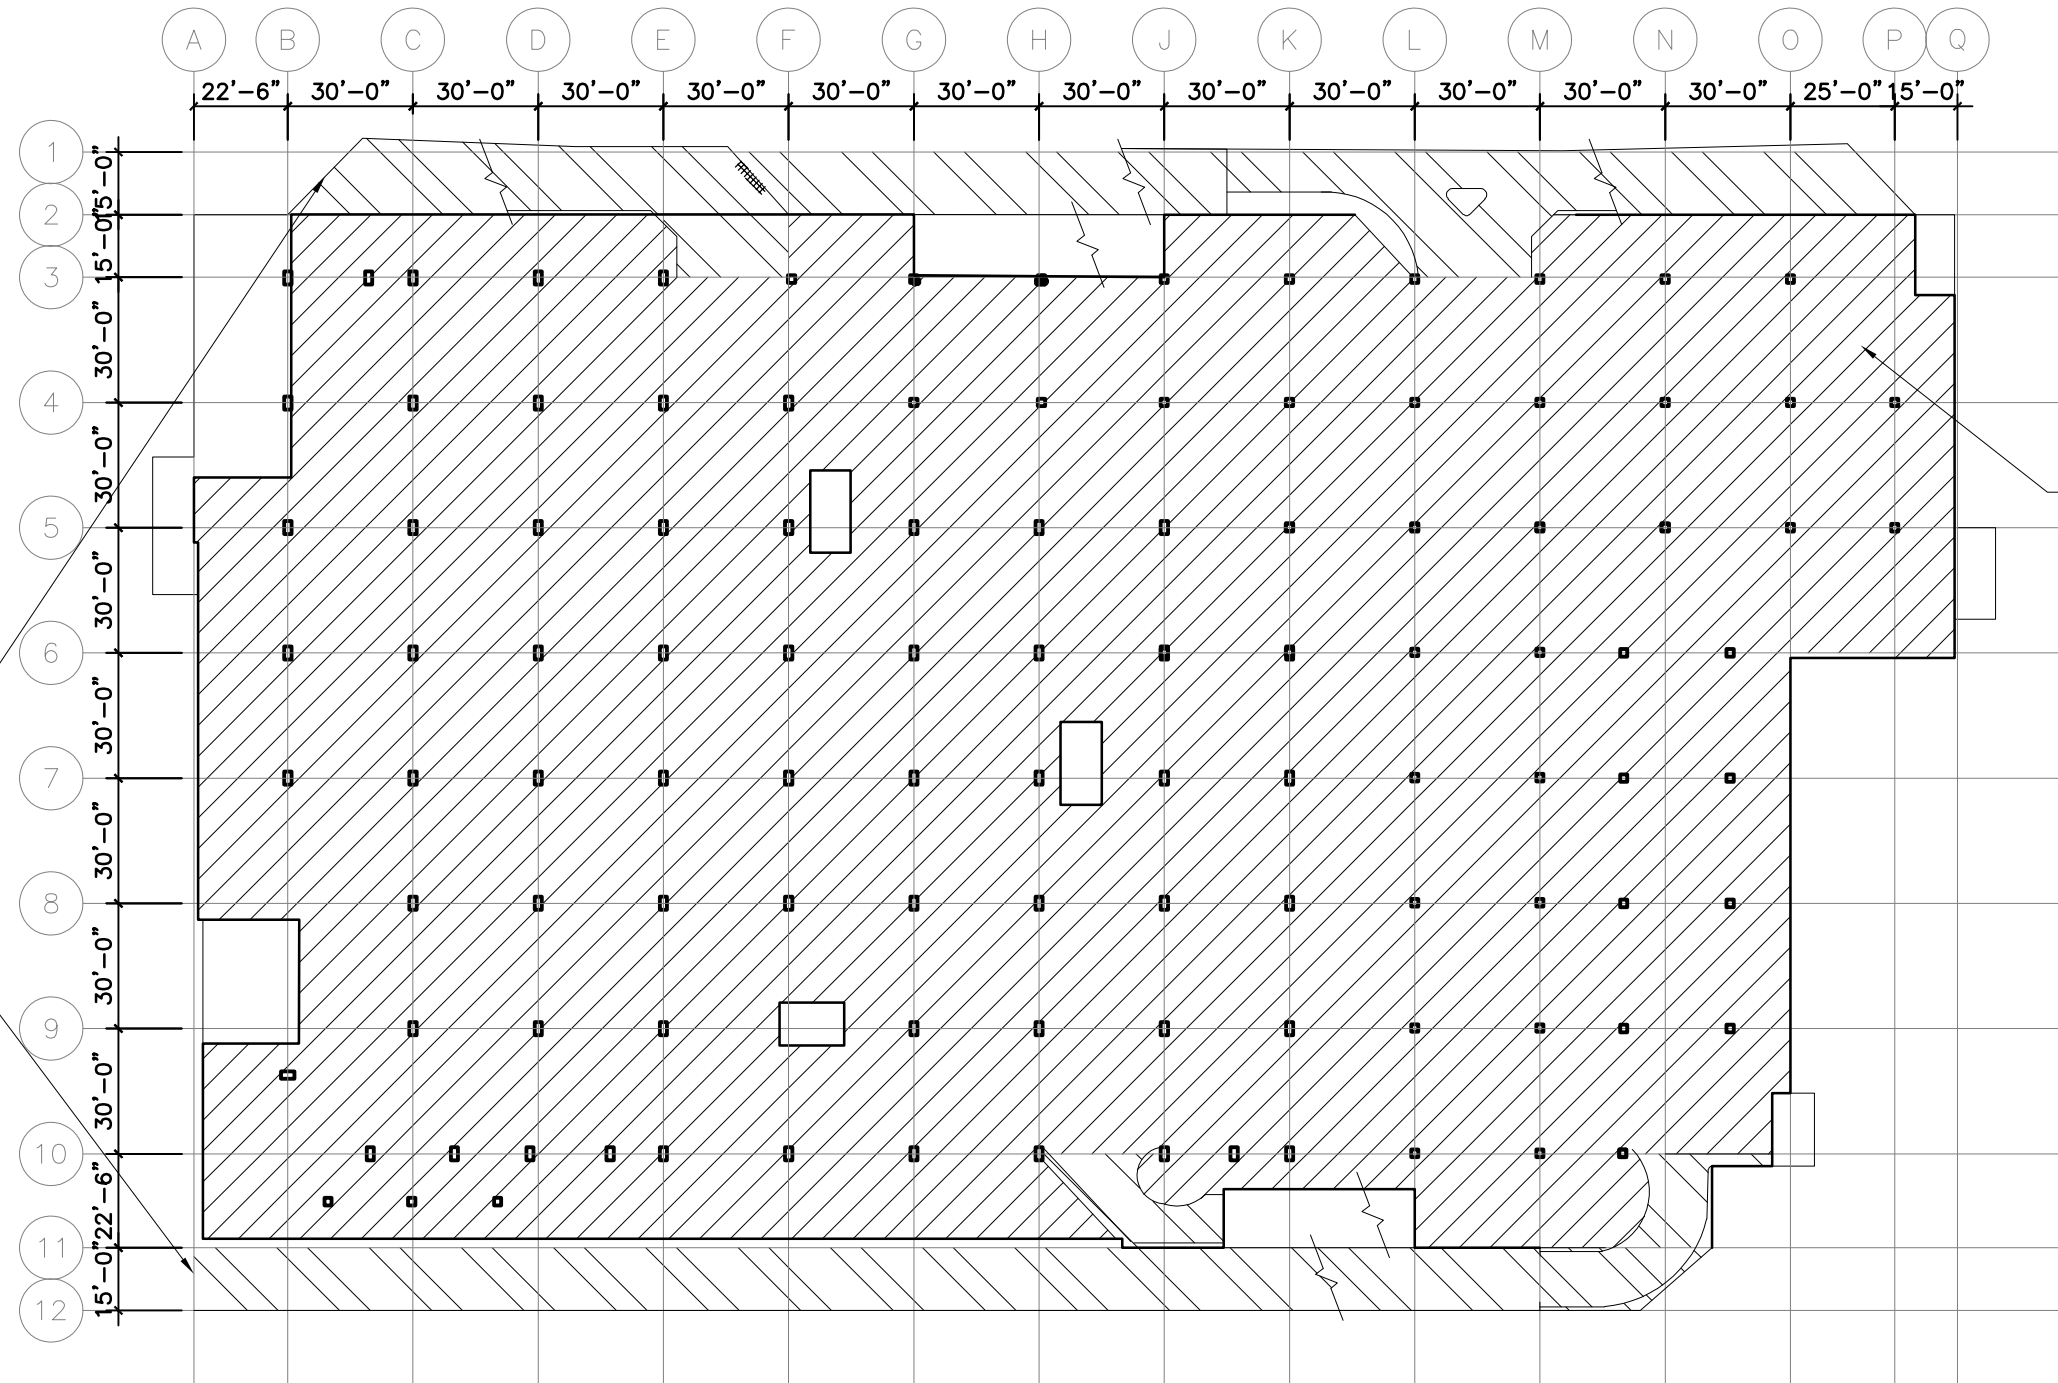
1
S-106

**P1 SURFACE REMOVAL, RESURFACING,
SLAB & RAMP WATERPROOFING**

INSTALL NEW
TRAFFIC MEMBRANE
ON ALL RAMPS

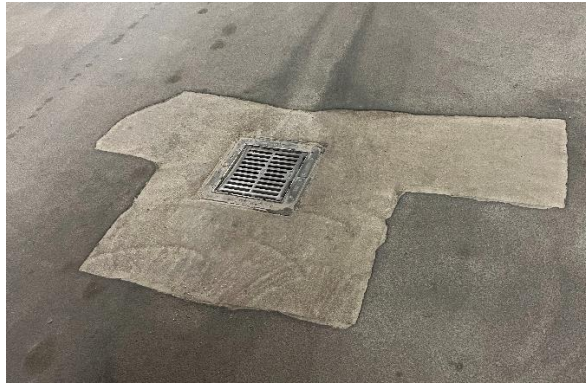
Figure 1: Traffic membrane repair on P1

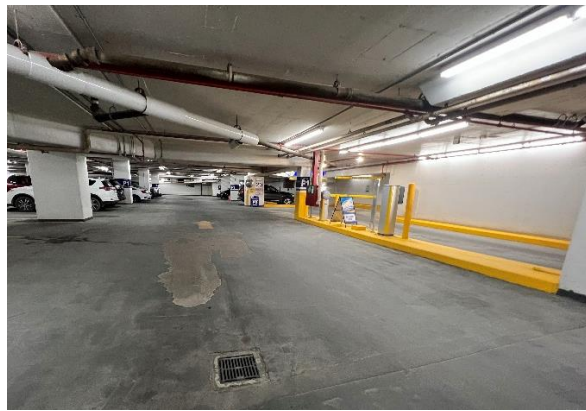
Figure 2: Traffic membrane repair on P1

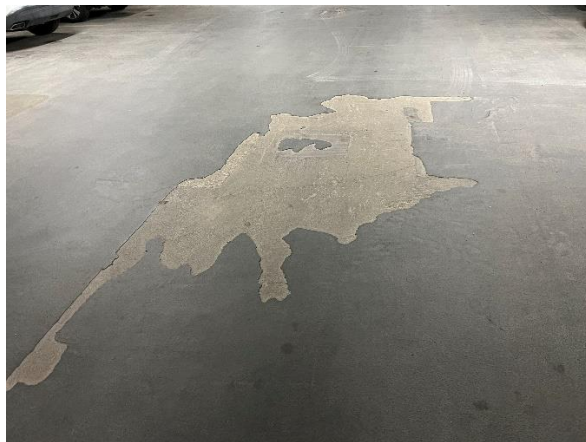
Figure 3: Traffic membrane repair on P1

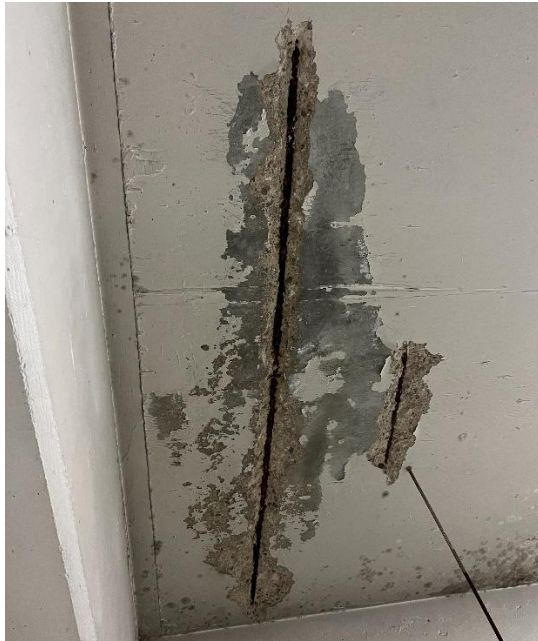
Figure 4: Exposed reinforcement

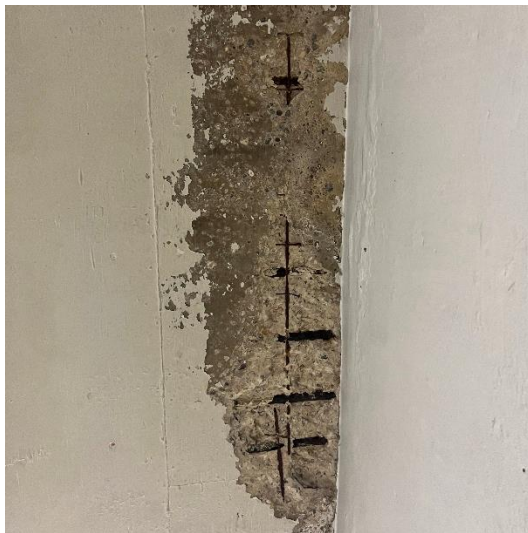
Figure 5: Exposed reinforcement

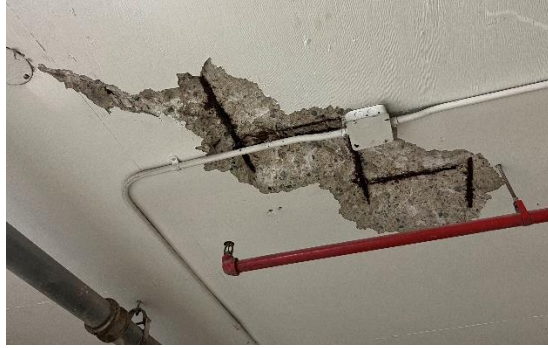
Figure 6: Exposed reinforcement

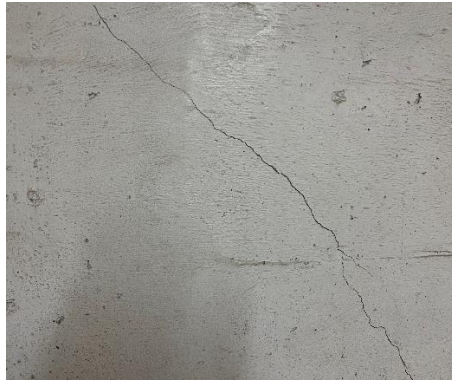
Figure 7: Wall Cracks

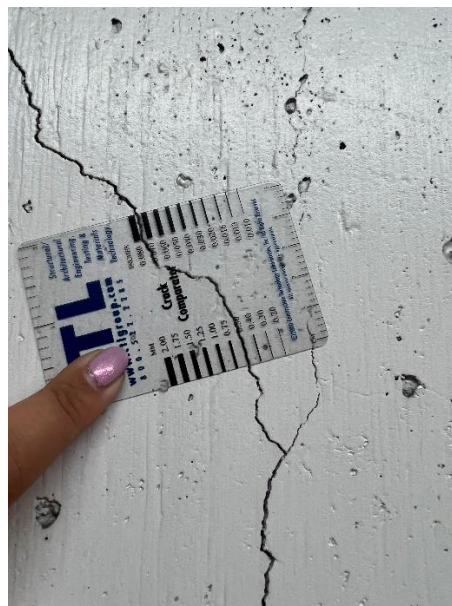
Figure 8: Wall Cracks

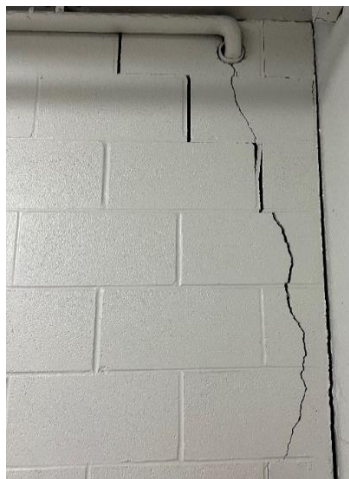
Figure 9: Vestibule Step Cracks

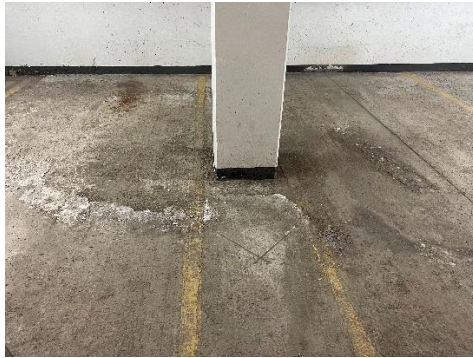
Figure 13: Staining around Column

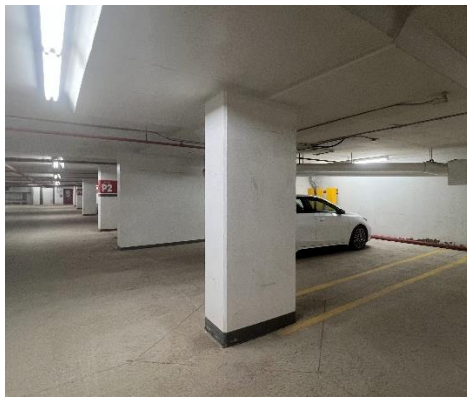
Figure 14: P2 Column

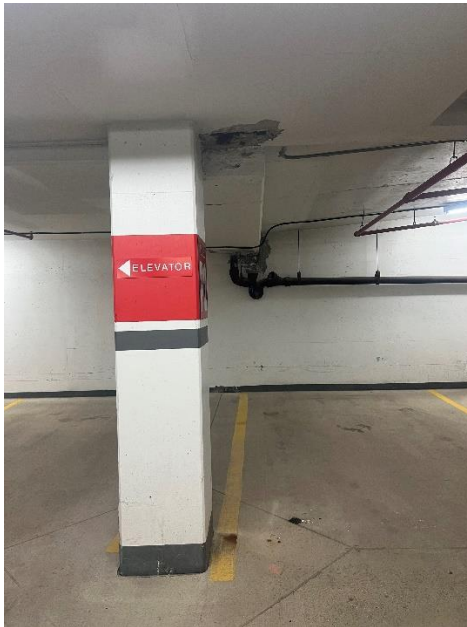
Figure 15: P2 Column

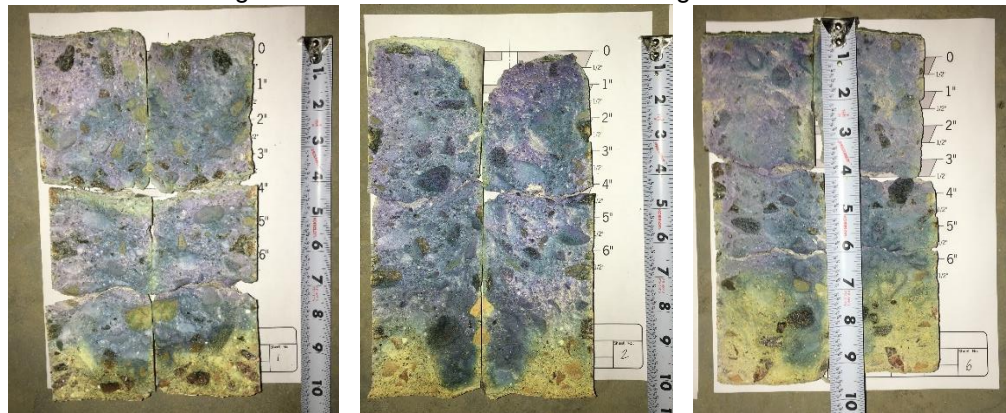
Figure 1: Results of Carbonation Testing

For this investigation, the cores were extracted full depth to provide results at the top surface and soffit of the structural slab. The results of the carbonation testing indicated a pH ranging from 7 to 9 on the bottom of the structural slab core samples. The depth ranges from 1 ¼” to 2” which suggests the carbonation has reached the bottom reinforcing steel and the protective film is no longer present. The pH at the top surface generally appears to be above 9. The results of the carbonation testing confirm that the passive protective film provided by a high pH is no longer present at the bottom reinforcing and the reinforcing steel is vulnerable to corrosion in the presence of moisture and oxygen.

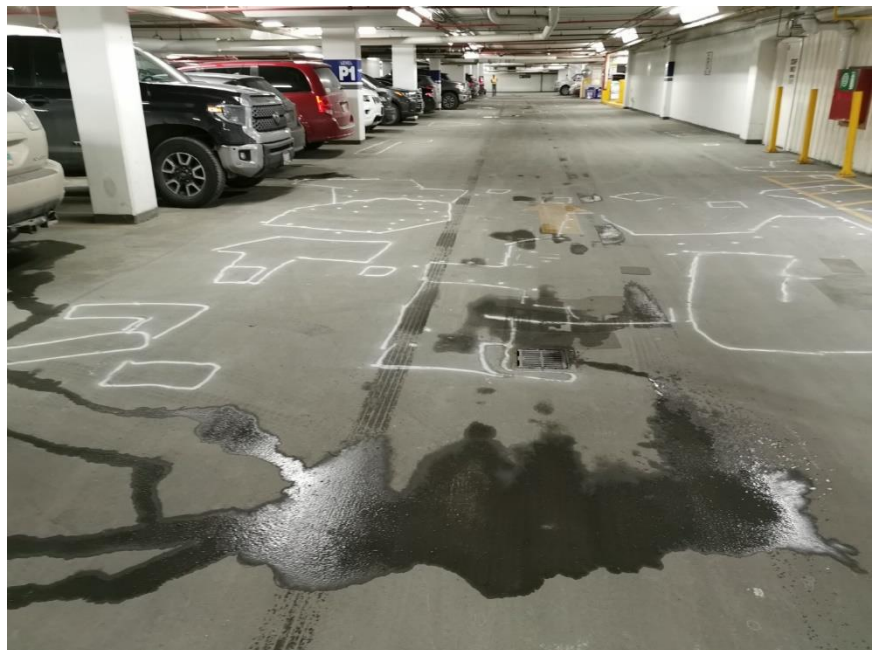
Photograph #4:

Although not apparent due to the presence of the waterproofing membrane, widespread top surface concrete deterioration is present throughout Level P1. The approximate extents of deterioration were identified during the sounding survey and marked onsite to allow a visual review of the locations and general scale of the deterioration (Photographs #3 & #4). The locations of deterioration appear to be sporadic in location and size (Photograph #5).

Approximate extents of apparent concrete delamination marked onsite.

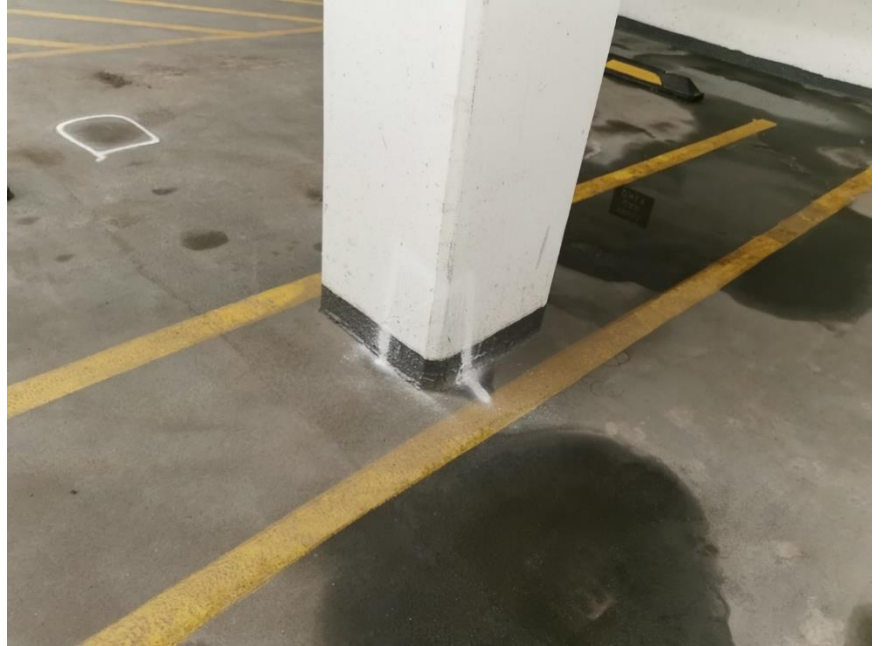
Photograph #7:

The concrete walls and columns are in overall good condition. Localized spalling and evidence of concrete deterioration were identified at a few columns (Photograph #7).

Approximate extents of apparent concrete delamination marked on column.

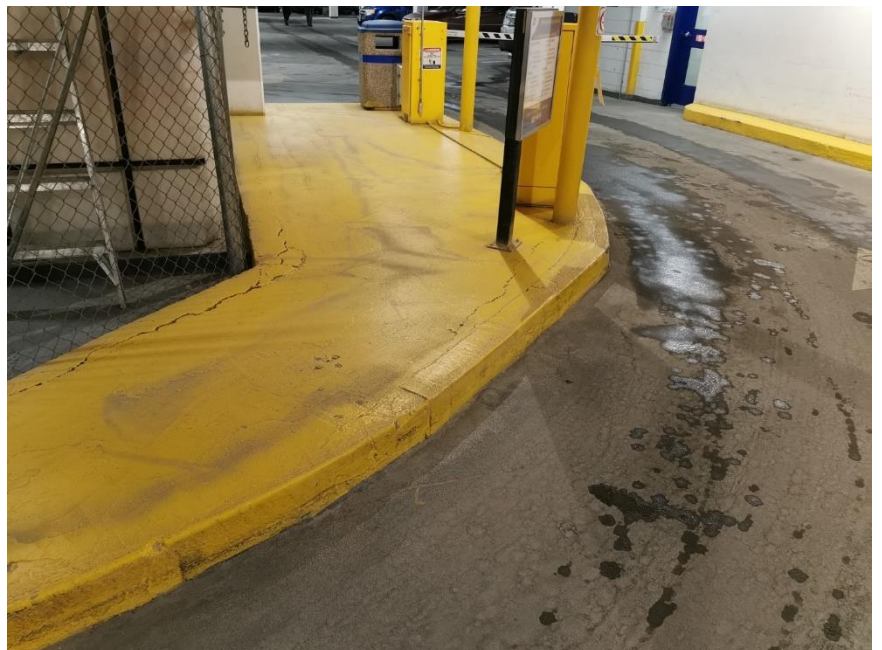
Photograph #10:

The rubber curbs installed in the parking stalls appear to be in good condition. A few curbs were observed to be damaged but are likely due to isolated vehicle impacts (Photograph #9). The condition of the concrete curbs at the entrance and exit ramps varies (Photograph #10). Approximately 85 sq.ft. of curb deterioration was observed. Localized repairs and or full depth replacement is recommended in the short term to minimize the risk of tripping hazards and damage to vehicles.

Existing concrete curb at Donald street entrance.

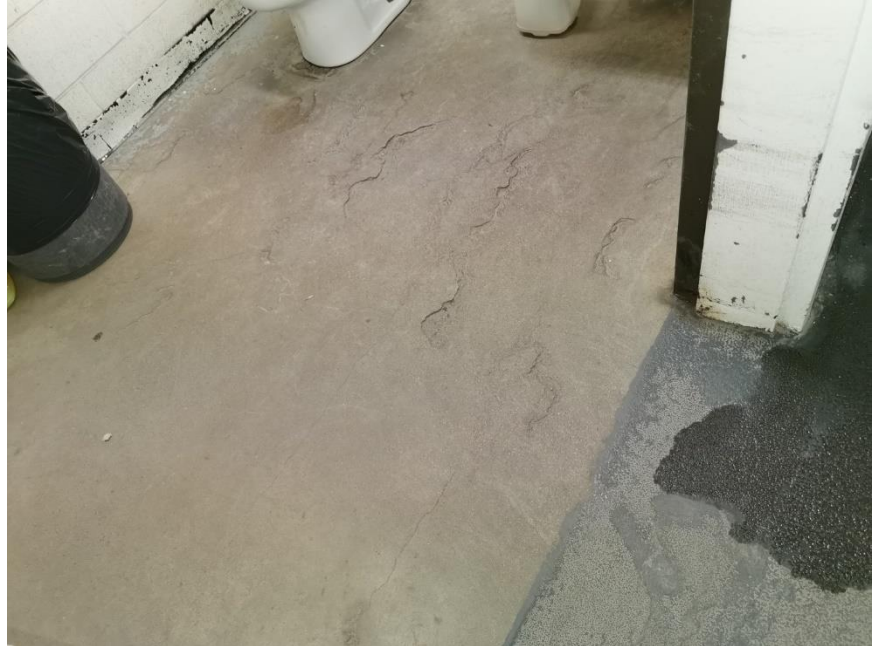
Photograph #17:

In general, the mechanical rooms are in fair condition. Although not sounded, localized top surface deterioration, was apparent in the mechanical rooms (Photograph #17). Locations of concrete deterioration were also noted on the walls, ramps, columns, soffits, and curbs (Photograph #18). It is recommended that localized concrete repairs be completed in the short term.

Visible concrete delamination in washroom.

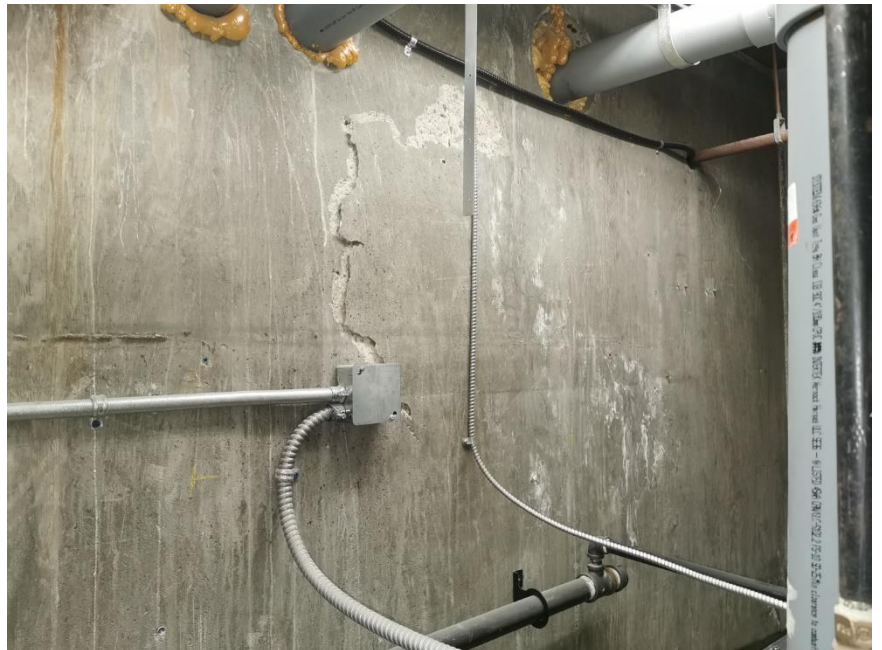
Photograph #18:

Visible concrete wall delamination in mechanical room on side of ramp.

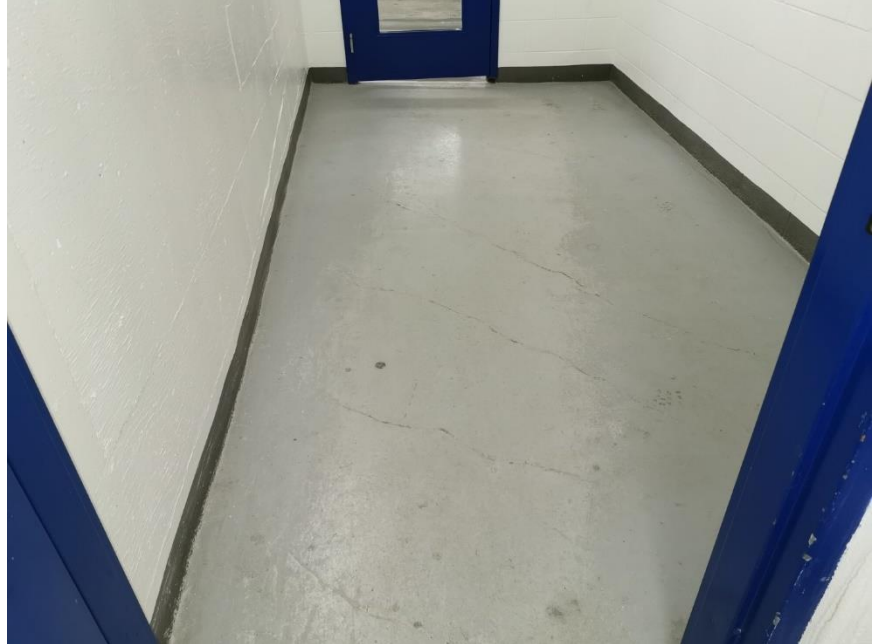
Photograph #23:

Existing coating in stairwell vestibule. Note cracking and apparent concrete delamination visible beneath coating.
