Feasibility Study

MILLENNIUM LIBRARY PARKADE | 201 DONALD STREET

Millennium Library Parkade
201 Donald Street

April 22, 2024

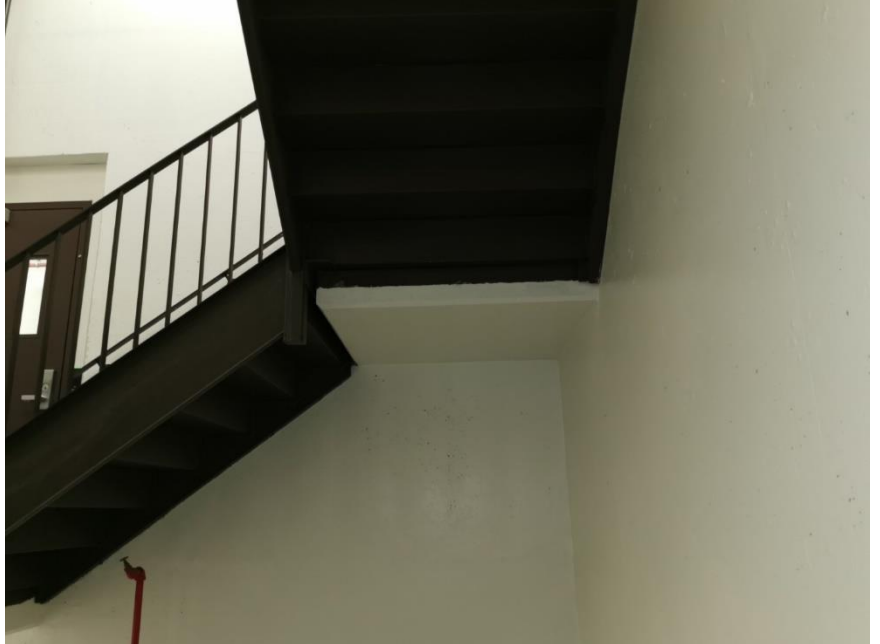
Photograph #25:

Typical condition of structural steel and steel stair pans.

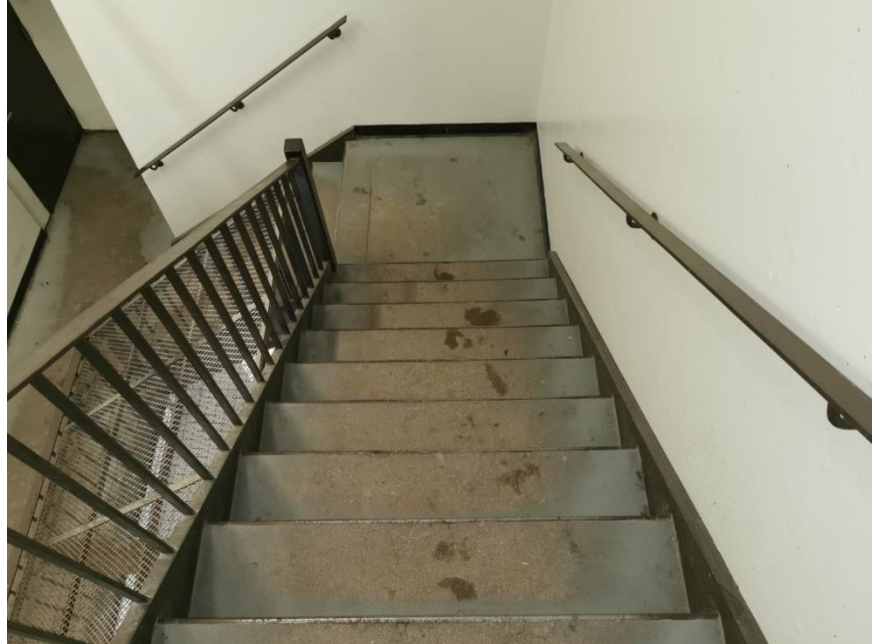
Photograph #27:

Cracking and minor deterioration of treads.

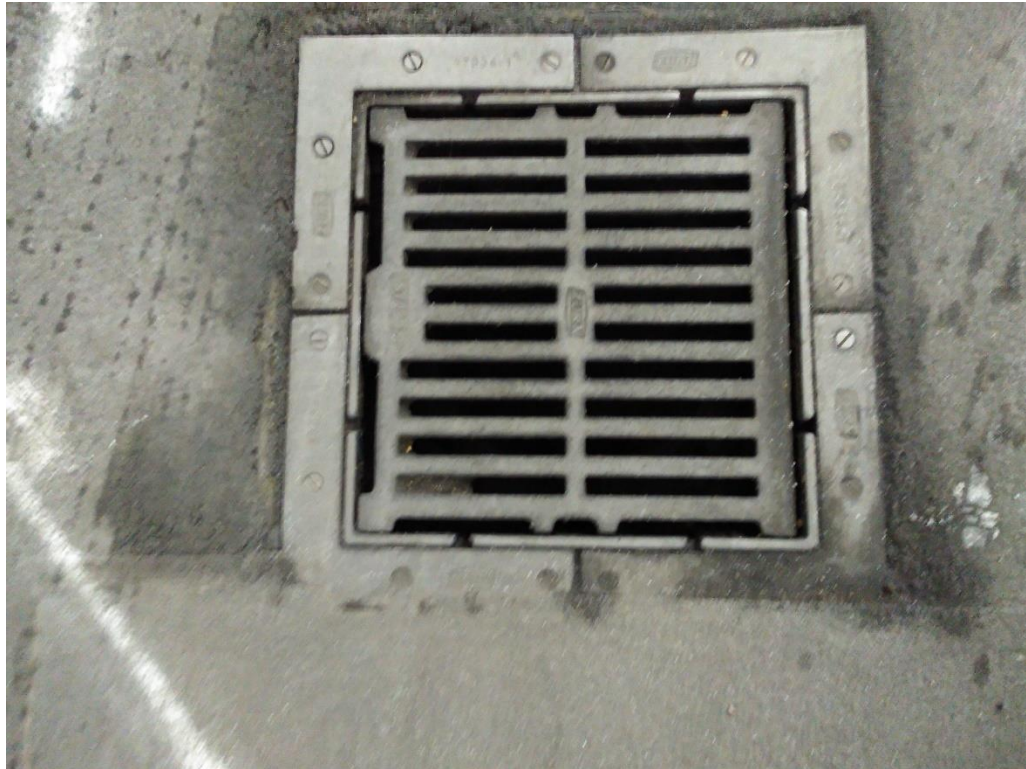
Figure 4: Galvanized drain on upper parkade level.

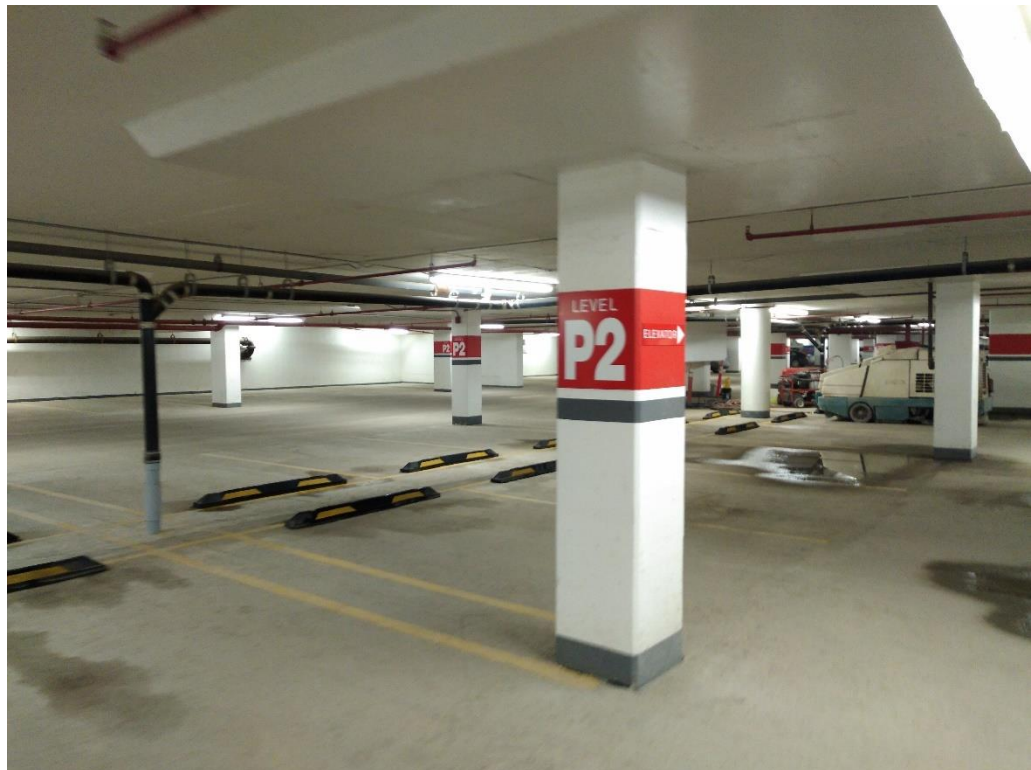
- .4 There is a grit interceptor on the lower level for the carwash. The interceptor is in fair condition and is required by code. No further recommendation.
- .5 The piping below the slab on grade section below appears to be plastic and is expected to have been replaced during the parkade renovation based on record information and section of visible plastic piping extending below the slab. All plastic piping as it passes below the slab is equipped with expansion joints as required by current plumbing code.

Figure 6: Lower level sanitary piping serving the parkade drainage with plastic piping passing below grade.

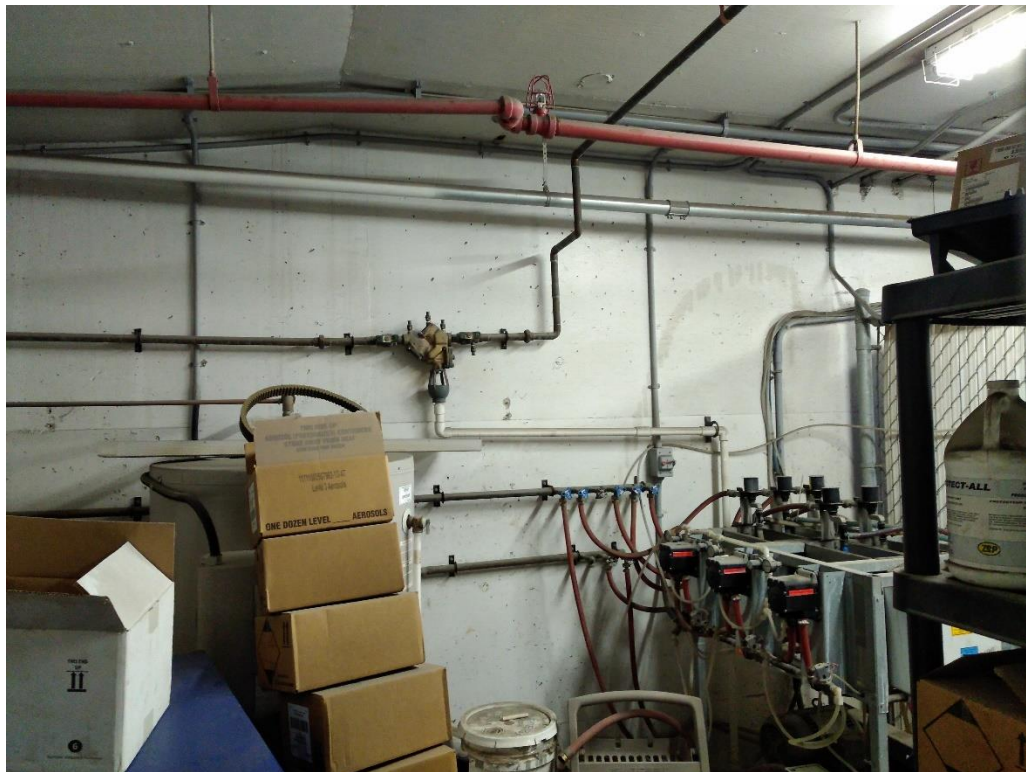
- .1 The domestic water system serves hose bibbs, the one washroom and the car wash on the parkade levels. There is other processes that use domestic water like “emptyful”, but it is not within the scope of this report.
- .2 The domestic water piping is believed to be mostly original to the facility. The insulation is in poor condition. The piping looks to be mostly copper and is within the service life of 80 years. It is recommended to replace the insulation to prevent condensation and possible mould growth.
- .3 The carwash area has a dedicated hot water tank which was replaced in 2017. The pumps for the high-pressure wash system are roughly 10 years old according to facility staff and would be nearing the end of their expected service life of 14 years. The pumps appear in fair condition and should be slated for replacement in coming years.

Figure 8: High pressure car wash pumps and dedicated hot water tank.

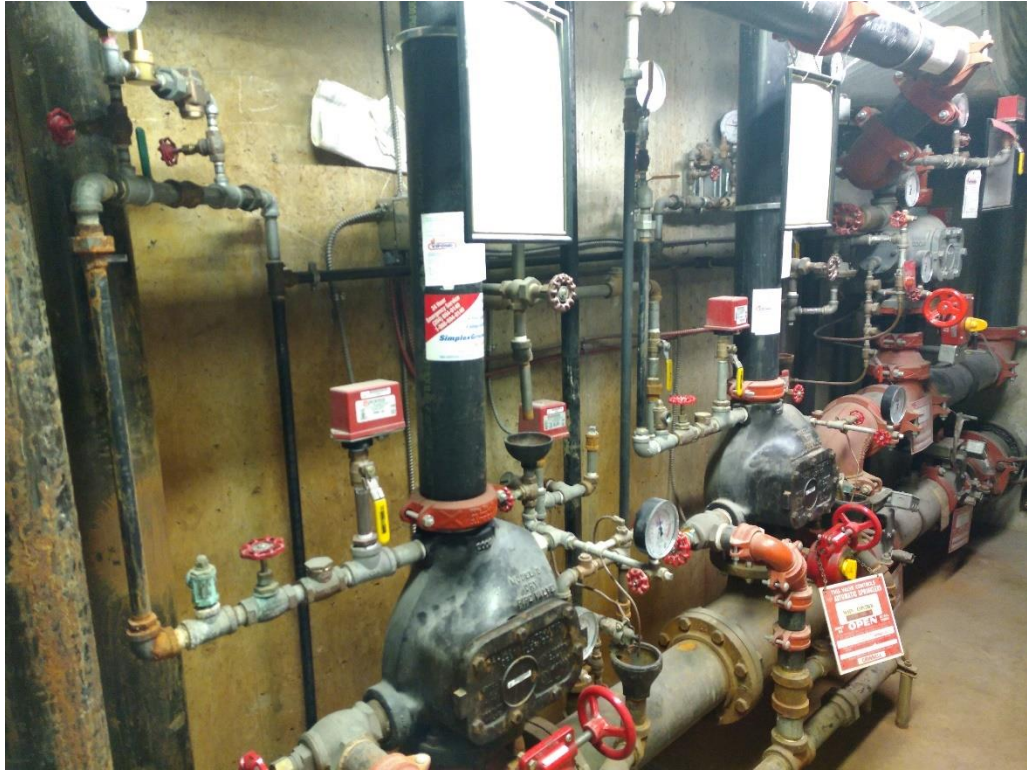
Figure 11: Sprinkler Header in Northeast service entrance room.

- .3 The header in the Northeast corner has three dry zones. The two zones are for the P1 and P2 north zones and the third is for the main floor dry zone.
- .4 The header which serves the south portion of the parkade is located on the Donald Street side in the Southwest corner of the upper level. The boiler system for the ramp heating is also installed in this room. The water service entrance comes from the level below. The vintage appears to be the same as the Northeast sprinkler system and would have the same recommendations.

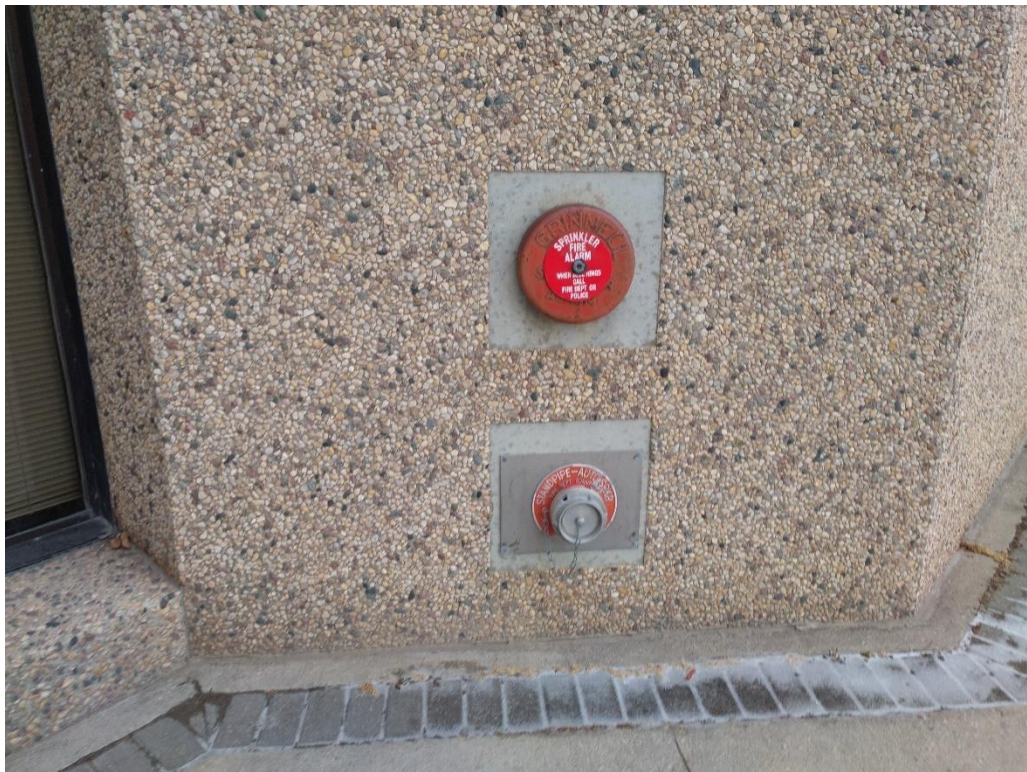
- .7 The fire department connection is in a pedestal on Donald Street near Graham. There is a second fire department connection for the Library located on the building at the corner of Graham Avenue and Smith Street.

Figure 13: Fire department connection on building face.

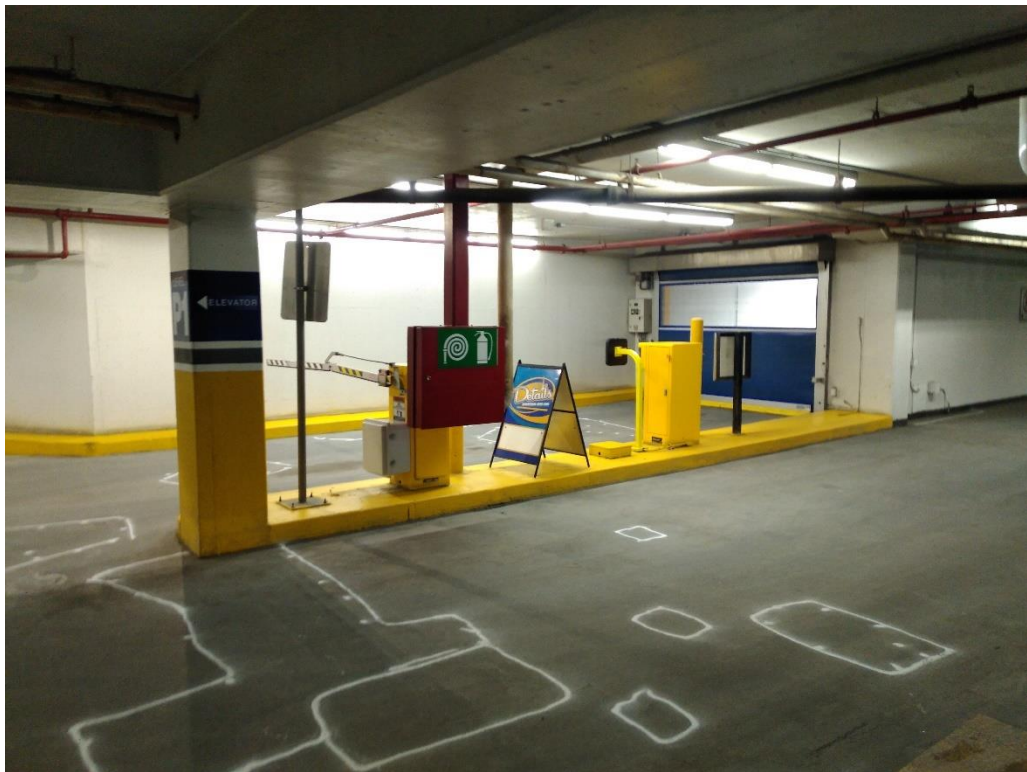
- .1 The stairwells have a wet standpipe system installed at the lowest, intermediate and the upper landing where they open to the plaza level. The standpipe system was installed as part of the renovation project for the library and therefore is within the expected service life of 30 years for a wet sprinkler system.
- .2 There are some additional hose cabinets installed on the upper and lower parkade levels. The cabinets are located roughly on the north end, middle and south end of the parkade and are typically three wide with one on the east, one on the west and one down the centre. These cabinets are in good condition and within the expected service life.

Figure 14: Hose cabinet and fire extinguisher installed as part of renovation project for Library

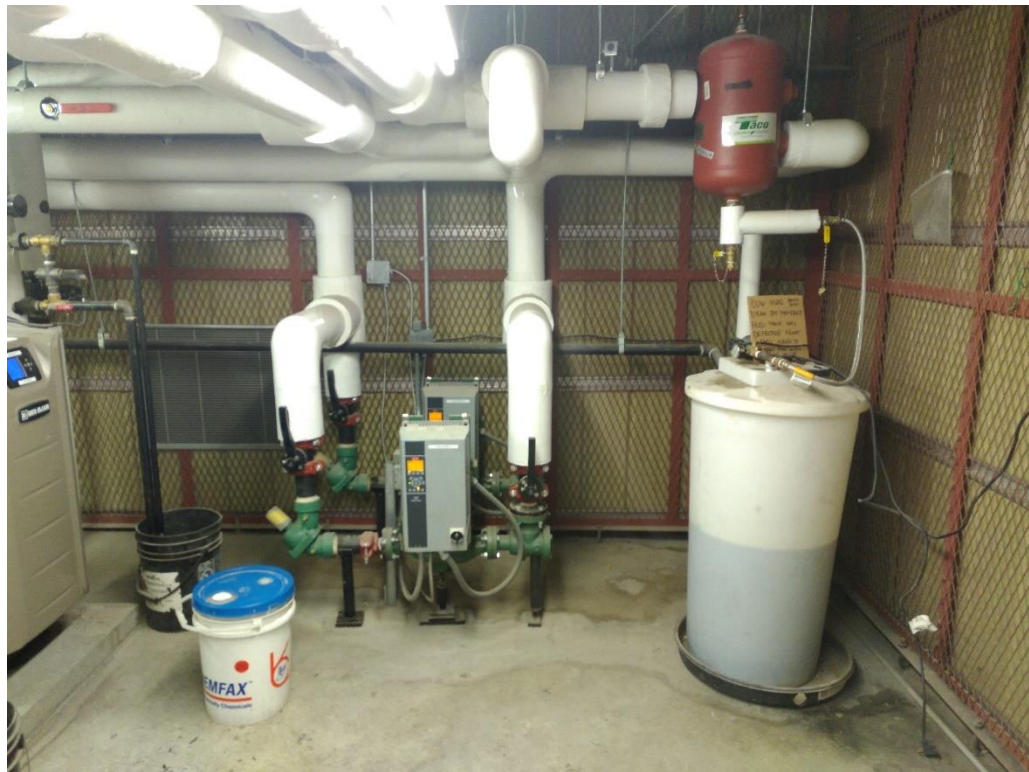
- .3 The boilers are manifolded together with a common circulating pump system and operate in a primary-secondary loop arrangement, the pumps are inline vertical style pumps with sensorless VFD drives. The pumps were installed as part of the modification in 2018, are within the expected service life of 19 years for hydronic pumps, and in good condition.

Figure 16: VFD driven pumps on hydronic system, in-line separator and glycol fill tank

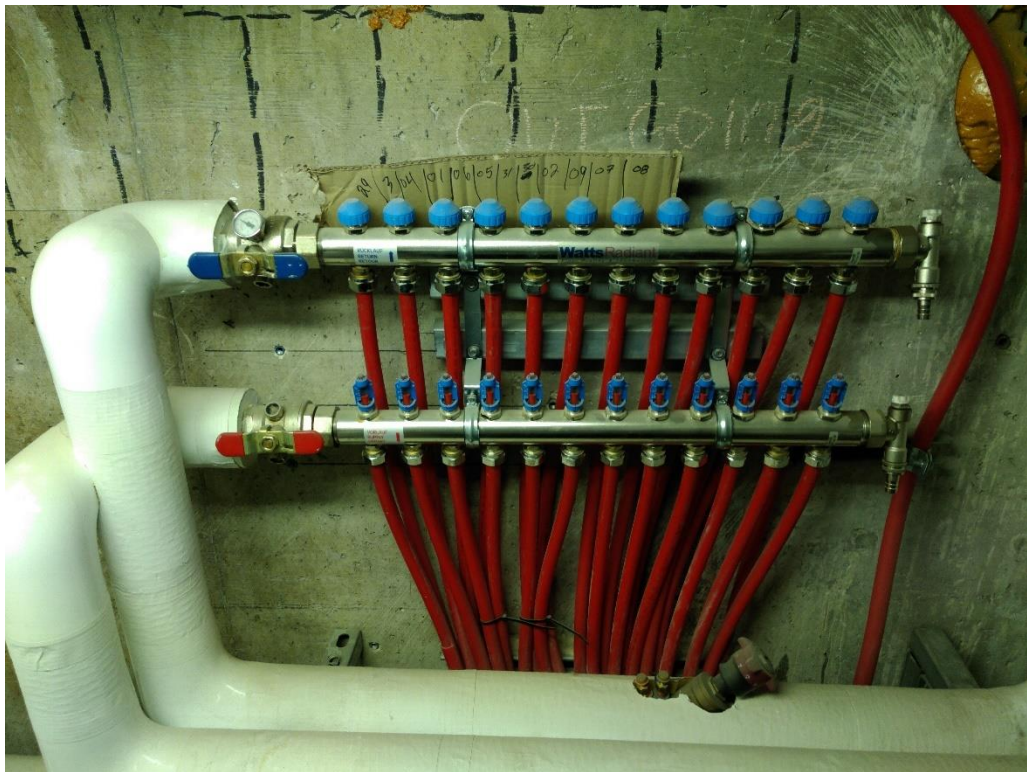
- .4 The hydronic system is equipped with an in-line tangential air separator, glycol fill tank and expansion tank. The pieces of equipment were all installed at the same time as the boiler modification and are in good condition.
- .5 The main hydronic loop connects to two sets of manifolds for the in-ramp heating system. The manifolds are of different material types on the Smith Street side due to the varying ages of installation. One set is brass while the other is stainless steel. Whether or not it was replaced in 2013 or 2018 both are within their expected service life of 25 years and are in good condition. The manifolds for the other side of the facility were both installed in 2018 and are in good condition.

Figure 17: Stainless steel snow melt manifold installed in 2018.

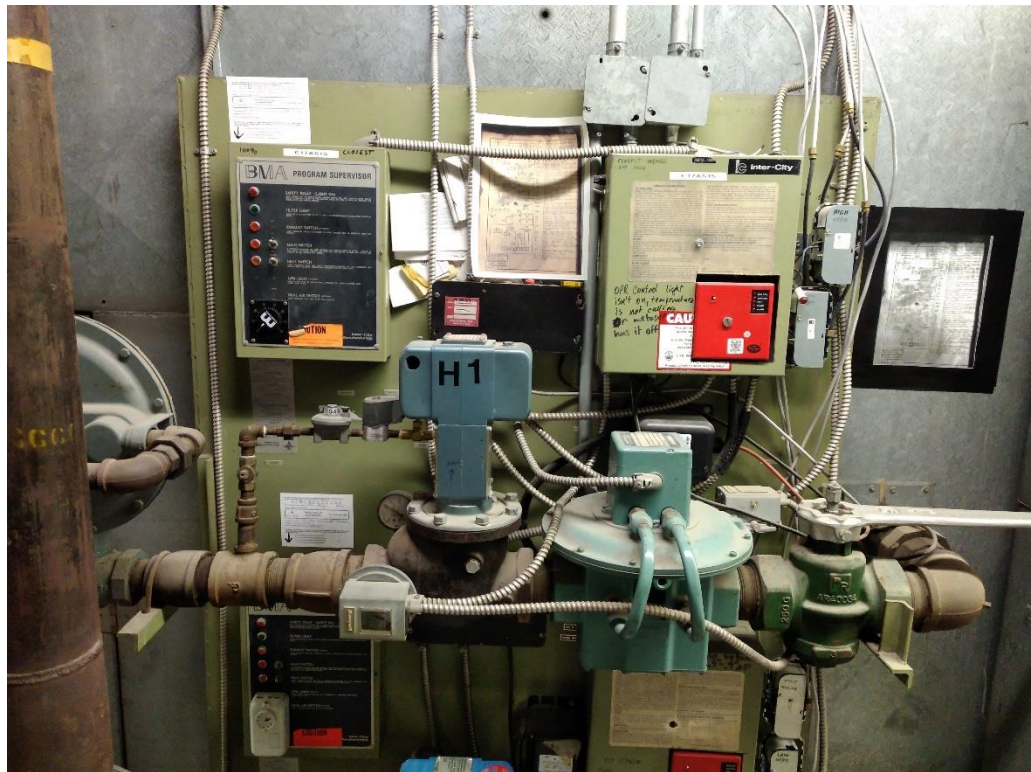
- .3 The original intent of the unit was that on intake temperature of 35 F the first stage heating for glycol heat reclaim and for electric pre-heat would be engaged. When the intake air was below 0F the second stage of glycol heat reclaim and electric heat would be engaged as well as the natural gas burner to raise the temperature. The electric re-heat coils would be controlled based on level temperature and discharge air. The fans are controlled based on timeclocks and CO/NO₂ sensors on each level. SF-1 serves the upper level and SF-2 serves the lower level. Damper arrangements allow for air to be directed to the corresponding level and shut-off if there is only a call from one level.

Figure 20: Natural gas manifold for direct fired burner on make-up air unit

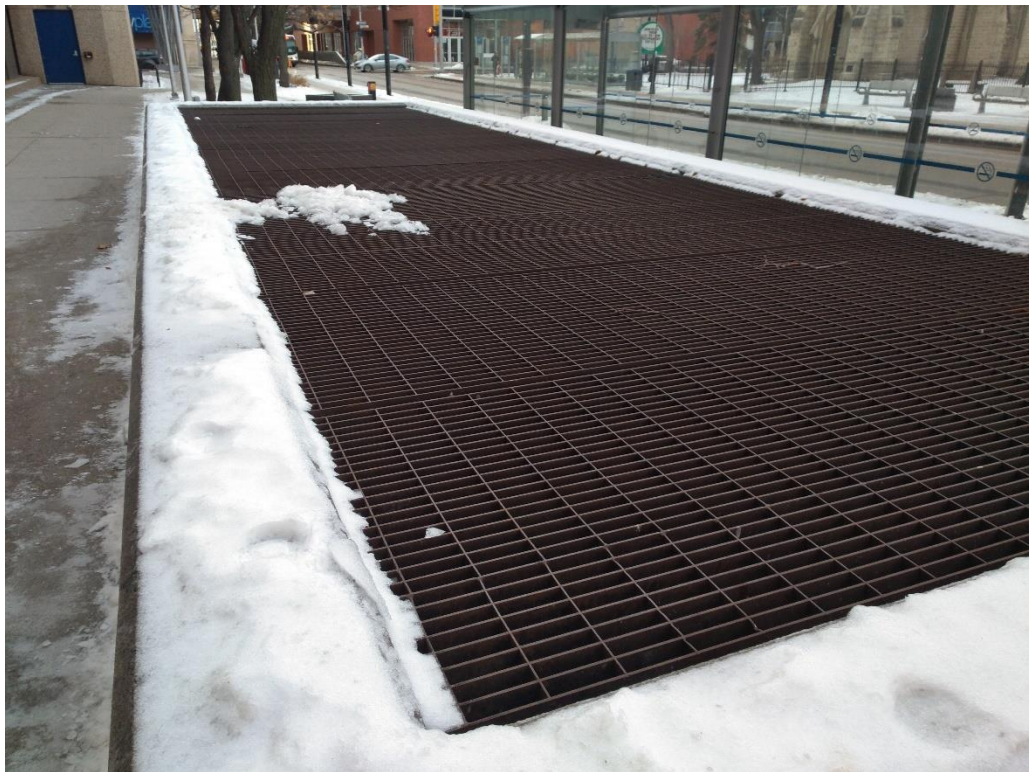
- .1 The intake louver for the make-up air serving the parkade is in an area well on Graham Avenue. The intake is approximately 10 feet from the street and therefore is not an ideal location to pull ventilation air from due the consistent bus traffic on Graham Avenue. It is an existing condition which will remain.

Figure 26: Intake louver for parkade make-up air unit.

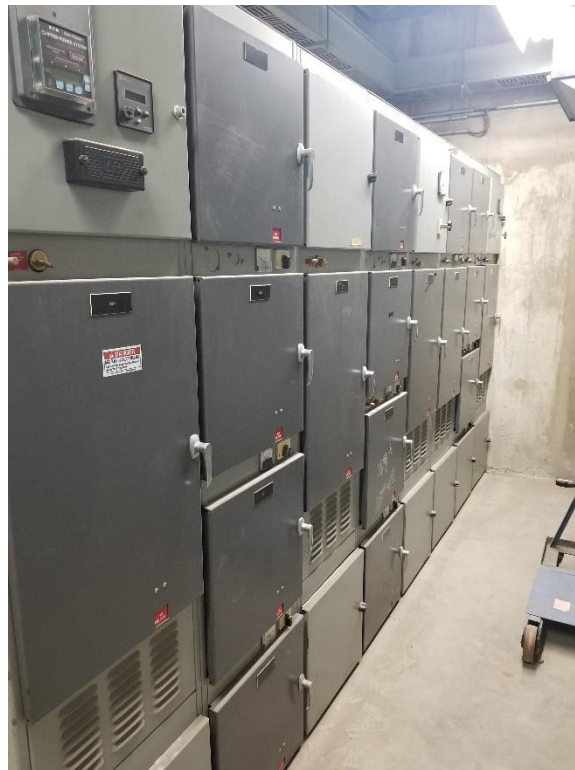
5.3.1 The main electrical distribution is located on level P2. The equipment appears original to the building but is still in fair working condition. Electrical equipment has a normal service life of 35 years. Although the equipment is still functioning, provisions should be made for replacement in the near future.

Figure 30: Part of the main distribution.

- 5.3.2 Additional labelling of equipment and the creation of a single distribution schematic is strongly recommended. The single line should be mounted in the main electrical room under a plexi-glass cover.

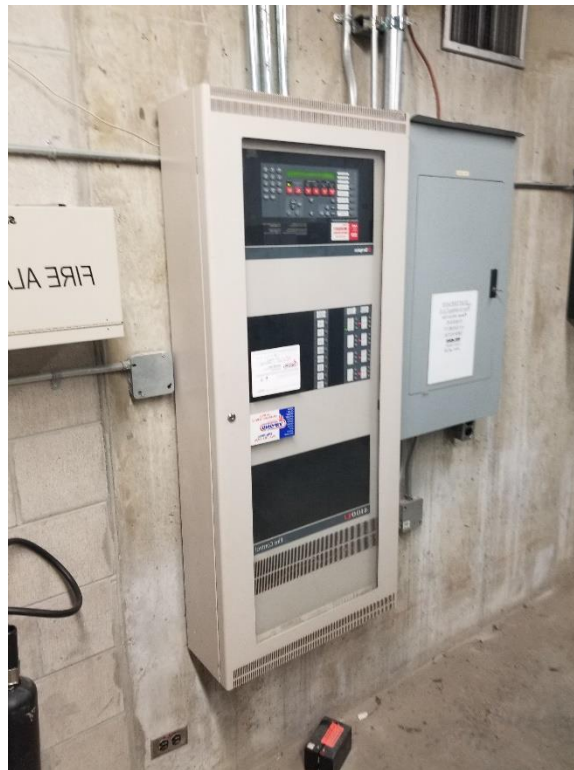
- 5.4.1 The fire alarm system consists of a single stage addressable system and is located in the main electrical room. The existing system manufacturer is Simplex and model is 4100U. Internal batteries provide power to the fire alarm panel during power outages. The initiating devices consist of smoke detectors, heat detectors, monitoring devices (flow, supervisory, tamper) and pull stations. Annunciation devices consist of horns and combination horn strobes. The notification devices are all horns with no strobes. The fire alarm system is monitored by a third-party agency.

Figure 34: Main fire alarm panel

5.4.2 The fire alarm system is in fair to good condition and meets NBC fire alarm code requirements. The system does not have strobe devices which are now required by code for new construction, but as this system was installed prior to this code requirement was adopted, the system is grandfathered, and upgrades are not required at this time. When the fire alarm system is replaced, strobes will need to be added throughout the parkade. Based on the latest verification report, the system is still functional. It is recommended that it be upgraded/udated in the next 1-5 years. Strobes could be added to the system at that time and the system would be ready for the next expected service life.
